Opportunities for Improvement Green River Panels August 2008

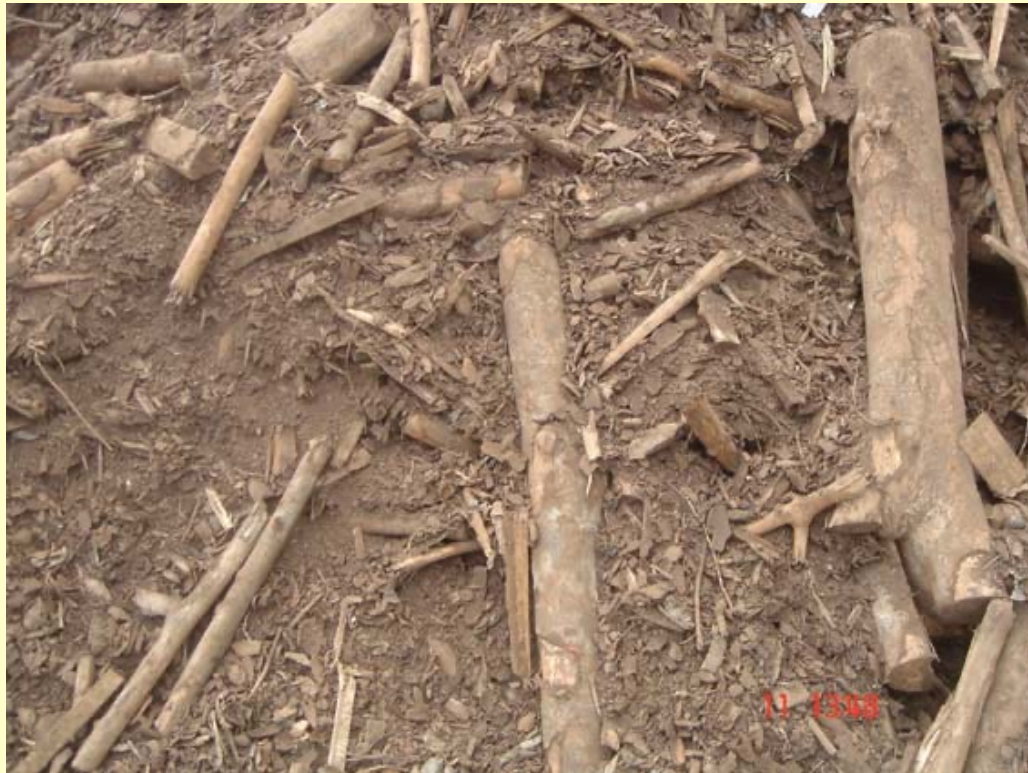
- Dirty raw material
 - Too much dirt is getting into process and causing excessive wear on flaker mill knives & wear plates

Grit in particleboard causes machinability problems once laminated.

It also results in poor quality flake (see over)

It must be eliminated

- The logyard should be kept cleaner to minimise dirt coming into process
- Chip disc screens are under capacity and a lot of good quality furnish is being wasted
- Flaker mills;
 - New wear plates & increase knife projections to 1.0mm
 - Collect data time knife change +0, +3, +6 & +9hrs for me to do an analysis on correct knife changing protocols and PAL flake screen configuration
- Reconfigure PAL flake screens to correctly balance core: surface and remove dust & grit on basis of above I will provide advice on screen sizes

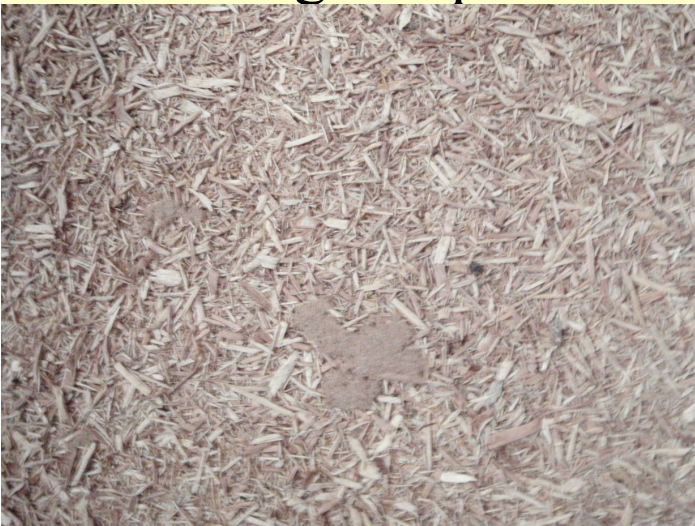
Poor flake geometry is having a negative effect on MOR property.

Difficult to maintain consistent core to surface flake ratio

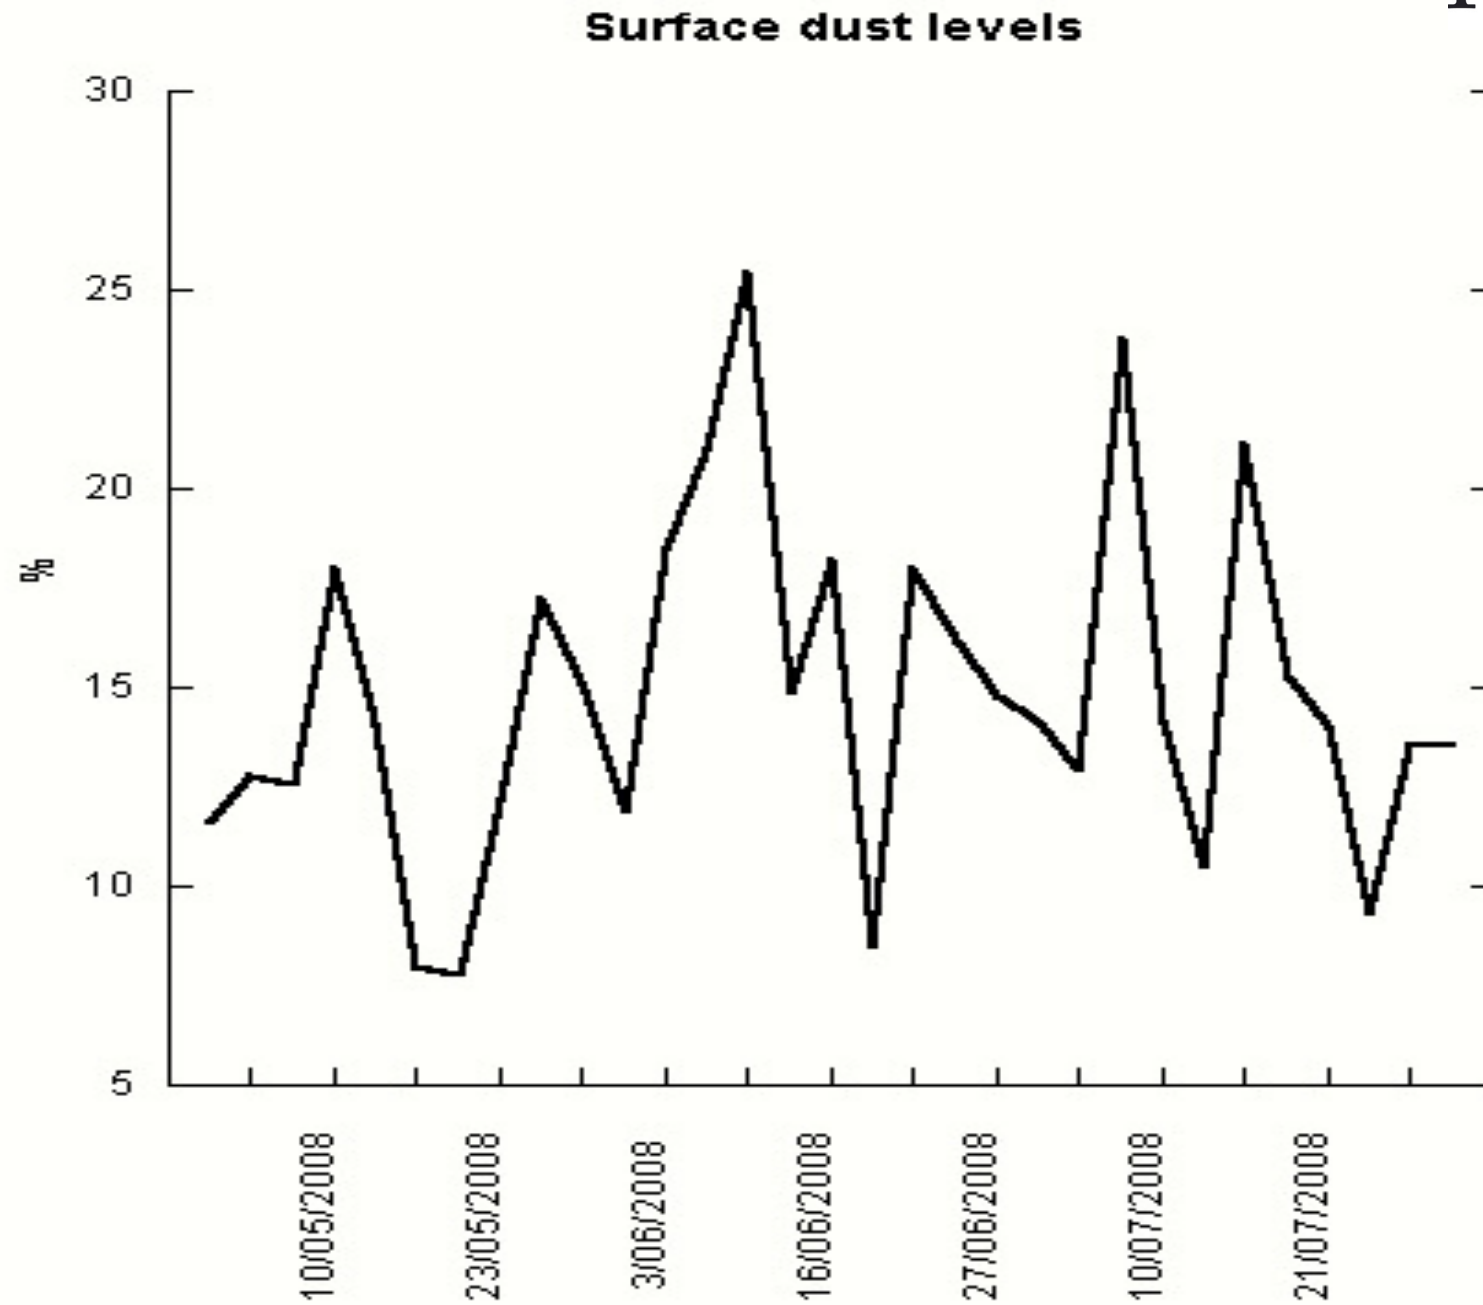
Core fines

- Flake quality at the blenders:
 - Ex flakers >4mm fraction can vary between 5% - 68% within 12 hrs.
 - Ex screens dust in surface can vary between 0 - 5%
 - Amount of surface flake in core fraction varies between 0-20%
 - This leads to excessive fines in core leading to excessive resin usage and low bending strength and lack of surface material.
 - This can also result in excessive dust in surface which causes dust and glue spots.

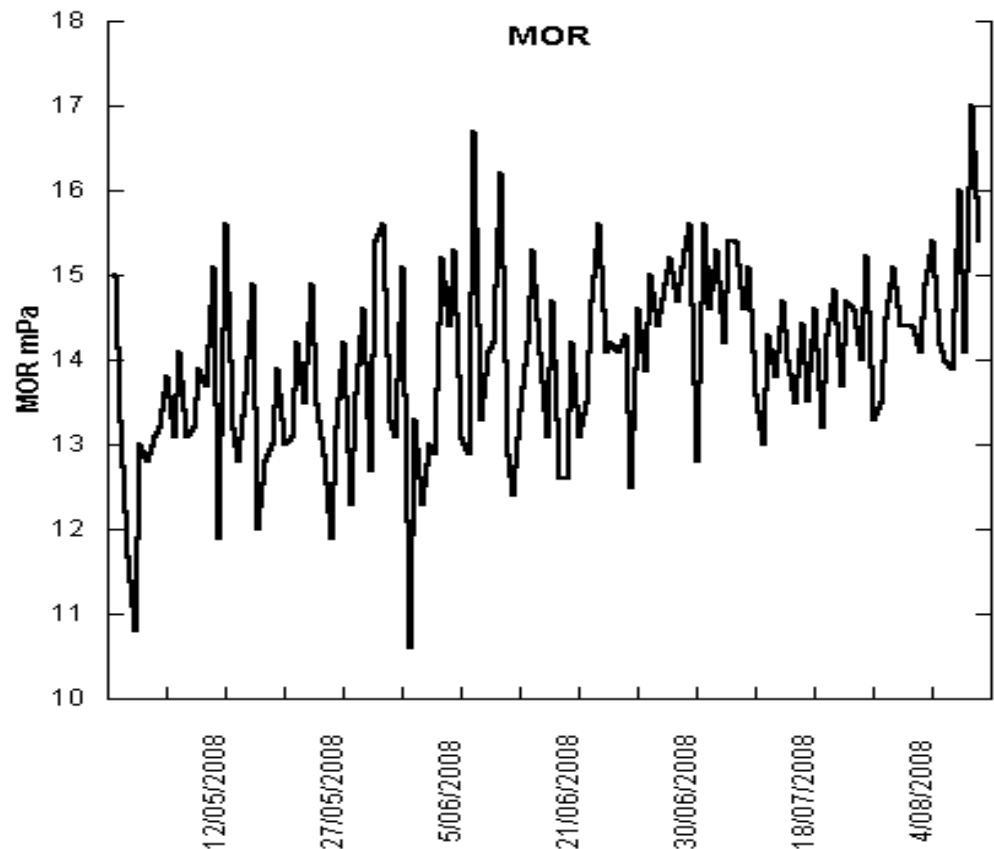
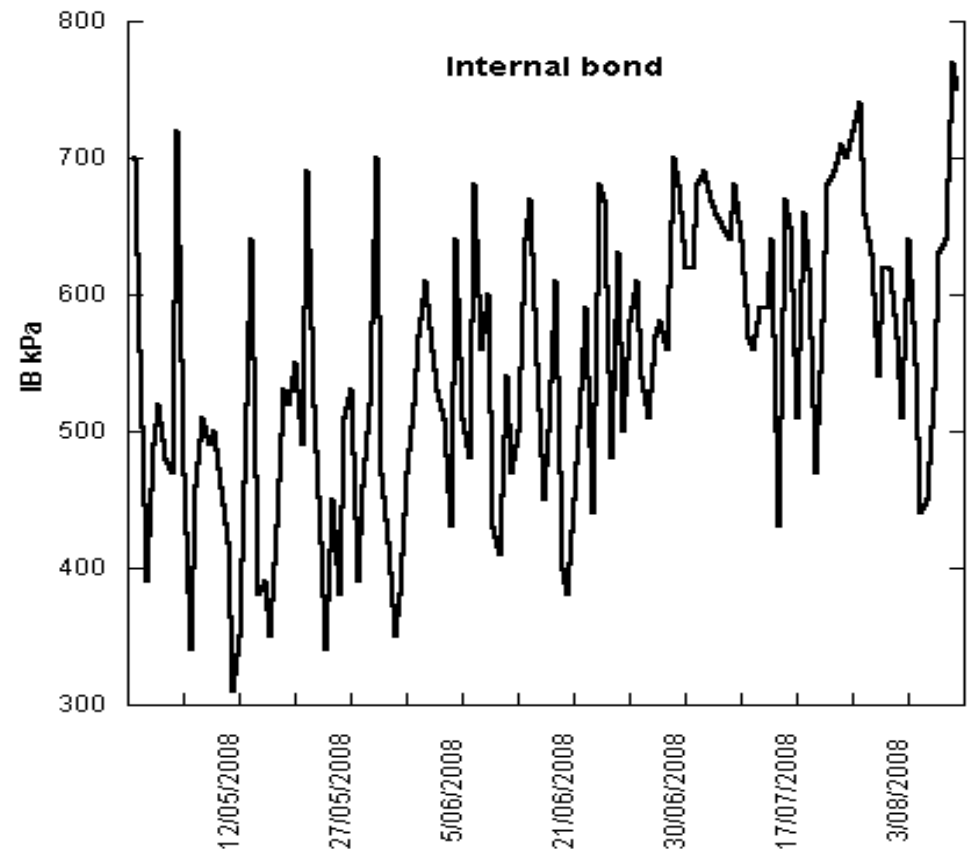
- Board properties exhibit too much variability:
 - IB's are generally acceptable, even too high
 - MOR's are generally borderline.
 - This is due to poor flake geometry
