Report on Consultation Work for Rexcel C.V., Zitacuaro October 2007

Raymond J. Roberts

Abstract. This report details observations on the plant inspection carried out over three weeks in October 2007. It lists the major problems, and gives short and long term recommendations.

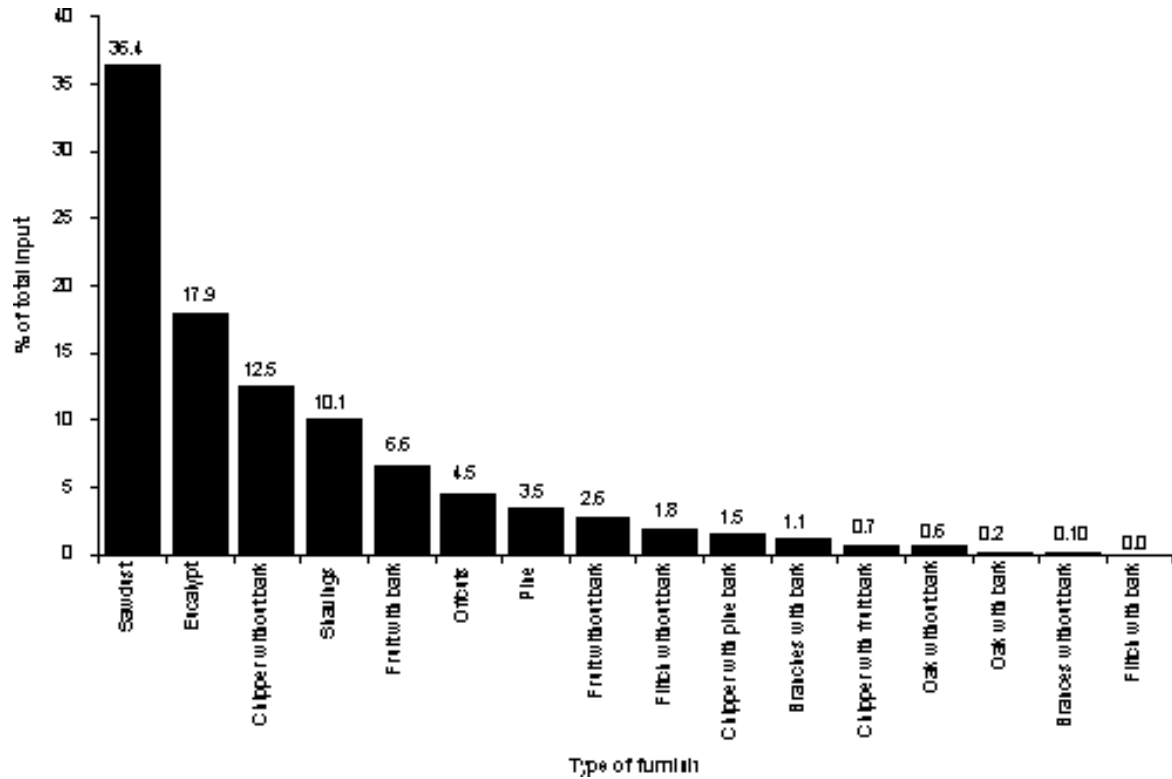
Figure 1. The furnish mix for the particleboard plant

Figure 1 shows the makeup of the furnish for the plant. Of the total input 11% comes in with bark on. This is unacceptable and the allowable bark specification will be talked about later, however as a matter of course, no material should come in with bark on. It was noted that the fruit tree roundwood did not have the bark removed (Figure 2). Bark in particleboard will cause problems with reduction in the physical strength properties as well as the quality of the surface. Bark does not resinate well and tends to chip out of the surface during sanding which results in a poor quality board for laminating. A bark content specification should be set up so that furnish contains no more than 0.05% bark.

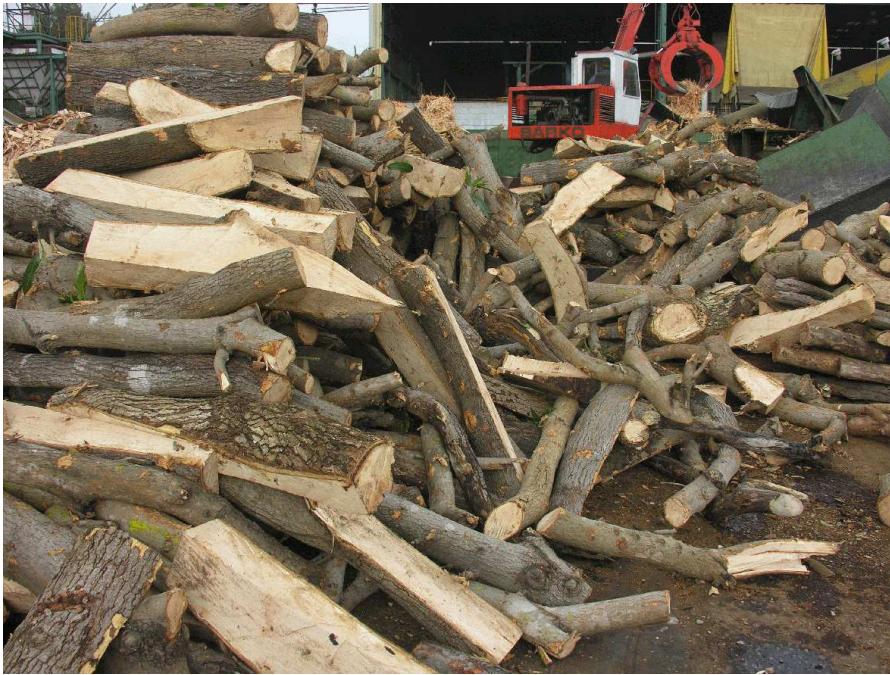
Figure 2. The roundwood sourced from fruit trees has got the bark on.

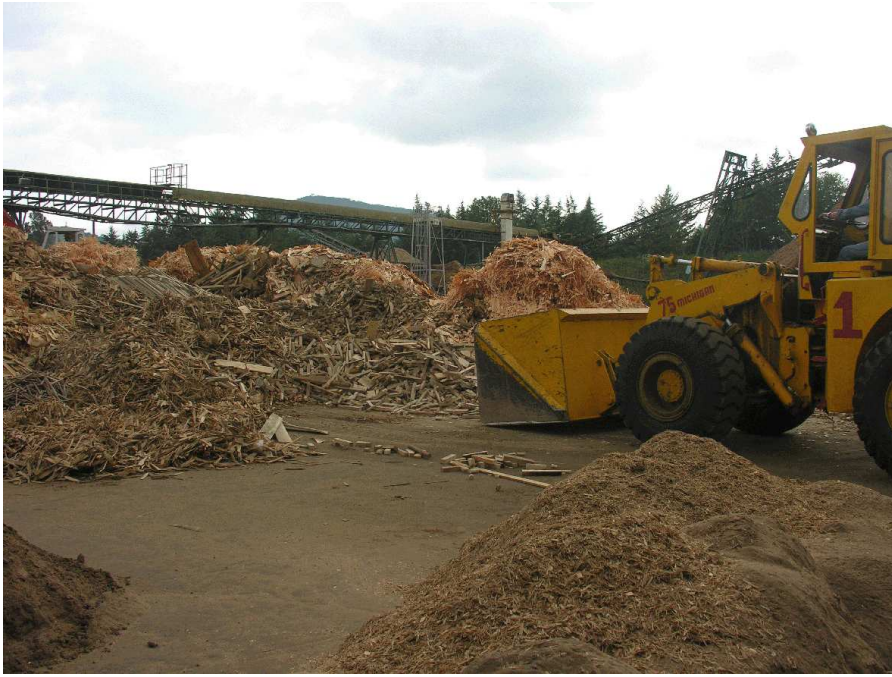
A factor noted above is that the furnish raw material contains large amounts of dirt. The log yard area is very dirty and this is swept into reclaimers (Figures 3 & 4). Figure 5 shows the amount of dirt coming in with furnish from external suppliers. The effect of dirt from external suppliers on the chip furnish about to be sent to the PZ mills is clearly seen in Figure 6. Not only does this cause problems with machinability as will be shown later, it also increases the need to change the knives in the PZ ring mill flaker as previously discussed. The dust material also contains the bulk of the grit which is 1.3% of the total of the surface flake which is which is nearly two orders of magnitude of what it should be i.e. $< 0.05\%$. Most plants in Australia have grit specifications of $< 0.05\%$ and actual results of 0.003 - 0.008% so there is a long way to go for the Rexcel plant at Zitacuaro (Figure 7). Interestingly the size of the sample required to obtain enough grit to put through the sieves was 1000g yielding 13g of grit which gives the exact percentage of the original grit analyses conducted. When considered as an 8 x 4 foot 16mm board, with a 55% surface ratio and 45% core ratio, there is 19.8kgs of surface in such a board. At 1.3% ash this yields 257g of ash per board. i.e. nearly $86\text{g}/\text{m}^2$. Figure 7 shows that the proposed 0.4mm dust screens will remove about 90% of the grit however it is the larger fraction of the grit that creates the most problems for customers. One of the recommendations from this report is that furnish contains no more than 0.01% grit, and that the logyard is regularly cleaned of mud and dirt and that the surface flake is passed through the air sifter currently used to remove metal from the core flake to remove the larger fractions of the grit that the flake classifiers will not.

Figure 3. Loader sweeping furnish and dirt into a reclaimer

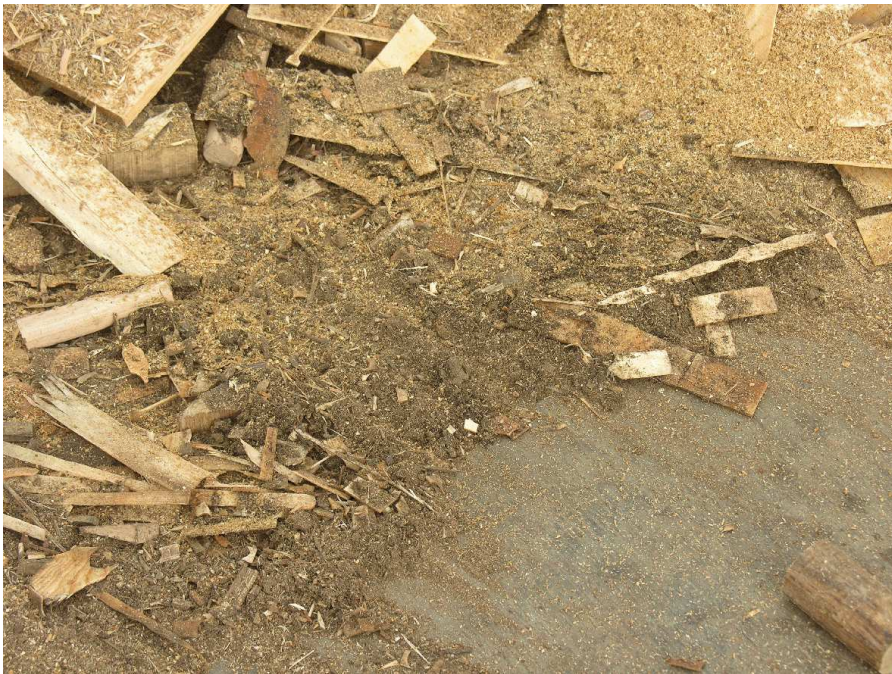
Figure 4. Close up image of the dirt in the furnish being swept into the reclaimer by the loader

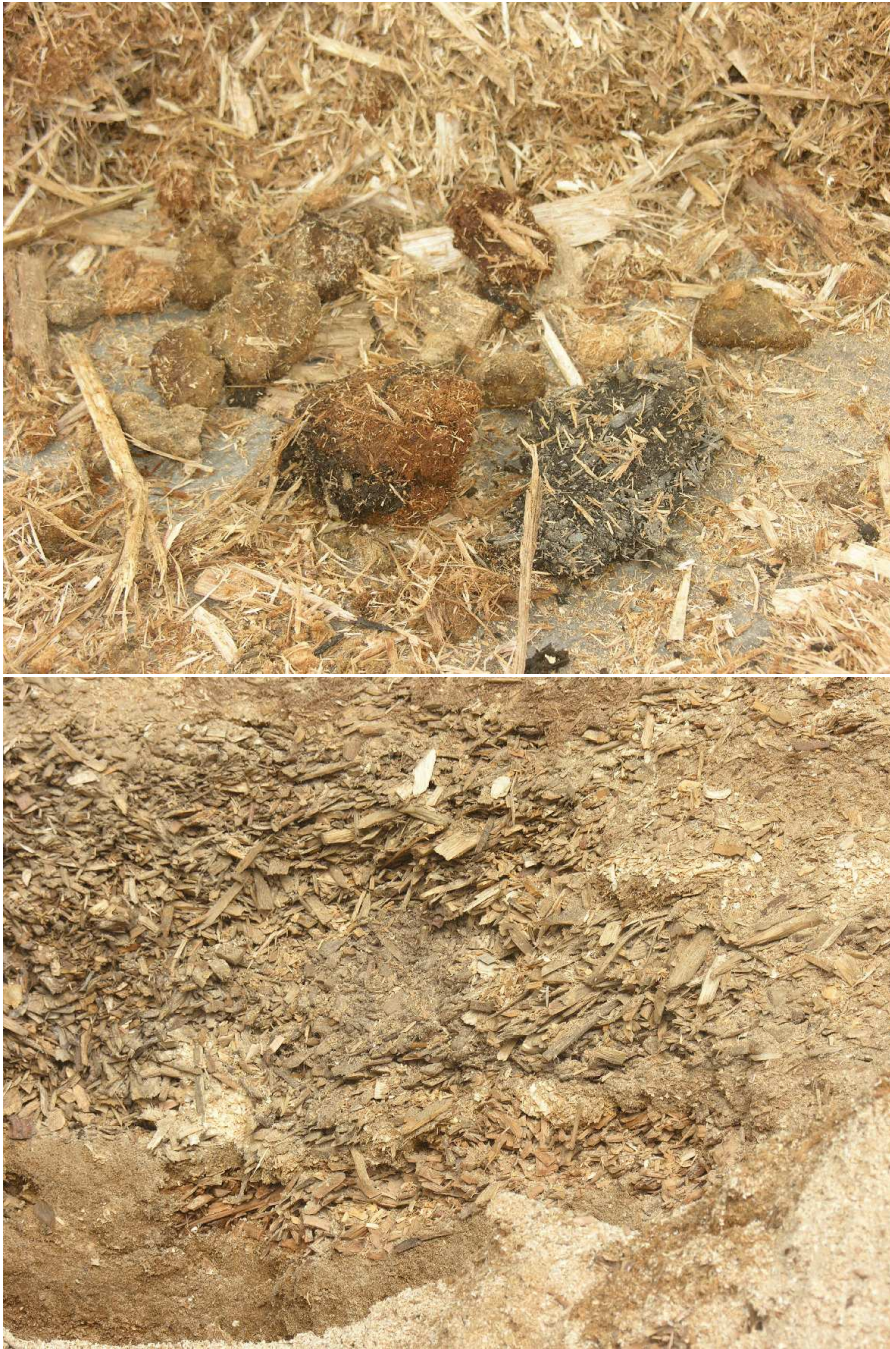
Figure 5. Dirt in the furnish from external suppliers

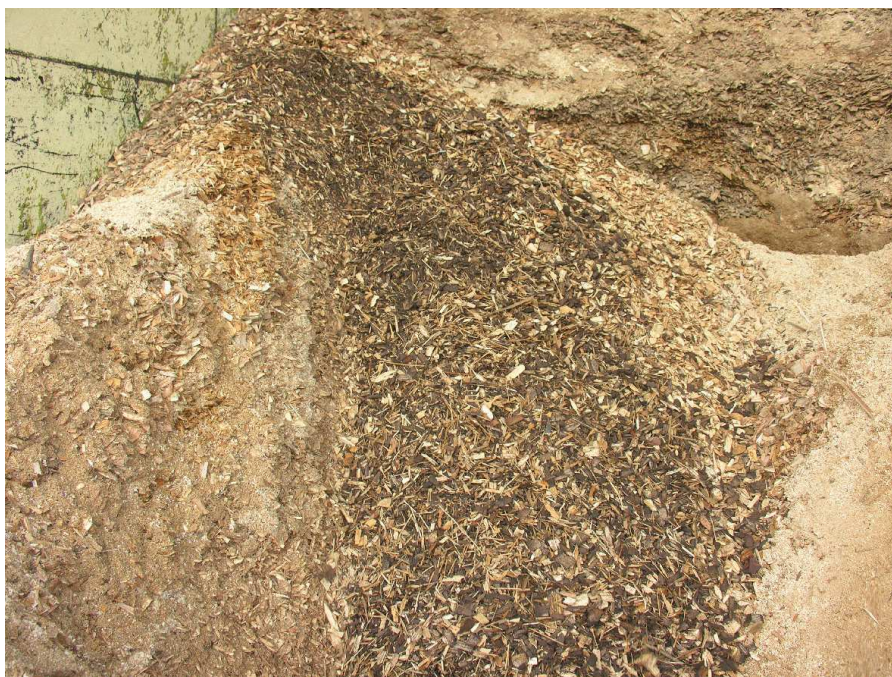
Figure 6. The effect of dirt on the chip furnish for the flakers.

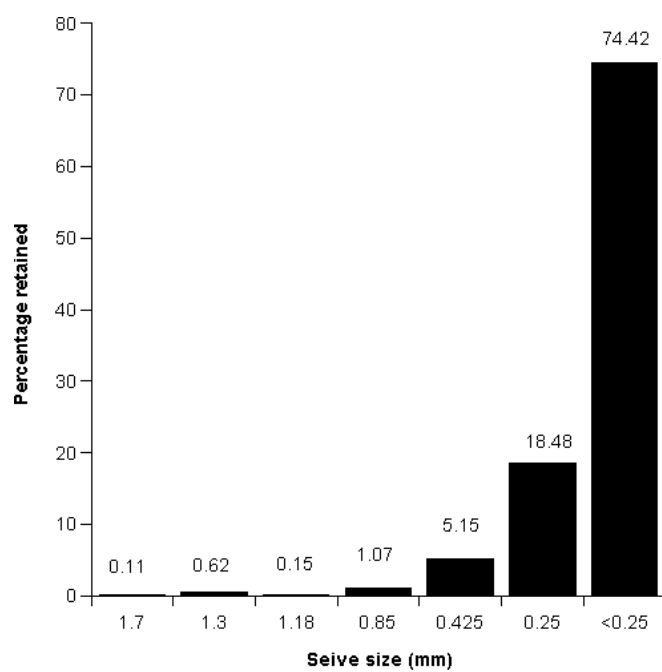
Figure 7. A sieve analysis of grit from surface flake

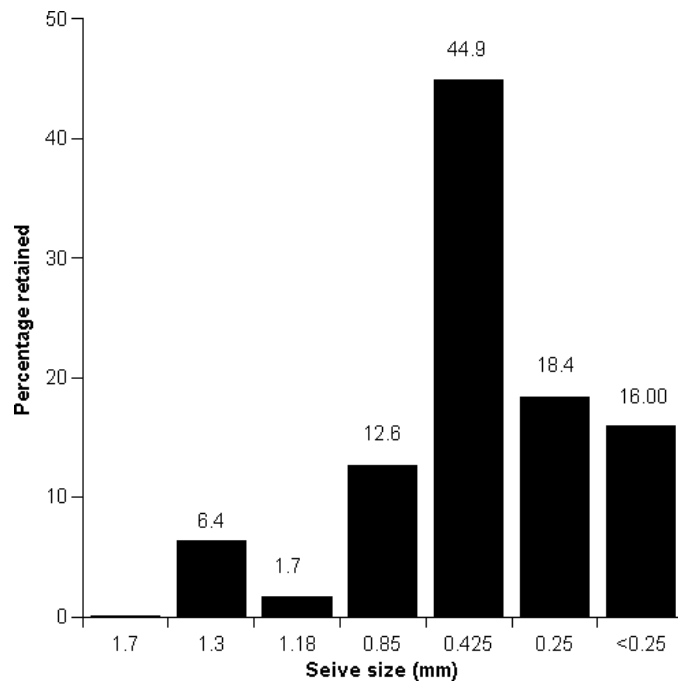
Figure 9. Analysis of surface flake before blending.

2. The second most significant problem is the amount of dust material in the surface flake. Figure 9 shows that an extraordinary 36.5% of the surface flake is $< 0.4\text{mm}$ and would be considered dust. This material is classified as being $< 0.4\text{mm}$ and does nothing for the strength of the surface. It in fact consumes most of the resin in the surface resulting in a poor resin distribution on the higher quality flake. This results in the surface of the board being of very low strength which results in removal of flake from the surface during sanding causing pinholes which leads to another major problem of the site, white-spots. It also means that as the surface has such low strength it has very poor machinability characteristics.

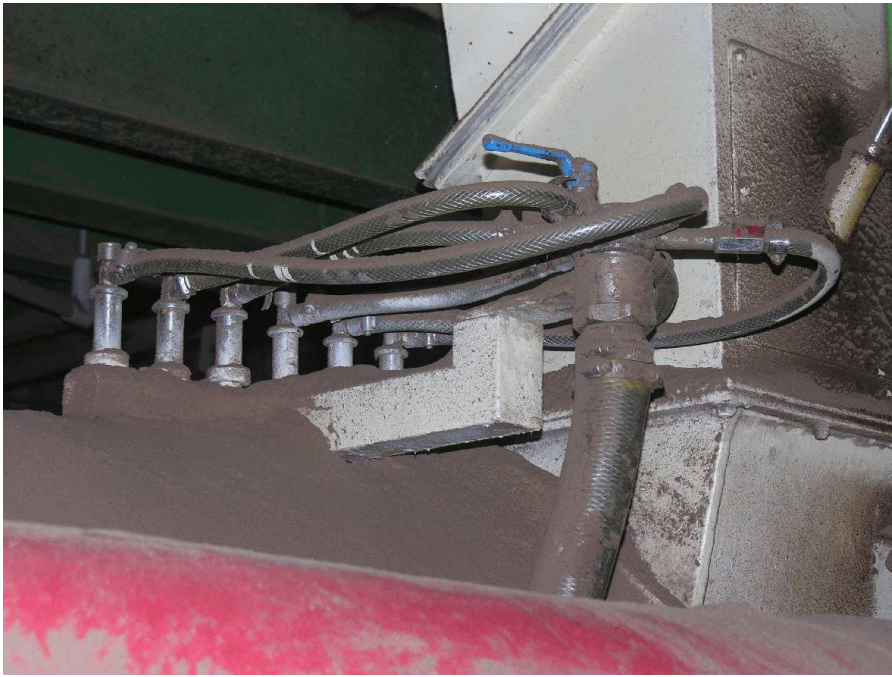
In the surface blender wax was added to the drop chute and the resins injected separately(Figure 13) . It is again recommended that static inline mixers be used to mix wax and resin prior to injection. It is also recommended that surface water makeup be added in the drop chute. This will become very important at the next visit when surfactants are going to be added in my patented method to improve machinability. An interesting feature which will be referred to later is the addition of dust ($<0.356\text{mm}$) back into the surface flake stream in a secondary surface blender (Figure 15). It will be recommended that water be added in the flake drop chute and that the wax and resin are mixed in a static inline mixer and added together.

Figure 13. Configuration of the injection nozzles on the surface blender

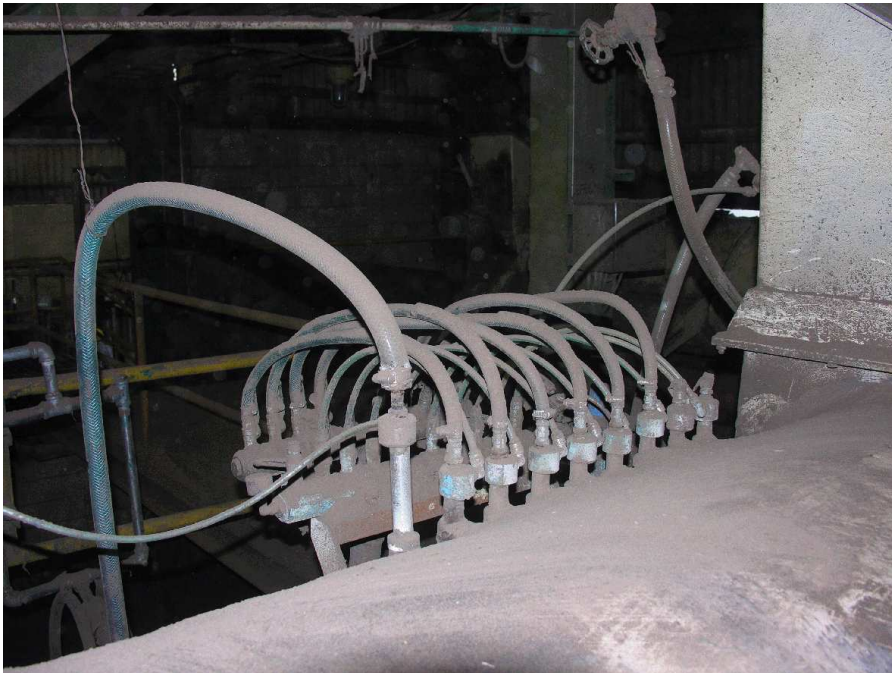
Figure 14. Configuration of the injection nozzles on the core blender

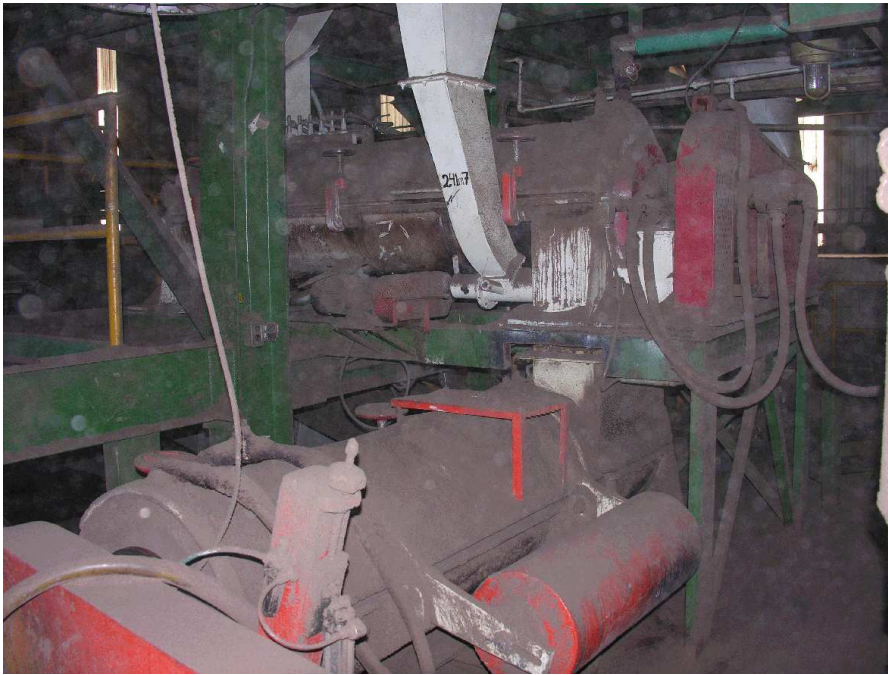
Figure 15. Configuration of the dust blender after the standard surface blender, note no injection nozzles.

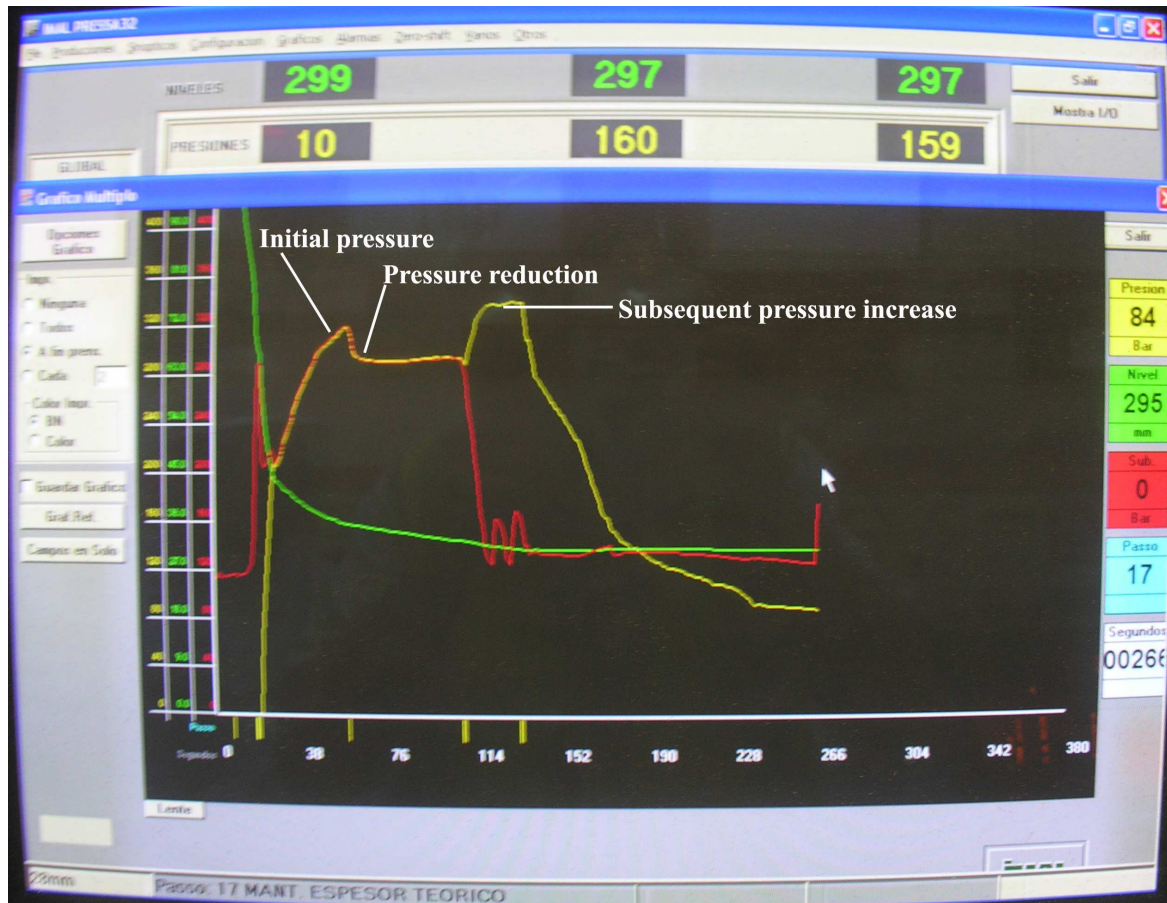
Figure 16. Press cycle showing pressure reduction after maximum pressure reached followed by a subsequent increase in pressure

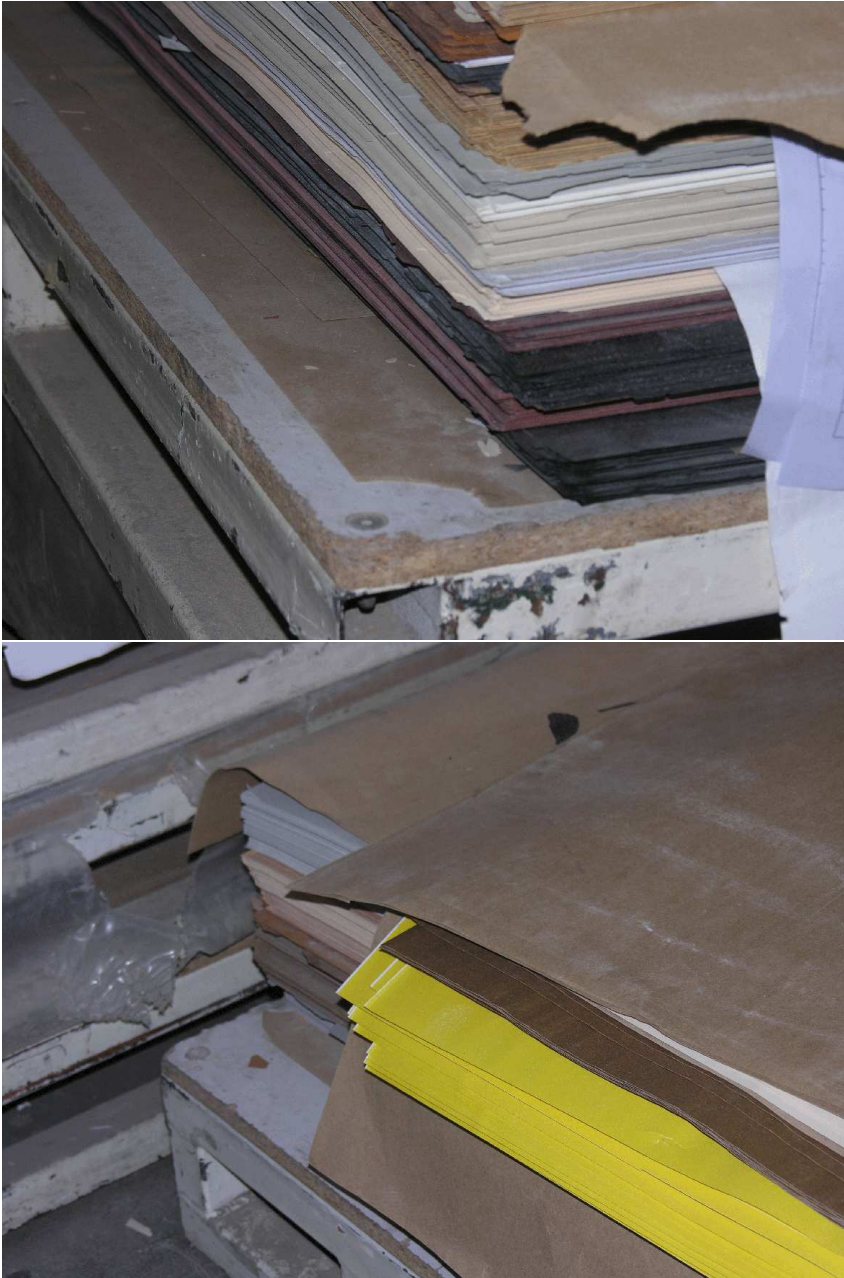
Stacking of the treated paper ex the treater was very poor, and would result in a large amount of paper chips occurring during lay-up. It is critically important that operators monitor stacking for the first 50mm of the stack to ensure a bookend finish on all edges of the pallet. If this is not achieved the whole pallet will exhibit poor stacking which will result in paper chips and torn paper lay-up. In fact paper chips caused by poor paper stacking are in the top five paper defects. Figure 18 clearly show the problem of poor stacking. The new Mt Gambier type of book end should be used which is fully earthed to the body of the treater (Figure 19). Another reason stacking ex the treater is so poor is that operators are using the internet rather than adjusting the stacking.

Figure 18. Images showing very poor stacking that will result in paper chips during lay-up

up to reverse the papers and this is done by hand. the way to solve this is to have a bottom pallet board and put down a large sheet of plastic that wraps the pallet of treated paper and can be reused. At the completion of the pallet, if the pallet is to be turned over put a top pallet board onto the treated paper after wrapping up the plastic and strap the pallet tightly. The pallet can then be turned over without ruining the quality of the stacking. Manual turning should not occur. In addition it appears as though rainbow packs are made by hand. When changing papers at laminating it is important not to make up mixed treated paper pallets but to change complete pallets i.e. handle the treated paper pallets as little as possible so as not to damage stacking. After the problem was demonstrated stacking improved significantly (Figure 20) however the problem of manual handling after treating must be dealt with. Bookends were produced locally and stacking is now acceptable however there is still too much manual handling of paper and this should be eliminated.

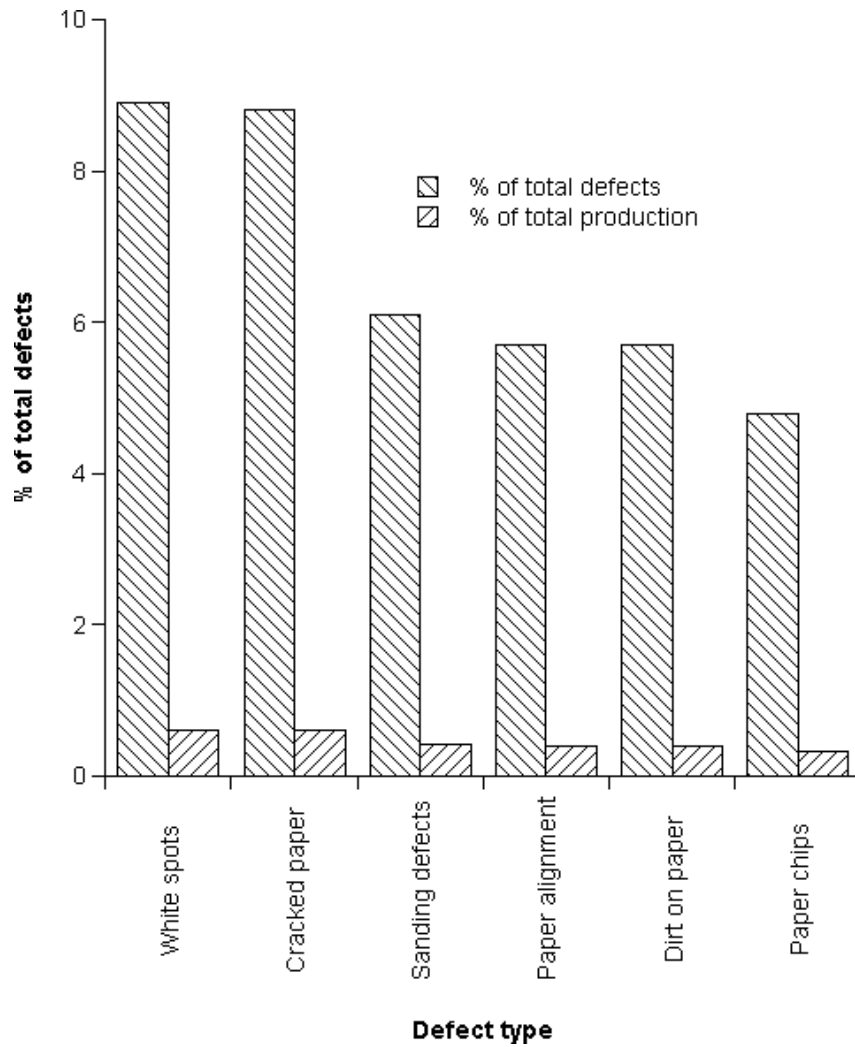
Figure 21 shows the laminating defects. The graph is self explanatory however white spots in dark colored laminates caused by pinholes in the particleboard substrate are the major cause of defect followed by cracked paper, poor sanded surface, paper alignment, dirt, and paper chips caused by very poor stacking.

Figure 21. Chart of LPM defects at Rexcel showing defects as a proportion of total production and as related to total defects

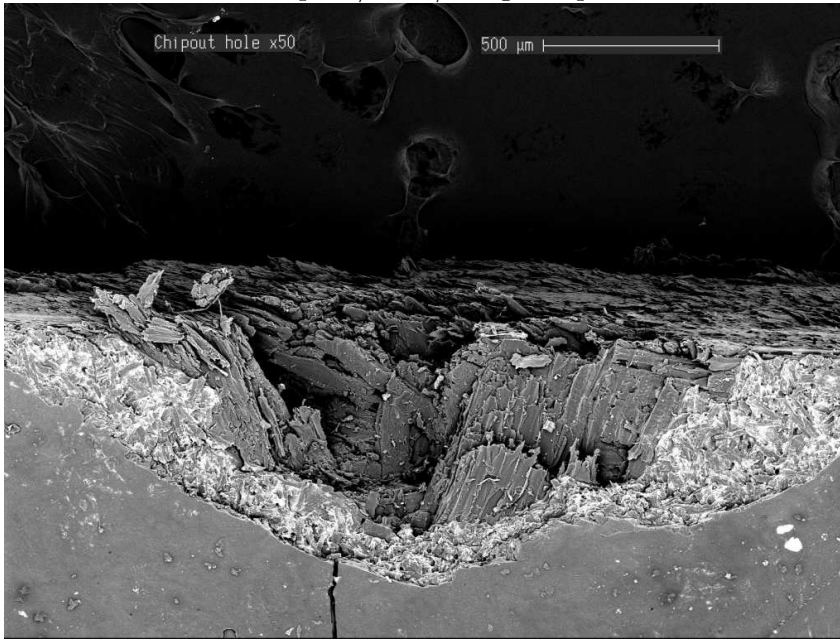
Chipout/SEM/Image60.eps

Figure 22. Scanning electron microscopy image x50 of the void caused by chipout.

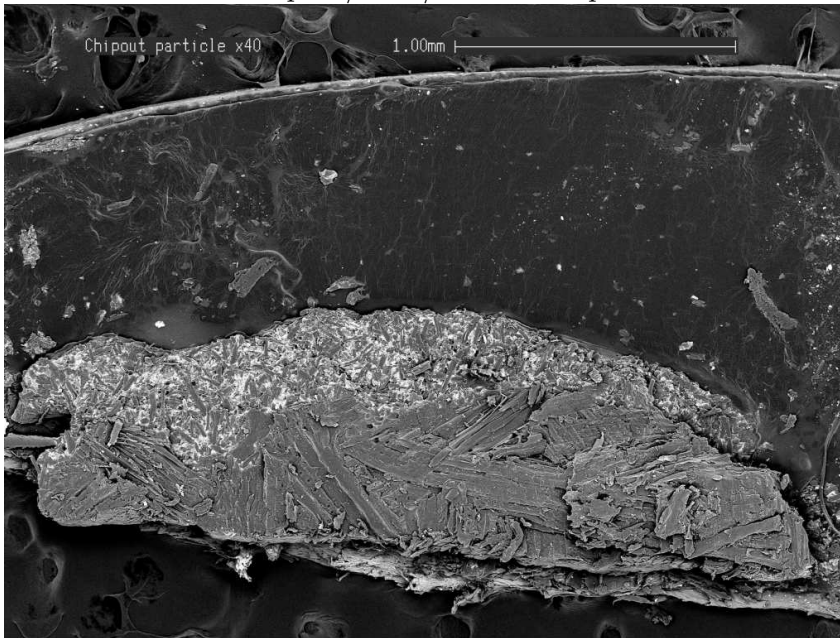
Chipout/SEM/IMAGE62.eps

Figure 23. Scanning electron microscopy image x40 showing the particle that came out of the chipout hole in Figure 22.

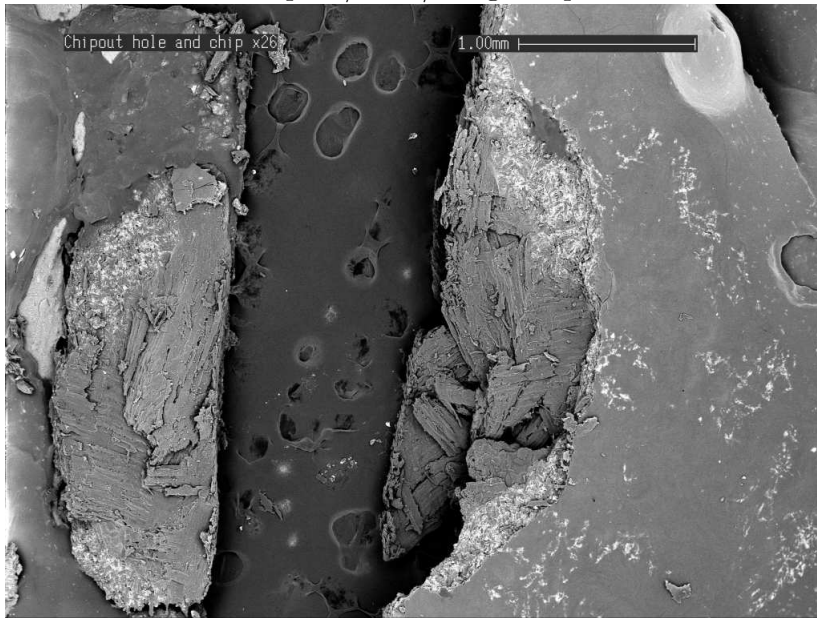
Chipout/SEM/Image33.eps

Figure 24. Scanning electron microscopy image x26 of the void (RHS) and particle (LHS) caused by chipout.

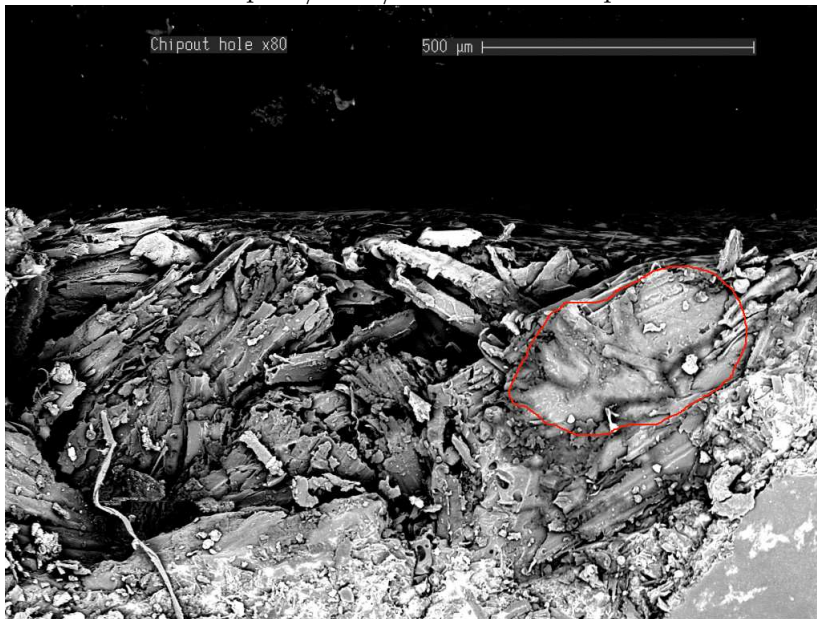
Chipout/SEM/IMAGE50mod.eps

On another project SEM analysis was used to examine the phenomenon of chipout and showed only one sample showed any evidence of resination either on the chipout piece or chipout hole (Figure 25). Note in Figure 25 that where there is resin present, the detail on the surface of the flake appears somewhat blurred and where there is no resin on the flake the surface detail can be seen with high clarity. Figure 24 shows both the hole and particle caused by chipout. This image shows that the only resin evident is the saturating resin within the LPM paper. There is no resin on any of the flake either in the remaining hole or the chipout particle itself. What SEM analysis does not make clear however is whether the particles of flake are actually breaking as opposed to being chipped out whole, which would obviously result in little resin being apparent or whether there is very poor resin distribution. Figures 22 & 23 show details of the hole left by chipout and the particle that caused it.

Figure 25. Scanning electron microscopy image x80 showing some resination of particles in the chipout hole.

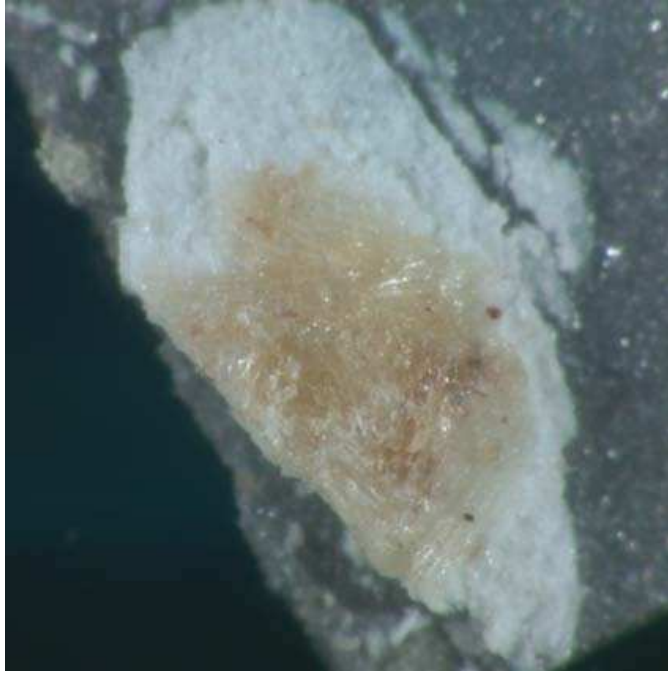
Chipout/Lightmicroscopy/Image5compressed.eps

Light microscopy was also used to examine chipout and Figure 26 shows a chipout particle showing that the area of paper is larger than the actual amount of wood particles removed. This was the case in every instance showing that even if a small particle is dislodged a resultant much larger section of laminated paper is removed leaving a bigger void caused by chipout. The paper actually delaminates i.e. the melamine coated layer splits from the UF impregnated core. This is more clearly shown by SEM, especially in backscattered mode. Figure 27 shows the corresponding void from the chipout particle in Figure 26. Figure 28 shows a chipout particle and corresponding void. It also shows that the chipout particle has evidence of sap-stain fungus and there is no corresponding sap-stain fungus on the chipout void. This suggests that the particles are chipping out whole i.e. they are not actually splitting up.

Figure 26. Light microscopy image x32 showing the particle removed during chipout.

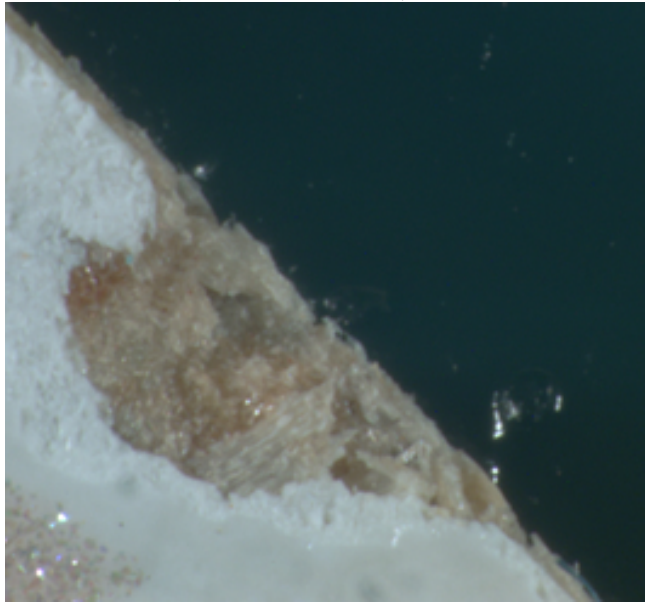
Chipout/Lightmicroscopy/Image4hole.eps

Figure 27. Light microscopy image x16 showing the void caused by the removal of the particle in Figure 26.

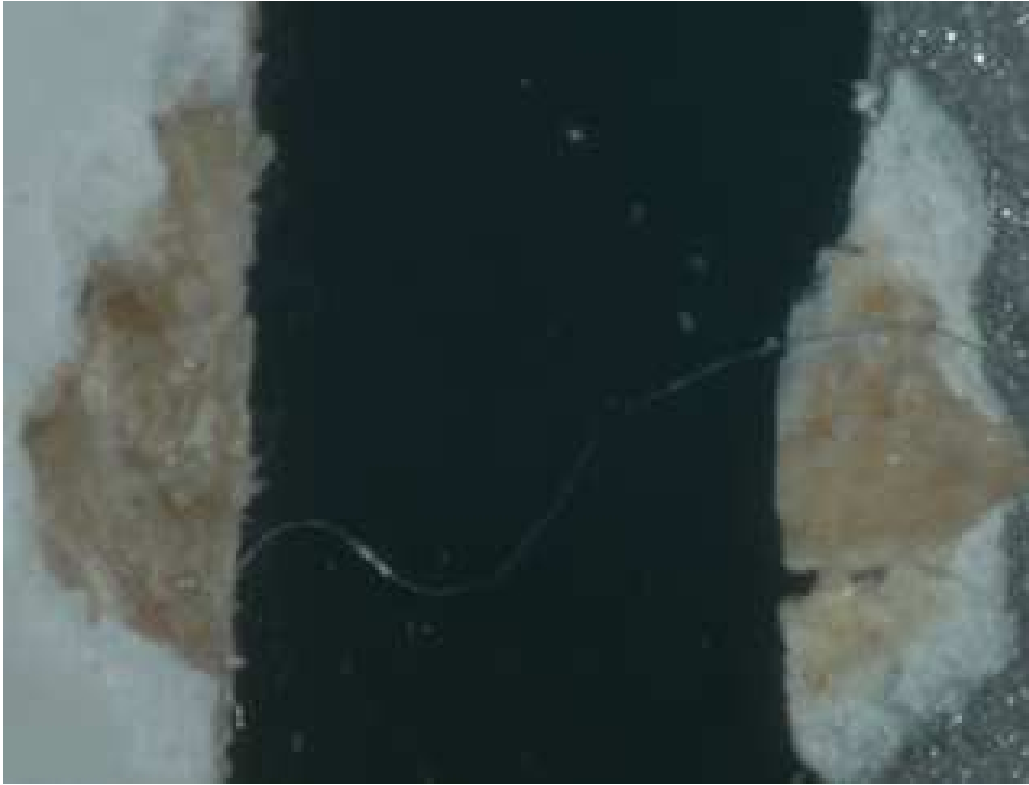
Figure 28. Light microscopy image x16 showing both the void and particle caused by chipout. Note that the evidence of sapstain in the hole is not evident in the removed particle, i.e. the particles which were removed were whole and not fractured.
