# BUILDING INSPECTION REPORT

Inspection prepared for: [REDACTED]  
Date of Inspection: [REDACTED]

Builder Practical Completion Report

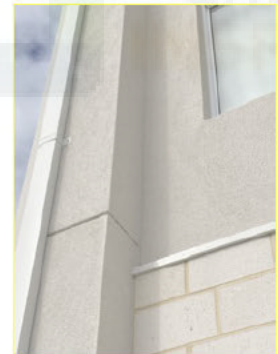
2.1. 4763 Rear - Crack in texture coat.

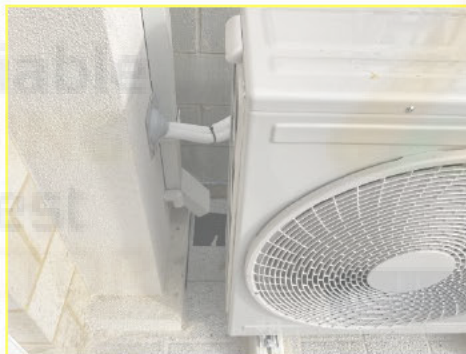
4765 Rear - Clean mortar and render of AC unit and finished plinth.

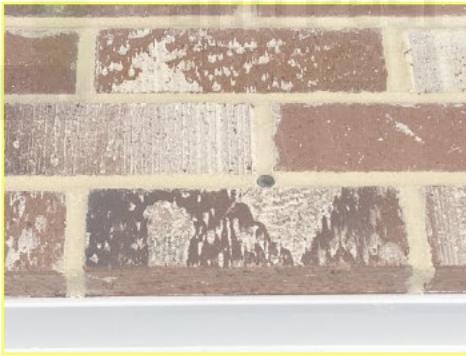
4753

4.1. 4753, 4764 Front - Weep hole without BAL ember guard.

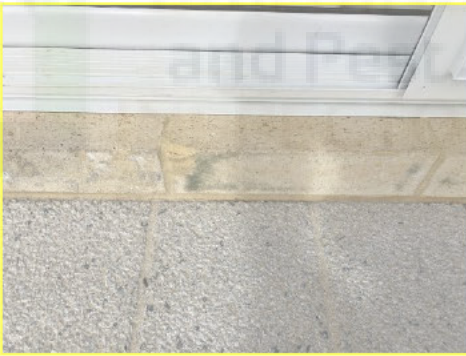
5.1. 4882 Rear - Chipped brickwork.

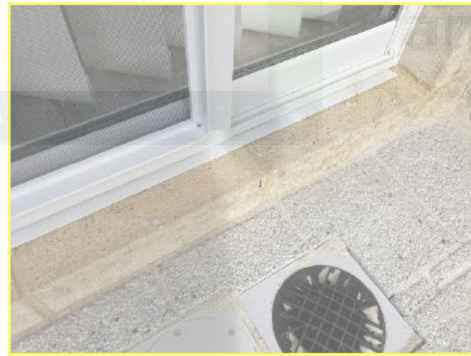
4883 Rear - Clean sill brickwork.
