Incident Report

Stainless Steel Tubing Accident

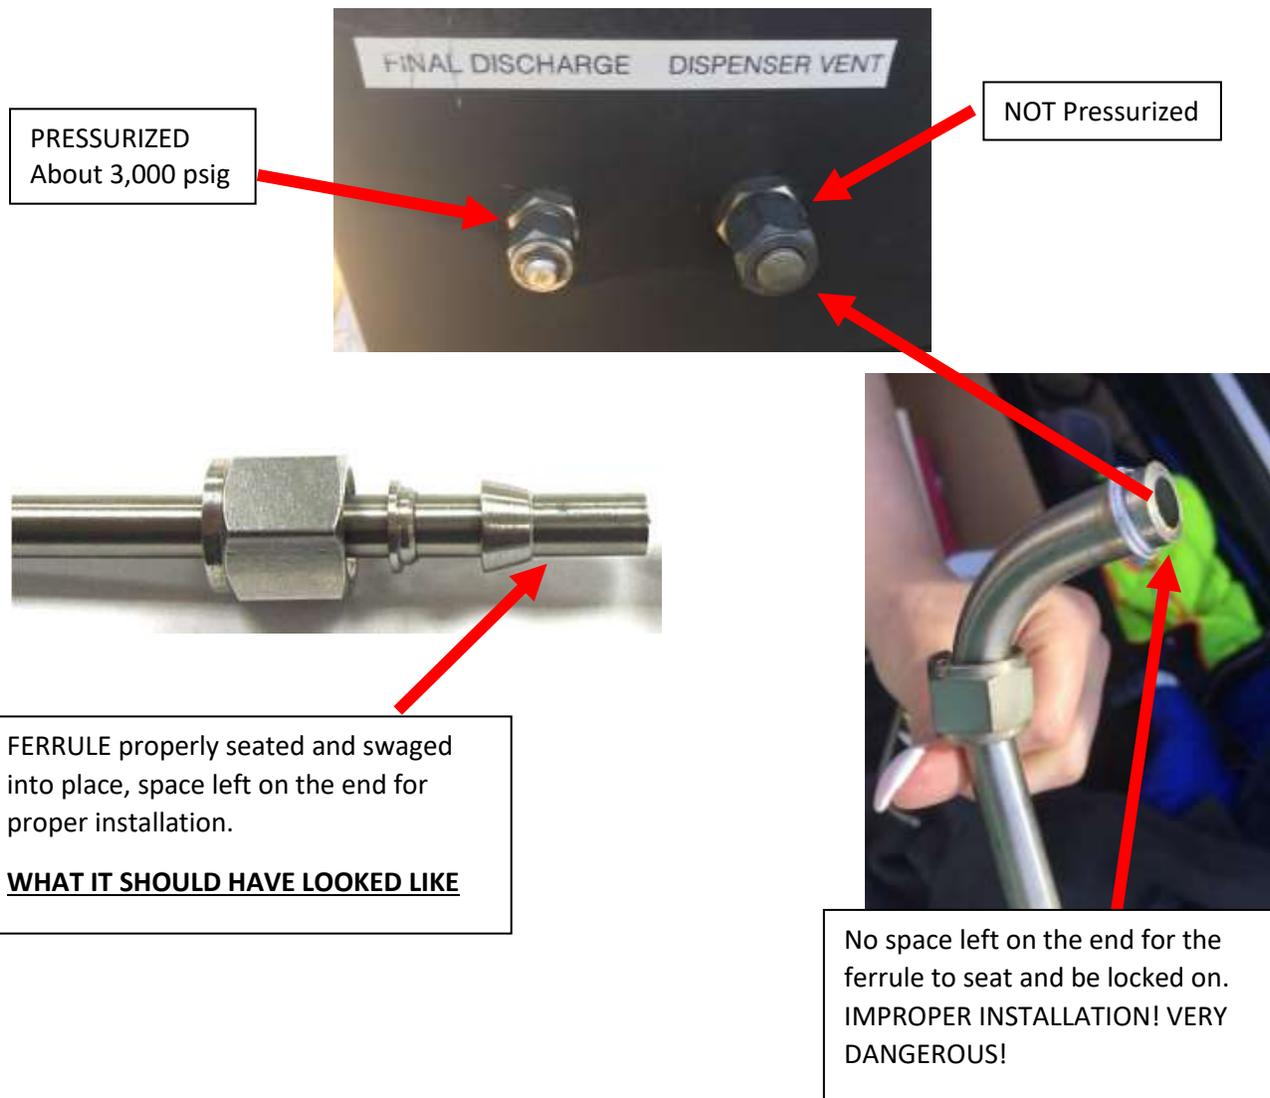
What Happened: A technician had just removed a fitting from a stainless-steel instrument line from an unpressurized vent connection and found it to be improperly done. He was then concerned about the state of the pressurized fitting next to it and wanted to check it.

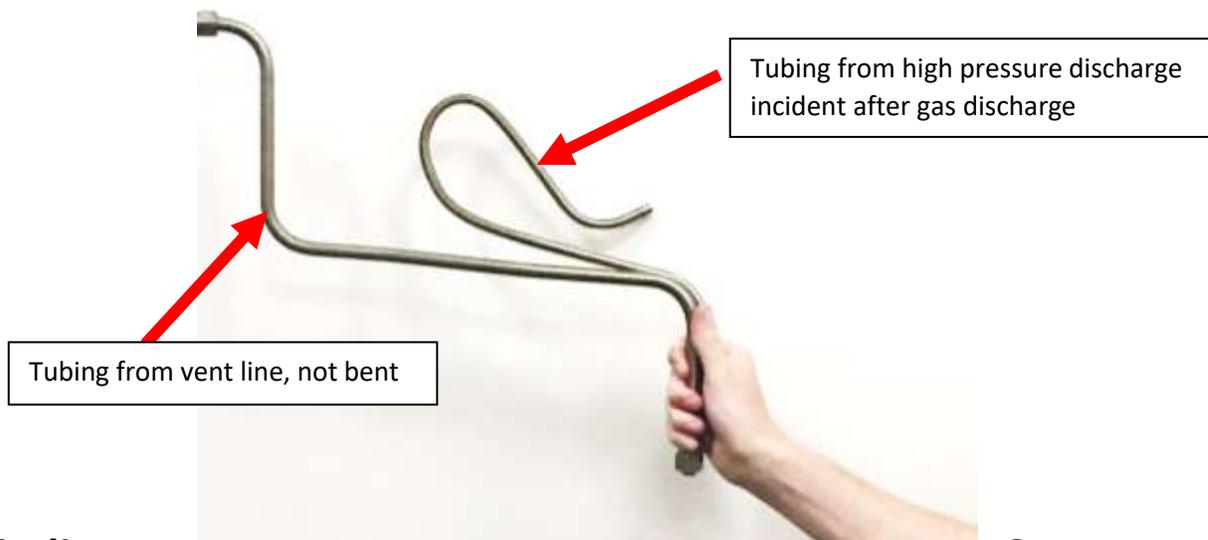
What Happened (cont'd): The technician had just touched his wrench to the high-pressure fitting in an attempt to turn the nut and bleed down the small section of pressurized tubing so that he could completely remove the nut and check the ferrule and installation. As soon as he touched it, it came apart in a violent manner ejecting gas and immediately bending the tubing. It made a loud “Pop” sound followed by the distinct sound of gas pressure being relieved.

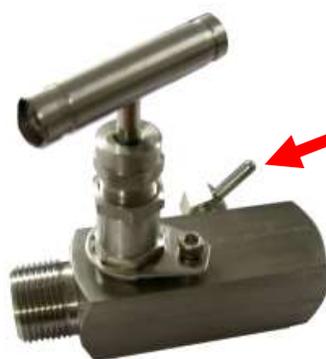
1. The instrument tubing on the high-pressure side had the correct length of tubing after the ferrule, however, it was never tightened properly and swaged onto the tubing.
2. A method to bleed the pressure off this line with a bleed valve was not immediately recognizable.

3. Make sure that all installers of tubing and fittings are properly trained in bending techniques, supporting the tubing, leaving space for flexibility, considerations for vibration, proper materials selections, pressure testing, and proper ferrule tightening and swaging. Swagelok and Parker have excellent training materials available.
<https://www.youtube.com/watch?v=FdthSQDH8qk>
4. Consider a program to depressurize and validate high pressure fittings installed.
5. Implement a quality control process in the future for any tubing installations where all of the factors identified above will be checked in the field and proper ferrule seating witnessed.
