# **Inspection Report**

18223 N 20th Dr Phoenix AZ 85023

**Sonic Property Inspections**

<b>Date:</b> 2/5/2019	<b>Time:</b> 03:00 PM	<b>Report ID:</b> 020519
Property: 18223 N 20th Dr Phoenix AZ 85023	<b>Customer:</b> Sample	<b>Real Estate Professional:</b> Robert Tolnai

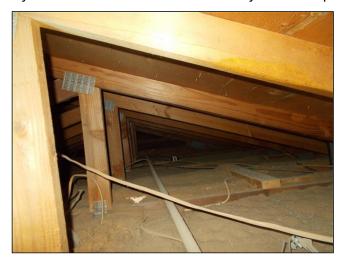
The photos show the roof structure as seen from the attic. These areas when reviewed showed no signs of any structural deficiencies on the day of the inspection.

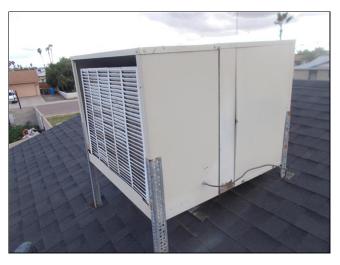
The roof installed evaporative cooler has been previously leaking onto the attic (see the obvious moisture stains on the attic sheathing beneath the unit). Further evaluation and service as necessary is recommended.

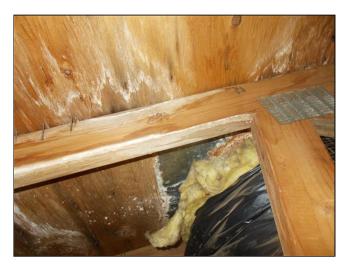
The roof sheathing is water-stained over the garage. The stain has occurred around a penetration (plumbing vent, roof vent) through the roof surface. The area should be monitored for leaks. If leaks occur, the penetration(s) should be caulked or re-flashed as necessary.

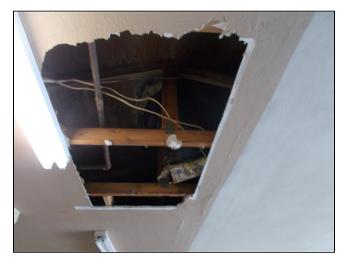
(1) Garage ceiling adjoining living space are considered fire barriers. Damage or holes were noted at one or more areas of the ceiling that would compromise the fire rating. A qualified drywall technician should make repairs.

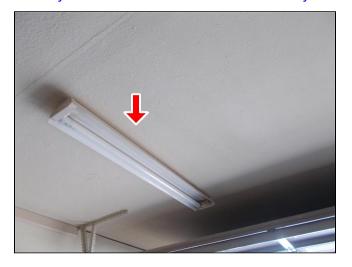
The fluorescent lighting did not fully illuminate. Bulbs and or starter may need replacement.

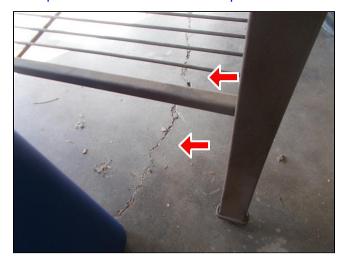
(1) Minor cracking is evident in the floor slab, but there is no noticeable vertical displacement.

Recommend sealing the crack to prevent water intrusion. A qualified contractor could perform the work.

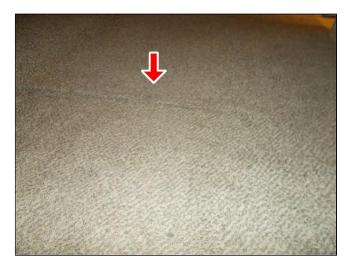
(1) The carpet is loose in the bedrooms, recommend further evaluation and repair/replace.

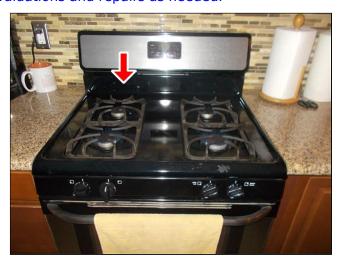
(1) The left rear burner did not respond when tested. I recommend having a qualified appliance technician make further evaluations and repairs as needed.

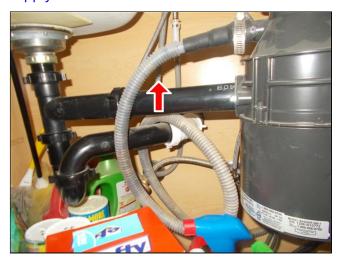
(1) The dishwasher drain is connected to a hose that connects directly to the sink drain line or discharges into the garbage disposal. This can allow contaminated water to mix with the potable water supply. A qualified technician should install either a "high loop" or an approved air gap device to prevent prevent mixture of supply and waste water.

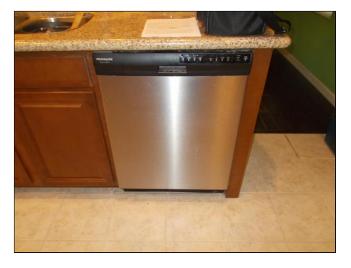
(2) Dishwasher was inoperable using standard controls. Recommend a qualified plumber or contractor evaluate.

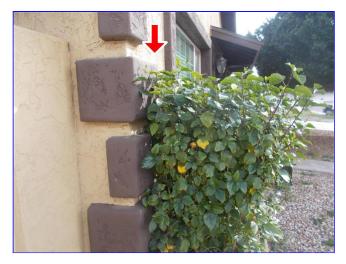
At time of inspection, one or more areas of the vegetation were observed to be against or close to the exterior walls. This should also be noted on your WDO (Termite) report. Irrigated vegetation against house walls is conducive to Subterranean Termites. Recommend removing or trimming the bushes

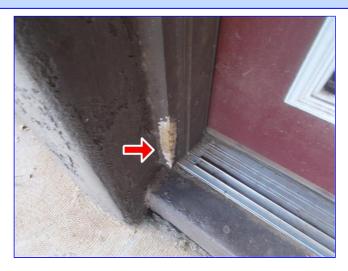
(3) The patio door rubs and the weatherstripping is damaged, recommend repair.

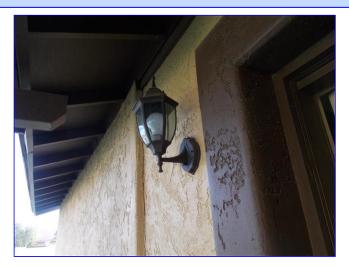
(2) The door bell was not operational using normal controls. Recommend repair.
