Sonic Property Inspections

Customer
Sample

Address
18223 N 20th Dr
Phoenix AZ 85023

Action Items

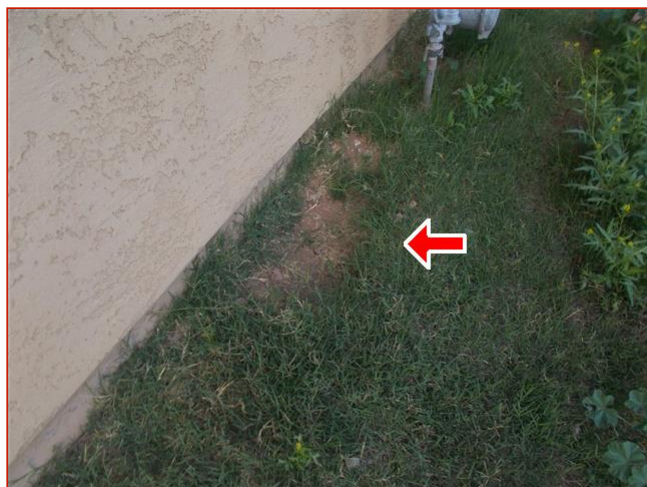
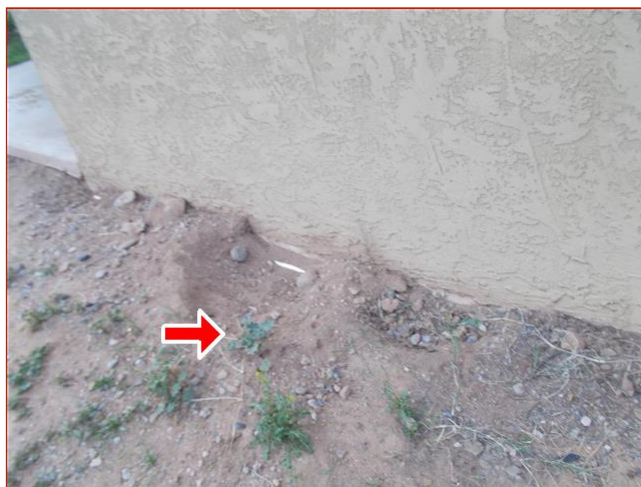
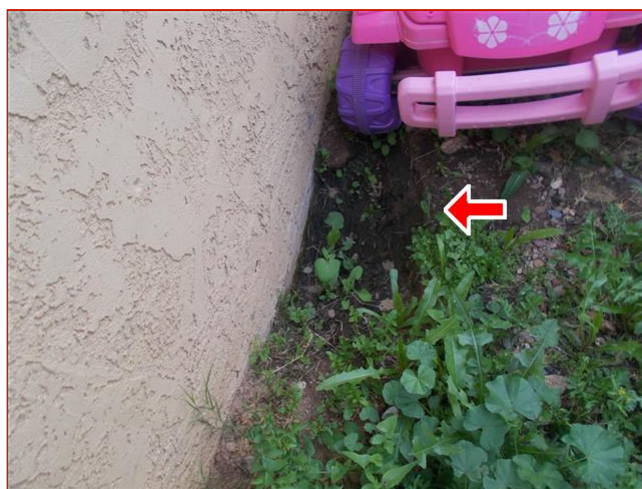
3.4 GRADING, DRAINAGE, and RETAINING WALL(S)

There is a negative slope at the several exterior areas and can cause or contribute to water intrusion or deterioration. Monitor the areas to determine if water is entering the structure. Have a qualified contractor or landscaper regrade the yard if needed.

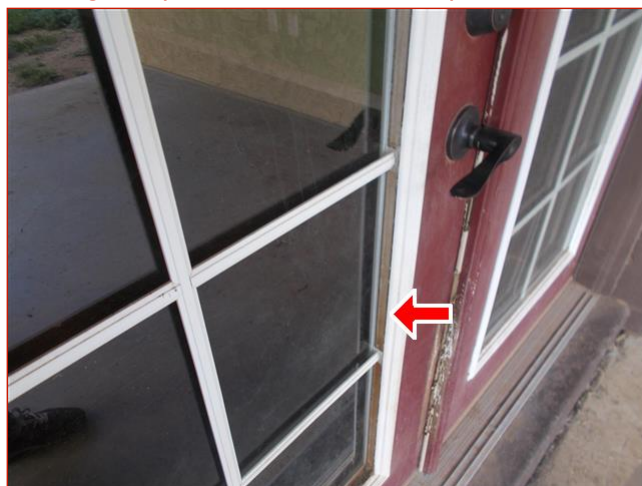
3.8 DOORS (Exterior)

(2) The patio door has one broken glass panel, recommend repair.

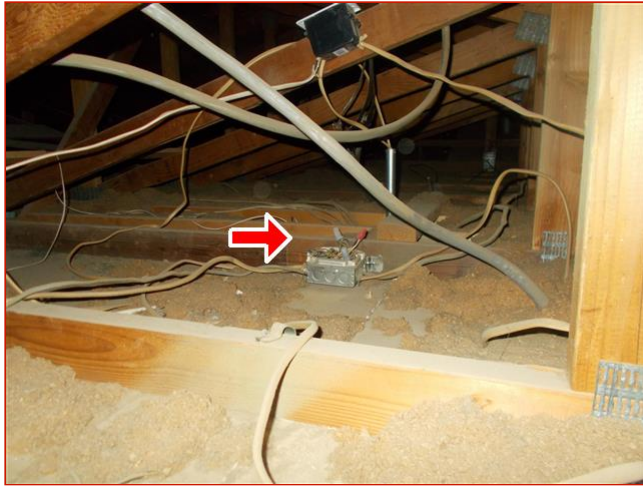
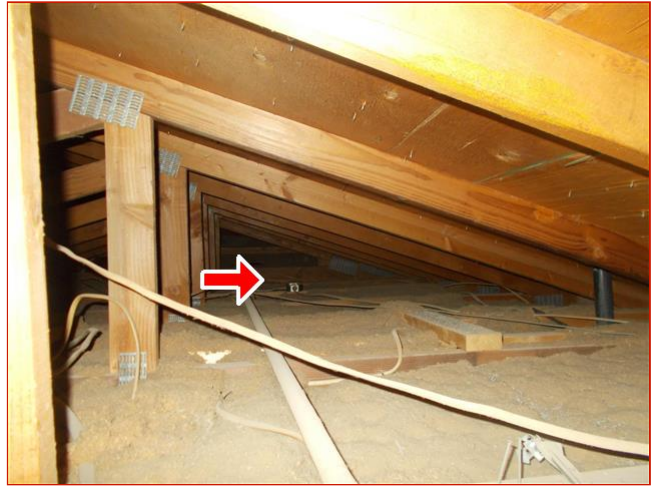
6.2 WIRING

(2) There is an open junction box in the attic. Lack of covers on junction boxes is a shock or fire hazard. We DID NOT necessarily list all locations. A qualified technician should check the system and install a proper cover on all junction boxes.

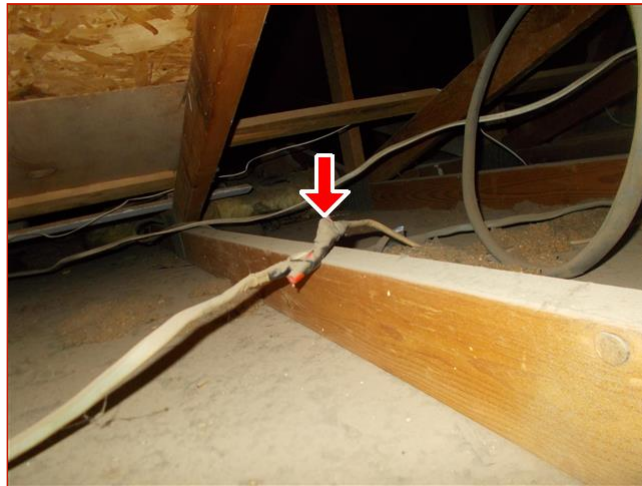
(3) There is an open wire splice(s) in the attic. We DID NOT necessarily list all locations. Open splices can be a shock or fire hazard. A qualified technician should properly splice all wiring inside covered junction boxes.

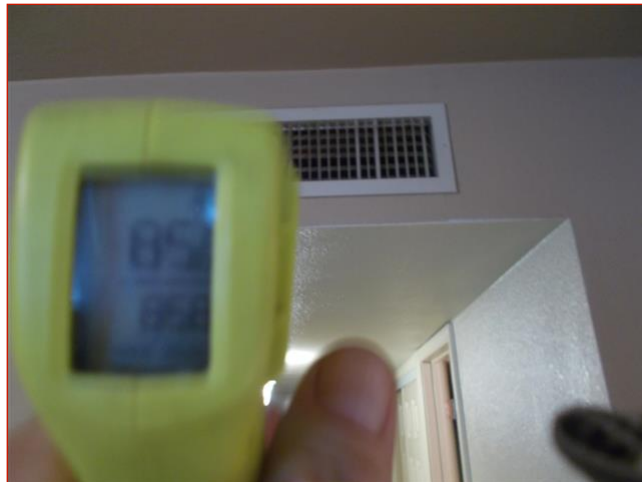
7.2 HEATING SYSTEM(S)

(1) The heat pump(s) did not perform its intended function in the heating mode on the day of the inspection. The heat pump(s) cycled however would not reach an acceptable temperature of 95 degrees or above. We recommend that a qualified HVAC technician evaluate the system and make repairs as needed

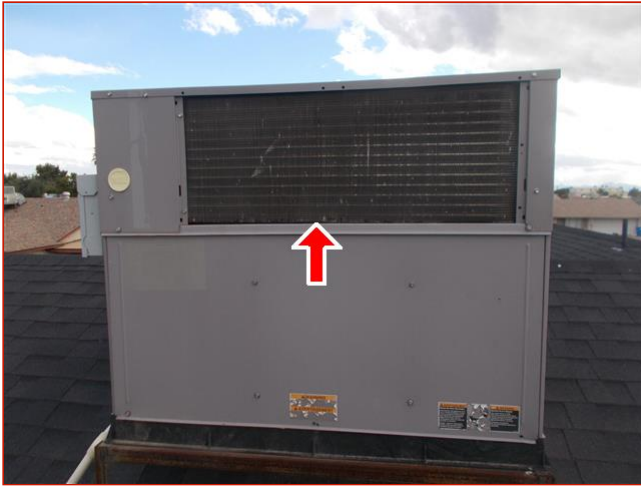
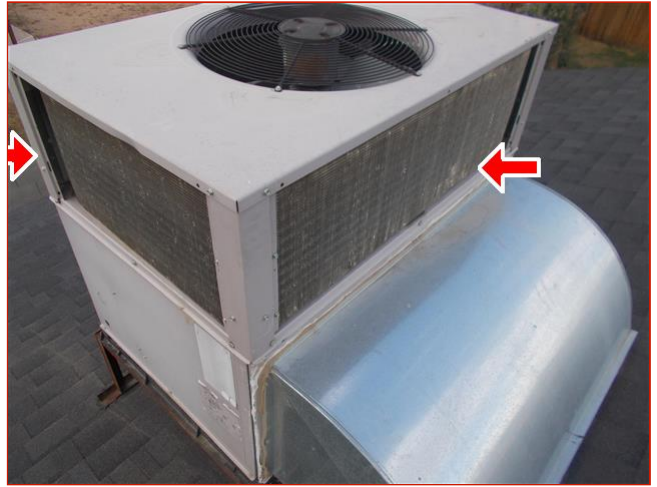
(2) The Heat Pump protective grill is missing, recommend further evaluation and repairs.

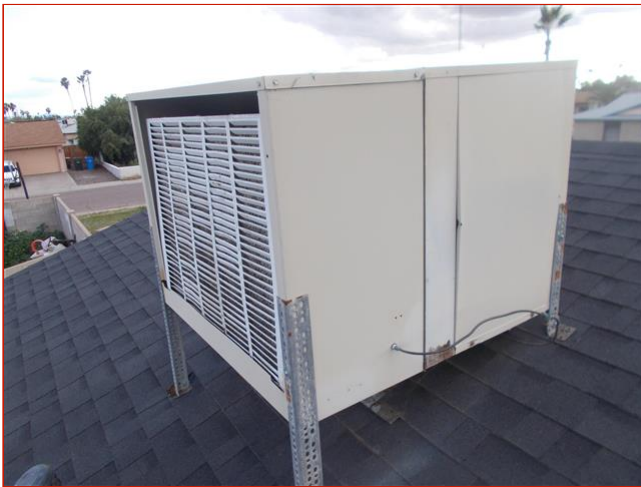
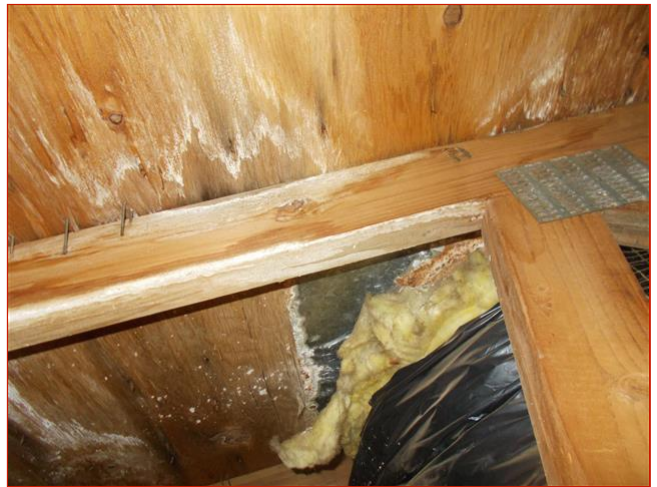
7.7 Swamp cooler

The roof installed evaporative cooler has been previously leaking onto the attic (see the obvious moisture stains on the attic sheathing beneath the unit). Further evaluation and service as necessary is recommended.

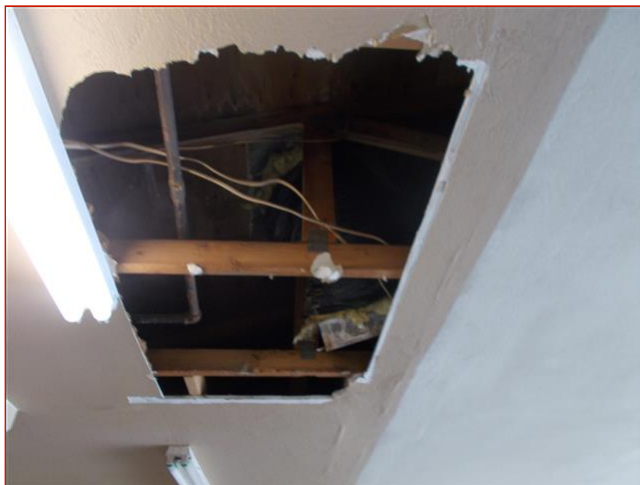
9.2 FIRE WALL and PASSAGE DOOR

(1) Garage ceiling adjoining living space are considered fire barriers. Damage or holes were noted at one or more areas of the ceiling that would compromise the fire rating. A qualified drywall technician should make repairs.

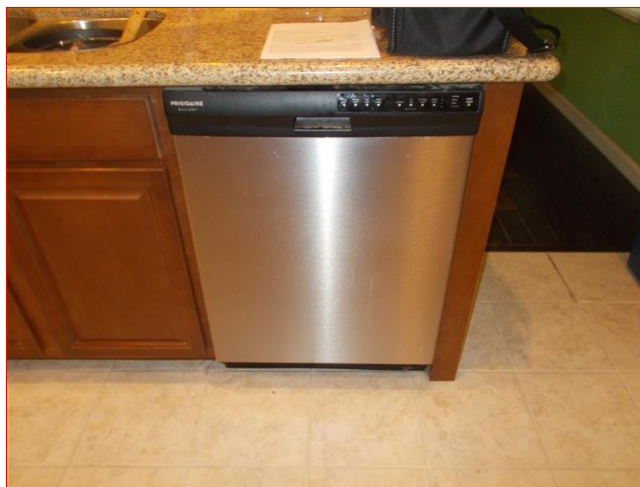
11.5 DISHWASHER(S)

(2) Dishwasher was inoperable using standard controls. Recommend a qualified plumber or contractor evaluate.

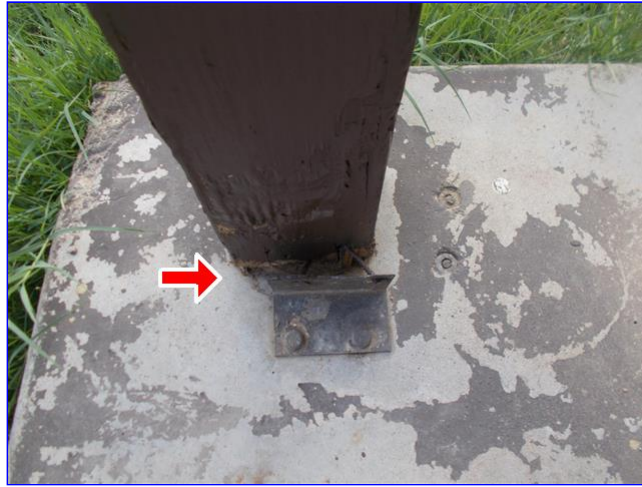
2.3 COLUMNS

The patio wood column metal bracket is loose, recommend further evaluation and repairs.

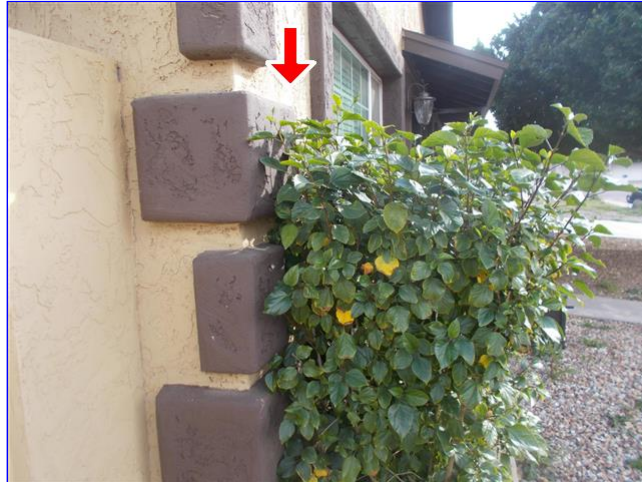
3.1 VEGETATION

At time of inspection, one or more areas of the vegetation were observed to be against or close to the exterior walls. This should also be noted on your WDO (Termite) report. Irrigated vegetation against house walls is conducive to Subterranean Termites. Recommend removing or trimming the bushes

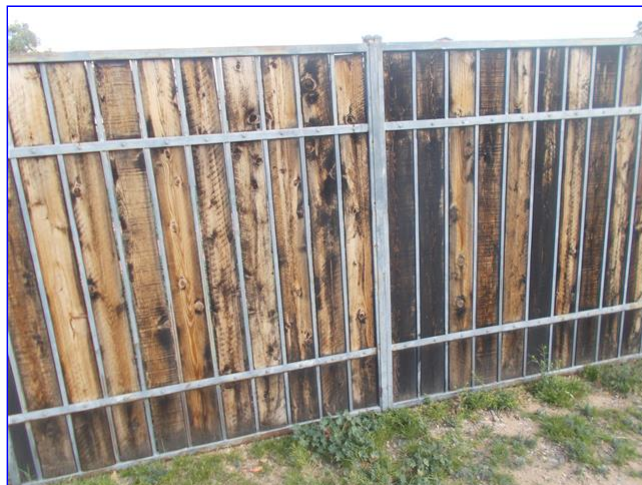
3.5 FENCES and GATES

(2) The wood gates are slightly weathered, and should be serviced as necessary to prevent further deterioration. Service such as scraping, repainting and sealing.

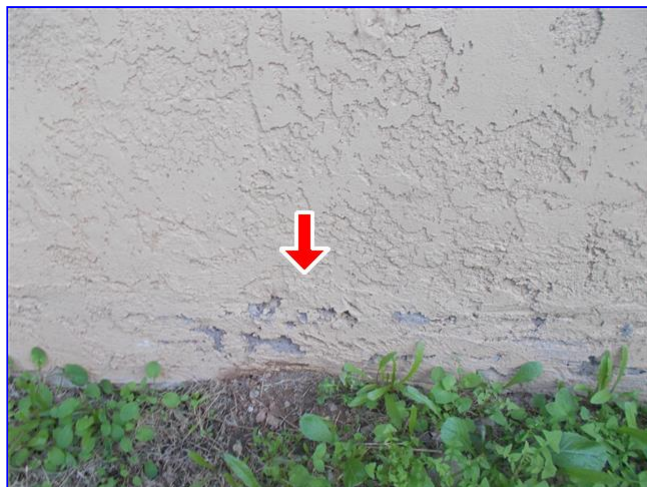
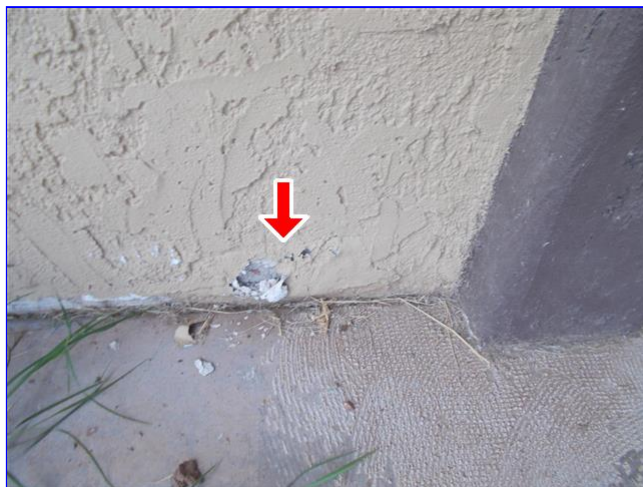
3.7 WALL CLADDING and TRIM

Minor damage to the stucco cladding was observed at one or more areas. Photos show example(s) and not individual areas. Repairs are advised.

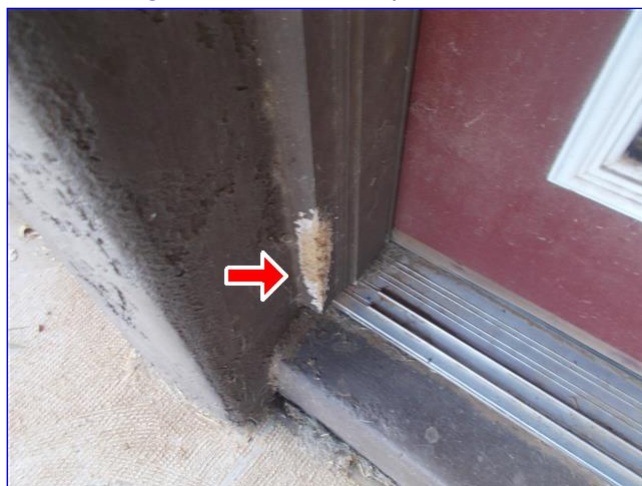
3.8 DOORS (Exterior)

(1) The patio door trim has small damage, recommend repair.

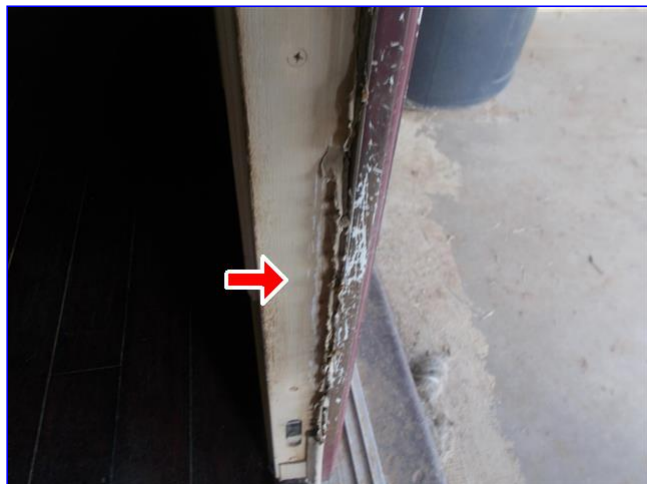
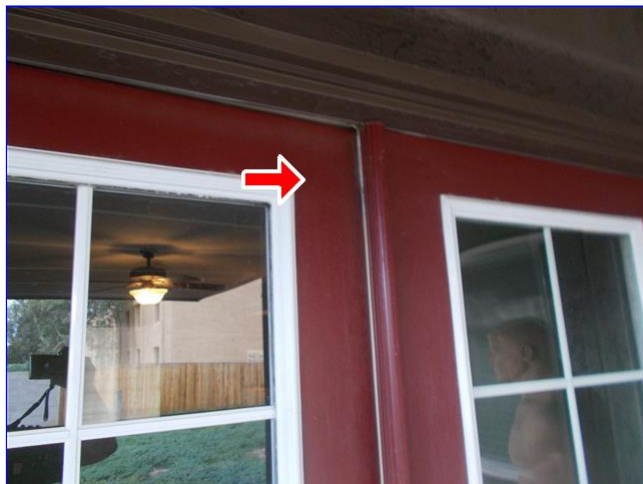
(3) The patio door rubs and the weatherstripping is damaged, recommend repair.

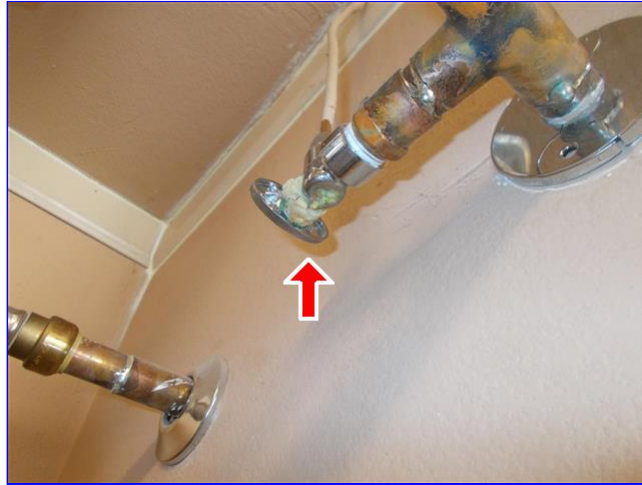
5.4 WATER HEATING SYSTEM

- (1) Corrosion was noted at the water heater water piping. Evidence of possible prior leaks were also noted. Recommend further evaluation and repair.

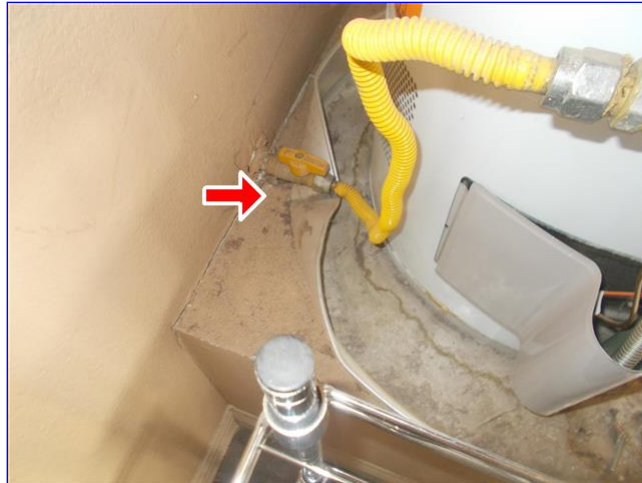
- (2) The water heater pan is bent, recommend repair.

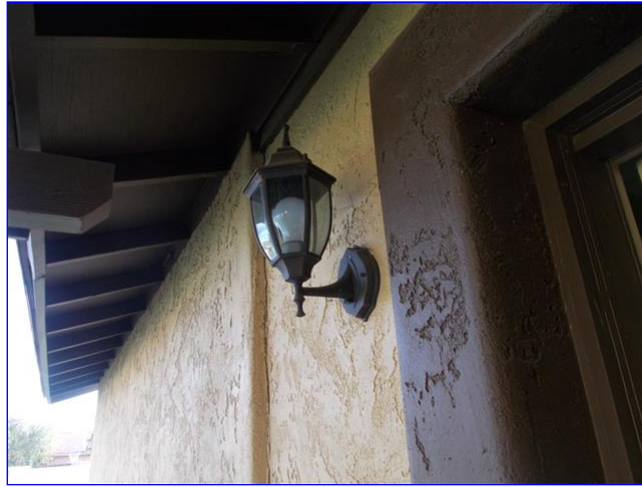
6.3 EXTERIOR RECEPTACLES, SWITCHES, and FIXTURES

- (1) The exterior light fixture(s) at the rear of the home is not functional. The bulb(s) may be burned out. The bulbs in non-functioning lights should be tested and replaced if necessary, and the proper operation of the fixtures should be verified. Repair any non-functional fixture.

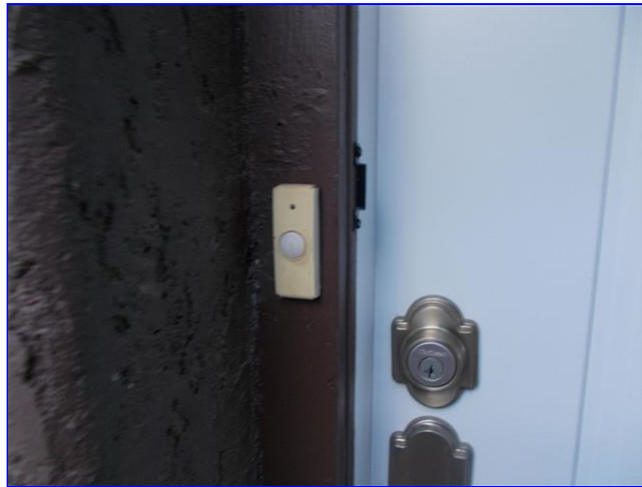
(2) The door bell was not operational using normal controls. Recommend repair.

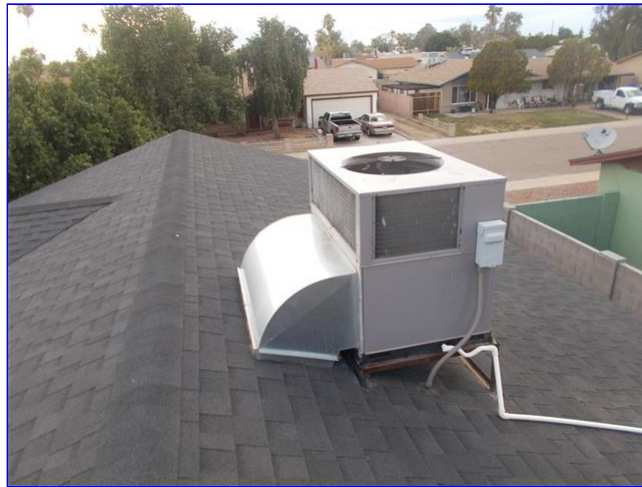
MFD 2005 2.5 ton

(3) The Heat Pump system is in the 3rd trimester of its design life and will need to be more closely monitored, serviced bi-annually, and should have its filter changed every two to three months. However, it would also be wise to keep a home protection policy current.

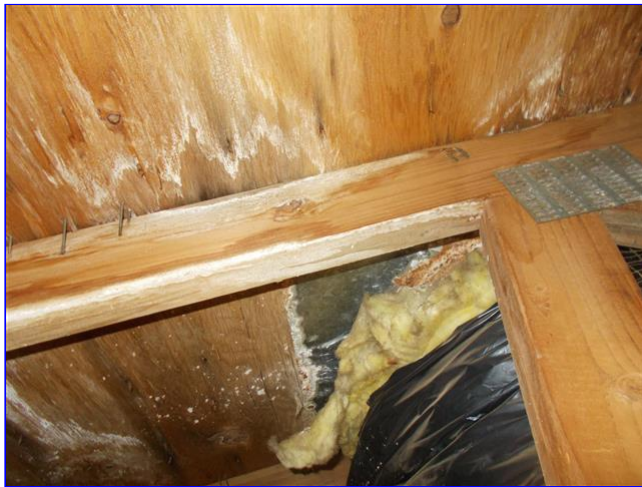
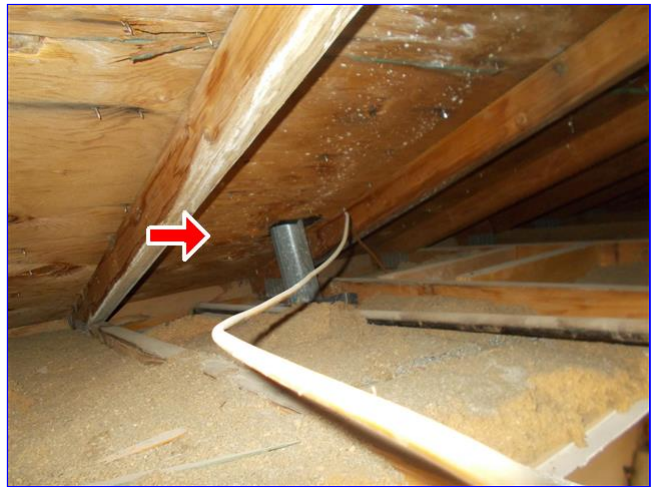
8.2 ATTIC MOISTURE and VENTILATION

The roof sheathing is water-stained over the garage. The stain has occurred around a penetration (plumbing vent, roof vent) through the roof surface. The area should be monitored for leaks. If leaks occur, the penetration(s) should be caulked or re-flashed as necessary.

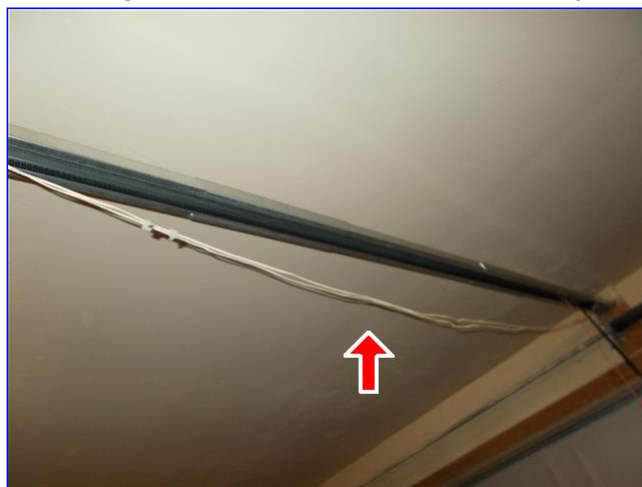
9.1 GARAGE DOOR(S) and OPENER(S)

(2) The garage door opener low voltage wires are loose, recommend repair.

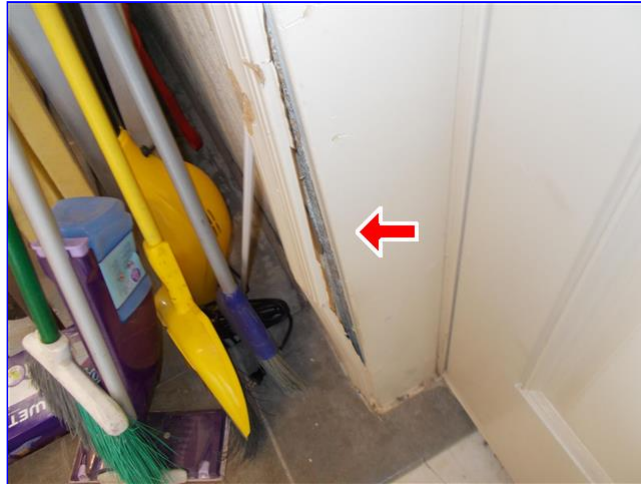
9.2 FIRE WALL and PASSAGE DOOR

(2) The passage door trim is damaged, recommend repair.

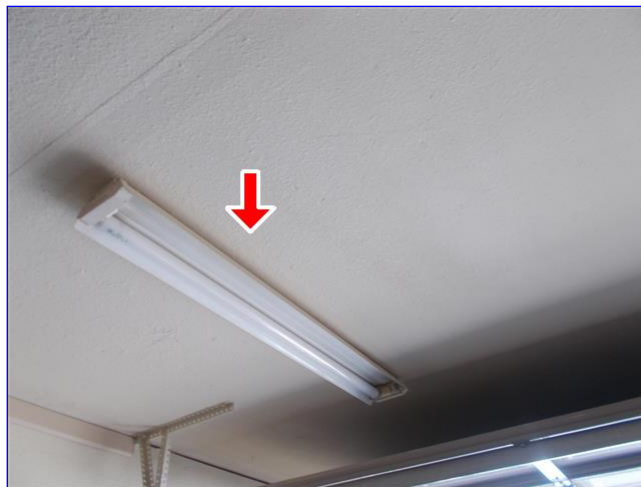
9.3 GARAGE OUTLETS & LIGHTING

The fluorescent lighting did not fully illuminate. Bulbs and or starter may need replacement.

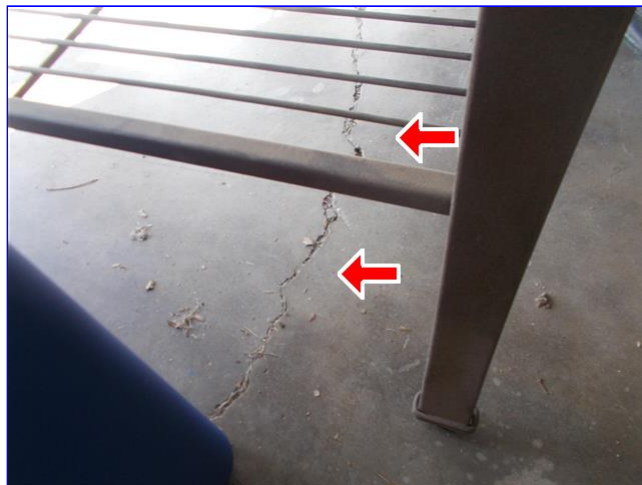
9.4 GARAGE FLOOR

(1) Minor cracking is evident in the floor slab, but there is no noticeable vertical displacement. Recommend sealing the crack to prevent water intrusion. A qualified contractor could perform the work.

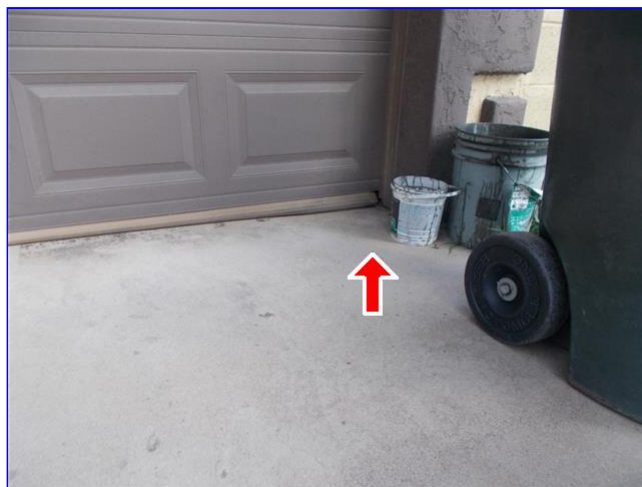
(2) The garage floor is uneven on the right side (facing front) and should be monitored.

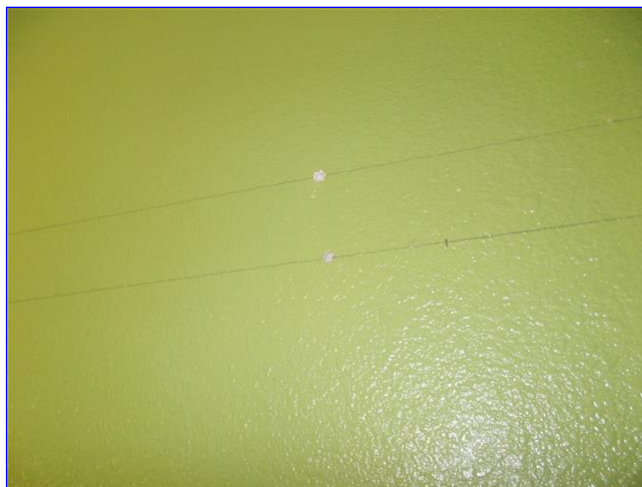
10.2 CEILINGS and WALLS

The walls or ceiling have minor cosmetic damage (scuffs, scrapes, nail holes etc) that you should view yourself and correct as desired.

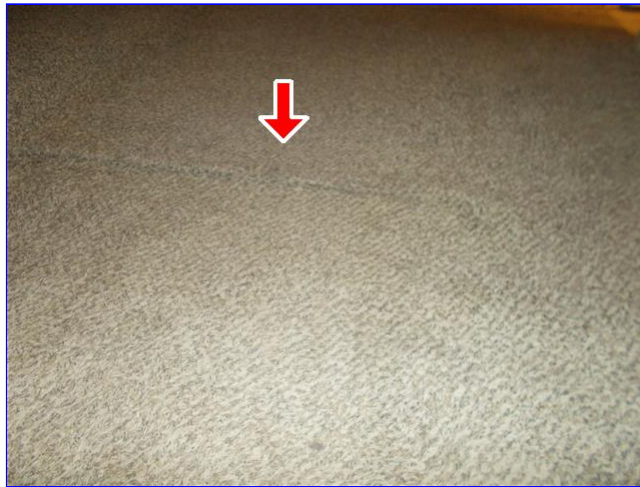
10.3 FLOORS

(1) The carpet is loose in the bedrooms, recommend further evaluation and repair/replace.

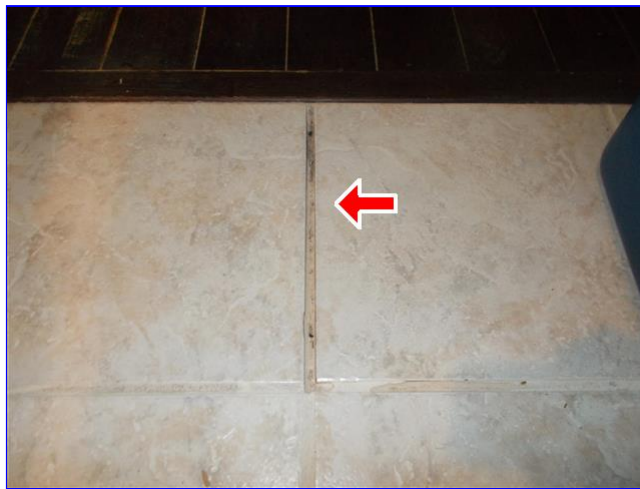
Kitchen

(2) Some of the tile grout is loose or missing. Affected areas could be re-grouted as part of routine maintenance. A qualified technician could make repairs or modifications as necessary.

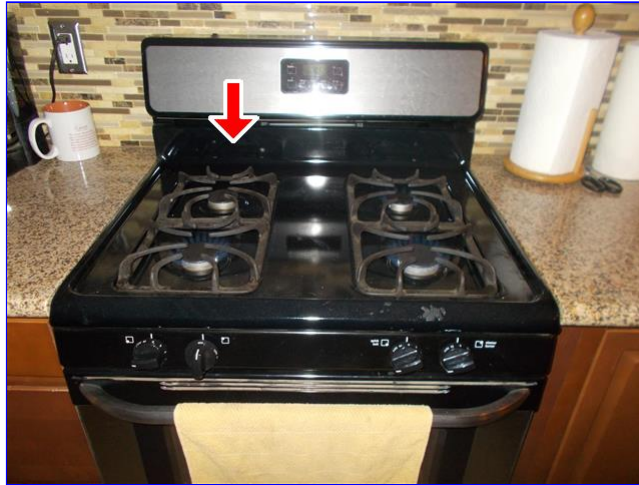
11.2 RANGE(S), OVEN(S), and COOKTOP(S)

(1) The left rear burner did not respond when tested. I recommend having a qualified appliance technician make further evaluations and repairs as needed.

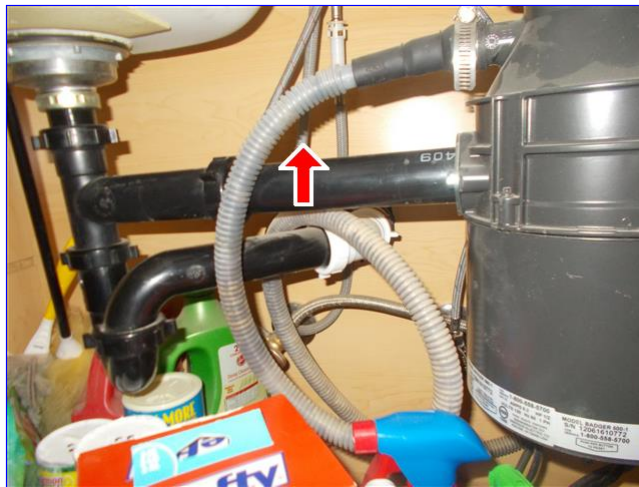
11.5 DISHWASHER(S)

(1) The dishwasher drain is connected to a hose that connects directly to the sink drain line or discharges into the garbage disposal. This can allow contaminated water to mix with the potable water supply. A qualified technician should install either a "high loop" or an approved air gap device to prevent prevent mixture of supply and waste water.
