SSE Firmware Upgrade on Older Boards

Building Technologies & Solutions – York
Johnson Controls Plc.

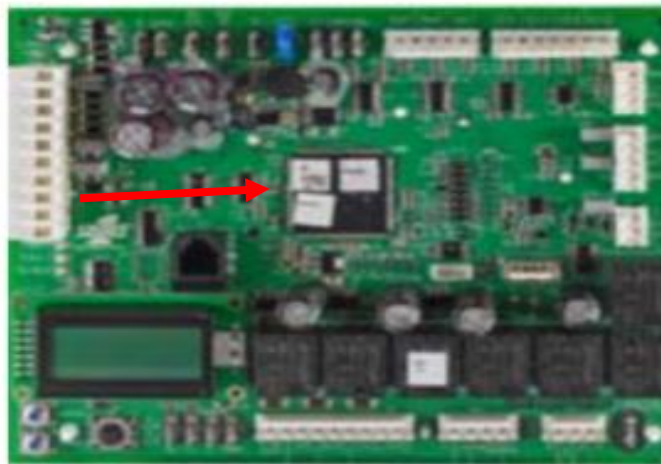
Before trying to upgrade a board, the **original** firmware needs to be known. The way to find out the original firmware version is to look at the SSE board. Just above center of the SSE will be a black circuit board (if there is a Comm board plugged in on top of this black circuit board remove the Comm board so the black board can be accessed).

This circuit board will have a white sticker/s on it with the original firmware version noted on this sticker. This info is what any upgrade must be based on; not what is seen if using the Update/View Firmware menu on the SSE.

- **If the firmware version on the sticker does not match the firmware found in the SSE Menu, the firmware on the sticker must be used to determine what upgrade can be used.**
- The older firmware version boards do not have enough memory on them to accept the newer firmware versions; if any version above 4.0 is installed on a 3.3 or lower board, the firmware will start removing information from the board to make room for itself.
- If this happens the board may not operate as it should and the SSE will need to be replaced.
