Ducted Systems Technical Services Service Tips Letter

Letter: **ST-004-2020**

Subject: **Furnace Door Panel and Quarter Turn Knob Engagement**

Product: **Residential 33" A & B cabinets, condensing and non-condensing furnaces**

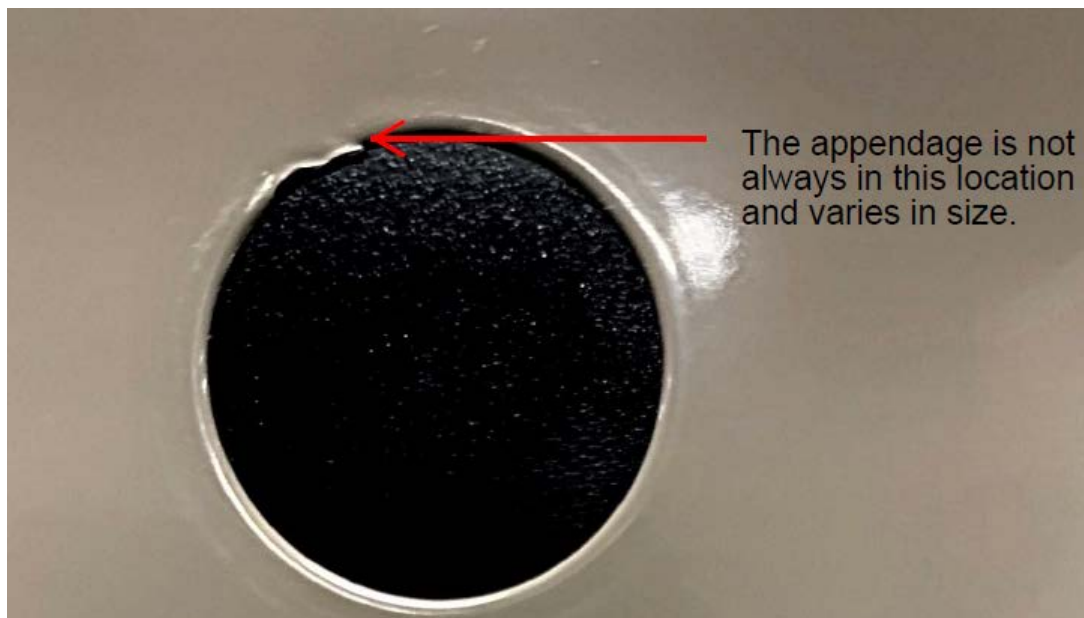
We have received some reports on the residential gas furnace used during July 2019 to Mid-October 2019 production, where the Upper and Bottom panel doorknobs are breaking or found being very loose. The reports indicated small amounts of issues with not being able to lock the knobs in place to seal the furnace's top or bottom compartments.

Through our investigation, we discovered that the reason for doorknobs being found broken or loose is because the "Hole Punch Die" tooling became dull, causing the hole to have a burr on the door panel. Due to the burr, it would cause the doorknob to break. All furnaces produced after December of 2019 are fixed. This is shown below.
