## *Ducted Systems Technical Services Service Tips Letter*

Letter: **ST-007-2018**

Subject: **Condensate dripping issue with Residential Early production model CM indoor coils applied in a horizontal application.**

Product: Residential CM Model cased coils: AP, AE, AVC, RFCX\*\*22 air handling units.

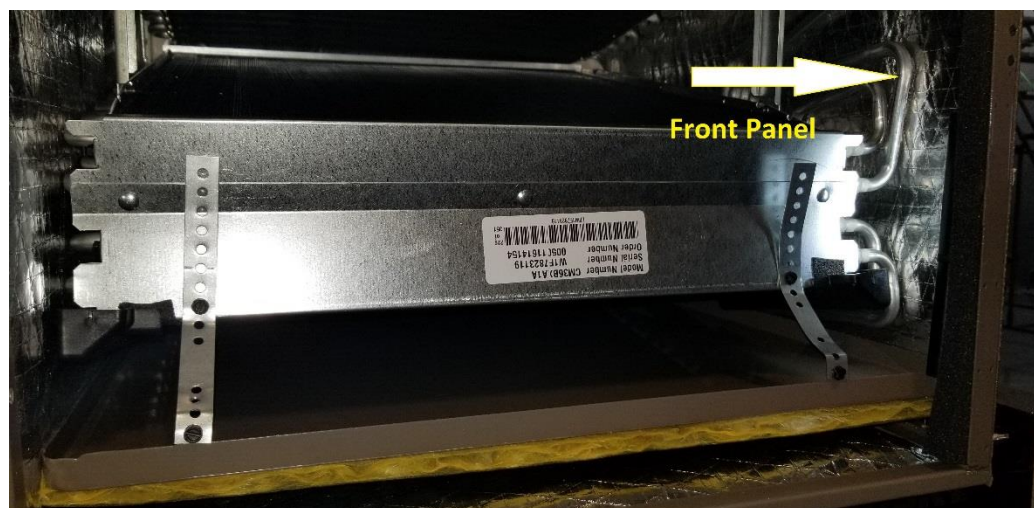
Through our investigation, we discovered that the distributor assembly, tubes, suction header and TXV body of the coil may be pressing against insulation of the front panels of the coil case, which is shown below.

When condensation is formed during normal operation, the condensation has the ability to make contact with the insulation face and travel down the foil surface. Due to the design of the first generation horizontal drain pan, the drain pan may be unable to capture all of the condensation coming off the front of the coil.

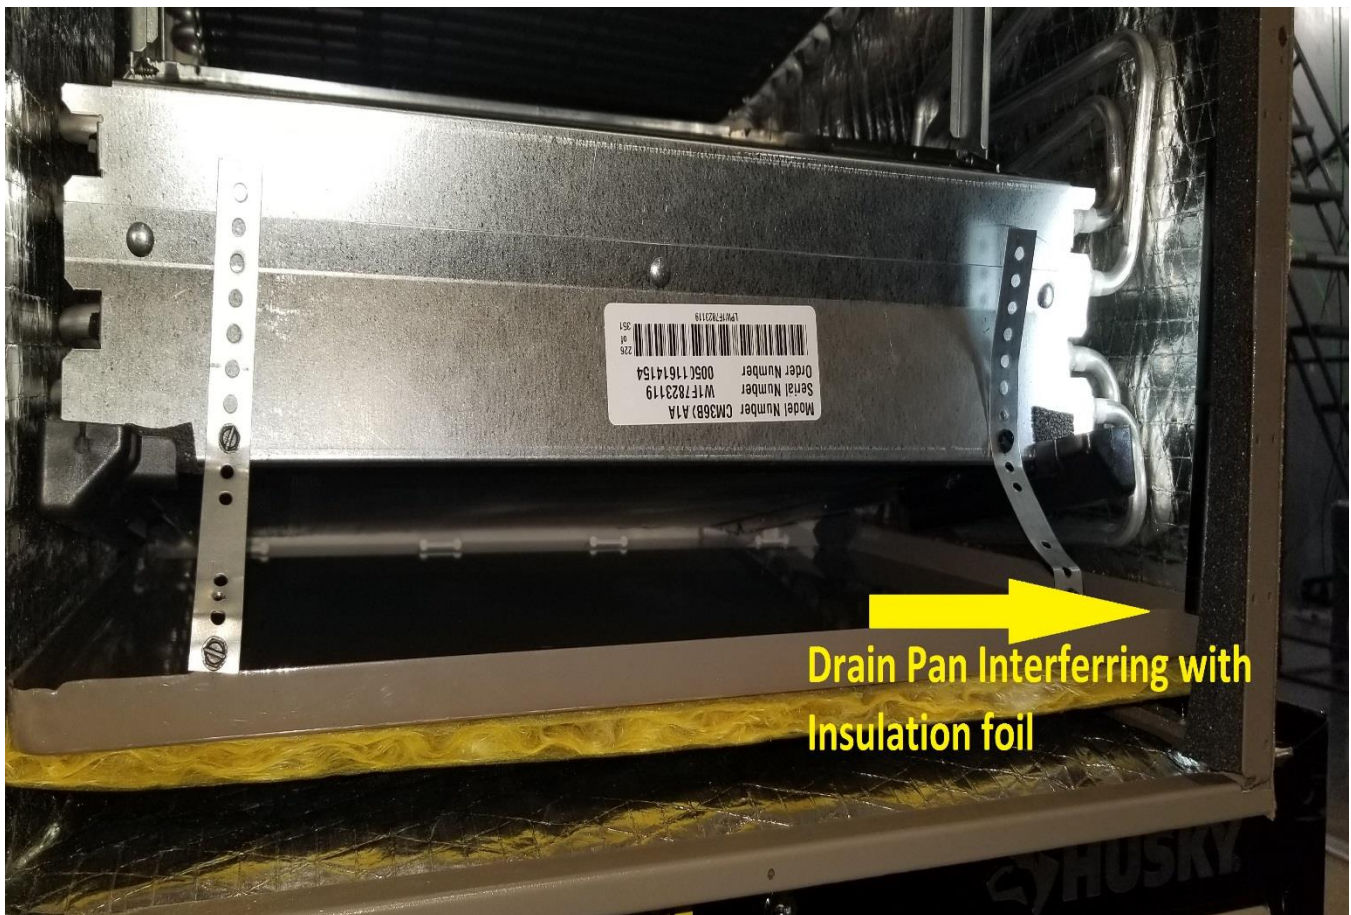
Based on these findings, Design Engineering implemented a wider horizontal condensate drain pan in July of 2017. The drain pan can be identified by the edge connected to the horizontal pan straps. The first generation drain pans had a 45-degree edge. The current drain pan has a 90-degree edge. The drain pan edge was changed to improve condensate management within the pan. Shown below is a picture of the current drain pan that now has an interference fit with the insulation on the back coil cabinet and front panel. Coils produced in August 2017 (W1H7) and later contain the new wider drain pan.

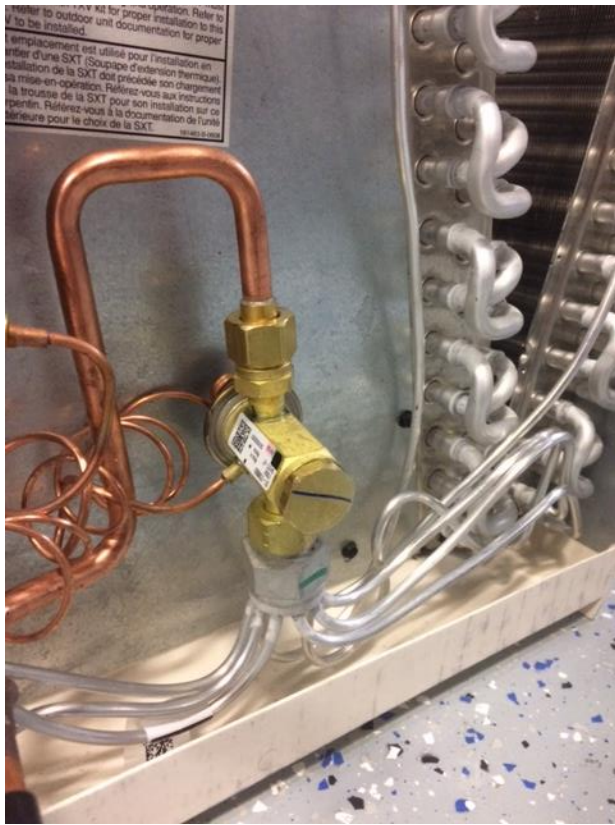
**INCORRECT INSTALLATION**

Another issue that may lead to condensate not managed properly, is the installation of the TXV to the distributor body. The improper orientation or position of the TXV can allow it to protrude into the insulation on the door panel. This may cause the condensate on the foil surface to drain around the pan. When installing the TXV, make sure that the TXV body is oriented parallel to the delta plate as shown in the unit installation manual. See photos below.
