Ducted Systems Technical Services Service Letter

Letter: **YS-001-2020**

Subject: **Blower motor location in belly-band – Regal Beloit Ensite® Blower Motors**

Product: **TM8X, TMLX, TM9X, TM9E, TM9Y, RGF19*E, RGF29*E, RGF1L*E, RGF2L*E, MM9E**

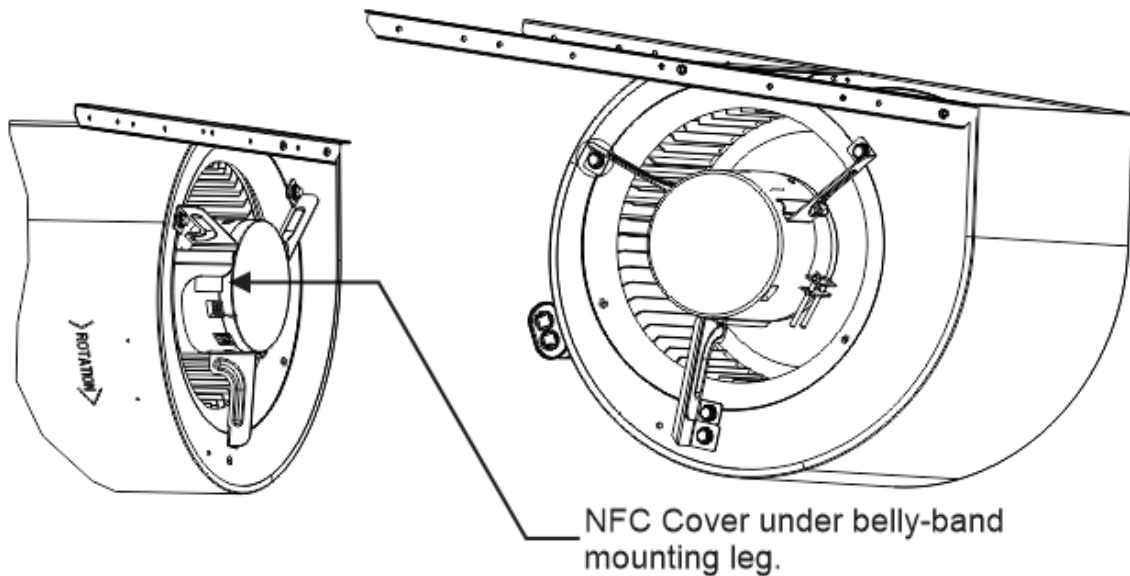
Another reason we found causing excessive blower motor noise is related to some of the motors not being installed correctly in their belly-band mounting assembly during furnace production. The Ensite® motor has a white plastic cover over the NFC programming sensor as shown in the image above. In some cases, the motor belly-band must be relocated/repositioned on the motor. Shown below is an assembly drawing of the motor, belly-band and blower assembly. Notice that the NFC cover is under one of the belly-band mounting legs. When the belly-band is in this position, the motor is not square with the blower assembly and this can lead to excessive noise.

commissioning, the blower motor should be checked to identify if it is an Ensite® motor and then if so, position of the motor in the belly-band as described above. If the motor is in the incorrect location, slide the blower assembly from the furnace, re-locate the motor in the belly-band and re-install the blower assembly. Take external static pressure readings and adjust blower motor speed per the unit installation manual. If excessive external static is present, the customer may need to make duct system modifications.

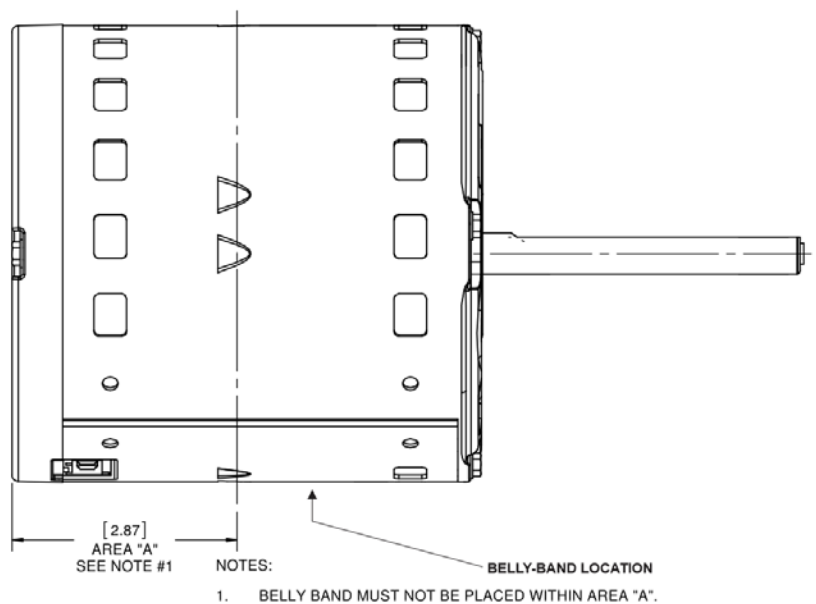
For ½ and ¾ horsepower motors, the belly-band **is** in the correct location in relationship to the end of the motor (location shown in the image to the right) but the motor must be rotated so that the NFC and electrical connections are in the area where the belly-band clamp bolts are located. Shown below is an assembly drawing of the blower assembly showing the blower motor NFC cover and electrical connections after the motor has been rotated in the belly-band. Notice the connections are in the section of the belly-band where the clamp bolts are located.

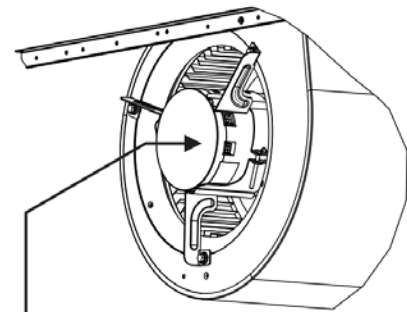
For 1 horsepower motors, the belly band needs to be adjusted so that it is within the appropriate area on the motor. The belly-band must be adjusted toward the shaft end of the motor. Reference the image below showing the correct location of the motor belly-band. The belly-band must be moved into area “A” as shown below.

NOTES:
 1. BELLY BAND MUST BE PLACED WITHIN AREA "A".
