Ducted Systems Technical Services Service Letter

Letter: **YS-002-2020**

Subject: **Nuisance low-pressure switch fault – Low ambient conditions - 3.5 ton (2nd generation) models**

Product: YHE42B22S, TH4B4222S, RHP14L42B22S, RHP14L42B23S,
THE42B32S, THE42B42S

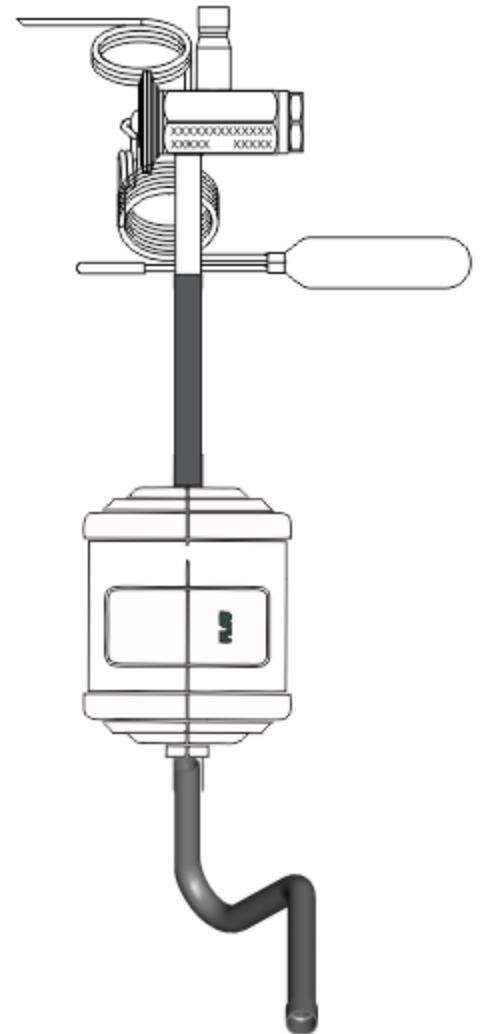
Our investigation revealed that even with a properly charged system when this model is operating in conditions lower than 15 degrees Fahrenheit, nuisance low-pressure switch trips will occur. The 15 degree Fahrenheit temperature data was verified through extensive engineering cold soak testing. The 5438494 demand defrost control utilized in this model unit ignores the low-pressure switch input during the following conditions:

Using a tubing cutter, the existing 3/8 distributor line can be cut directly above the piston metering device. The existing 3/8 copper tube connecting the liquid line base valve to the filter drier can then be un-sweat from the base valve. The entire assembly can then be removed from the unit. Using the components in the kit, the assembly shown to the right can be put together all at one time inside the unit and then perform the five 3/8 braze joints. The only other braze joint is the 1/8 TXV equalizing line into the suction tube connecting the reversing valve to the outdoor coil. The suction tube does not have to be replaced, therefore there is no need to worry about potential damage to the reversing valve. Specific step by step repair instructions have been included in the Source One kit.
