**RE: River Falls Hydroelectric Project, FERC Project No. 10489
Post-Flood Dam Safety Inspection and Repair Options**

Post-Flood Dam Safety Inspection and Repair Options Letter

Re: Post-Flood Dam Safety Inspection and Repair Options Letter for Powell Falls Dam (P-10489)

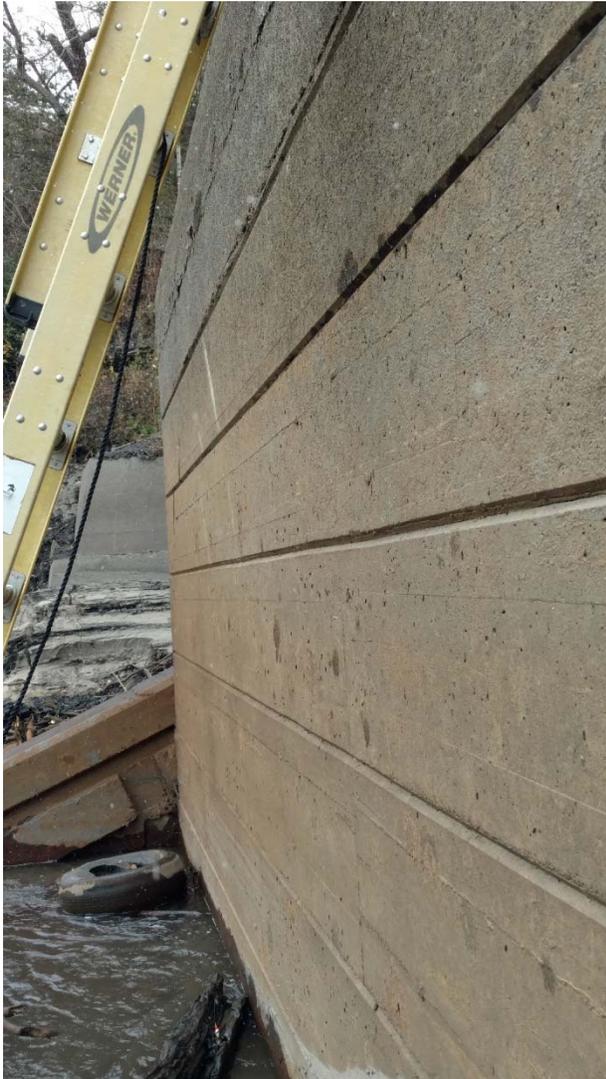
Figure 2, upstream lift joints on left spillway

The RFMU provided a ladder for Ayres to obtain a perpendicular view and up-close visual inspection of the upstream face of spillway concrete (Figure 2). Ayres was able to inspect the left and right ends, plus the third points, of the upstream face with a ladder. The uppermost lift joints had been apparently coated with a flexible (still flexible after installation in 1992) coating shown in Figure 3, though the coating had

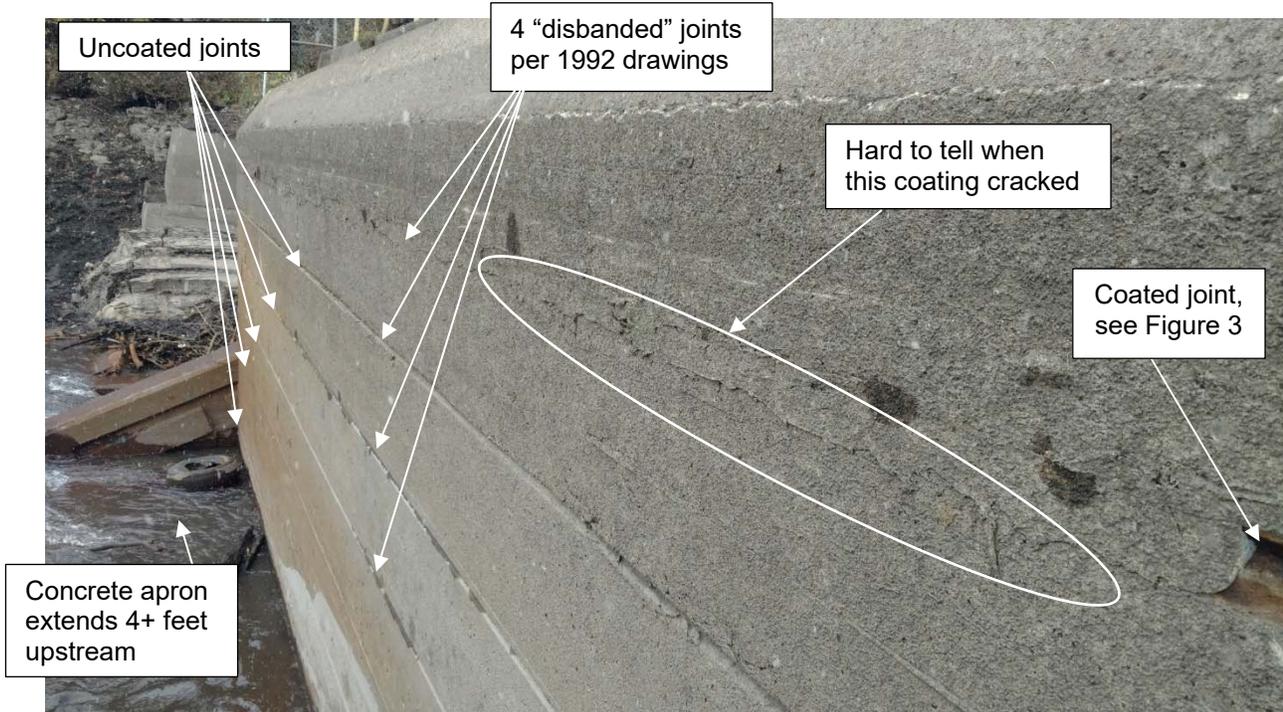
separated from the lift joints in multiple locations and water was found behind the coating in several places. All upstream face concrete (not the coating) sounded solid when struck with hammer.

Figure 3. Lift joints, viewed from upstream face of spillway

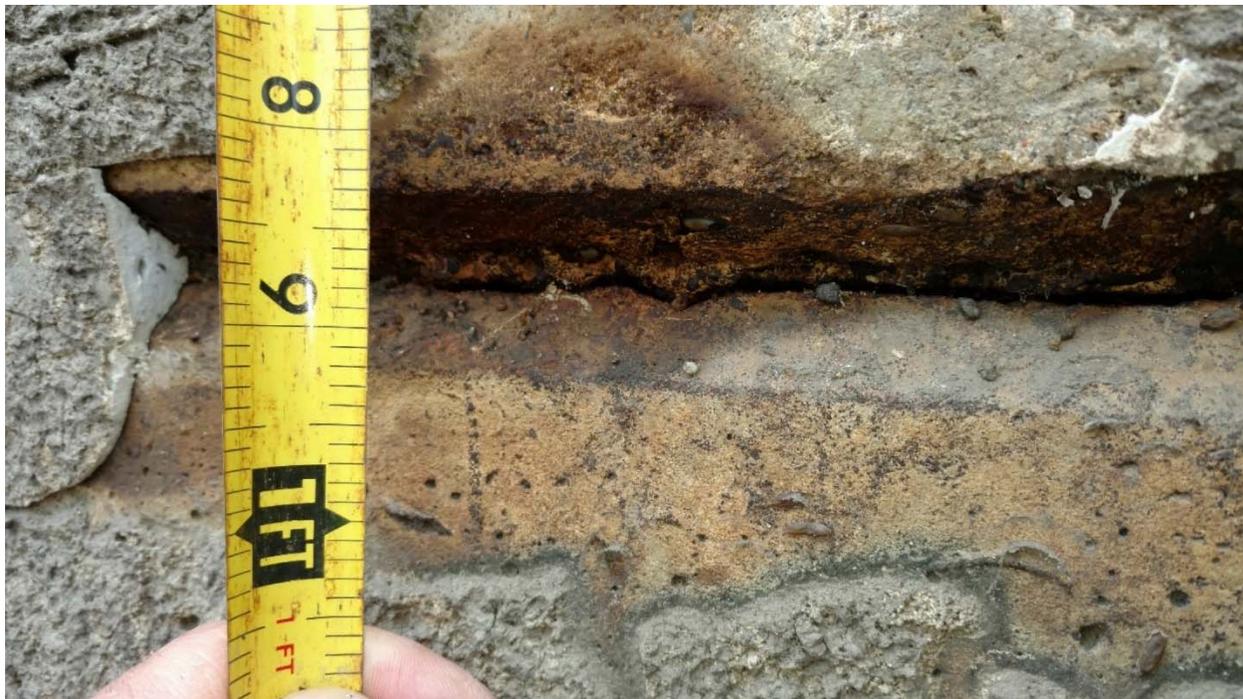
Figure 4. Closeup of coated lift joint shown on right side of Figure 3, approximate elevation 819.3

Other than the top two lift joints (Figure 4 and 5), none of the lower lift joints appear to have significant separation. The corner looks tight and free of any major cracks.

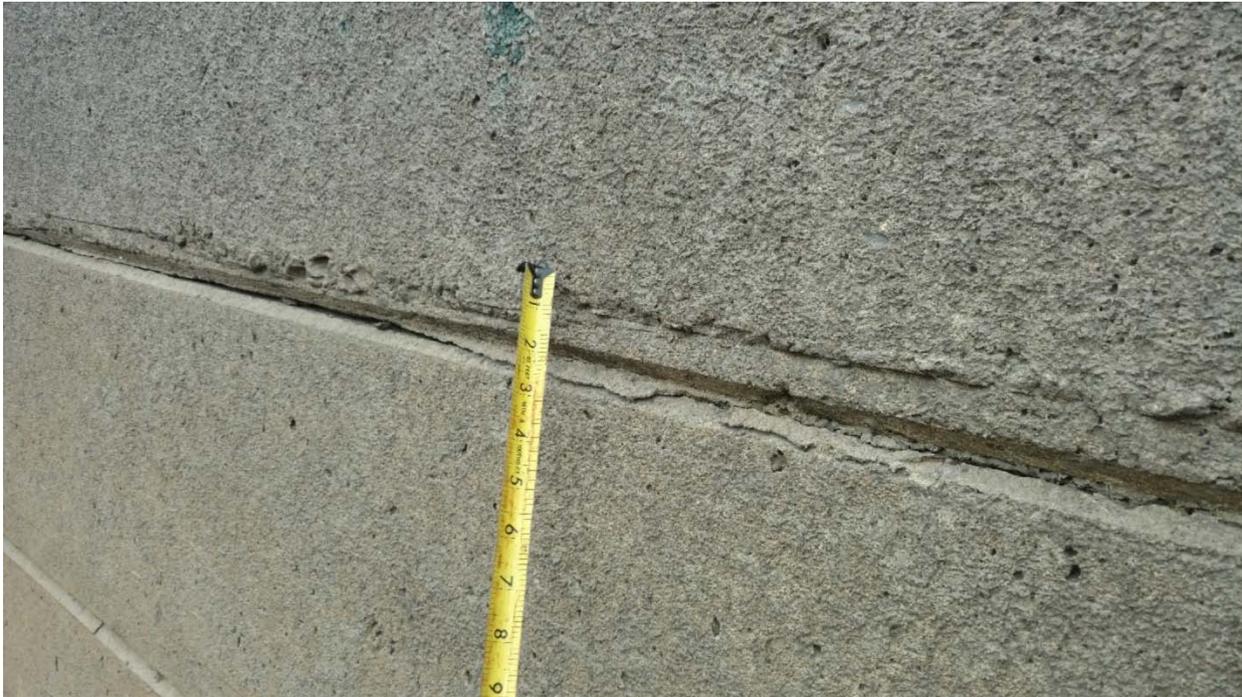
Figure 5. Separation of second lift joint, approximate elevation 817.8. Separation does not look recent.

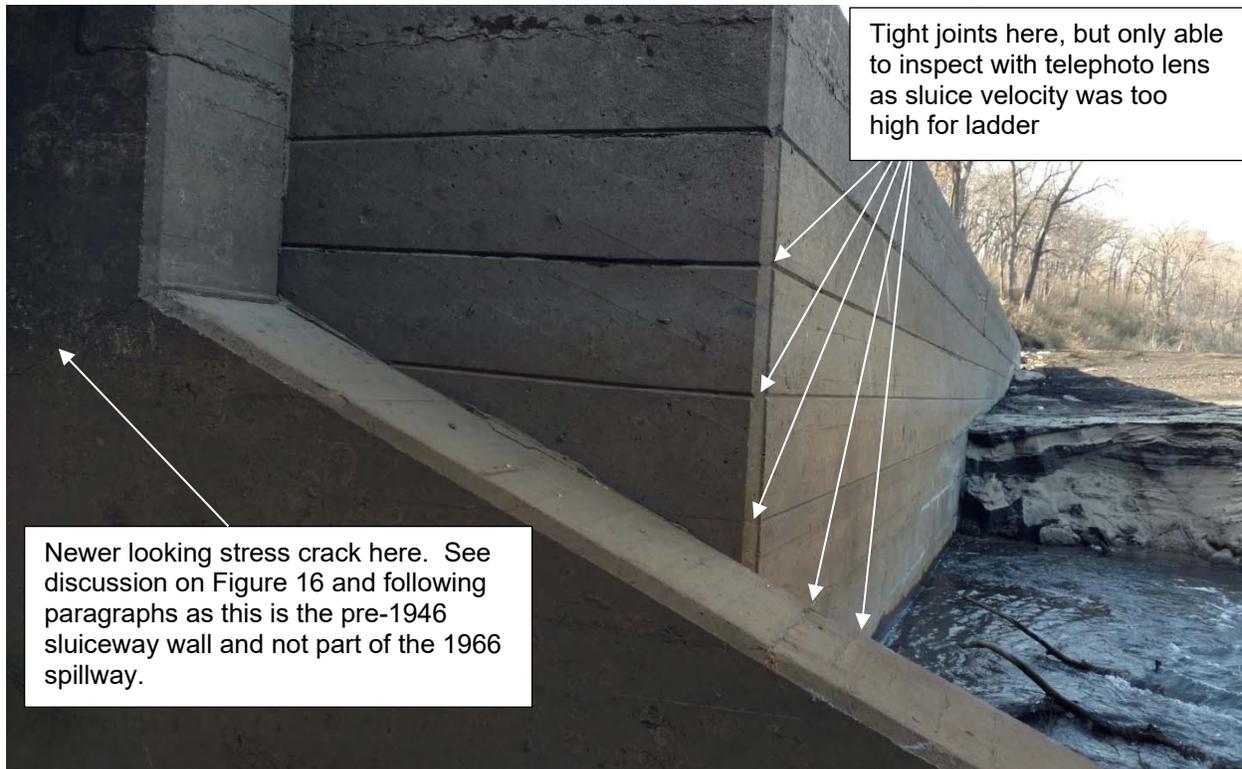
Tight joints here, but only able to inspect with telephoto lens as sluiceway velocity was too high for ladder

Newer looking stress crack here. See discussion on Figure 16 and following paragraphs as this is the pre-1946 sluiceway wall and not part of the 1966 spillway.

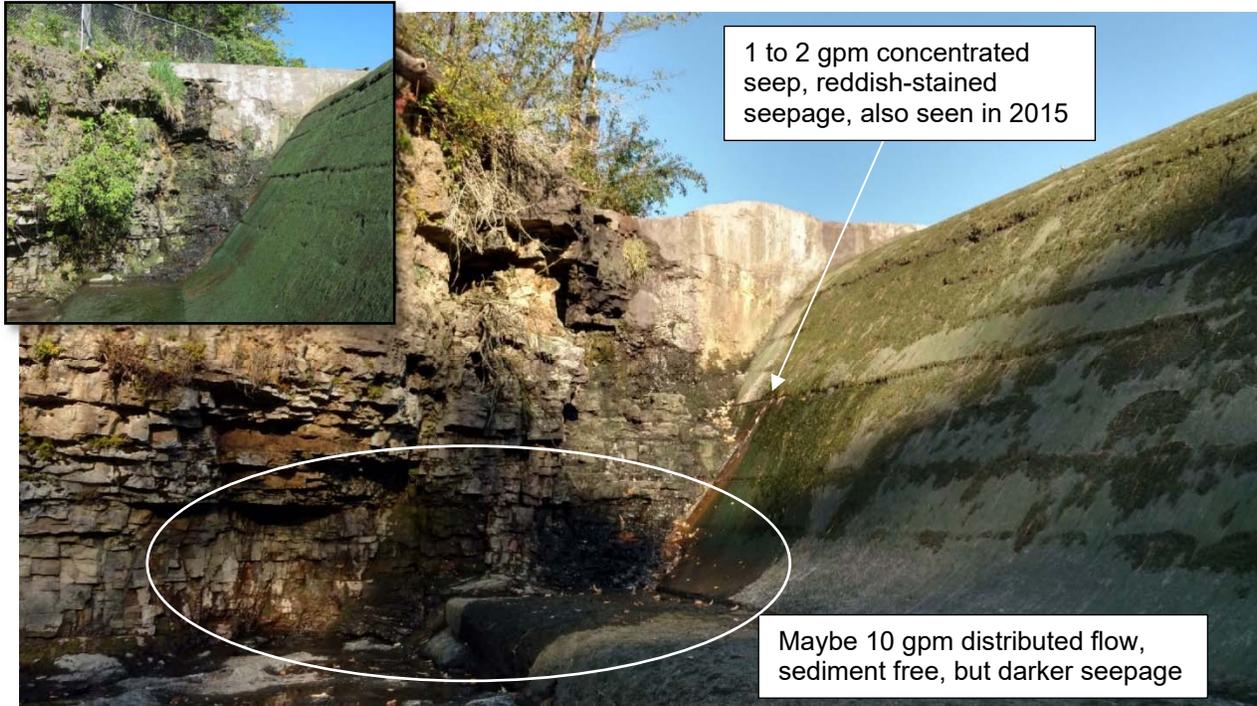
Seepage coming from the downstream face of dam near the right abutment was noted from the fourth lift joint down from top. However, Ayres was unable to determine if this seepage was coming from under the right abutment (transferring along crack) or flowing from the impoundment sediments through the crack. Figure 7 shows the lower rock layers are weeping about two feet lower than the lift joint.

Figure 7. Downstream face of spillway near right abutment. Inset shows condition in 2015.

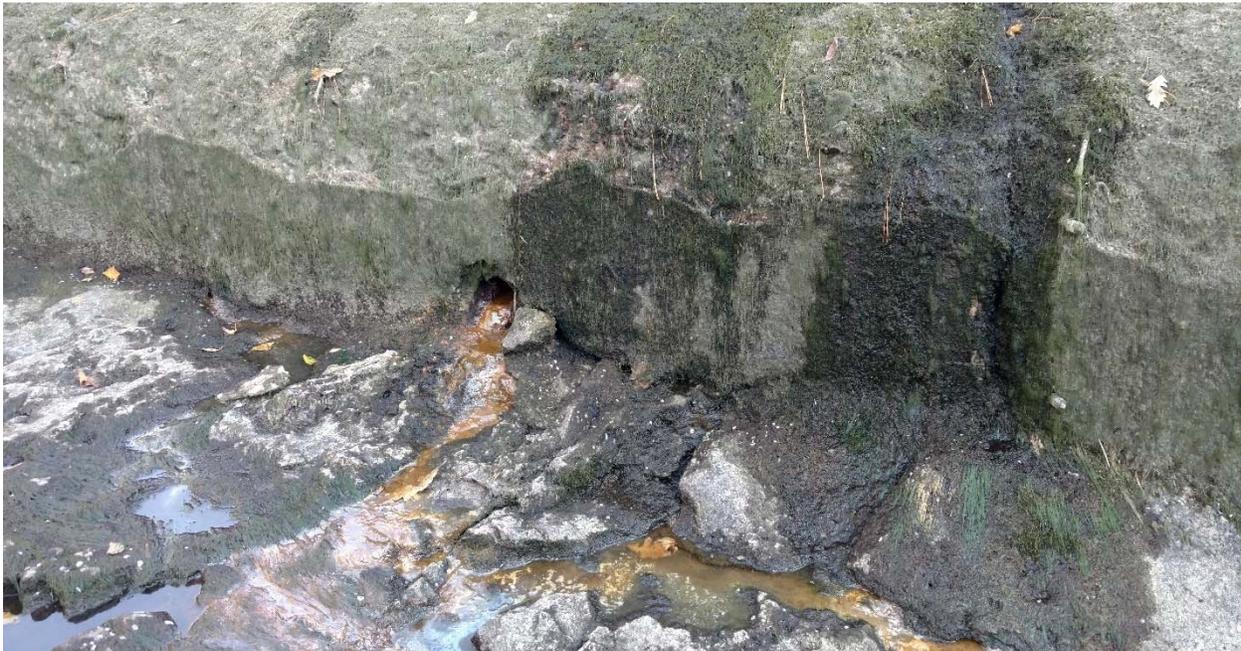
Figure 8. Typical discharge for clay tile foundation drains, possibly containing iron bacteria (red stains, labeled as “ochre” in the 1992 documents) and indicating significant levels of calcite deposits in drains (2020 minus 1966 is only 54 years, but 6” drain exits are partially blocked with calcite)

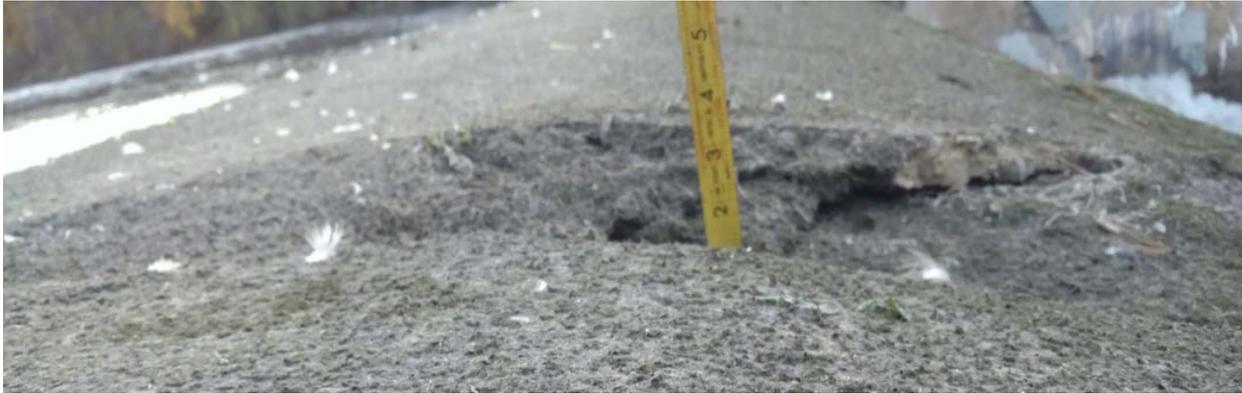
Figure 9. Looking eastward along spillway crest at spalling loss of 0.33 feet of concrete depth along deep longitudinal crack that runs from spillway crest down through at least one lift joint. Crack (but not the spall) is shown in October 1992 crack inventory, and no post-tensioned anchor is within damaged concrete area.

- Divots in spillway should be pressure-washed, cleaned, and repaired in accordance with a suitable concrete repair product. A competent concrete patch should be installed to last at least four years (including three Wisconsin winters).

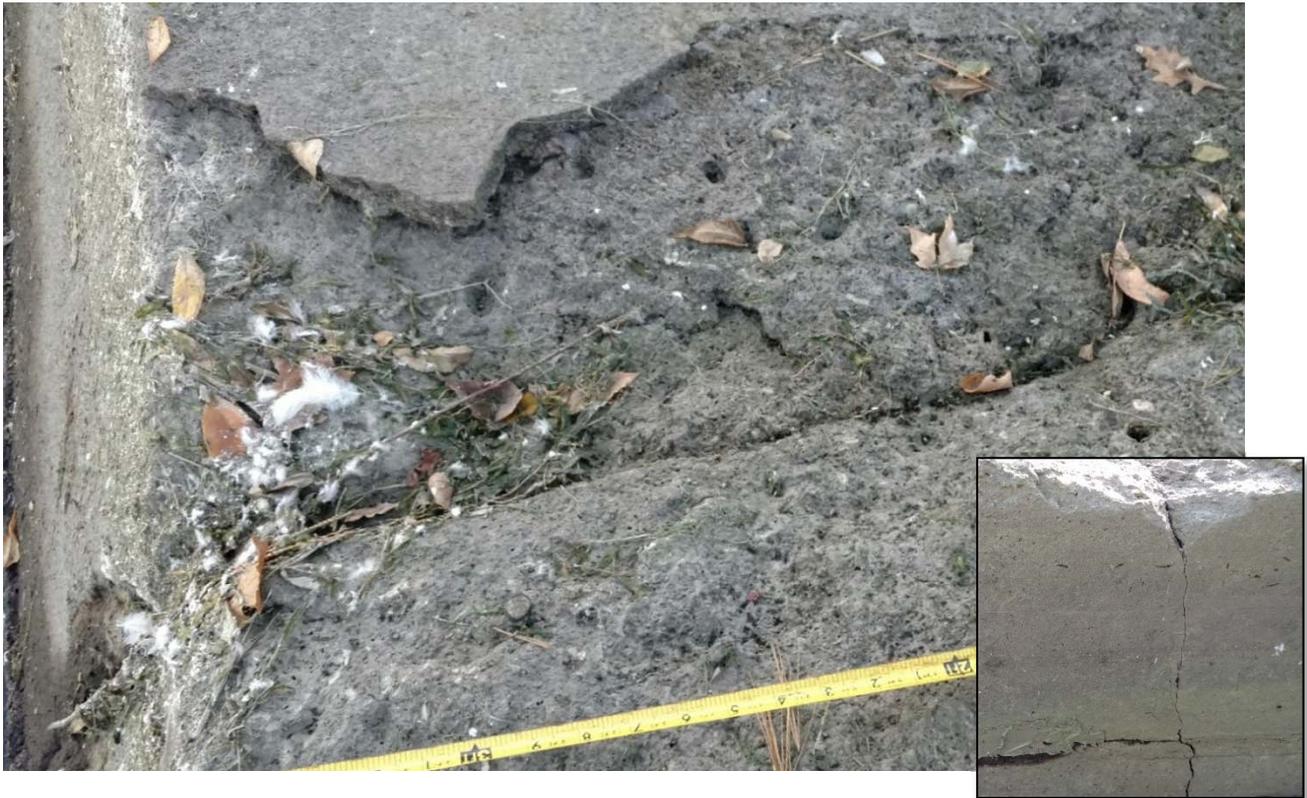
Figure 10. Another large spall, looking at top of spillway with upstream face inset to right. This crack extends through at least two lift joints, perhaps this is the same spall noted in 1992 but repaired thereafter. Inset shows view of this crack from upstream after cleaning – note how crack goes down at least through two lift joints (three horizontal monoliths).

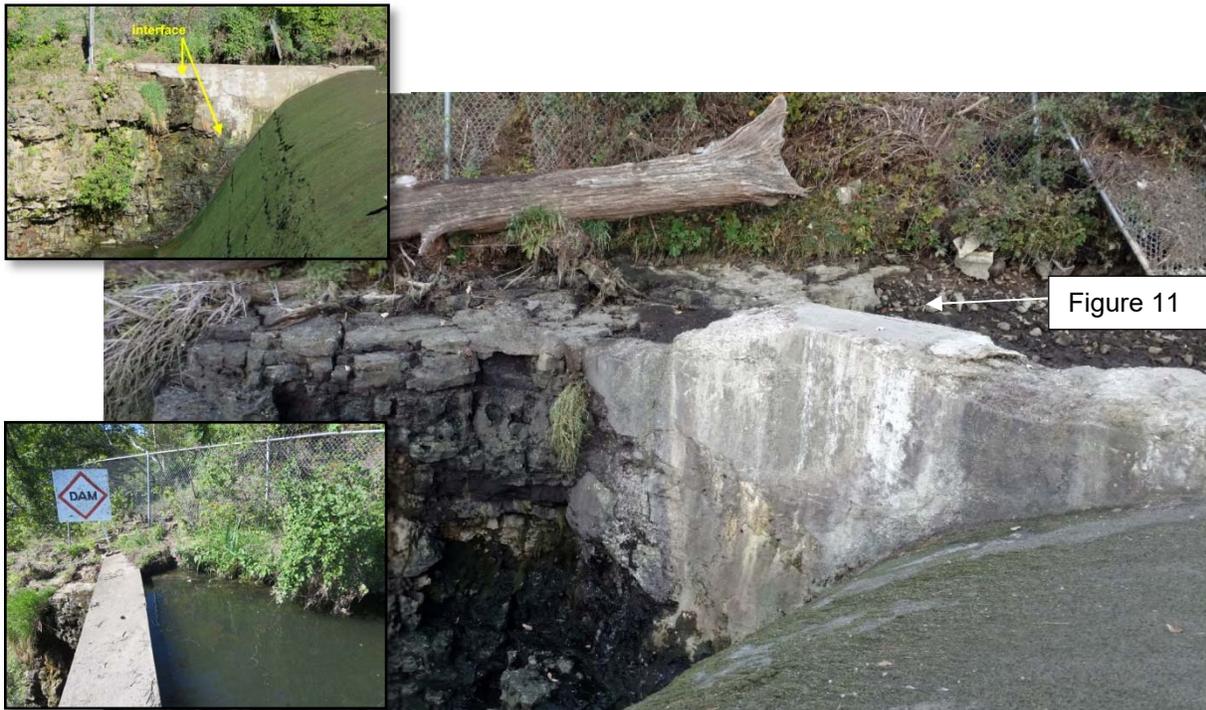
Between 9 and 15 inches (variable height along length of prior abutment tie-in wall) of the right abutment concrete and bedrock was removed by the 2020 flood. Figure 11 shows the overall area, and Figure 12 shows the remaining bedrock where the concrete used to hold back headwater.

Figure 11. Looking west at right abutment, noting loss of up to 36 inches of shoreline soil. The tree trunk is approximately 21 inches in diameter at breast height for scale reference. Insets show 2015 condition.

- Repair needs (around³ \$100,000 for design, construction, and permitting)
 - Right abutment must be restored to allow low flow in winter to be distributed across the entire upstream face of spillway to keep ice pressures below the 5000 pounds per linear foot threshold assumed during the 1992 anchor design

- As a preliminary estimate, this requires 25 cubic feet of reinforced concrete wall, doweled with anchors into the bedrock; and then the upstream bedrock is slush-grouted to prevent seepage through the highly fractured layers of exposed bedrock.

- A geotechnical engineer should confirm the suitability of this bedrock for reinforcing dowels. From Ayres' surficial inspection, the bedrock is highly fractured, so a geotechnical engineer may prescribe deep dowels and/or removal of the top layer of weak bedrock.

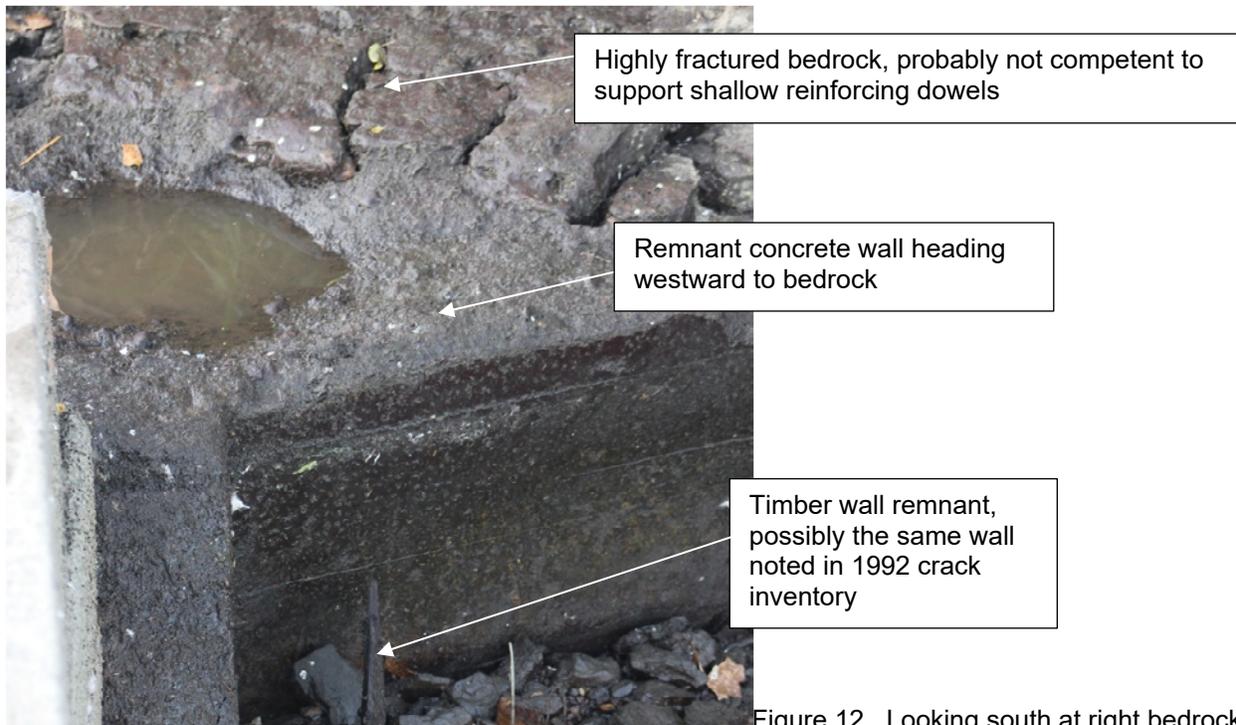
Figure 12. Looking south at right bedrock

The bedrock is most likely the same as recovered in nearby borings to elevation 820 at Junction Falls by SOCON in 1989. If so, this bedrock would be light brown dolomite with vugs, numerous vertical,

horizontal, and inclined joints with intermittent shaley seams and a RQD value of 7%. From Ayres' experience on this same bedrock at other local dams, this type of bedrock is susceptible to freeze-thaw damage (external weathering), internal seepage, and hydraulic plucking during overtopping events.

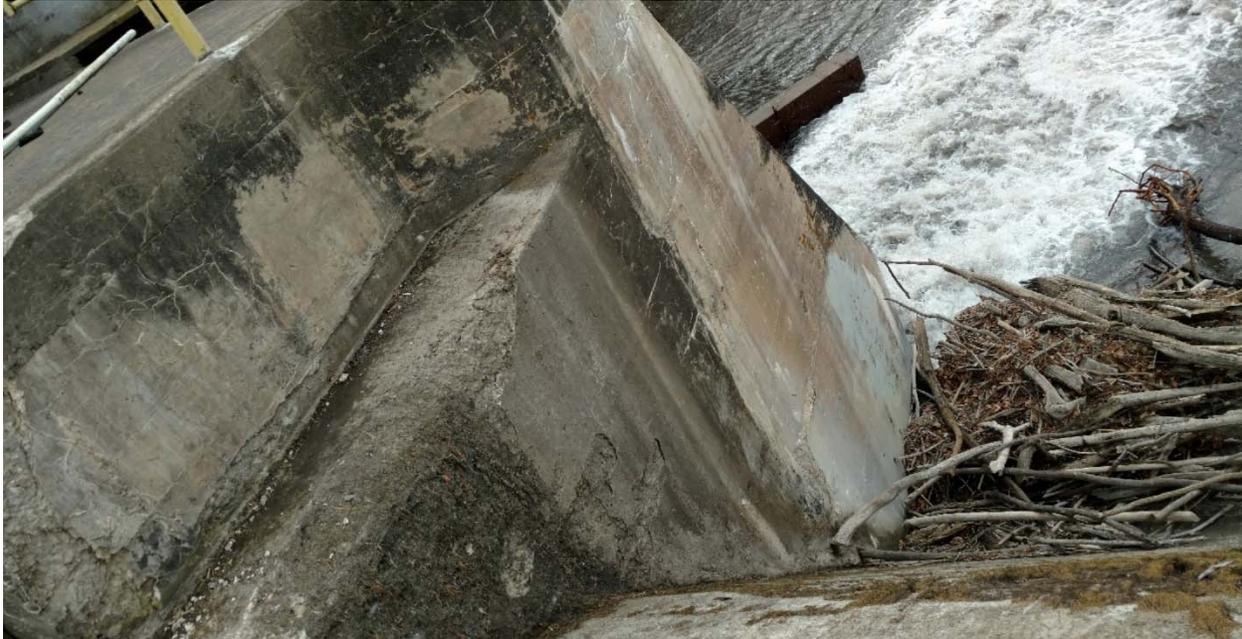
The left abutment of the spillway is sound, but surface weathering and efflorescence are widespread.

Figure 13. Left abutment of spillway, note all these logs are from the October 12 rain event

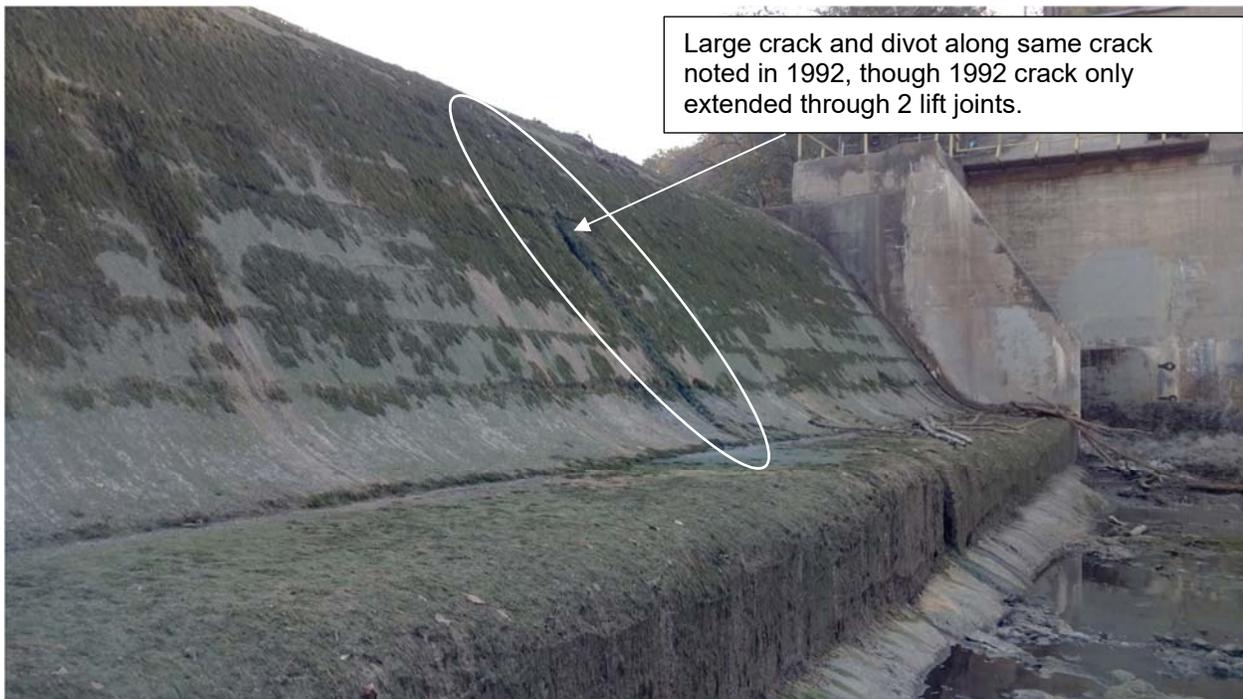
Figure 14. Looking northeast at spillway and left spillway abutment on October 5 (note lack of logs shown in Figure 13).

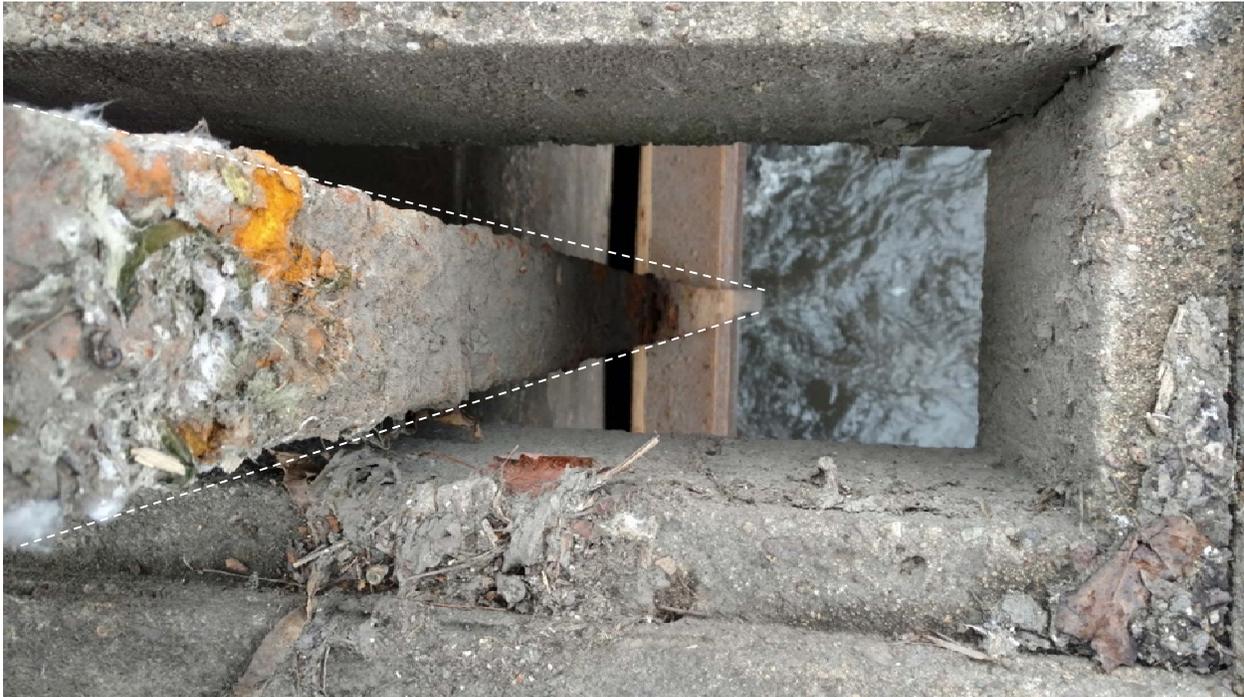
Figure 15. Looking downward at sluice gate stem, note loss of structural section, severe corrosion, and possible bow (dashed lines indicate expected edge of beam). Gate was extremely difficult to operate.

- Repair the sluice gate to allow dependable operation during the future proposed decommissioning and dam removal efforts. This repair would include replacement of the gate's bottom chord, strapping, and lift beam, and an overhaul of the gear/actuation system is highly recommended.

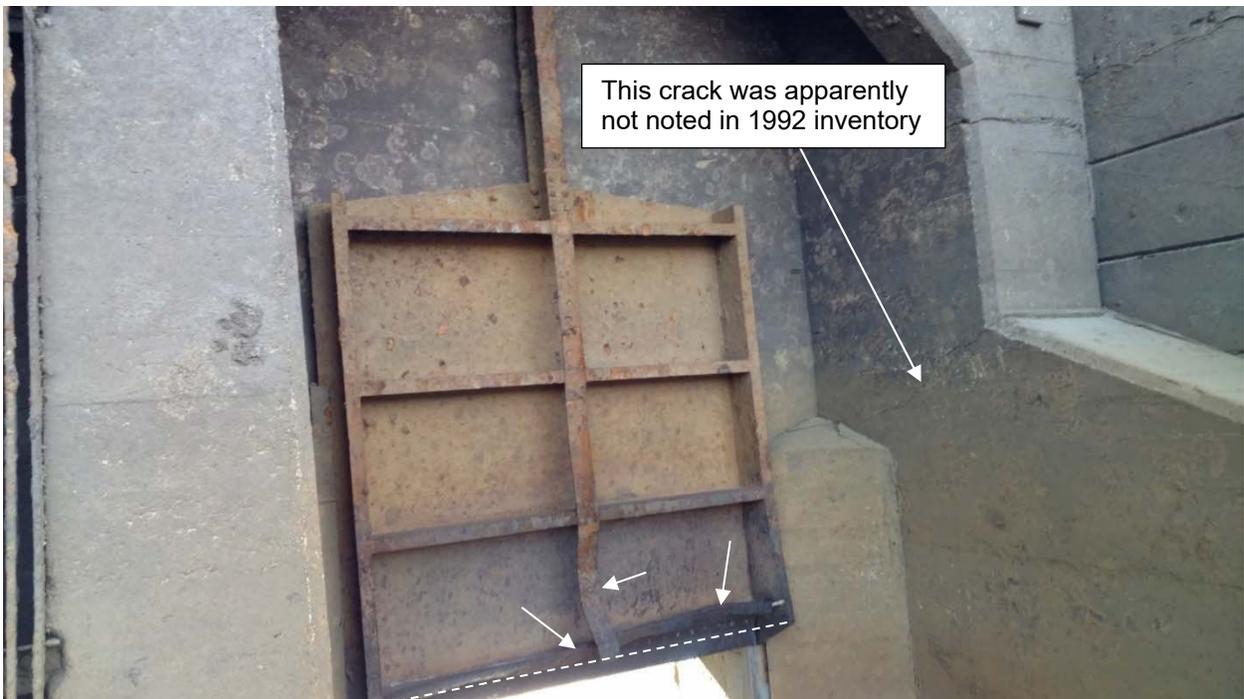
Figure 16. Looking southward at sluice gate, note damage to lower chord (log strikes) and strapping

The crack on the right sluice wall was not written in the October 1992 inventory, and this crack does appear newer than the other cracks on the dam. A differential diagnosis of this crack's cause would

include impoundment ice pushing southward against the relatively thin sluice structure OR thermal expansion differences between the large spillway mass and relatively thin sluice/powerhouse masses. The crack is a concern as it cannot be monitored directly during impoundment refill events. However, Ayres believes if the City wants to refill the lake, then the sluice deck movement could be monitored with a bubble level (simple inclinometer), regular monument surveys, and/or visual checks.

- A thorough trashrack cleaning should be completed prior to refill.
 - Monitoring needs
 - Regular monitoring of the sluiceway deck for movement that might indicate the crack shown in Figure 16 is progressively opening.

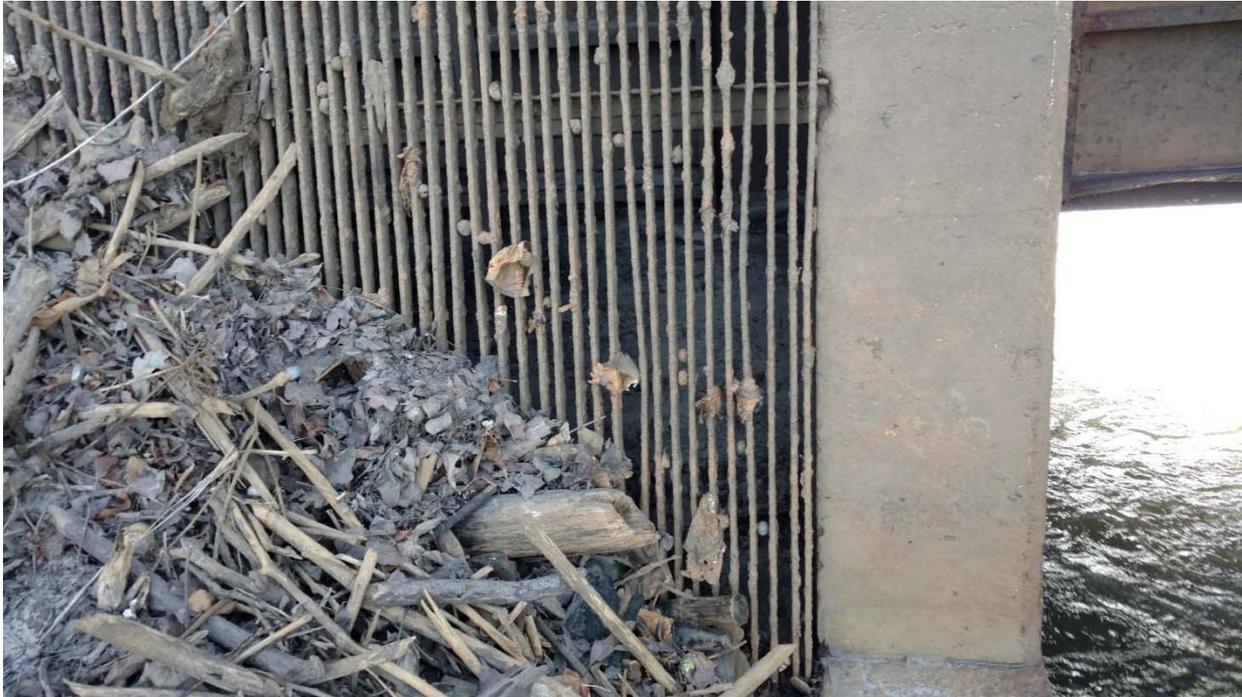
In Figure 17, the powerhouse trashrack is no less than 50% clogged with debris, which is the same clog percentage noted in 1992. Indeed, some of this debris looks very old. Given the large range in trash size and composition and understanding that cleaning a rack 12 feet below the surface is difficult for manual rakes, this rack plugging is most likely due to inadequate reach on the rack cleaning utensils.

Figure 17. Trashrack, plugged 50%. Also note sand deposits faintly visible in intake bay behind trashrack. Powerhouse intake bay gate is also faintly appearing behind trashrack – note that this gate's invert sill is several feet higher than the sluiceway gate.

- The powerhouse trashrack should be cleaned completely and adequate utensils procured to allow full rack cleaning. Note that most trashracks are only designed for a few feet of head differential before the rack fails, and debris/ice plugging have been responsible for historical trashrack failures at other projects.

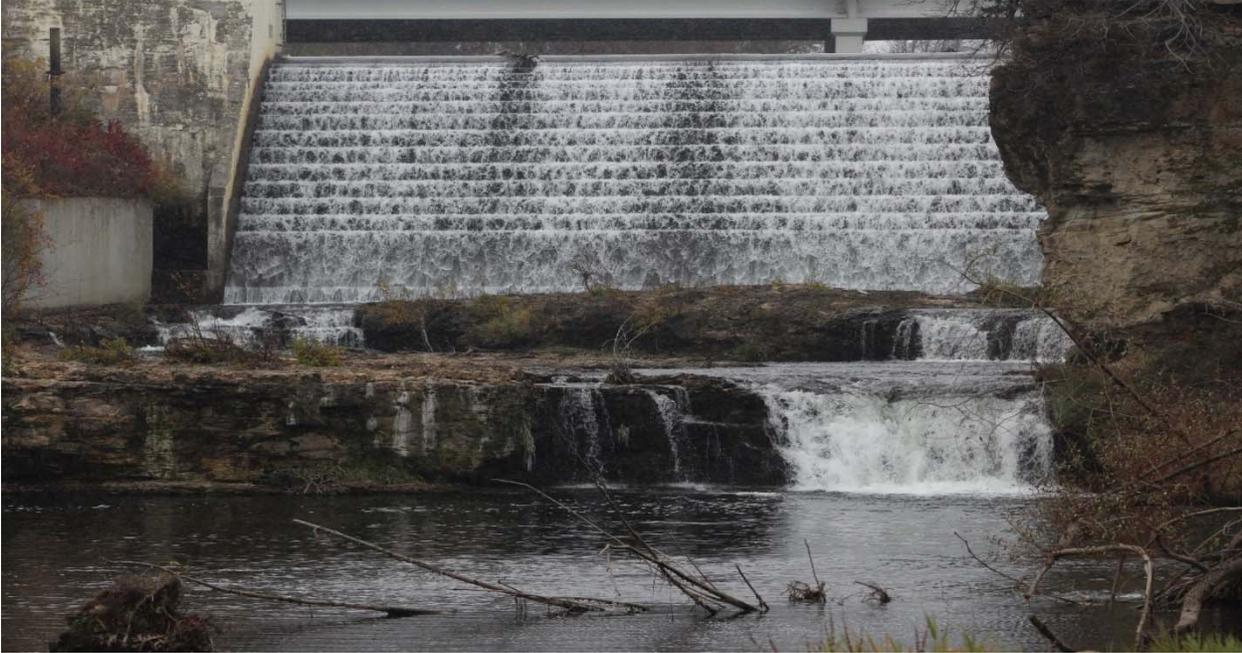
Figure 18. Looking upstream at Junction Falls tailrace. Note that waterline of scour hole is well downstream of spillway toe. However, Ayres did not walk on the toe of the Junction Falls spillway, so this view is as close as Ayres was able to safely access during the inspection.

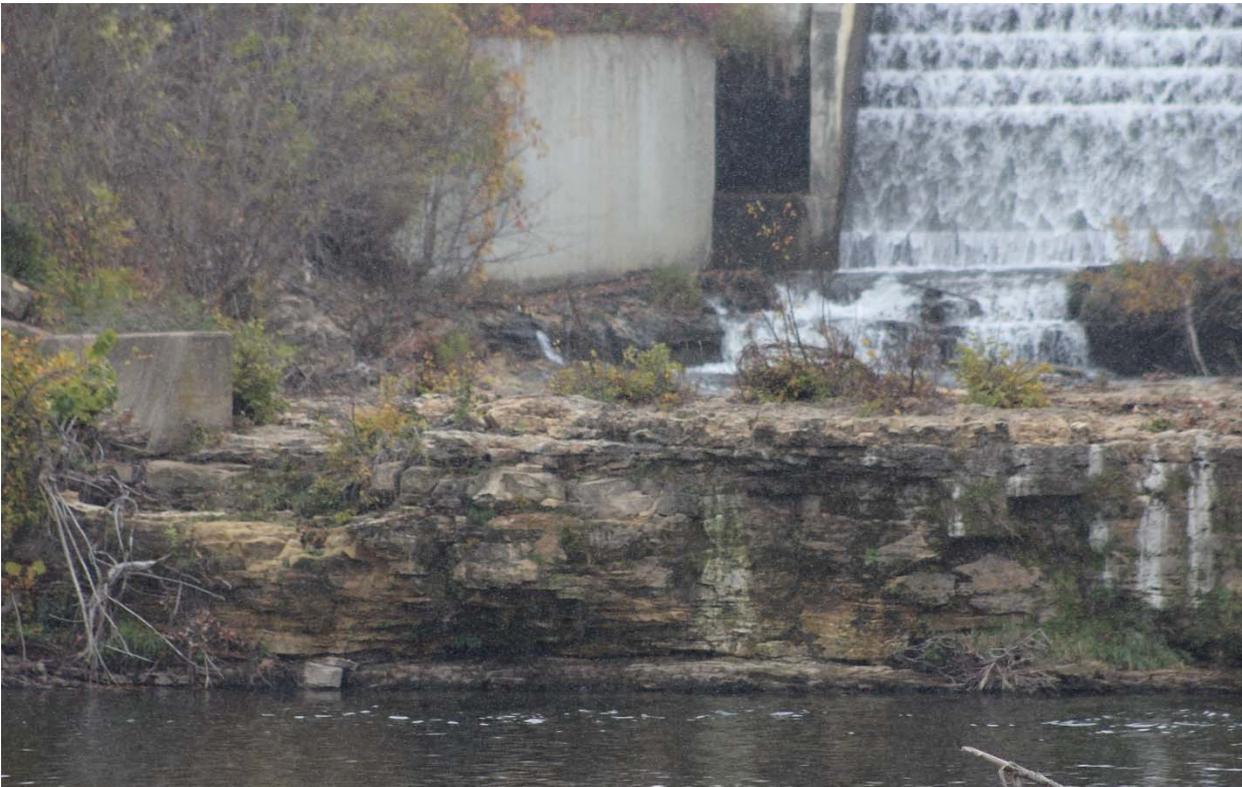
Figure 19. Looking northward at tailrace of Junction Falls. The scour hole along the training wall does not seem to be under the wall, though Ayres did not dive or hydrosurvey the ponded water.
