**River Falls Hydroelectric Project No. 10-489
12.10 Report**

This document has been created to satisfy 18 CFR 12.10 Reporting safety related incident during large rain event on June 28-29, 2020.

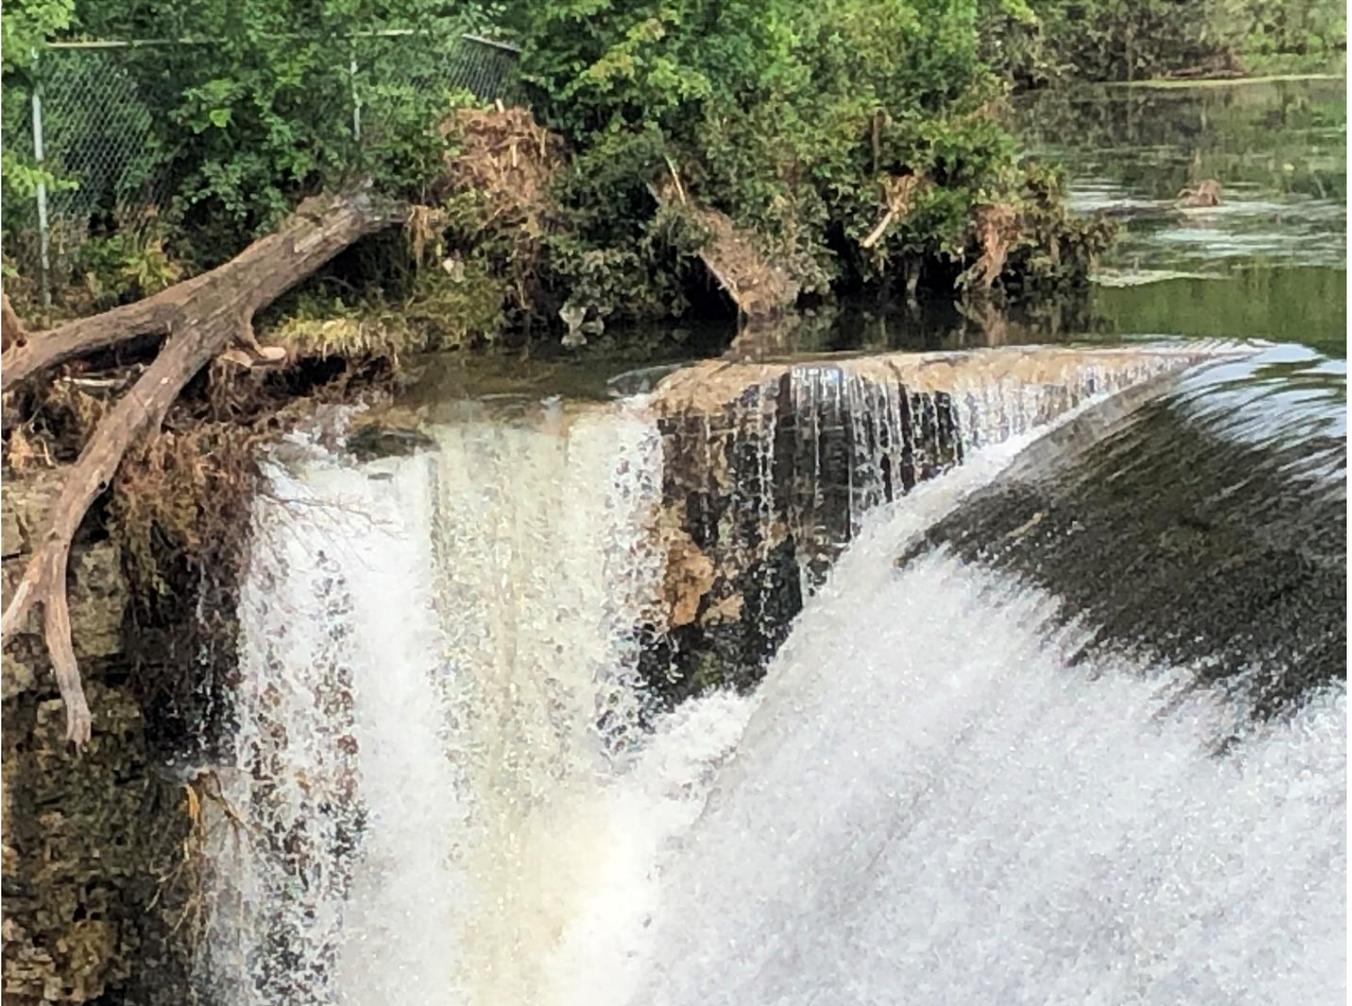
The Powell Falls dam has had the right-side training wall damaged to the extent of missing concrete and possible lowering Lake Louise 3 feet.

Right side of Powell training wall
broken off warning sign
bent over by log.
@ 8 ft section of the wall
gone hole left is 2'-
3' deep. It will drain down
Lake Louise

sandbags, stop logs
posts, or boards are we going
to fix it? or start the
lowering + remove process early

- The damage done by the flash flood on June 29 -July 1, 2020.
- Powell training wall, at this time no repair has been scheduled.
- Junction intake prescreen pulled from mounts sent downstream ending up below Junction Falls tailrace. Will try to salvage this.
- Junction Falls level gauge transducer pulled from mount sent downstream. Will need to replace.
- Warning buoys broke will need to reattach.
- Dam warning sign smashed right side Powell. Have replacement sign.
- The property around the project area is owned by the city. No private property in project boundary.

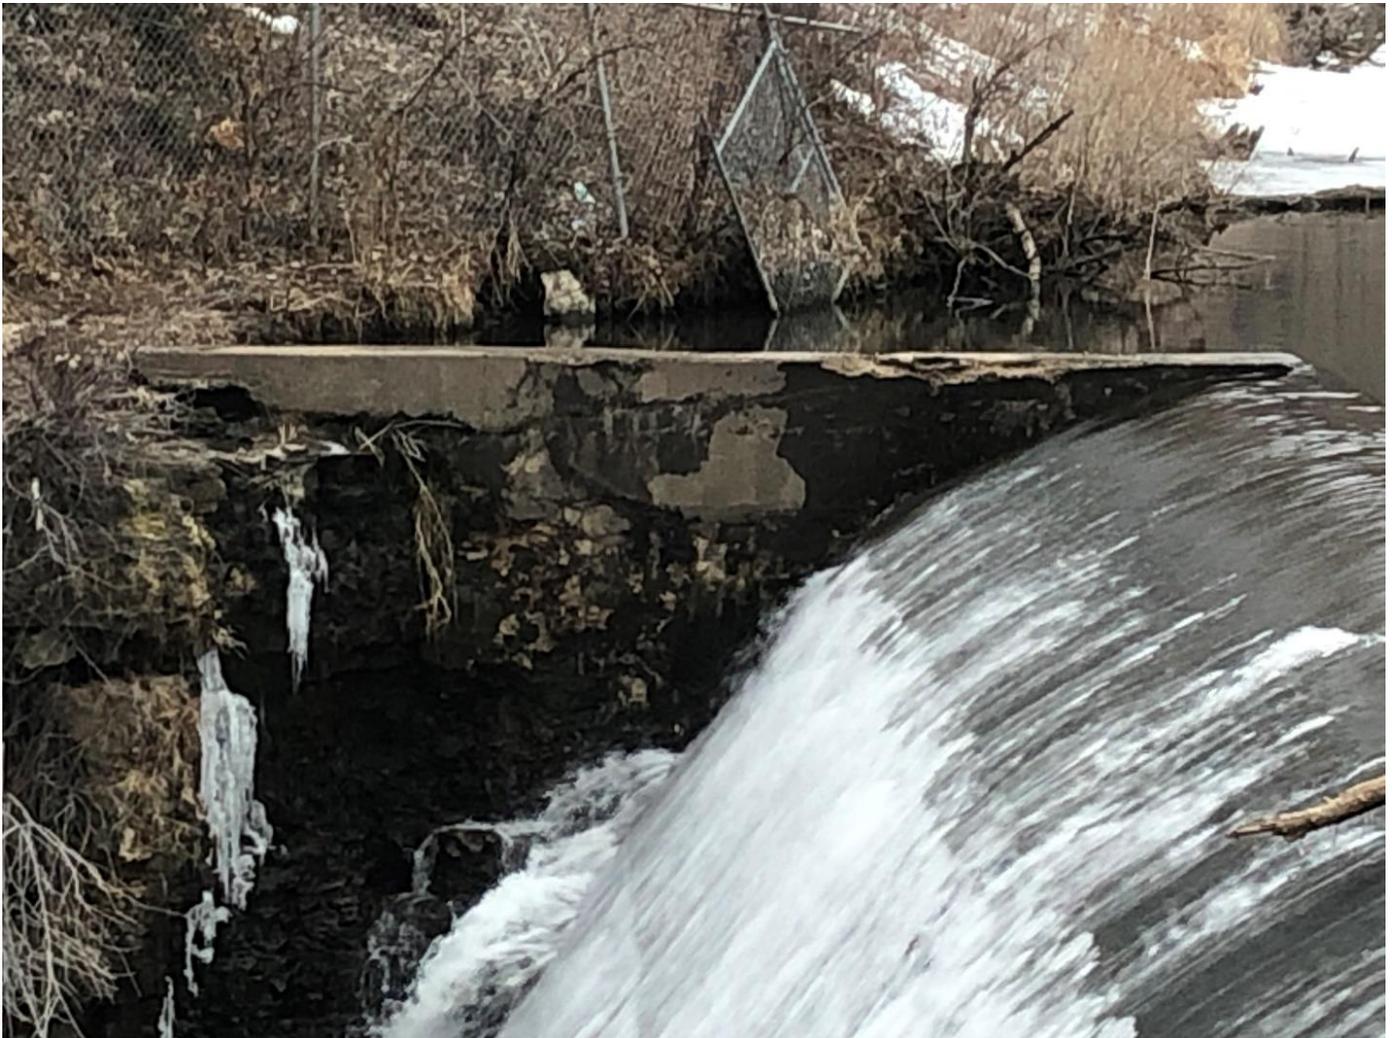
The picture below was on taken on March 16, 2020 before the damage.

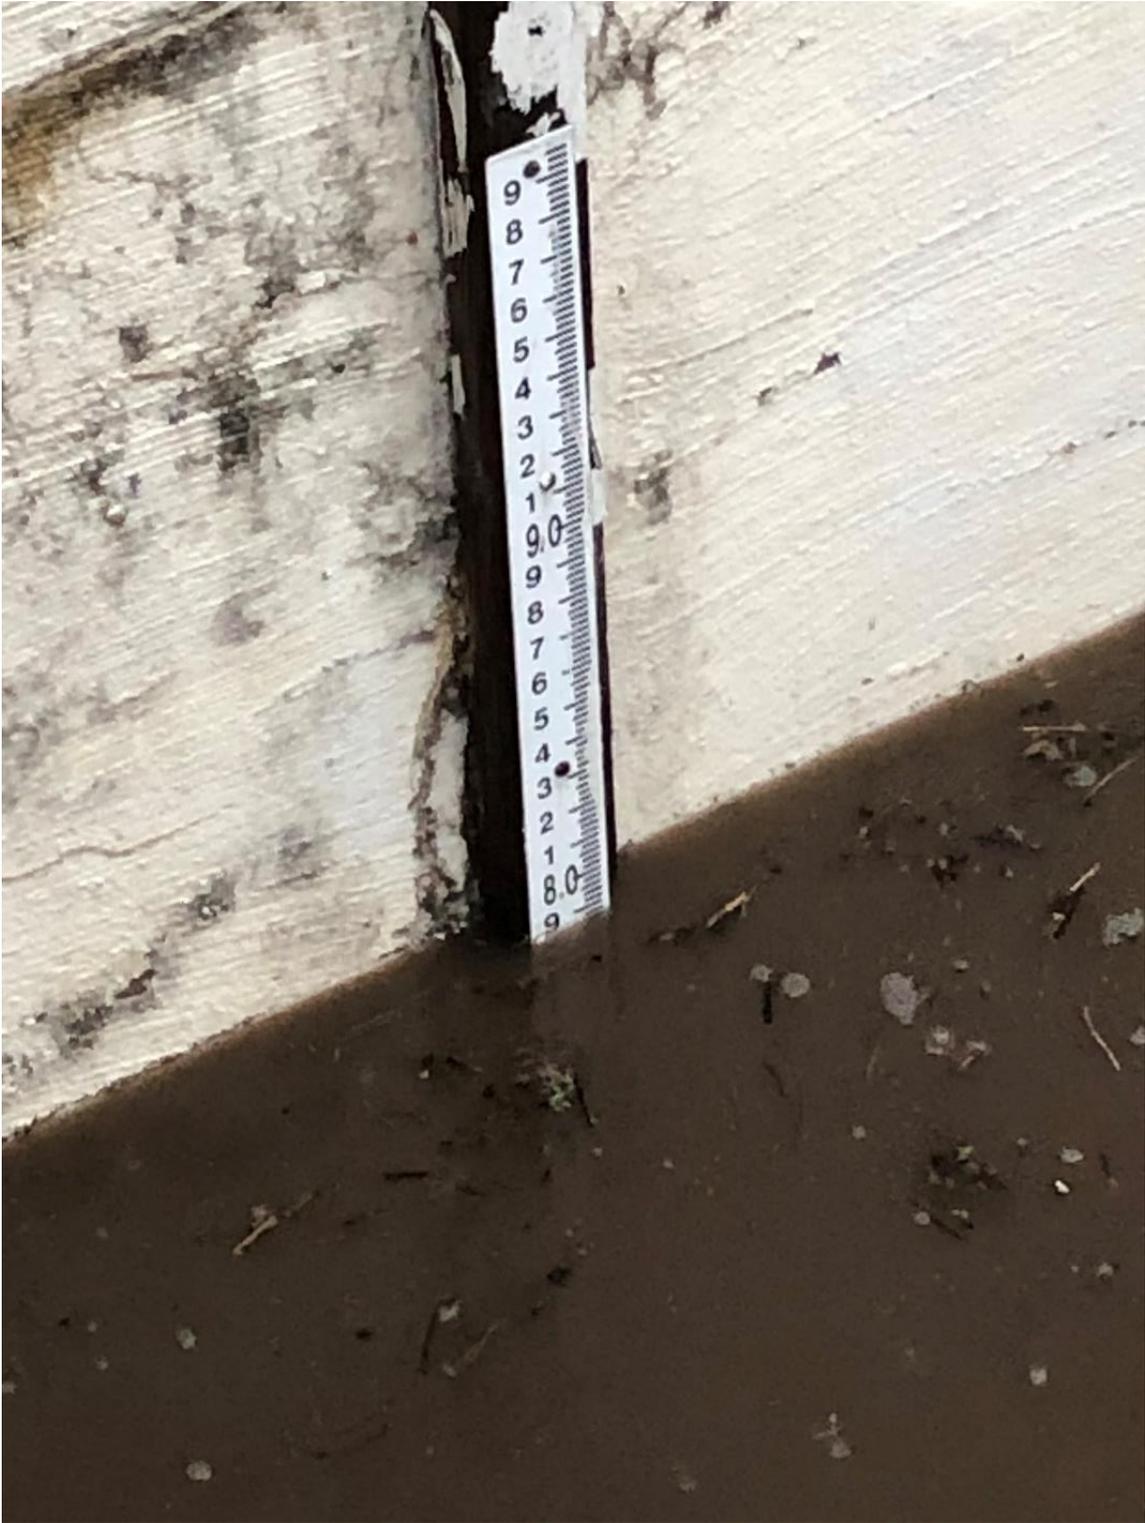
There were no measures taken to prevent worsening. The river was rising fast, and the picture shows the staff gauge at the Junction Falls intake. The dam crest is at 865.3 and the picture below reflects it at 867.9 at 7:06 a.m. on June 29.

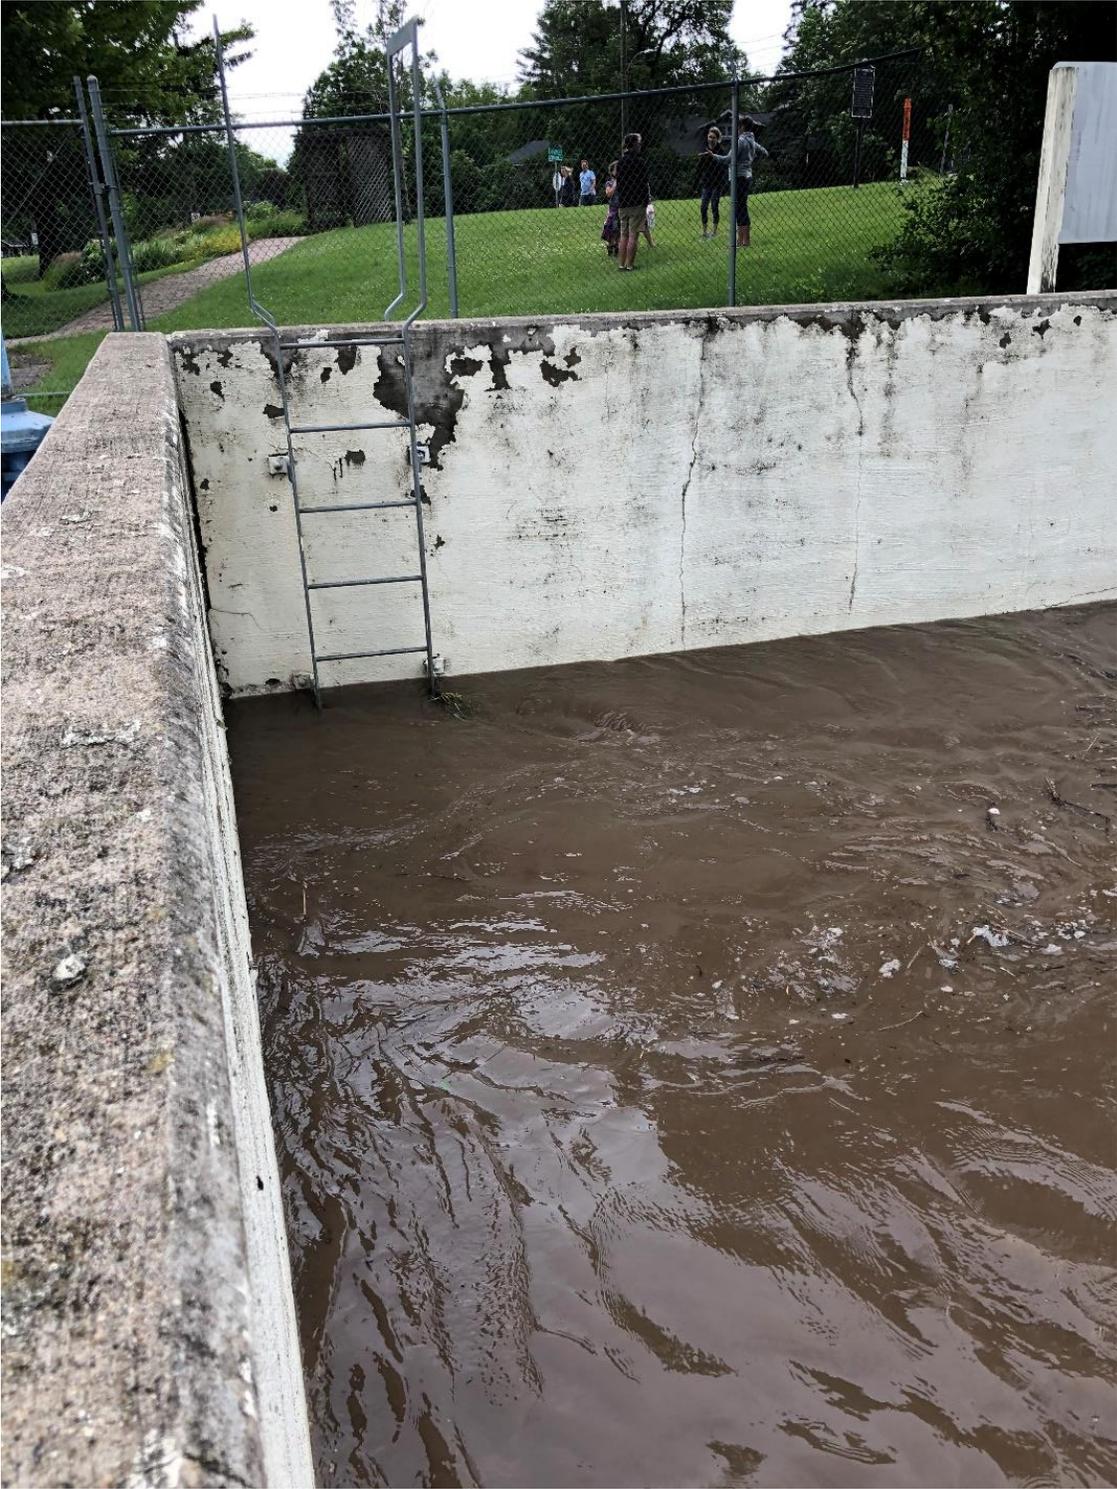
On June 29 at 2:20 p.m. the staff gauge was underwater.

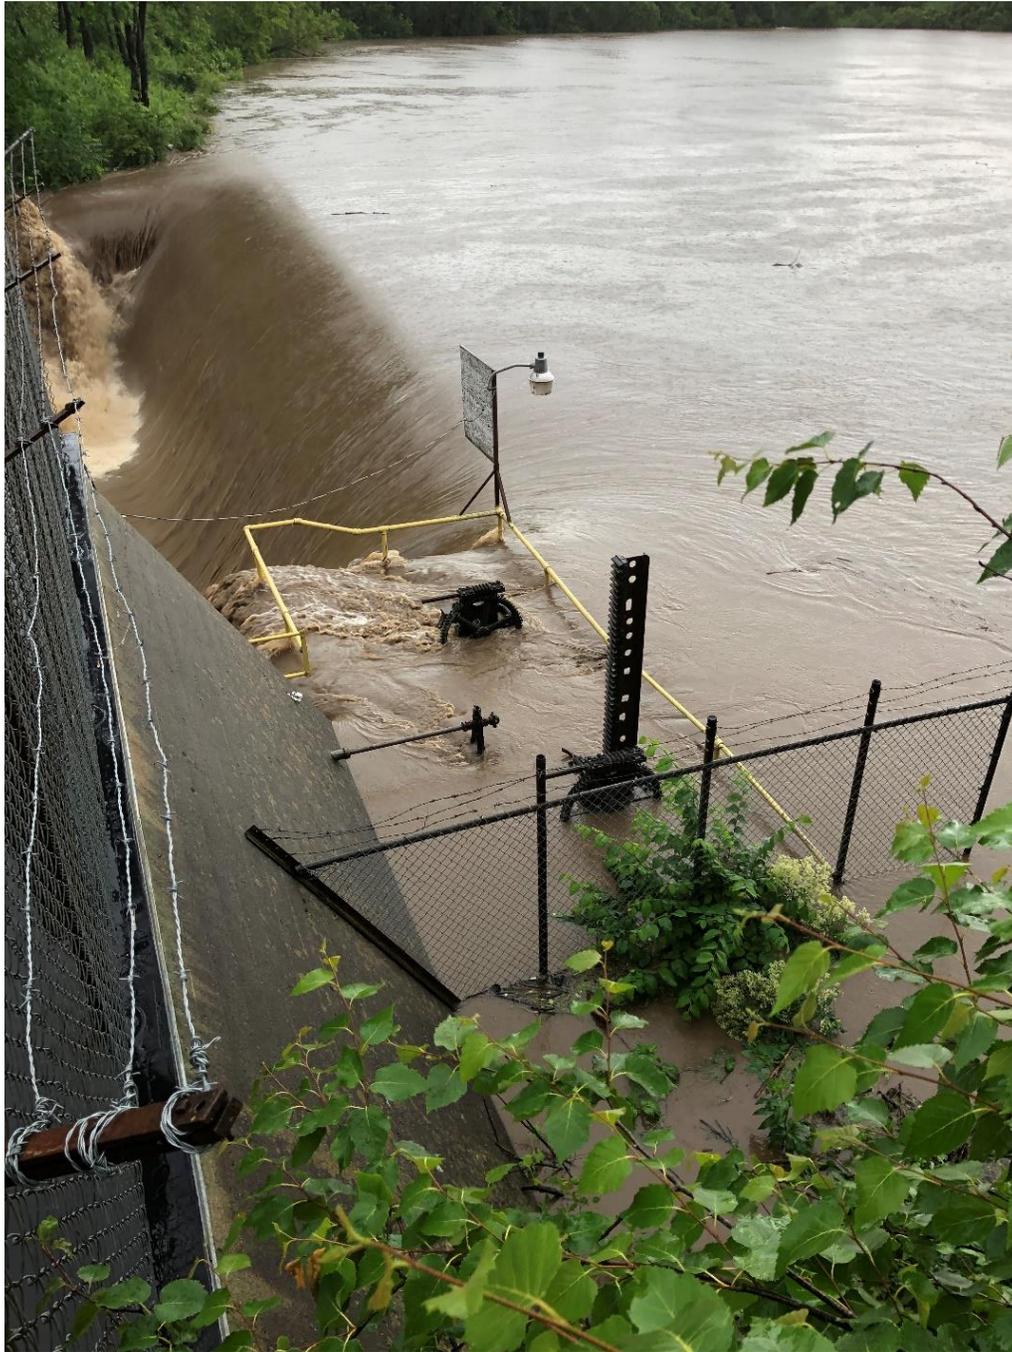
The water was carrying large debris downriver during this time frame. The headworks at Powell Falls were underwater with water flowing fast over it and was unsafe to access (time 7:55 a.m. on June 29).

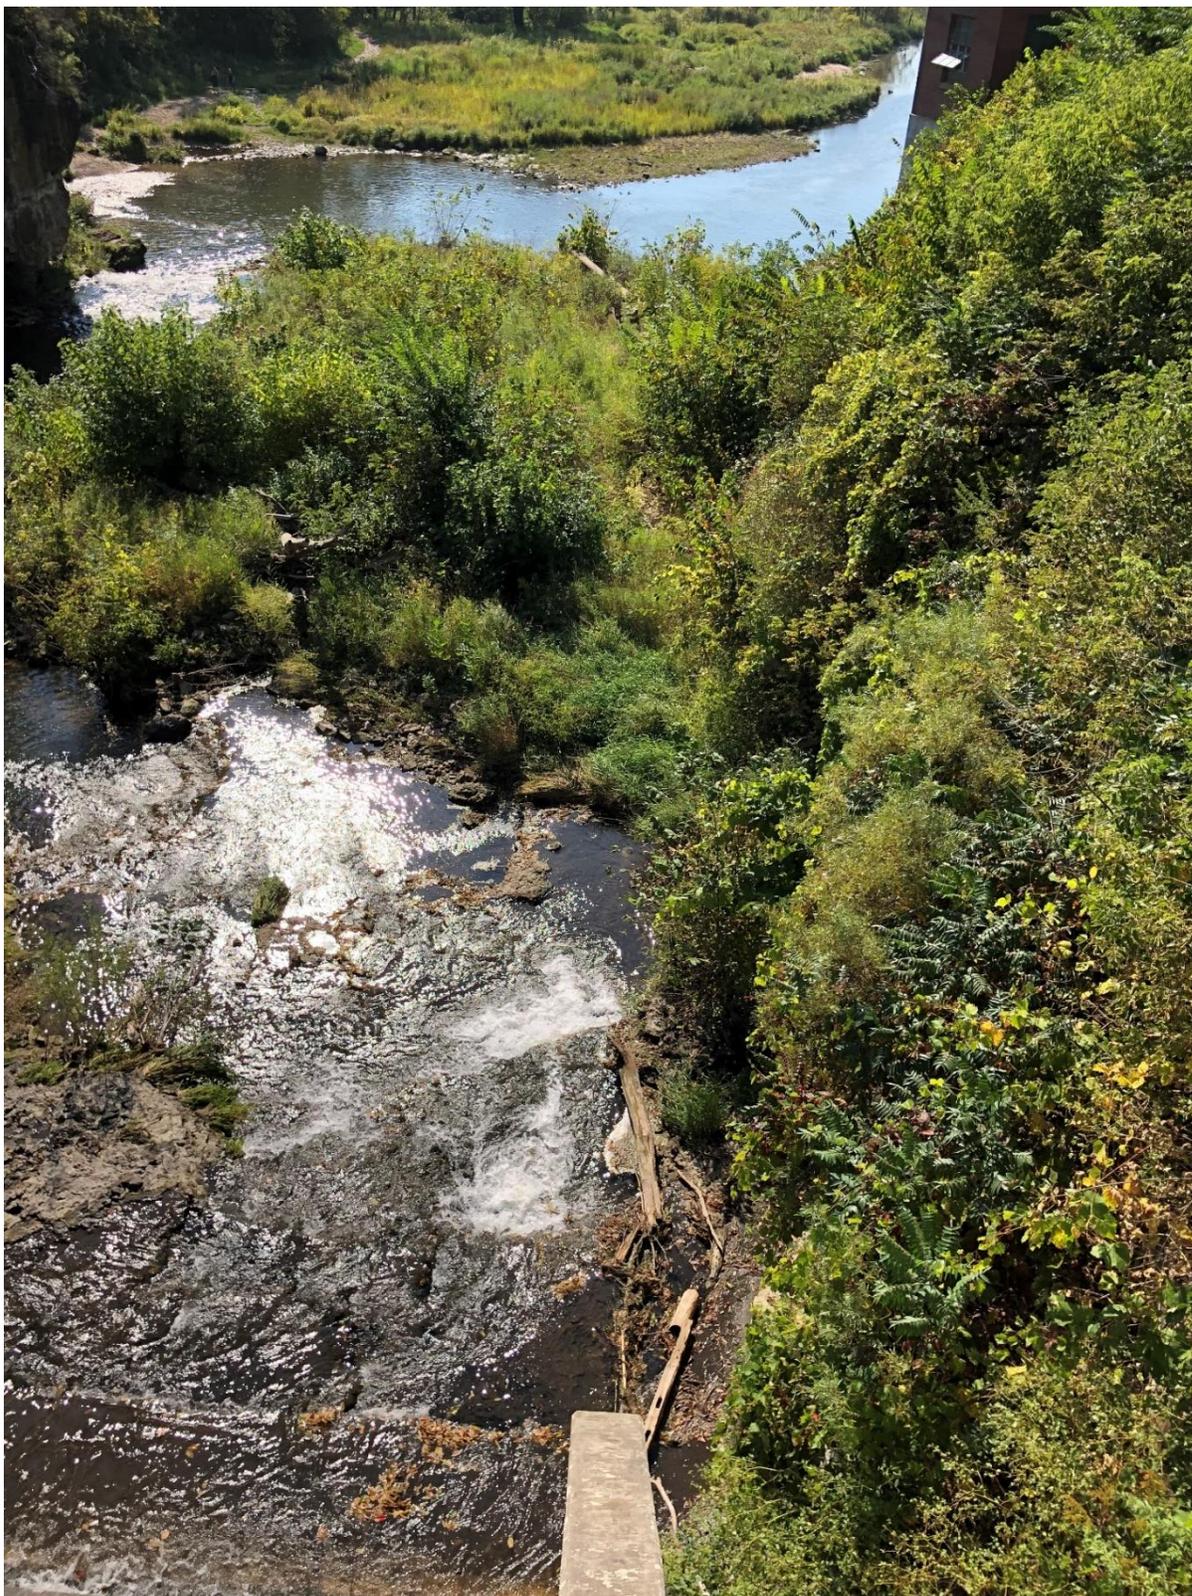
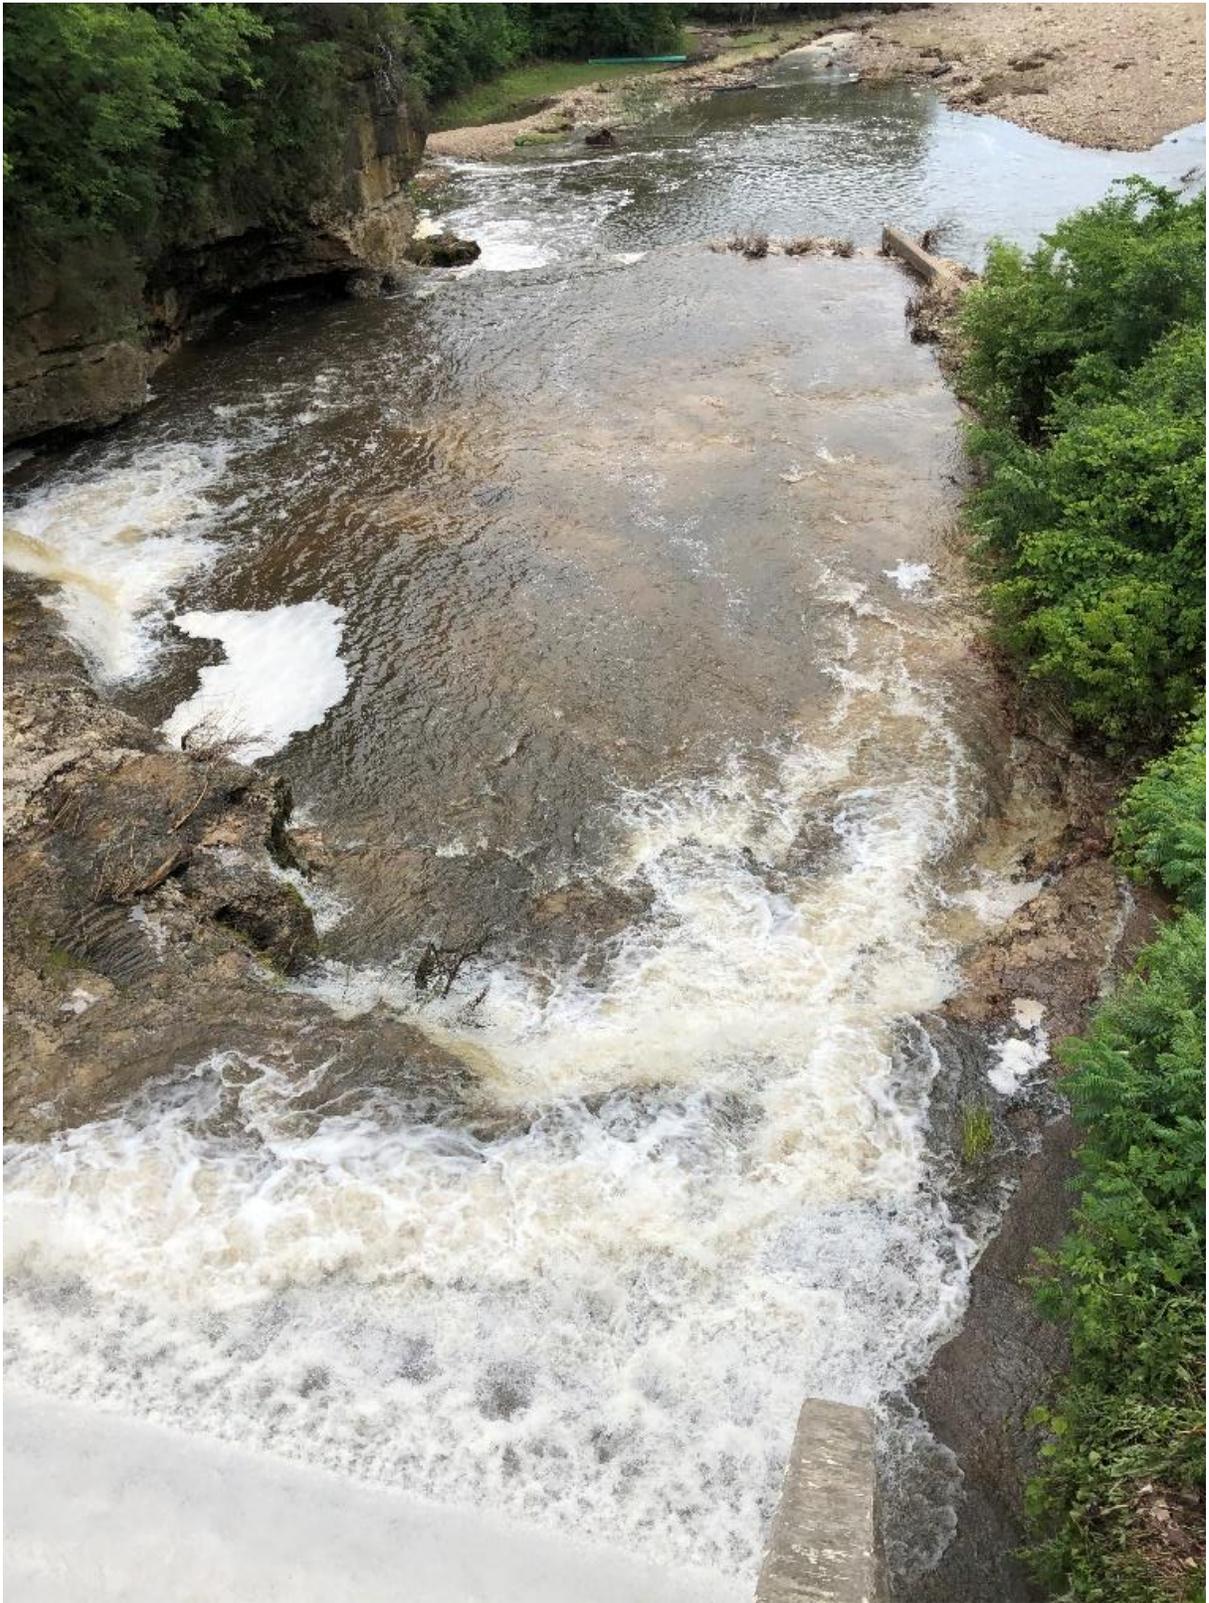
More pics before and after below of Junction Falls on the next two pages.

below Junction limestone
wiped clean of brush + weeds
looks nice.
Lost transducer for level
lost ext screen it is below
Junction in tailrace all bent

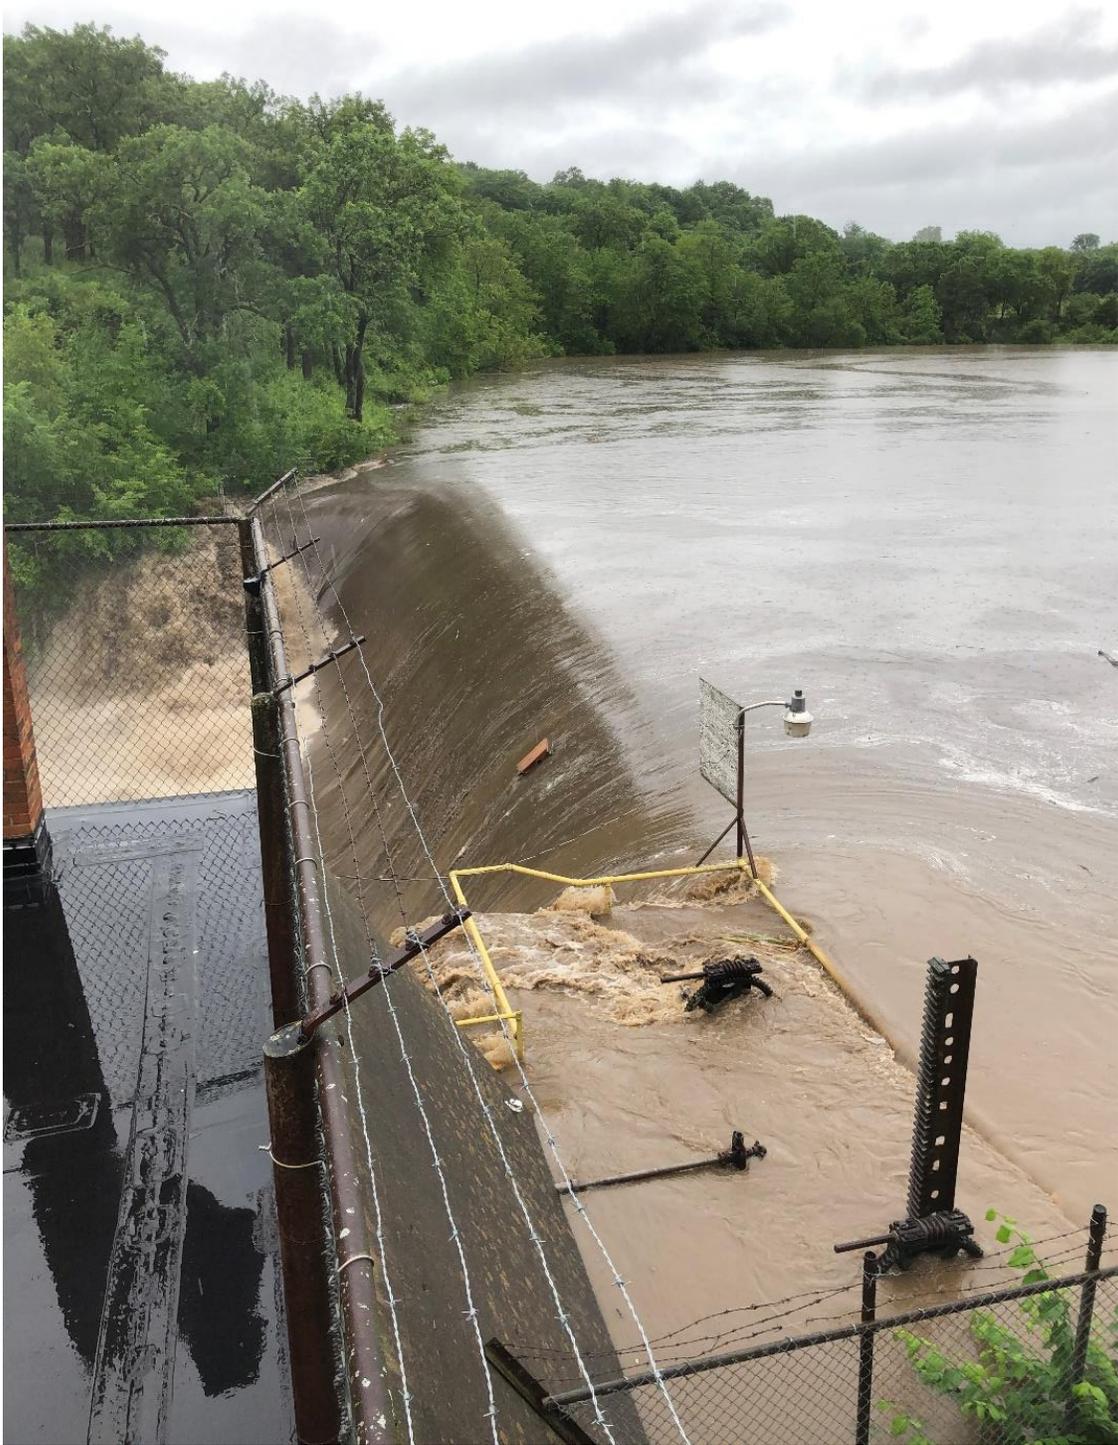
The pictures below are from the height of the flood at Powell Falls and Junction Falls. At the USGS station downstream the flow was at 3890 cfs at 905 a.m. June 29th.

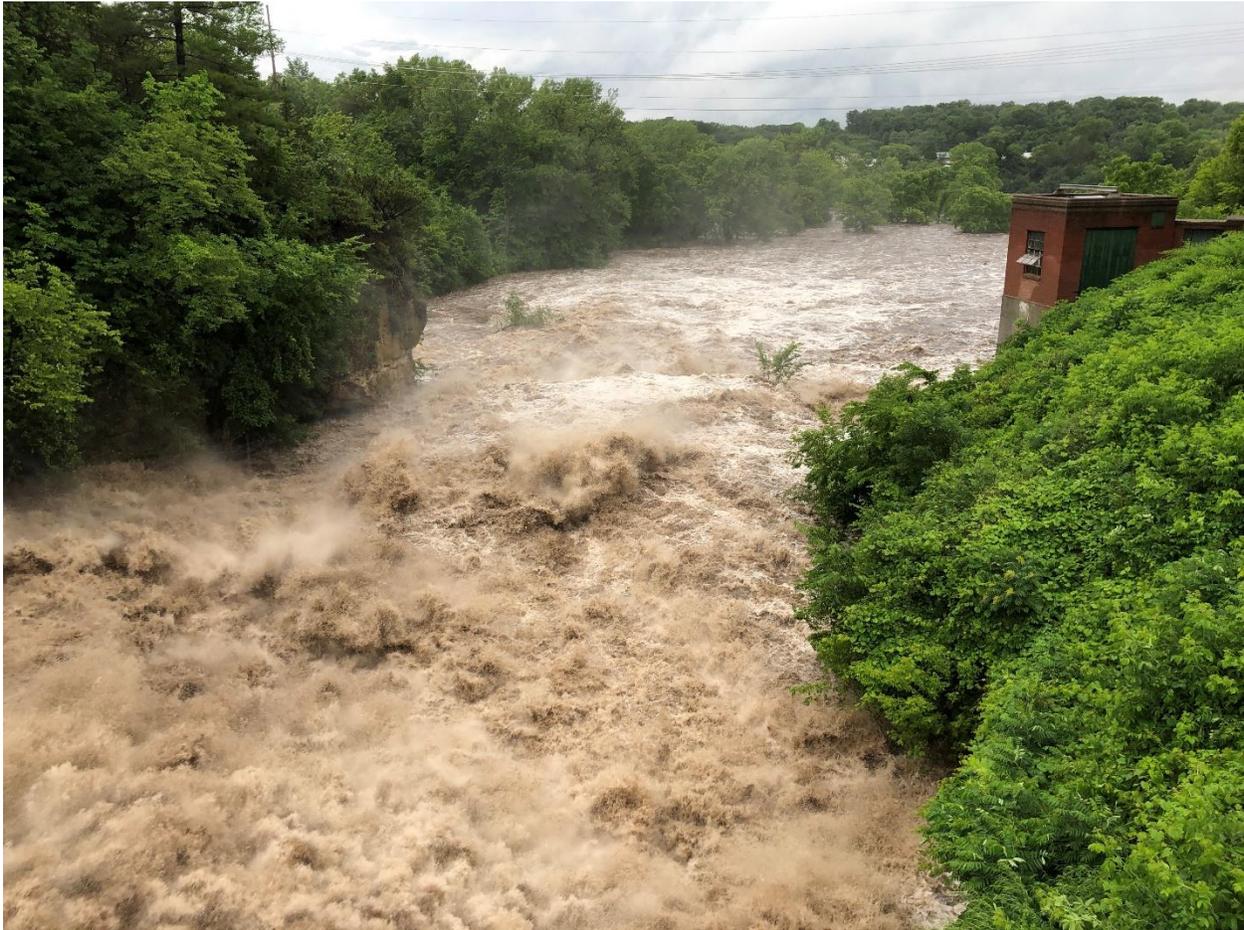
At the height of the flood it was at 7 feet above the crest of the dam (this is an enormous amount of water).
