# Repair Summary - Immediate Action

**Date:** 9/23/2025  
**Time:** 3:31:41 PM  
**Temperature:** Over 65  
**Weather:** Clear  
**Age Of Building:** Over 50 years  
**Building Type:** Single Family

**Client:** RAHB Investor Inspection  
**Real Estate Agent:** Steven Brockway  
**Attendance:**

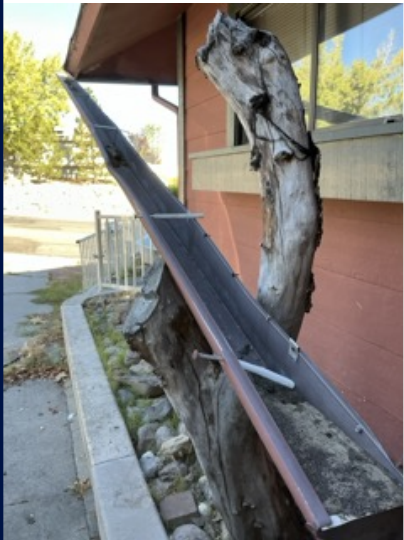
Exterior Picture:9

Gutter is leaking at the front. --See Exterior Picture 9

Gutter is leaking at the front.

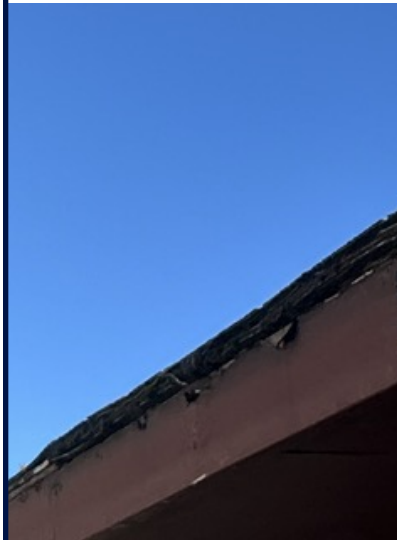
Exterior Picture: 10

Gutter has fallen out of place. --See Exterior Picture 10

Gutter has fallen out of place.

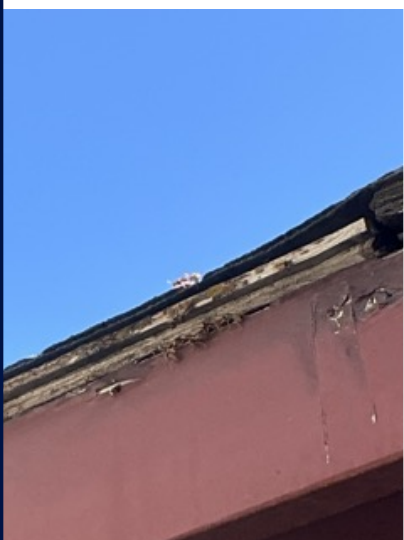
Exterior Picture: 11

There is no drip edge and the roof sheeting is moisture damaged. --See Exterior Picture 11

There is no drip edge and the roof sheeting is moisture damaged.

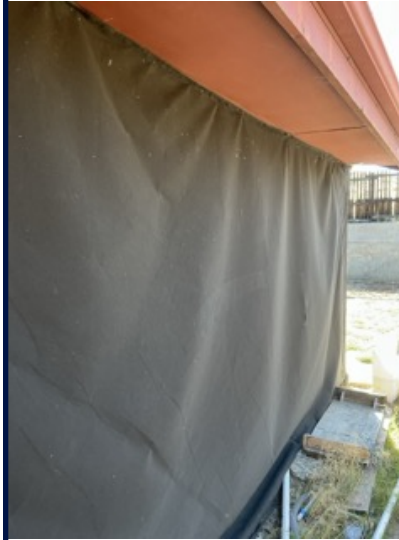
Exterior Picture:20

Siding is moisture damaged. --See Exterior Picture 20

Siding is moisture damaged.

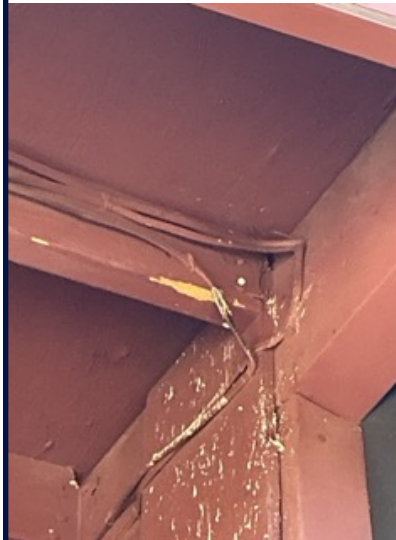
Exterior Picture:28

Electrical wiring under the back porch should be in conduit. --See Exterior Picture 28

Electrical wiring under the back porch should be in conduit.

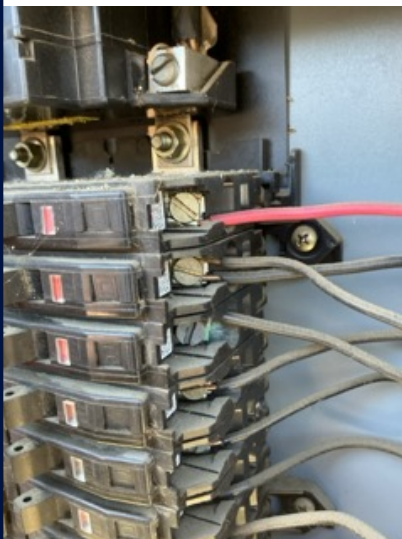
Exterior Picture:35

The electrical panel is not well marked. Recommend marking for safety. --See Exterior Picture 35

The electrical panel is not well marked. Recommend marking for safety.

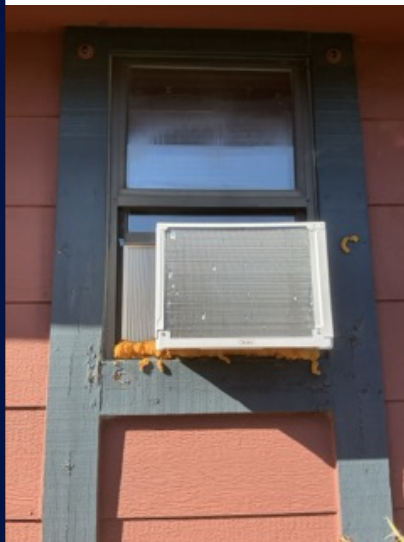
Exterior Picture:37

The seals on some windows around the home may be broken. There is moisture/staining inside the windows. The windows still function but are less efficient and when the water evaporates, it leaves stains on the inside. --See Exterior Picture 37

The seals on some windows around the home may be broken. There is moisture/staining inside the windows. The windows still function but are less efficient and when the water evaporates, it leaves stains on the inside.

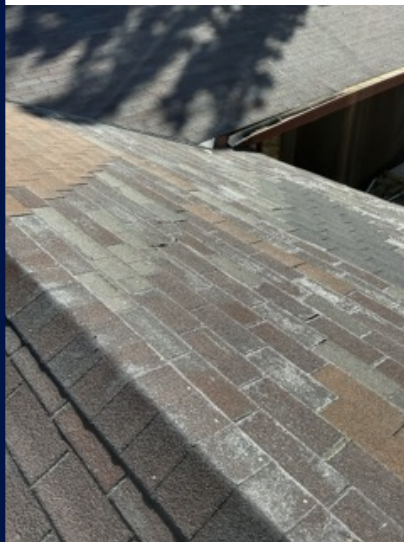
Exterior Picture:39

Roof sheeting is lifting over the garage. --See Exterior Picture 39

Roof sheathing is lifting over the garage.

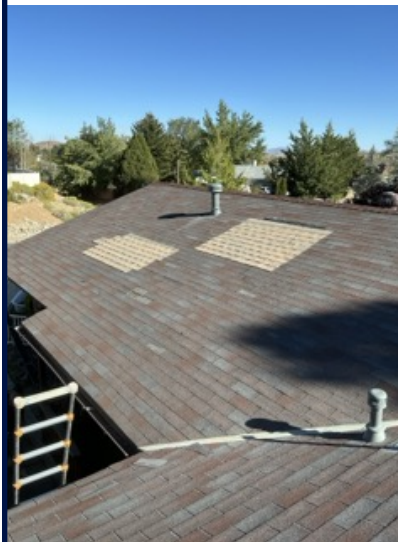
Exterior Picture:40

The roof is past its useful life. Recommend roofing inspection. --See Exterior Picture 40

The roof is past its useful life. Recommend roofing inspection.

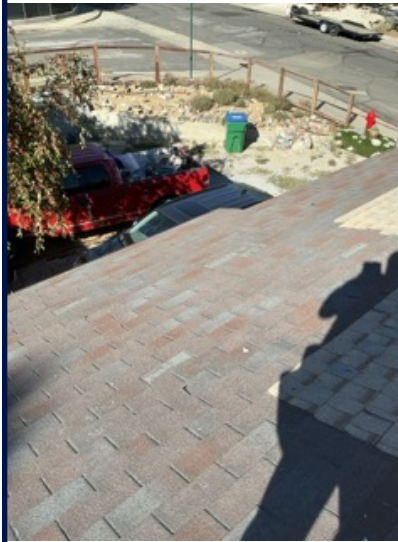
Exterior Picture:44

Roof has been patched in multiple areas. --See Exterior Picture 44

Roof has been patched in multiple areas.

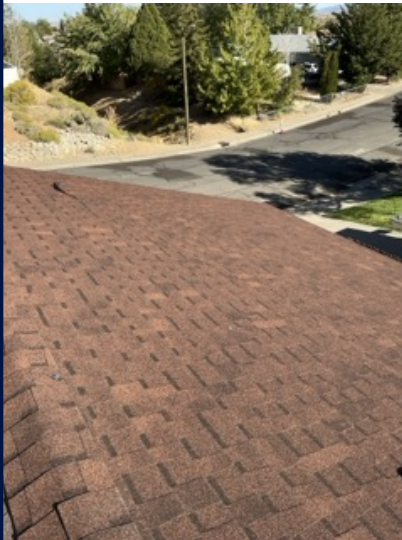
Exterior Picture:45

Shingles are missing in multiple areas. --See Exterior Picture 45

Shingles are missing in multiple areas.

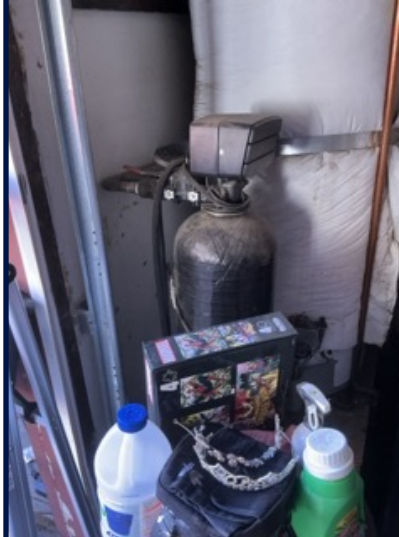
Interior Picture: 3

Water heater does not have a pan or expansion tank. . . . See Interior Picture 3

Water heater does not have a pan or expansion tank.

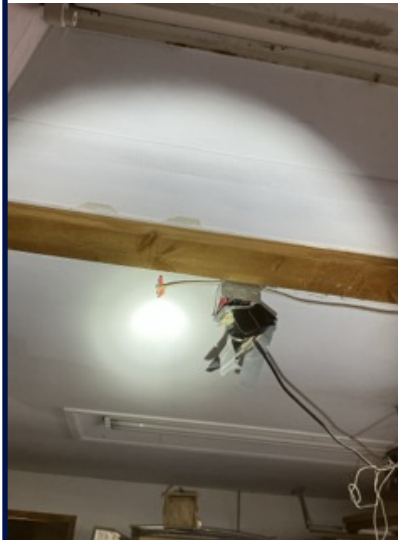
Interior Picture: 8

Some of the electrical wiring in the garage does not appear to be professionally done. The junction plate cover is held in place with duct tape and has fallen out of place. . . . See Interior Picture 8

Some of the electrical wiring in the garage does not appear to be professionally done. The junction plate cover is held in place with duct tape and has fallen out of place.

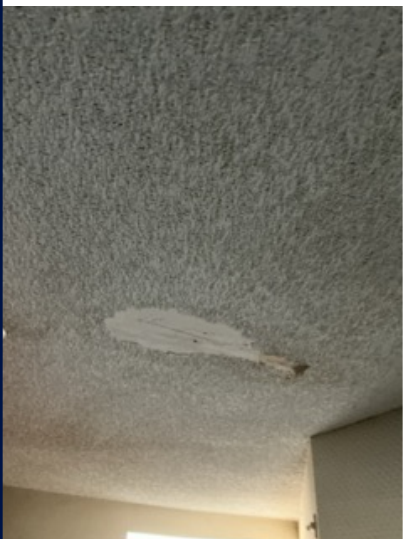
Interior Picture: 11

There is evidence of leaking in the entryway. . . . See Interior Picture 11

There is evidence of leaking in the entryway.

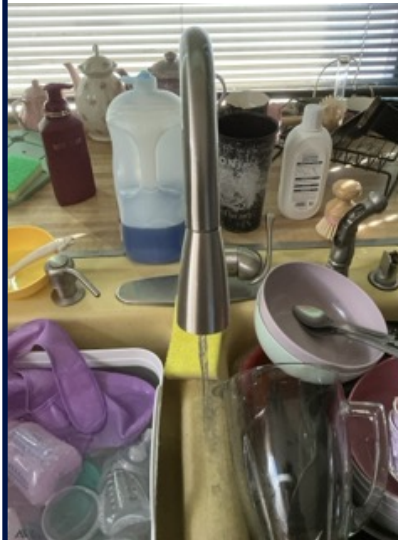
Interior Picture: 16

Water pressure is lower than we generally see. Recommend investigating. . . . See Interior Picture 16

Water pressure is lower than we generally see. Recommend investigating.

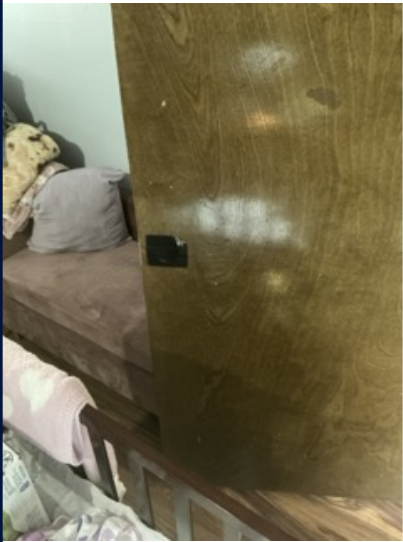
Interior Picture: 20

Door hardware is missing. . . . See Interior Picture 20

Door hardware is missing.

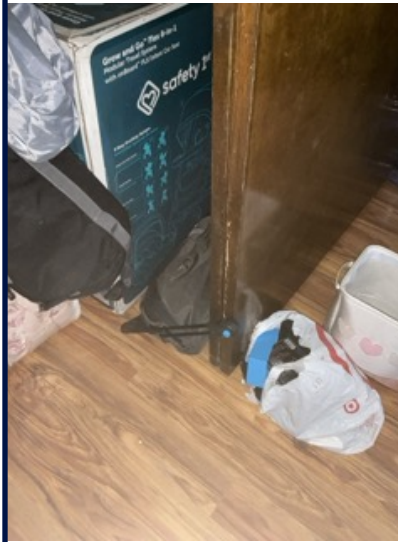
Interior Picture: 21

The closet door guides are missing. This can allow the door to fall over and cause injury. . . . See Interior Picture 21

The closet door guides are missing. This can allow the door to fall over and cause injury.

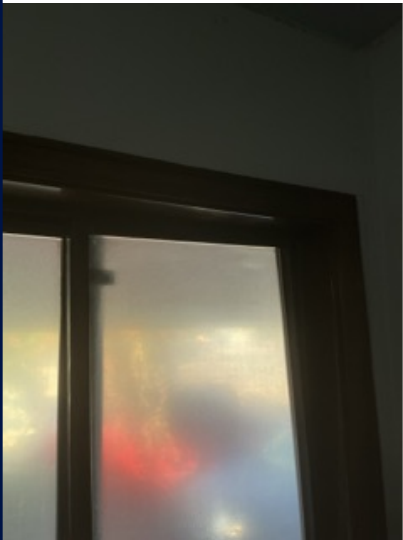
Interior Picture: 22

Front bedroom window sits at an angle. . . . See Interior Picture 22

Front bedroom window sits at an angle.

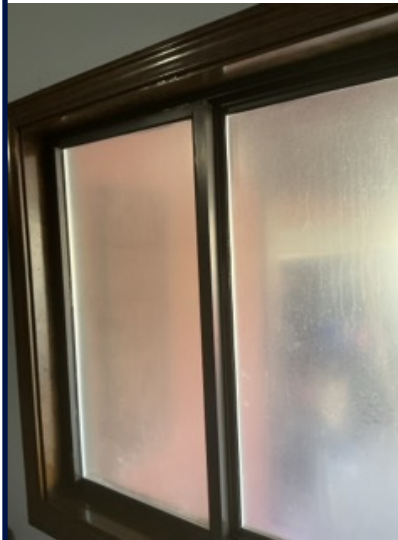
Interior Picture: 23

Bedroom window locks are missing. . . . See Interior Picture 23

Bedroom window locks are missing.

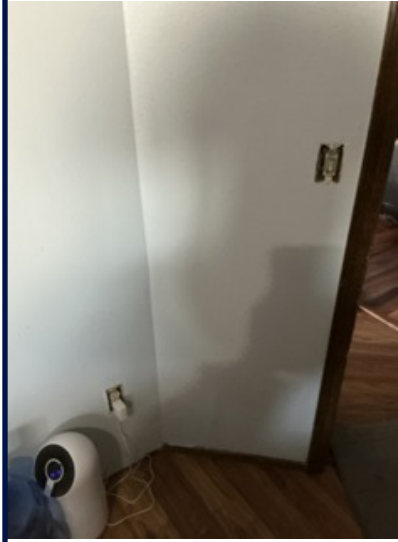
Interior Picture: 27

Multiple light switch covers and electrical covers are missing. . . . See Interior Picture 27

Multiple light switch covers and electrical covers are missing.

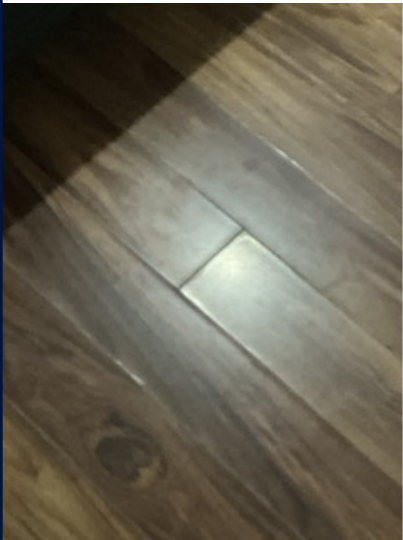
Interior Picture: 28

Flooring shows signs of minor moisture damage in multiple areas. . . . See Interior Picture 28

Flooring shows signs of minor moisture damage in multiple areas.

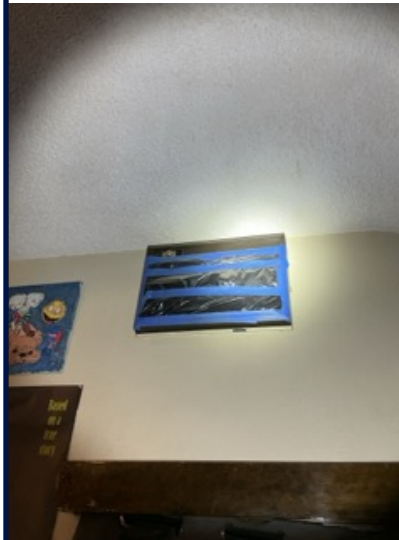
Interior Picture: 32

The furnace filters are very dirty. Recommend changing and servicing the unit. . . . See Interior Picture 32

The furnace filters are very dirty. Recommend changing and servicing the unit.

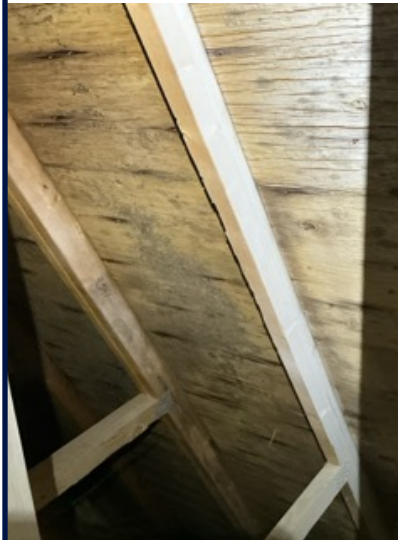
Interior Picture: 58

Some areas of the attic have been painted white. This generally indicates moisture damage and black/white staining or growth. . . . See Interior Picture 58

Some areas of the attic have been painted white. This generally indicates moisture damage and black/white staining or growth.

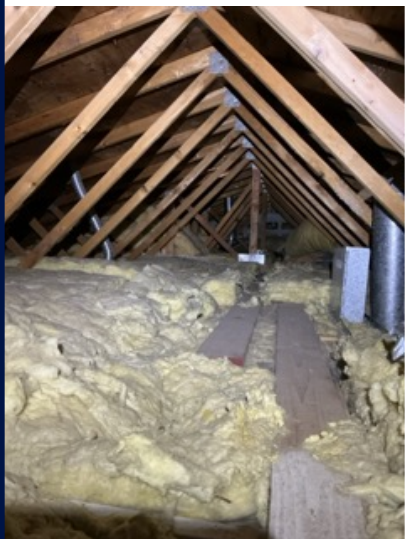
Interior Picture: 59

There is staining in the attic in multiple areas. Recommend pest inspection. . . . See Interior Picture 59

There is staining in the attic in multiple areas. Recommend pest inspection.
