YOUR INSPECTION REPORT

107 Meudon Street
Duson, LA 70529

Friday, April 15, 2022

RE: Report No. 3182
107 Meudon Street
Duson, LA
70529

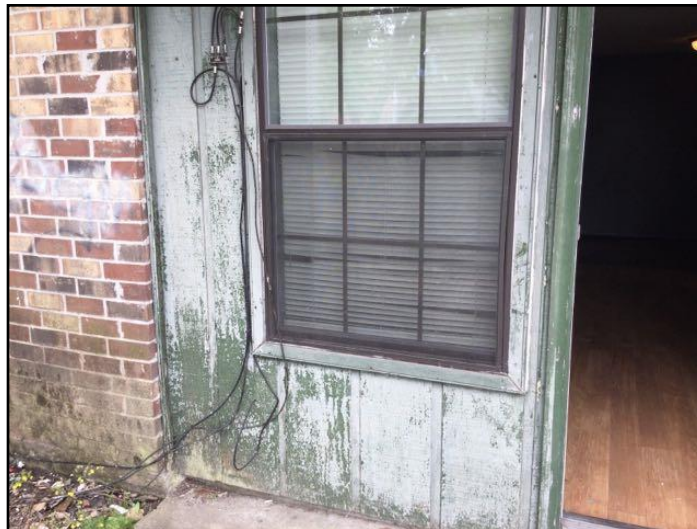
1. *Paint or stain - needed*

Condition: • [Paint or stain - needed](#)

The exterior wood siding needs caulking and paint.

Implication(s): Shortened life expectancy of material

Task: Repair

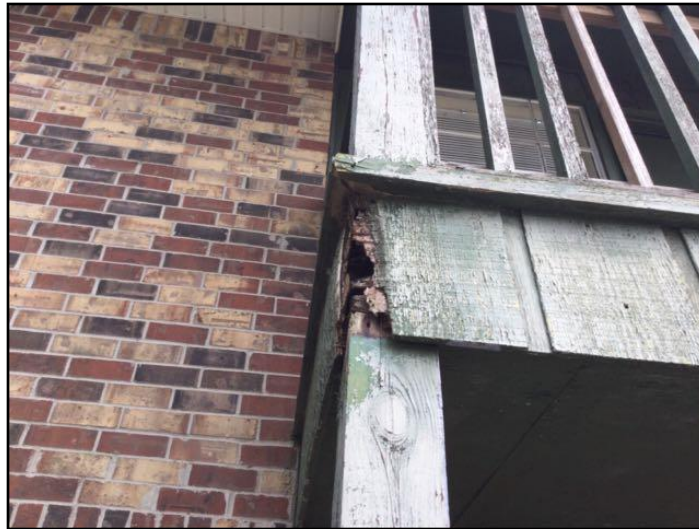
2. Rot or insect damage

Condition: • [Rot or insect damage](#)

Some of the wood siding is damaged due to water and/or potential WDI.

Implication(s): Chance of water damage to structure, finishes and contents | Material deterioration

Task: Repair or replace

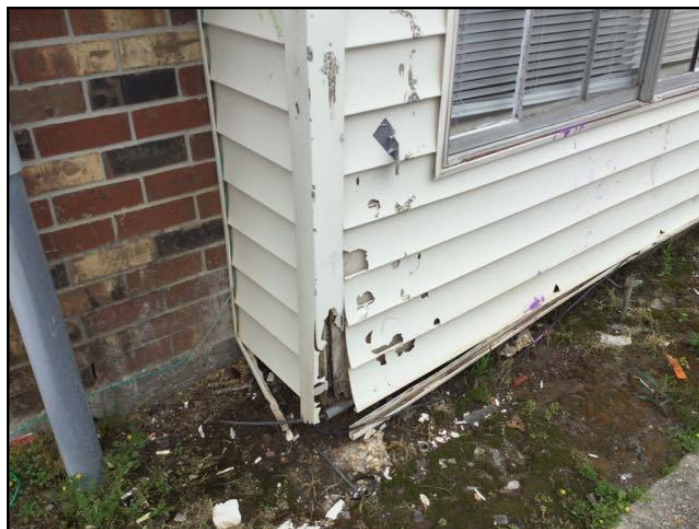
3. Damage

Condition: • Damage

There are holes in the vinyl siding. The inspector recommends repair or replacement in order to prevent water penetration.

Task: Repair or replace

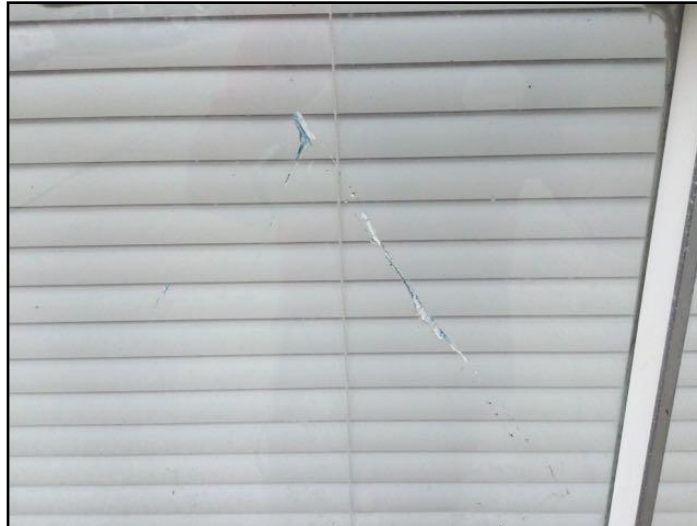
4. Broken

Condition: • [Broken](#)

There are broken panes in some of the windows.

Implication(s): Chance of water entering building | Chance of pests entering building | Increased heating and cooling costs | Reduced comfort

Task: Replace

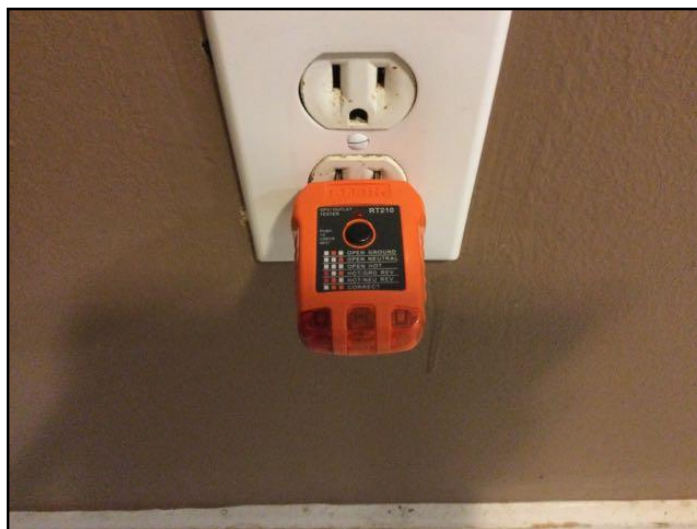
5. Inoperative

Condition: • [Inoperative](#)

The outlet on the north wall in the dining room in unit B is not functional.

Implication(s): Equipment inoperative

Task: Repair

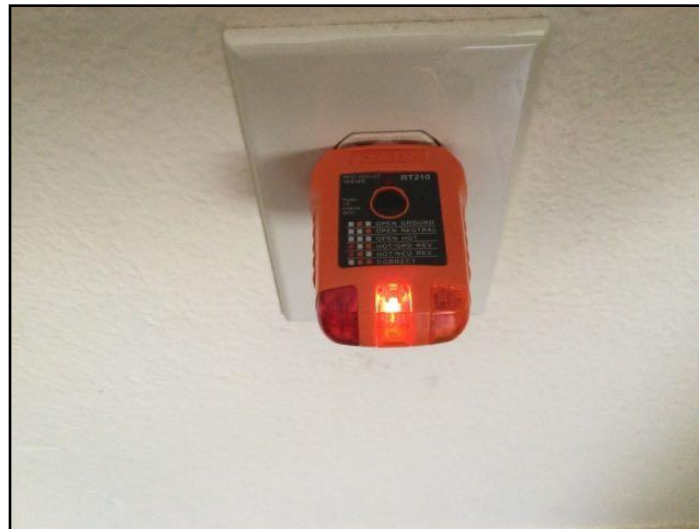
6. Ungrounded

Condition: • [Ungrounded](#)

All of outlets in the west bedroom in unit C have open grounds.

Implication(s): Electric shock

Task: Repair

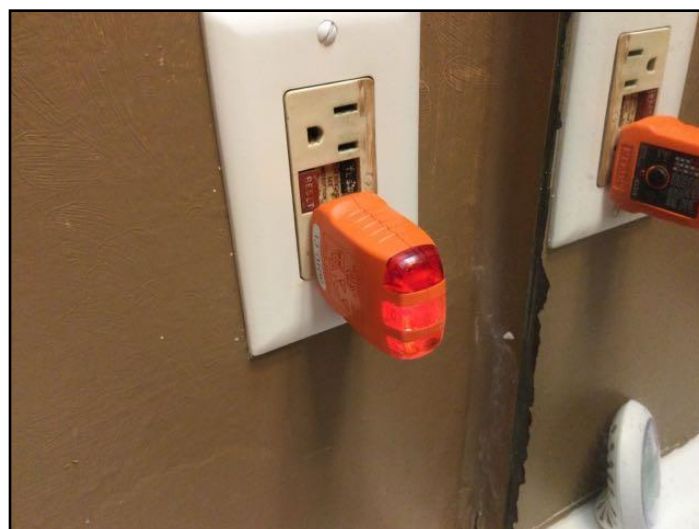
7. Test faulty on GFCI/GFI (Ground Fault...

Condition: • [Test faulty on GFCI/GFI \(Ground Fault Circuit Interrupter\)](#)

The GFCI outlet in the east bathroom in unit B has failed. The outlet trips with the outlet's test button, but the outlet does not cut power. The inspector recommends replacing the outlet.

Implication(s): Electric shock

Task: Replace

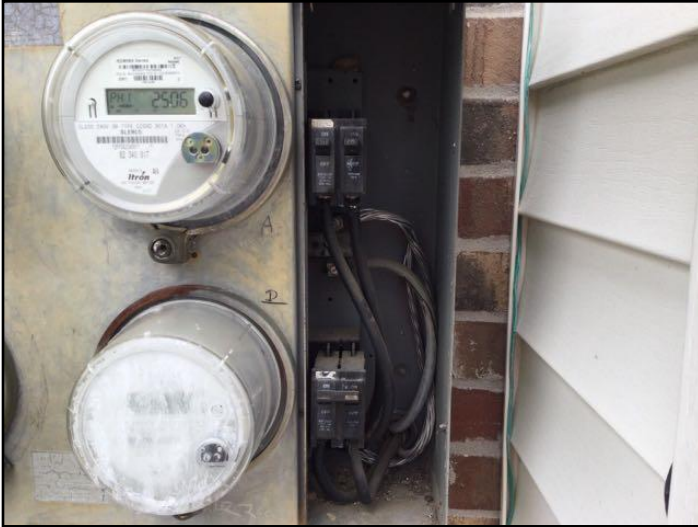
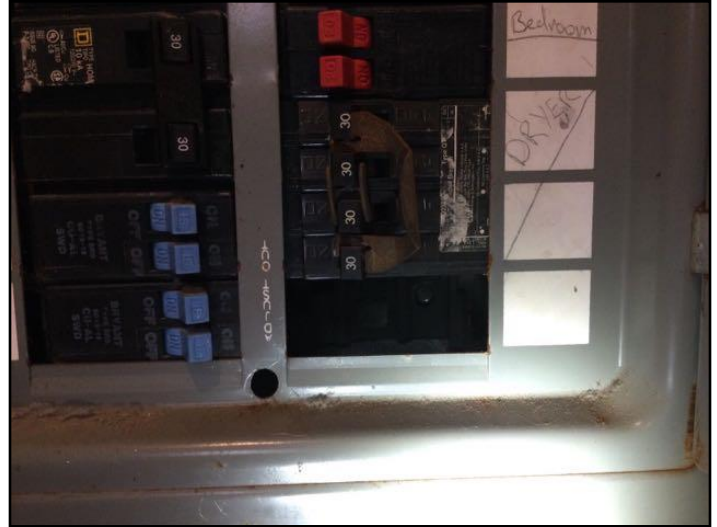
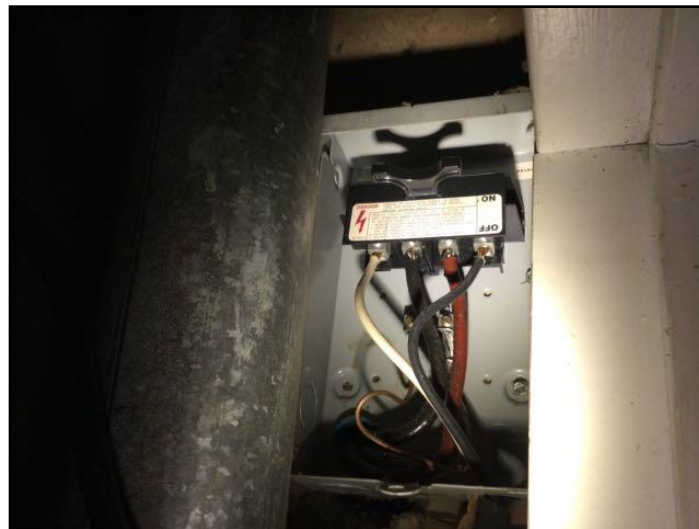
Condition: • [Missing](#)

The inside cover is missing on the main electrical shut offs for units A and D. Also, one of the breaker slot covers is missing on the electrical subpanel in unit A. Also, the cover is missing on the HVAC subpanel in unit D.

Implication(s): Electric shock

Task: Replace

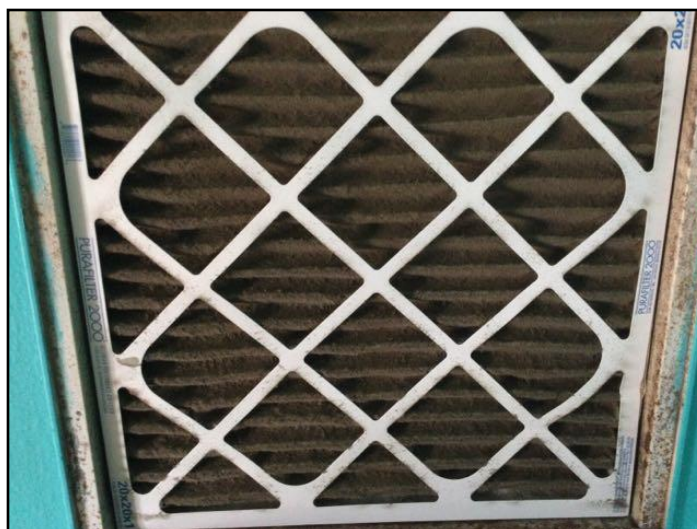
11. Dirty

Condition: • [Dirty](#)

The HVAC filters need to be replaced. The inspector recommends replacing the filters and having the HVAC systems cleaned and serviced.

Implication(s): Increased heating costs | Reduced comfort

Task: Replace

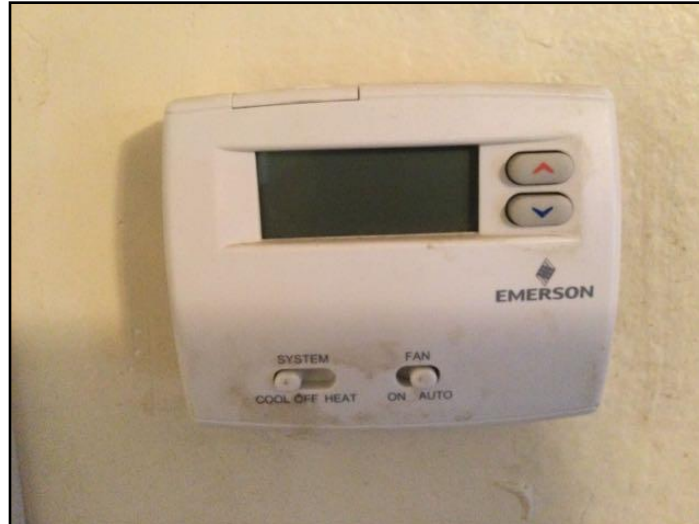
12. Not functional

Condition: • Not functional

The thermostat was not functional in unit D. The inspector was unable to test the heater or the air conditioner in unit D.

Task: Repair or replace

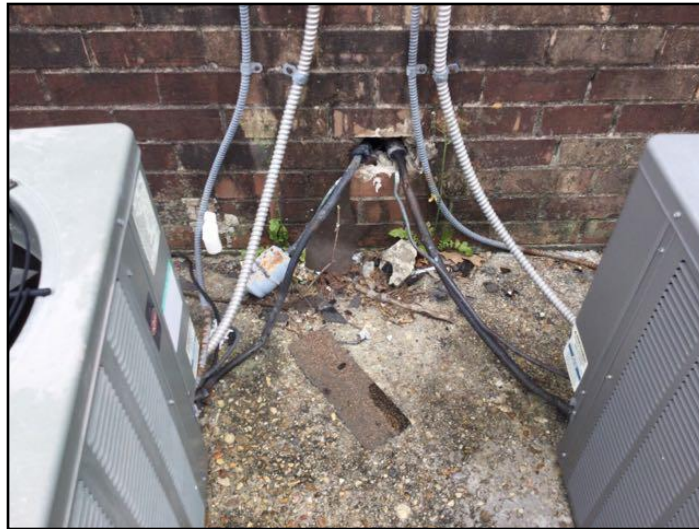
13. Insulation - missing

Condition: • [Insulation - missing](#)

Some of the insulation is missing around the air conditioning refrigerant lines.

Implication(s): Reduced system life expectancy | Increased cooling costs | Reduced comfort

Task: Replace

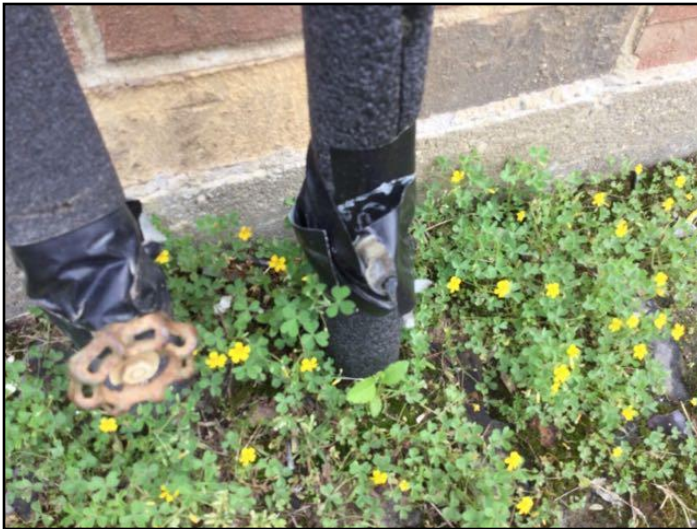
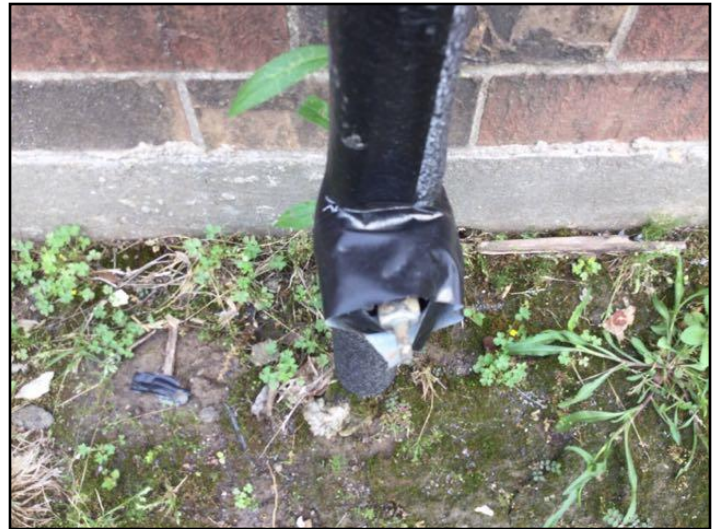
Condition: • [Missing or cannot be located](#)

The handles are missing on two of the main water shut offs.

Implication(s): Chance of water damage to structure, finishes and contents | Difficult to service

Task: Replace

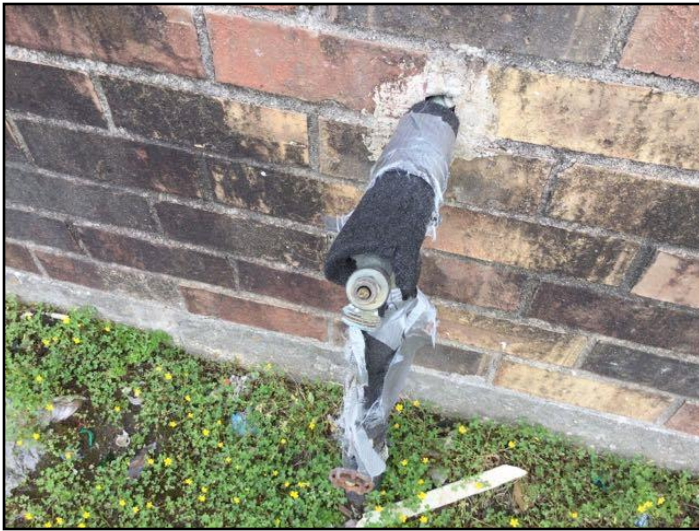
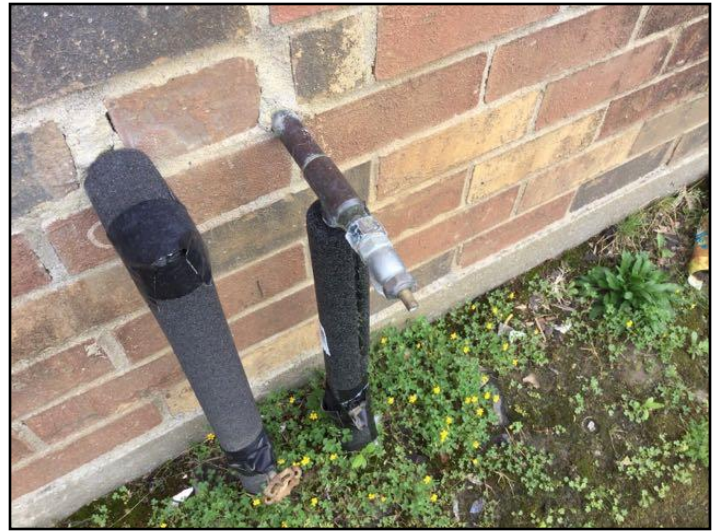
Condition: • Missing handle

The handles are missing on the exterior faucets.

Task: Replace

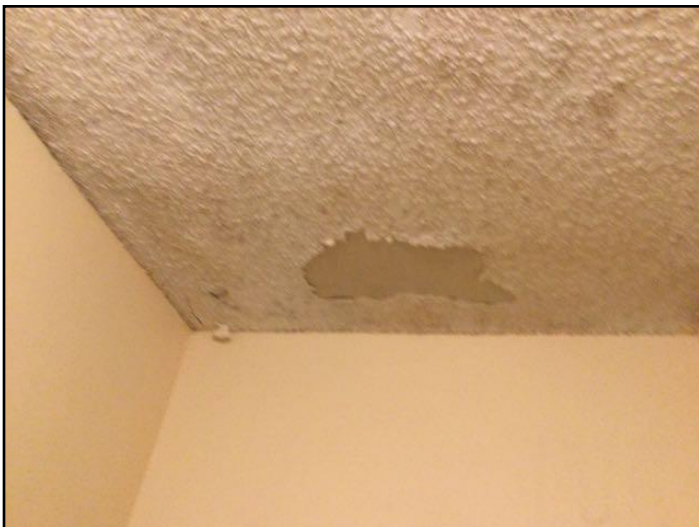
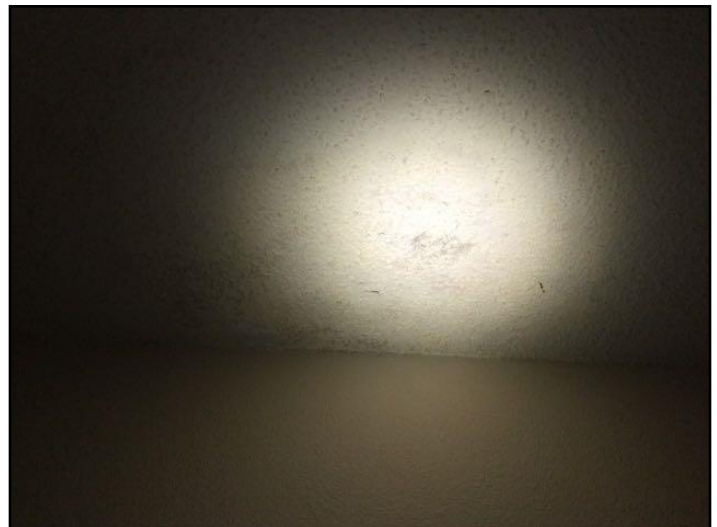
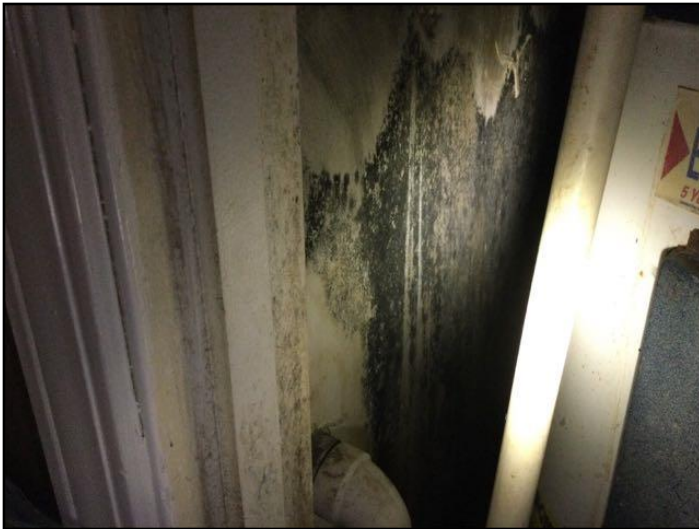
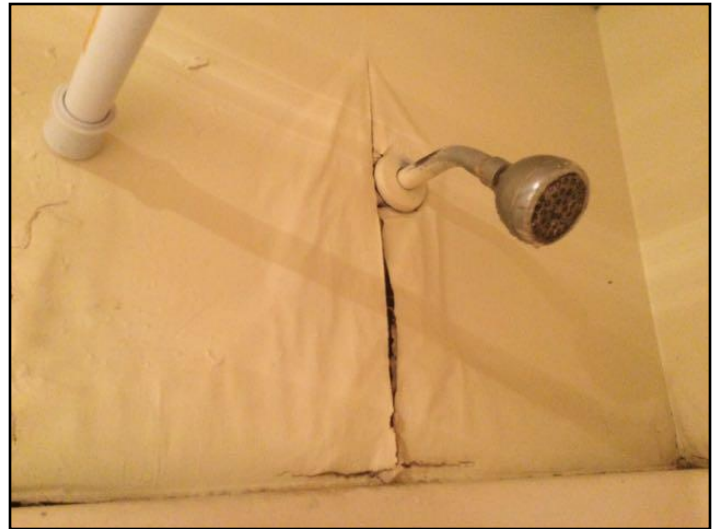
Condition: • [Water damage](#)

The inspector noted past water damage and potential mold on the ceilings and walls in all four of the units. The inspector recommends further evaluation by a mold specialist and remediation if required.

Task: Further evaluation

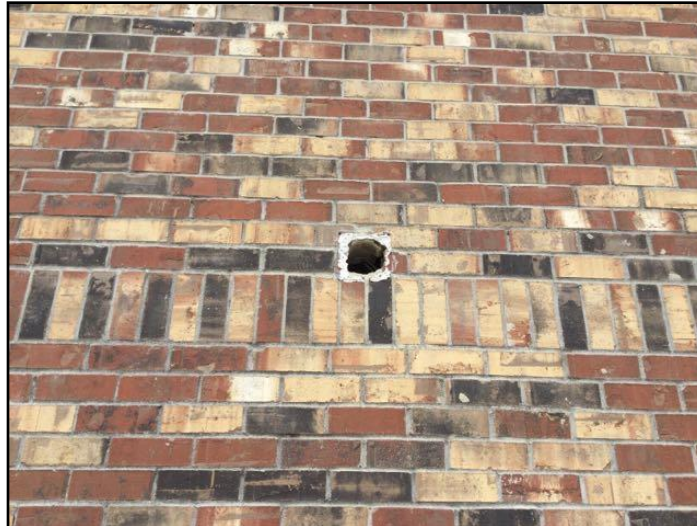
22. Missing exterior cover

Condition: • Missing exterior cover

The exterior covers are missing on the dryer vents.

Task: Replace

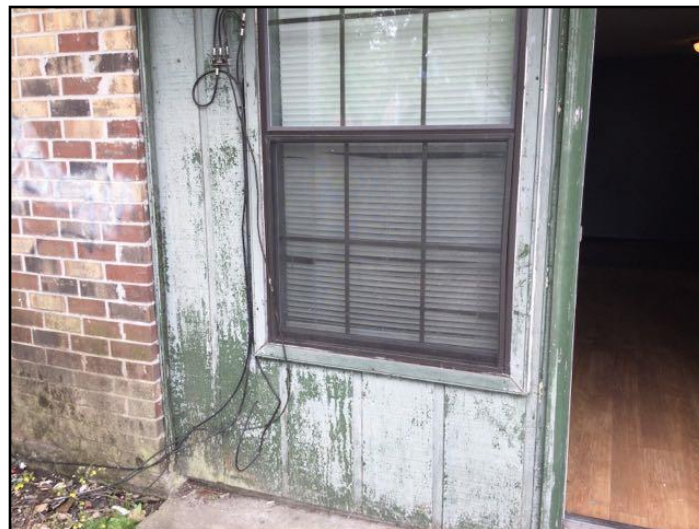
23. *Paint or stain - needed*

1. Condition: • [Paint or stain - needed](#)

Task: Repair

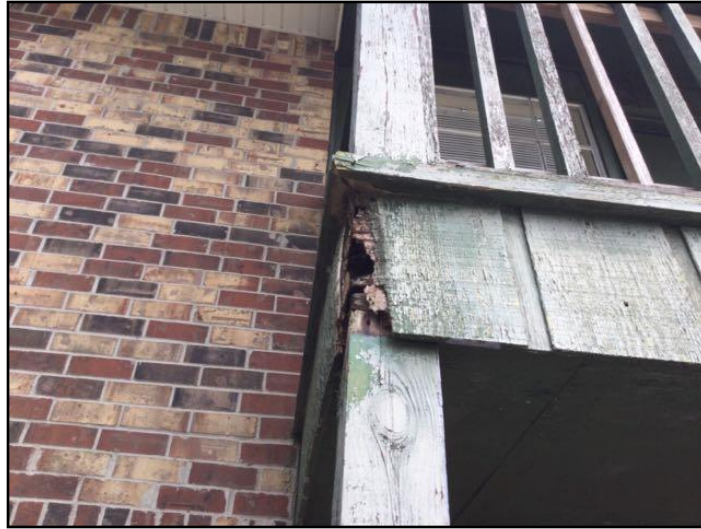
24. Rot or insect damage

2. Condition: • [Rot or insect damage](#)

Some of the wood siding is damaged due to water and/or potential WDI.

Implication(s): Chance of water damage to structure, finishes and contents | Material deterioration

Task: Repair or replace

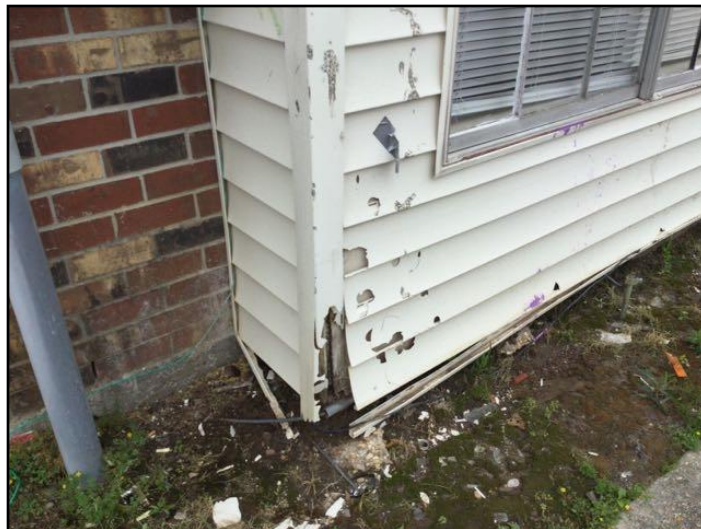
25. Damage

3. Condition: • Damage

There are holes in the vinyl siding. The inspector recommends repair or replacement in order to prevent water penetration.

Task: Repair or replace

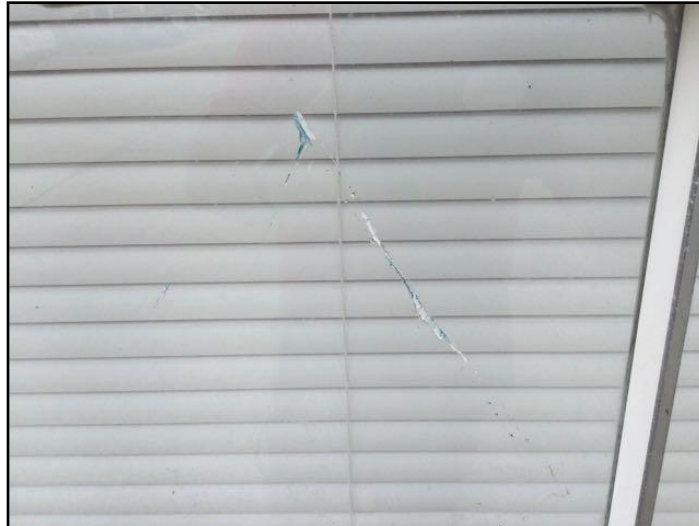
26. *Broken*

4. Condition: • [Broken](#)

There are broken panes in some of the windows.

Task: Replace

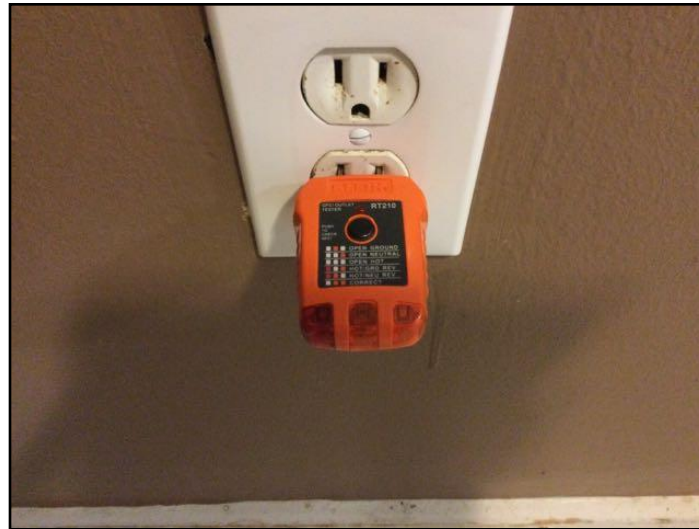
32. Inoperative

5. Condition: • [Inoperative](#)

Task: Repair

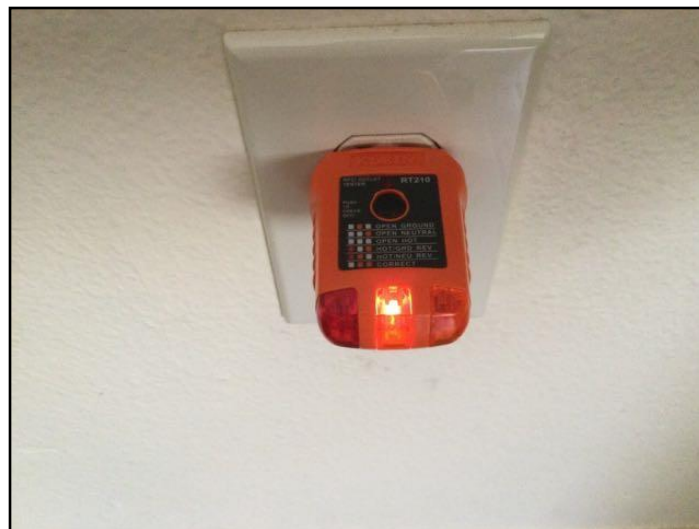
33. Ungrounded

6. Condition: • [Ungrounded](#)

Task: Repair

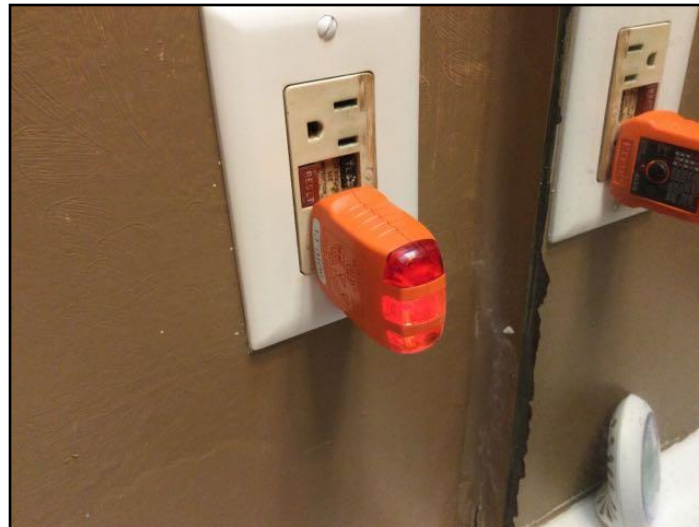
34. Test faulty on GFCI/GFI (Ground Fault...

7. Condition: • [Test faulty on GFCI/GFI \(Ground Fault Circuit Interrupter\)](#)

The GFCI outlet in the east bathroom in unit B has failed. The outlet trips with the outlet's test button, but the outlet does not cut power. The inspector recommends replacing the outlet.

Task: Replace

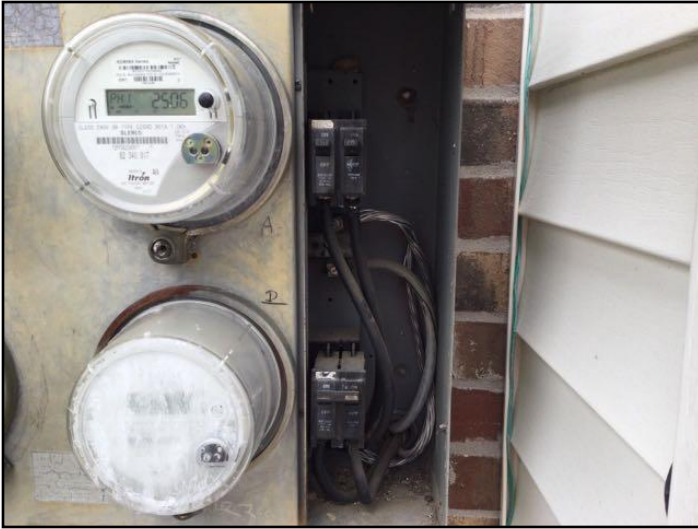
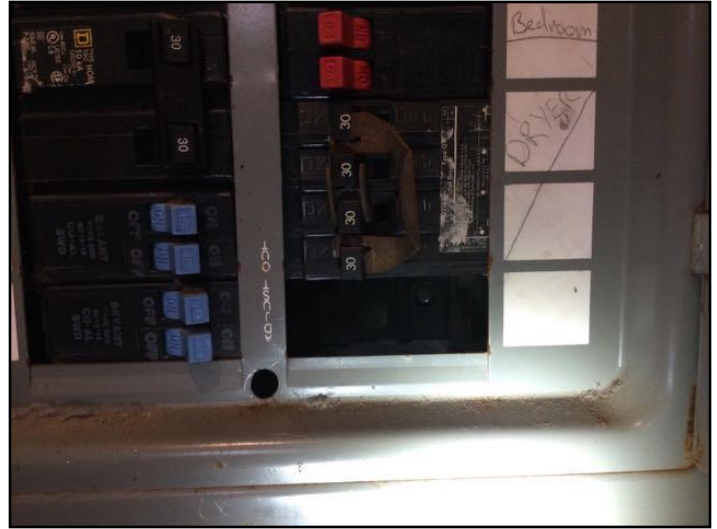
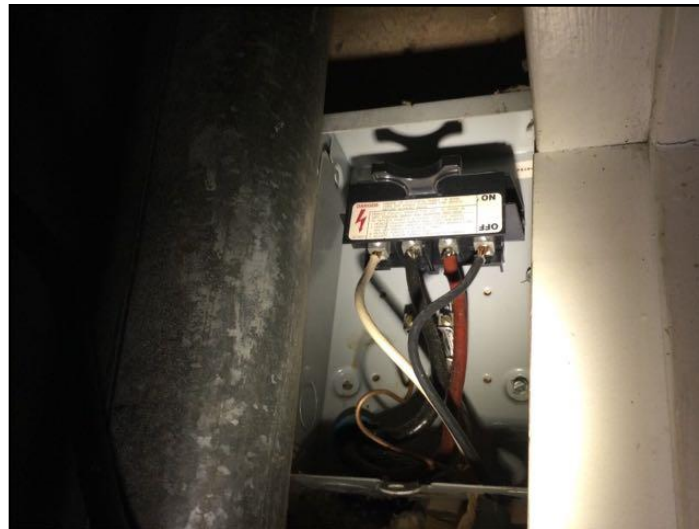
9. Condition: • [Missing](#)

The inside cover is missing on the main electrical shut offs for units A and D. Also, one of the breaker slot covers is missing on the electrical subpanel in unit A. Also, the cover is missing on the HVAC subpanel in unit D.

Task: Replace

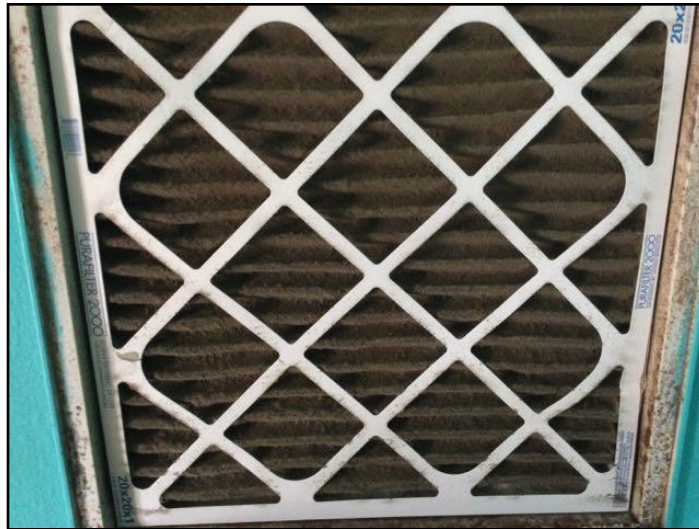
38. Dirty

13. Condition: • [Dirty](#)

The HVAC filters need to be replaced. The inspector recommends replacing the filters and having the HVAC systems cleaned and serviced.

Task: Replace

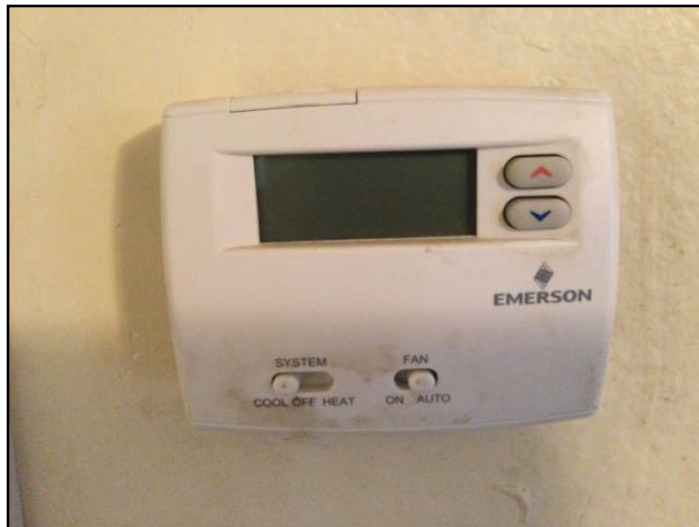
39. Not functional

14. Condition: • Not functional

The thermostat was not functional in unit D. The inspector was unable to test the heater or the air conditioner in unit D.

Task: Repair or replace

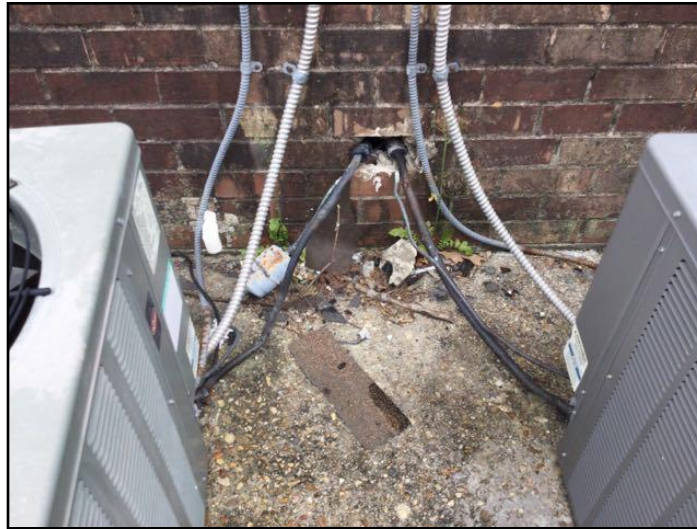
40. *Insulation - missing*

16. Condition: • [Insulation - missing](#)

Some of the insulation is missing around the air conditioning refrigerant lines.

Task: Replace

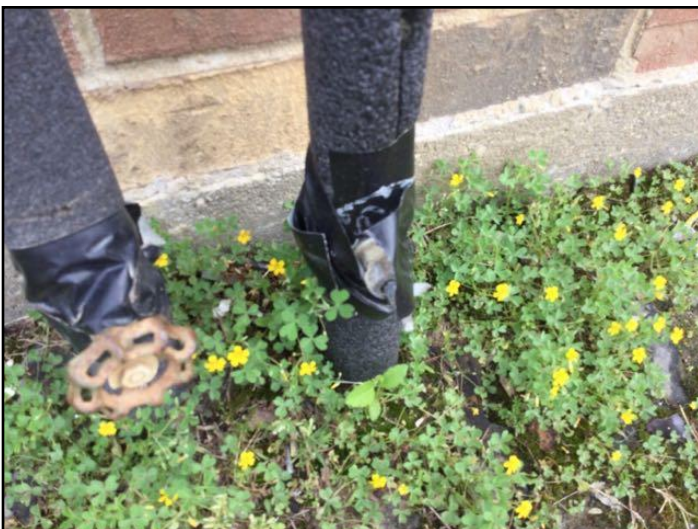
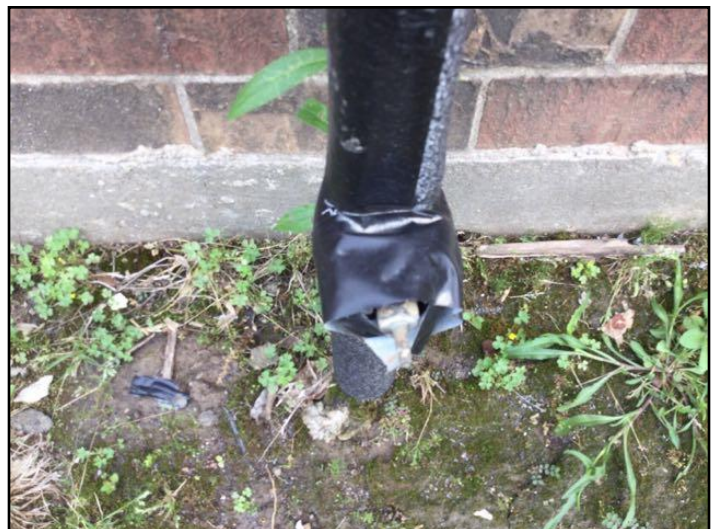
18. Condition: • [Missing or cannot be located](#)

The handles are missing on two of the main water shut offs.

Implication(s): Chance of water damage to structure, finishes and contents | Difficult to service

Task: Replace

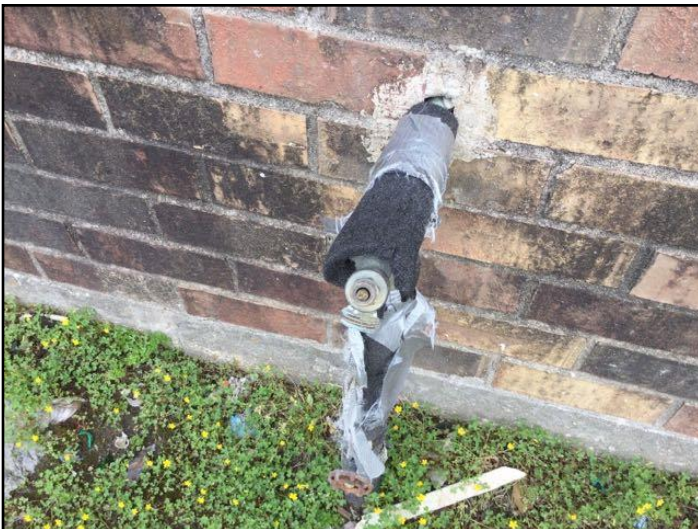
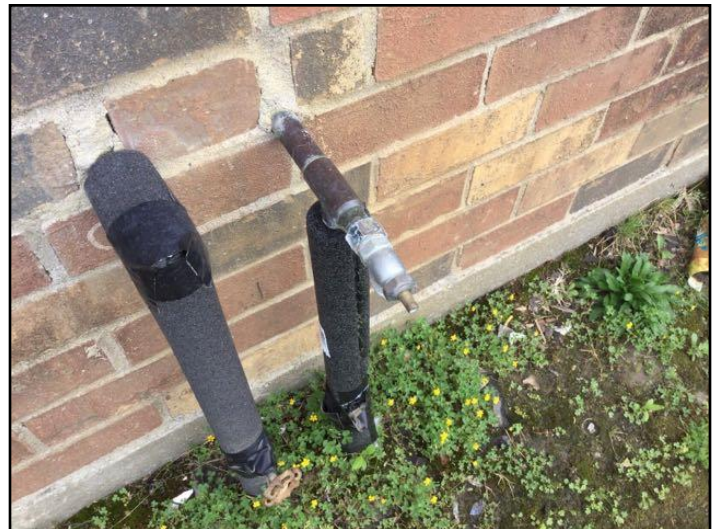
21. Condition: • Missing handle

The handles are missing on the exterior faucets.

Task: Replace

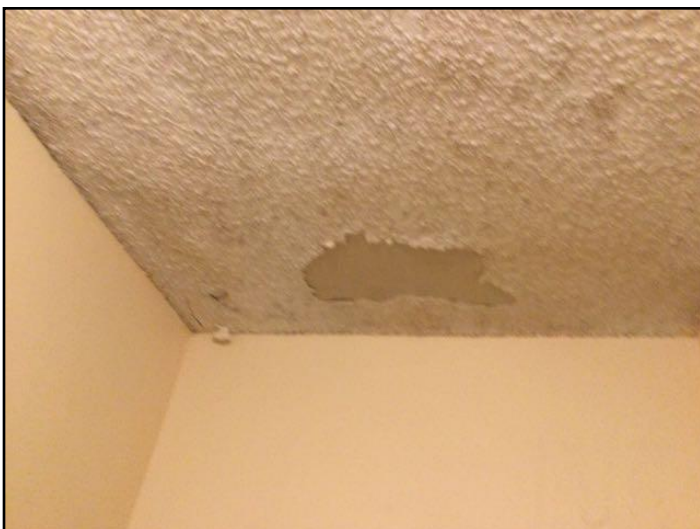
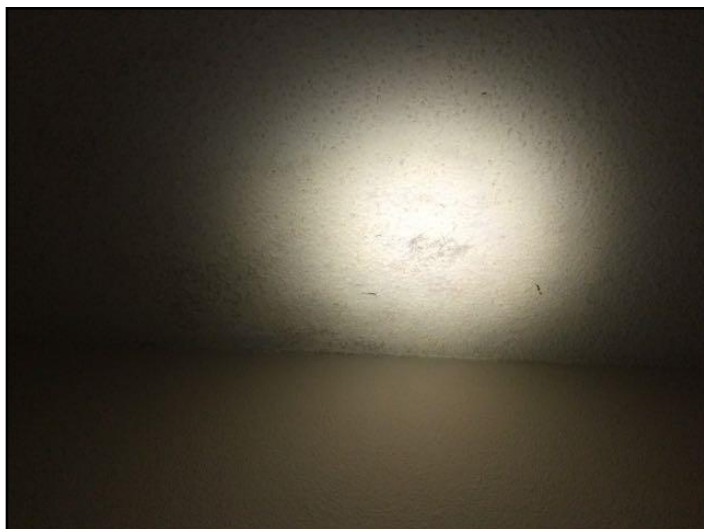
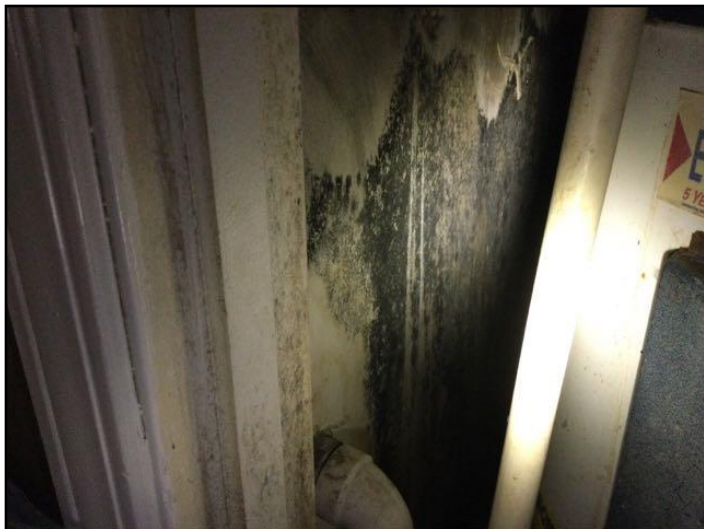
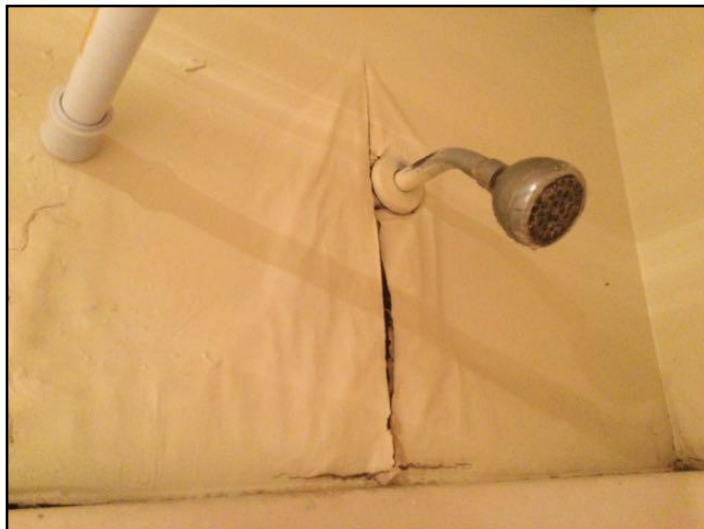
22. Condition: • [Water damage](#)

The inspector noted past water damage and potential mold on the ceilings and walls in all four of the units. The inspector recommends further evaluation by a mold specialist and remediation if required.

Task: Further evaluation

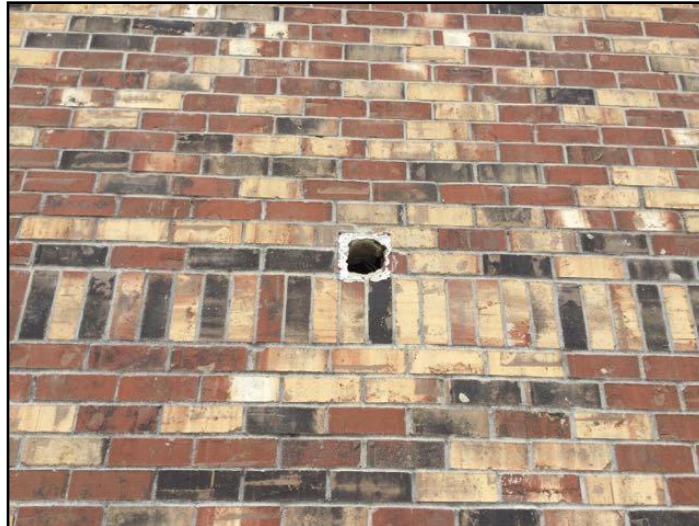
50. *Missing exterior cover*

27. Condition: • Missing exterior cover

The exterior covers are missing on the dryer vents.

Task: Replace
