YOUR INSPECTION REPORT

109 Limoges Street
Duson, LA 70529

Friday, April 15, 2022

RE: Report No. 3181
109 Limoges Street
Duson, LA
70529

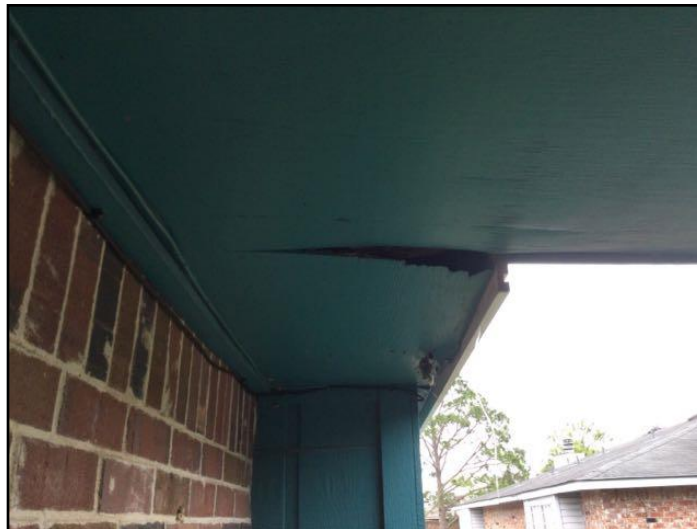
1. *Rot or insect damage*

Condition: • Rot or insect damage

Some of the soffit fascia boards are damaged due to water and/or potential WDI.

Implication(s): Chance of water damage to structure, finishes and contents | Material deterioration

Task: Repair or replace

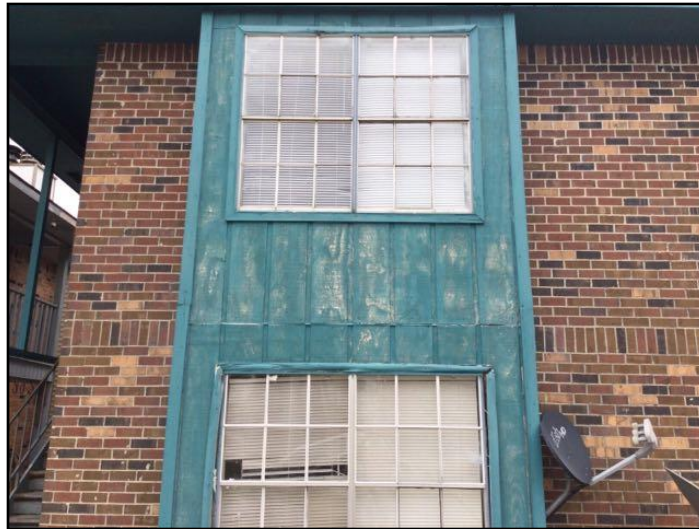
2. Paint or stain - needed

Condition: • [Paint or stain - needed](#)

The exterior wood siding needs caulking and paint.

Implication(s): Shortened life expectancy of material

Task: Repair

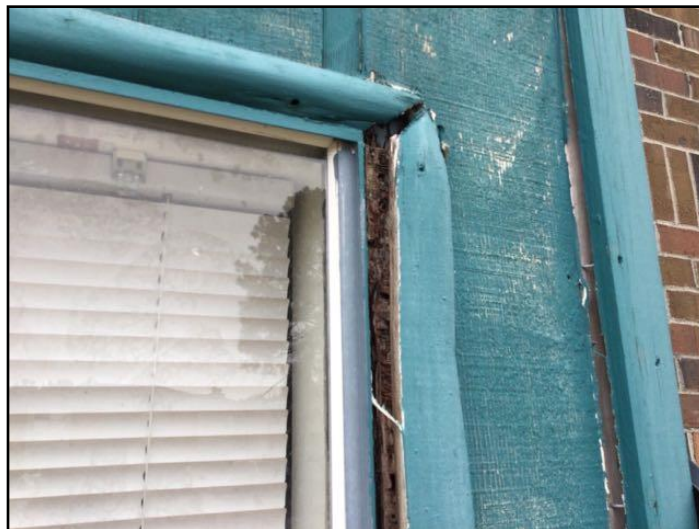
3. Rot or insect damage

Condition: • [Rot or insect damage](#)

Some of the wood siding is damaged due to water and/or potential WDI.

Implication(s): Chance of water damage to structure, finishes and contents | Material deterioration

Task: Repair or replace

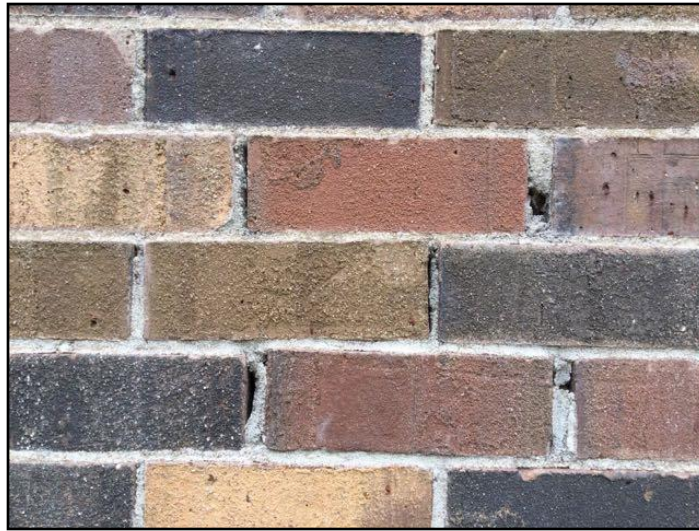
4. Masonry deterioration

Condition: • [Masonry deterioration](#)

The bricks need some tuck point maintenance.

Implication(s): Weakened structure | Chance of structural movement

Task: Repair

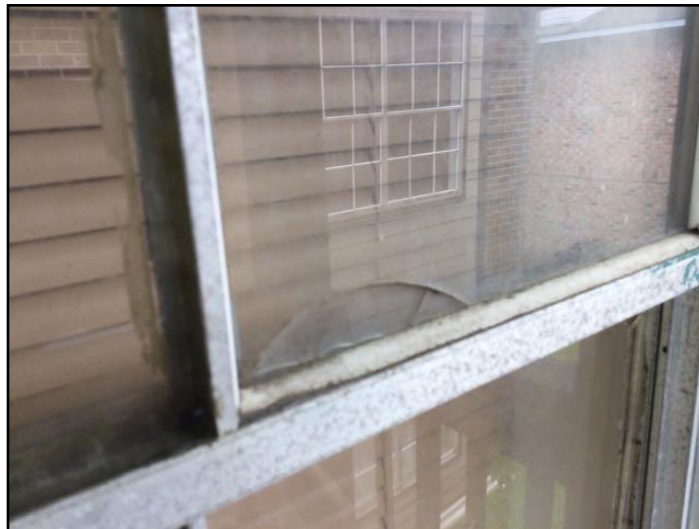
5. Broken

Condition: • [Broken](#)

There are several broken panes in the windows.

Implication(s): Chance of water entering building | Chance of pests entering building | Increased heating and cooling costs | Reduced comfort

Task: Replace

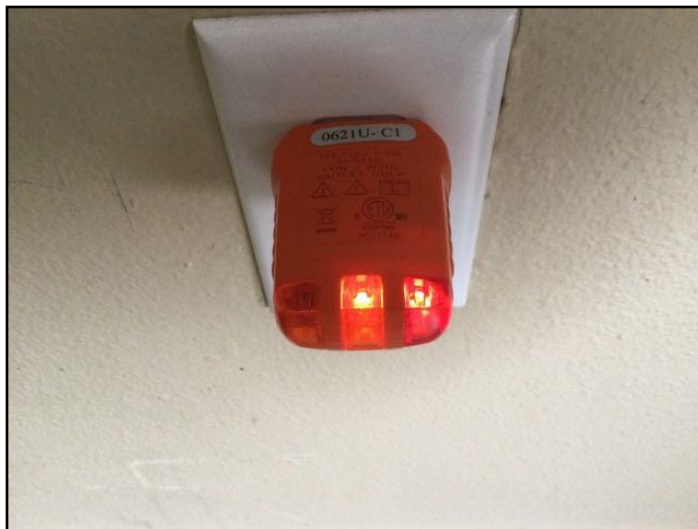
6. *Reversed polarity*

Condition: • [Reversed polarity](#)

Three of the four outlets in the west bedroom in unit A have the hot and neutral wires reversed.

Implication(s): Electric shock

Task: Repair

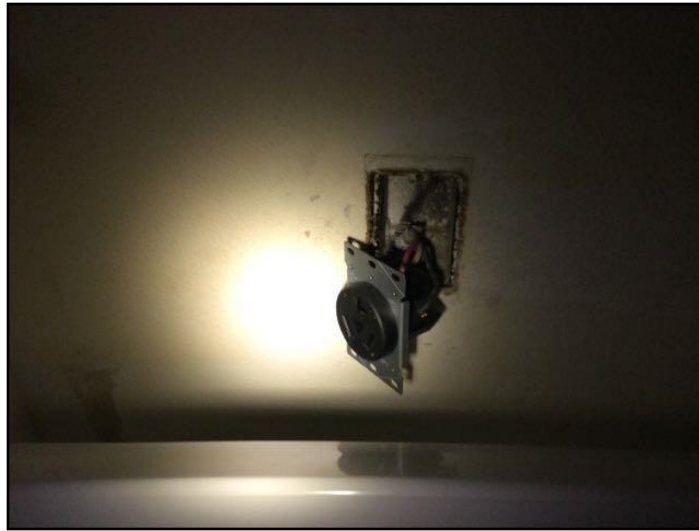
7. Not mounted properly

Condition: • Not mounted properly

The dryer outlet in unit D is not mounted properly.

Task: Repair

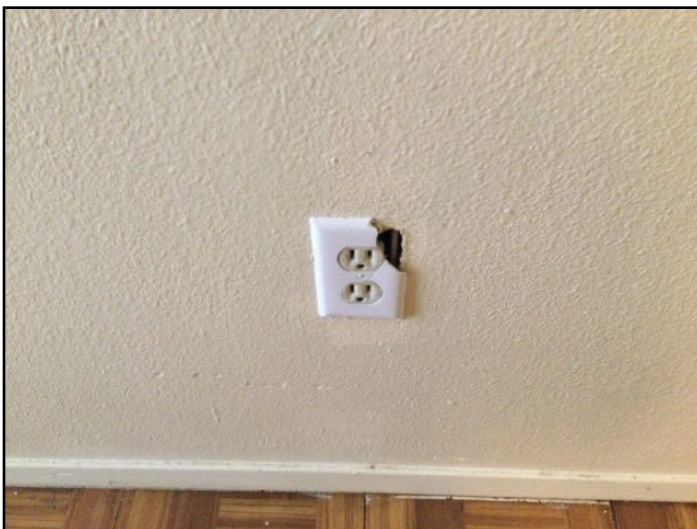
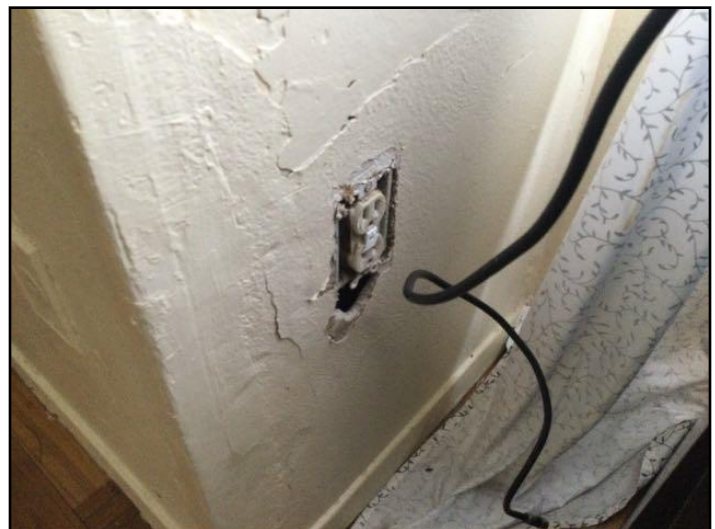
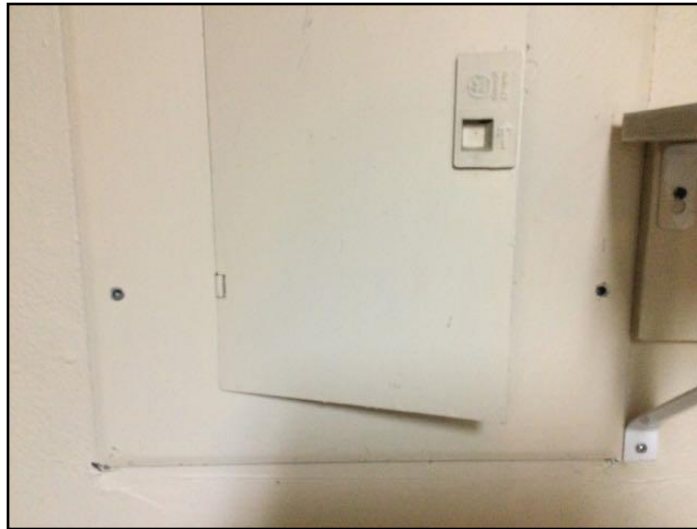
Condition: • [Missing](#)

There are broken or missing switch and outlets in all four of the units. Also, there are cover screws missing on all four of the electrical panel sub panels.

Implication(s): Electric shock

Task: Replace

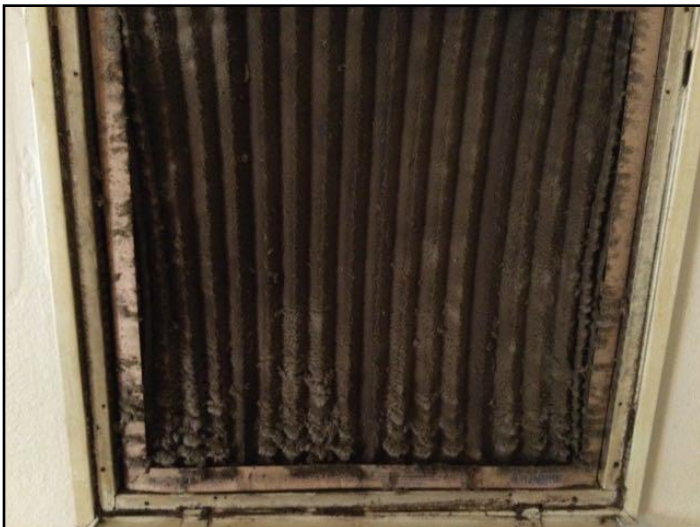
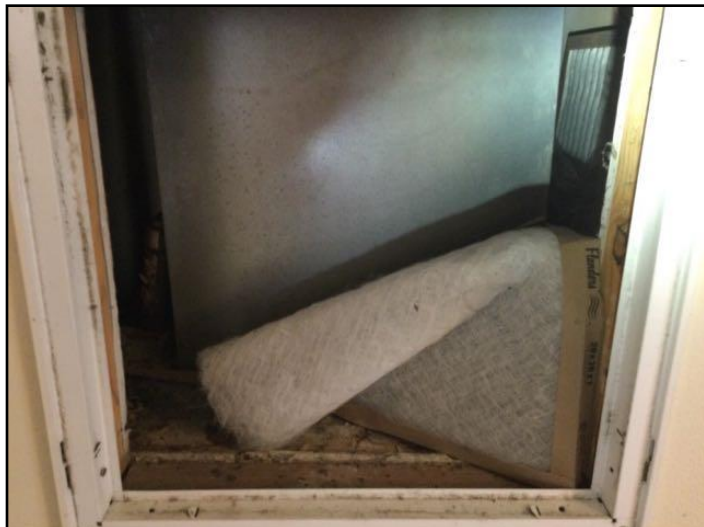
Condition: • [Dirty](#)

The HVAC filters need to be replaced. The inspector recommends replacing the filters and having the HVAC systems cleaned and serviced.

Implication(s): Increased heating costs | Reduced comfort

Task: Replace

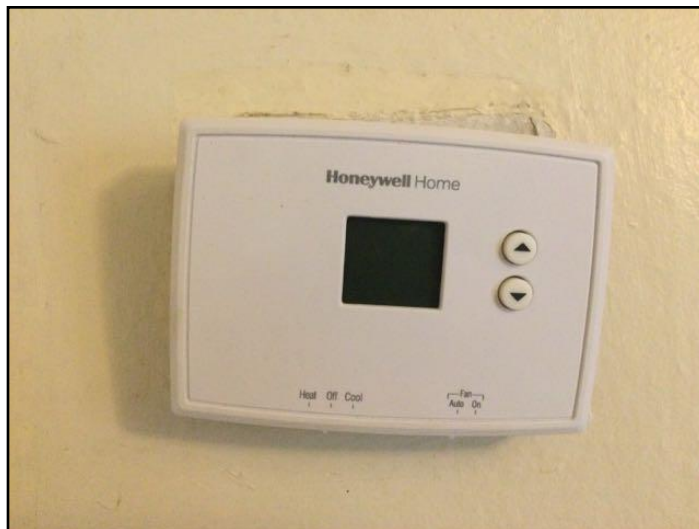
13. Not functional

Condition: • Not functional

The thermostat in unit B was not functional. The inspector was unable to test the heater or the air conditioner in unit B.

Task: Repair or replace

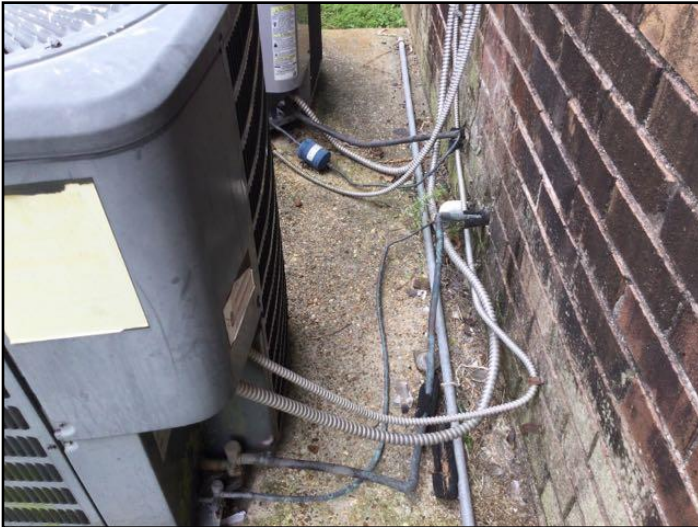
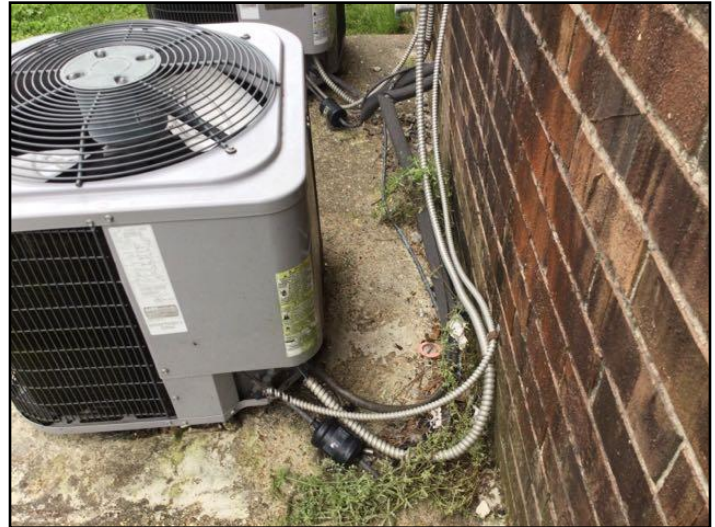
Condition: • [Insulation - missing](#)

Some of the insulation is missing around the air conditioning refrigerant lines.

Implication(s): Reduced system life expectancy | Increased cooling costs | Reduced comfort

Task: Replace

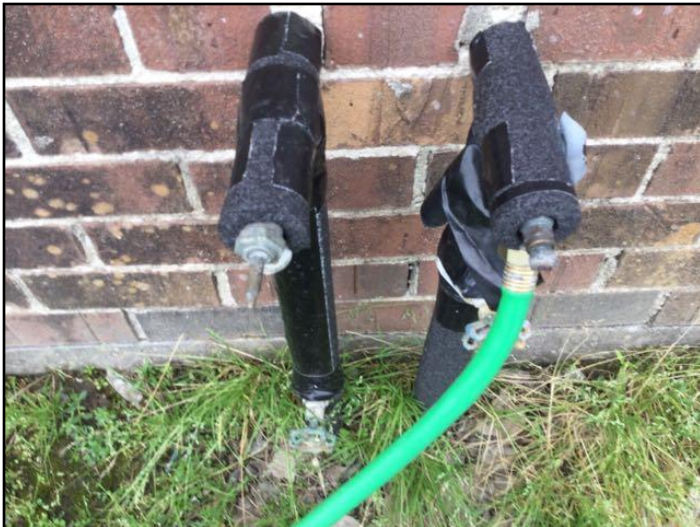
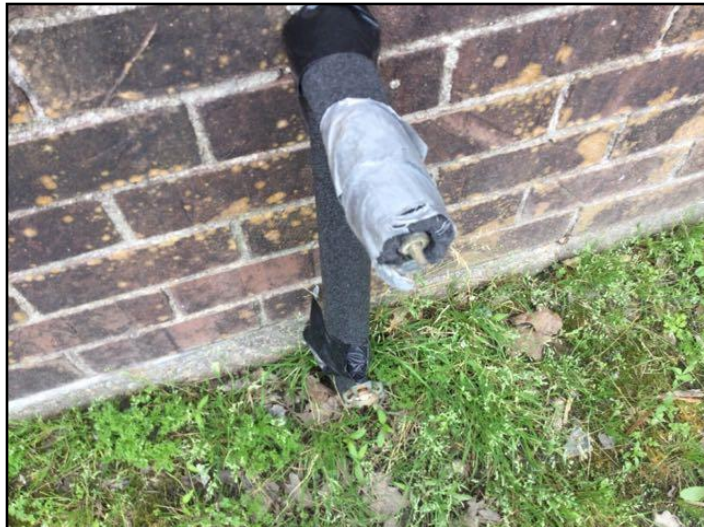
Condition: • Missing handle

The handles are missing on three of the exterior faucets.

Task: Replace

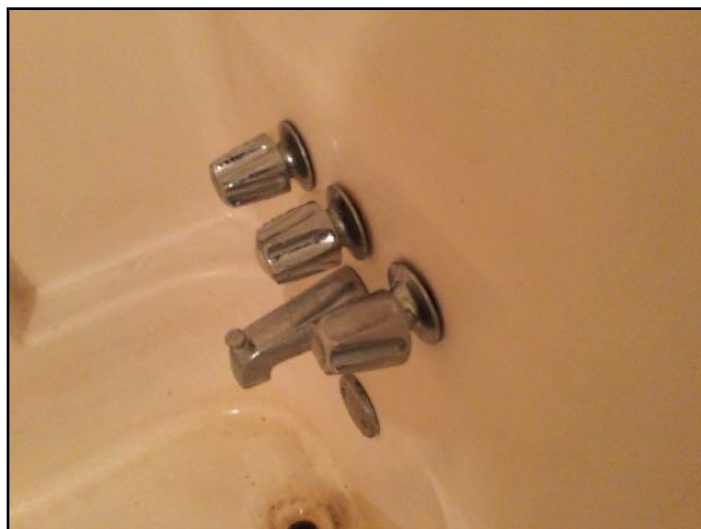
18. Stiff or inoperative

Condition: • [Stiff or inoperative](#)

The cold water faucet handle is not functional on the tub in the west bathroom in unit A. Also, the cold water faucet handle is not functional on the tub in the east bathroom in unit B. Also, the shower activation knob is not functional on the tub in the east bathroom in unit B.

Implication(s): System inoperative or difficult to operate

Task: Repair or replace

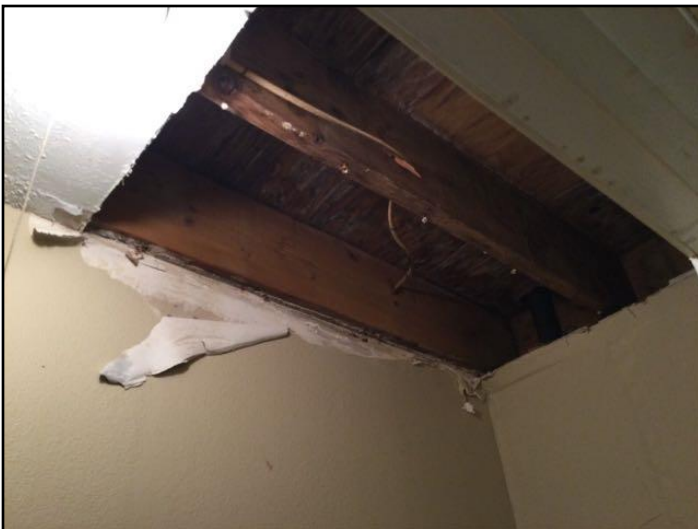
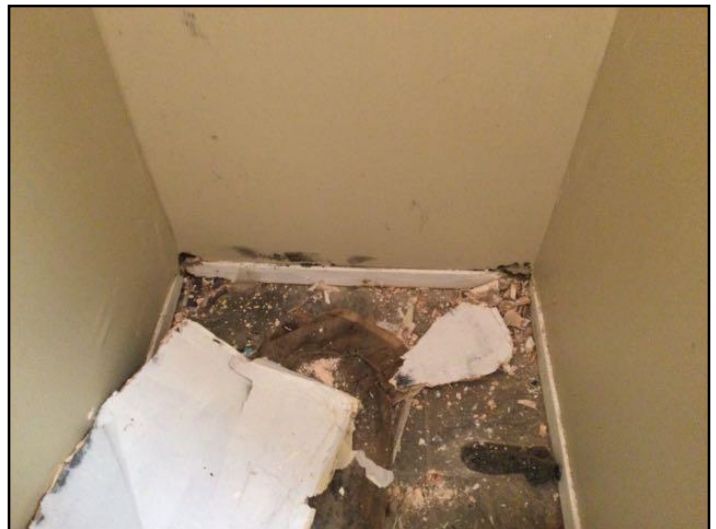
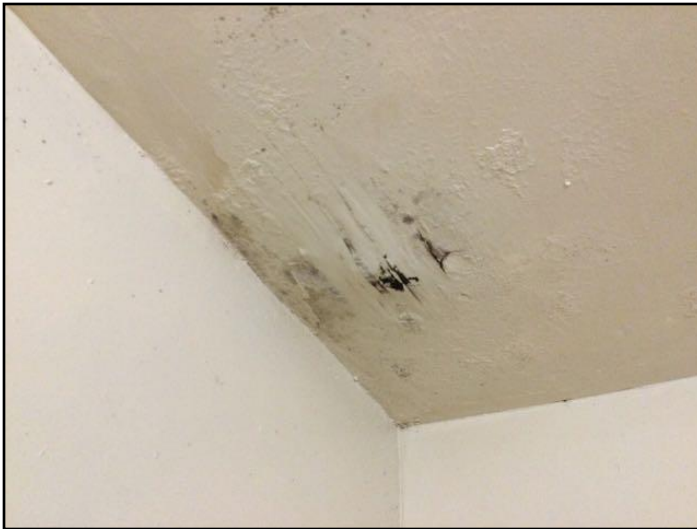
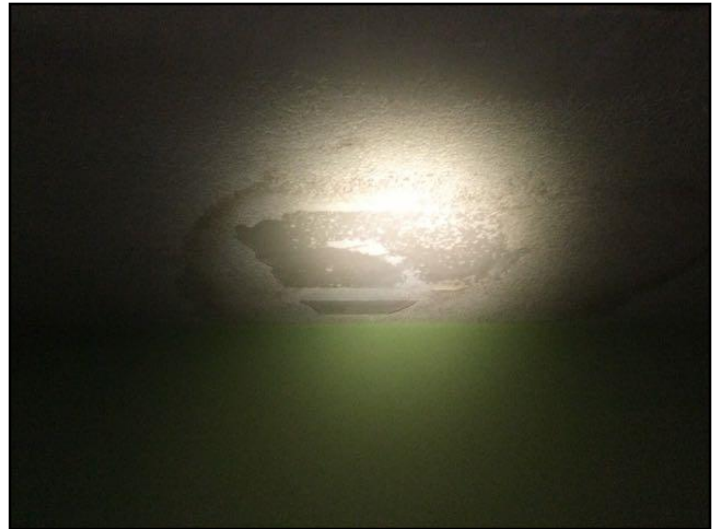
Condition: • [Water damage](#)

The inspector noted past water damage and potential mold on the ceilings and walls in units A & B. The inspector recommends further evaluation by a mold specialist and remediation if required.

Task: Further evaluation

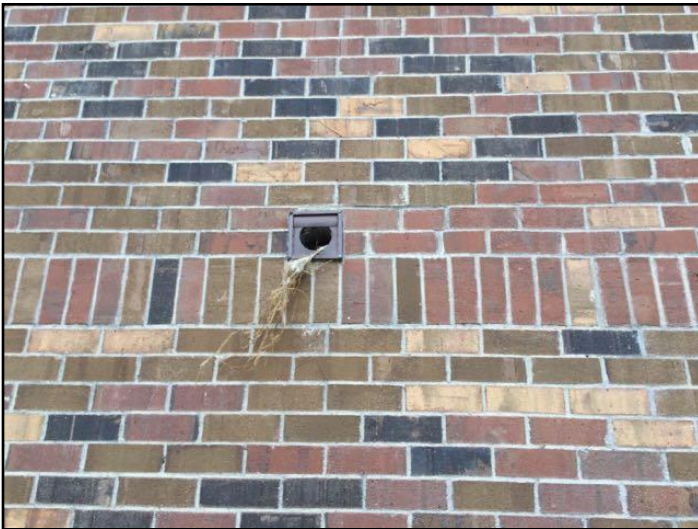
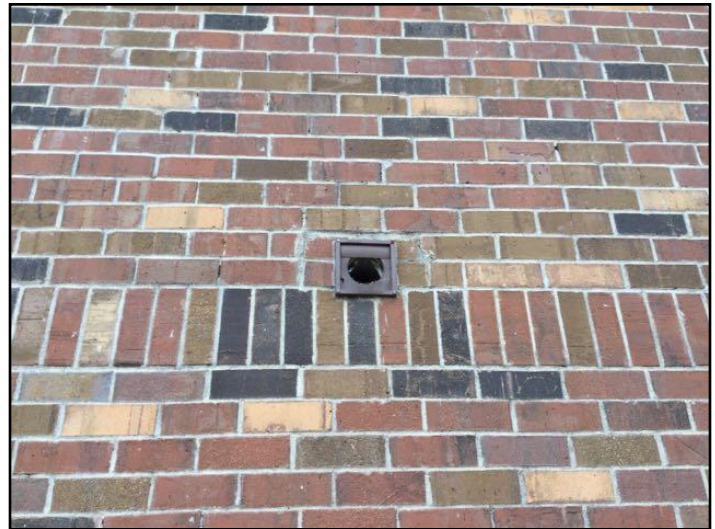
Condition: • Missing exterior cover

The exterior covers are missing on the dryer vents.

Task: Replace

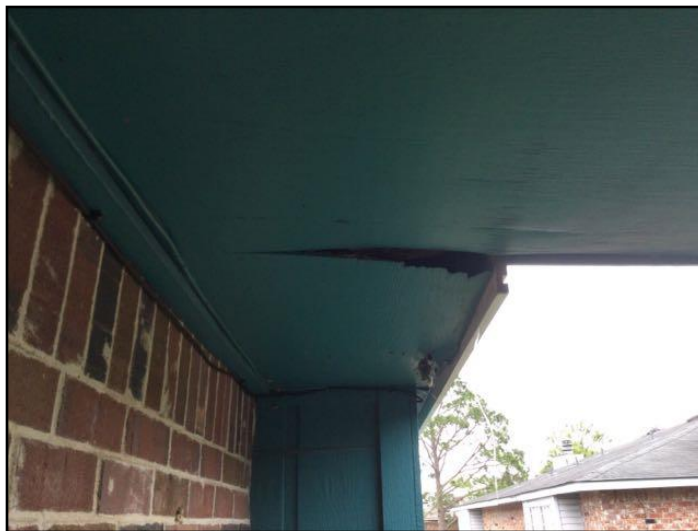
25. Rot or insect damage

1. Condition: • Rot or insect damage

Some of the soffit fascia boards are damaged due to water and/or potential WDI.

Implication(s): Chance of water damage to structure, finishes and contents | Material deterioration

Task: Repair or replace

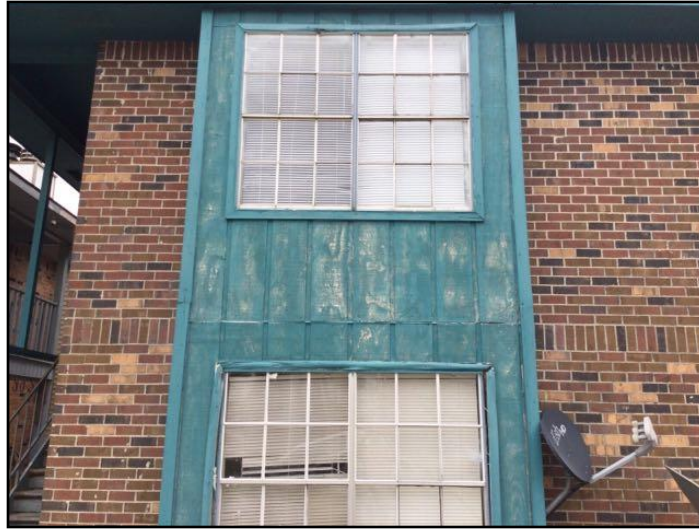
26. *Paint or stain - needed*

2. Condition: • [Paint or stain - needed](#)

Task: Repair

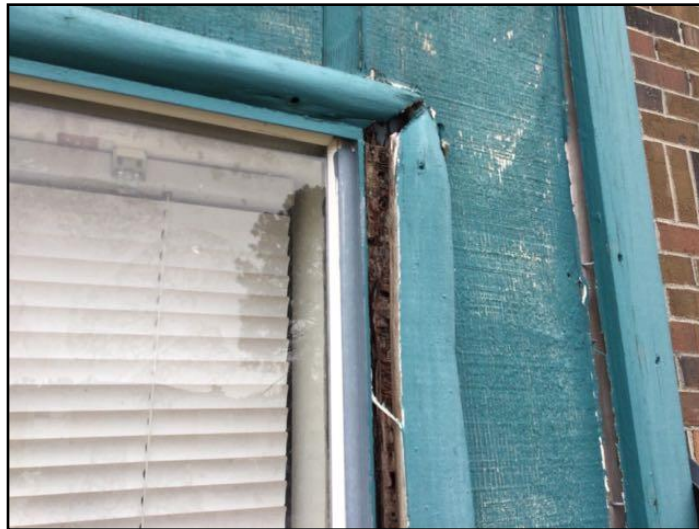
27. *Rot or insect damage*

3. Condition: • [Rot or insect damage](#)

Some of the wood siding is damaged due to water and/or potential WDI.

Implication(s): Chance of water damage to structure, finishes and contents | Material deterioration

Task: Repair or replace

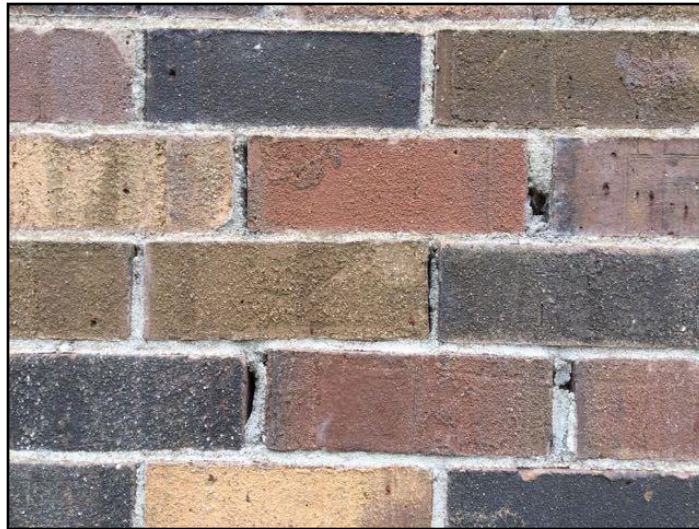
28. Masonry deterioration

4. Condition: • [Masonry deterioration](#)

Task: Repair

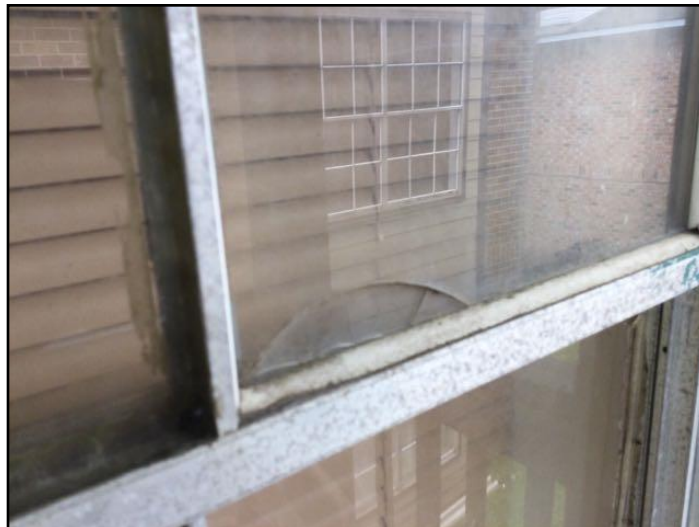
29. Broken

5. Condition: • [Broken](#)

There are several broken panes in the windows.

Task: Replace

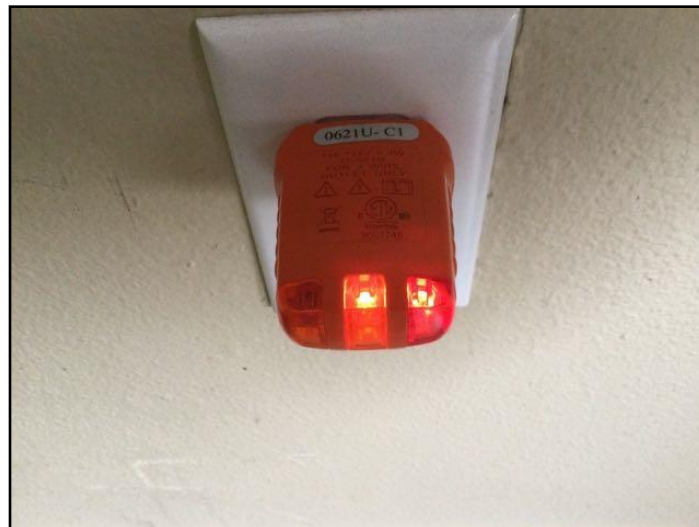
35. *Reversed polarity*

7. Condition: • [Reversed polarity](#)

Task: Repair

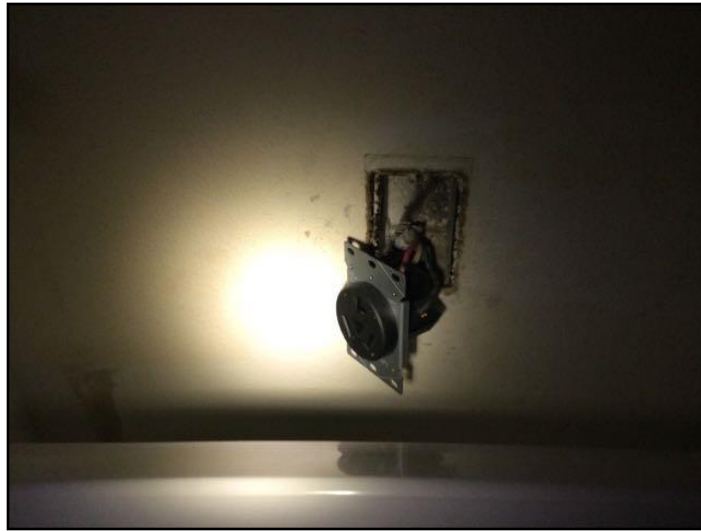
36. Not mounted properly

8. Condition: • Not mounted properly

Task: Repair

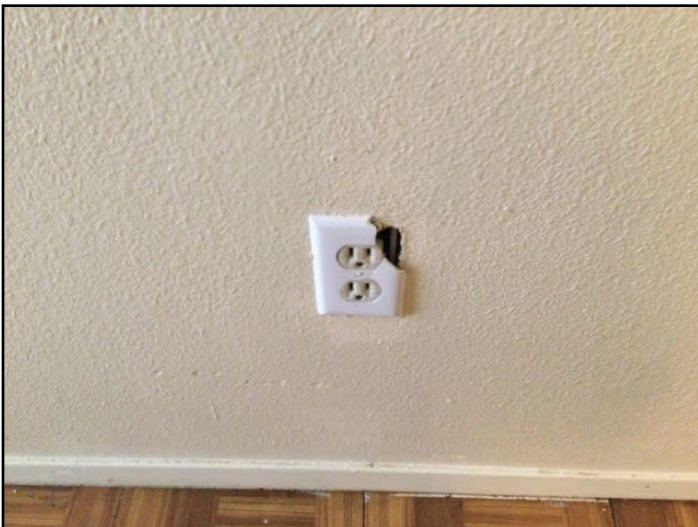
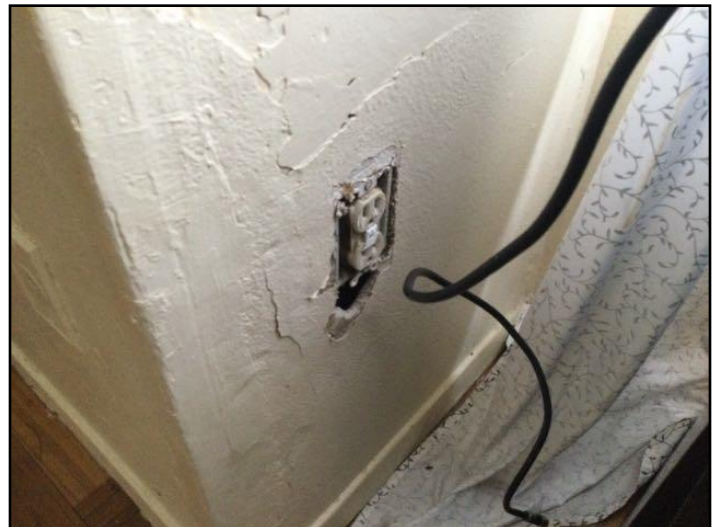
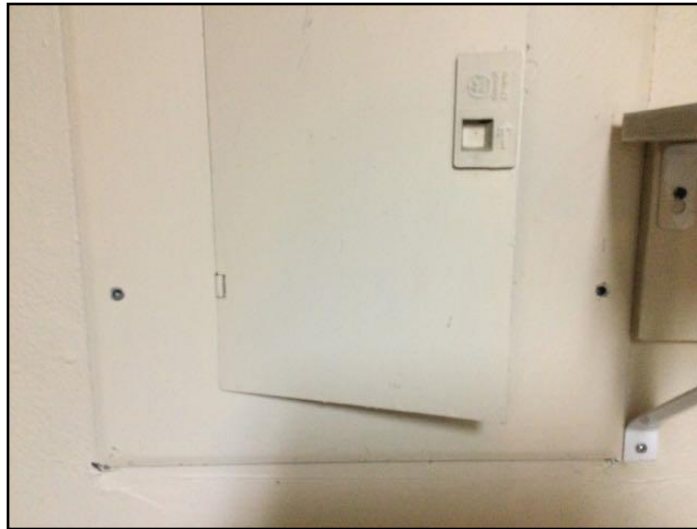
10. Condition: • [Missing](#)

There are broken or missing switch and outlets in all four of the units. Also, there are cover screws missing on all four of the electrical panel sub panels.

Task: Replace

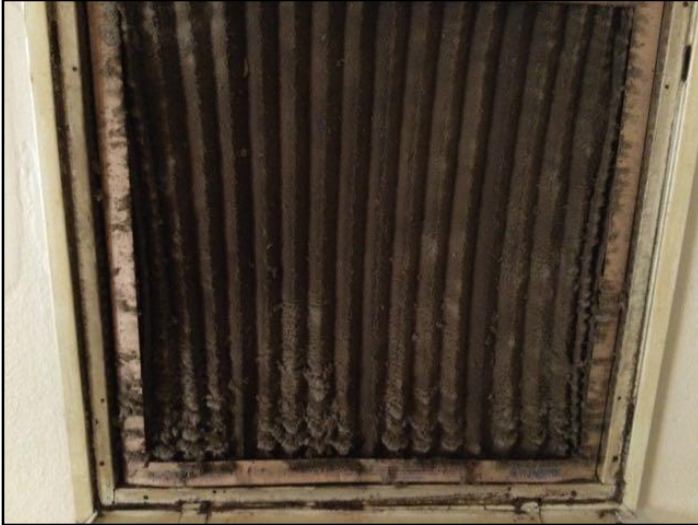
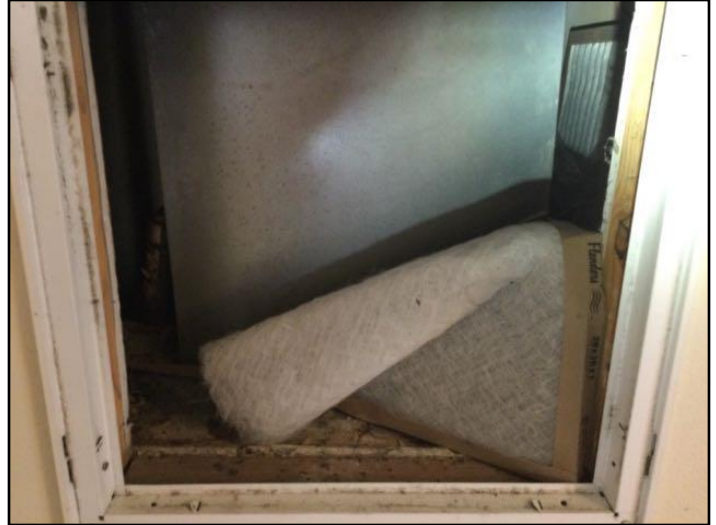
14. Condition: • [Dirty](#)

The HVAC filters need to be replaced. The inspector recommends replacing the filters and having the HVAC systems cleaned and serviced.

Task: Replace

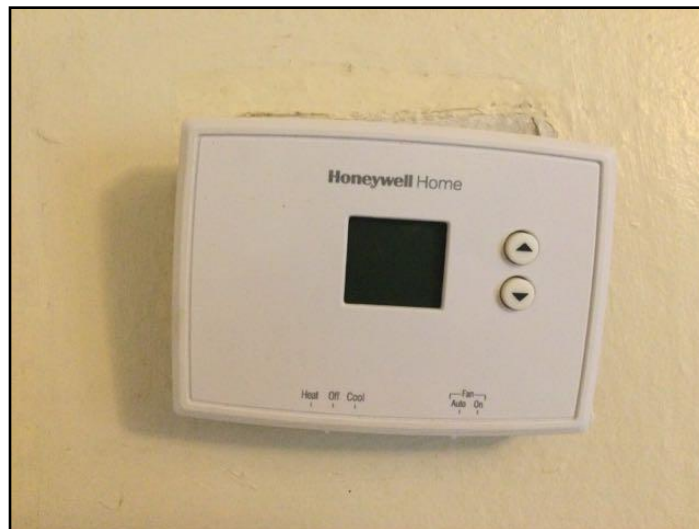
42. Not functional

15. Condition: • Not functional

The thermostat in unit B was not functional. The inspector was unable to test the heater or the air conditioner in unit B.

Task: Repair or replace

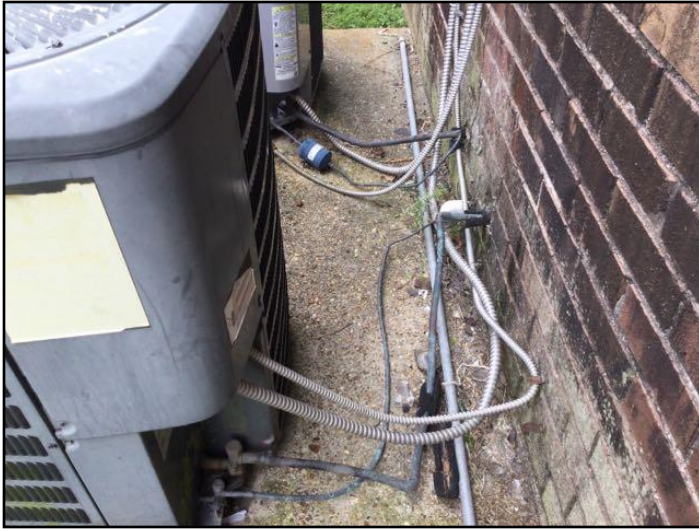
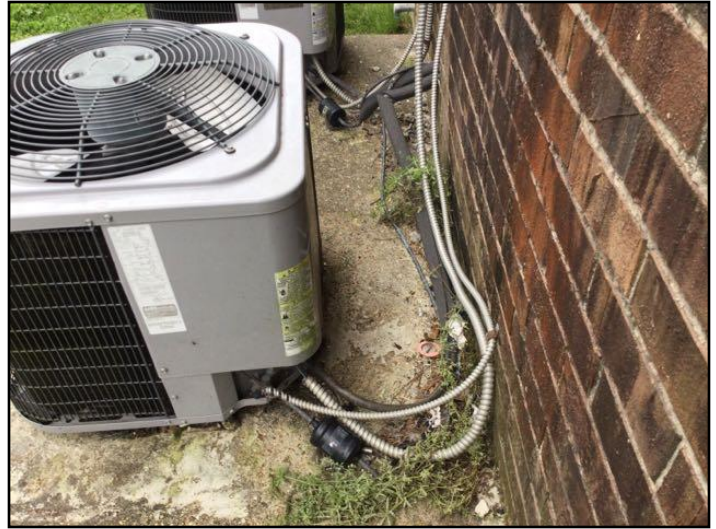
16. Condition: • [Insulation - missing](#)

Some of the insulation is missing around the air conditioning refrigerant lines.

Task: Replace

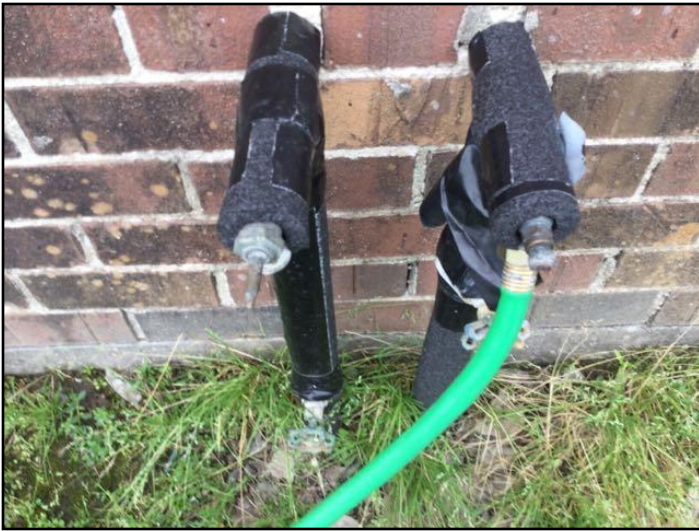
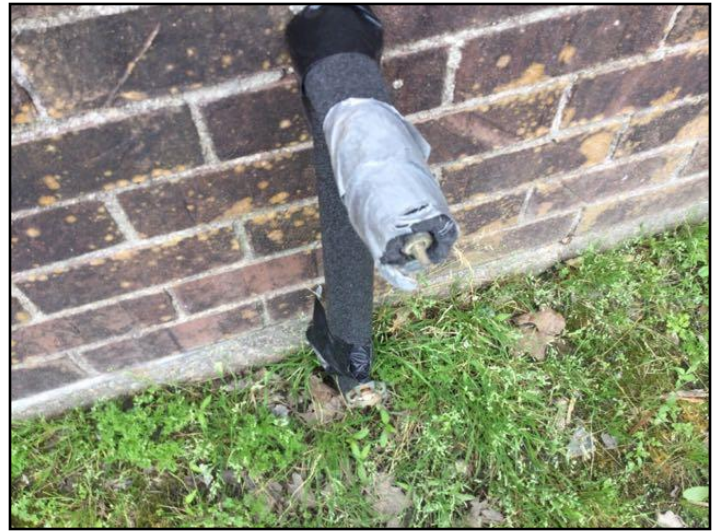
19. Condition: • Missing handle

The handles are missing on three of the exterior faucets.

Task: Replace

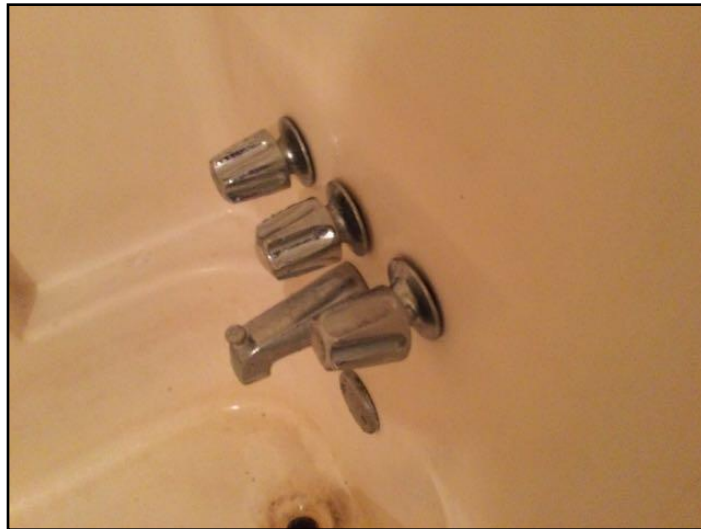
48. Stiff or inoperative

20. Condition: • [Stiff or inoperative](#)

Task: Repair or replace

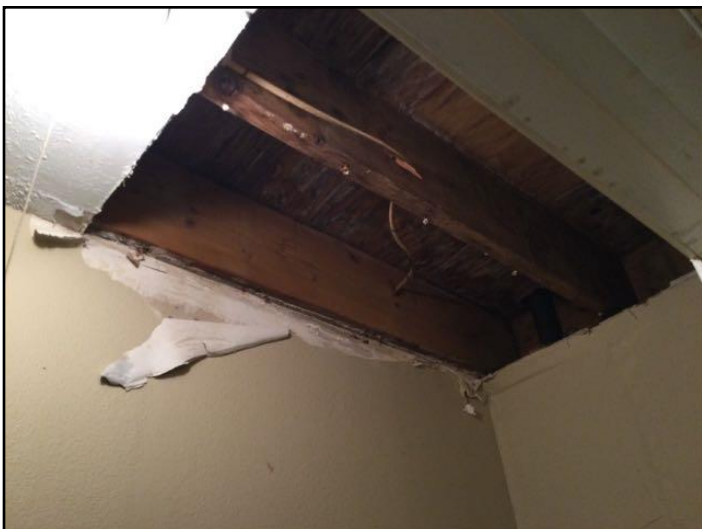
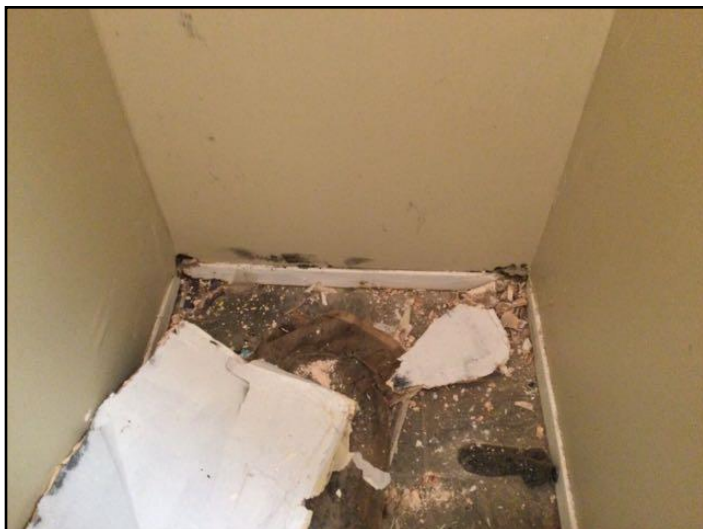
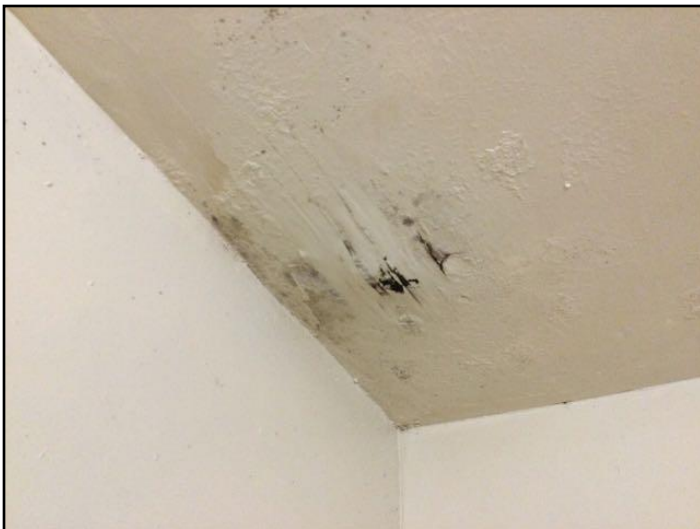
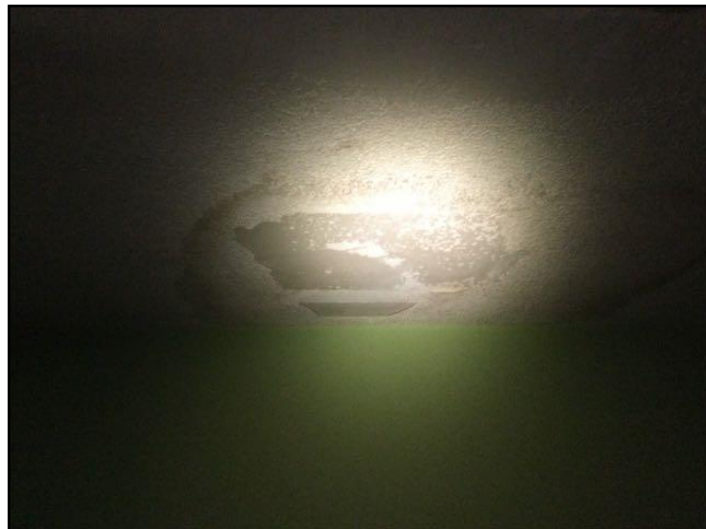
22. Condition: • [Water damage](#)

The inspector noted past water damage and potential mold on the ceilings and walls in units A & B. The inspector recommends further evaluation by a mold specialist and remediation if required.

Task: Further evaluation

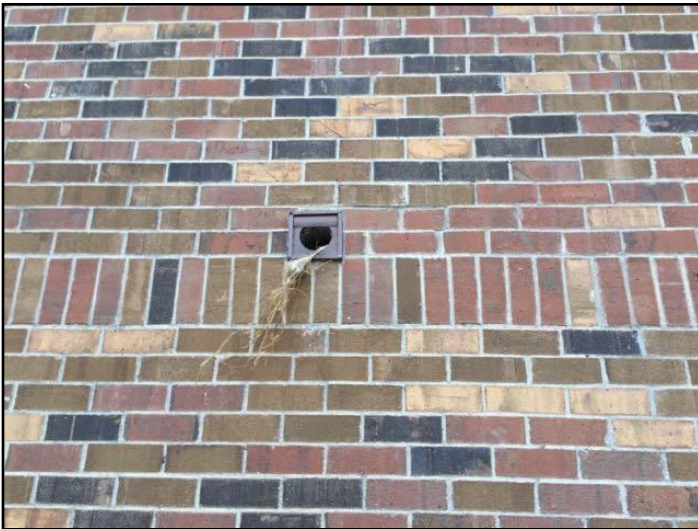
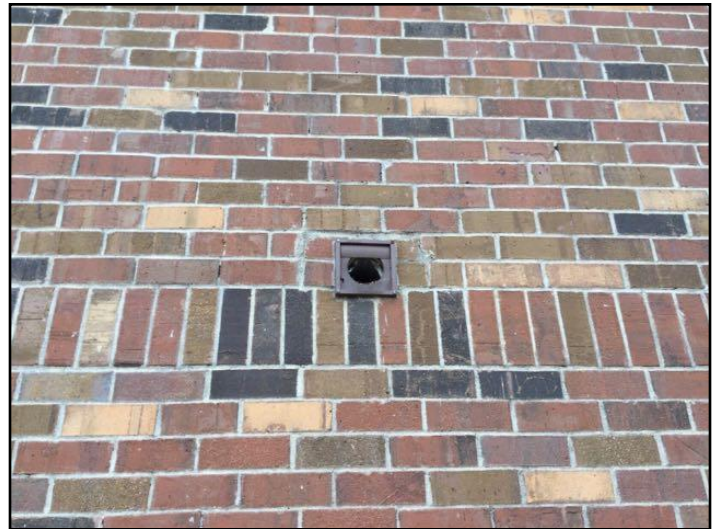
28. Condition: • Missing exterior cover

The exterior covers are missing on the dryer vents.

Task: Replace
