## **Dueblin Joint on SC13**

23 July 2026

## Executive Summary

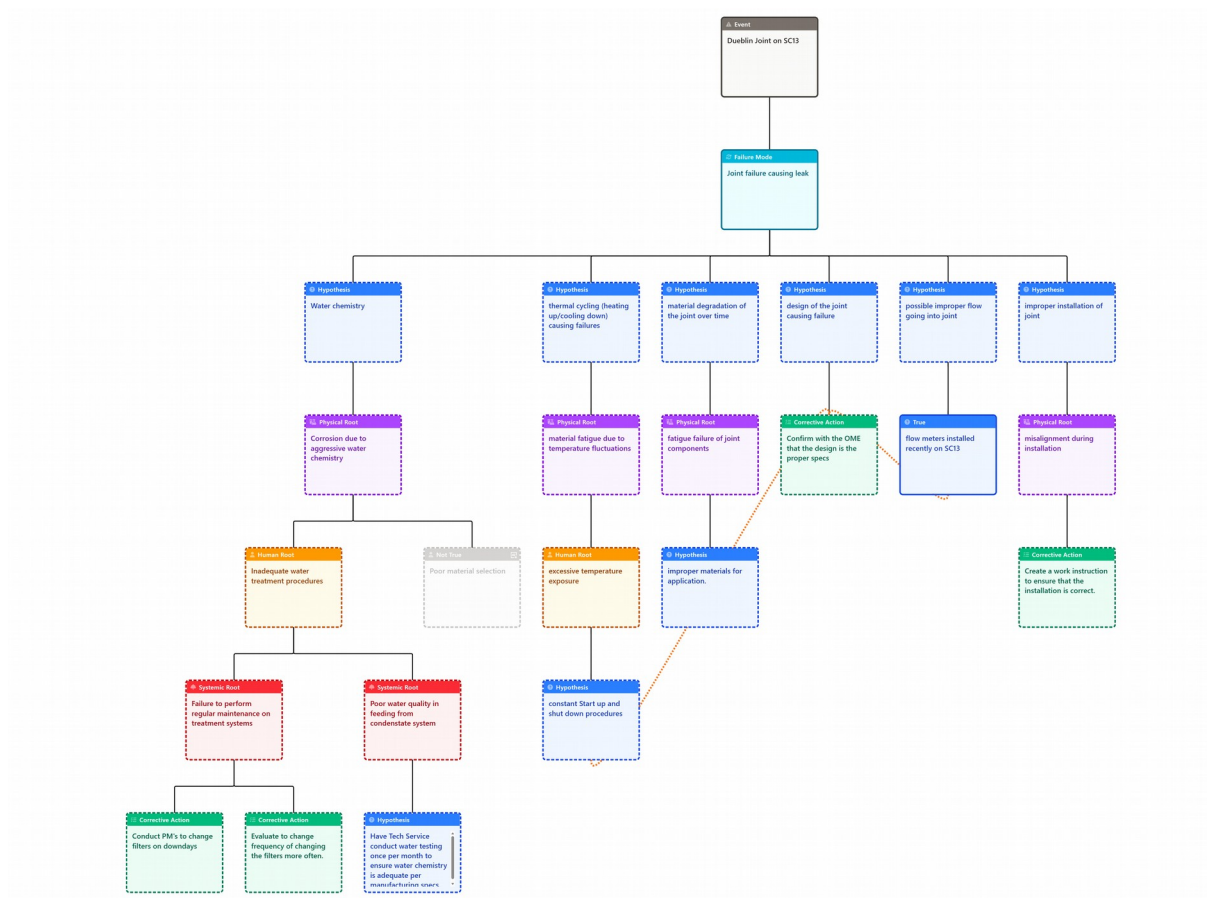
## Logic Tree

| Type | Root Cause | Corrective Actions |
|---|---|---|
| PHYSICAL | Corrosion due to aggressive water chemistry | |
| PHYSICAL | fatigue failure of joint components | |
| PHYSICAL | material fatigue due to temperature fluctuations | |
| PHYSICAL | misalignment during installation | 1. Create a work instruction to ensure that the installation is correct. |
| HUMAN | excessive temperature exposure | |
| HUMAN | Inadequate water treatment procedures | |
| SYSTEMIC | Failure to perform regular maintenance on treatment systems | 1. Evaluate to change frequency of changing the filters more often.<br>2. Conduct PM's to change filters on downdays |
| SYSTEMIC | Poor water quality in feeding from condensate system | |
