THERMAL IMAGE REPORT

Client	
Name	THE LANDMARK CONDOMINIUM
Site	20185 E COUNTRY CLUB DRIVE AVENTURA, FL 33180
Insp. Date	02/27/2024

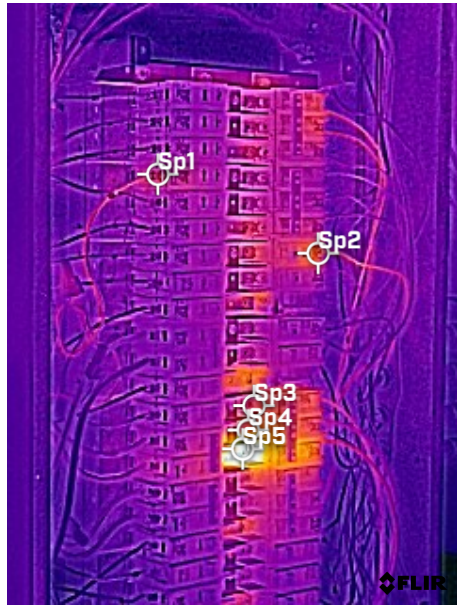
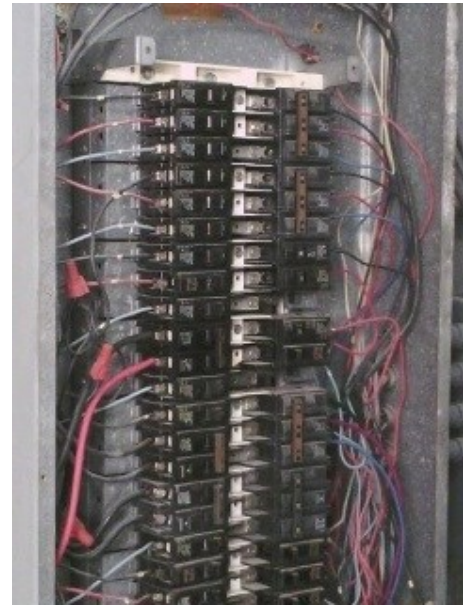
THE LANDMARK CONDOMINIUM	
Date	02/27/2024
Location	Electrical Room Pool
Equipment	NO ID
Component	Panelboard
File name	FLIR0257.jpg
Condition	MAJOR DEFICIENCY

Sp1	31.5 °C
Sp2	32.5 °C
Sp3	32.0 °C
Sp4	32.7 °C
Sp5	55.6 °C

3P Circuit breaker 26.28.30.
A temperature differential is observed between lines (line side).

- Remove the circuit breaker.
- Inspect bars, screws, and circuit breaker.
- Clean the parts, and install circuit breaker (apply torque according to manufacturer specifications).
- Ensure all three-phase loading is balanced.

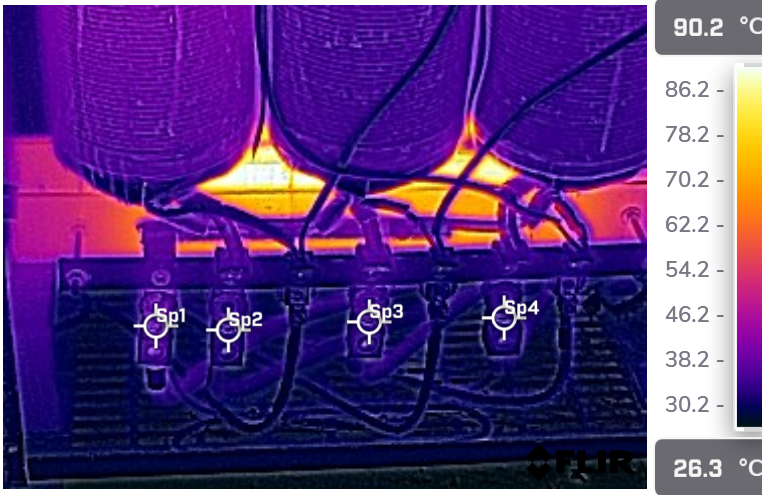
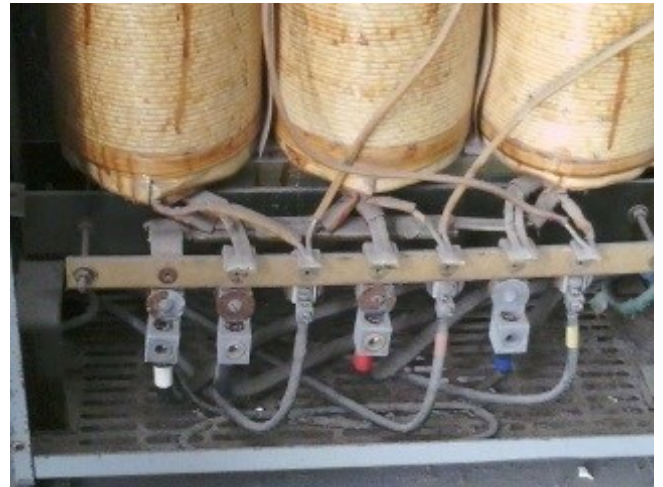
THE LANDMARK CONDOMINIUM	
Date	02/27/2024
Location	Electrical Room Pool
Equipment	NO ID
Component	30KVA Transformer
File name	FLIR0277.jpg
Condition	POSSIBLE DEFICIENCY

Sp1	38.2 °C
Sp2	34.8 °C
Sp3	35.6 °C
Sp4	34.1 °C

Possible deficiency in the neutral lug on the secondary side.

- Remove conductor. Inspect, conductors, lug, and screw for damage.
- Clean the parts, add antioxidant compound, and install conductor (apply torque according to manufacturer specifications.).
- Ensure all three-phase loading is balanced.

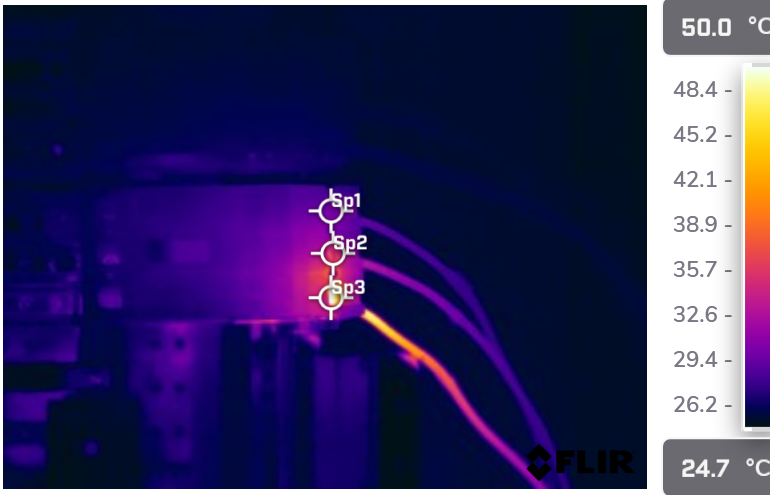
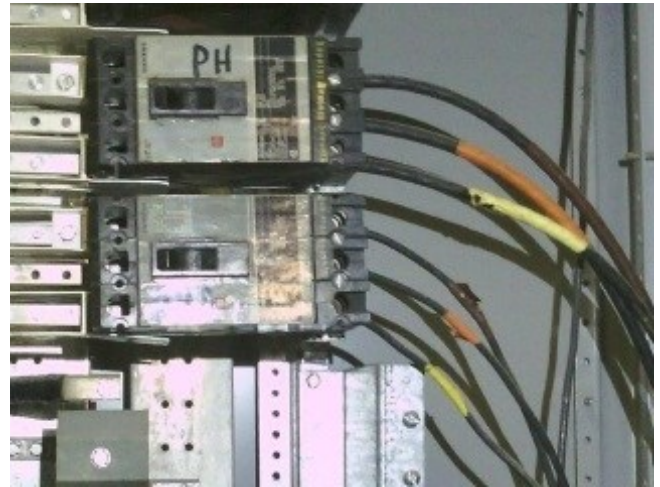
THE LANDMARK CONDOMINIUM	
Date	02/27/2024
Location	Main Electrical Room
Equipment	NDH Sec 2
Component	Circuit Breaker NHA
File name	FLIR0311.jpg
Condition	MAJOR DEFICIENCY

Sp1	30.1 °C
Sp2	35.0 °C
Sp3	57.3 °C

3P Circuit Breaker NHA.
A temperature differential is observed between lines (load side).

- Remove conductors.
- Inspect conductors, lugs, screws, and circuit breaker.
- Clean the parts, and install conductors (apply torque according to manufacturer specifications).
- Ensure all three-phase loading is balanced.

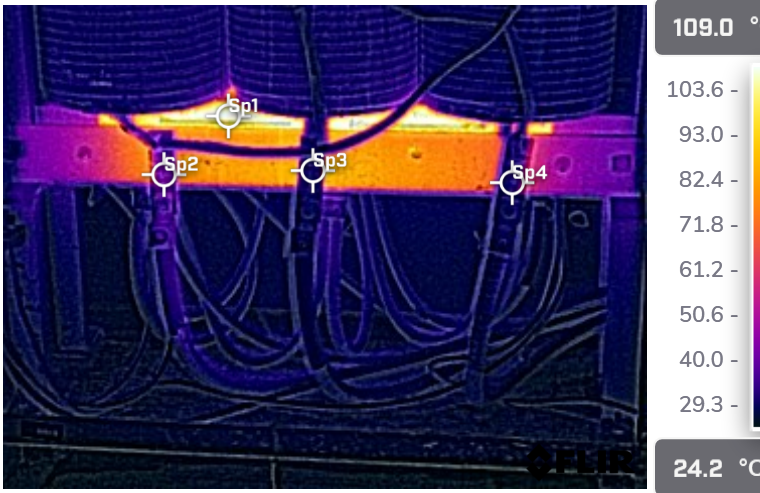
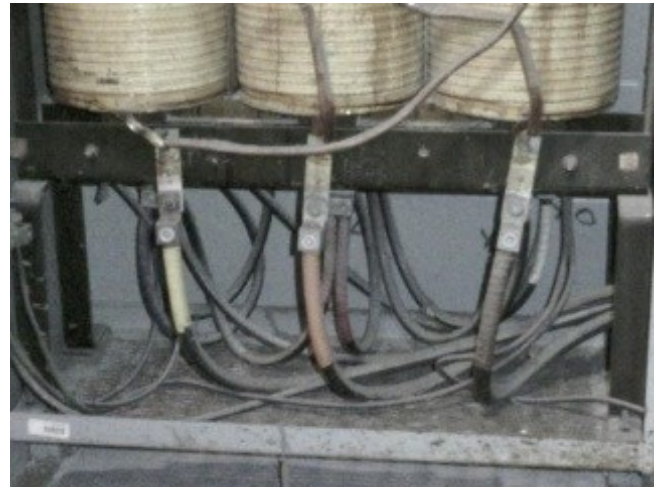
THE LANDMARK CONDOMINIUM	
Date	02/27/2024
Location	Main Electrical Room
Equipment	T1
Component	Transformer
File name	FLIR0373.jpg
Condition	DEFICIENCY

Sp1	110.2 °C
Sp2	46.1 °C
Sp3	32.1 °C
Sp4	32.7 °C

Possible deficiency in the line-1 lug on the primary side.

- Remove the conductor. Inspect, conductors, lug, and screw for damage.
- Clean the parts, add antioxidant compound, and install conductor (apply torque according to manufacturer specifications.).
- Ensure all three-phase loading is balanced.

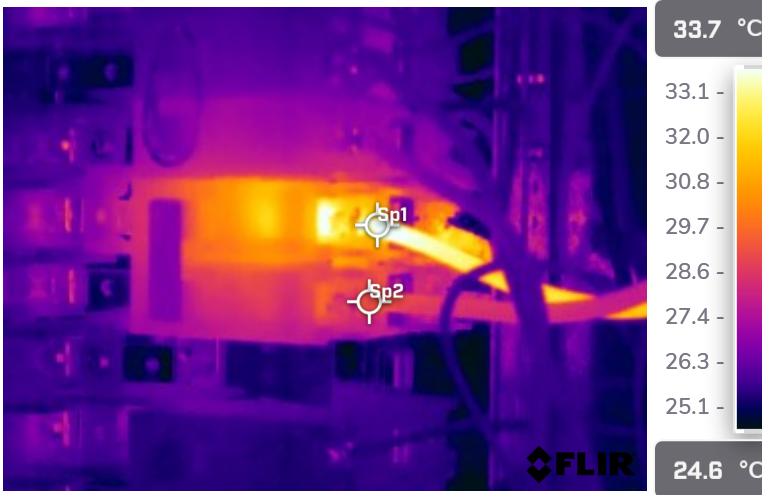
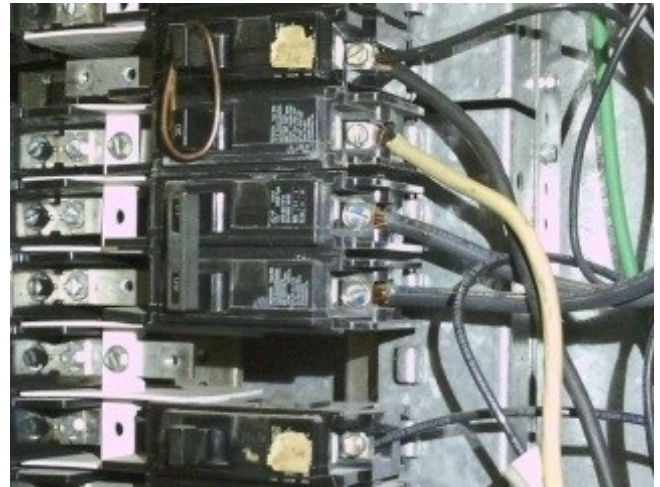
Date	02/27/2024
Location	Main Electrical Room
Equipment	NL Panelboard
Component	Circuit breaker 28.30
File name	FLIR0411.jpg
Condition	DEFICIENCY

Sp1	34.2 °C
Sp2	29.0 °C

2P Circuit breaker 28.30.
A temperature differential is observed between lines (load side).

- Remove conductors.
- Inspect conductors and circuit breaker.
- Clean the parts, and install conductors (apply torque according to manufacturer specifications).

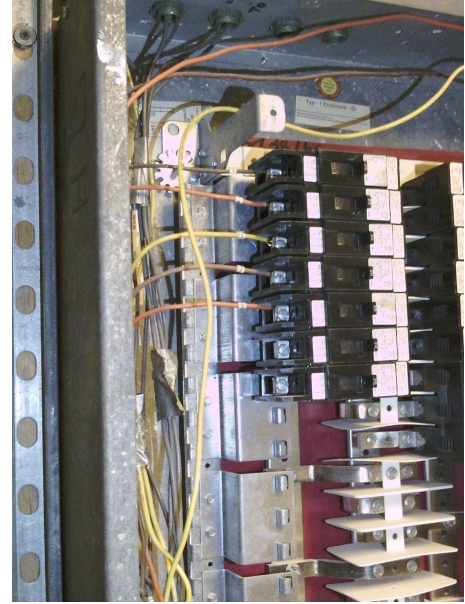
THE LANDMARK CONDOMINIUM	
Date	02/27/2024
Location	Level 7 Meter Room
Equipment	7H Panelboard
Component	Circuit breakers 7 & 9
File name	FLIR0569.jpg
Condition	POSSIBLE DEFICIENCY

Sp1	47.5 °C
Sp2	44.0 °C

1P Circuit breakers 7 & 9.
Abnormal temperature is observed in circuit breakers (load side).

- Remove conductors.
- Inspect conductors and circuit breakers.
- Clean the parts, and install conductors (apply torque according to manufacturer specifications).

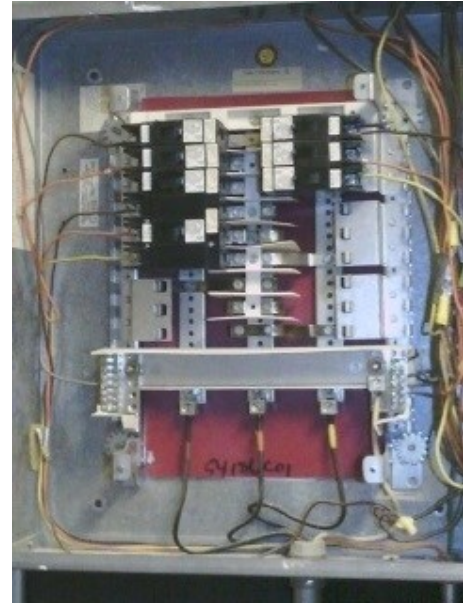
THE LANDMARK CONDOMINIUM	
Date	02/27/2024
Location	Level 7 Meter Room
Equipment	7EH Panelboard
Component	Wire splices
File name	FLIR0577.jpg
Condition	POSSIBLE DEFICIENCY

Sp1	32.2 °C
Sp2	31.7 °C
Sp3	48.3 °C
Sp4	40.7 °C

Possible deficiency in wire splices.

- Remove splices and inspect wires.
- Use proper wire nut.
- Perform splicing according to wirenut specification.
