City of Aventura

MINIMUM INSPECTION PROCEDURAL GUIDELINES FOR BUILDING ELECTRICAL RECERTIFICATION

a. Name on Title: THE LANDMARK CONDO

b. Building Street Address: 20185 E COUNTRY CLUB DRIVE, AVENTURA, FL 33180

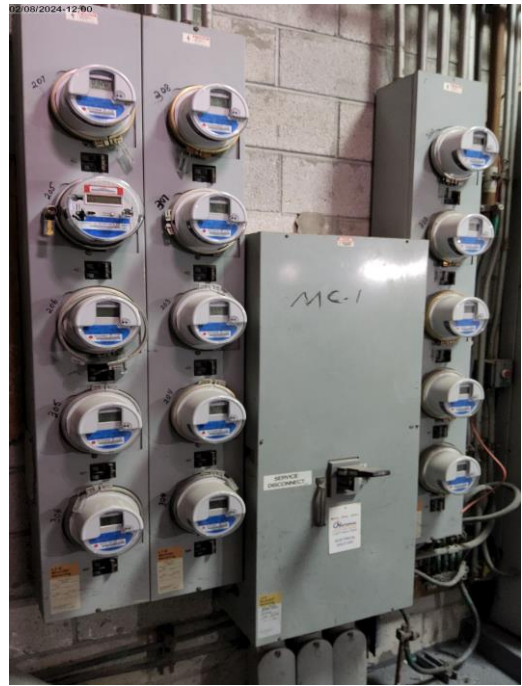
2. MC-1 (Disconnect Switch)
a. Size: Voltage (208) Amperage (1200) Type: Fuses (1000) Breakers ()
b. Phase: Three-phase (●) Single-phase ()
c. Condition: Good () Fair () Needs Repair (●)
Comments: Location: Level 1 - Main Electrical Room
Repairs are required as follows:
Missing proper panel identification (x of Y). All service equipment must be identified. See Annex "A", photo #2.

Photo # 2. Item 3.2. Electrical Room. MC-1. Disconnect Switch. All service equipment must be identified.

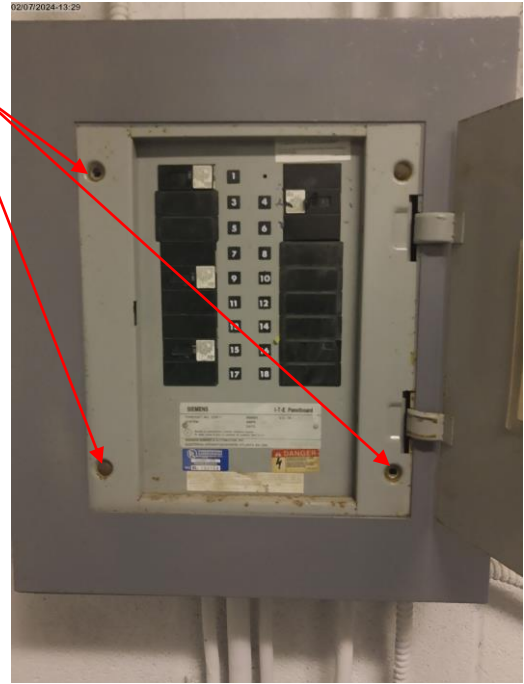
1. Panel #:	No ID	Location:	Level Roof.
		Good ()	Needs Repair (<input checked="" type="radio"/>)
Comments:	Size: 100 AMPS	Volt: 480	Phases: 3 Type: MCB
Repairs are required as follows: a. Missing panel Identification. See Annex "A", photo #13. b. Missing screws. See Annex "A", photo #14.

Photo # 14. Item 7.1.b. Level Roof. Mechanical Room. Panelboard No ID. Missing screws.

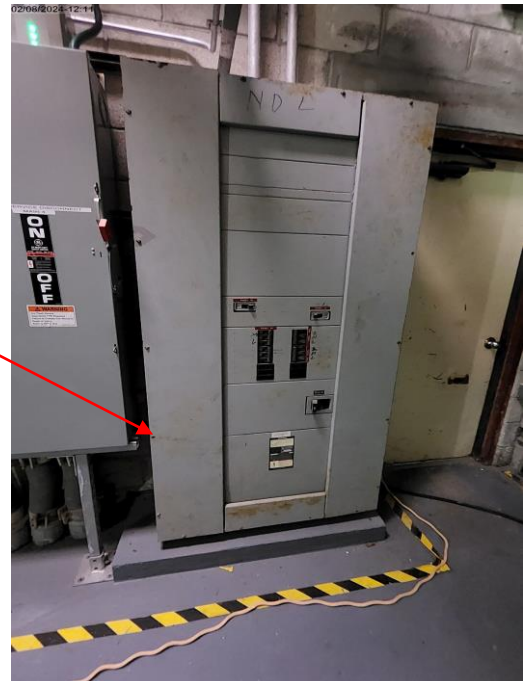
3. Panel #:	NDL	Location:	Main Electrical Room
		Good ()	Needs Repair (<input checked="" type="radio"/>)
Comments:	Size: 800 AMPS	Volt: 208	Phases: 3 Type: MCB
Repairs are required as follows: Missing screws. See Annex "A", photo #16.

Photo # 16. Item 7.3. Level 1. Main Electrical Room. Panel NDL. Missing screws.

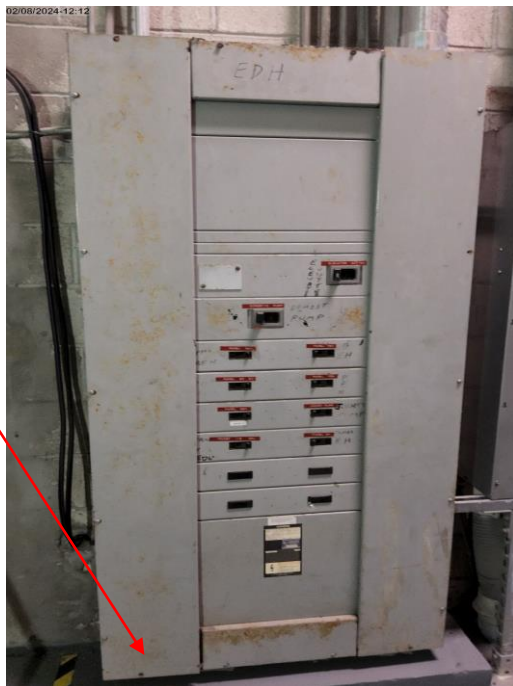
4. Panel #:	EDH	Location:	Main Electrical Room
		Good ()	Needs Repair (<input checked="" type="radio"/>)
Comments:	Size: 600 AMPS	Volt: 480	Phases: 3 Type: MLO
Repairs are required as follows: Missing screws. See Annex "A", photo #17.

Photo # 17. Item 7.4. Level 1. Main Electrical Room. Panel EDH. Missing screws.

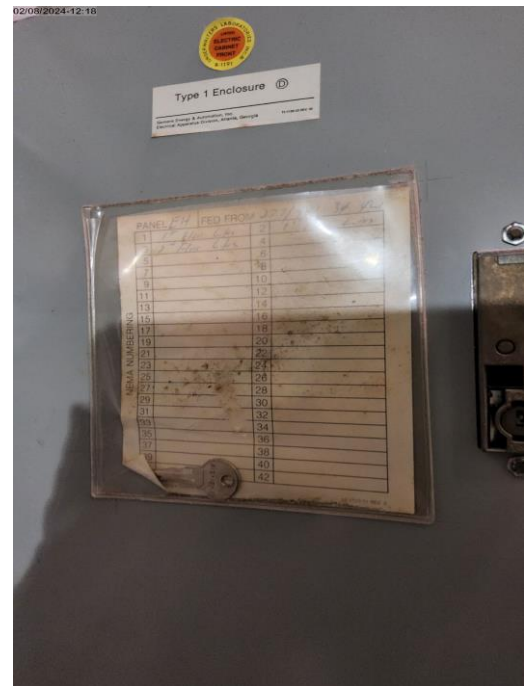
5. Panel #:	EH	Location:	Main Electrical Room
		Good ()	Needs Repair (<input checked="" type="radio"/>)
Comments:	Size: 100 AMPS	Volt: 480	Phases: 3 Type: MLO
Repairs are required as follows: a. Missing proper circuit identification. See Annex "A", photo #18. b. Missing screws. See Annex "A", photo #19.

Photo # 18. Item 7.5.a. Level 1. Main Electrical Room. Panel EH. Missing proper circuit identification.

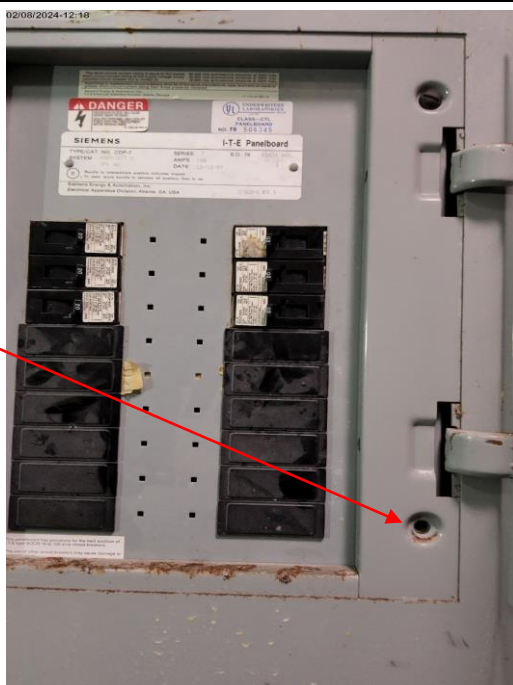
Photo # 19. Item 7.5.b. Level 1. Main Electrical Room. Panel EH. Missing screws.

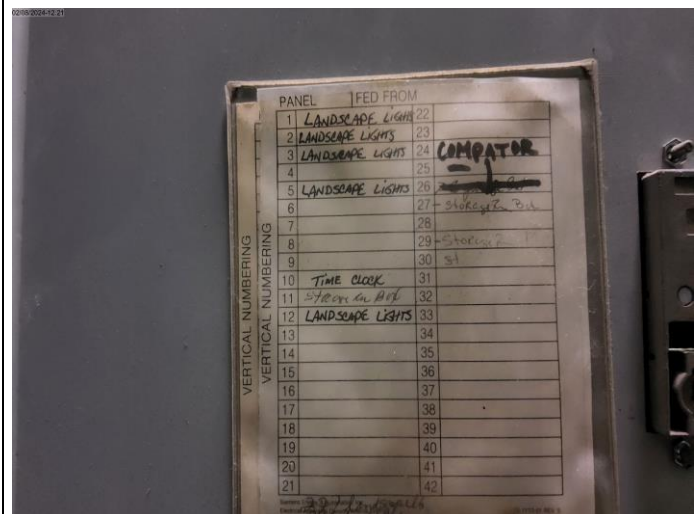
6. Panel #:	OL	Location:	Main Electrical Room		
		Good	()	Needs Repair	(<input checked="" type="radio"/>)
Comments:	Size: 225 AMPS	Volt: 208	Phases: 3	Type: MLO	
Repairs are required as follows:					
a. Missing proper circuit identification. See Annex "A", photo #20.					
b. Missing screws. See Annex "A", photo #21.

Photo # 20. Item 7.6.a. Level 1. Main Electrical Room. Panel OL. Missing proper circuit identification.

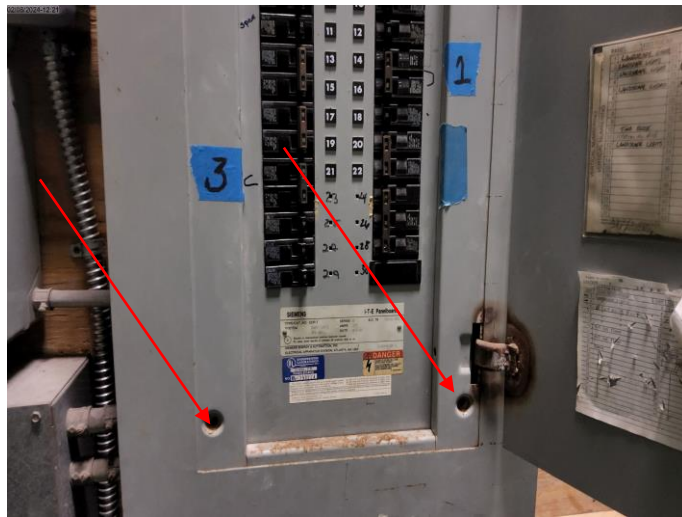
Photo # 21. Item 7.6.b. Level 1. Main Electrical Room. Panel OL. Missing screws.

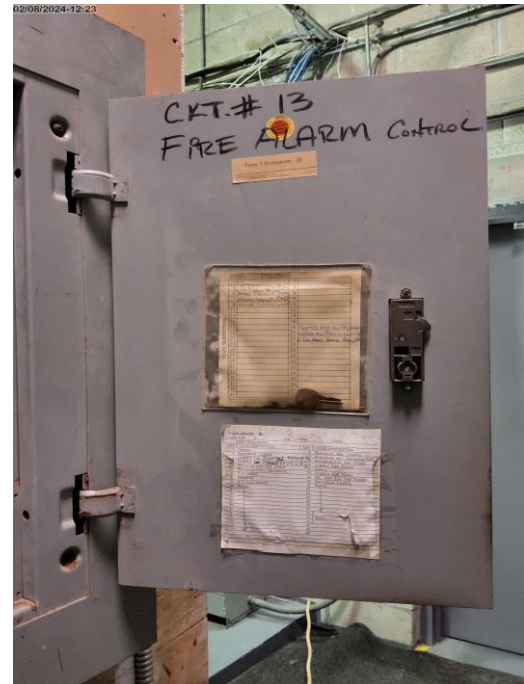
7. Panel #:	EL	Location:	Main Electrical Room		
		Good	()	Needs Repair	(<input checked="" type="radio"/>)
Comments:	Size: 100 AMPS	Volt: 208	Phases: 3	Type: MLO	
Repairs are required as follows:					
a. Missing proper circuit identification. See Annex "A", photo #22.					
b. Missing screws and rusted. See Annex "A", photo #23.

Photo # 22. Item 7.7.a. Level 1. Main Electrical Room. Panel EL. Missing proper circuit identification.

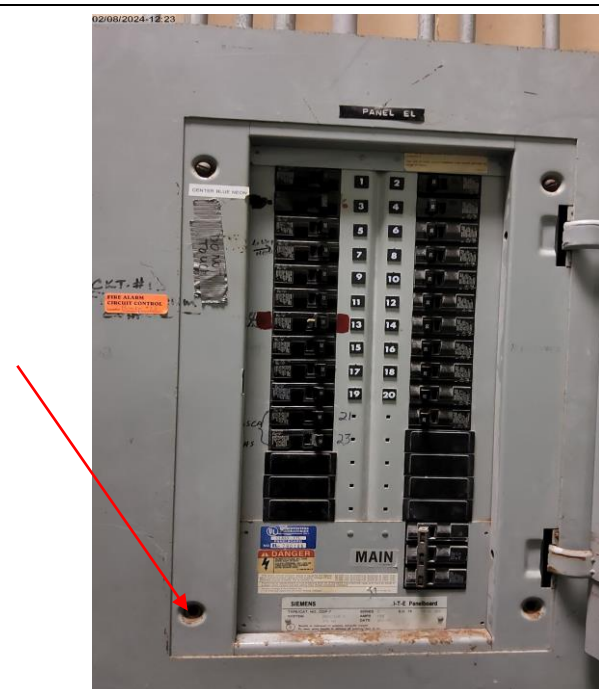
Photo # 23. Item 7.7.b. Level 1. Main Electrical Room. Panel EL. Missing screws.

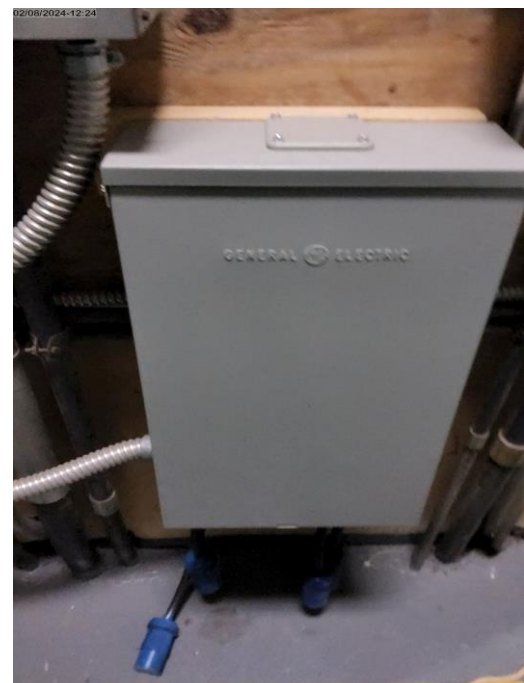
8. Panel #:	NO ID	Location:	Main Electrical Room		
		Good	()	Needs Repair	(<input checked="" type="radio"/>)
Comments:	Size: No rating	Volt: 480	Phases: 3	Type: MLO	
Repairs are required as follows:					
a. Missing panel Identification. See Annex "A", photo #24.					
b. Missing proper circuit identification and opening in circuit space. See Annex "A", photo #25.					
c. Connector cable to panel is detached. See Annex "A", photo #26.

Photo # 24. Item 7.8.a. Panel NO ID. Main Electrical Room. Missing panel Identification.

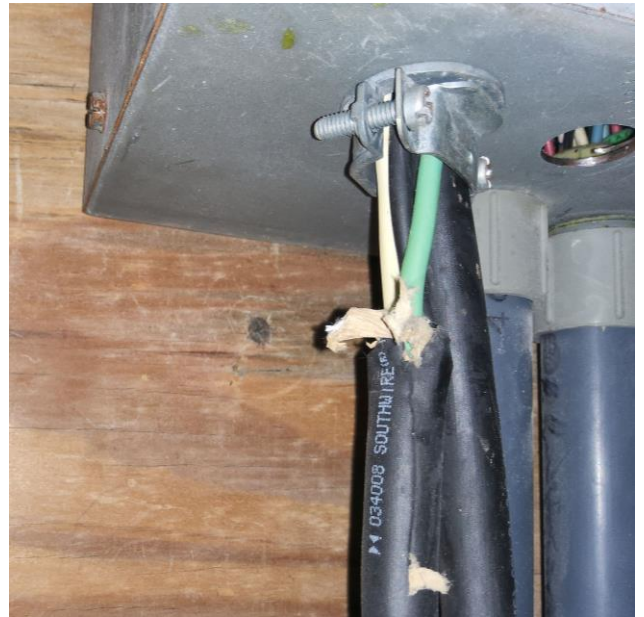
Photo # 26. Item 7.8.c. Level 1. Main Electrical Room. Panel NO ID. Connector cable to panel is detached.

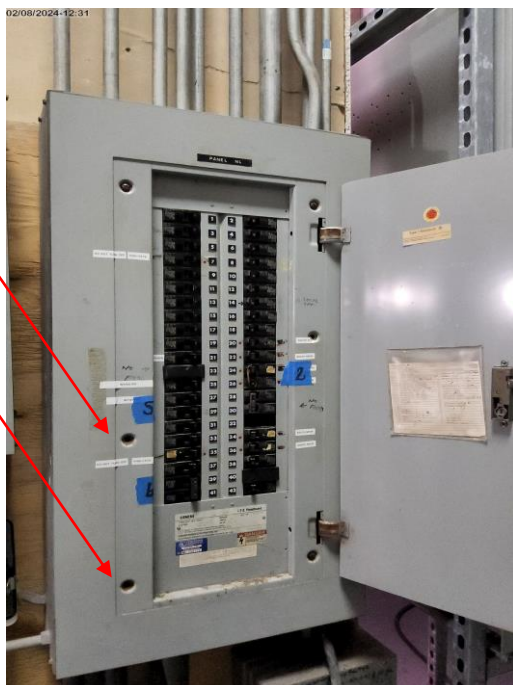
9. Panel #:	NL	Location:	Main Electrical Room		
		Good	()	Needs Repair	(<input checked="" type="radio"/>)
Comments:	Size: 225 AMPS	Volt: 208	Phases: 3	Type: MLO	
Repairs are required as follows:					
a. Missing proper circuit identification and missing screws. See Annex "A", photo #27.					
b. Opening in circuit space. See Annex "A", photo #28.					
c. Double tapping in circuit breaker CB#24 and no proper Handle Tie. See Annex "A", photo #29.

Photo # 27. Item 7.9.a. Level 1. Main Electrical Room. Panel NL. Missing proper circuit identification and missing screws.

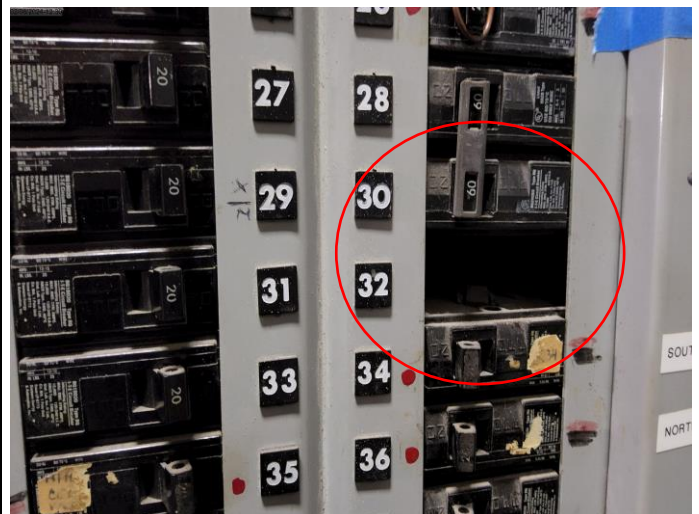
Photo # 28. Item 7.9.b. Level 1. Main Electrical Room. Panel NL. Opening in circuit space.

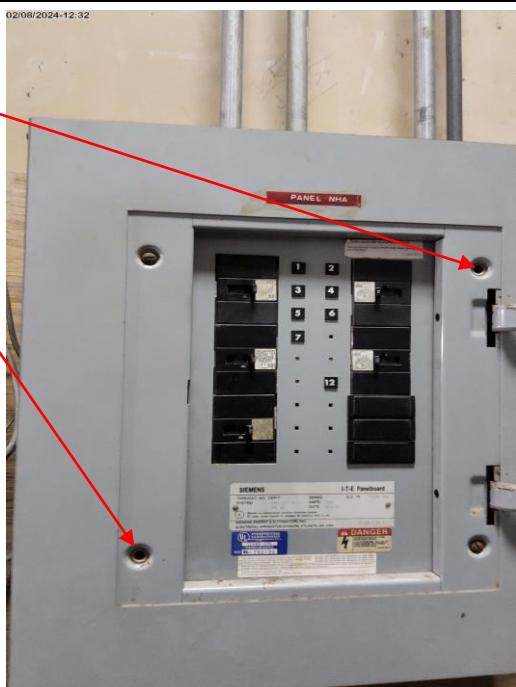
10. Panel #:	NHA	Location:	Main Electrical Room		
		Good	()	Needs Repair	(<input checked="" type="radio"/>)
Comments:	Size: 100 AMPS	Volt: 480	Phases: 3	Type: MLO	
Repairs are required as follows:					
a. Missing proper circuit identification. See Annex "A", photo #30.					
b. Missing screws. See Annex "A", photo #31.

Photo # 31. Item 7.10.b. Level 1. Main Electrical Room. Panel NHA. Missing screws.

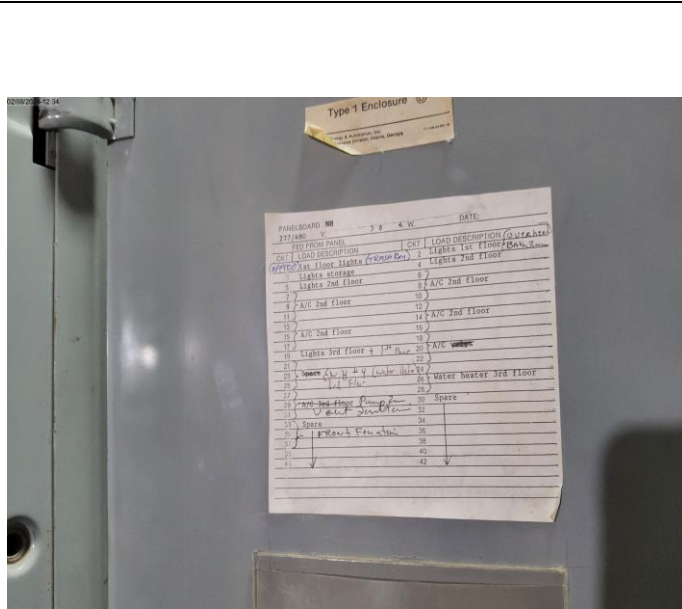
11. Panel #:	NH	Location:	Main Electrical Room		
		Good	()	Needs Repair	(<input checked="" type="radio"/>)
Comments:	Size: 225 AMPS	Volt: 480	Phases: 3	Type: MLO	
Repairs are required as follows:					
a. Missing panel Identification. See Annex "A", photo #32.					
b. Missing proper circuit identification. See Annex "A", photo #33.					
c. Missing screws. See Annex "A", photo #34.					
d. Double tapping in circuit breaker CB#2 and CB#3. See Annex "A", photo #35.

Photo # 33. Item 7.11.b. Level 1. Main Electrical Room. Panel NH. Missing proper circuit identification.

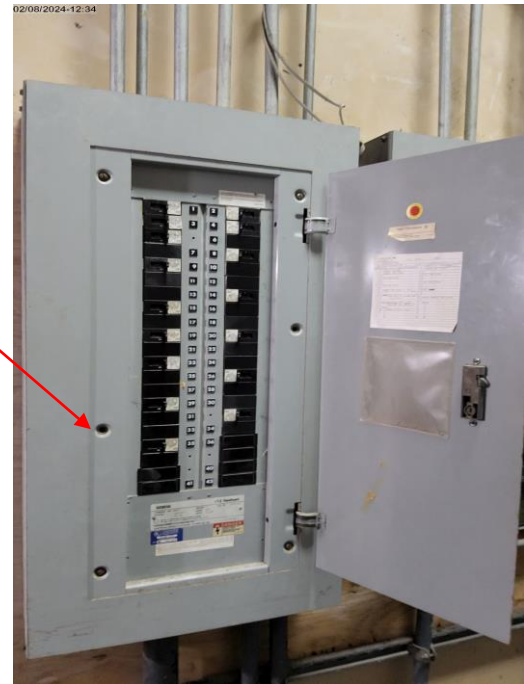
Photo # 34. Item 7.11.c. Level 1. Main Electrical Room. Panel NH. Missing Screws.

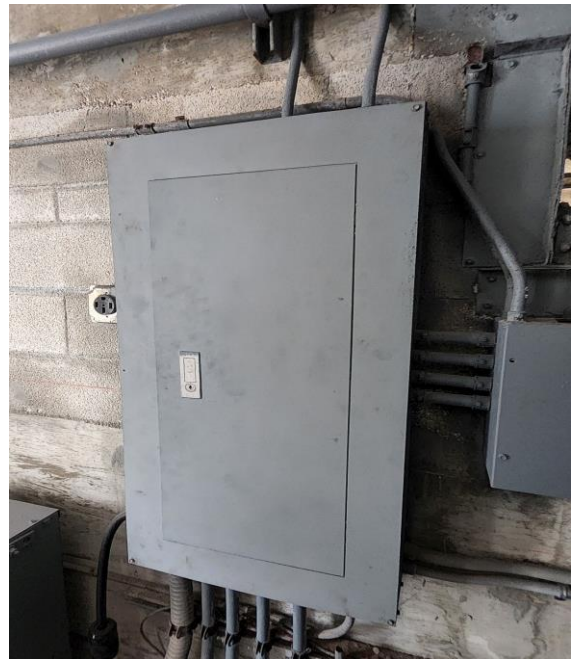
12. Panel #:	No ID	Location:	Pool- Electrical Room
		Good ()	Needs Repair (<input checked="" type="radio"/>)
Comments:	Size: 150 AMPS	Volt: 208	Phases: 3 Type: MCB
Repairs are required as follows:			
a. Missing panel Identification. See Annex "A", photo #36.			
b. Missing proper circuit identification and opening in circuit space. See Annex "A", photo #37.			
c. Missing screws. See Annex "A", photo #38.

Photo # 36. Item 7.12.a. Pool. Electrical Room. Panel NO ID. Missing panel Identification.

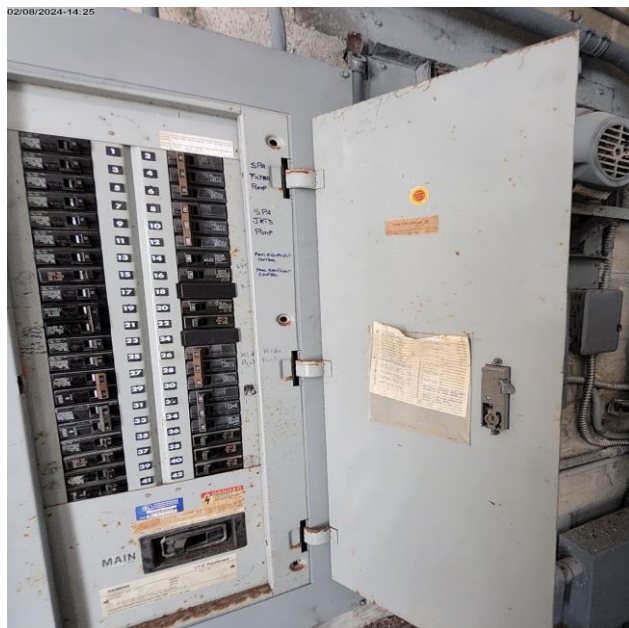
Photo # 37. Item 7.12.b. Pool. Electrical Room. Panel NO ID. Missing proper circuit identification.

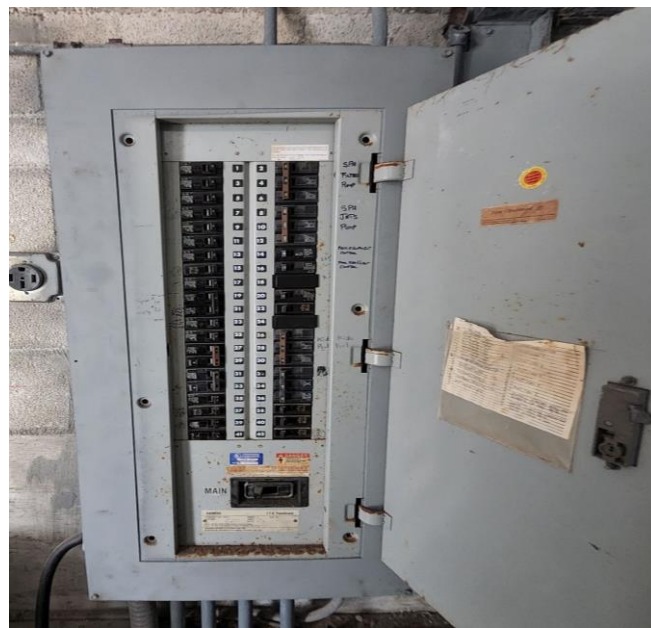
Photo # 38. Item 7.12.c. Pool. Electrical Room. Panel NO ID. Missing Screws.

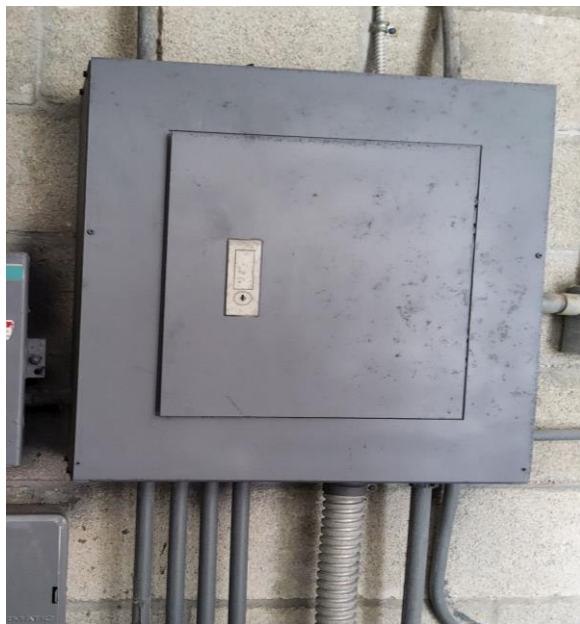
13. Panel #:	No ID	Location:	Pool- Electrical Room
		Good ()	Needs Repair (<input checked="" type="radio"/>)
Comments:	Size: 100 AMPS	Volt: 208	Phases: 3 Type: MLO
Repairs are required as follows:			
a. Missing panel Identification. See Annex "A", photo #39.			
b. Missing proper circuit identification, and missing screws. See Annex "A", photo #40.

Photo # 39. Item 7.13.a. Pool. Electrical Room. Panel NO ID. Missing panel Identification.

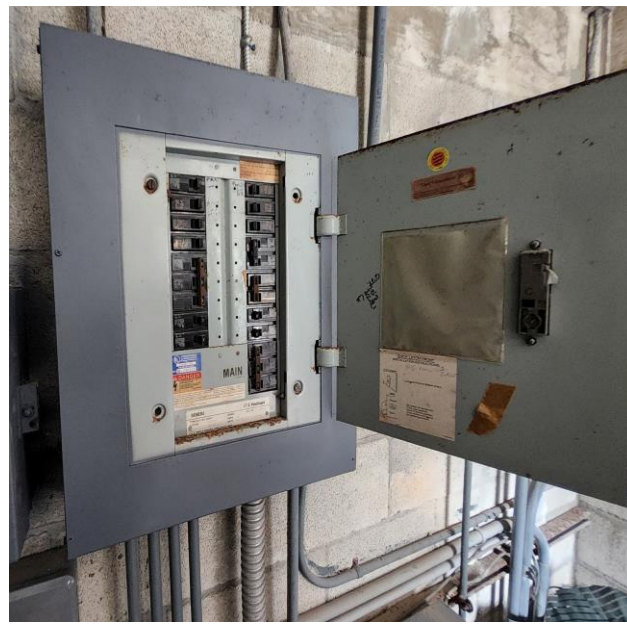
Photo # 40. Item 7.13.b. Pool. Electrical Room. Panel NO ID. Missing proper circuit identification, and missing screws.

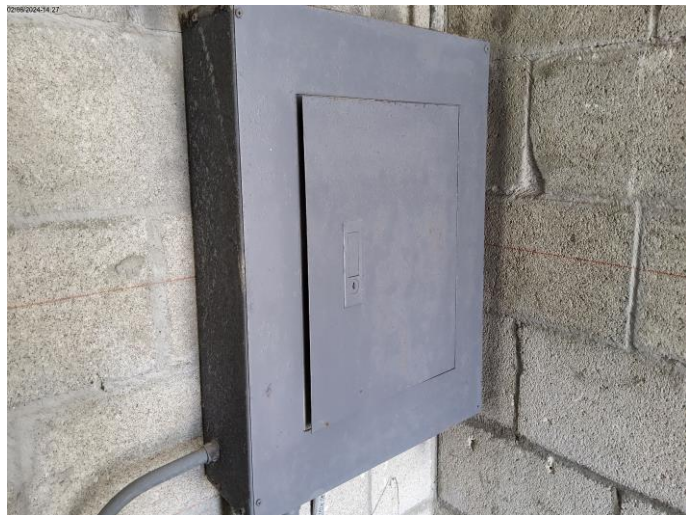
14. Panel #:	PEH	Location:	Pool- Electrical Room
		Good ()	Needs Repair (<input checked="" type="radio"/>)
Comments:	Size: 100 AMPS	Volt: 480	Phases: 3 Type: MLO
Repairs are required as follows:			
a. Missing panel Identification. See Annex "A", photo #41.			
b. Missing proper circuit identification. See Annex "A", photo #42.

Photo # 41. Item 7.14.a. Pool. Electrical Room. Panel PEH. Missing panel identification.

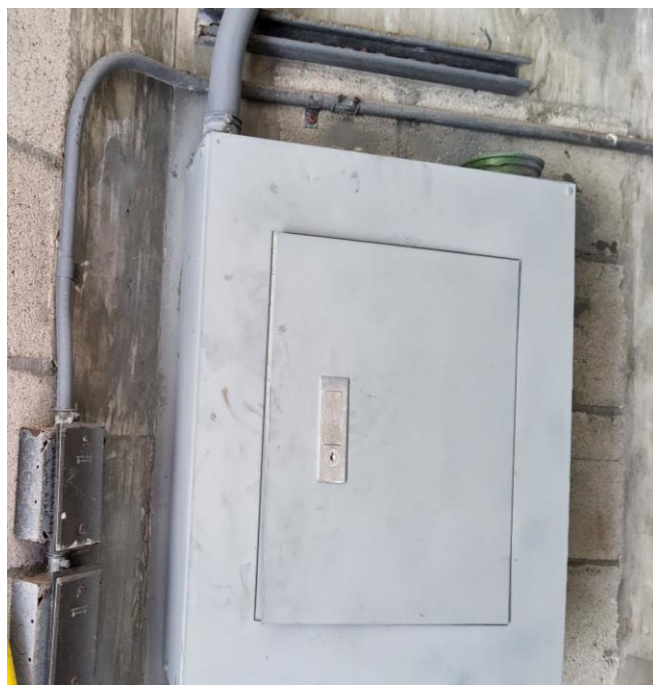
15. Panel #:	No ID	Location:	Pool- Electrical Room
		Good ()	Needs Repair (<input checked="" type="radio"/>)
Comments:	Size: 100 AMPS	Volt: 208	Phases: 3 Type: MLO
Repairs are required as follows:			
a. Missing proper panel ID label. See Annex "A", photo #43.			
b. Missing proper circuit identification, and missing screws. See Annex "A", photo #44.

Photo # 43. Item 7.15.a. Pool. Electrical Room. Panel NO ID. Missing panel identification.

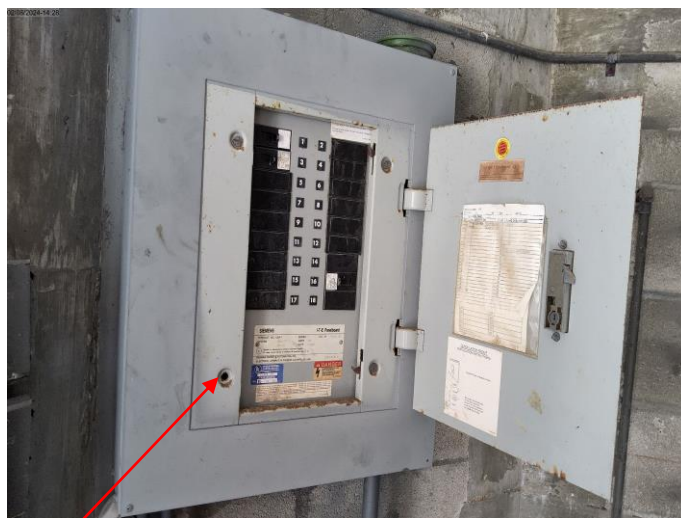
Photo # 44. Item 7.15.b. Pool. Electrical Room. Panel NO ID. Missing proper circuit identification, and missing screws.

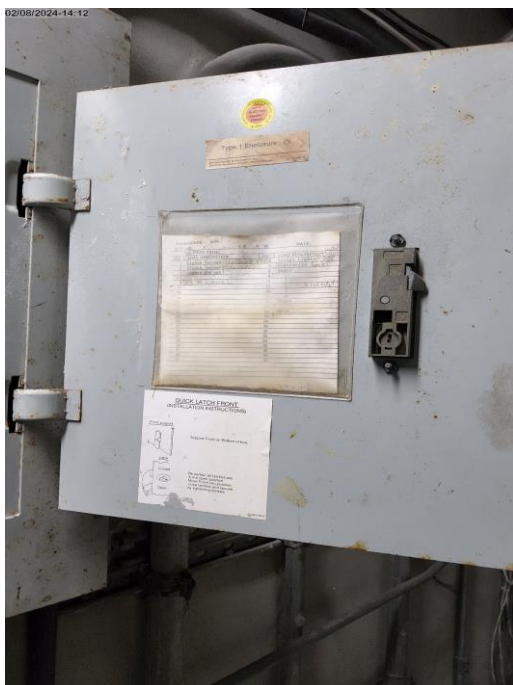
16. Panel #:	Panel 3	Location:	Emergency Generator Room
		Good ()	Needs Repair (<input checked="" type="radio"/>)
Comments:	Size: 100 AMPS	Volt: 480	Phases: 3 Type: MCB
Repairs are required as follows:			
Missing proper circuit identification. See Annex "A", photo #45.

Photo # 45. Item 7.16. Generator Room. Panel 3. Missing proper circuit identification.

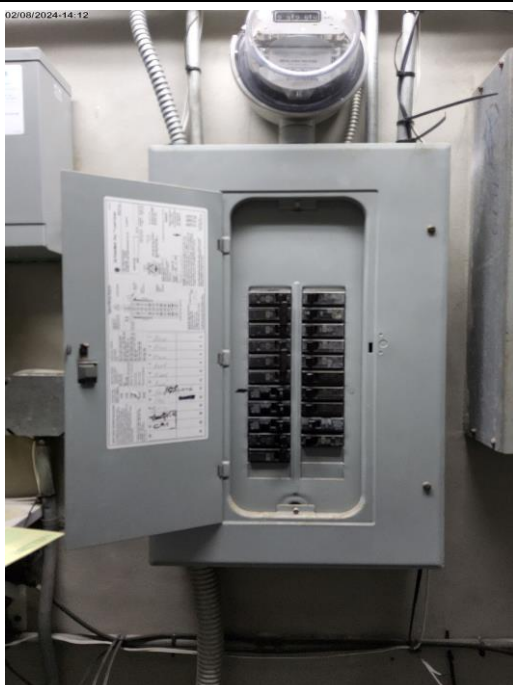
17. Panel #:	No ID	Location:	Emergency Generator Room
		Good ()	Needs Repair (<input checked="" type="radio"/>)
Comments:	Size: 125 AMPS	Volt: 208	Phases: 3 Type: MLO
Repairs are required as follows:			
a. Missing panel Identification. See Annex "A", photo #46.			
b. Missing proper circuit identification. See Annex "A", photo #47.

Photo # 47. Item 7.17.b. Generator Room. Panel No ID. Missing proper circuit identification.

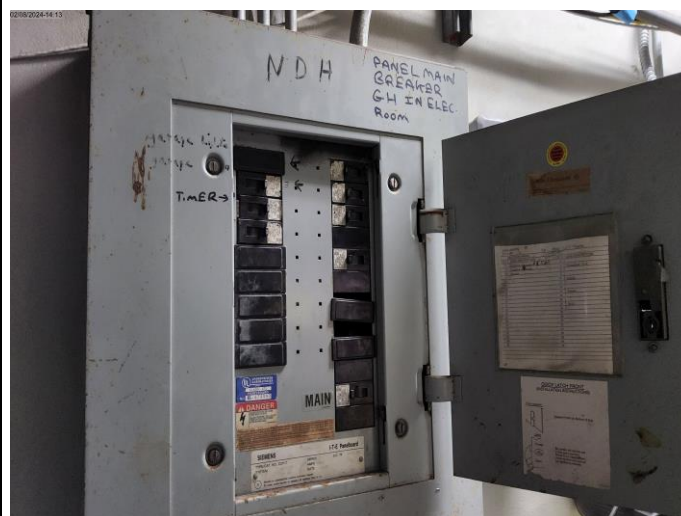
18. Panel #:	GH	Location:	Emergency Generator Room
		Good ()	Needs Repair (<input checked="" type="radio"/>)
Comments:	Size: 100 AMPS	Volt: 480	Phases: 3 Type: MLO
Repairs are required as follows:			
a. Missing proper circuit Identification. See Annex "A", photo #48.			
b. Opening in circuit space. See Annex "A", photo #49.

Photo # 48. Item 7.18.a. Emergency Room. Panelboard GH. Missing proper circuit Identification.

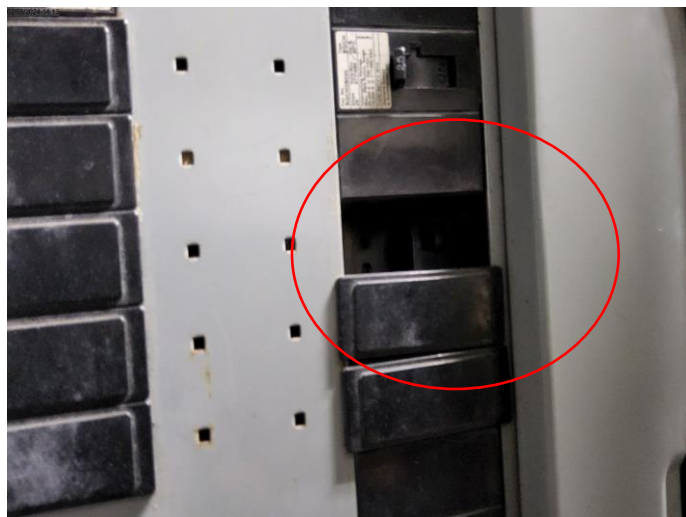
Photo # 49. Item 7.18.b. Emergency Room. Panelboard GH. Opening in circuit space.

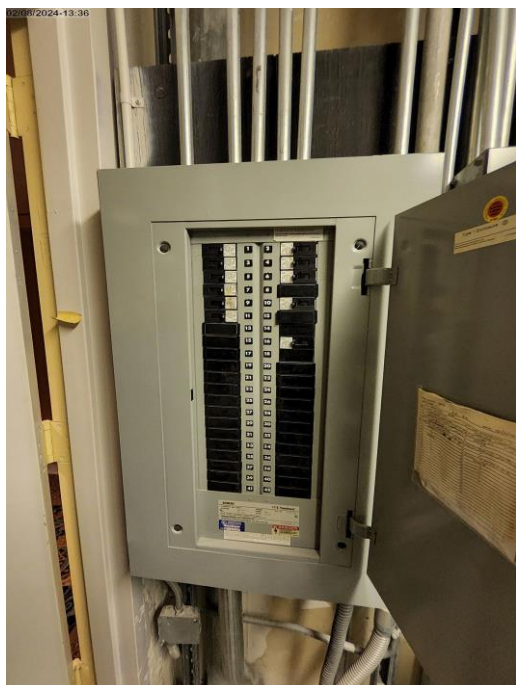
19. Panel #:	20H	Location:	Level 20. Meter Room
		Good ()	Needs Repair (<input checked="" type="radio"/>)
Comments:	Size: 100 AMPS	Volt: 480	Phases: 3 Type: MLO
Repairs are required as follows:			
a. Missing panel Identification. See Annex "A", photo #50.			
b. Missing proper circuit identification and missing screws. See Annex "A", photo #51.

Photo # 51. Item 7.19.b. Level 20. Meter Room. Panelboard 20H. Missing proper circuit identification and missing screws.

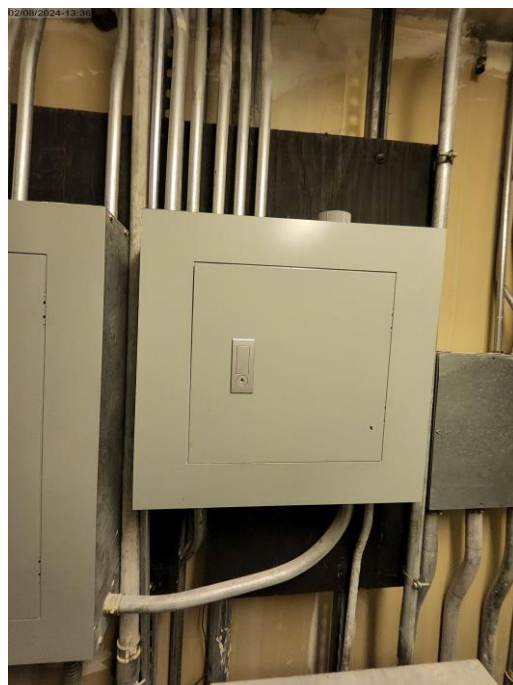
20. Panel #:	20EH	Location:	Level 20. Meter Room
		Good ()	Needs Repair (<input checked="" type="radio"/>)
Comments:	Size: 100 AMPS	Volt: 480	Phases: 3 Type: MLO
Repairs are required as follows:			
a. Missing panel Identification. See Annex "A", photo #52.			
b. Missing proper circuit identification and missing screws. See Annex "A", photo #53.

Photo # 52. Item 7.20.a. Level 20. Meter Room. Panelboard 20EH. Missing panel Identification.

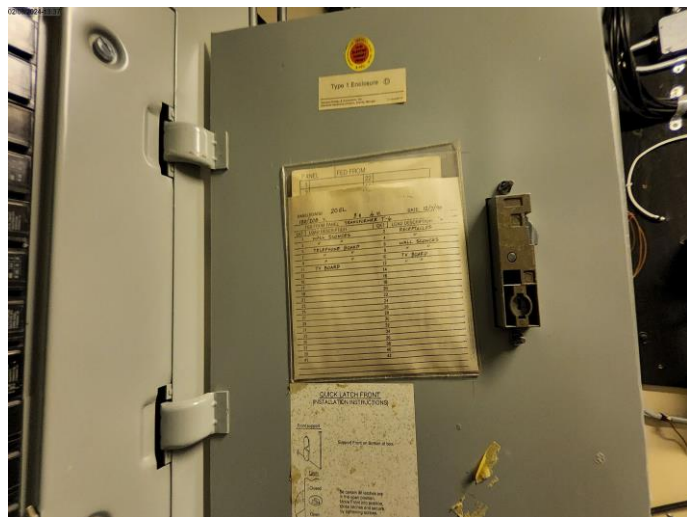
22. Panel #:	20EL	Location:	Level 20. Meter Room
		Good ()	Needs Repair (<input checked="" type="radio"/>)
Comments:	Size: 100 AMPS	Volt: 208	Phases: 3 Type: MCB
Repairs are required as follows:			
a. Missing panel Identification. See Annex "A", photo #56.			
b. Missing proper circuit identification. See Annex "A", photo #57.

Photo # 57. Item 7.22.b. Level 20. Meter Room. Panelboard 20EL. Missing proper circuit identification.

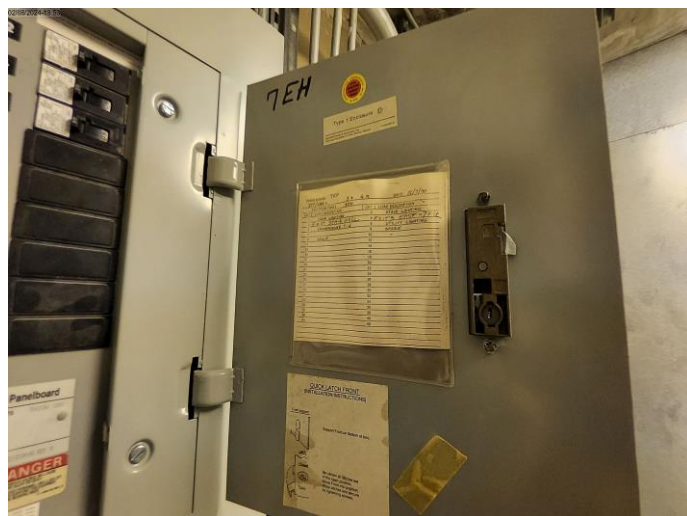
24. Panel #:	7EH	Location:	Level 7. Meter Room
		Good ()	Needs Repair (<input checked="" type="radio"/>)
Comments:	Size: 100 AMPS	Volt: 480	Phases: 3 Type: MLO
Repairs are required as follows:			
Missing proper circuit identification. See Annex "A", photo #59.

Photo # 59. Item 7.24. Level 7. Meter Room. Panelboard 7EH. Missing proper circuit identification.

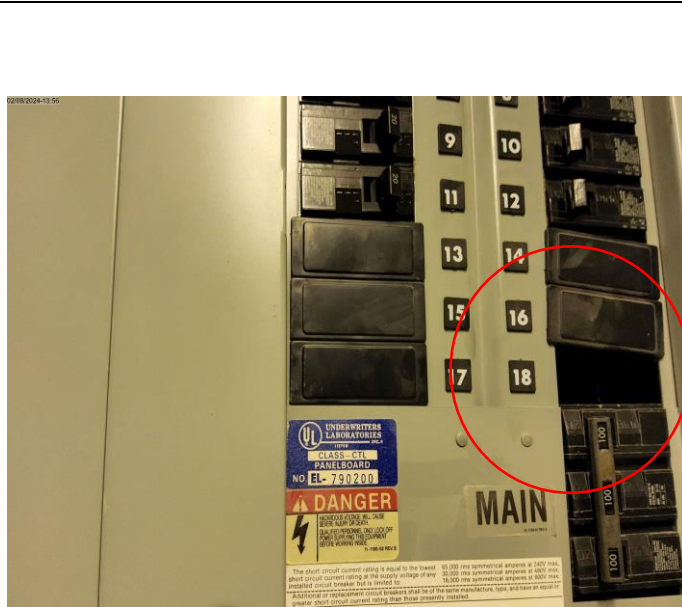
26. Panel #:	7EL	Location: Level 7. Meter Room			
		Good	()	Needs Repair	(<input checked="" type="radio"/>)
Comments:	Size: 100 AMPS	Volt: 208	Phases: 3	Type: MCB	
Repairs are required as follows: Opening in circuit space. See Annex "A", photo #61.

Photo # 61. Item 7.26. Level 7. Meter Room. Panelboard 7EL. Opening in circuit space.

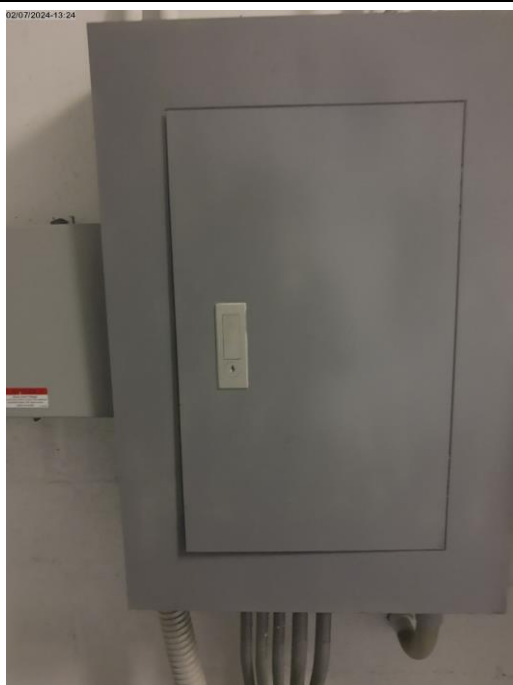
28. Panel #:	RL	Location: Level Roof.			
		Good	()	Needs Repair	(<input checked="" type="radio"/>)
Comments:	Size: 100 AMPS	Volt: 208	Phases: 3	Type: MCB	
Repairs are required as follows: a. Missing panel Identification. See Annex "A", photo #63. b. Missing screws. See Annex "A", photo #64. c. Missing proper circuit identification. See Annex "A", photo #65. d. Opening in circuit space. See Annex "A", photo #66.

Photo # 63. Item 7.28.a. Level Roof. Mechanical Room. Panelboard RL. Missing panel Identification.

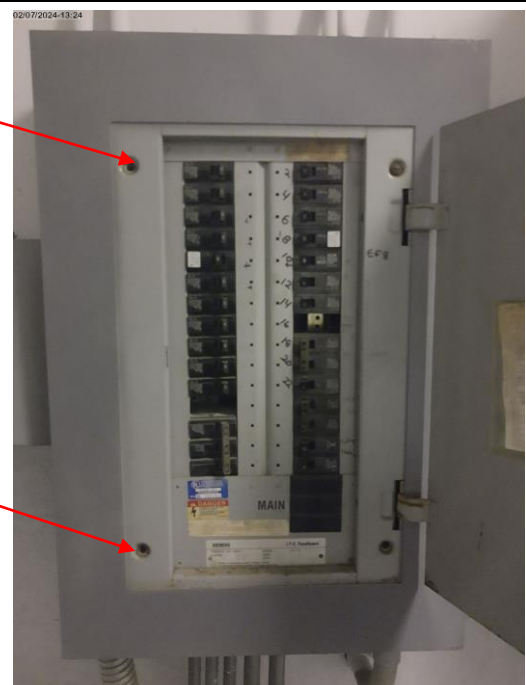
Photo # 64. Item 7.28.b. Level Roof. Mechanical Room. Panelboard RL. Missing screws.

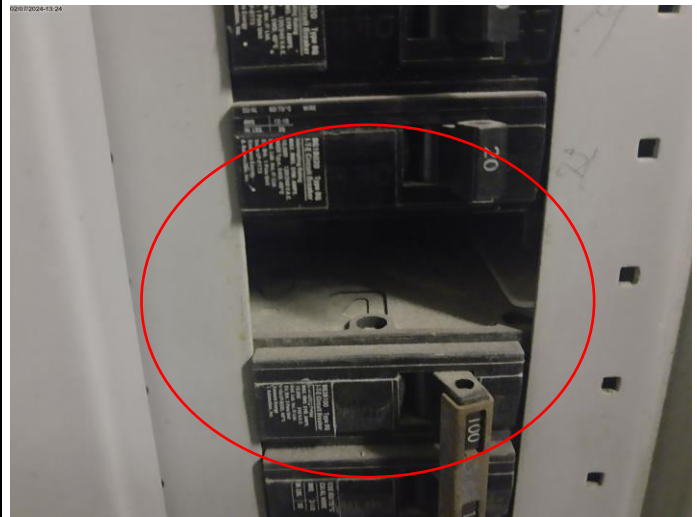
Photo # 66. Item 7.28.d. Level Roof. Mechanical Room. Panelboard RL. Opening in circuit space.

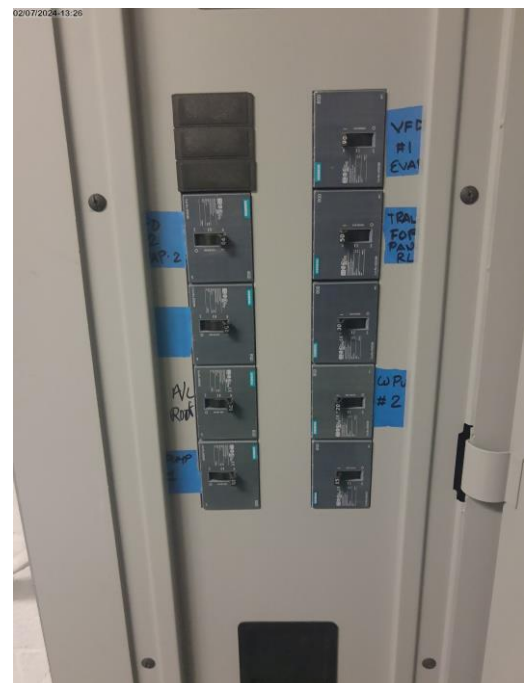
29. Panel #:	No ID	Location: Level Roof.			
		Good	()	Needs Repair	(<input checked="" type="radio"/>)
Comments:	Size: 400 AMPS	Volt: 480	Phases: 3	Type: MLO	
Repairs are required as follows: a. Missing panel Identification. See Annex "A", photo #67. b. Missing proper circuit identification. See Annex "A", photo #68.

Photo # 68. Item 7.29.b. Level Roof. Mechanical Room. Panelboard No ID. Missing proper circuit identification.

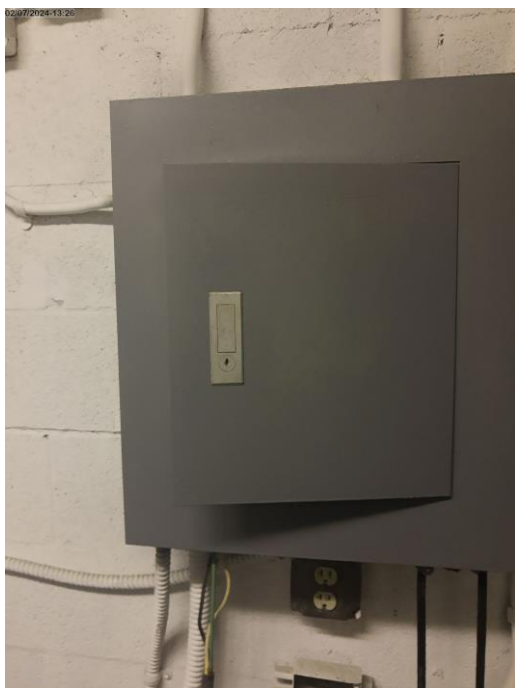
30. Panel #:	REL	Location: Level Roof.			
		Good	()	Needs Repair	(<input checked="" type="radio"/>)
Comments:	Size: 100 AMPS	Volt: 208	Phases: 3	Type: MCB	
Repairs are required as follows: a. Missing panel Identification. See Annex "A", photo #69. b. Missing proper circuit identification and missing screws. See Annex "A", photo #70.

Photo # 69. Item 7.30.a. Level Roof. Mechanical Room. Panelboard REL. Missing panel Identification.

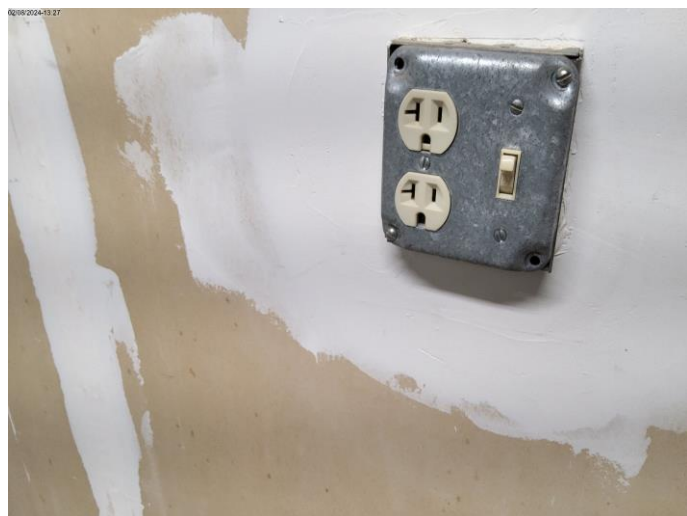
Photo # 75. Item 17.a. All Meter Room. Missing GFCI protection for receptacles.

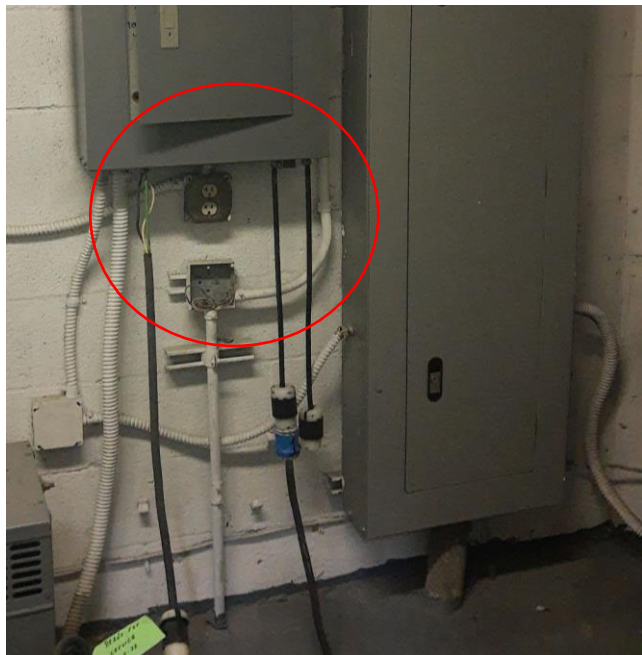
Photo # 77. Item 17.c. Roof. Electrical Room. Missing Cover for Junction Box and missing GFCI protection for receptacle

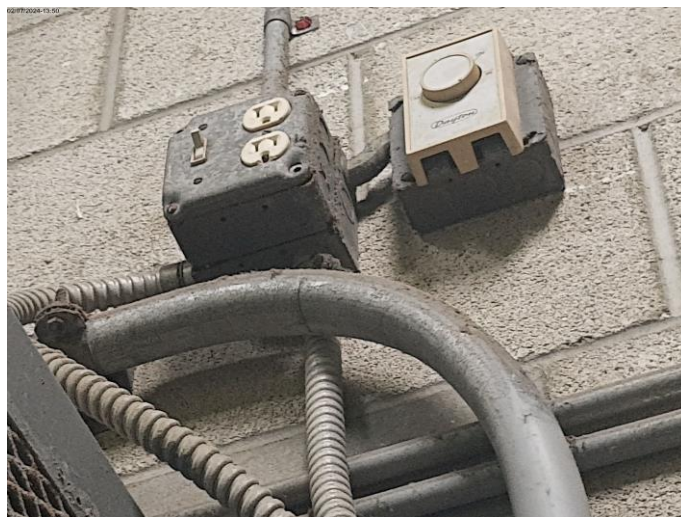
Photo # 78. Item 17.d. Pump Room. Missing GFCI protection for receptacles.

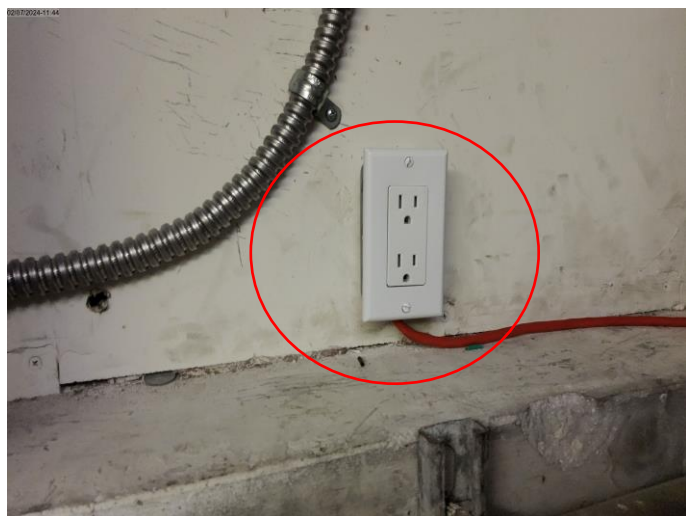
Photo # 79. Item 17.e. Roof. Mechanical room. Missing GFCI protection for receptacles.

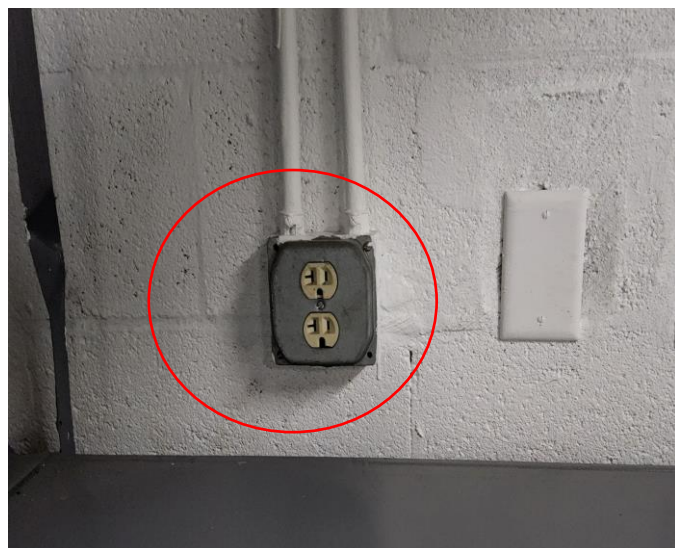
Photo # 80. Item 17.f. Level 2. Roof. Mechanical Room. Missing GFCI protection for receptacles.

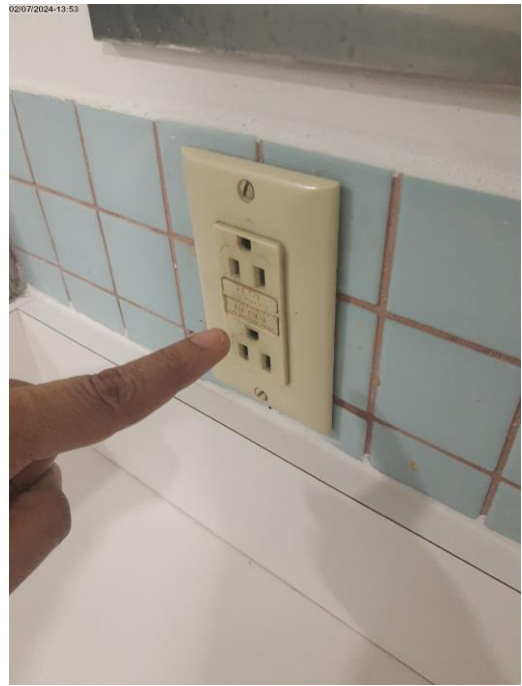
Photo # 82. Item 17.h. Restroom. Missing GFCI protection for receptacles- test fail.

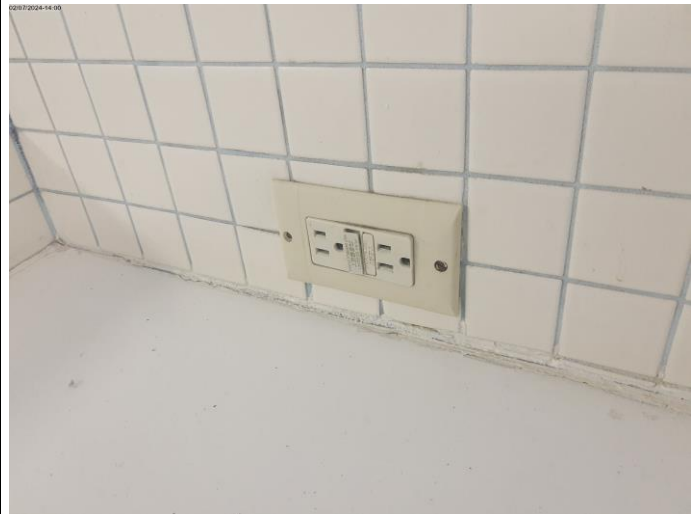
Photo # 84. Item 17.i. Restroom Staff. Missing GFCI protection for receptacles- test fail.

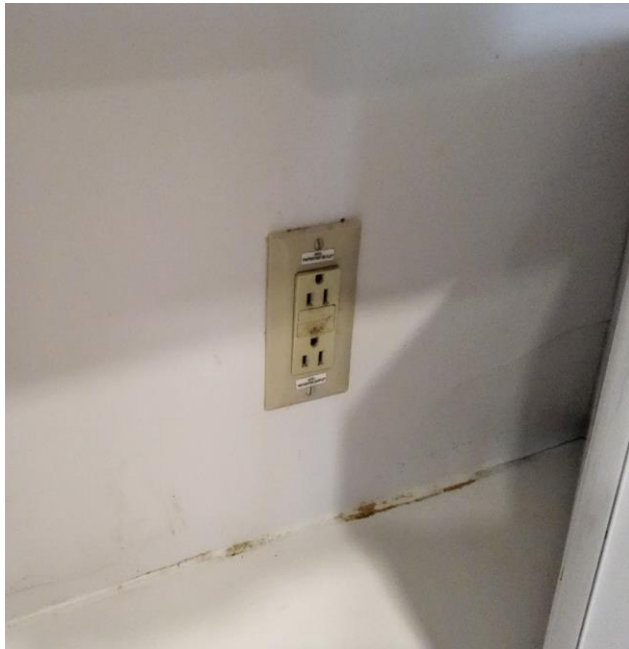
Photo # 85. Item 17.j. Club Room. Kitchen. Missing GFCI protection for receptacles - test fail.

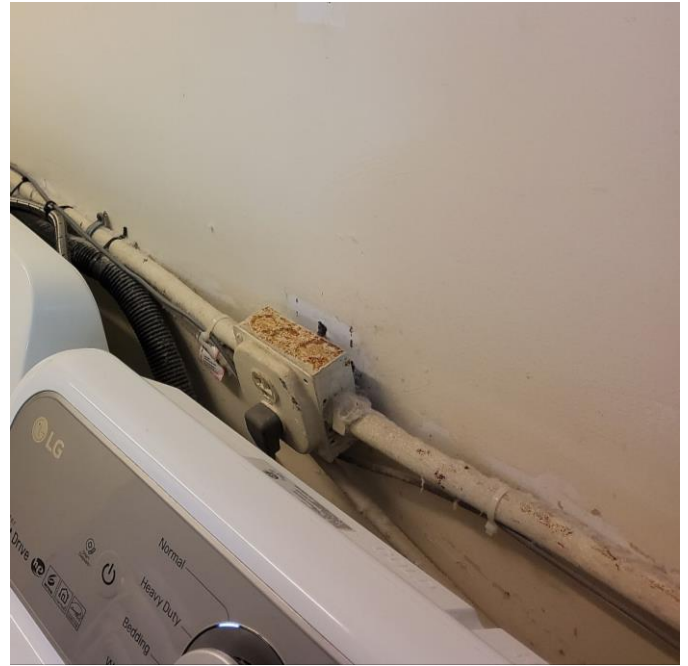
Photo # 86. Item 17.k. Laundry Room. Missing GFCI protection for receptacles.

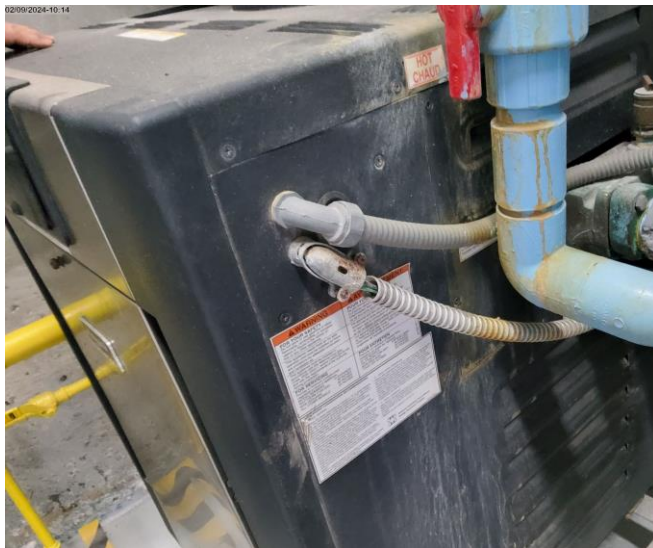
Photo # 89. Item 17.n. Water heater. Flexible detached and broken connector.

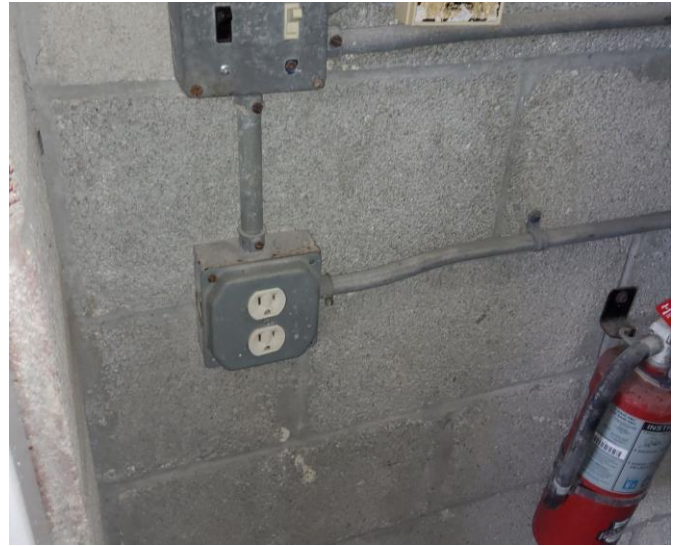
Photo # 90. Item 17.o. Heater Room. Missing GFCI protection for receptacles.

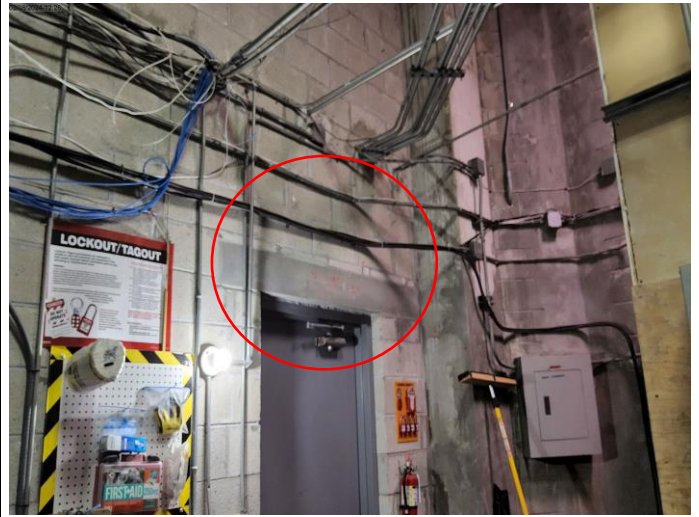
Photo # 94. Item 22.b. Main Electrical Room. Missing exit sign.
