City of Aventura

MINIMUM INSPECTION PROCEDURAL GUIDELINES FOR BUILDING ELECTRICAL RECERTIFICATION

a. Name on Title: THE LANDMARK CONDO

b. Building Street Address: 20185 E COUNTRY CLUB DRIVE, AVENTURA, FL 33180

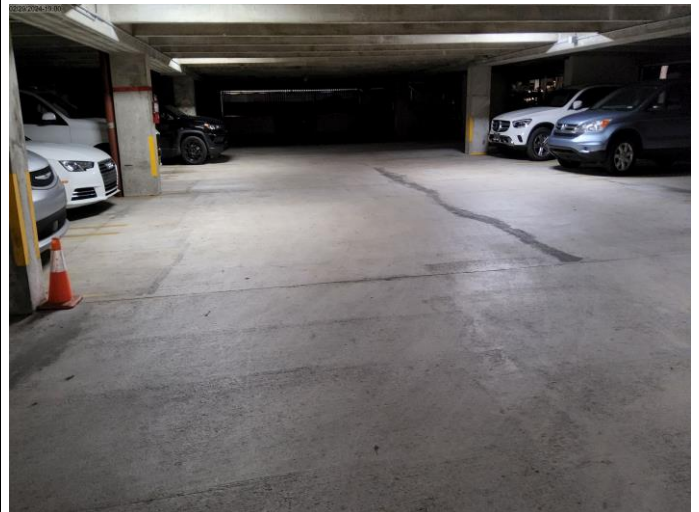
Photo # 96. Item 25.a. Level A. Cover parking garage. Missing proper illumination -fc = 0.3.

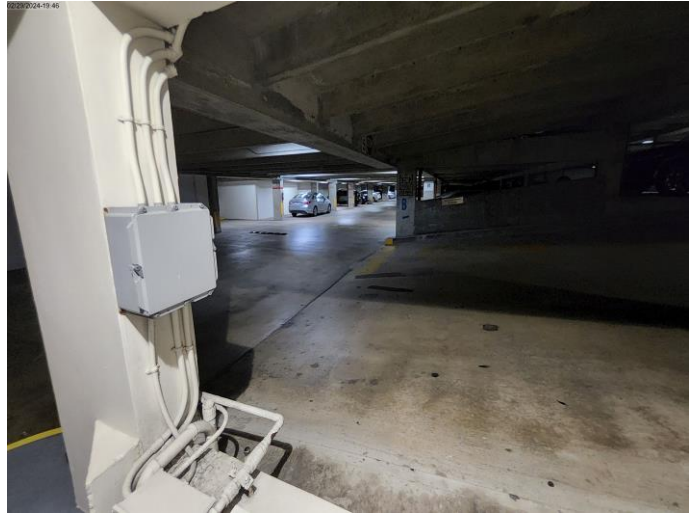
Photo # 98. Item 25.c. Level A. Cover parking garage. Missing proper illumination -fc = 0.89.

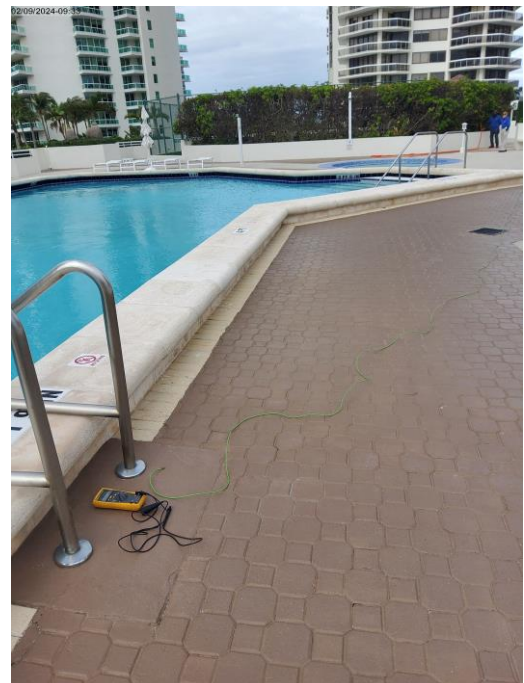
Photo # 100. Item 26.a. Swimming Pool. Pool equipotential bonding: Failed test.

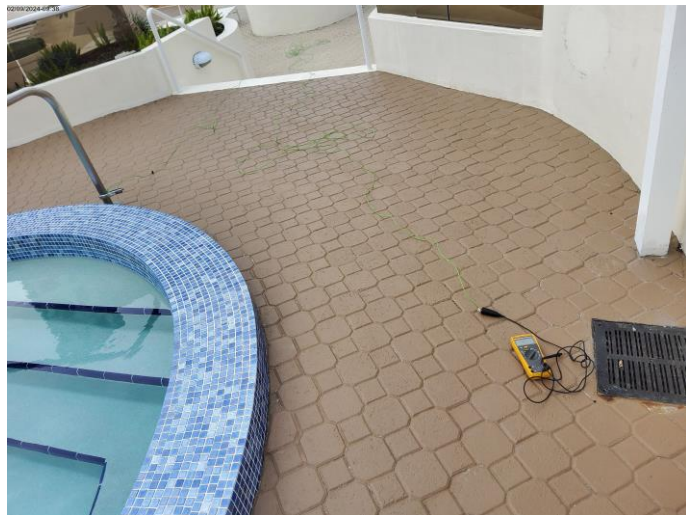
Photo # 101. Item 26.b. Jacuzzi. Equipotential bonding: Failed test.

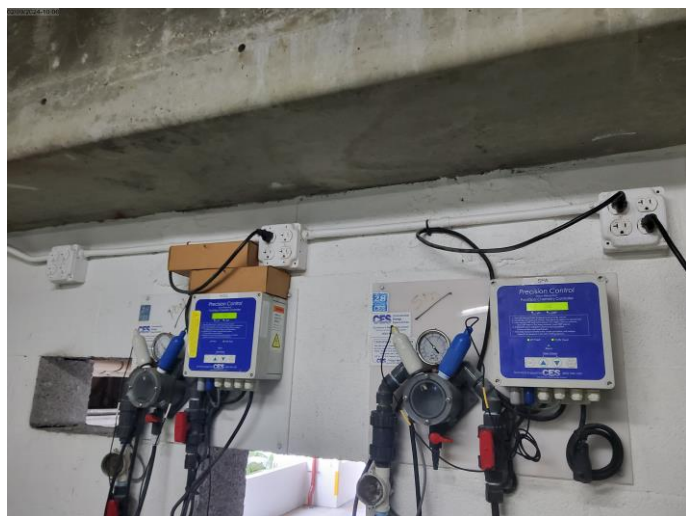
Photo # 103. Item 26.d. Pump Pool Room. Missing GFCI protection for receptacles.

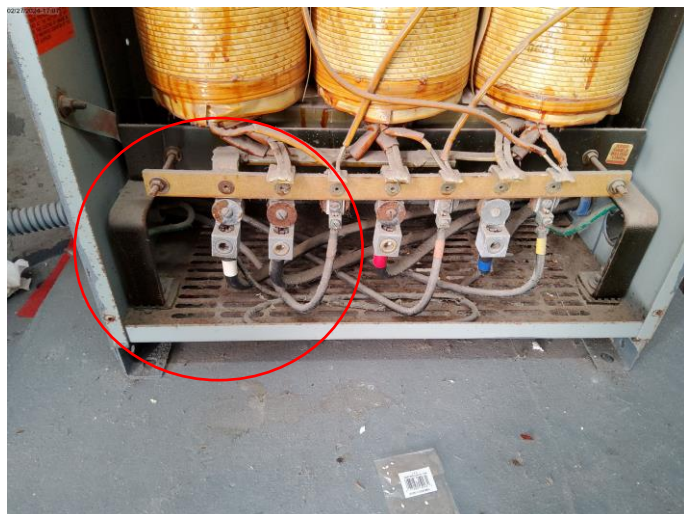
Photo # 105. Item 26.f. Pool - Electrical Room. Transformer 30 KVA. Double tapping in neutral.

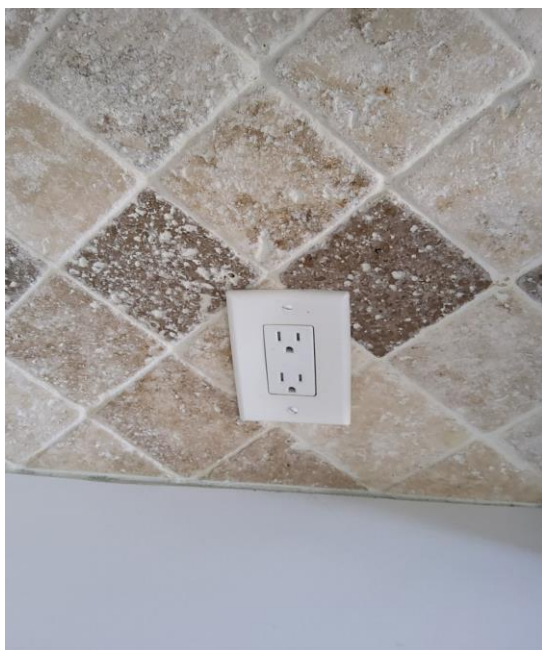
Photo # 107. Item 28.1. Missing GFCI protection for receptacles in the kitchen.

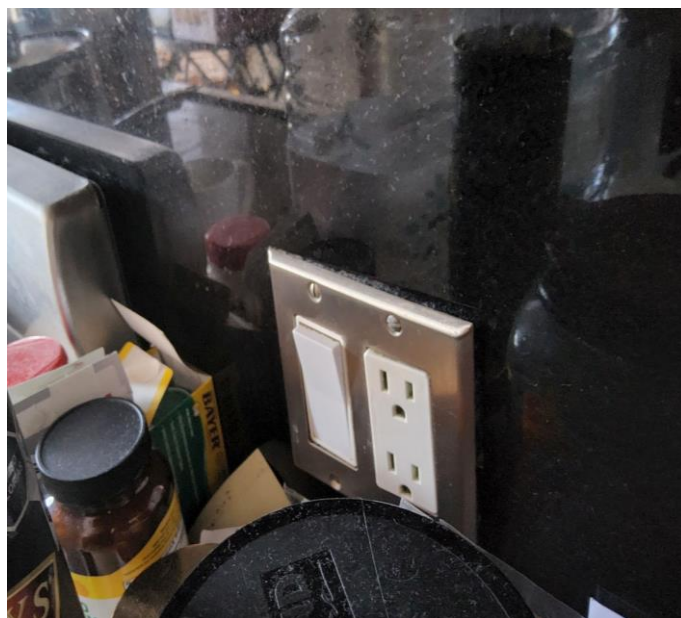
Photo # 108. Item 28.1. Missing GFCI protection for receptacles in the kitchen.

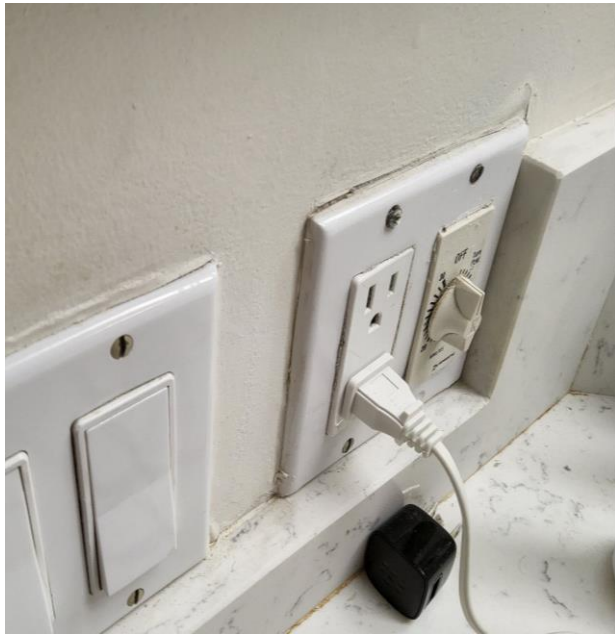
Photo # 109. Item 28.2. Missing GFCI protection for receptacles in the bathroom.

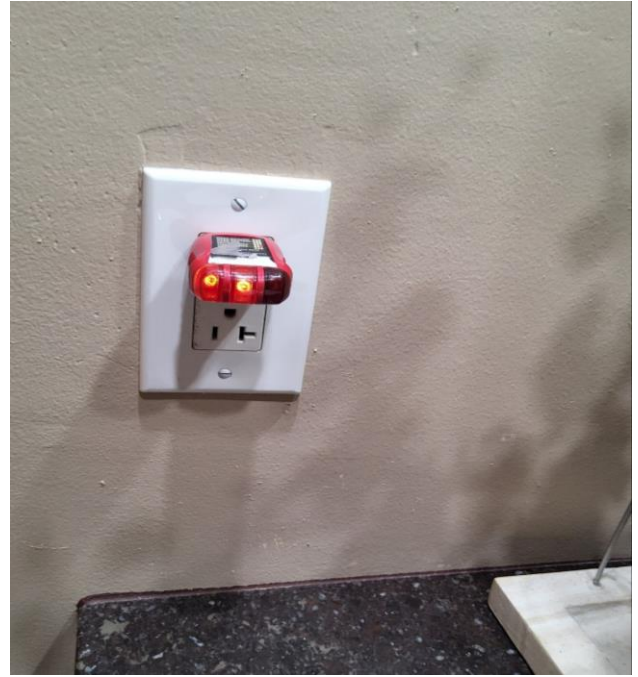
Photo # 110. Item 28.2 Missing GFCI protection for receptacles in the bathroom- test fail.

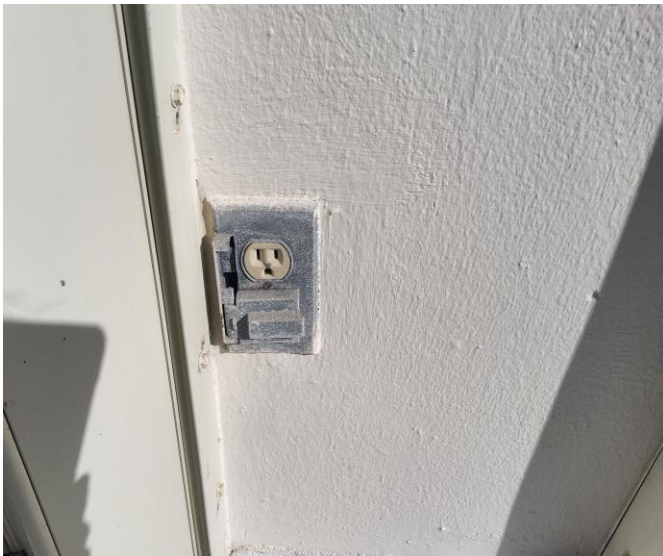
Photo # 111. Item 28.3. Missing GFCI protection for receptacles in the balcony.

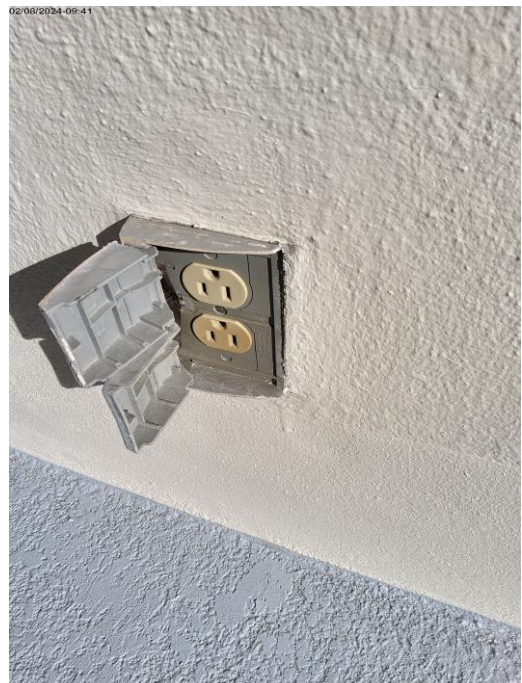
Photo # 112. Item 28.3 Missing GFCI protection for receptacles in the balcony.

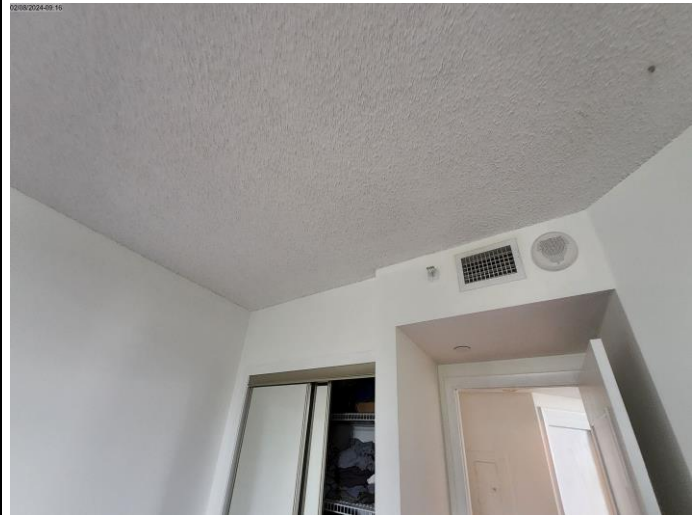
Photo # 114. Item 28.4. Missing smoke alarm inside the sleeping rooms.

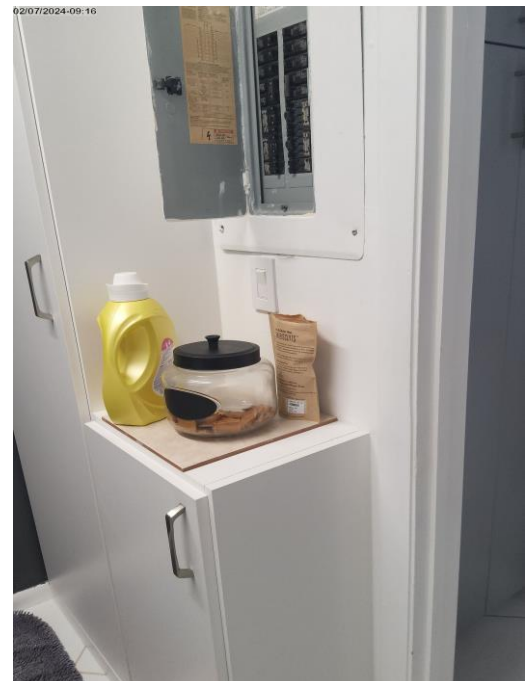
Photo # 116. Item 28.6. Electrical panel: working space clearance violation.

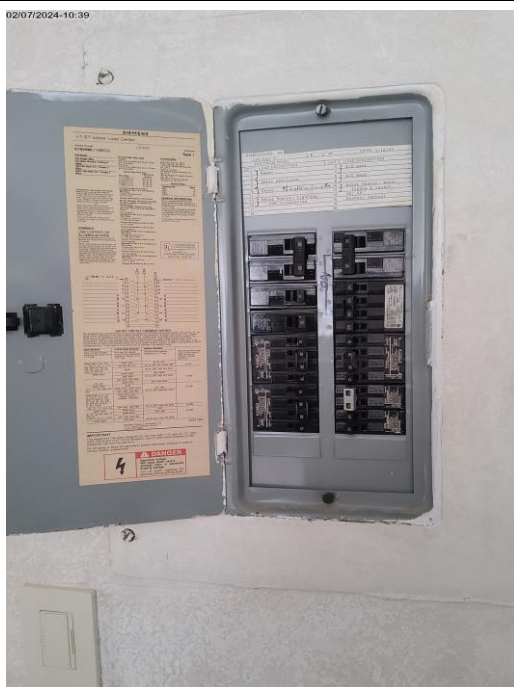
Photo # 117. Items 28.7. Electrical panel missing or incomplete proper circuit directory.

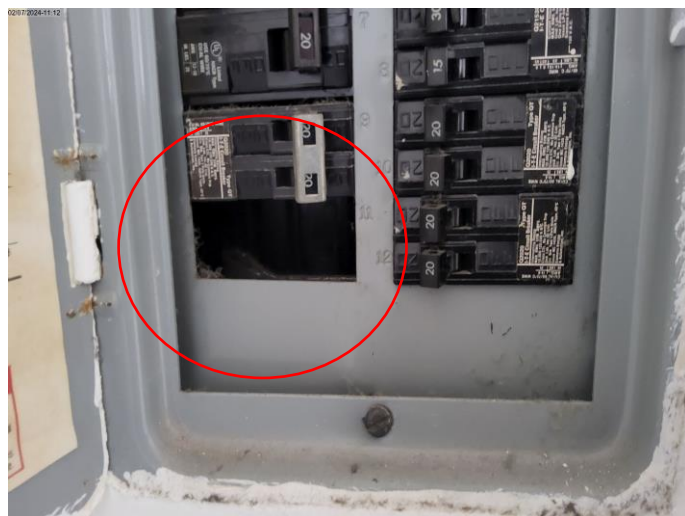
Photo # 119. Items 28.8. Electrical panel opening in circuit spaces.

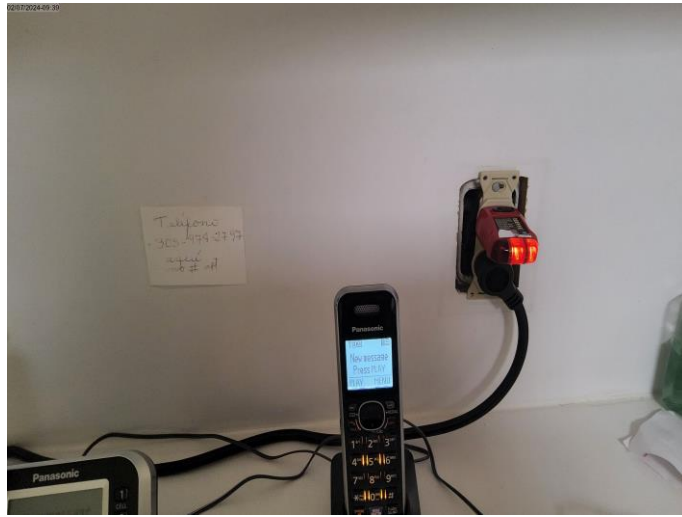
Photo # 121. Item 28.9. Missing GFCI protection and cover for receptacles in the Kitchen.

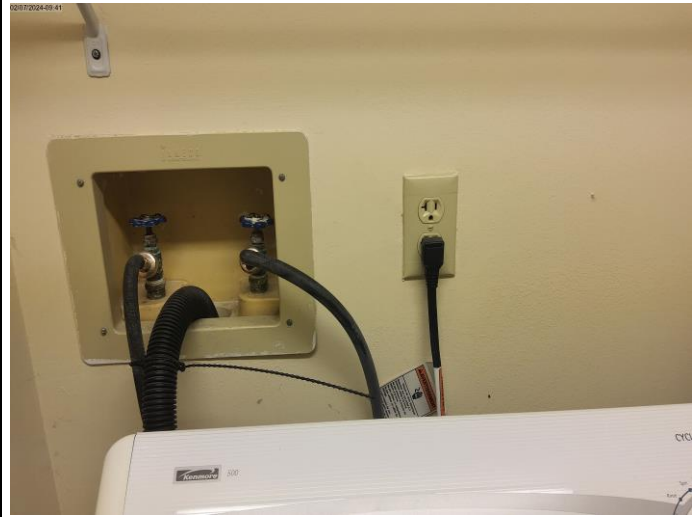
Photo # 122. Item 28.9. Missing GFCI protection in the Laundry.
