# Inspection report for the property at 101 Stubbs Avenue, Monroe, LA 71201

This report is prepared exclusively for **Glynis Davis**  
Inspected On: **2023-10-27**

Michael Burroughs , LA  
State License #LHI 10044,  
ASHI 202398

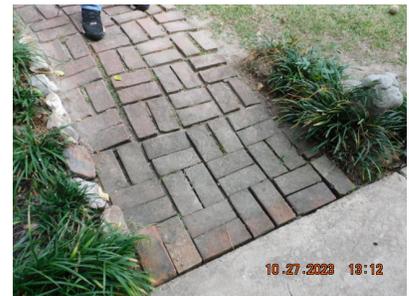
**🔧 (G-2) Review:** Portions of the walkway flatwork around the home are settling creating trip hazards. Hire a qualified general contractor to further investigate and repair to eliminate all trip hazards and ensure a reliable walking surface.

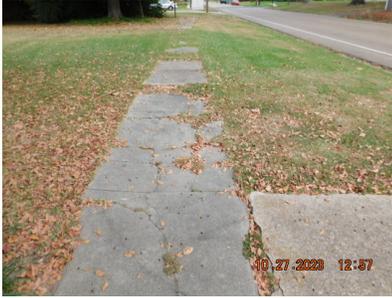
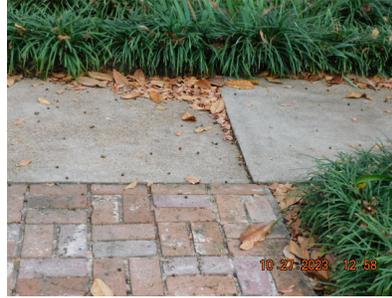
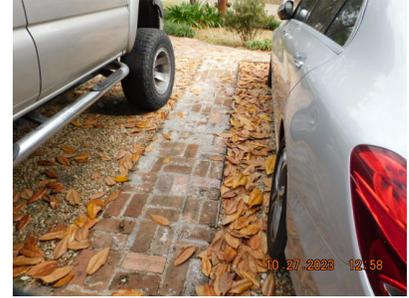
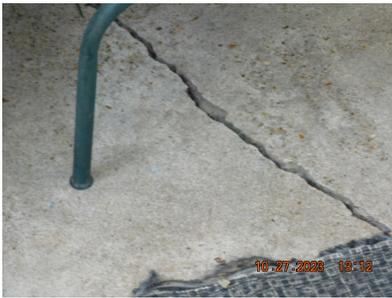
**🔧 (G-3) Recommended Preventive Maintenance:**  
Cracks were noted in walkway flatwork. Regular sealing of small to moderate cracks with a quality exterior flexible sealant can minimize water penetration and prolong the life of the flatwork. Large

cracks can present a more urgent need for repair, especially if the cracks lead to displacement and trip hazards.

- *No immediate repair appears necessary, though water will continue to deteriorate the surface until the flatwork is repaired or replaced.*

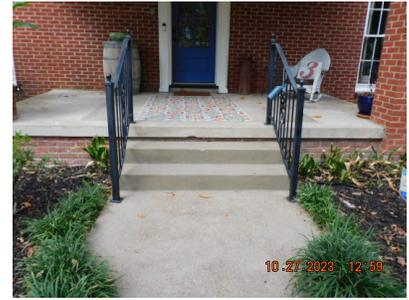
**🔍 (G-5) Review:**

Front step rise uneven at the top. Refer to line 0390 of the Uniform Building Inspection Report Binder.

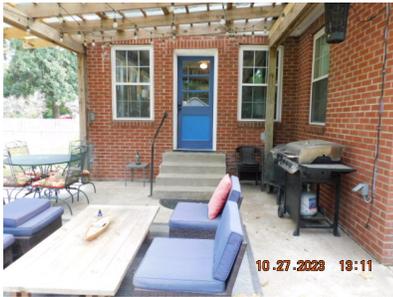
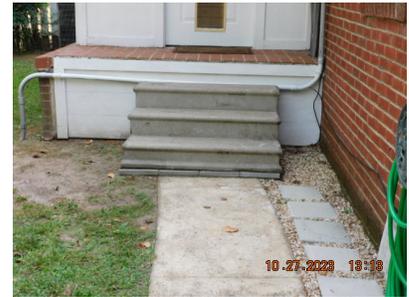
🔧 **G-6 Grounds:** Rear exterior stairs hand and guard rails improper. Refer to line 0290 of the Uniform Building Inspection Report Binder.

**🔍 (G-6) Review:** Rear exterior stairs hand and guard rails improper. Refer to line 0290 of the Uniform Building Inspection Report Binder.

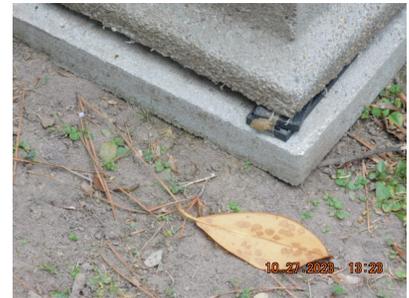
**🔍 (G-7) Review:**

Exterior steps installation questionable. Refer to line 0280 of the Uniform Building Inspection Report Binder.

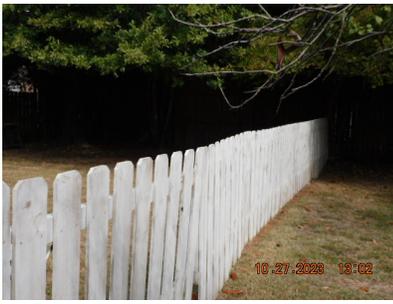
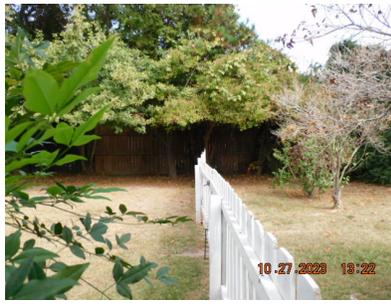
🔧 **G-8 Grounds:** The gates for the fencing are sagging and require adjustment / repair for proper operation.

🔧 **G-9 Grounds:** Localized damage was noted to the fencing - see Rear side. Implement carpentry repairs as needed. Fence appears to be tilted in various locations. Gates appear to need adjustment. Refer to line 0640, 0630 and 0510 of the Uniform Building Inspection Report Binder.

**🔍 (G-8) Review:** The gates for the fencing are sagging and require adjustment / repair for proper operation.

**🔍 (G-9) Review:** Localized damage was noted to the fencing - see Rear side. Implement carpentry repairs as needed. Fence appears to be tilted in various locations. Gates appear to need adjustment. Refer to line 0640, 0630 and 0510 of the Uniform Building Inspection Report Binder.

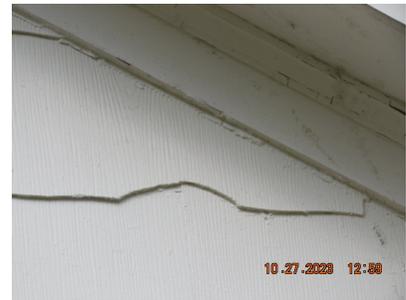
*This building has an old cement shingle siding system that likely contains asbestos. Please note that asbestos testing and identification are beyond the scope of this inspection. These shingles have not been installed for many years and often have a number of cracked and damaged shingles. These tile shingles are brittle and difficult to work with and replacement tiles can be difficult to find as they are no longer manufactured. It is common to use caulking and sealants to make improvised repairs to these shingles until a larger renovation type project is done. Sometimes these shingles are even installed on top of another layer of siding. Please note that if you wish to remove this siding, you will likely have a disposal liability and caution should be used when working with this siding as it may pose a health hazard. Tiles appear damaged in various locations around the home.*

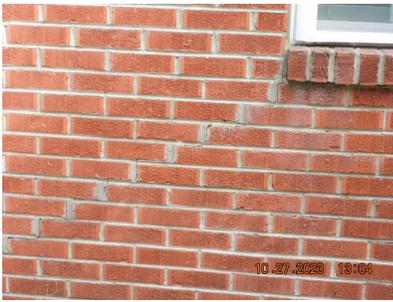
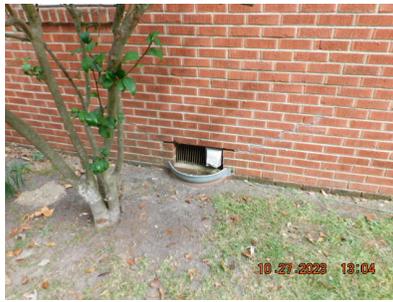
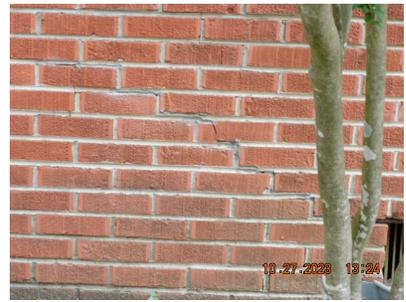
🔧 **ED-3 Exteriors and Decks:** Masonry siding cracked possibly indicating foundation movement or defect. These cracks may only be a masonry issue and not foundational as the foundation is a pier and beam system.

**🔧 (ED-3) Review:** Masonry siding cracked possibly indicating foundation movement or defect. These cracks may only be a masonry issue and not foundational as the foundation is a pier and beam system.

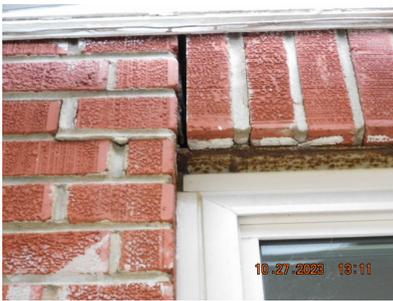
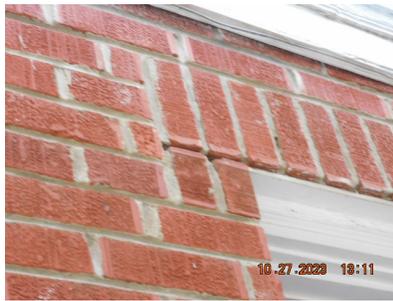
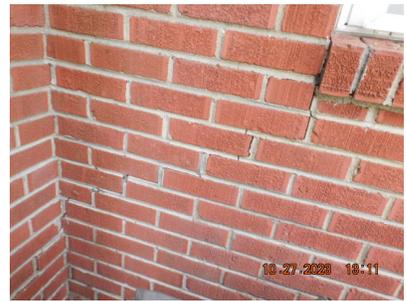
🔧 **ED-4 Exteriors and Decks:** Masonry siding mortar joints missing or damaged in numerous locations.

**🔧 (ED-4) Review:** Masonry siding mortar joints missing or damaged in numerous locations.

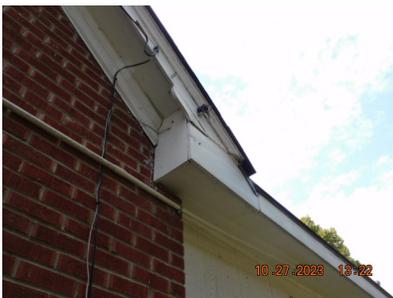
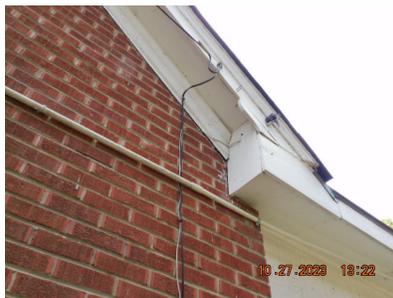
🔧 **ED-6 Exteriors and Decks:** Siding and roof trims appear damaged in various locations. Refer to line 1310 of the Uniform Building Inspection Report Binder.

**🔧 (ED-6) Review:** Siding and roof trims appear damaged in various locations. Refer to line 1310 of the Uniform Building Inspection Report Binder.

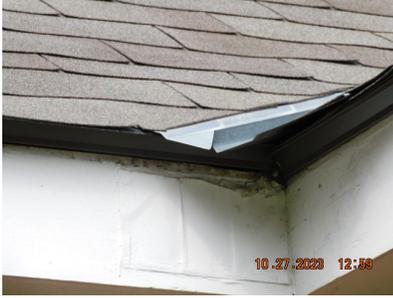
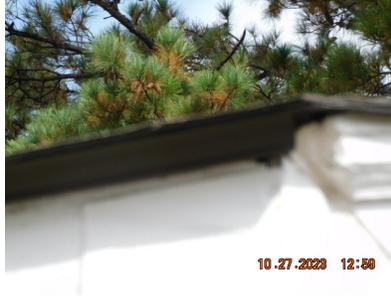
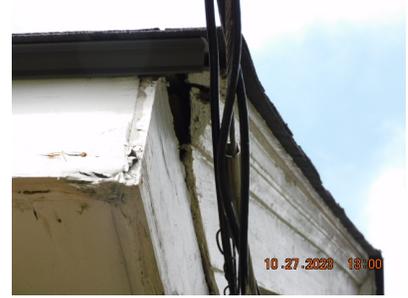
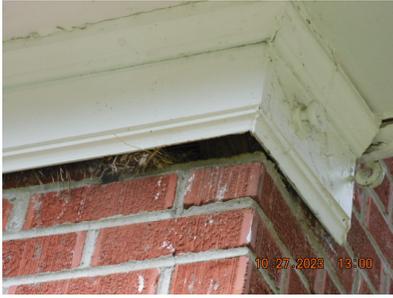
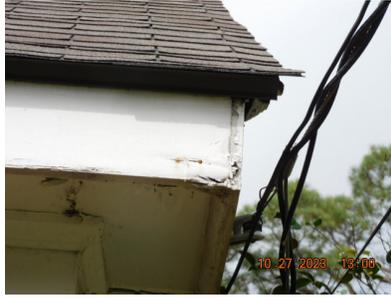
**✂ (ED-2) Recommended Preventive Maintenance:**

Fascia damaged and paint peeling.

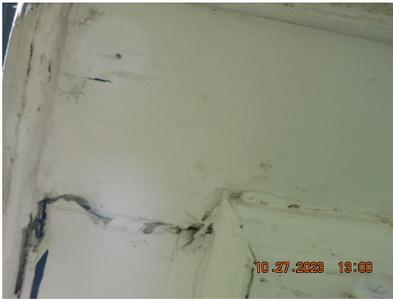
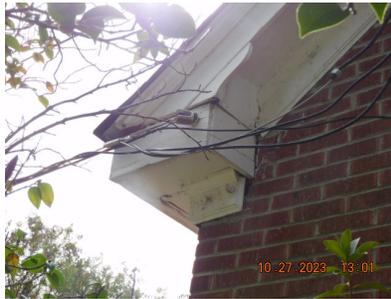
🔧 **ED-7 Exteriors and Decks:** Soffit /eaves damaged or cracked in various locations. Refer to line 1450 of the Uniform Building Inspection Report Binder.

**🔍 (ED-7) Review:** Soffit /eaves damaged or cracked in various locations. Refer to line 1450 of the Uniform Building Inspection Report Binder.

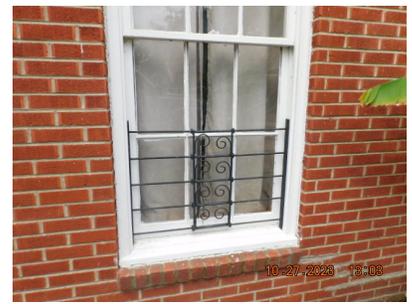
**🔍 (ED-8) Review:**

Windows appear to be painted shut. Refer to line 1530 of the Uniform Building Inspection Report Binder.

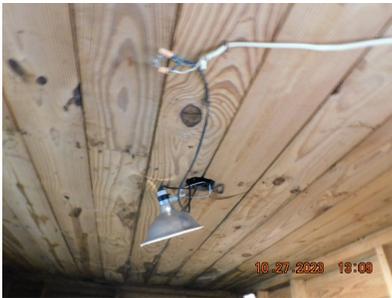
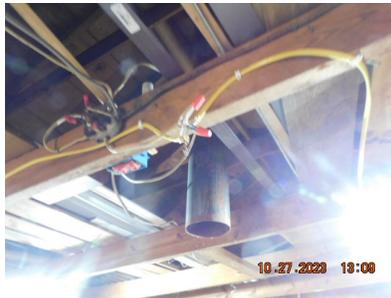
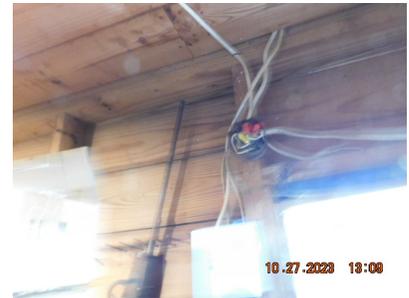
🔧 **G1-1 Garage:** Exposed electrical splices noted in numerous locations in the garage. Electrical wiring exposed where it can be damaged. Surface installed non metallic sheathed cable is exposed and can be damaged. Junction box covers are missing in numerous locations. Refer to line 5440,5300, 5340,& 5310 of the Uniform Building Inspection Report Binder.

**⚠ (G1-1) Review:** Exposed electrical splices noted in numerous locations in the garage. Electrical wiring exposed where it can be damaged. Surface installed non metallic sheathed cable is exposed and can be damaged. Junction box covers are missing in numerous locations. Refer to line 5440,5300, 5340,& 5310 of the Uniform Building Inspection Report Binder.

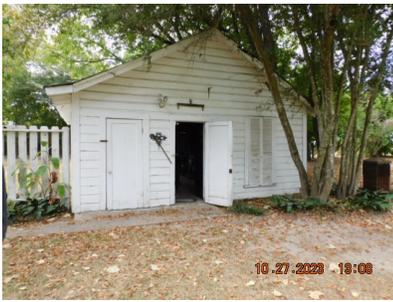
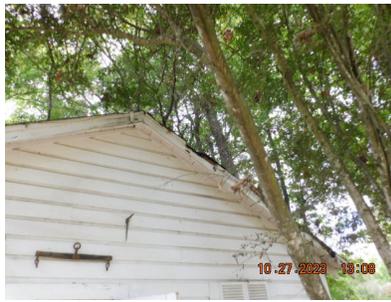
**⚠ (G1-2) Review:** Tree limbs in contact with detached garage. Refer to line 0660 & 0680 of the Uniform Building Inspection Report Binder.

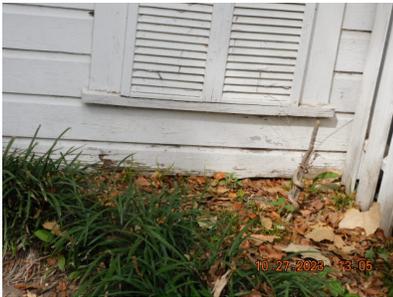
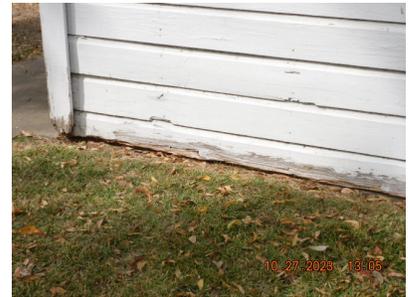
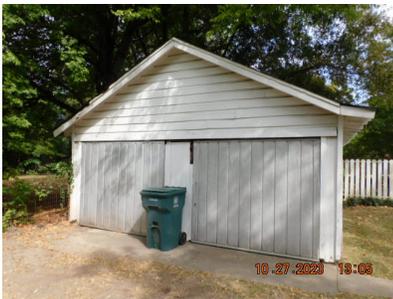
🔧 **G1-3 Garage:** Wood siding in contact with earth and damaged. Refer to line 0800 of the Uniform Building Inspection Report Binder.

**🔗 (G1-3) Review:** Wood siding in contact with earth and damaged. Refer to line 0800 of the Uniform Building Inspection Report Binder.

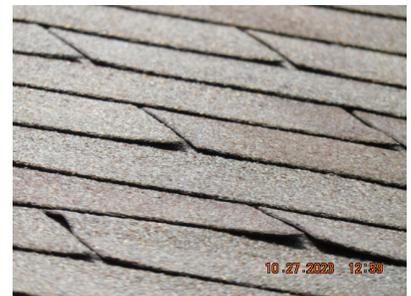
### 👁️ **(RCG-1) Monitor:**

Shingles appear to be lifted in numerous locations which may allow wind damage or lifting to shingles. Refer to line 1010-1019 of the Uniform Building Inspection Report Binder.

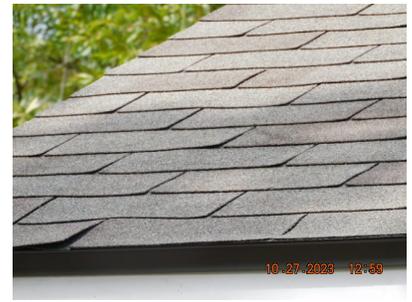
### 👁️ **(RCG-2) Monitor:**

Shingles or roof deck appears to sag in various locations around the home. Refer to line 1000 -1009 of the Uniform Building Inspection Report Binder.

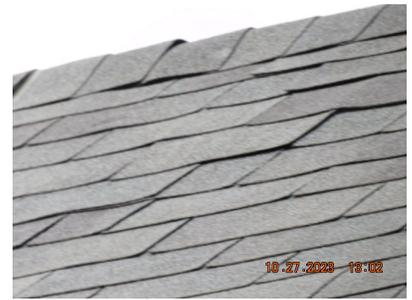
👁️ (RCG-3) Monitor:

Suspected roof repairs noted. Refer to line 1190 of the Uniform Building Inspection Report Binder.

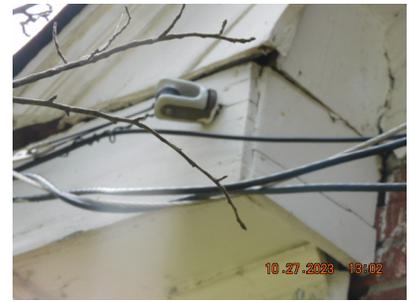
🔧 (ES-2) Review:

🔧 **ES-2 Electric Service:** Anchoring pulling loose noted. Refer to line 5040 of the Uniform Building Inspection Report Binder.

Anchoring pulling loose noted. Refer to line 5040 of the Uniform Building Inspection Report Binder.

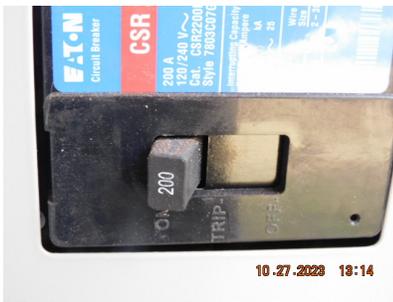
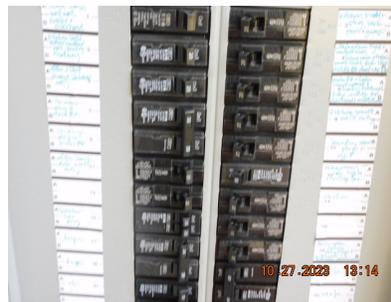
**🏠 (ES-4) Improve:** Inadequate or unconfirmed labeling of the electric panel circuit breakers was noted during inspection. This should be corrected for improved safety.

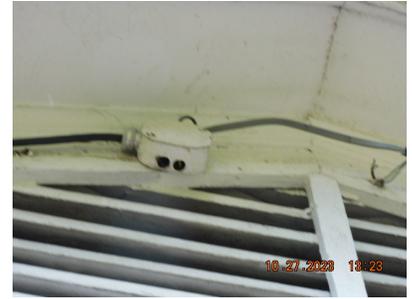
### 🔧 (EDFW-1) Review:

🔧 **EDFW-1 Electric Distribution and Finish Wiring:** Knock outs missing from junction box. Refer to line 5310 & 5340 of the Uniform Building Inspection Report Binder.

Knock outs missing from junction box. Refer to line 5310 & 5340 of the Uniform Building Inspection Report Binder.

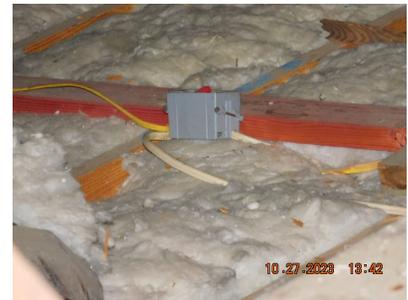
### 🔧 (EDFW-4) Review:

🔧 **EDFW-4 Electric Distribution and Finish Wiring:** The open electrical junction box in the garage and crawl space and attic needs to be covered for improved safety. This is as simple as installing a cover plate over the box to protect the wiring. Sometimes, an extension ring is needed if finishes are covering the box. Repair as needed for improved safety.

The open electrical junction box in the garage and crawl space and attic needs to be covered for improved safety. This is as simple as installing a cover plate over the box to protect the wiring. Sometimes, an extension ring is needed if finishes are covering the box. Repair as needed for improved safety.

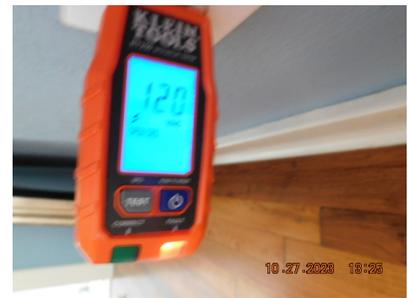
If GFCI protection is used, the outlets on this circuit should be labeled so it is clear they are ungrounded and GFCI protected. Examples of locations where open grounds were found include: Refer to line 5600 of the Uniform Building Inspection Report Binder.

- Running an equipment grounding conductor or a new three-wire circuit
- Filling the third prong of the receptacle or restoring a two-prong receptacle or
- Installing GFCI protection for this circuit and labeling the open ground receptacles

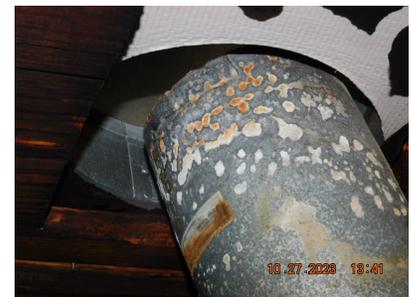
🔧 **HCFV-3 Heating, Cooling, Fireplaces and Ventilation:** Heater exhaust vent improper and needs review or repair. Refer to line 2150 of the Uniform Building Inspection Report Binder.

Heater exhaust vent improper and needs review or repair. Refer to line 2150 of the Uniform Building Inspection Report Binder.

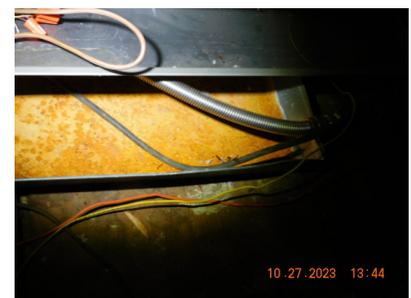
### 🏠 (HCFV-5) Improve:

Power supply cord laying in condensation pan under heating unit. Refer to line 2400 of the Uniform Building Inspection Report Binder.

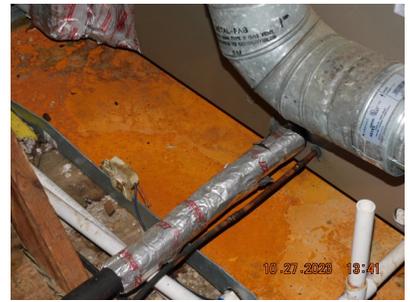
### 👁️ (HCFV-4) Monitor:

Pan under evaporator coils and heating unit rusted. Refer to line 2830 of the Uniform Building Inspection Report Binder.

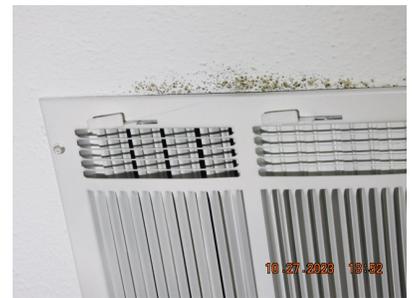
Signs of possible Microbial growth (suspected Mold) noted at a/c registers in various locations. Refer to line 7015 of the Uniform Building Inspection Report Binder.

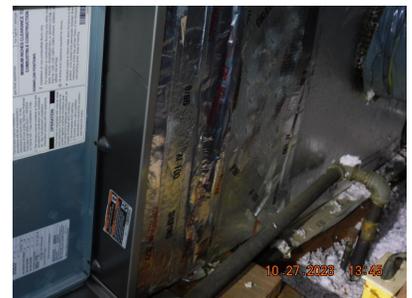
### (HCFV-6) Improve:

Tape joints appear to be coming loose in duct work. Refer to line 2230 of the Uniform Building Inspection Report Binder.

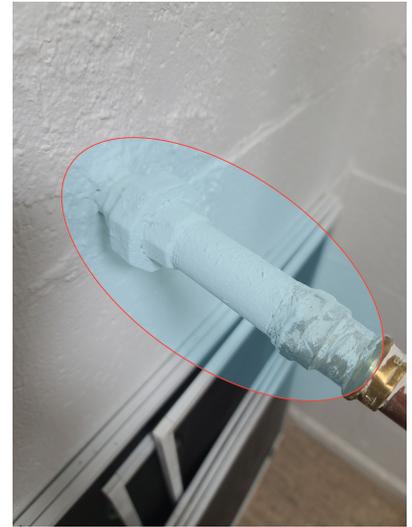
*It looks as though the main water pipe to the house is older galvanized steel.*

- Please also note that when updating older metal pipes, there is a risk of disabling important grounding systems for your electrical service. During updates to older metal pipes, consider having your electrical grounding and bonding systems further investigated and repaired as recommended by a licensed electrical contractor.

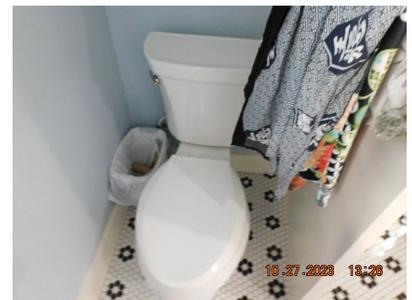
**(B-2) Improve:**  
Water closet loose on floor.

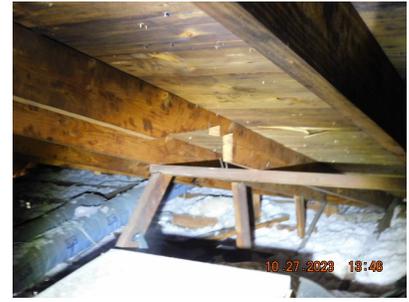
⚠️ **A-2 Attic:** Liberties have been taken with good framing practices on this roof frame that could create unreliable performance from this roof structure. Multiple red flags were noted during inspection:

- There is a pronounced sag in the middle of the running ridge.
- Multiple repairs were noted inside the attic with some odd sistered 2/4 material on top of a very humble looking home made truss that appears to be the original roof frame.
- There is another large sag of the roof and the addition appears to be poorly attached to the home.
- At the entry porch the front post is clearly rotted and making poor connections to the roof frame.
- Sagging or bellies were also noted in the field of the roof indicating sagging rafters.
- Over notching of the rafters.

I recommend hiring a framing contractor or structural engineer to further evaluate and repair this roof frame. Implement repairs as recommended. Refer to line 9200 & 9230 of the Uniform Building Inspection Report Binder.

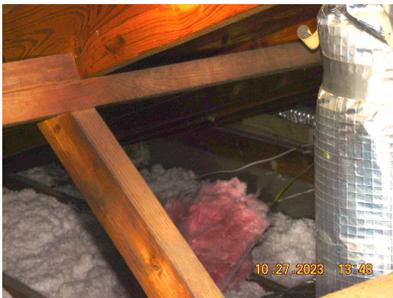
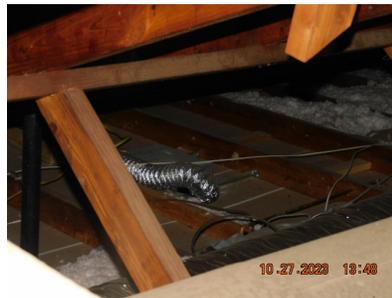
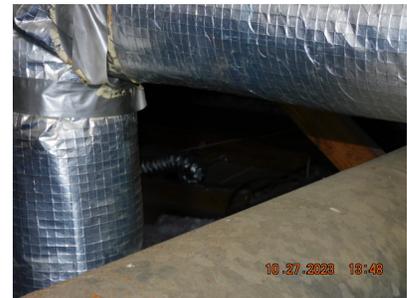
🔧 (A-3) Review: The attic insulation is out of position and incomplete in places. For improved energy efficiency and to reduce heat loss, I recommend repairing incomplete thermal barriers and re-insulate to modern standard or to best possible levels. Be sure to seal up all air leakage points during repairs and prior to insulating to modern standard be sure all projects such as wiring and bath fans have been completed. Refer to line 9700 & 9710 of the Uniform Building Inspection Report Binder.

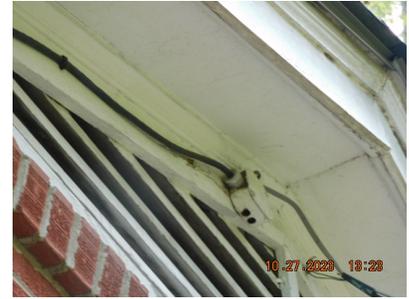
Gable vent screens damaged. Refer to line 9620 of the Uniform Building Inspection Report Binder.

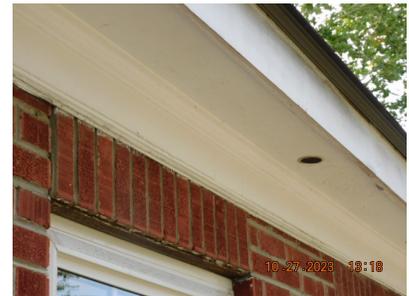
### 🔧 (A-5) Review:

The attic and roof cavity ventilation look to be inadequate. Standards recommend open ventilation levels in a ratio of 1 to 150 of the attic area. During re-roofing, I recommend having a roofing company evaluate the level of ventilation on this roof and improve with ridge, soffit, core or other vents as recommended. Additional ventilation will likely be recommended by a roofing contractor when re-roofing.

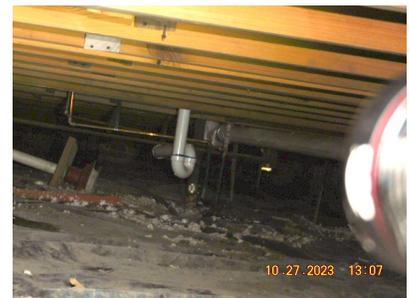
The crawl space could not be accessed during inspection. The access below the building was inadequate for me to crawl; this limits the scope of this home inspection and increases risks of hidden problems. General standards recommend an 18 by 24 inch access opening and at least 30 inches of clearance between the framing and the ground. This access and the below house clearances need to be improved / repaired so that the entire crawl area can be inspected. Implement repairs as needed and then re-inspect.

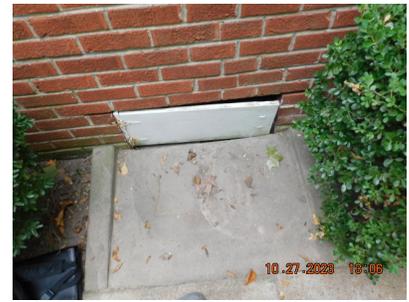
Crawlspace access door damaged and faulty. Refer to line 9410 of the Uniform Building Inspection Report Binder.

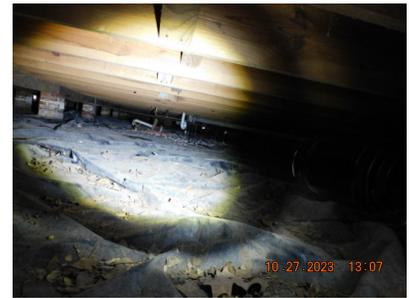
No vapor barrier has been installed on the soils of this crawl space to contain the moisture in the ground. This is a conducive pest condition and can lead to high moisture conditions. Install a 6 mil. black plastic vapor barrier to cover all exposed earth. Refer to line 9750 of the Uniform Building Inspection Report Binder.

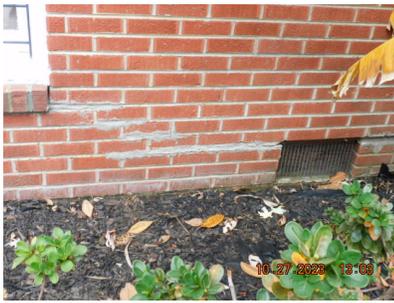
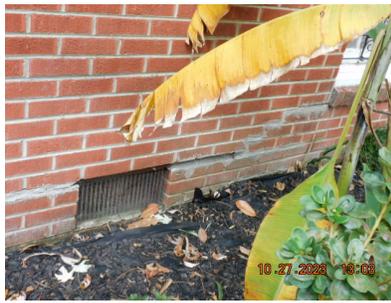
**? (SB-1) Review:** Signs of possible foundation movement noted in the masonry siding. Refer to line 1190, 9190 and 9070 of the Uniform Building Inspection Report Binder.
