Inspection report for the property at  
**2108 Bienvielle, Monroe, LA**

This report is prepared exclusively for **Sue Kuruvilla**  
On: **2022-07-30**

QED Service

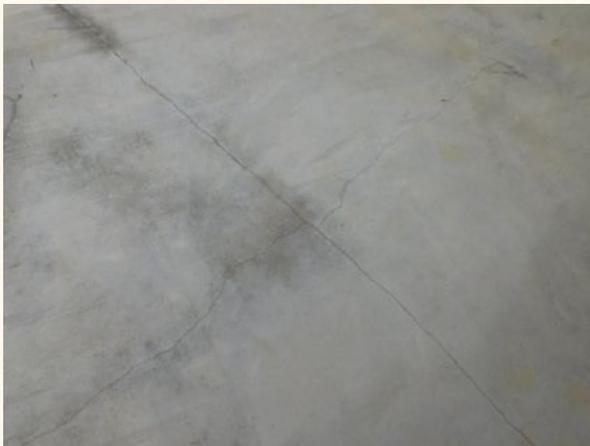
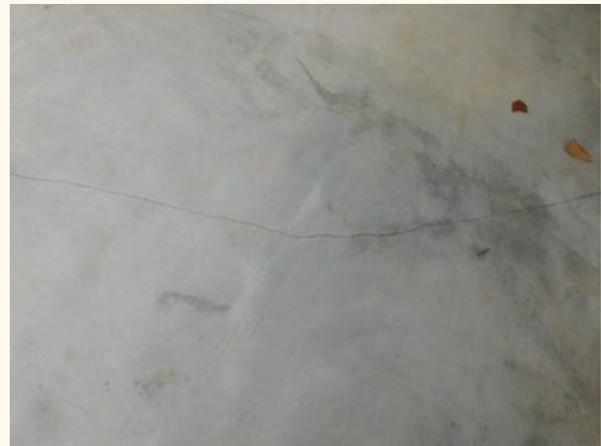
**🔍 (GC-3) Review:** Typical concrete cracks noted in concrete

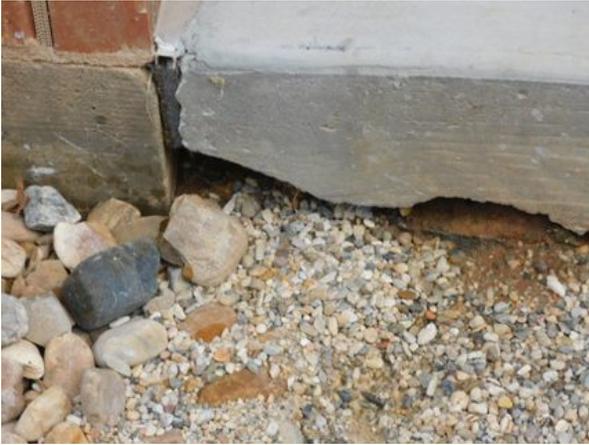
**🔍 (GC-4) Review:** Earth settlement noted under patio slab.

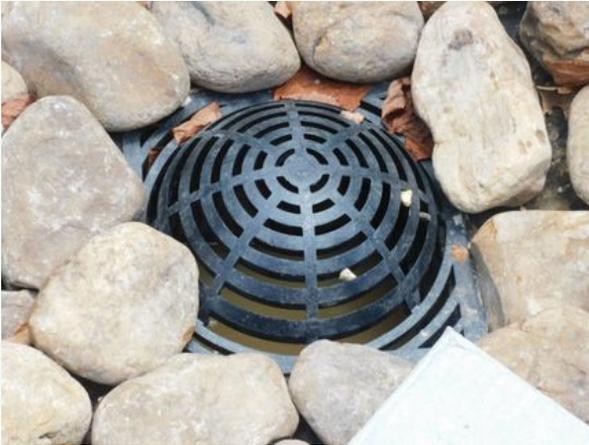
**(G-2) Completed:** Newer-looking drainage work was noted on this house site - see the PVC drain lines. Disclose any additional information about the scope and extent of this work and any plans for this work in case future repairs or modifications are needed.

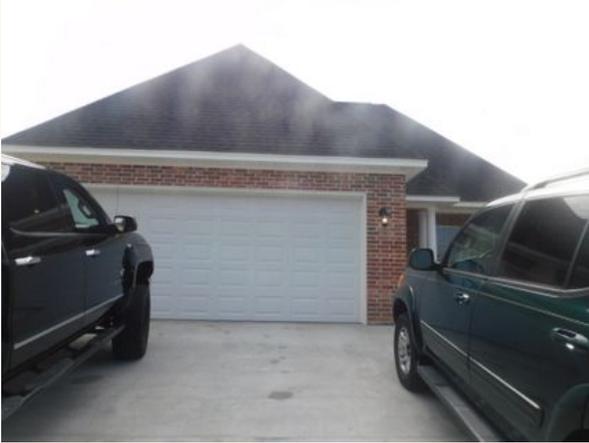
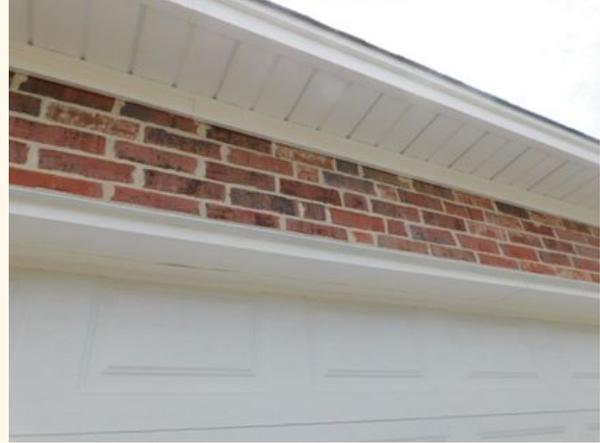
🔗 (ED1-2) Review: Masonry weep holes missing over garage door.

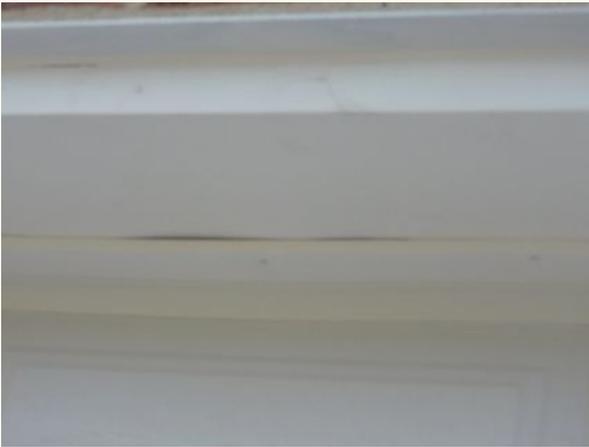
🔗 (ED1-3) Review: gaps noted at garage door weather strip.

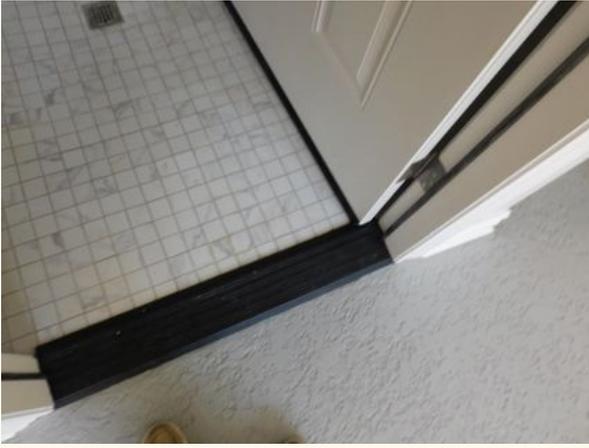
🔗 (ED1-4) Review: Threshold loose and needs to be sealed.

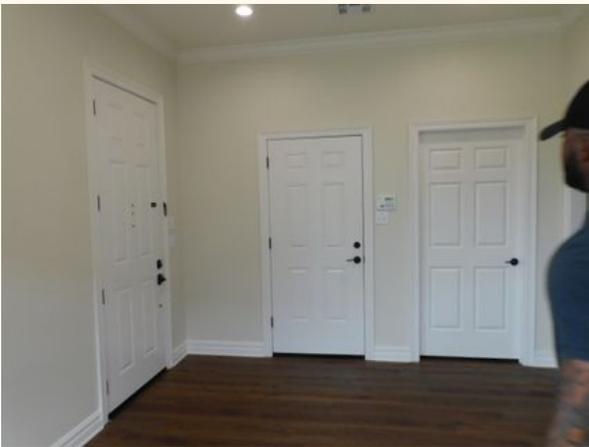
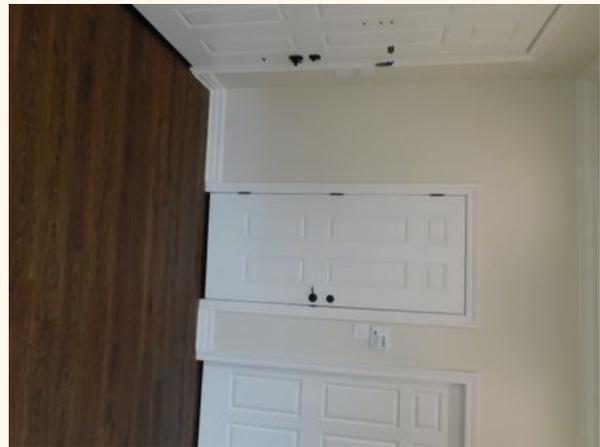
🔧 (ED1-5) Review: Doors not properly closing and engaging the door seals.

🔧 (ED1-6) Review: Doors appear to be out of square or not properly installed. This is based on the visual gapping around the door at seal.

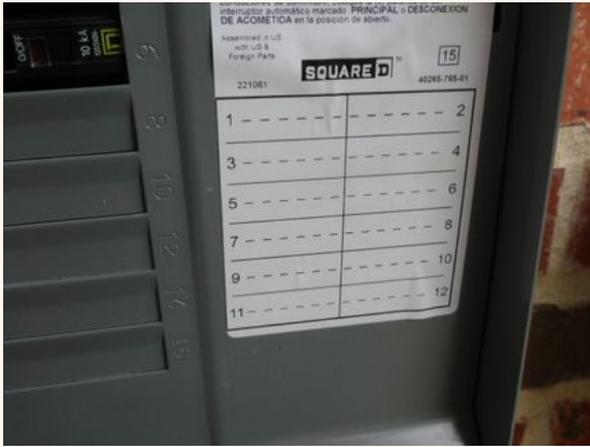
**🔧 (ES1-2) Review:** Inadequate labeling of the electric panel circuit breakers was noted during inspection. This should be corrected for improved safety.

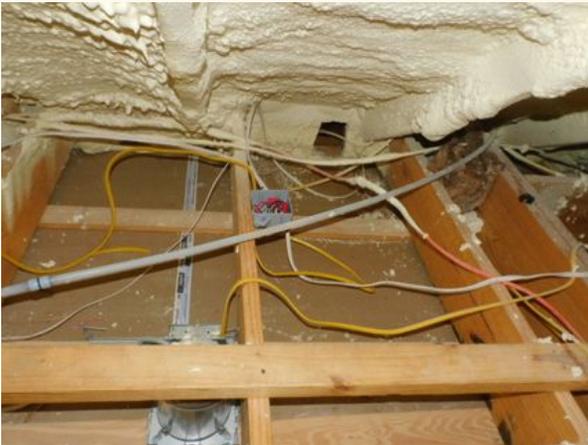
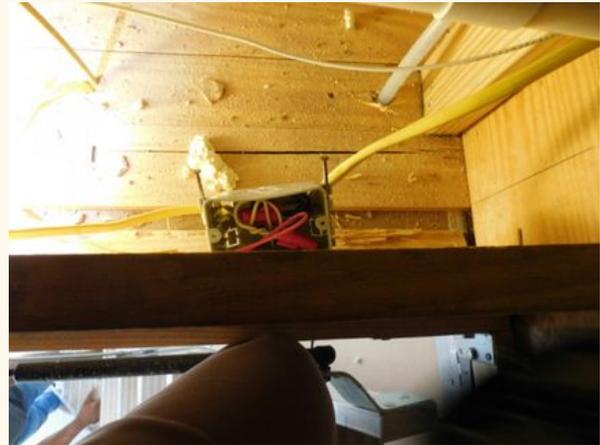
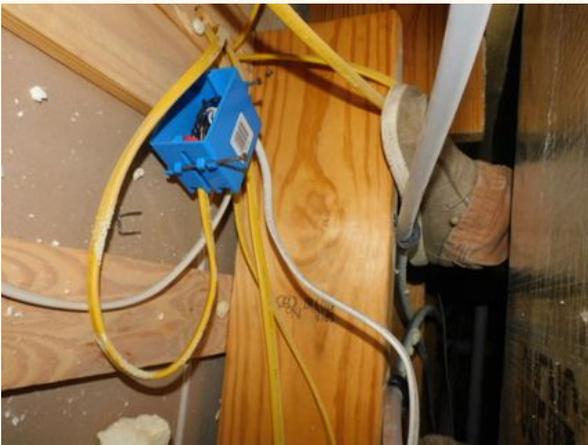
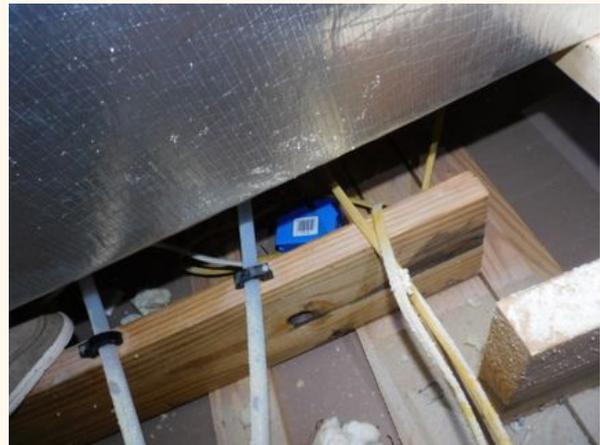
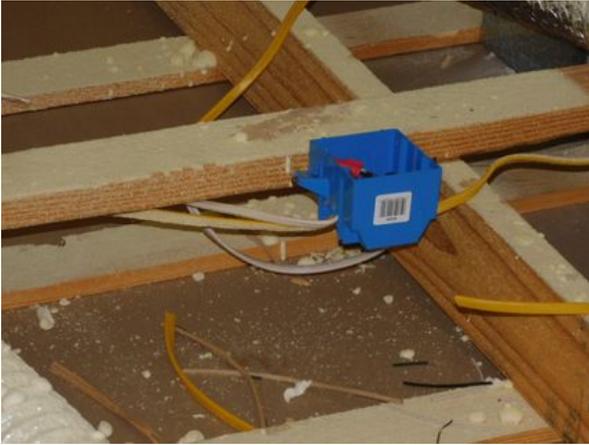
🔧 (EDFW-1) **Review:** Open junction boxes noted in attic space.

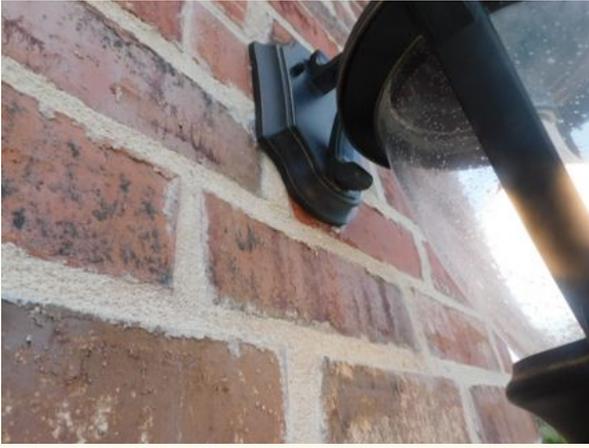
🔧 (EDFW-3) Review: Exterior lights appear to be caulked /sealed at masonry on all sides - the lower part should not be sealed to allow for any moisture that may enter to be able to drain out.

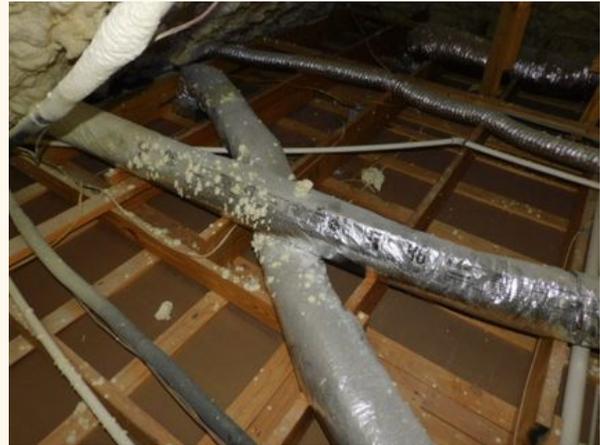
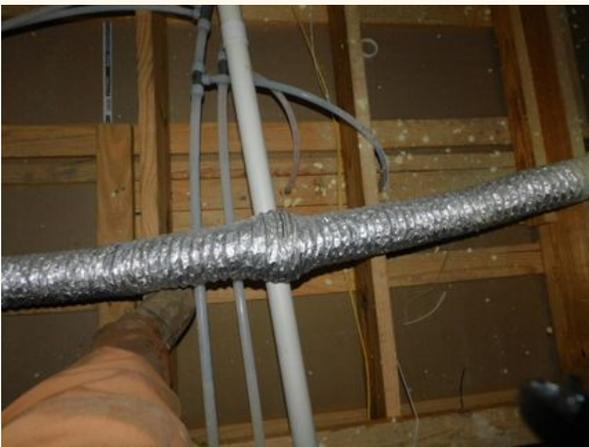
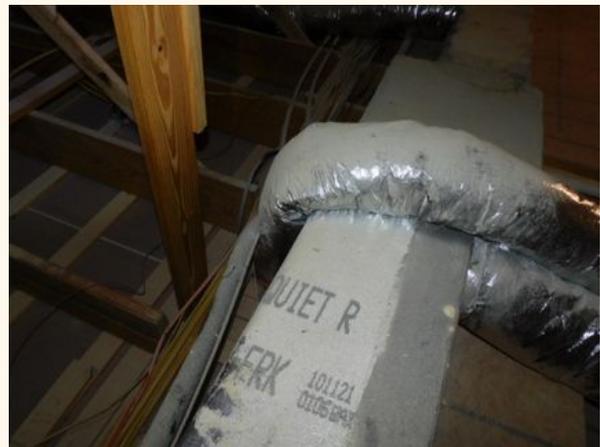
🔧 (HCFV-2) **Review:** Flex ducting being crushed in attic in various locations.

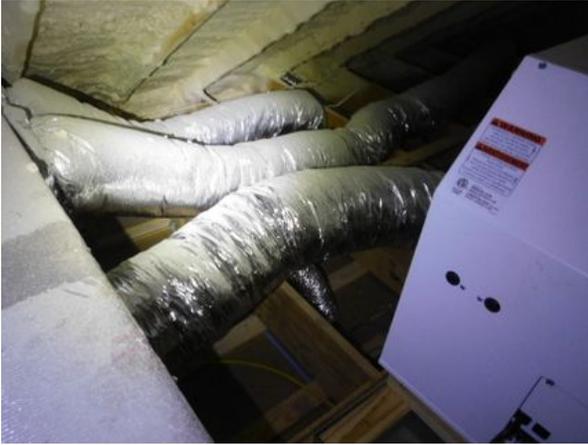
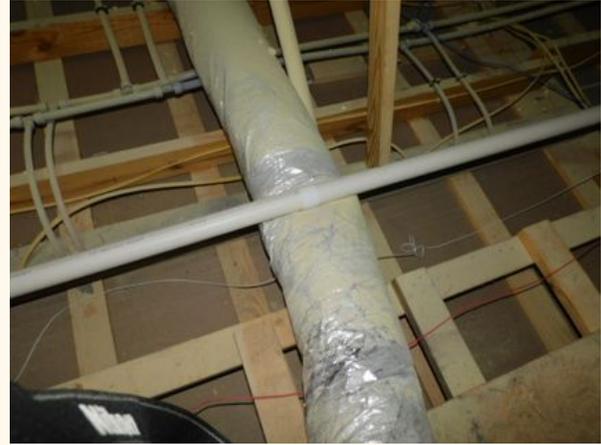
🔧 (HCFV-3) Review: Ducting not properly supported.

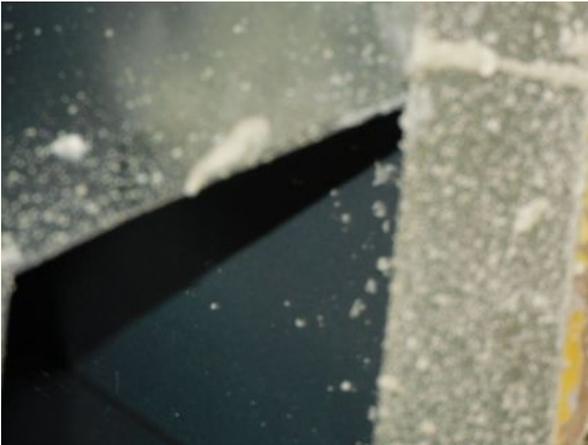
🔧 (HCFV-4) Review: Tape joints coming loose at plenum.

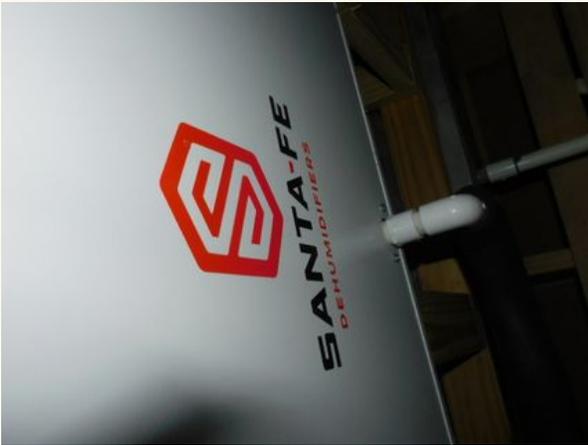
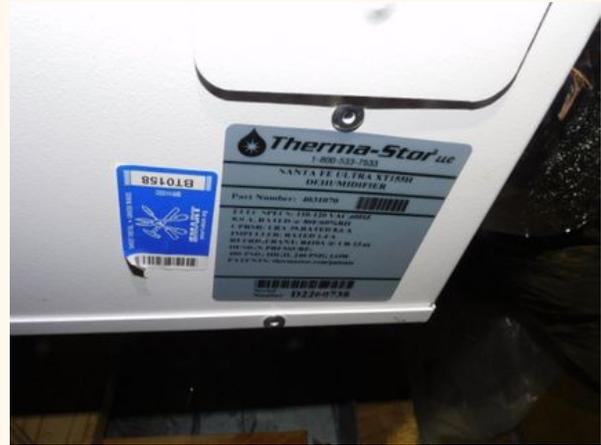
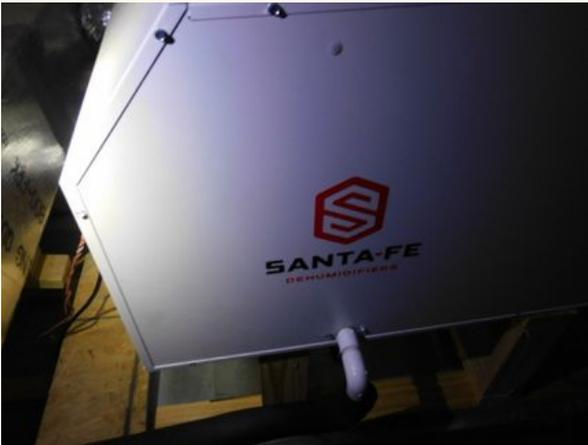
**🔍 (HCFV-5) Review: Dehumidifier present in system**

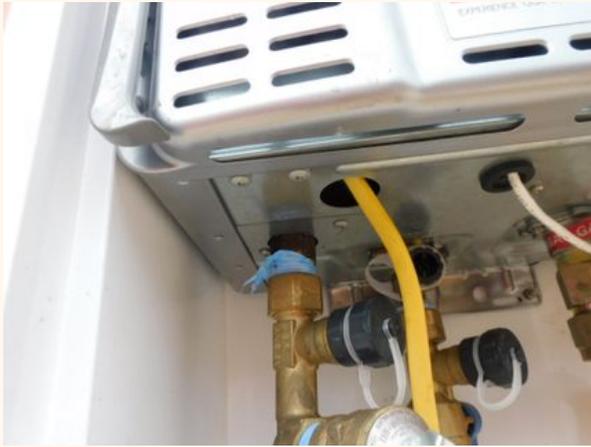
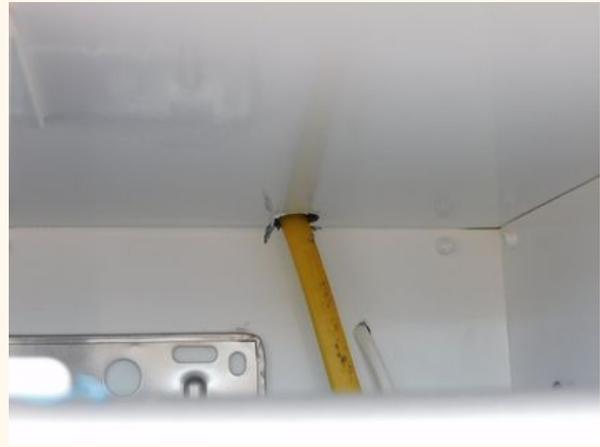
↗ **(P2-2) Review:** Evaporator coil drainage line improper.

🔧 (P2-3) Review: Box wire clamp missing at water heater.

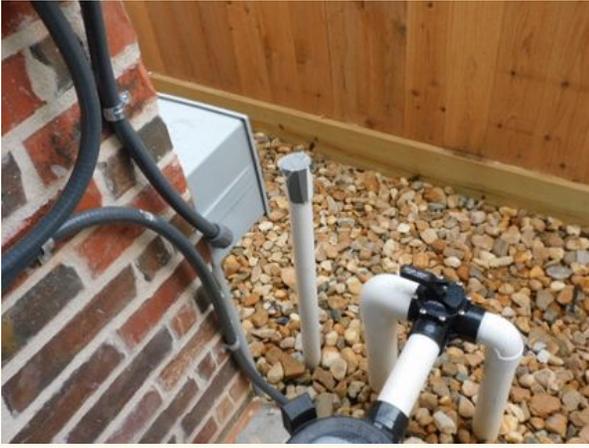
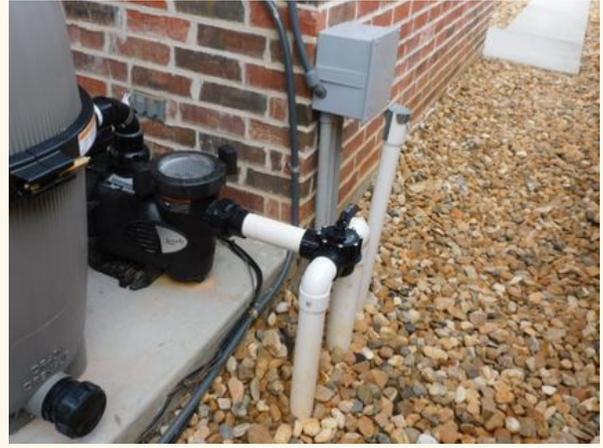
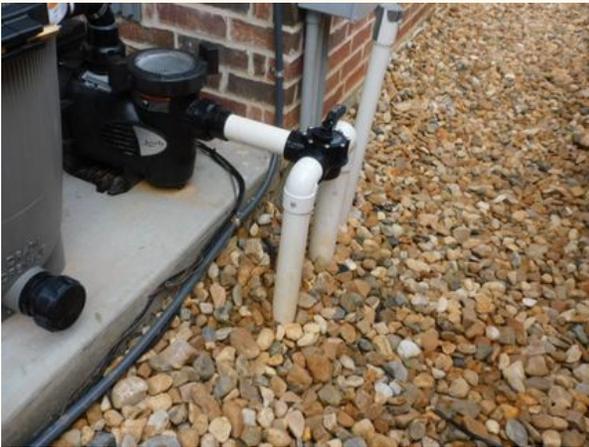
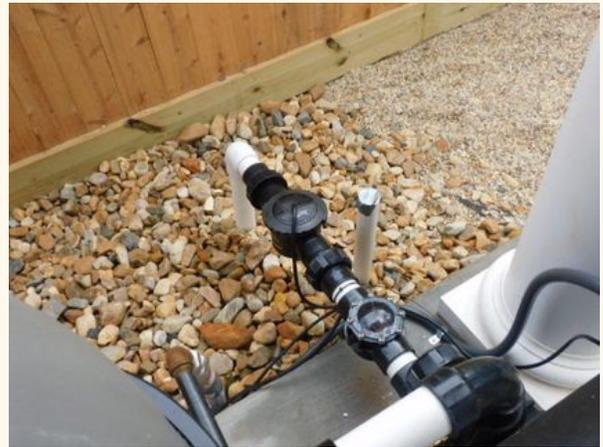
🔧 **(AP-9) Review:** open pipes noted at pool equipment.

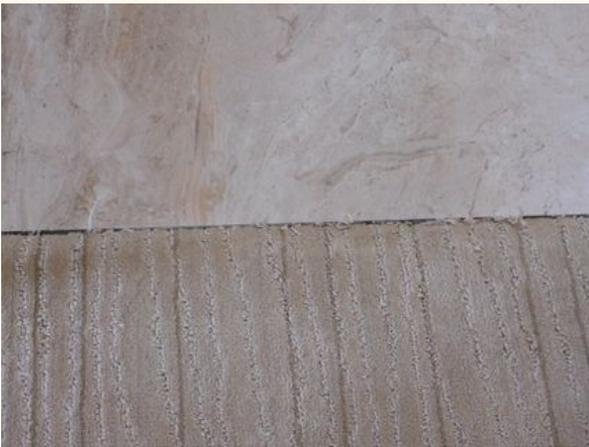
**?** (I-2) **Review:** gaps noted at carpet to tile flooring.

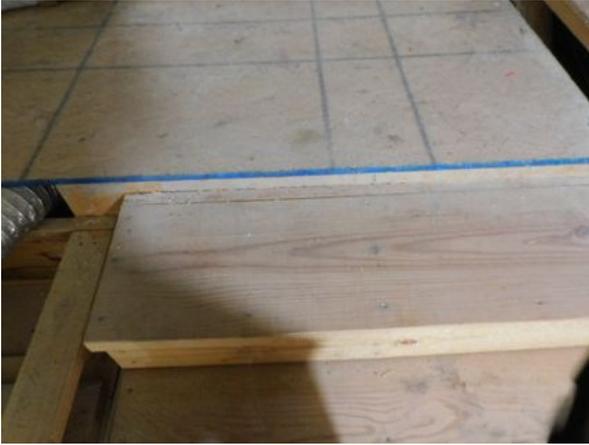
🔧 (I-3) **Review:** Uneven stairs risers.

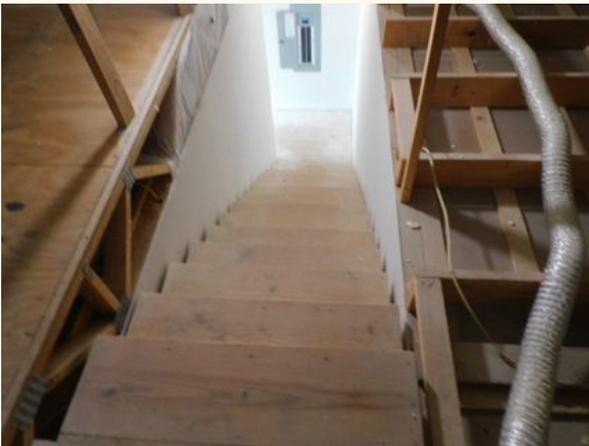
🔧 (I-4) **Review:** A guardrail is needed for the interior stairs to eliminate a safety hazard, especially for children. Railings with openings no larger than 4 inches are recommended for all stairs with three or more stairs. Handrails that have returns into the walls are needed for the length of the stairs. Hire a carpenter to repair and bring guardrail and handrail up to modern standards.

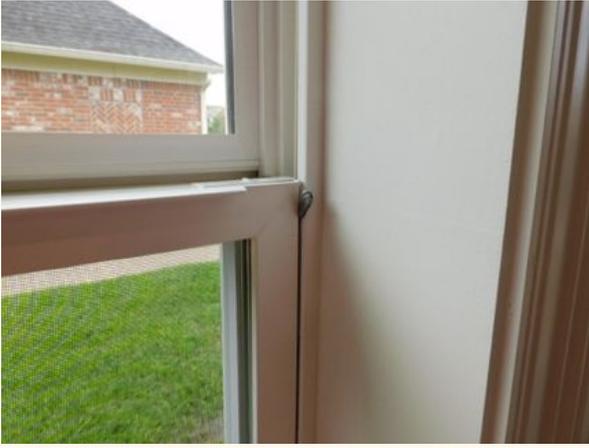
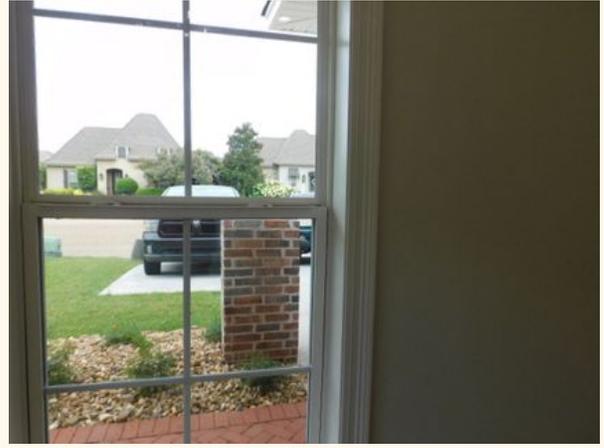
🔧 (I-5) **Review:** Windows difficult to operate - may be out of square.

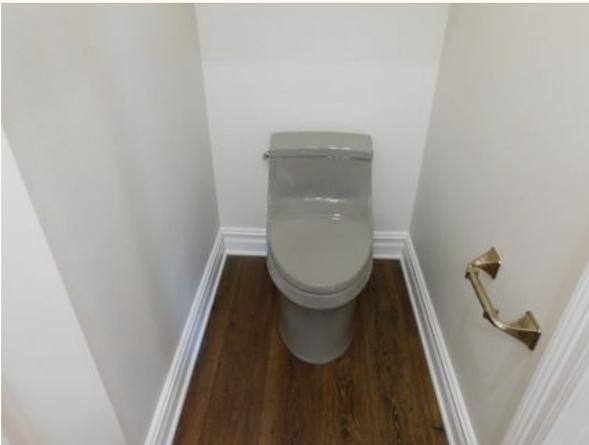
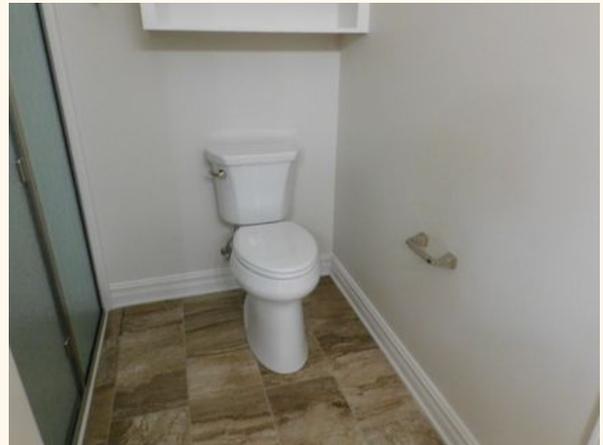
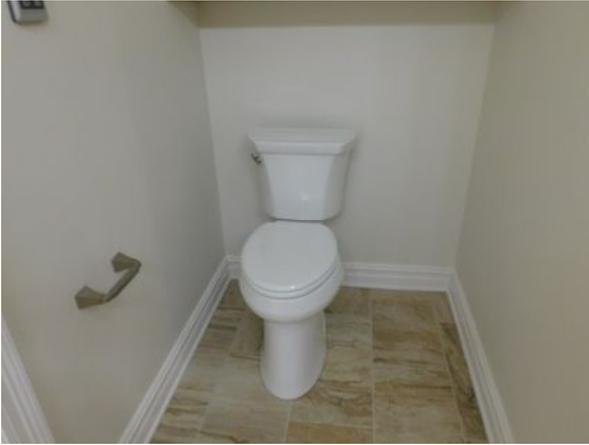
**🔧 (B-2) Review:** appears to loose on floor.

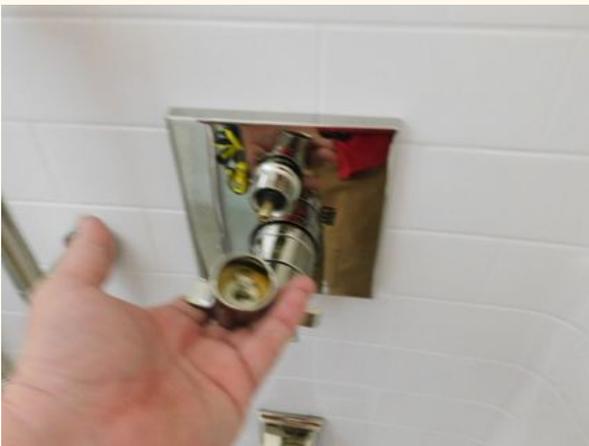
**🔧 (B-4) Review:** Shower control valve handle not secured.

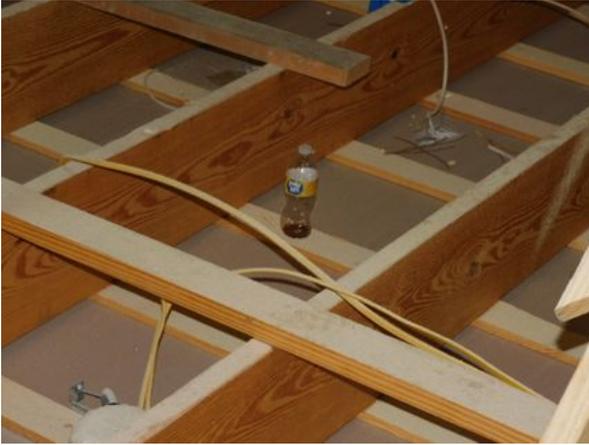
🔍 (A-1) Review: bottles with liquid noted in attic space.

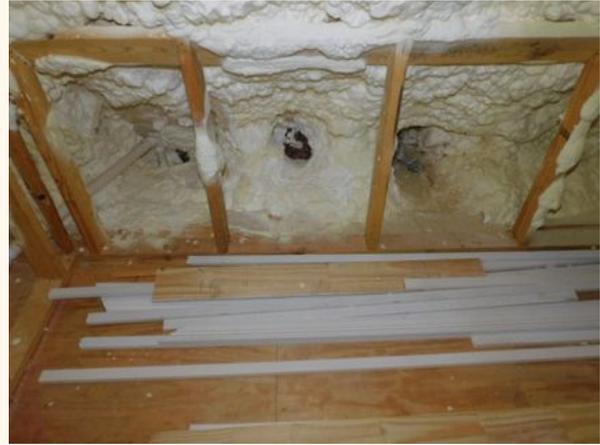
🔍 (A-3) Review: Holes cut into spray foam insulation in various locations.
