Inspection report for the property at
2708 Bramble Drive, Monroe, LA 71201

This report is prepared exclusively for **Michael & Holly Gray**
On: **2022-08-02**

QED Service

Inspector: Michael Burroughs : LA State License #LHI 10044,

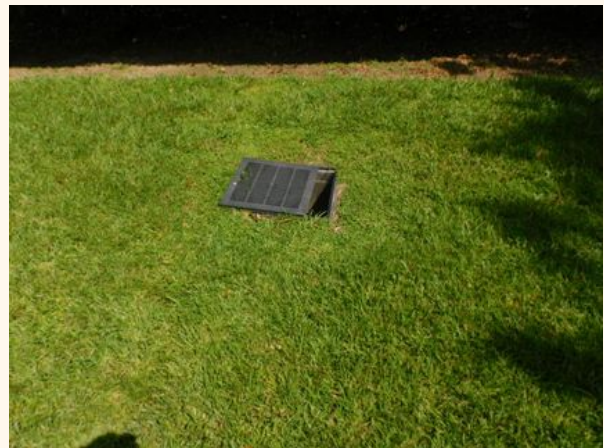
(G-2) Review: Site drain covers appear to be improperly installed.

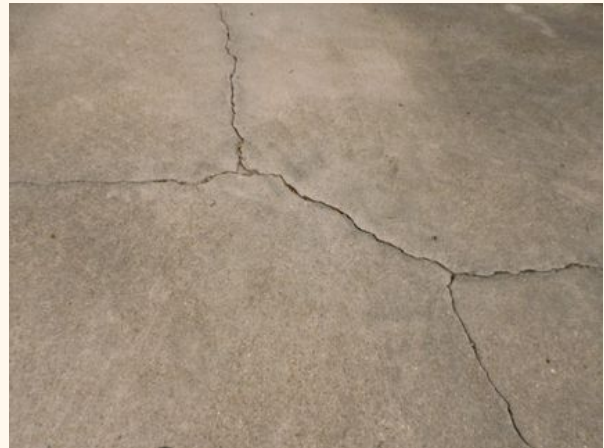
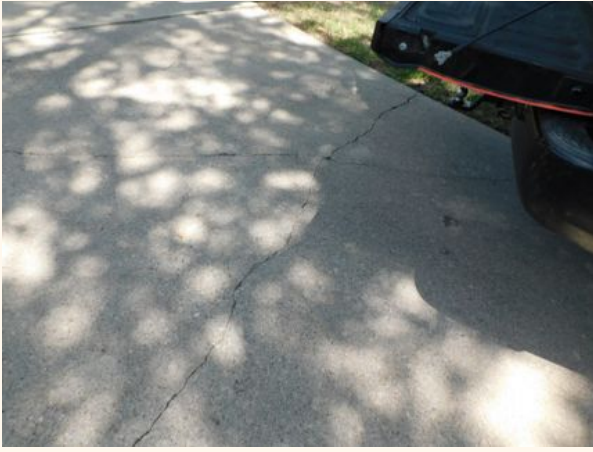
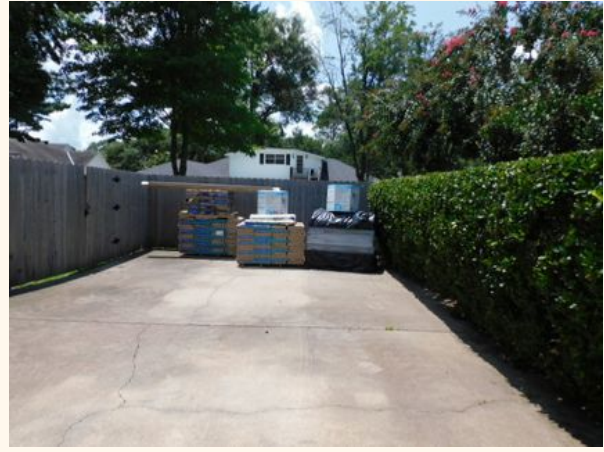
🔧 (G-4) Review: Concrete cracks noted in Driveway. Refer to line 0210 of the Uniform Building Inspection Report Binder.

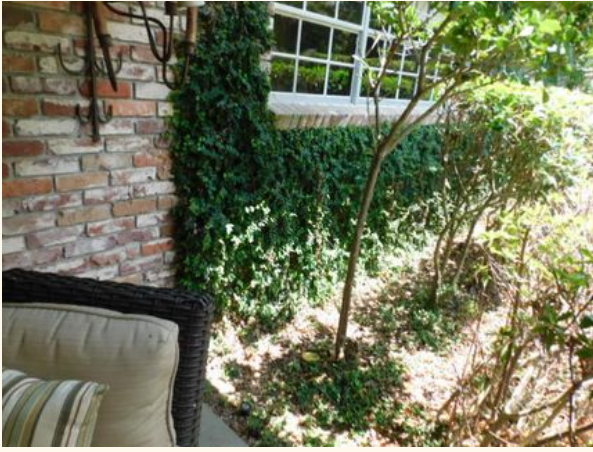
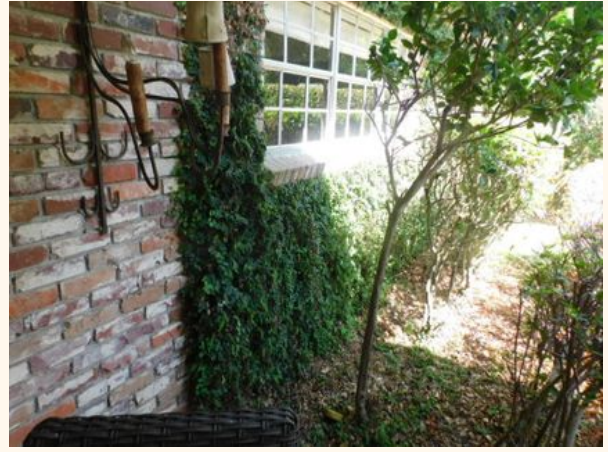
**(G-7) Review:** Ivy growing on siding of the home which can lead to decay of the siding materials. Refer to line 1920 of the Uniform Building Report Binder.

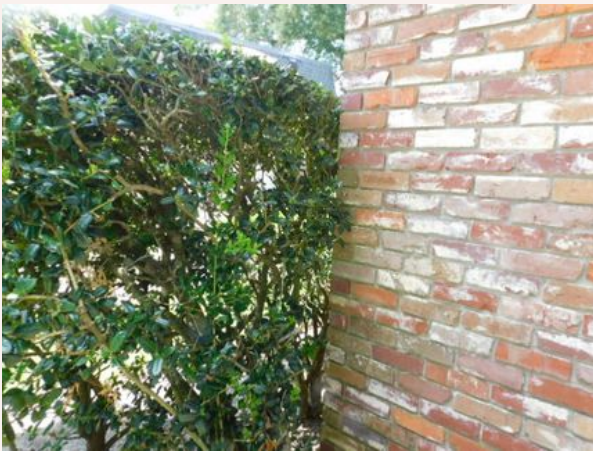
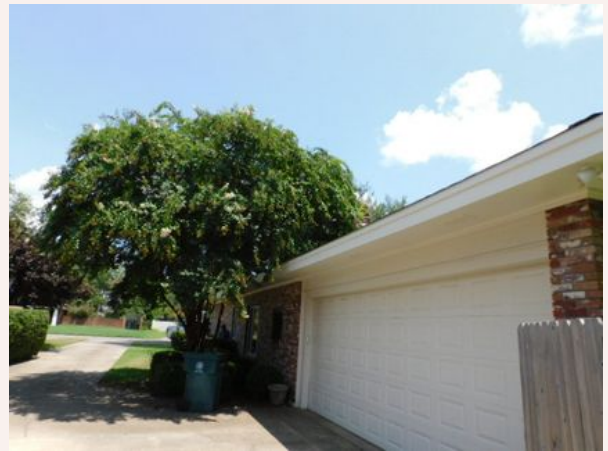
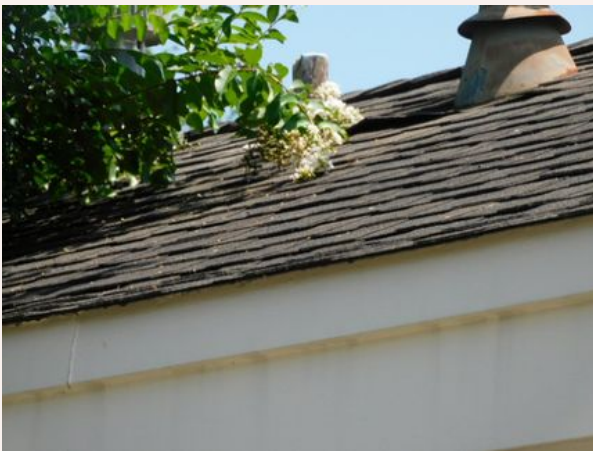
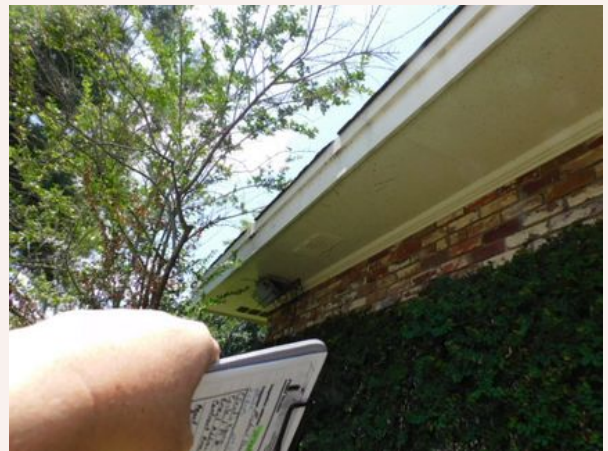
✂️ **(G-6) Recommended Preventive Maintenance:** Pruning trees, branches and vegetation away from the house is recommended. Where trees, branches and large shrubs can provide rodent access to the roof, a minimum 6-foot clearance is recommended as many rodents can jump 6-feet. All vegetation, including smaller landscaping such as grasses, flowers and shrubs should be kept 1-foot off the house to eliminate contact which could trap moisture against the building.

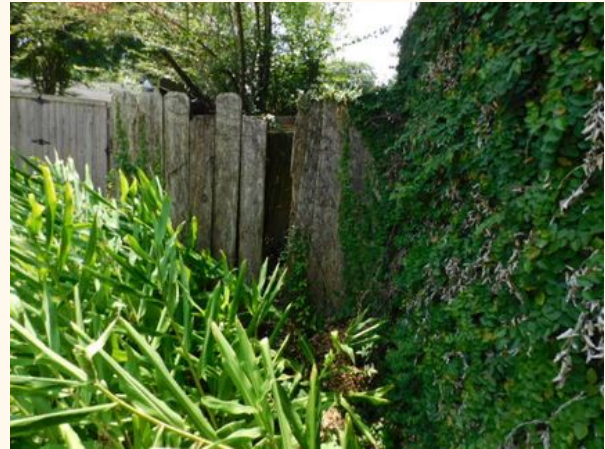
🔧 **(G-10) Review:** Localized damage was noted to the fencing - see west side. Implement carpentry repairs as needed.

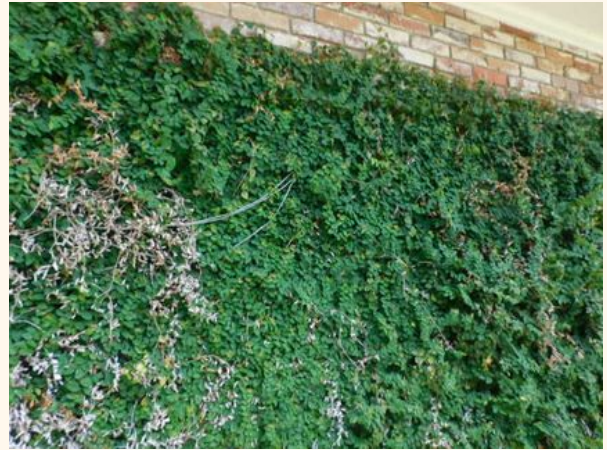
🔍 (ED1-1) Review: Ivy or vines covering masonry siding.

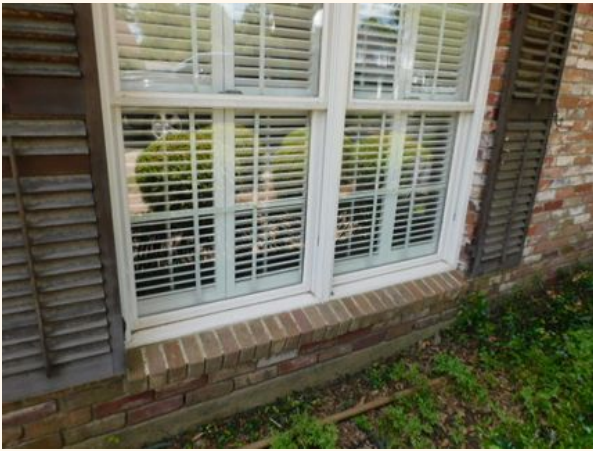
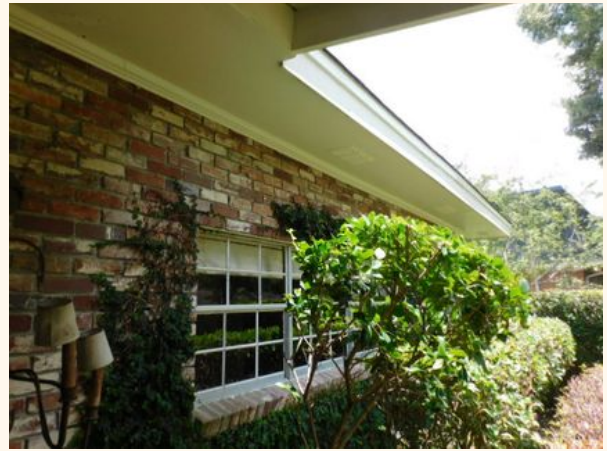
🔑 (ED1-5) Review: Window screens missing.

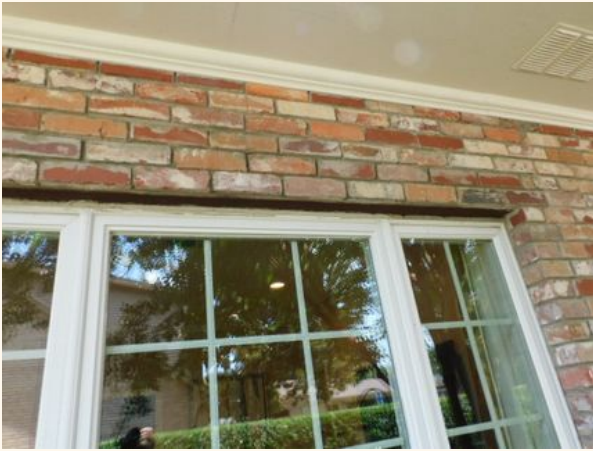
🔑 (ED1-6) Review: Metal lintels rusting over windows and doors.

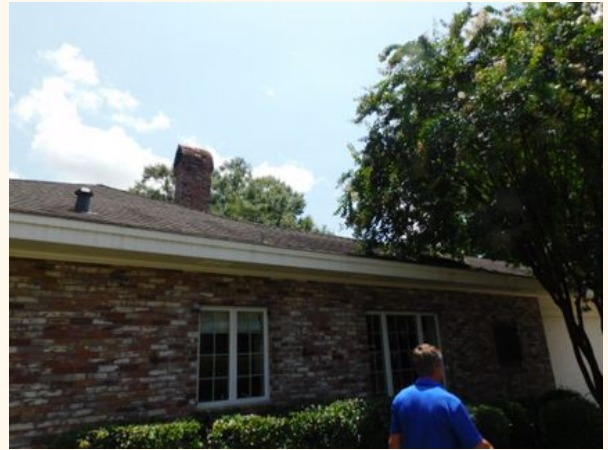
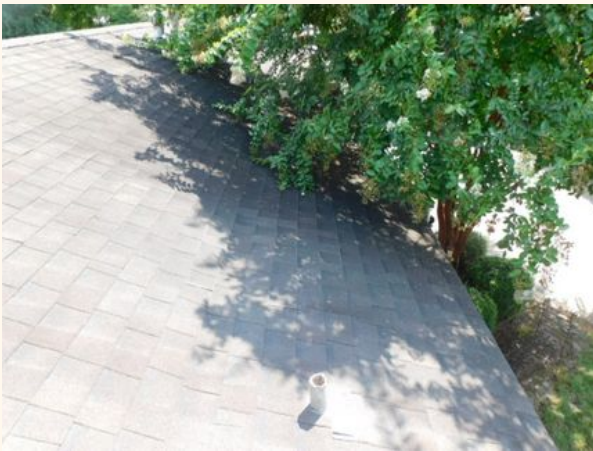
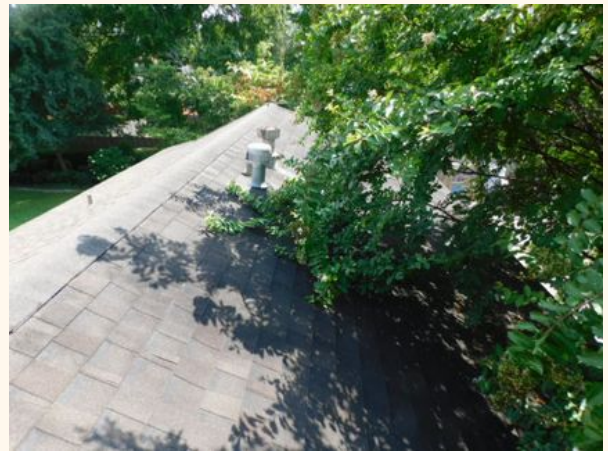
🔧 (RCG2-2) Review: Tree limbs in contact with roofing materials.

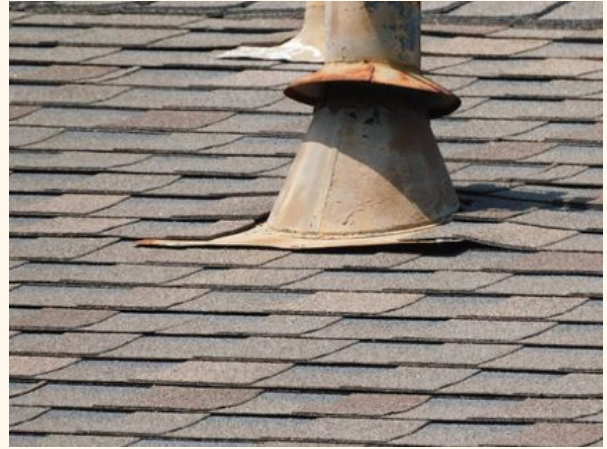
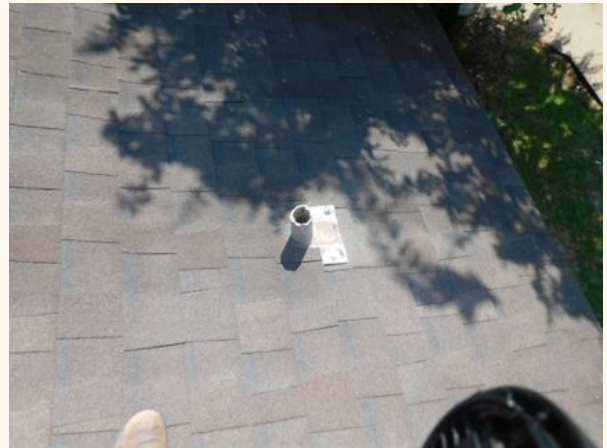
🔧 (RCG2-3) Review: Flashings damaged and lifting off of roof.

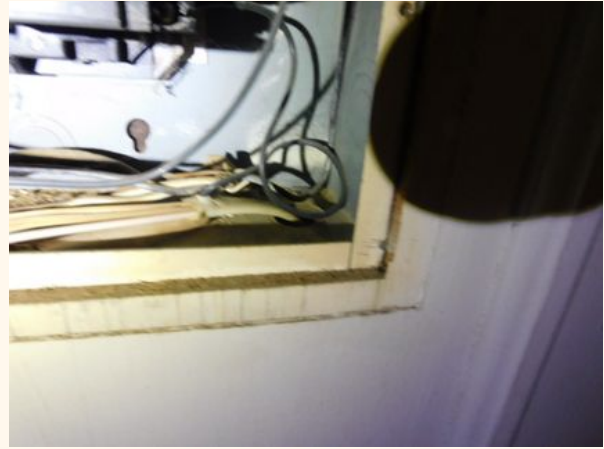
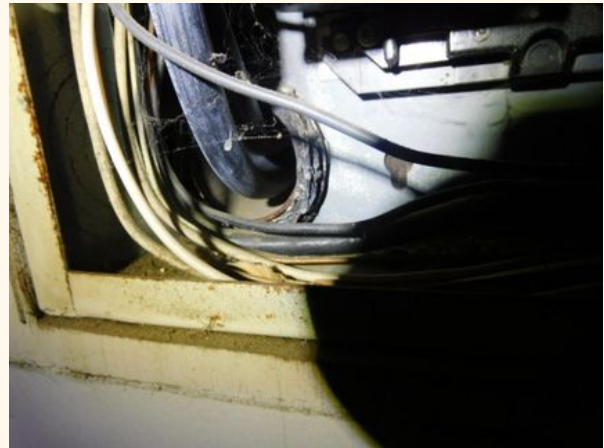
⚠ (ES1-2) Review: Conduit connectors missing at panel.

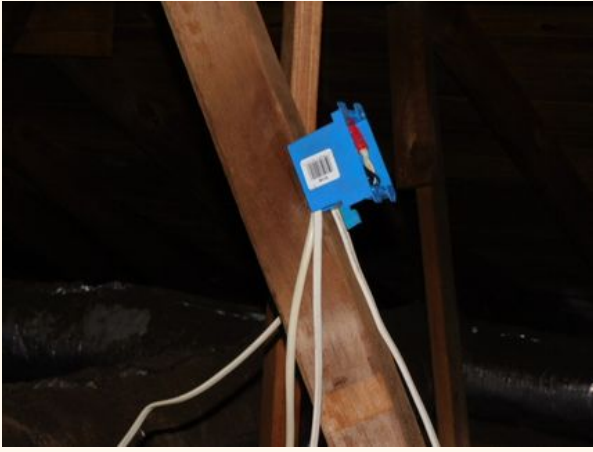
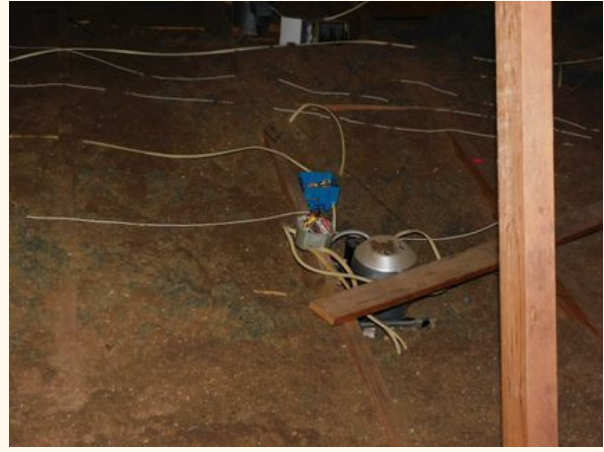
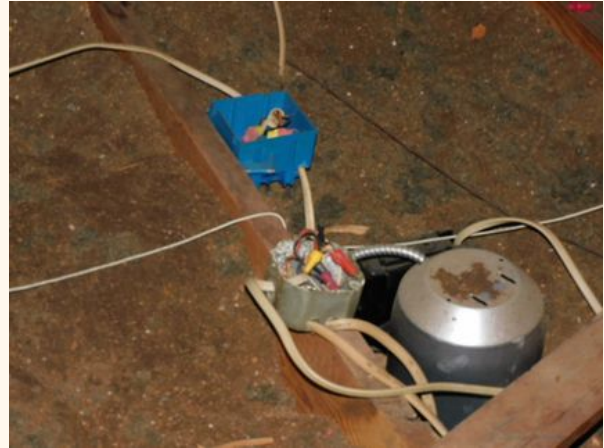
🔧 **(EDFW-3) Review:** The open electrical junction box in the garage and attic needs to be covered for improved safety. This is as simple as installing a cover plate over the box to protect the wiring. Sometimes, an extension ring is needed if finishes are covering the box. Repair as needed for improved safety.

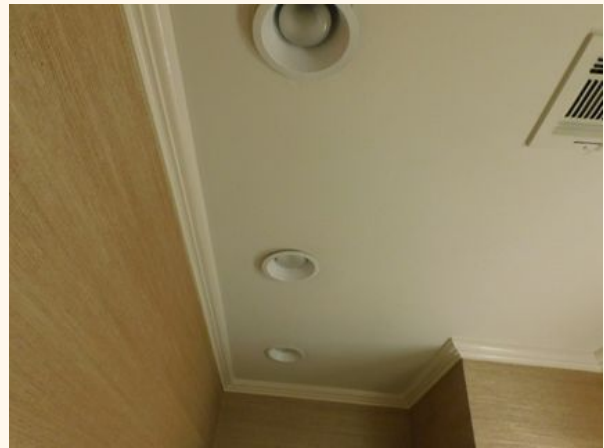
🔧 (EDFW-9) Review: Light fixture lights fixture not flush with ceiling.

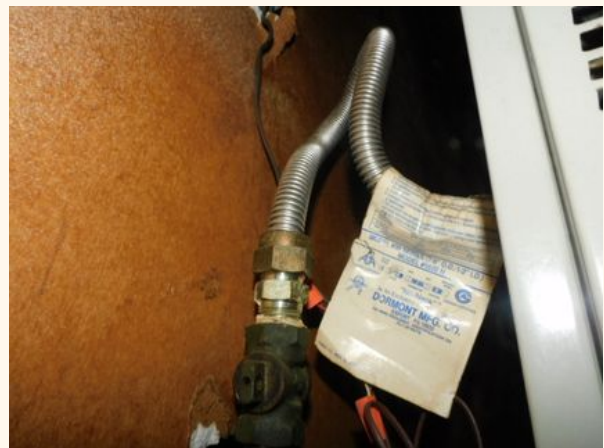
⚠ (HCFV-1) Review: Flex gas line enters the heating unit - this line should be hard pipe through the wall.

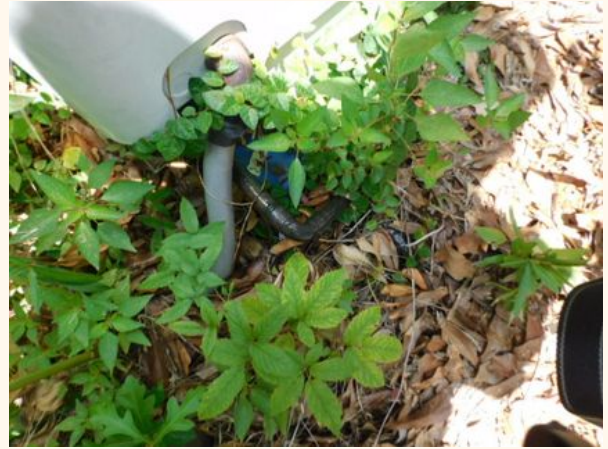
🔍 (HCFV-4) **Review:** Refrigerant line insulation damaged / missing at condenser.

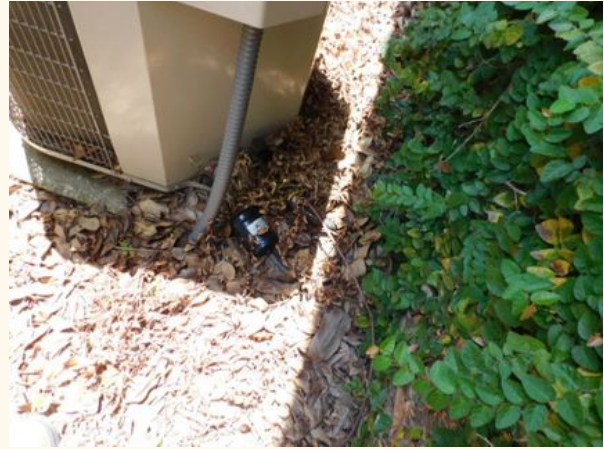
🔧 (HCFV-7) Review: Clean and service HVAC system recommend.

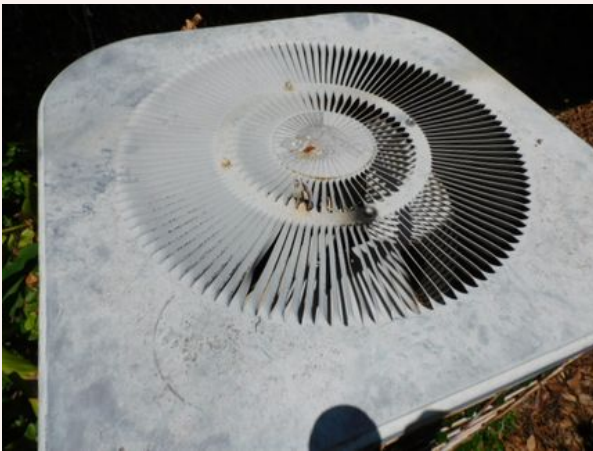
✂ (HCFV-5) **Recommended Preventive Maintenance:** Condenser fan control wires exposed above fan cover. Disconnect boxes missing or not readily accessible.

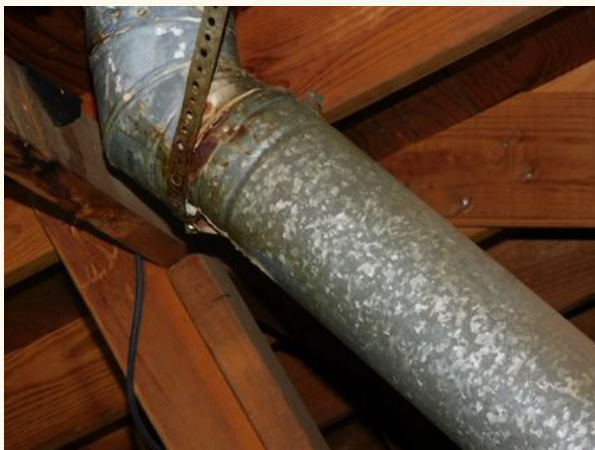
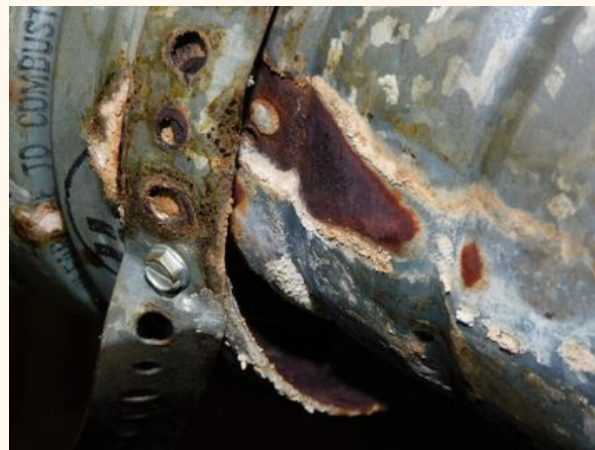
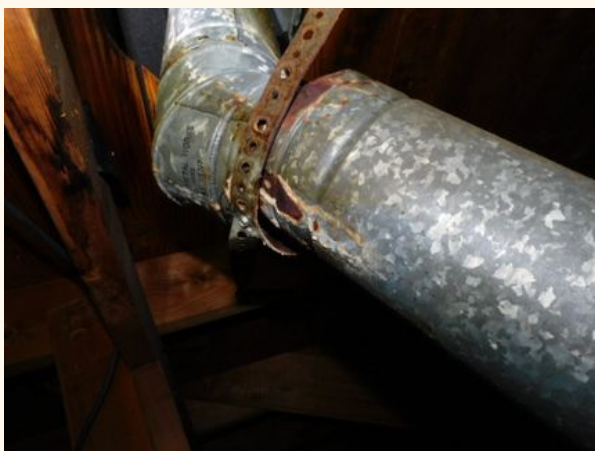
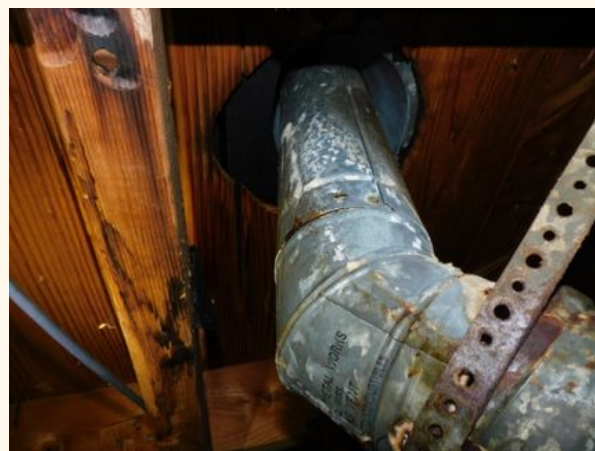
🔧 (HCFV-13) Review: Heater vent damaged, sperated and rusting.

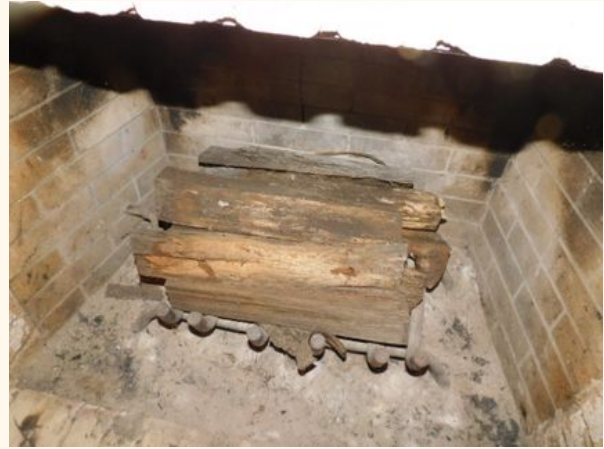
🔧 (HCFV-14) Review: Cracked brick were noted in the back wall of the fireplace firebox. This can make the fireplace unsafe for fires. Hire a mason or chimney sweep to further evaluate this condition and repair as needed to insure safe and reliable performance from the fireplace. Firebox repairs need to be made using firebrick and proper refractory mortars designed for high temperatures.

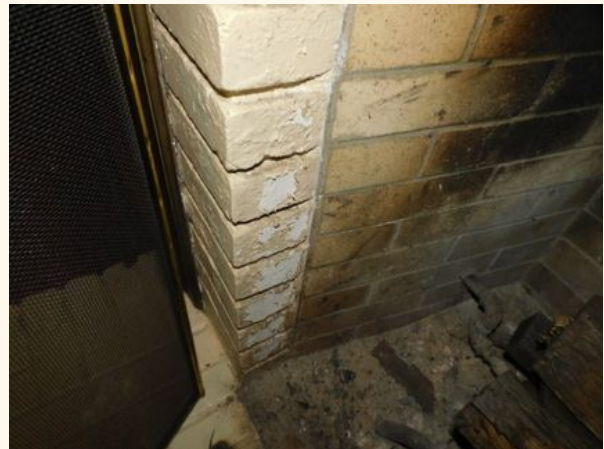
🔧 (HCFV-15) Review: Failing / missing masonry mortar was noted in the fireplace firebox. This can make the fireplace unsafe for fires. Hire a mason or chimney sweep to further evaluate this condition and repair as needed to insure safe and reliable performance from the fireplace. Firebox repairs need to be made using firebrick and proper refractory mortars designed for high temperatures. Mortar repairs are often referred to as tuck pointing.

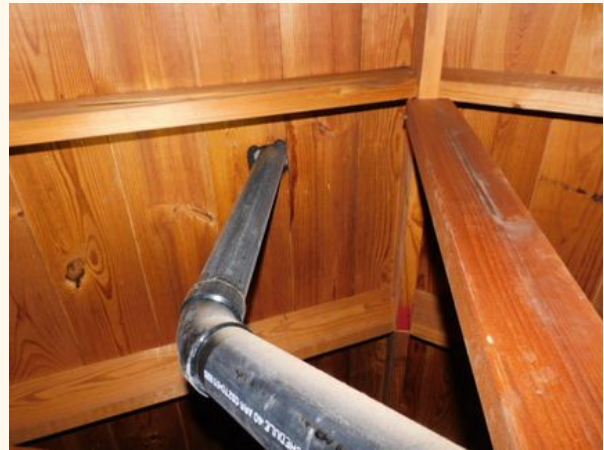
🔧 (P2-2) Review: Plumbing fixture vent not properly supported.

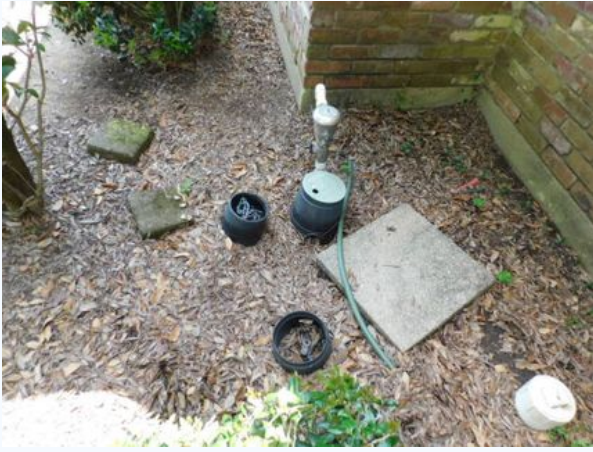
🔍 (AP-2) Due Diligence: An exterior irrigation system was noted for this yard. Sprinkler systems are beyond the scope of this inspection. My own experience with irrigation systems is that they require annual attention / repair / servicing after every winter. Inquire with the seller for any information about how to winterize this system as this should be done prior to cold weather. When testing the system, be sure sprinkler heads are adjusted so the system is not watering the side of the house. Hire a specialist to further evaluate this system as desired.

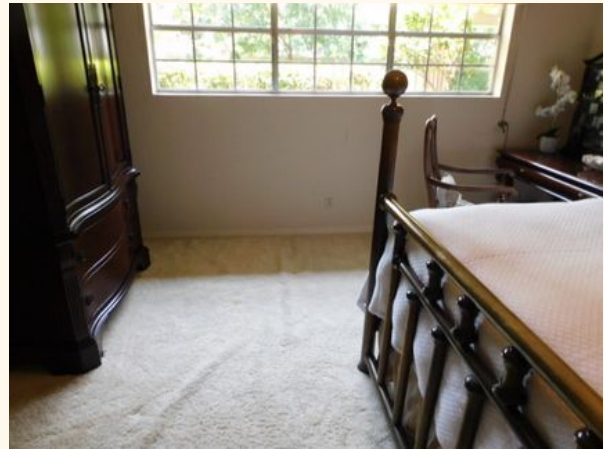
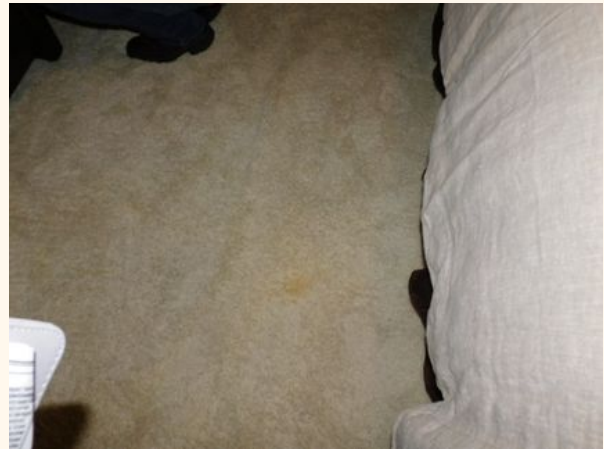
(I-3) Review: Carpet loose in numerous locations in the home.

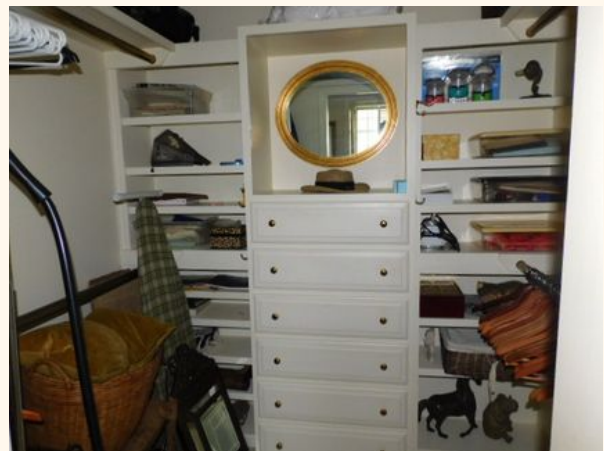
(I-4) Review: Closets full limiting inspector's view of areas.

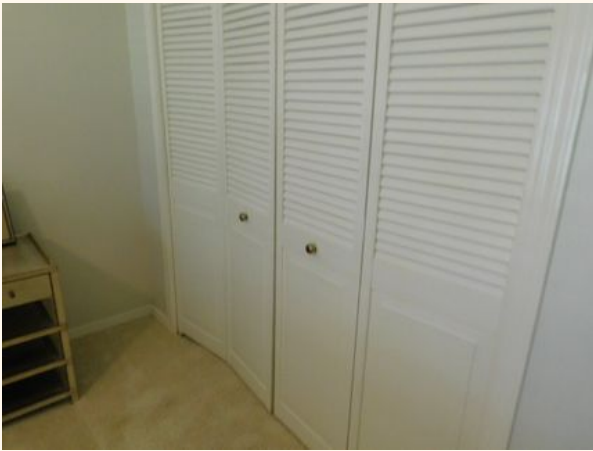
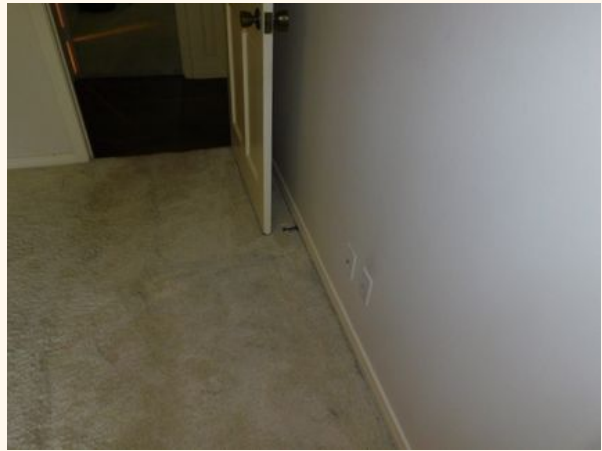
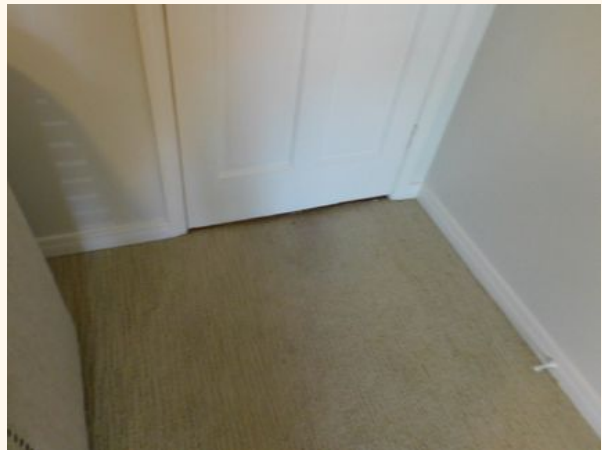
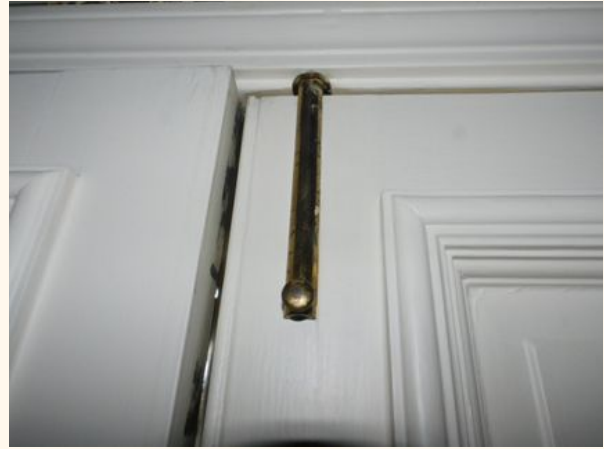
🔧 (I-8) **Review:** Doors dragging on carpet in bedrooms. Improper return air under door.

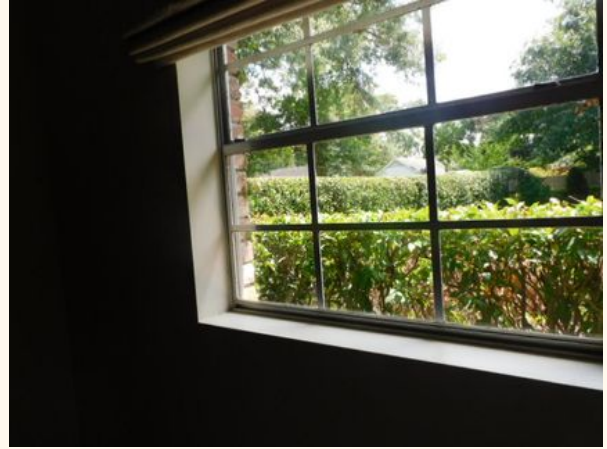
🔍 (I-11) Review: windows faulty.

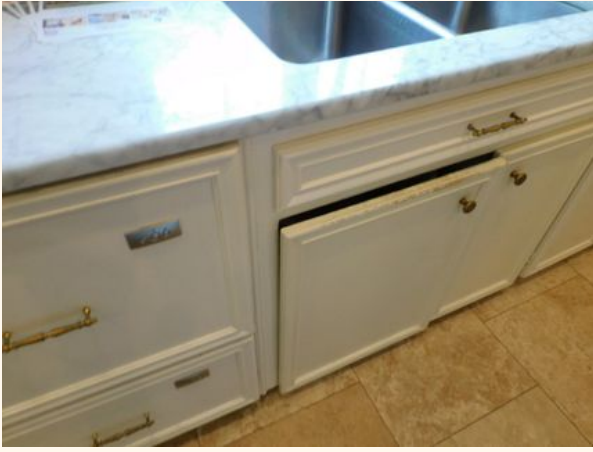
🔧 (K-2) Review: Cabinet door and drawer adjustment is needed for proper operation of the kitchen cabinets. This is common on new construction. Be sure all scratches are removed and all shelves are installed and drawers and doors are working properly. Examples of specific observations noted during inspection include:

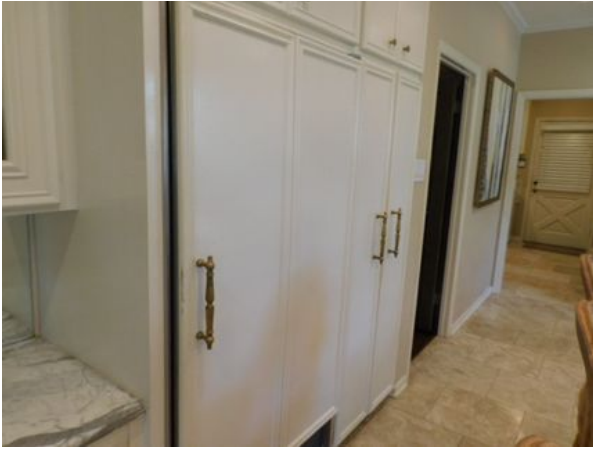
🔧 (K-4) Review: Door trim damaged

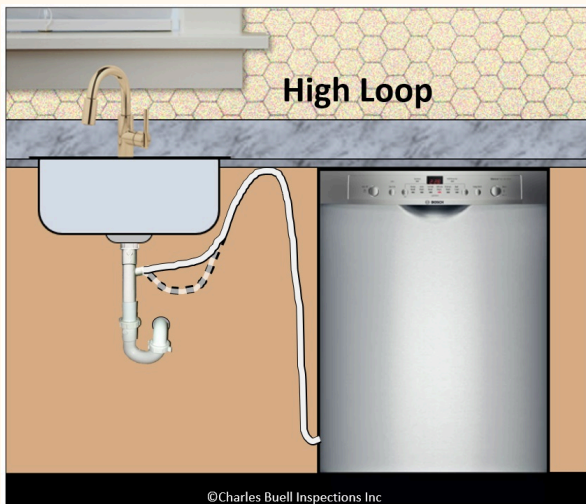
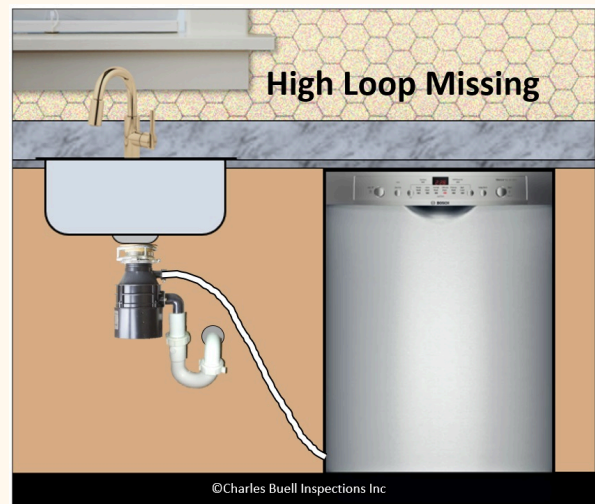
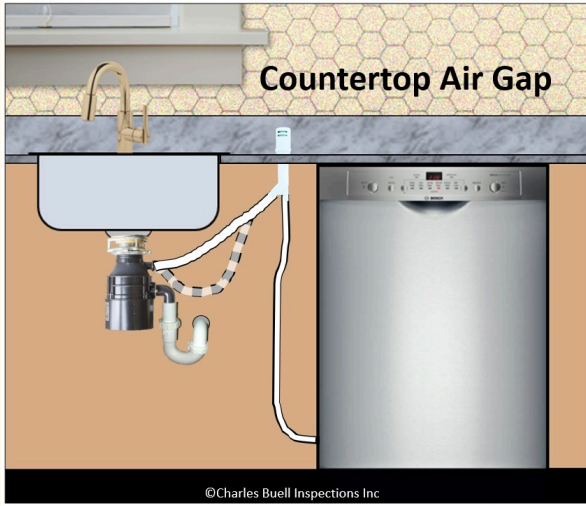
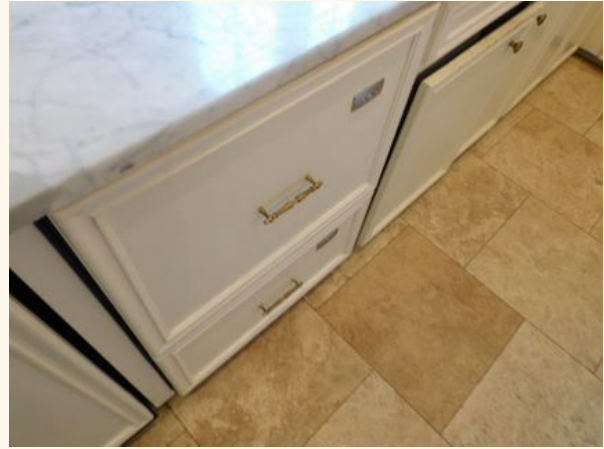
🔧 (K-5) **Review:** An **air gap** is recommended to protect the dishwasher from accidental contamination if the sewer line were to back up. If an air gap cannot be installed, at least run the drain line above the level of the sink drain to create a high loop. This was an older way of protecting the dishwasher. Hire a licensed plumber to install an air gap.

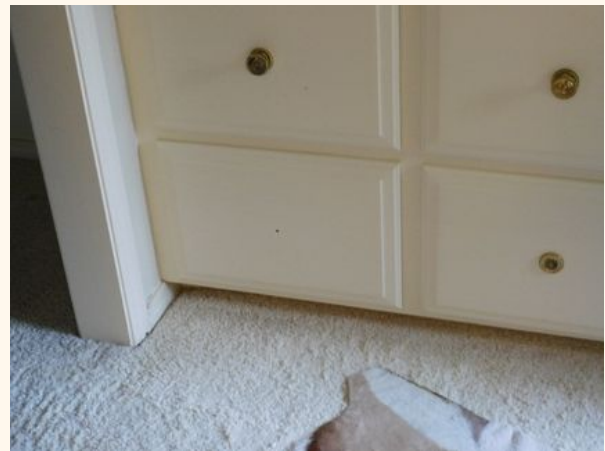
🔧 (B-2) Review: bathroom cabinet doors and drawers need adjustment or repairs.

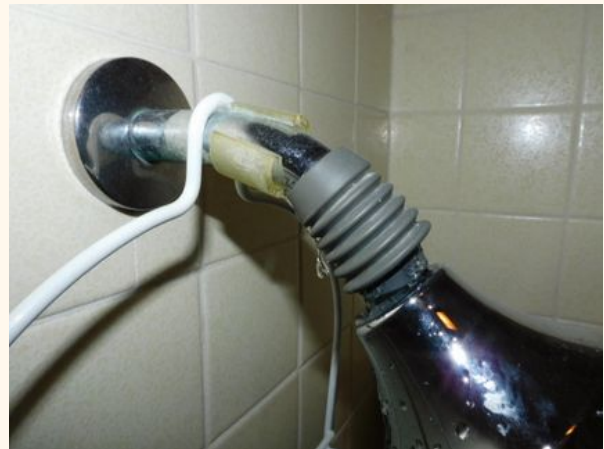
🔧 (B-7) Review: The shower head in the main bath is leaking and requires repair. Leaky shower heads are common and not a significant concern. Adjust as needed to prevent leakage at the shower head.

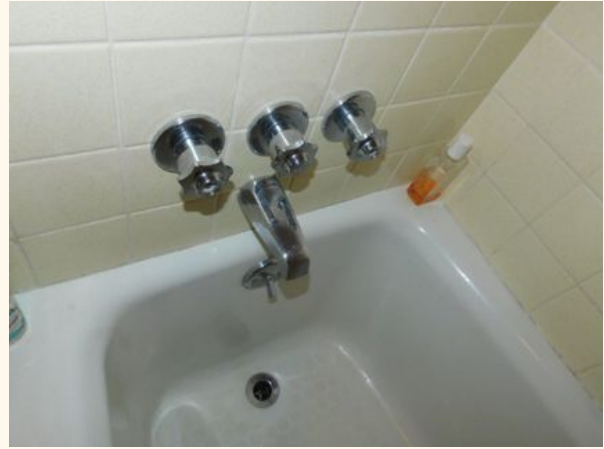
🔧 (B-8) Review: Shower valves leaking at the handles.

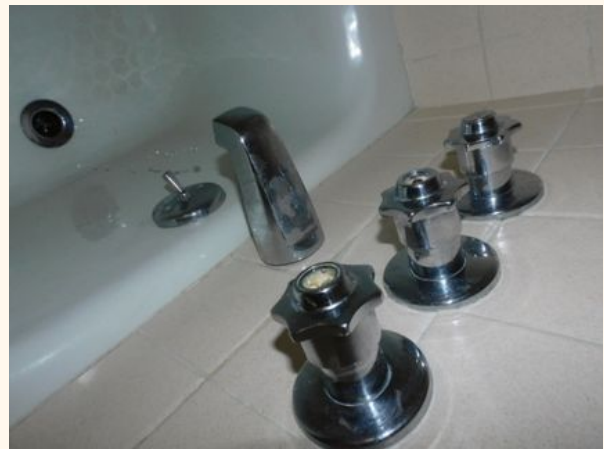
🔧 (B-11) Review: Caulk bathtub spout to wall.

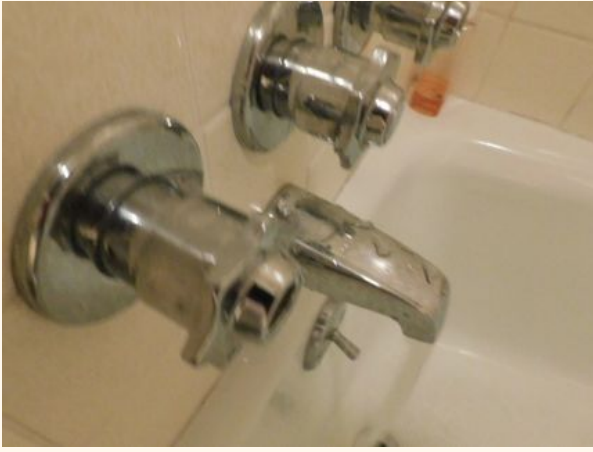
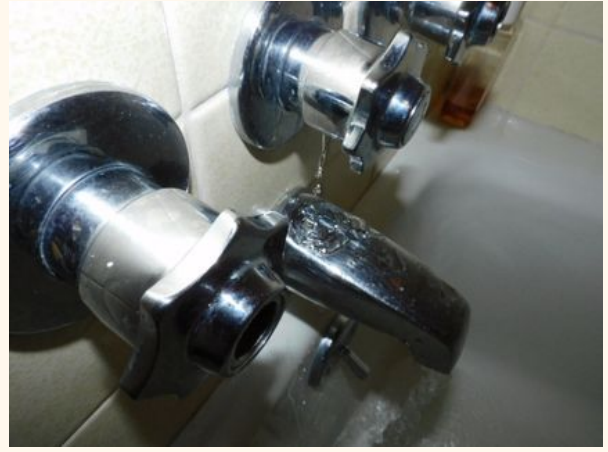
🔧 (B-12) Review: Shower valves leaking around handles.

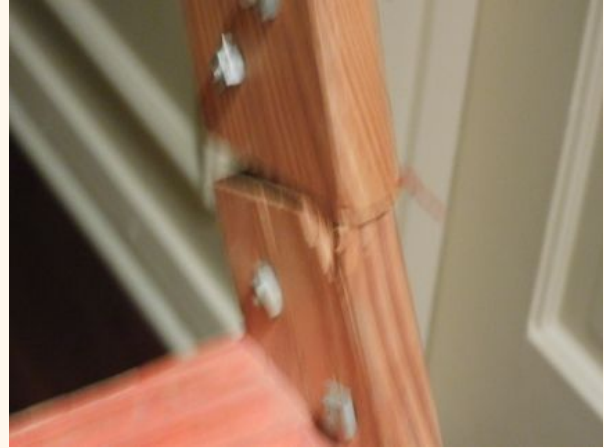
🔗 (A-1) Review: Attic access ladder damaged.

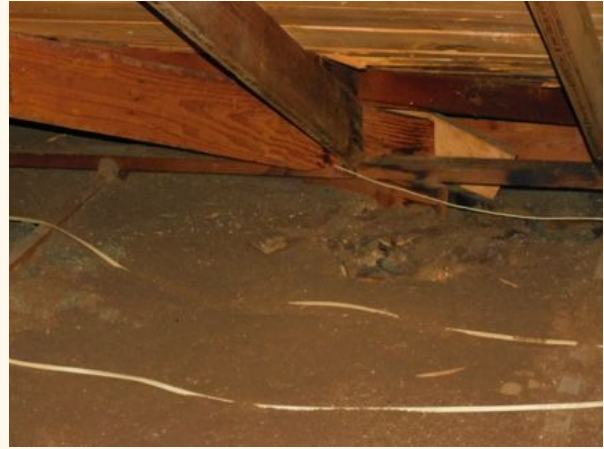
🔍 (A-3) Review: Signs of roof leaks noted in attic.

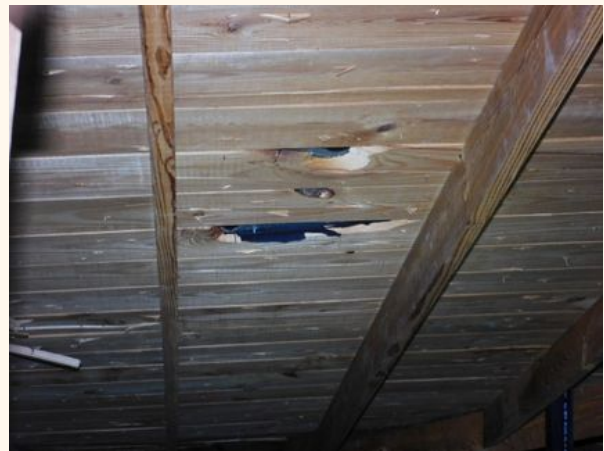
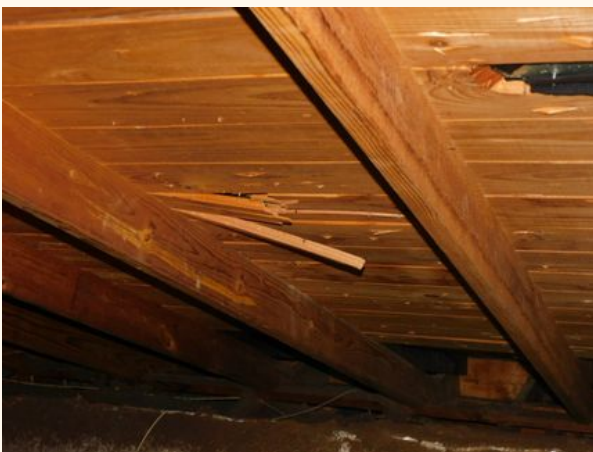
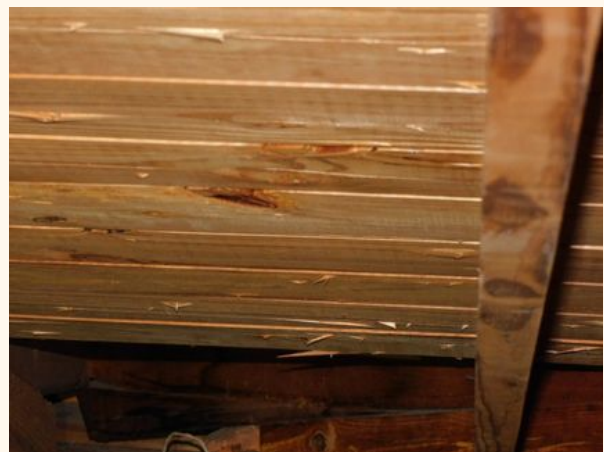
🔧 (A-5) Review: Signs of roof leakage and damage decking.
