Inspection report for the property at
302/306 West Mary, Plain Dealing, LA,

This report is prepared exclusively for **Kattie**
Inspected On: **06-24-2024**

The Professional Real Estate Inspection Report

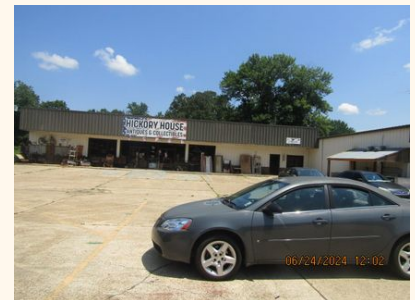
(G-1) Review:

🔧 **G-1 Grounds:** Localized physical damage was noted to the concrete flatwork. Have the builder repair damaged concrete as needed.

Localized physical damage was noted to the concrete flatwork. Have the builder repair damaged concrete as needed.

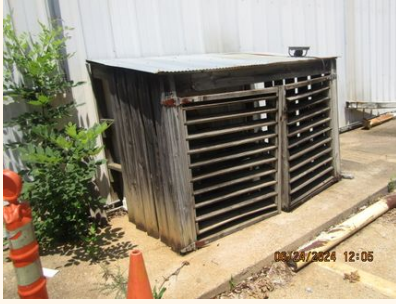
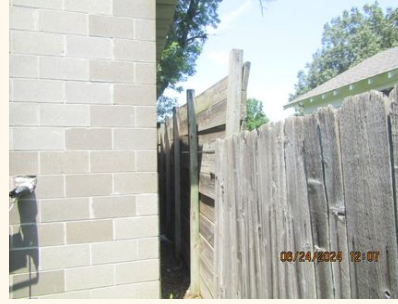
🔧 **G-2 Grounds:** Localized areas of rot and loose and damaged fencing was noted. This is characteristic of older fencing. Implement repairs to the fencing as needed until the fencing is systematically updated. The urgency of this project is subjective. The timing for and scope of repair will depend on how much the occupant wants to have a fence and what they want it for.

(G-2) Review: Localized areas of rot and loose and damaged fencing was noted. This is characteristic of older fencing. Implement repairs to the fencing as needed until the fencing is systematically updated. The urgency of this project is subjective. The timing for and scope of repair will depend on how much the occupant wants to have a fence and what they want it for.

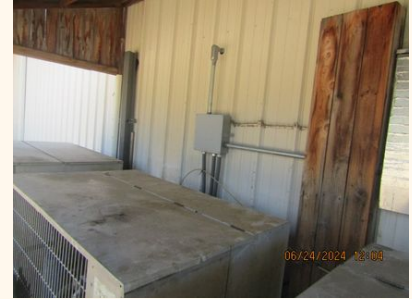
🔧 **ED-1 Exteriors and Decks:** Caulking and sealing around pipes passing through wall recommend.

🔧 (ED-1) Review:
Caulking and sealing around pipes passing through wall recommend.

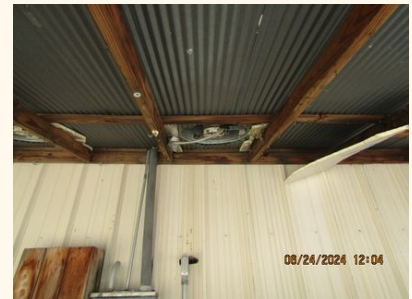
🔧 **ED-2 Exteriors and Decks:** Exterior exhaust fan blades exposed under overhang.

🔧 (ED-2) Review:
Exterior exhaust fan blades exposed under overhang.

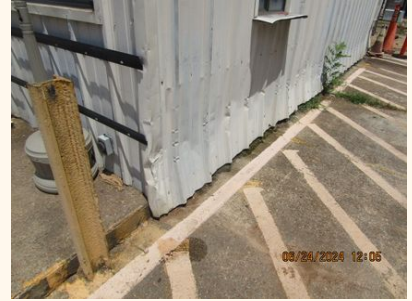
🔧 **ED-3 Exteriors and Decks:** Metal siding damaged.

🔧 (ED-3) Review:
Metal siding damaged.

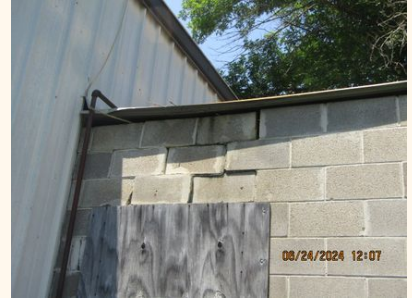
🔧 **ED-4 Exteriors and Decks:** CMU wall damaged / improper and should be reviewed and repaired.

🔧 (ED-4) Review:
CMU wall damaged / improper and should be reviewed and repaired.

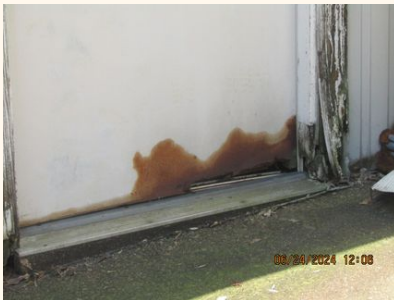
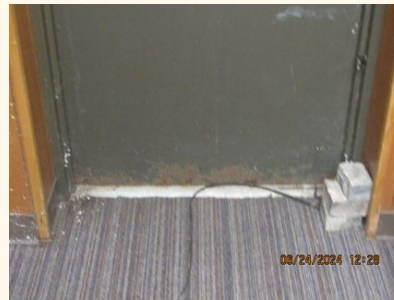
🔧 **ED-5 Exteriors and Decks:** Extensive corrosion was noted at the exterior metal doors. Replacement of all these corroded doors is recommended.

🔧 (ED-5) Review: Extensive corrosion was noted at the exterior metal doors. Replacement of all these corroded doors is recommended.

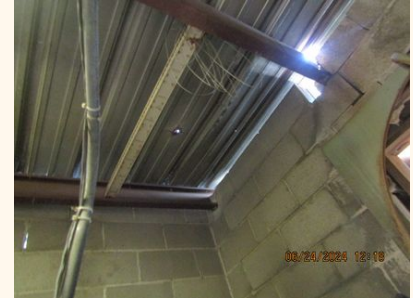
(RCG-1) Review:

🔧 **RCG-1 Roof, Chimney and Gutters:** Roofing panels damaged in various locations.

Roofing panels damaged in various locations.

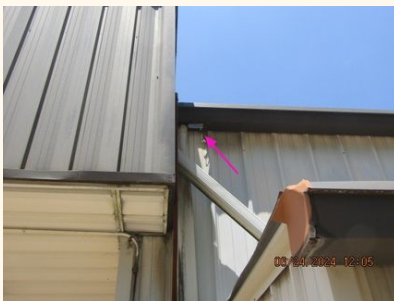
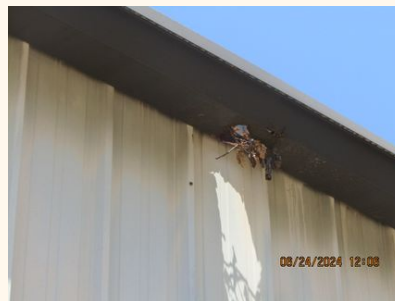
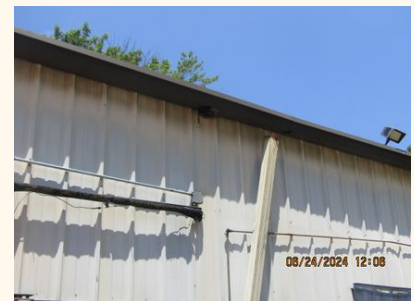
🔧 **RCG-2 Roof, Chimney and Gutters:** Downspouts disconnected or damaged in various locations.

(RCG-2) Review: Downspouts disconnected or damaged in various locations.

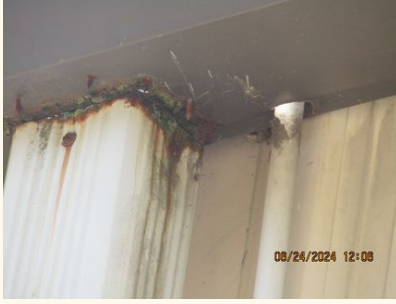
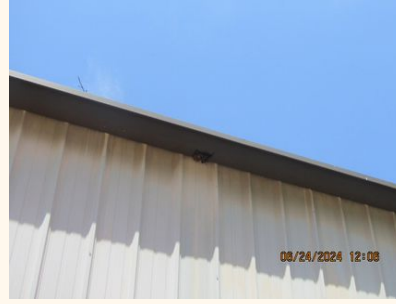
🔧 **RCG-3 Roof, Chimney and Gutters:** Gutters damaged and appear to be leaking.

(RCG-3) Review: Gutters damaged and appear to be leaking.

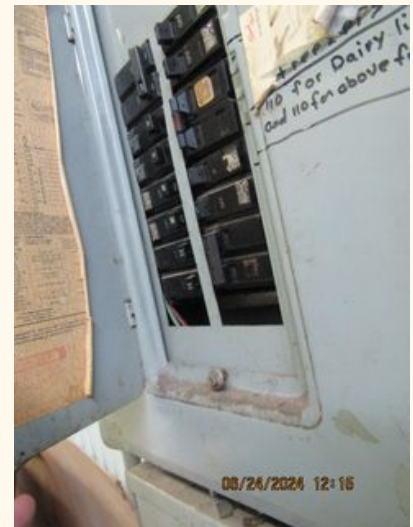
(ES-1) Review:

🔧 **ES-1 Electric Service:** Breaker panel knockouts missing.

Breaker panel knockouts missing.

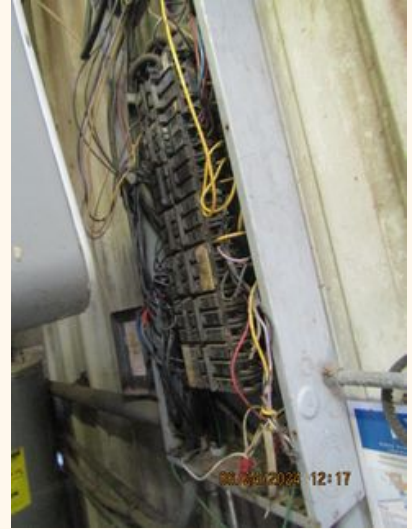
🔧 **ES-2 Electric Service:** Panel cover missing.

🔧 (ES-2) Review:
Panel cover missing.

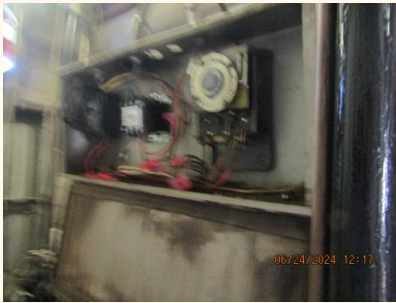
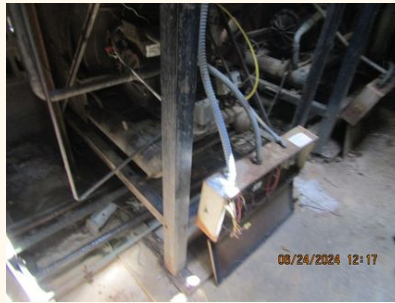
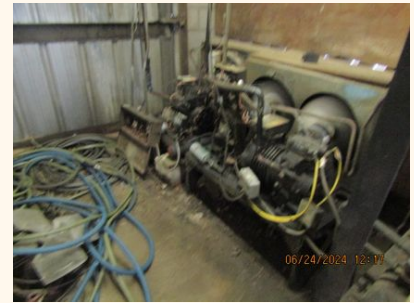
🔧 **ES-3 Electric Service:** Equipment service panel amiss and open.

🔧 (ES-3) Review: Equipment service panel amiss and open.

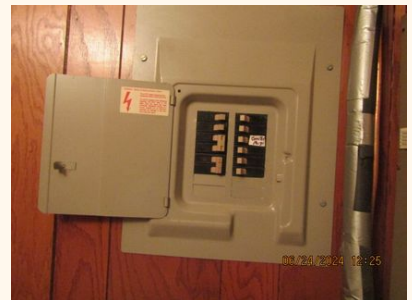
🔧 **ES-4 Electric Service:** Unit missing a main breaker.

🔧 (ES-4) Review:
Unit missing a main breaker.

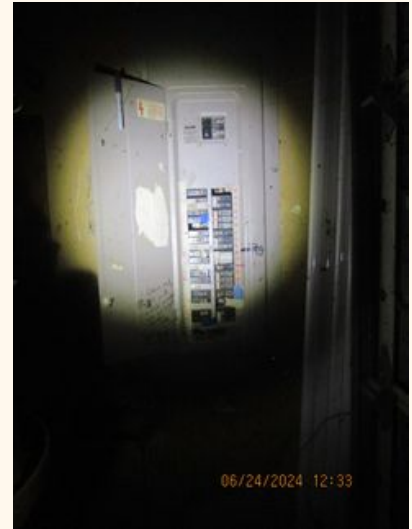
🔑 (ES-5) Review:

🔧 **ES-5 Electric Service:** Panel labeling incomplete.

Panel labeling incomplete.

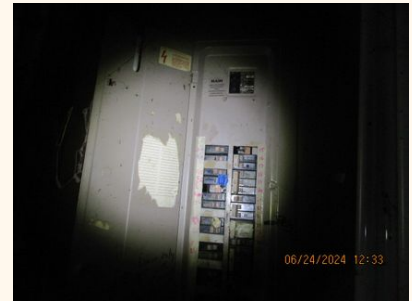
🔑 (ES-6) Review:

🔧 **ES-6 Electric Service:** Breaker panel cover knockout missing.

Breaker panel cover knockout missing.

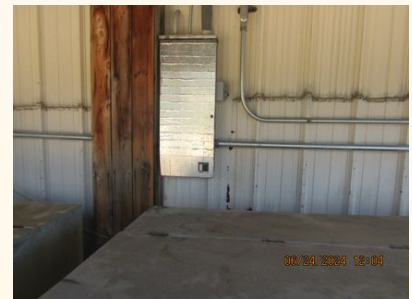
🔑 (ES-7) Review:

🔧 **ES-7 Electric Service:** Sub panel cover damaged and panel clearance questionable.

Sub panel cover damaged and panel clearance questionable.

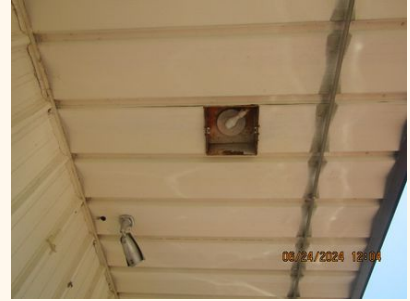
🔧 **EDFW-1 Electric Distribution and Finish Wiring:** Exterior light covers missing.

🔧 (EDFW-1) Review:
Exterior light covers missing.

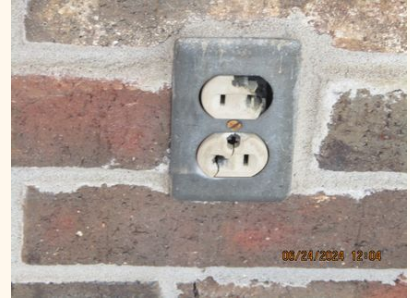
🔧 **EDFW-2 Electric Distribution and Finish Wiring:** Exterior outlet damaged and missing proper cover.

🔧 (EDFW-2) Review:
Exterior outlet damaged and missing proper cover.

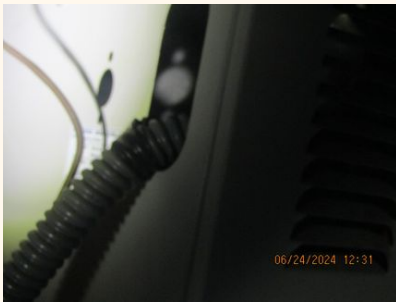
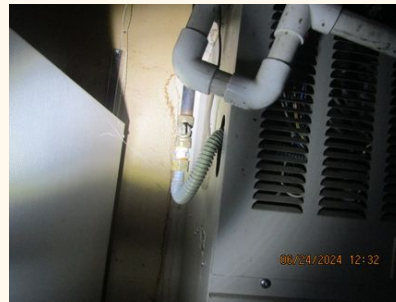
🔧 **HCFV-1 Heating, Cooling, Fireplaces and Ventilation:** Flex gas line passes through hard metal cabinet without protection.

🔧 (HCFV-1) Review: Flex gas line passes through hard metal cabinet without protection.

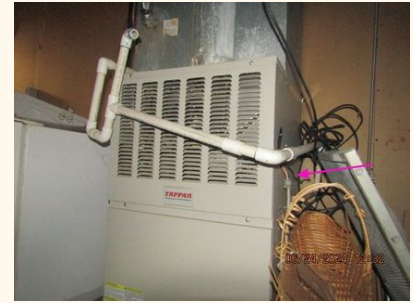
🔧 **HCFV-2 Heating, Cooling, Fireplaces and Ventilation:** Electrical to heating unit improper.

🔧 (HCFV-2) Review:
Electrical to heating unit improper.

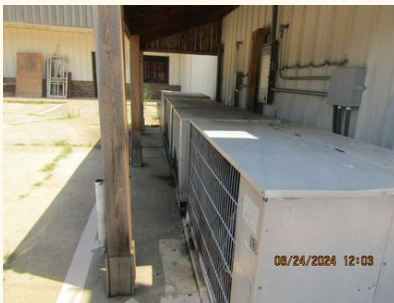
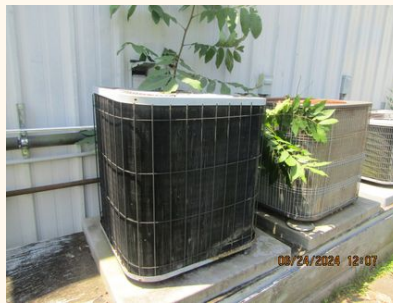
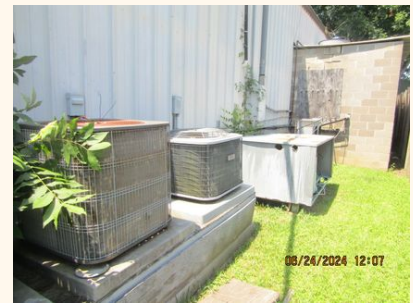
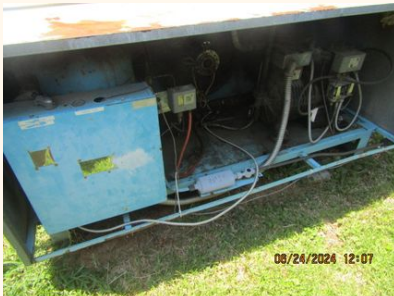
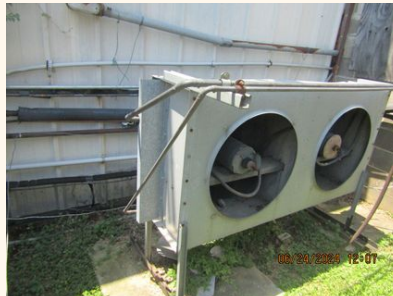
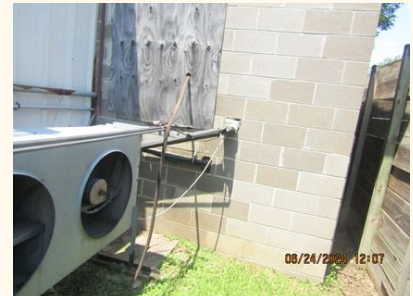
🔧 **HCFV-3 Heating, Cooling, Fireplaces and Ventilation:** Condensers appear to need servicing.

🔧 (HCFV-3) Review: Condensers appear to need servicing.

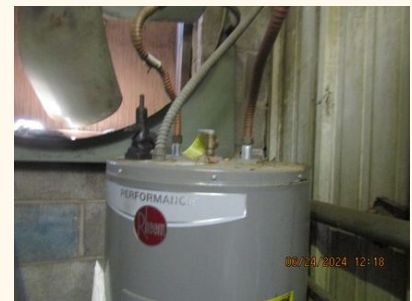
⚠ (P-3) Review:

🔧 **P-3 Plumbing:** The discharge tube for the water heater [temperature and pressure relief valve](#) (TPRV) is not correctly installed - see attached link. This is a potential safety hazard. Ideally, the discharge tube for a relief valve:

The discharge tube for the water heater [temperature and pressure relief valve](#) (TPRV) is not correctly installed - see attached link. This is a potential safety hazard. Ideally, the discharge tube for a relief valve:

- Terminates to an exterior location or above a drain, though this is not always possible
- Terminates between 6 and 24-inches off the ground (UPC)
- Slopes to drain to prevent water pooling inside the discharge tube
- Is not made from pipe with an inside diameter less than 3/4 on an inch
- Terminates to a visible location that can be monitored for

leaks and discharges

- Does not have a threaded termination point which would prevent accidental capping of this important discharge
- Does not terminate into a drain pan

I recommend having this relief valve discharge tube further investigated and repaired as recommended by a licensed plumber.

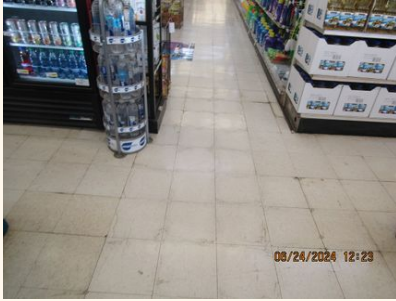
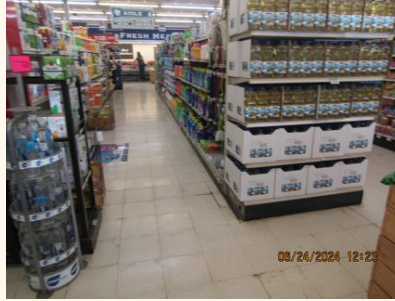
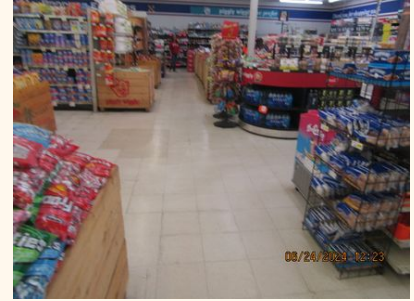
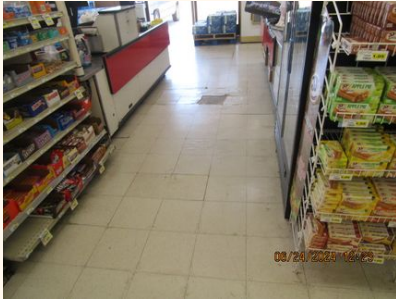
🔧 **I-2 Interior:** Floor tiles showing signs of wear and damage.

**(I-2) Review:** Floor tiles showing signs of wear and damage.

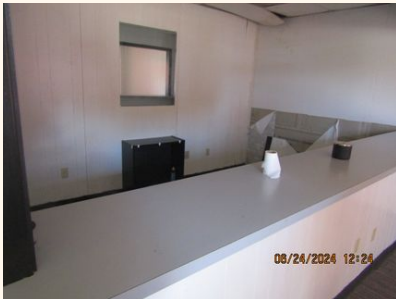
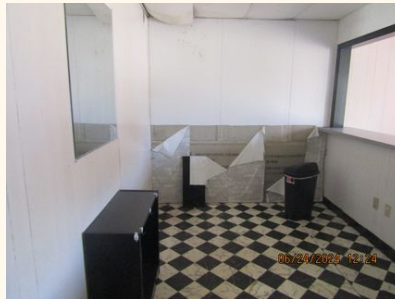
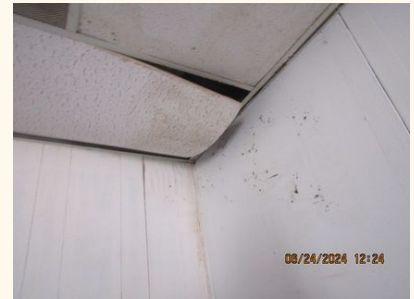
🔧 **I-3 Interior:** Ceiling tiles loose and hanging.

(I-3) Review: Ceiling tiles loose and hanging.

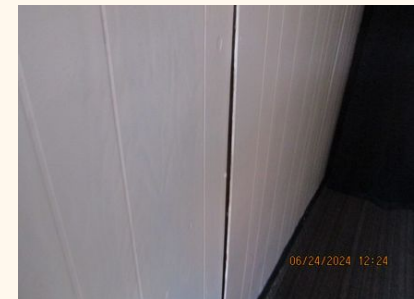
🔧 **I-4 Interior:** Paneling appear to be loose.

(I-4) Review:
Paneling appear to be loose.

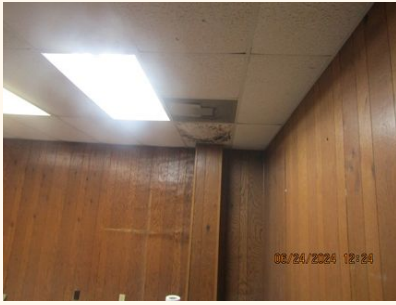
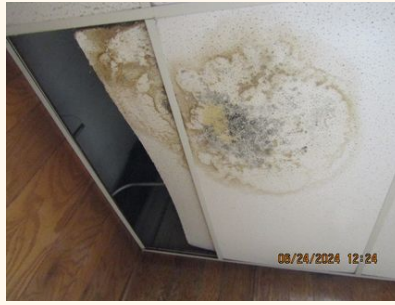
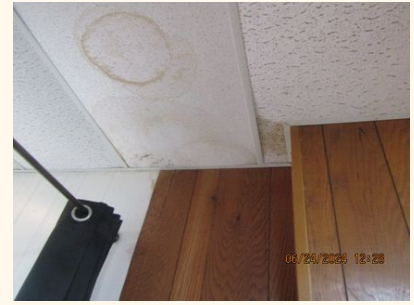
🔧 **I-5 Interior:** Ceiling showing signs of water leakage.

(I-5) Review: Ceiling showing signs of water leakage.

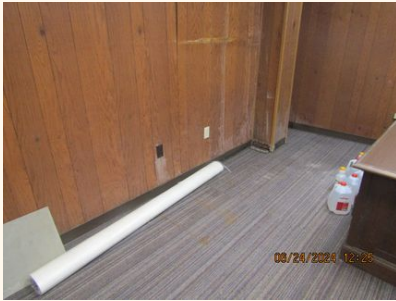
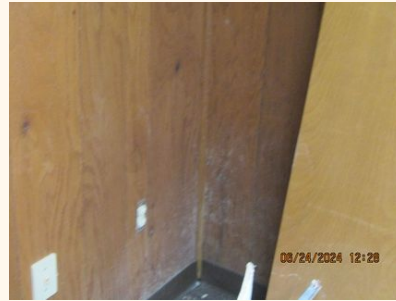
🔧 **I-6 Interior:** Wood paneling showing signs of possible water damaged and suspected mold.

(I-6) Review: Wood paneling showing signs of possible water damaged and suspected mold.

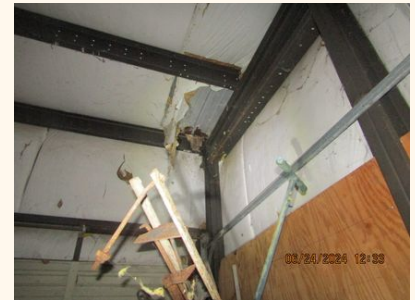
🔧 **I-7 Interior:** Visible signs of roof leakage and damage.

(I-7) Review:
Visible signs of roof leakage and damage.

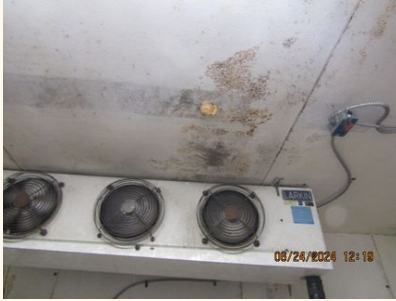
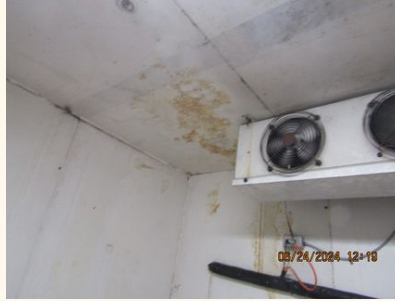
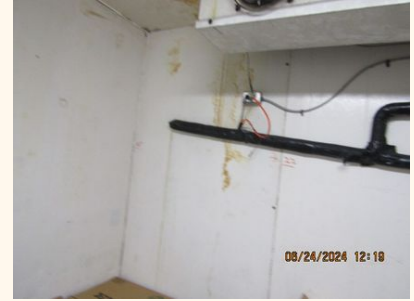
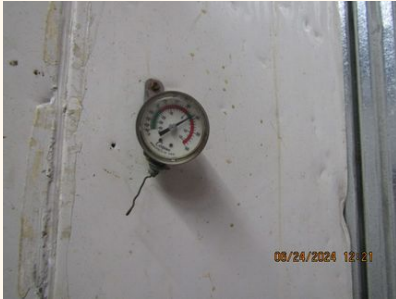
🔧 **K-1 Kitchen:** Walk in coolers showing signs of rusting and blowers needing servicing.

(K-1) Review: Walk in coolers showing signs of rusting and blowers needing servicing.

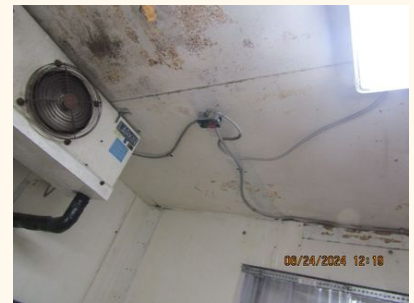
🔧 (K-2) Review:

🔧 **K-2 Kitchen:** Open electrical junction boxes noted in walk in coolers.

Open electrical junction boxes noted in walk in coolers.

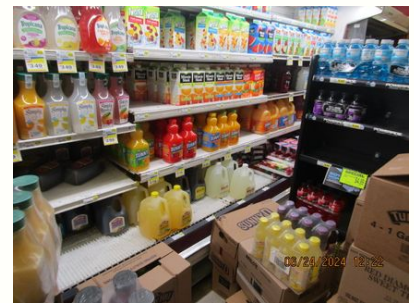
🌟 (K-3) Note:

Display coolers appear to be functional at the time of the inspection.

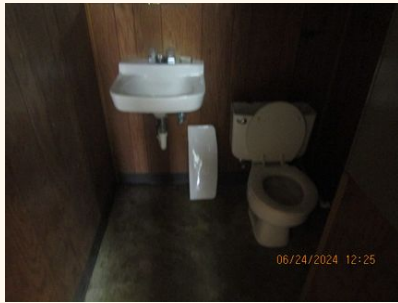
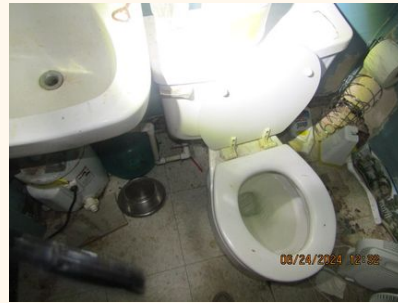
🔧 **B-1 Bathrooms:** The toilet in the master bath has not been caulked to the floor. Caulking the toilet to the floor is recommended and even required though opinions on this can vary. I prefer caulking the toilet to the floor, but leaving a gap on the back of the toilet that remains un-caulked so if the toilet leaks, water has an escape route. The biggest risk of not caulking the toilet to the floor is that the toilet can become loose which is the biggest problem here. Repair as recommended by a licensed plumber.

🔧 (B-1) Review: The toilet in the master bath has not been caulked to the floor. Caulking the toilet to the floor is recommended and even required though opinions on this can vary. I prefer caulking the toilet to the floor, but leaving a gap on the back of the toilet that remains un-caulked so if the toilet leaks, water has an escape route. The biggest risk of not caulking the toilet to the floor is that the toilet can become loose which is the biggest problem here. Repair as recommended by a licensed plumber.

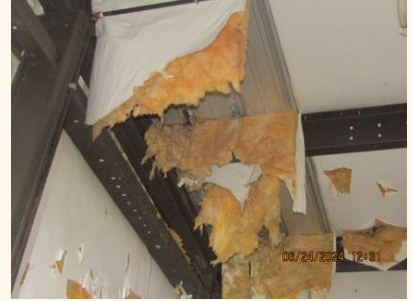
🔑 (SB-1) Review:

🔧 **SB-1 Structure and Basement:** insulation damaged in various locations.

insulation damaged in various locations.
