Inspection report for the property at
3212 White Street, Monroe, LA 7120

This report is prepared exclusively for **Elvrin Worthey**
Inspected On: **2023-10-17**

QED Service
318-376-0482

Michael Burroughs , LA State License #LHI
10044, ASHI 202398

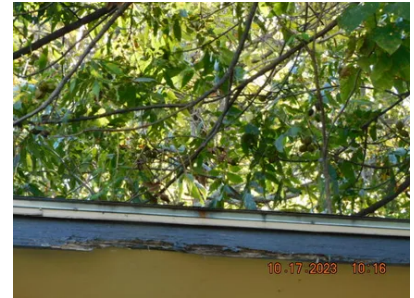
(G-1) Recommended Preventive Maintenance:

Pruning trees, branches and vegetation away from the house is recommended. Where trees, branches and large shrubs can provide rodent access to the roof, a minimum 6-foot clearance is recommended as many rodents can jump 6-feet. All vegetation, including smaller landscaping such as grasses, flowers and shrubs should be kept 1-foot off the house to eliminate contact which could trap moisture against the building.

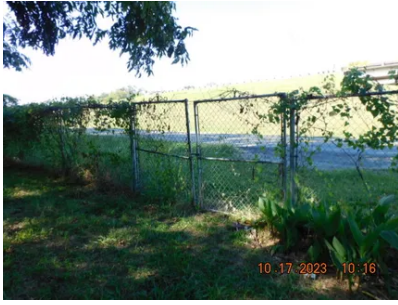
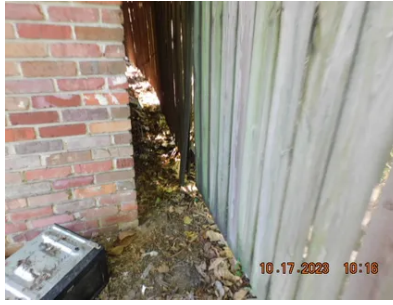
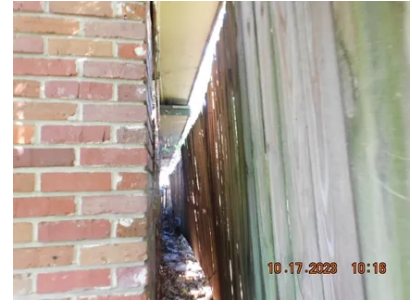
🔧 **G-3 Grounds:** The gates for the fencing are sagging and require adjustment / repair for proper operation.

(G-2) **Review:** Localized areas of rot and loose and damaged fencing was noted. This is characteristic of older fencing. Implement repairs to the fencing as needed until the fencing is systematically updated. The urgency of this project is subjective. The timing for and scope of repair will depend on how much the occupant wants to have a fence and what they want it for.

🔑 (G-3) Review: The gates for the fencing are sagging and require adjustment / repair for proper operation.

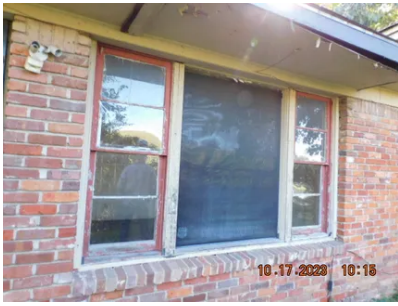
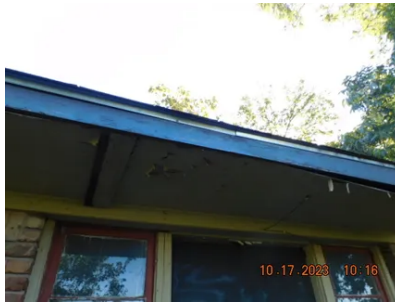
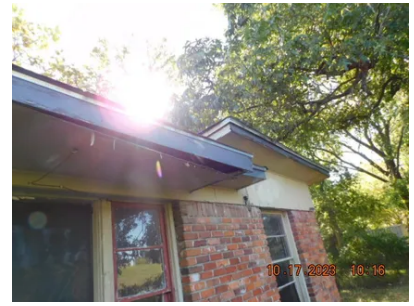
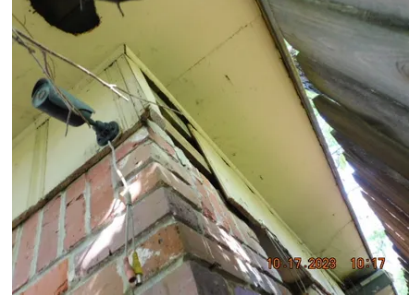
🔧 **ED-2 Exteriors and Decks:** Siding damaged or loose in numerous locations.

🔑 (ED-2) Review: Siding damaged or loose in numerous locations.

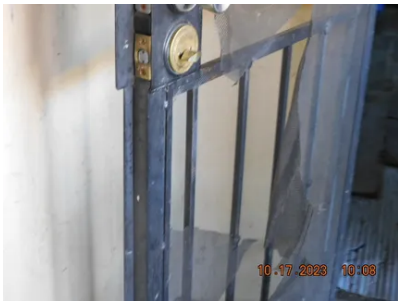
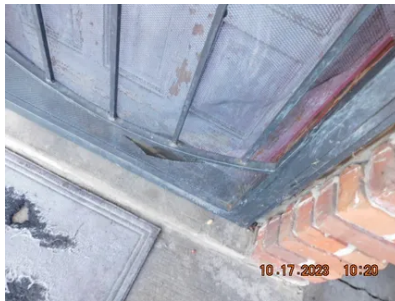
🔧 **ED-3 Exteriors and Decks:** Security door damaged. Refer to line 1690 of the Uniform Building Inspection Report Binder.

🔧 (ED-3) Review: Security door damaged. Refer to line 1690 of the Uniform Building Inspection Report Binder.

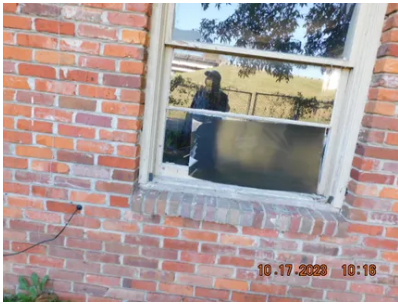
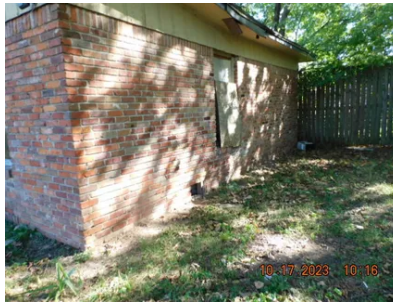
🔧 **ED-4 Exteriors and Decks:** Windows damaged in various locations.

🔧 (ED-4) Review: Windows damaged in various locations.

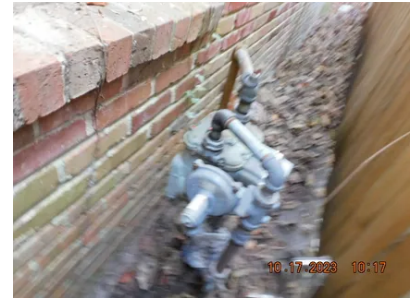
📍 (FSD-1) Note:

Gas is off to home and was turned on for the inspection only. Gas company leak tested system and found no leaks at the time of the inspection. Gas fired equipment operated within limits. Gas was turned off by gas company.

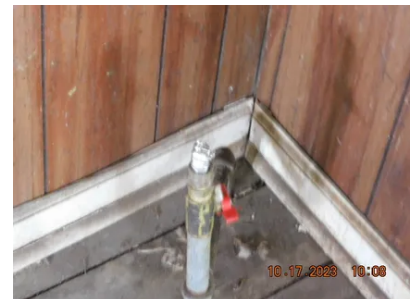
🔧 **FSD-2 Fuel Storage and Distribution:** Flex gas line pipe cut / damaged noted at stove location. Refer to line 4380 of the Uniform Building Inspection Report Binder.

🔧 (FSD-2) Review:

Flex gas line pipe cut / damaged noted at stove location. Refer to line 4380 of the Uniform Building Inspection Report Binder.

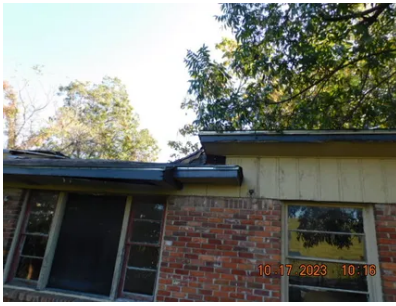
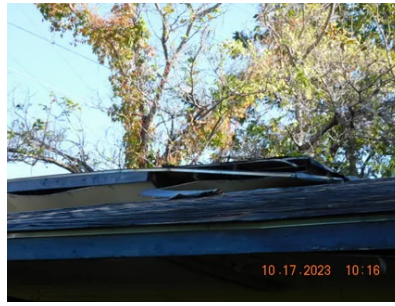
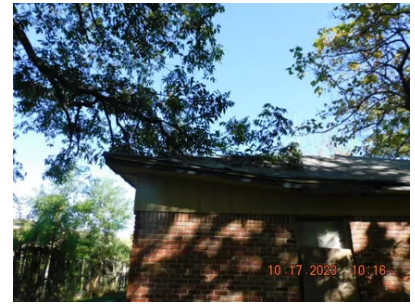
🔧 **RCG-1 Roof, Chimney and Gutters:** /Roof damaged and needs review in numerous locations.

**(RCG-1) Review:** /Roof damaged and needs review in numerous locations.

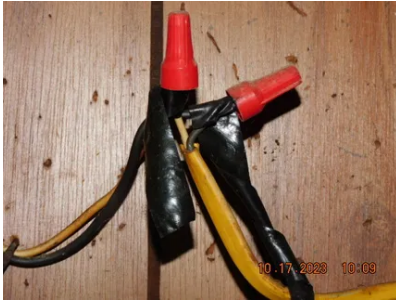
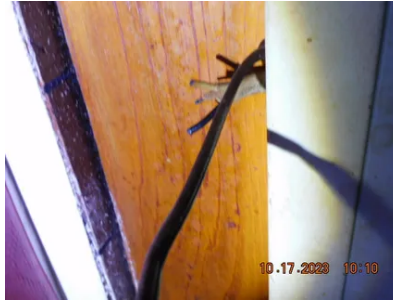
🔧 **EDFW-1 Electric Distribution and Finish Wiring:** Overall, numerous defects and red flags were noted in the wiring system indicating old, unreliable and incomplete wiring practices. I recommend additional inspection and repair of the entire wiring system by a licensed electrical contractor as additional repairs could be needed that are latent or concealed. **This should be considered urgent for safety reasons.** Examples of observations and defects found during inspection are included in the Electric chapter as repair items and also include:

- **Running splices noted.** This is when wires are spliced together and left exposed. Splicing should be done inside of junction boxes.
- **Inadequate cable support:** The non-metallic sheathed cable is poorly supported and requires staples or hangers for additional support and strain relief. This type of wiring should be supported every 4 feet and within 2 feet of junction boxes. Where cable less than #8 is run on the bottoms of floor joists, 1x4 running boards should be used to support the cable.
- **Physically damaged wiring** cable was noted. This can indicate a potentially unsafe condition with the wiring.
- **Surface-run cable wiring** was noted. Exposed non-metallic sheathed cable requires protection from physical damage. Protection methods can include specific conduit material or raceways. This is a potential safety issue.

- *A cable to plug connection* was noted on the non-metallic sheathed cable wiring. This wiring is designed to be hard-wired with terminations inside listed junction boxes. The wiring should be repaired to eliminate this configuration.

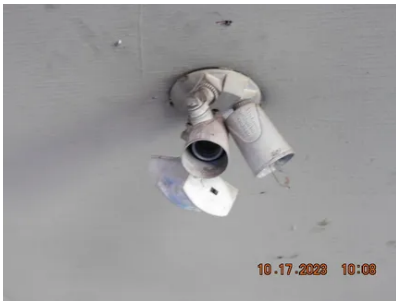
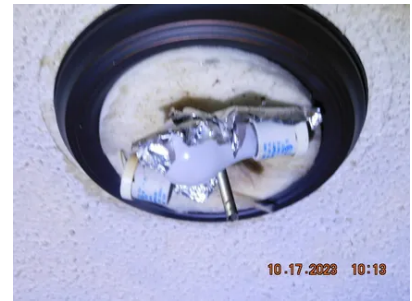
🔧 **EDFW-2 Electric Distribution and Finish Wiring:** Light fixtures damaged in various locations. Photo is only examples. Refer to line 5650 of the Uniform Building Inspection Report Binder.

🔍 (EDFW-2) Review: Light fixtures damaged in various locations. Photo is only examples. Refer to line 5650 of the Uniform Building Inspection Report Binder.

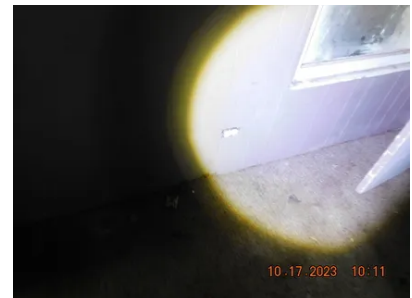
🔧 **EDFW-3 Electric Distribution and Finish Wiring:** Electrical outlets damaged in various locations and missing covers. Refers to lines 5650 & 5640 of the Uniform Building Inspection Report Binder.

🔍 (EDFW-3) Review: Electrical outlets damaged in various locations and missing covers. Refers to lines 5650 & 5640 of the Uniform Building Inspection Report Binder.

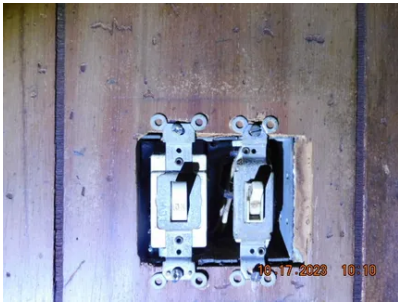
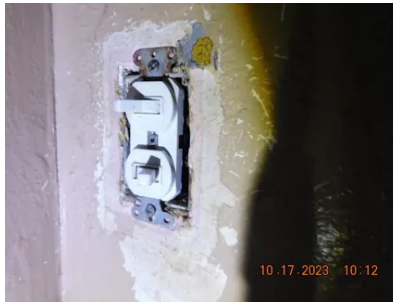
🔧 **EDFW-4 Electric Distribution and Finish Wiring:** The missing cover plates to electric receptacles, switches and junction boxes should be installed to cover all access to wiring at switches and receptacles. Where switches, receptacles or junction boxes are positioned below wall or ceiling or cabinet finishes, an extension ring may be needed. Refer to 5640 of the Uniform Building Inspection Report Binder.

🔍 (EDFW-4) Review: The missing cover plates to electric receptacles, switches and junction boxes should be installed to cover all access to wiring at switches and receptacles. Where switches, receptacles or junction boxes are positioned below wall or ceiling or cabinet finishes, an extension ring may be needed. Refer to 5640 of the Uniform Building Inspection Report Binder.

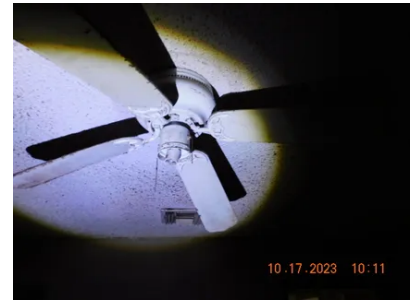
🔧 **EDFW-5 Electric Distribution and Finish Wiring:** Ceiling fan missing parts and could not be tested due to no power supplied to home. Refer to lines 5850 & 7860 of the Uniform Building Inspection Report Binder.

(EDFW-5) Review:

Ceiling fan missing parts and could not be tested due to no power supplied to home. Refer to lines 5850 & 7860 of the Uniform Building Inspection Report Binder.

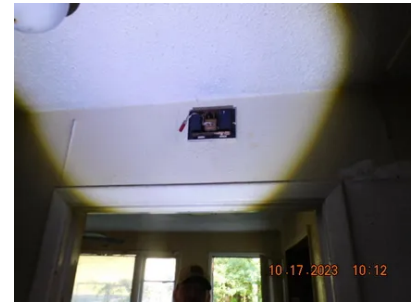
✦ (EDFW-7) Note:

Door bell controller appears to be missing parts. Refer to line 5800 of the Uniform Building Inspection Report Binder.

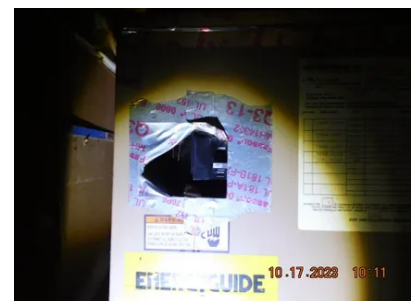
🔧 **HCFV-1 Heating, Cooling, Fireplaces and Ventilation:** Excessive gap noted at heating unit breaker exposing wiring. Refer to line 2020 of the Uniform Building Inspection Report Binder.

🔧 (HCFV-1) Review:

Excessive gap noted at heating unit breaker exposing wiring. Refer to line 2020 of the Uniform Building Inspection Report Binder.

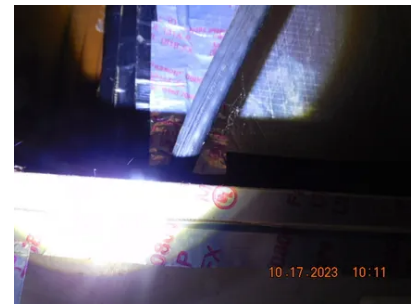
🔧 **HCFV-2 Heating, Cooling, Fireplaces and Ventilation:** Electrical supply improper at heating unit. Refer to line 2010 of the Uniform Building Inspection Report Binder.

🔧 (HCFV-2) Review:

Electrical supply improper at heating unit. Refer to line 2010 of the Uniform Building Inspection Report Binder.

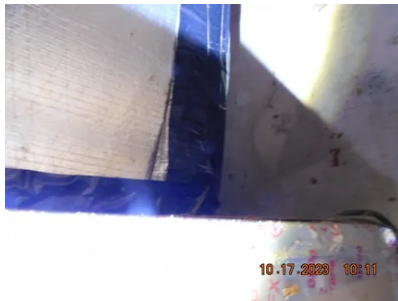
🔧 **HCFV-3 Heating, Cooling, Fireplaces and Ventilation:** Suspect Mold observed in heating unit closet. No testing was done by inspector to confirm the present of actual mold. Testing is recommend. Refer to line 2850 of the Uniform Building Inspection Report Binder.

🔍 (HCFV-3) Review: Suspect Mold observed in heating unit closet. No testing was done by inspector to confirm the present of actual mold. Testing is recommend. Refer to line 2850 of the Uniform Building Inspection Report Binder.

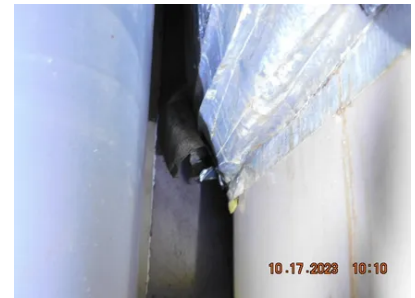
🔧 **HCFV-5 Heating, Cooling, Fireplaces and Ventilation:** Tape joints coming loose on unit causing air leaks. Refer to line 2230 of the Uniform Building Inspection Report Binder.

🔑 (HCFV-5) Review:

Tape joints coming loose on unit causing air leaks. Refer to line 2230 of the Uniform Building Inspection Report Binder.

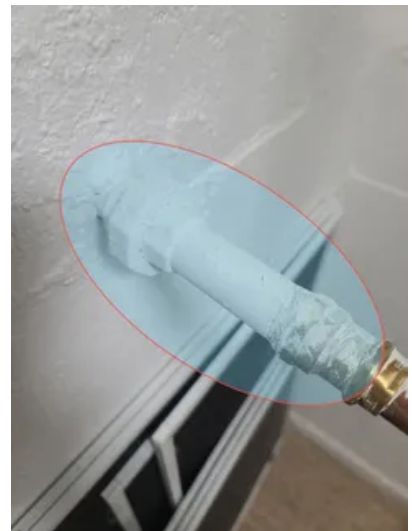
It looks as though the main water pipe to the house is older galvanized steel.

- *Please also note that when updating older metal pipes, there is a risk of disabling important grounding systems for your electrical service. During updates to older metal pipes, consider having your electrical grounding and bonding systems further investigated and repaired as recommended by a licensed electrical contractor.*

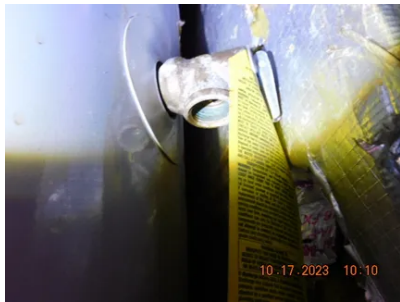
- Terminates to an exterior location or above a drain, though this is not always possible
- Terminates between 6 and 24-inches off the ground (UPC)
- Slopes to drain to prevent water pooling inside the discharge tube
- Is not made from pipe with an inside diameter less than 3/4 on an inch
- Terminates to a visible location that can be monitored for leaks and discharges
- Does not have a threaded termination point which would prevent accidental capping of this important discharge
- Does not terminate into a drain pan
- Does not have a drain pan under unit

🔧 **(P-8) Review:** The discharge tube for the water heater relief valve is installed too high off the ground and into a sink. Discharge tubes should always terminate by pointing toward the ground to eliminate a scald hazard and should be no more than 6" off the ground. Ideally, the discharge tube terminates to an exterior or unfinished location or above a drain, though this is not always possible. The drain should also slope to drain to prevent water pooling inside the discharge tube and should be visible so it can be monitored. The end of the tube should not be threaded to prevent accidental capping of this important discharge. have this further investigated and repaired as recommended by a qualified plumber.

I recommend having this relief valve discharge tube further investigated and repaired as recommended by a licensed plumber.

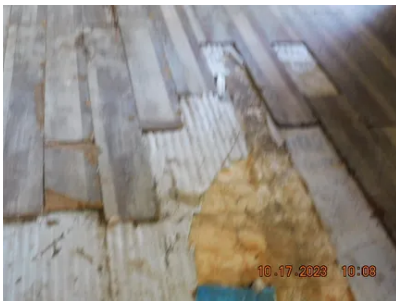
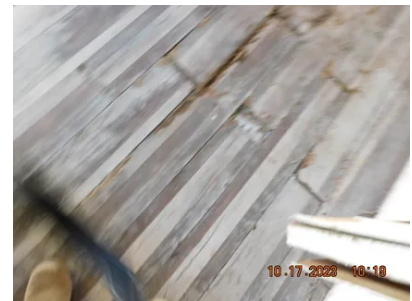
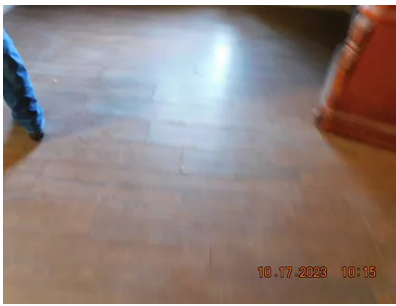
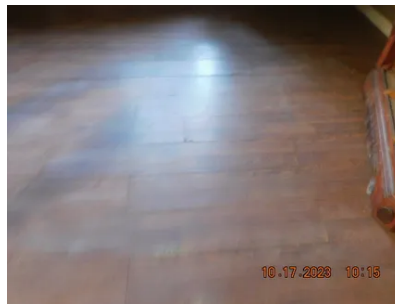
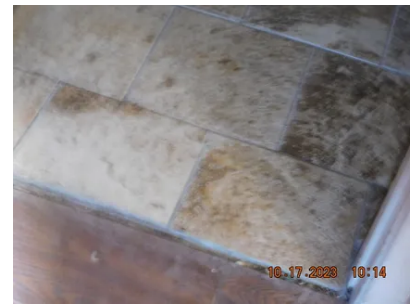
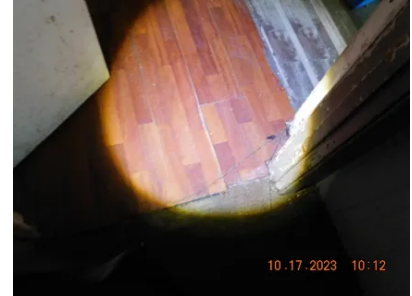
🔑 **(I-1) Review:** Interior flooring damaged and missing in numerous locations in the home. Refer to line 7200 & 7250 of the Uniform Building Inspection Report Binder.

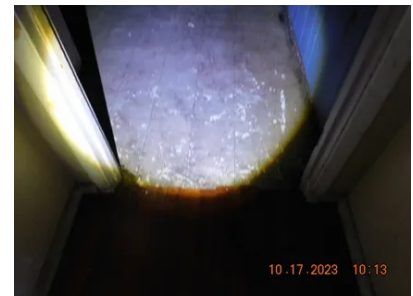
(I-3) Review:

Possible asbestos flooring noted in bedrooms. No testing was done by Inspector to confirm the actual presence of the product. Refer to line 7950 of the Uniform Building Inspection Report Binder.

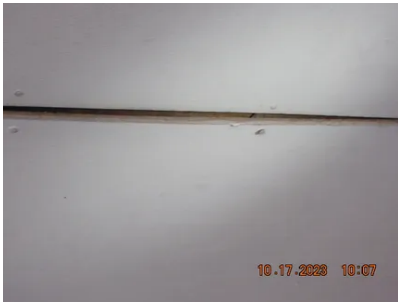
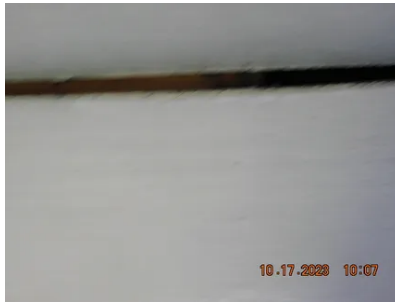
(I-4) Review: Walls and ceiling gapping. Refer to line 7040 of the Uniform Building Inspection Report Binder.

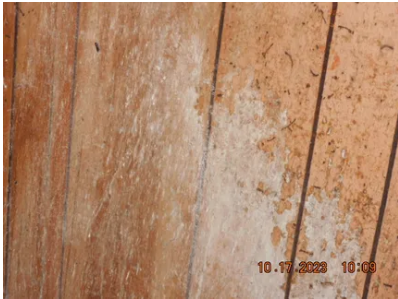
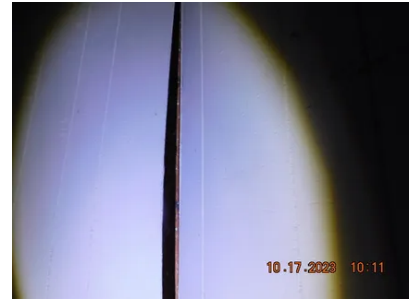
(I-5) Review: Wall paneling damaged in numerous locations in the home. Refer to line 7060 of the Uniform Building Inspection Report Binder.

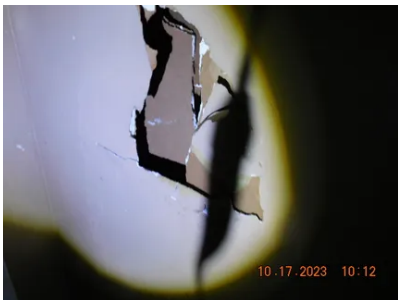
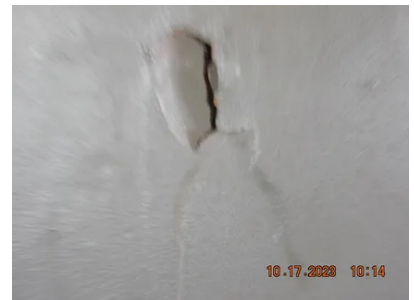
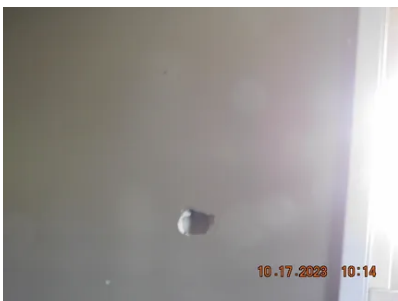
(I-6) Review: Interior walls damaged in numerous locations. Refer to line 7040 of the Uniform Building Inspection Report Binder.

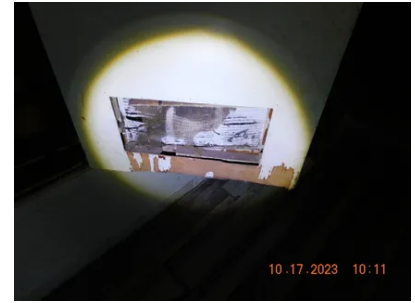
(I-7) Review:

HVAC closet doors damaged. Refer to line 7330 of the Uniform Building Inspection Report Binder.

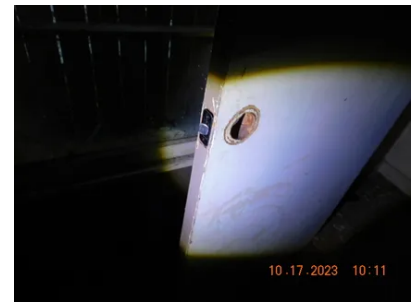
(I-8) Review:

Interior door locks missing in various locations. Refer to line 7420 of the Uniform Building Inspection Report Binder.

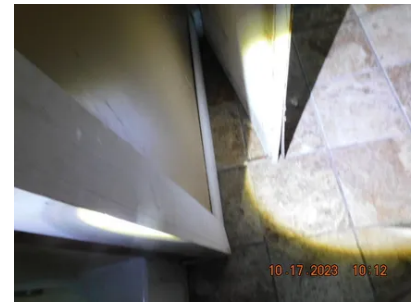
(I-9) Review:

Interior door damaged in numerous locations. Refer to line 7330 of the Uniform Building Inspection Report Binder.

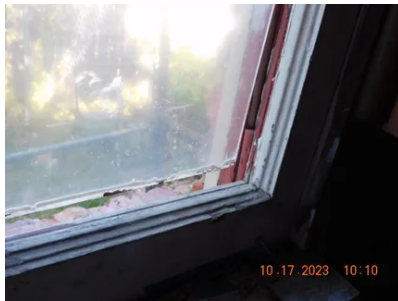
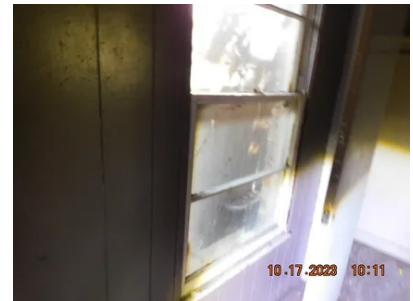
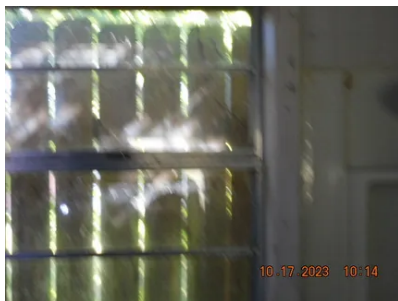
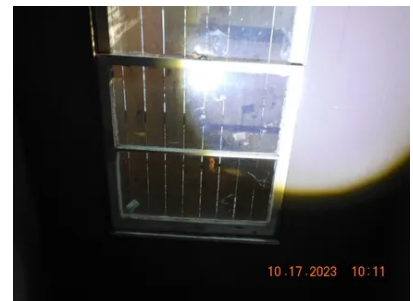
⚠️ **I-10 Interior:** All of the windows in this home are old windows that require maintenance and repair. You need to decide how you want to approach the windows in this home as they are generally older and do not comply with modern standards for safety glass and energy efficiency. Repairs can be made on an as needed basis and efficiency can be added with storm windows and curtains. Existing windows that have character are often worth preserving and restoring, where windows that are in worse condition and have less character may be good candidates for replacement. The windows are in poor condition for age and type.

Examples of observations noted during inspection include:

- *Some windows in the home are not operating* and may be painted shut.
- *Glazing is missing from some of the windows* - this is used to secure the window pane to the wood frame of the window
- *Many of the windows are single pane glass* - these older windows do not comply with modern energy efficiency standards
- **Windows are showing signs of leakage and moisture control problems.**
- *Loose window hardware* was noted
- *Missing window hardware* was noted
- *Cracked panes of glass were noted* - glass replacement is needed in these windows.
- *Gaps were noted in windows* that can allow excessive air into the house.

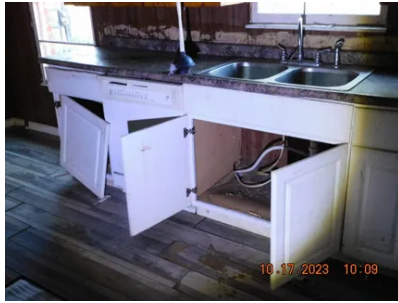
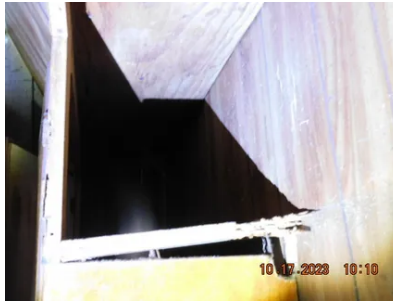
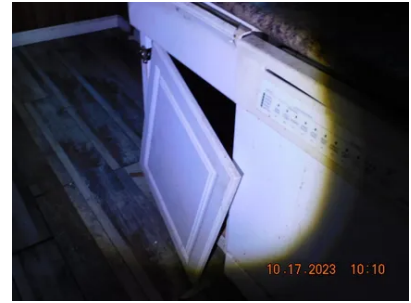
🔧 (K-1) Review: Tune-up repairs are needed to the kitchen cabinets. Repair as desired. Examples of observations noted during inspection include:

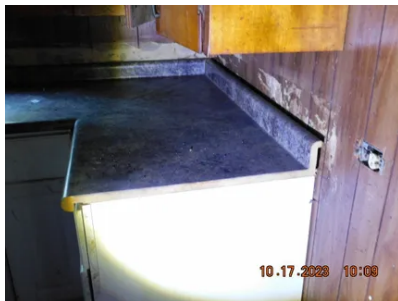
🔧 (K-2) Review: Cabinet countertop damaged and not secured. Refer to line 8810 of the Uniform Building Inspection Report Binder.

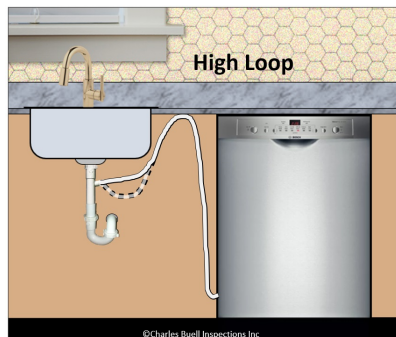
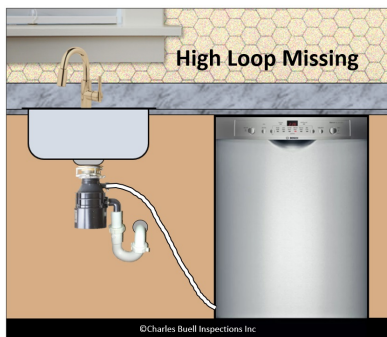
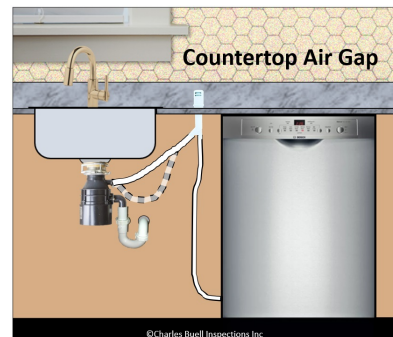
🔑 (K-4) Review: An **air gap** is recommended to protect the dishwasher from accidental contamination if the sewer line were to back up. If an air gap cannot be installed, at least run the drain line above the level of the sink drain to create a high loop. This was an older way of protecting the dishwasher. Hire a licensed plumber to install an air gap.

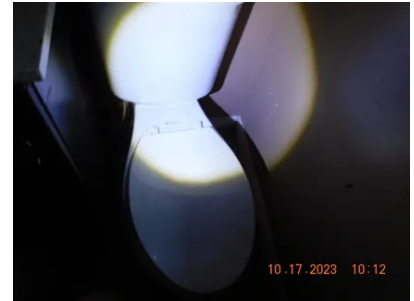
(B-2) Review:

Commode loose on flooring. Refer to line 6200 of the Uniform Building Inspection Report Binder.

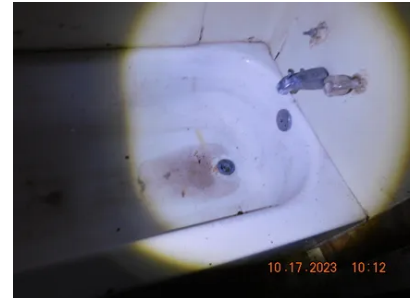
(B-3) Review:

Tub finish damaged. Refer to line 6080 of the Uniform Building Inspection Report Binder.

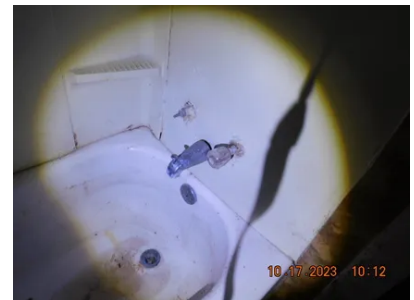
(B-4) Review:

Tub valve damaged and missing parts. Refer to 6190 of the Uniform Building Inspection Report Binder.

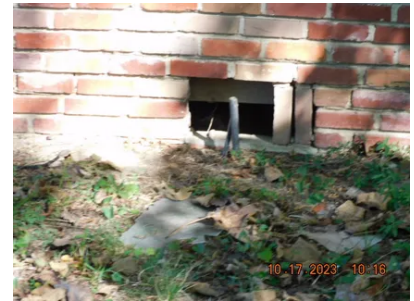
📍 (CS-1) Note:

Crawl space too low to enter - inspected by viewing through vent openings. Vent coverings missing.

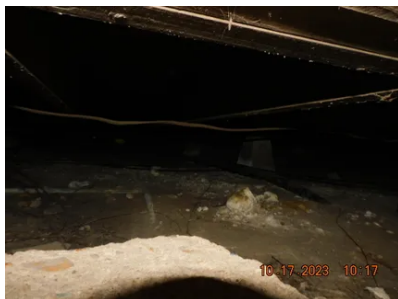
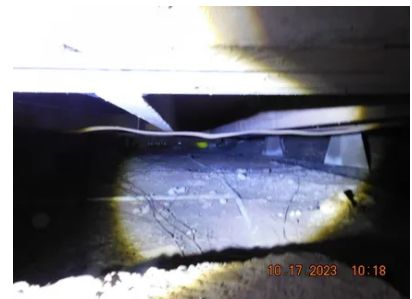
🔧 (CS-2) Review: No vapor barrier has been installed on the soils of this crawl space to contain the moisture in the ground. This is a conducive pest condition and can lead to high moisture conditions. Install a 6 mil. black plastic vapor barrier to cover all exposed earth.

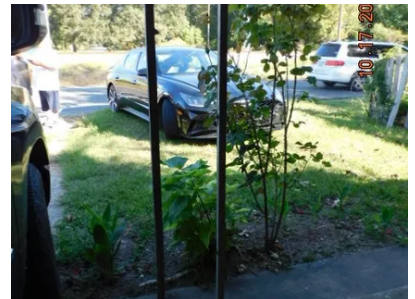
**(SB-1) Review:**
Carport post damaged.
