Inspection report for the property at
505 East Union, Minden, LA

This report is prepared exclusively for **Southern Meat Market**
Inspected On: **06-25-2024**

The Professional Real Estate Inspection Report

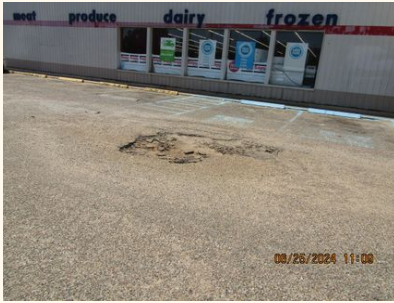
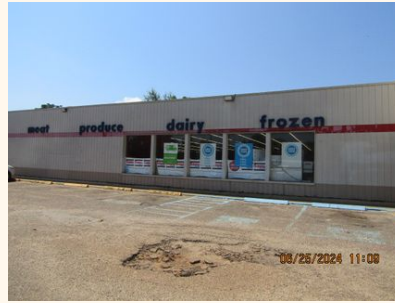
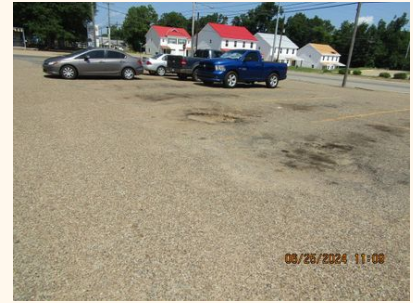
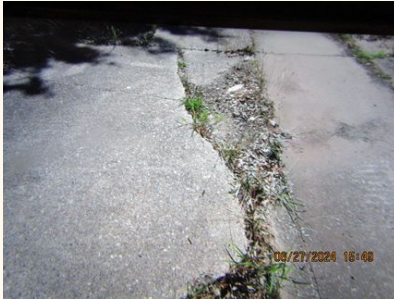
- 🔧 **G-3 Grounds:** Asphalt parking lot damaged in various locations.
- 🔧 **G-4 Grounds:** Concrete flatwork damaged, cracked.
- 🔧 **ED-1 Exteriors and Decks:** Signs of excessive moisture runoff down siding at sign.

(G-3) Review: Asphalt parking lot damaged in various locations.

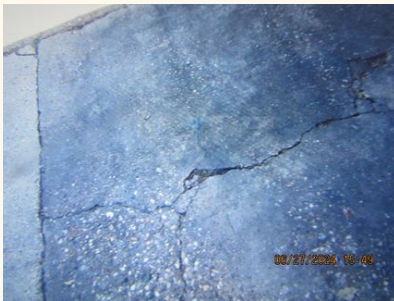
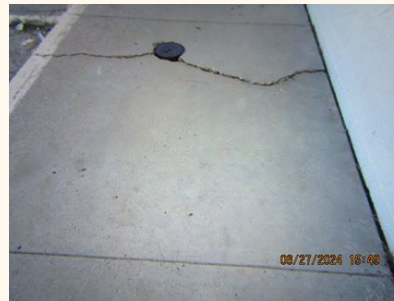
(G-4) Review: Concrete flatwork damaged, cracked.

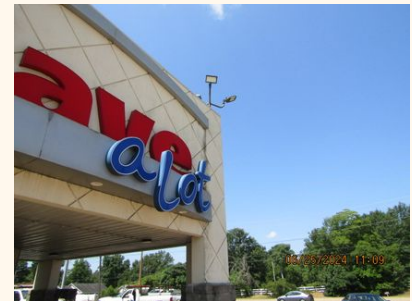
(ED-1) Review:

Signs of excessive moisture runoff down siding at sign.

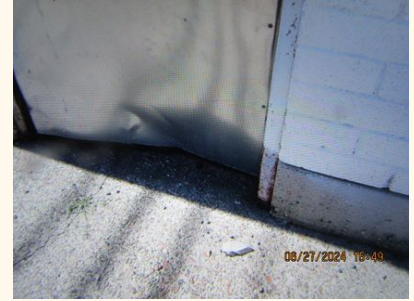
(ED-2) Review:

Exterior doors damaged.

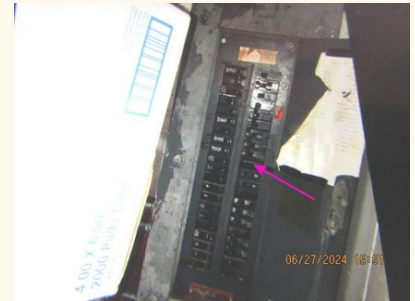
(ES-1) Review:

Breaker knock outs plates missing exposing main bus bar.

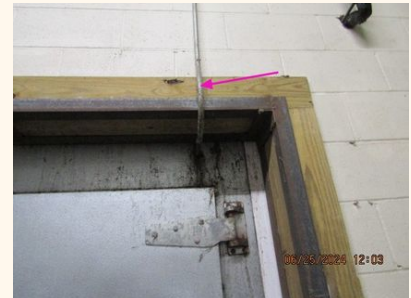
🔍 (EDFW-1) Review:

Wire exposed in warehouse area near coolers

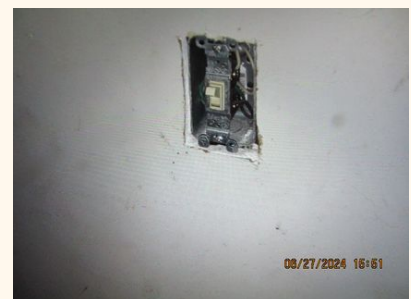
🔍 (EDFW-2) Review:

Light switch plates missing in various locations.

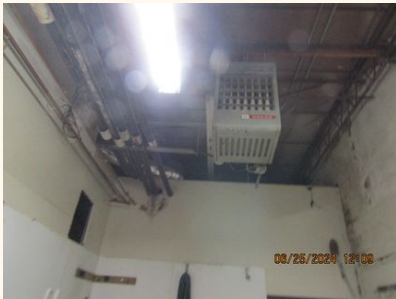
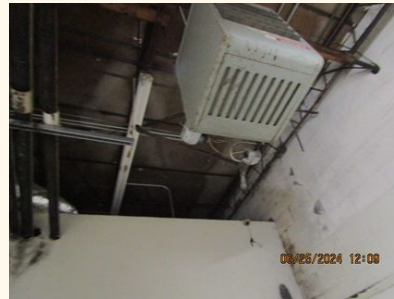
**(HCFV-1) Review:** Gas warehouse space heaters do not appear to be operational.

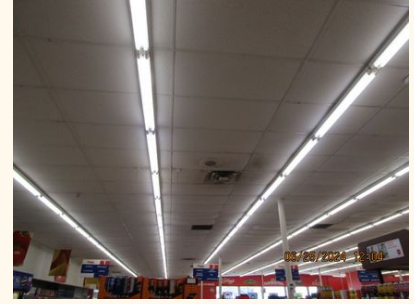
(HCFV-2) Review:

A/C registers dirty and need servicing.

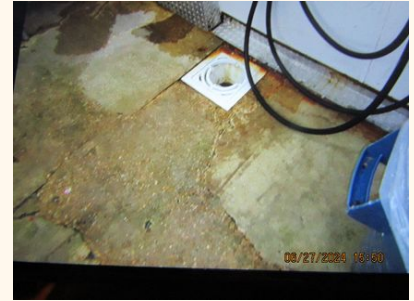
🔧 (AP-1) Review:

The floor drain in the basement is missing a cover. Install the missing cover and check with a plumber to verify that this drain trap will stay primed top prevent sewer gas from entering the home.

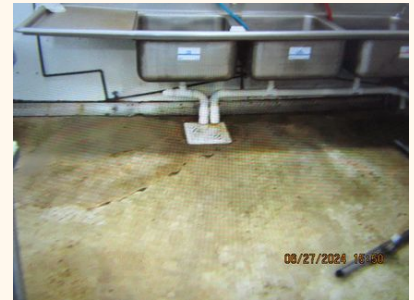
🔧 (AP-2) Review:

Possible plumbing modifications noted.

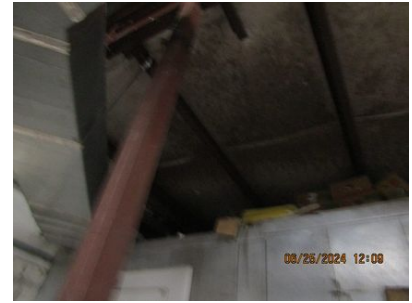
Warehouse ceiling (insulation) shows signs of possible dirt or suspected visible mold.

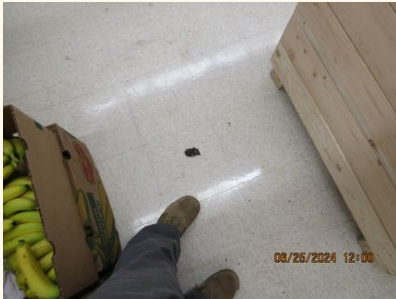
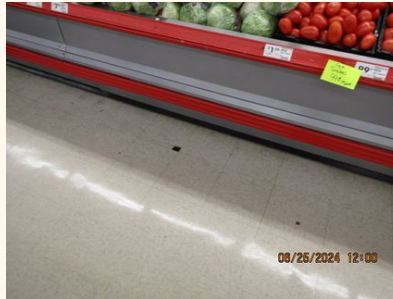
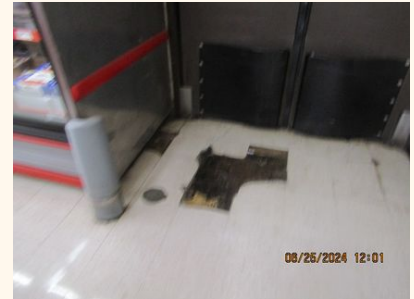
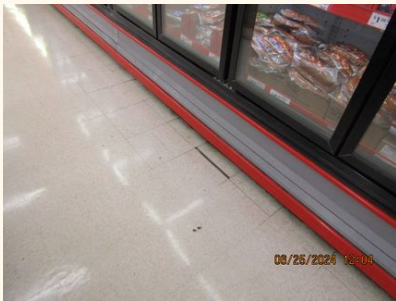
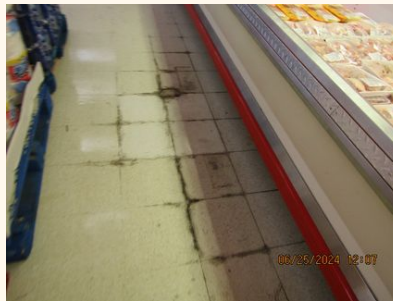
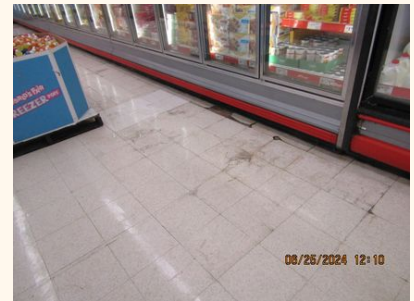
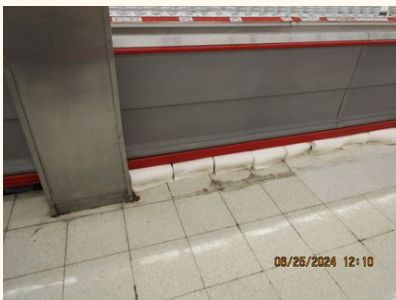
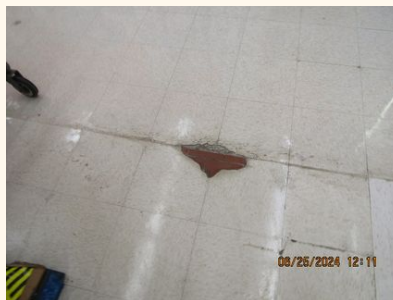
(I-3) Review: Floor tile damaged in various locations.

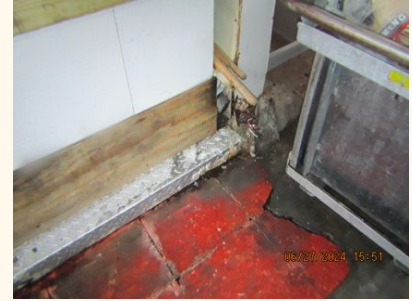
🔍 (I-4) Review:

Warehouse floors appear damaged

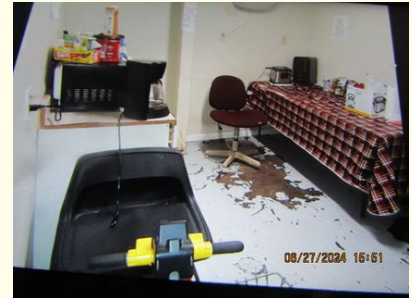
🏠 (I-5) Improve:

Floor finish damaged.

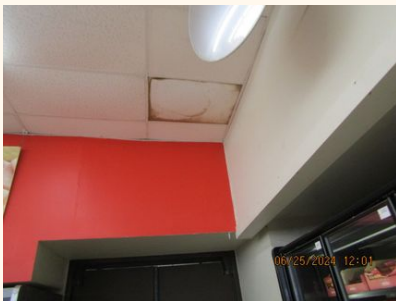
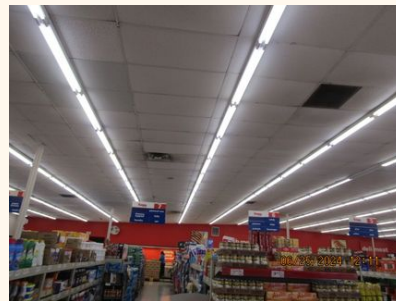
🔍 (I-6) Review: Ceiling tiles water stained in various locations.

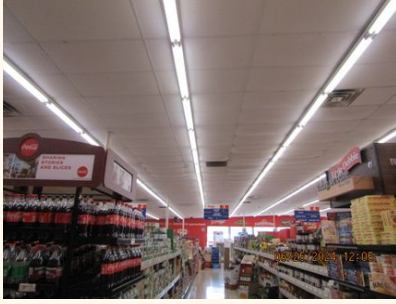
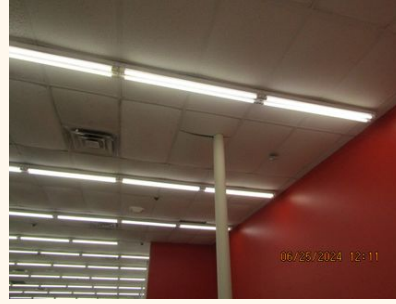
🔍 (I-7) Review: Ceiling tiles appear to be sagging in various locations. Could be an indicator of excessive moisture.

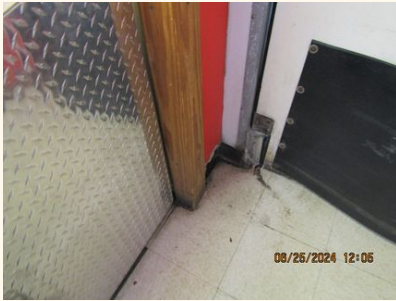
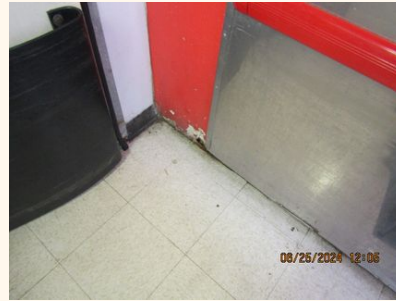
(I-8) Review: Walls damaged in various locations.

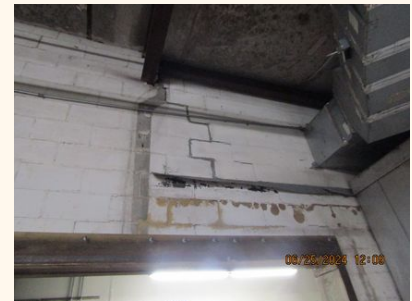
(I-9) Review:
Warehouse CMU walls cracked and repaired.

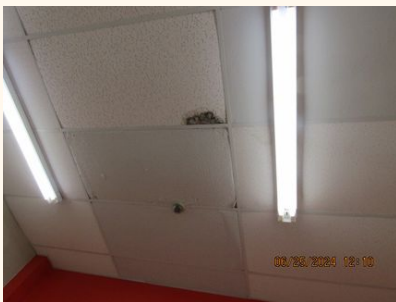
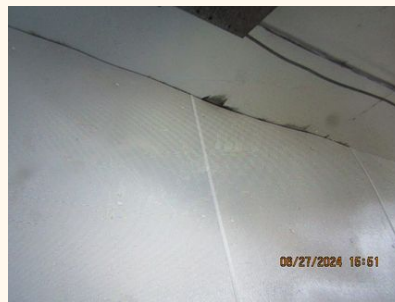
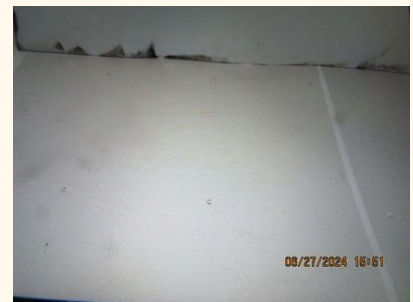
(I-10) Review: Signs of suspected mold growth noted.

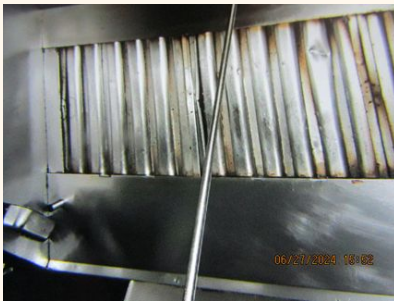
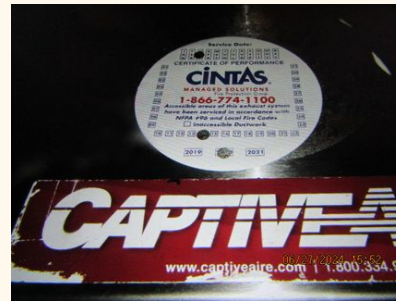
(K-2) Review: Vent grills damaged.

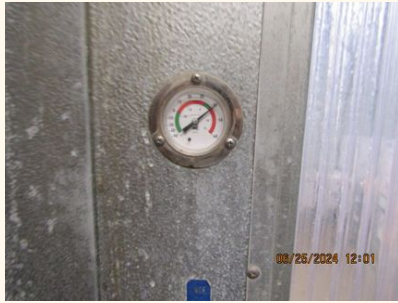
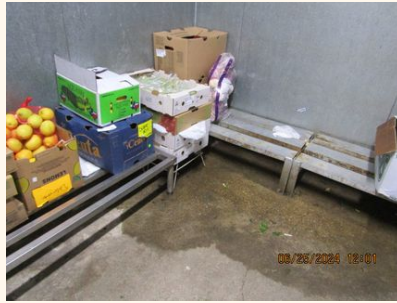
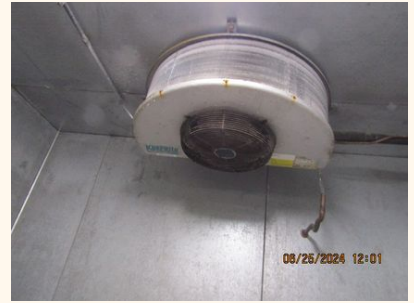
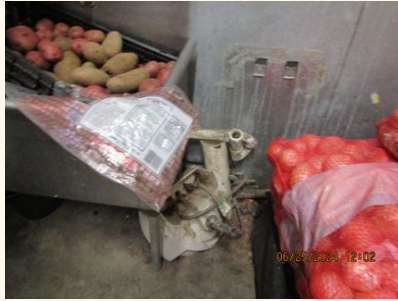
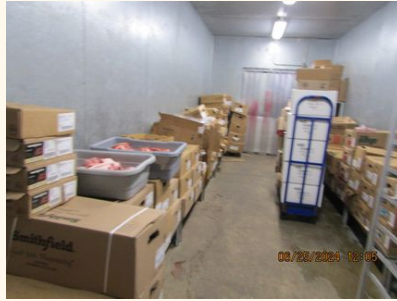
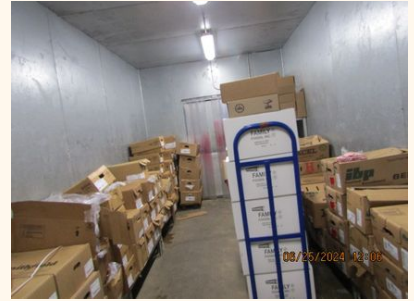
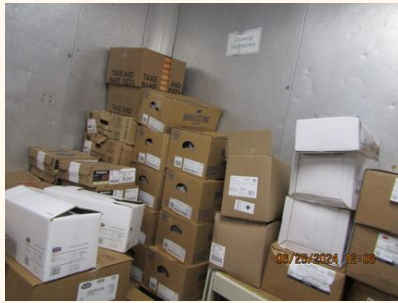
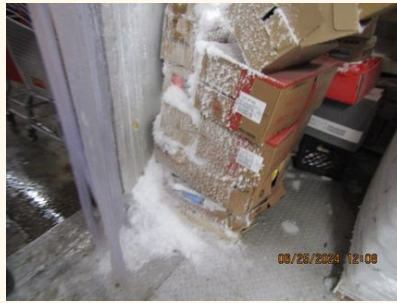
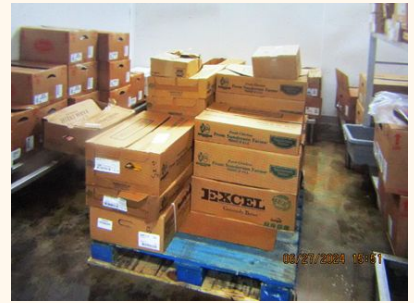
(K-3) Review: The refrigerator requires servicing by a qualified appliance repair contractor;

repair or replace as recommended. During inspection I noted:

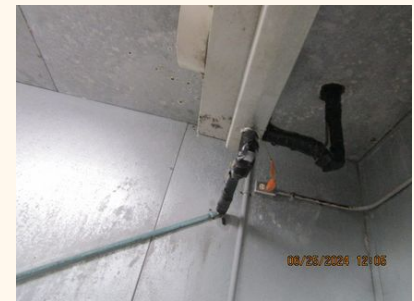
🔧 (K-4) Review:

Signs of rusting and moisture noted in the walk in coolers.

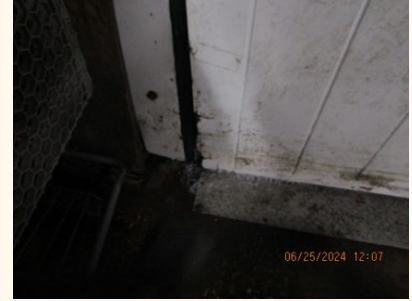
🔧 (K-6) Review:
Cooler doors damaged.

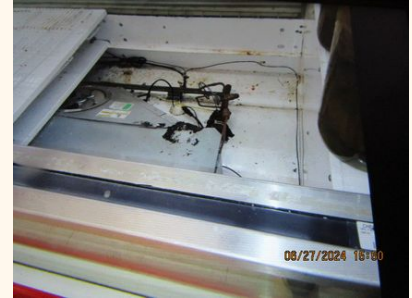
🔧 (K-7) Review:
Sales cooler appears to be non functional.

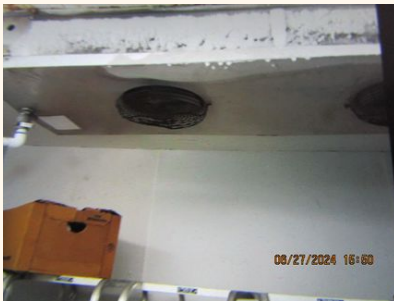
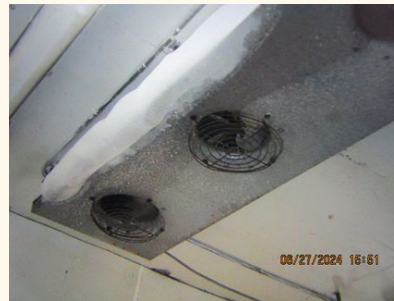
🔧 (K-8) Review: Walk in freezer appears to be icing up.

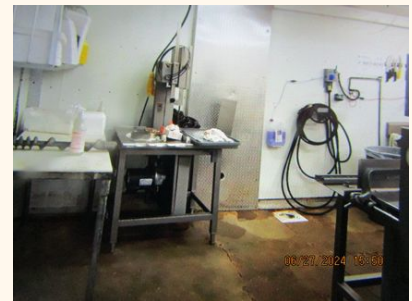
🔧 (K-9) Review:
Signs of water leaking from the walk ins.

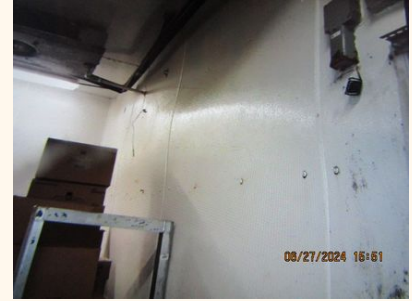
🔑 (K-10) Review:

Walk in walls appear to be bowing.

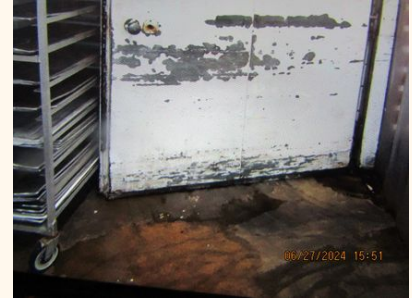
🔑 (K-11) Review:

Walk in cooler doors appear damaged.

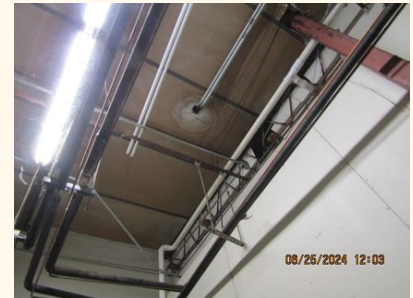
(SB-1) Review:

Signs of past water leakage at vent stacks in warehouse.

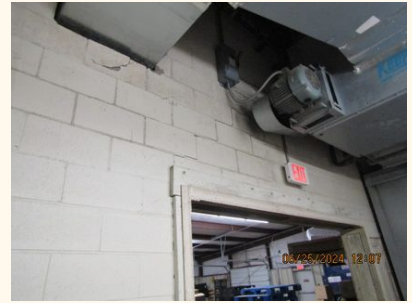
🔑 (SB-2) Review:

Interior warehouse CMU wall cracking noted.
