Inspection report for the property at
616 Lakeshore Drive, Chatham, LA 71226

This report is prepared exclusively for **Tim Atkins**
On: **2022-07-26**

QED Service

Inspector: Michael Burroughs : LA State License #LHI 10044,
ASHI 202398

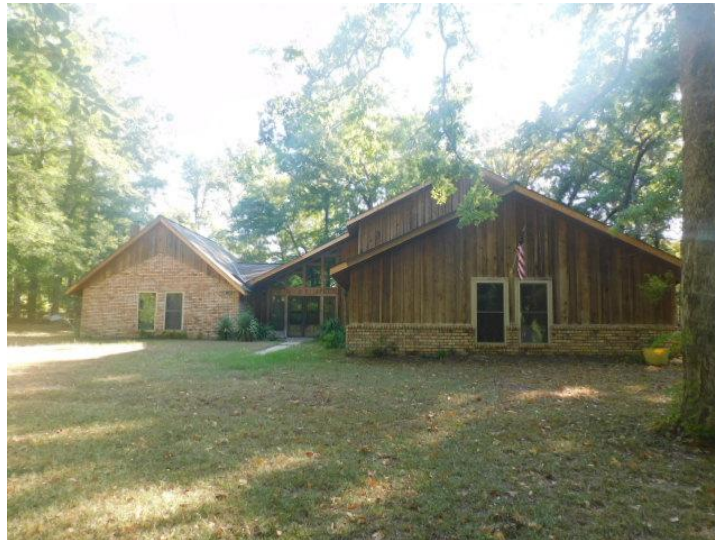
Board and batten siding home. The wood siding is cracking and gaped in numerous locations.

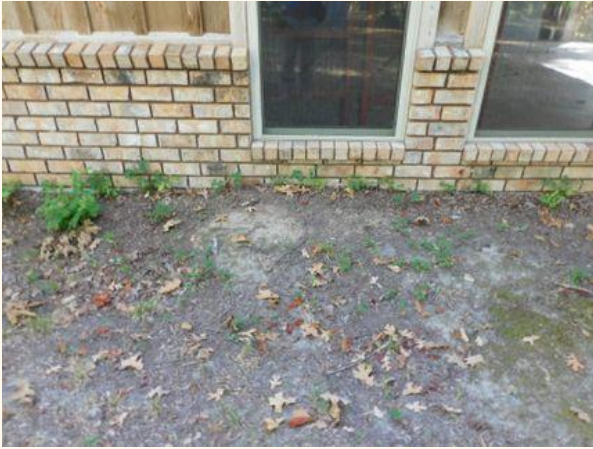
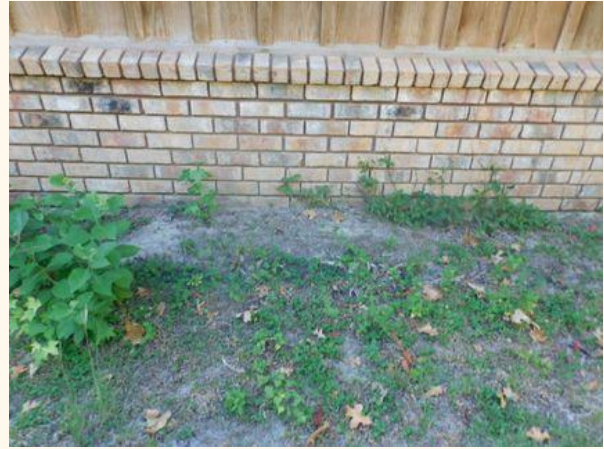
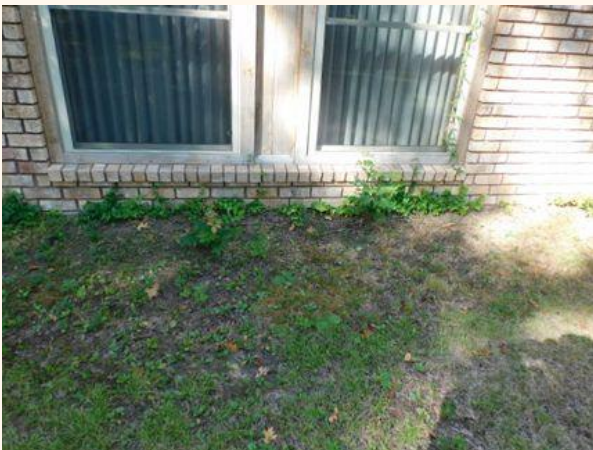
Clearance to Grade: Siding Too Close to Soils - Repair

🔧 (G-2) Review: Eliminate [wood /soil contact](#) to reduce the chances for rot and pest damage and repair any hidden rot as needed - see all around the house. Generally, a 6-inch clearance between soils and wood is recommended. This is often not realistic on older homes, but repairs should be made to get as much clearance as is possible and all contact with the soils should be eliminated.

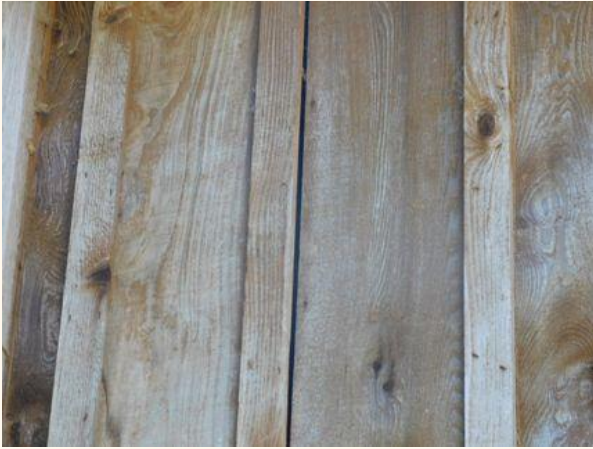
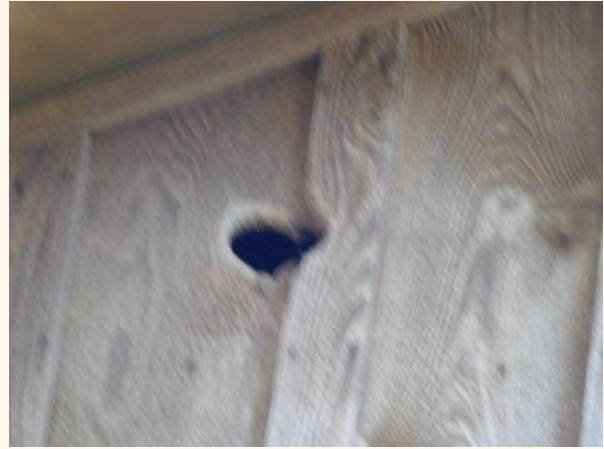
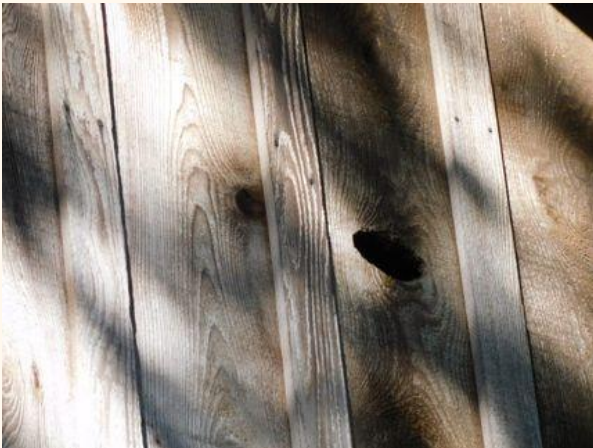
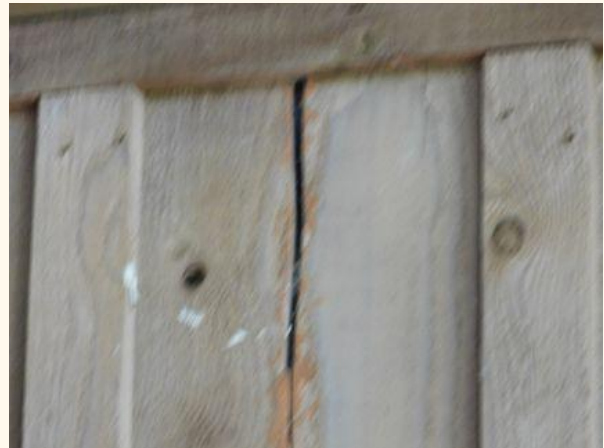
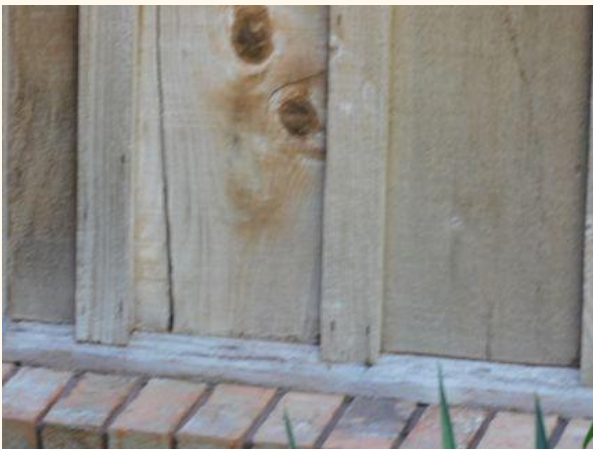
Board and batten wood siding which is cracking in numerous locations .

**(ED1-1) Review:** gaps and cracks noted in siding and trims.

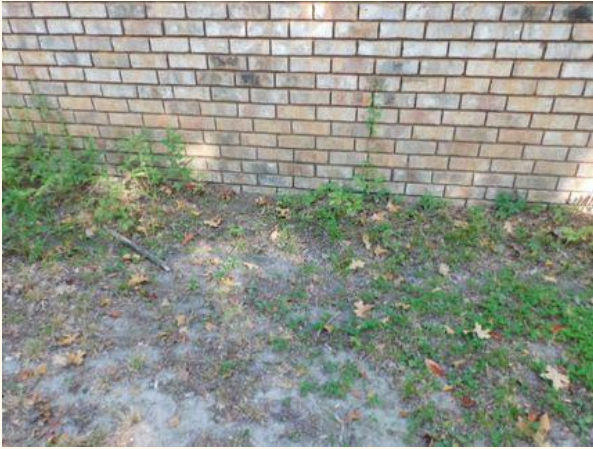
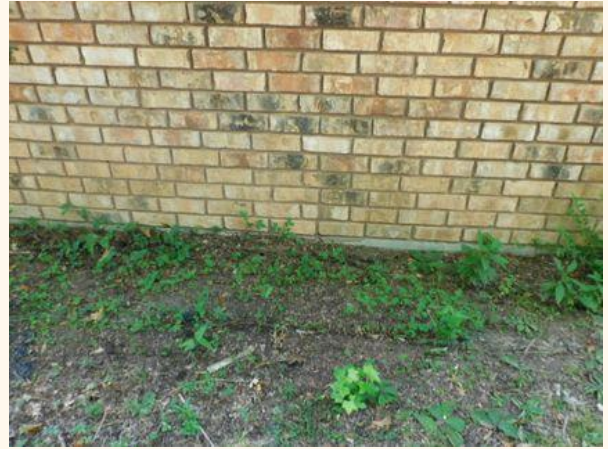
🔧 (ED1-3) Review: Earth in contact with siding materials in various areas around the home.

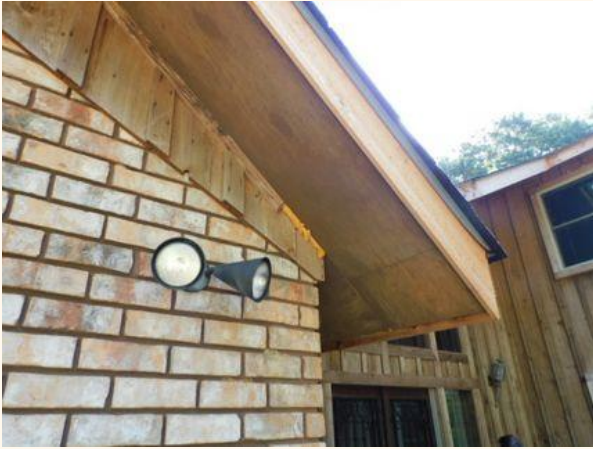
🔧 (ED1-5) **Review:** Siding trim missing.

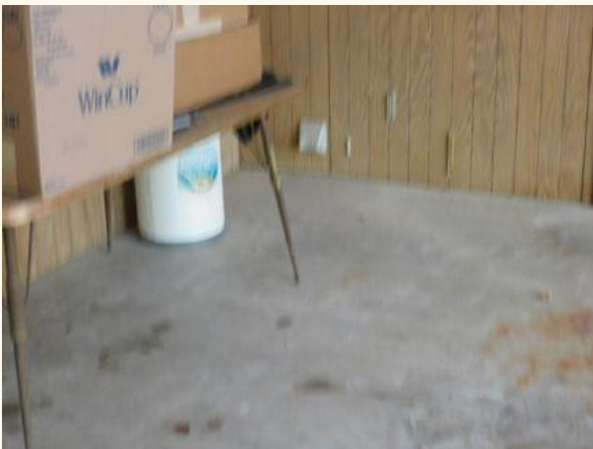
🔗 (ED1-7) Review: Dryer vent terminates in carport.

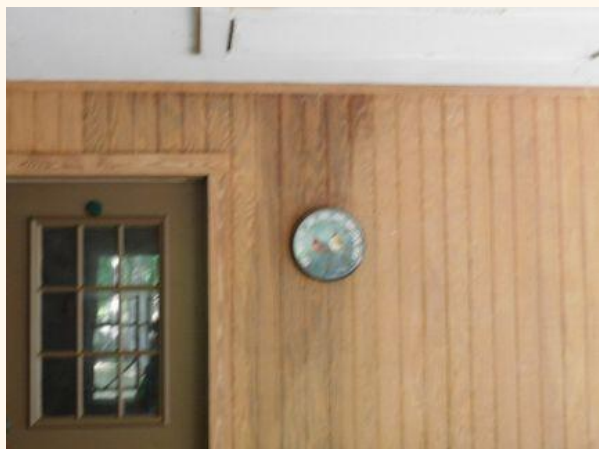
🔗 (ED1-8) Review:

Siding stained in carport.

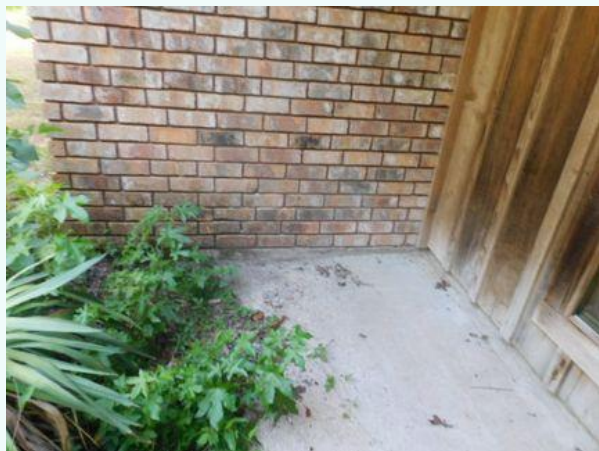
👁️ (ED1-2) Monitor: siding appears to be water stained.

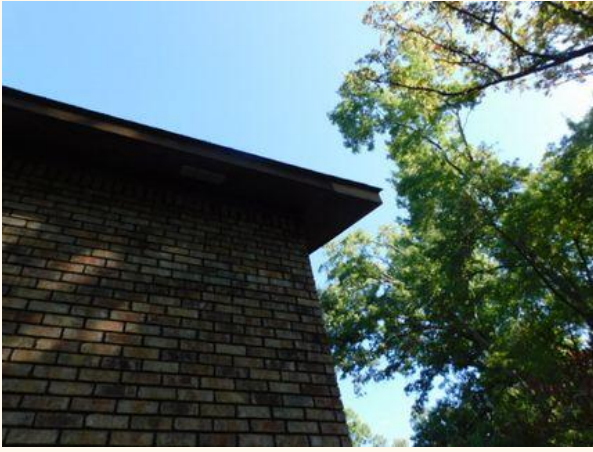
🔧 (ED1-9) Review: Repairs to trim noted.

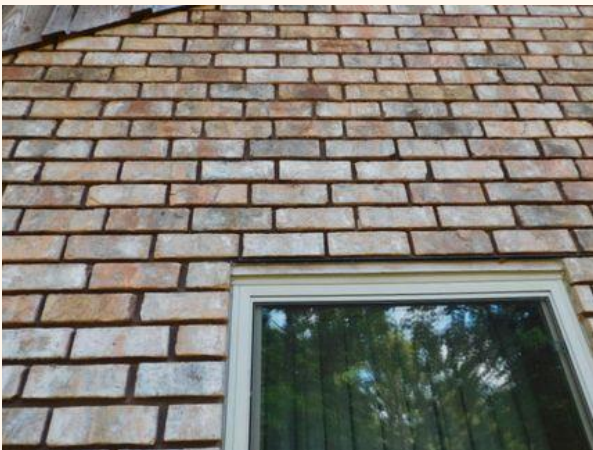
**(ED1-10) Review:** Metal lintels rusting over windows and doors.

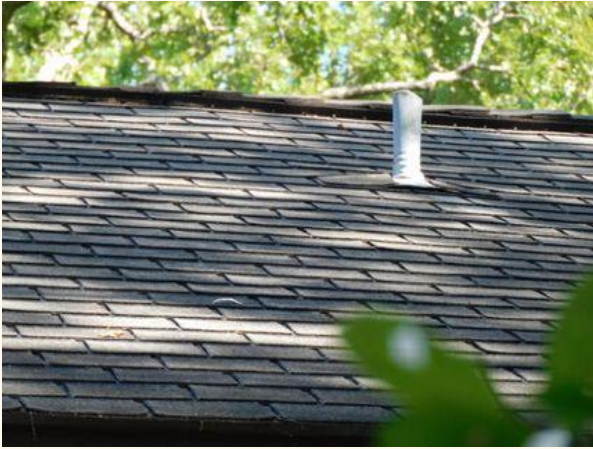
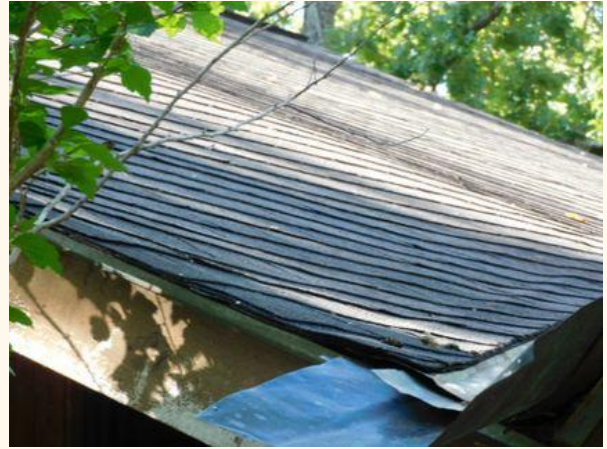
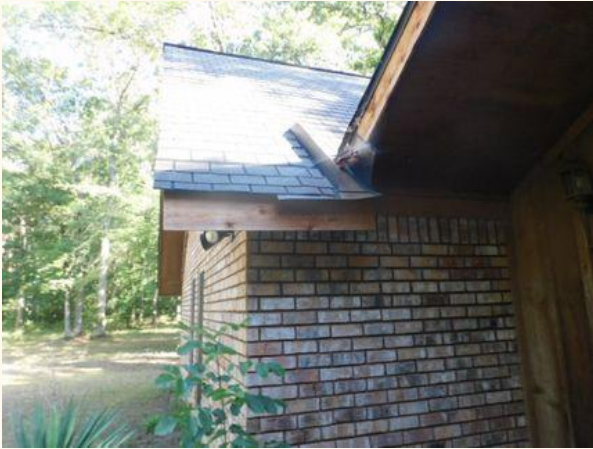
🔧 (RCG2-3) **Review:** Flashing lifted at plumbing vents and improperly installed.

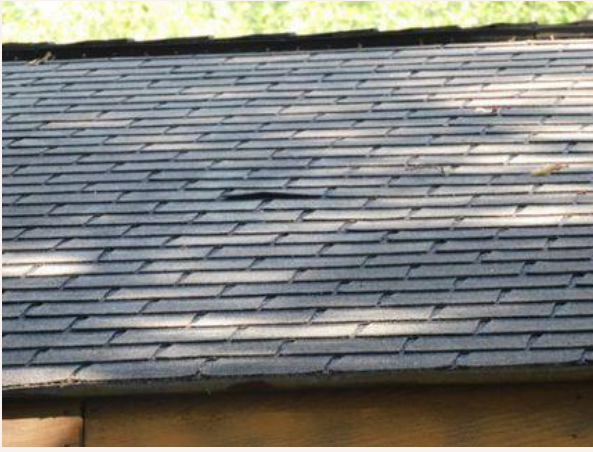
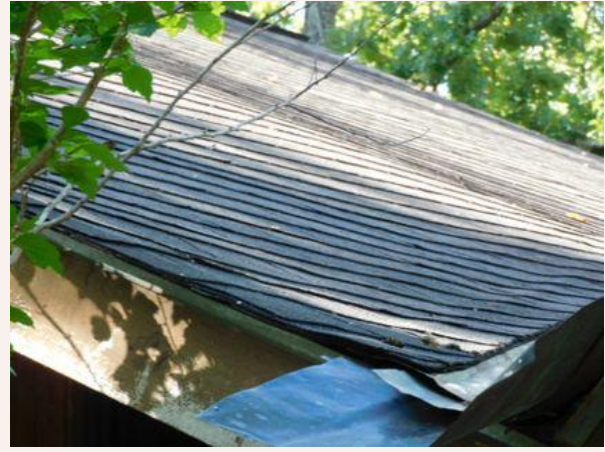
🔧 (RCG2-1) **Recommended Preventive Maintenance:** Shingles lifted which may allow wind to tear off shingles.

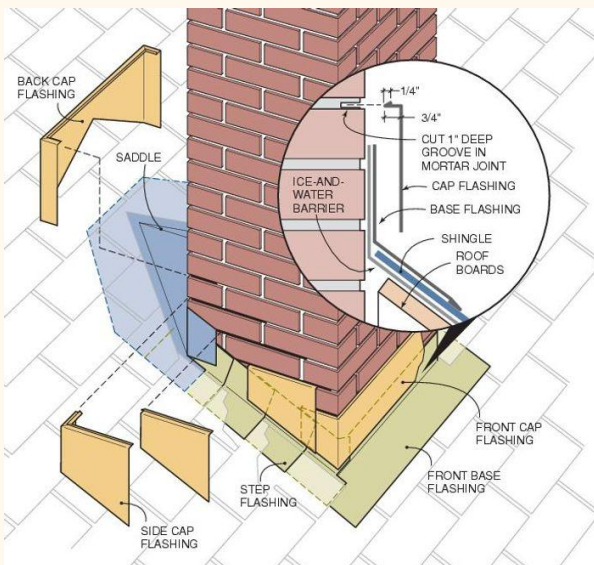
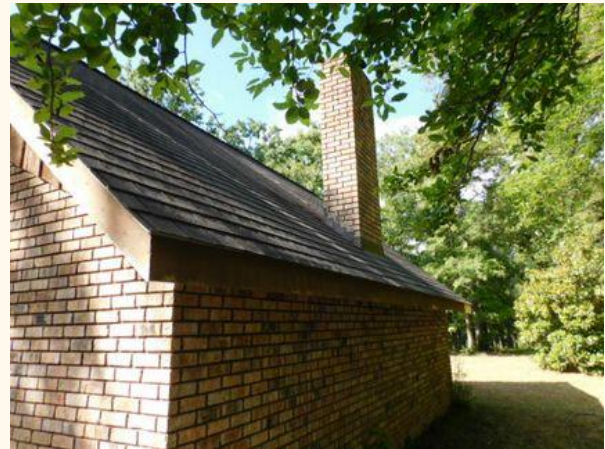
🔧 (RCG2-5) Review: I recommend having a cricket flashing installed for this chimney to divert water around the chimney. The current installation is vulnerable to leaks as the entire roof drains toward the chimney. Please note that modern standards require chimney cricket flashings when the chimney is at the bottom of a roof and more than 30 inches wide.

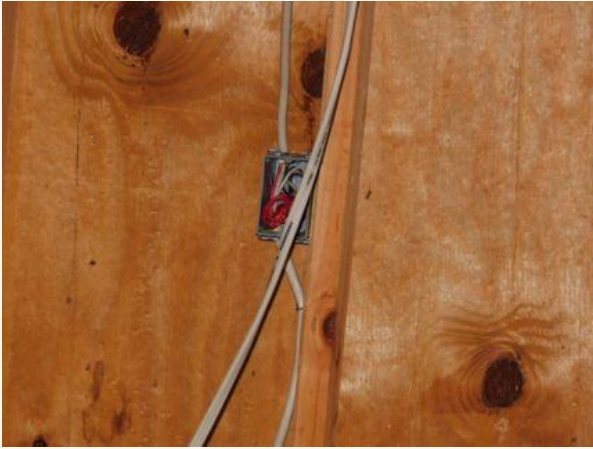
**(EDFW-1) Review:** Junction box missing covers.

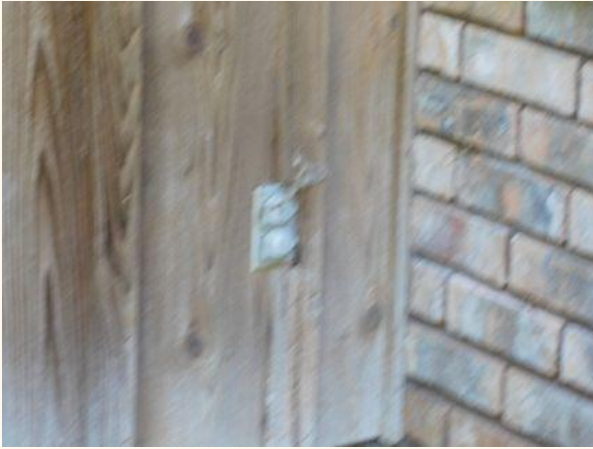
🔧 (EDFW-5) **Review:** Outdoor outlet not GFCI protected. These are typical of age of the home.

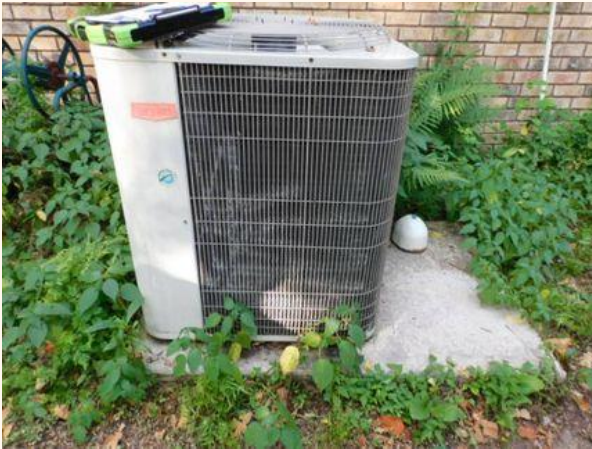
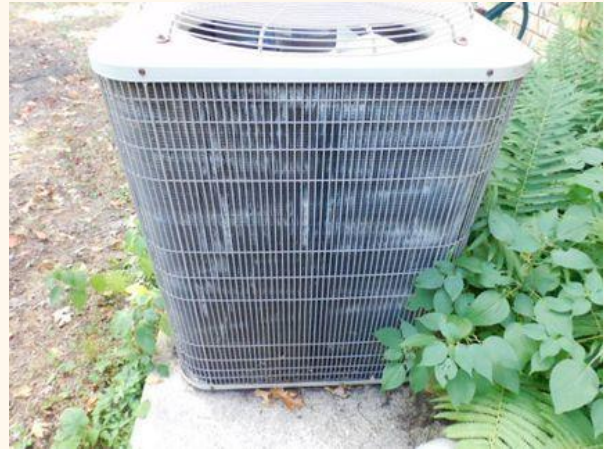
🔧 (HCFV-2) Review: Condenser coils damaged.

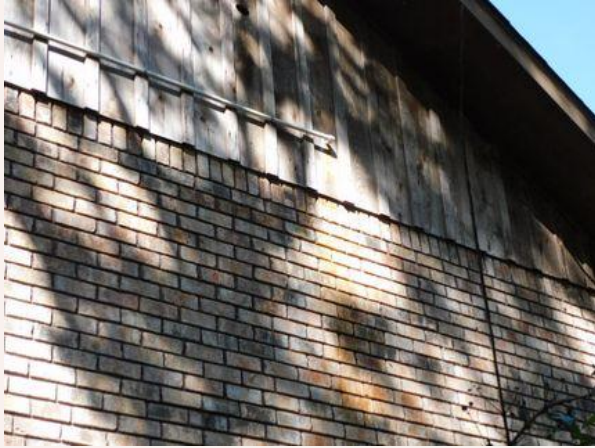
✂ (HCFV-1) **Recommended Preventive Maintenance:** Stains noted on rear of the home from possible condensation drainage.

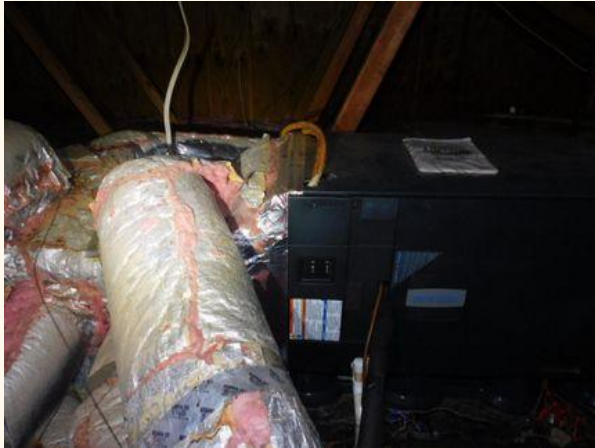
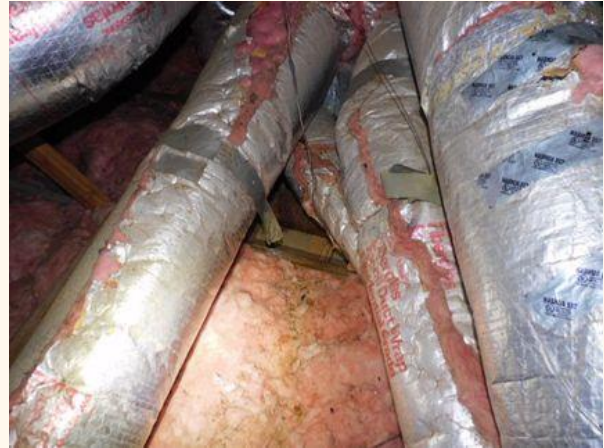
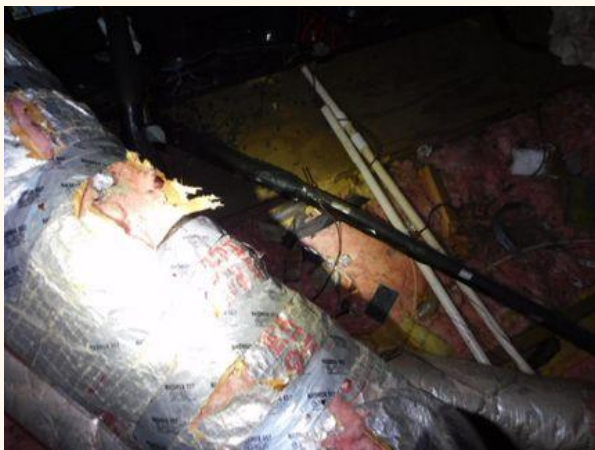
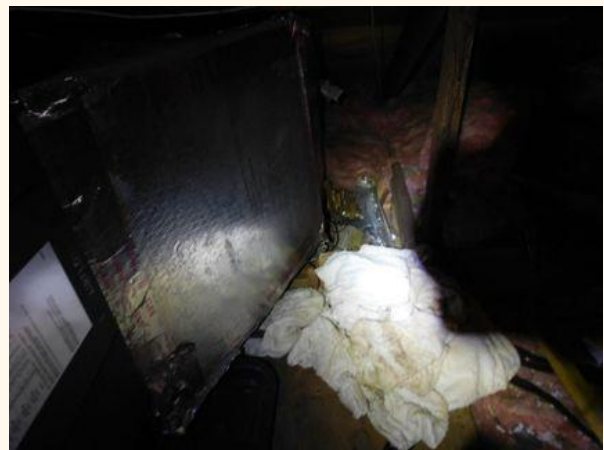
🔧 (HCFV-3) **Review:** Ducting insulation damaged / loose.

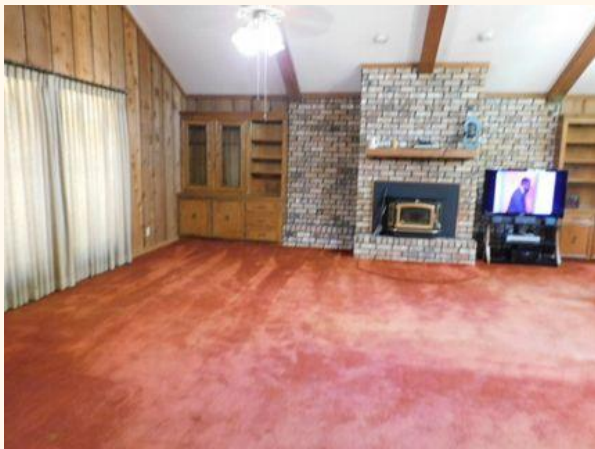
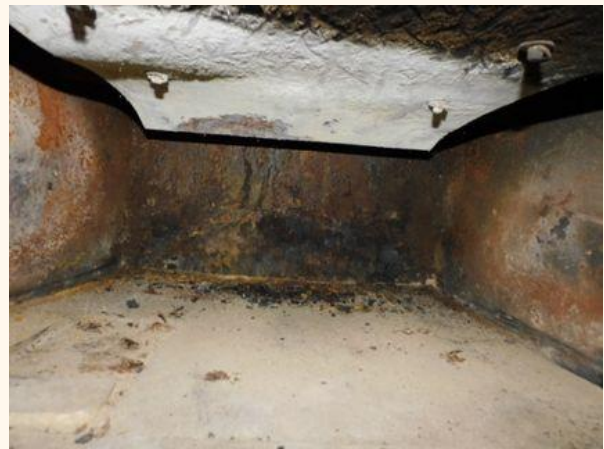
🔧 (HCFV-6) Review: system need cleaning, servicing and repairs.

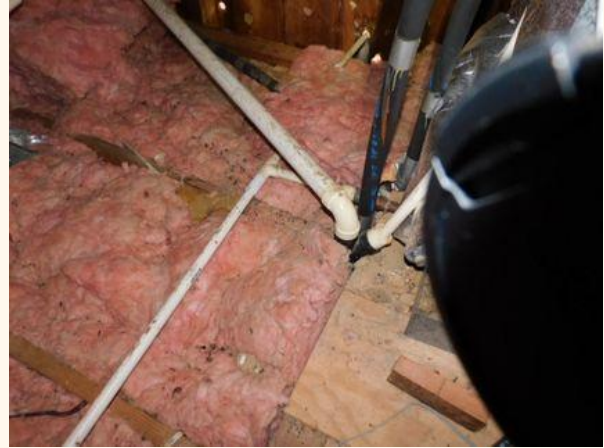
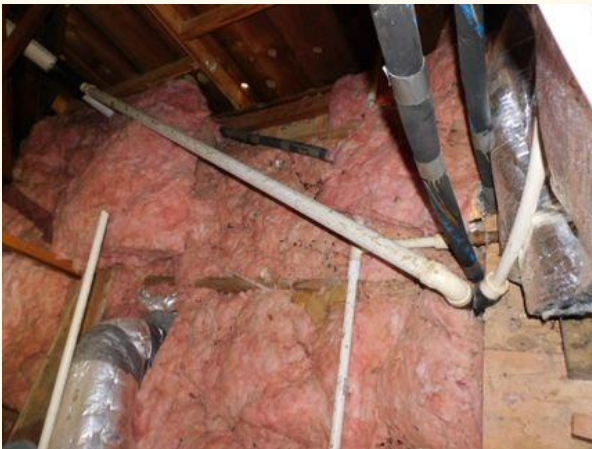
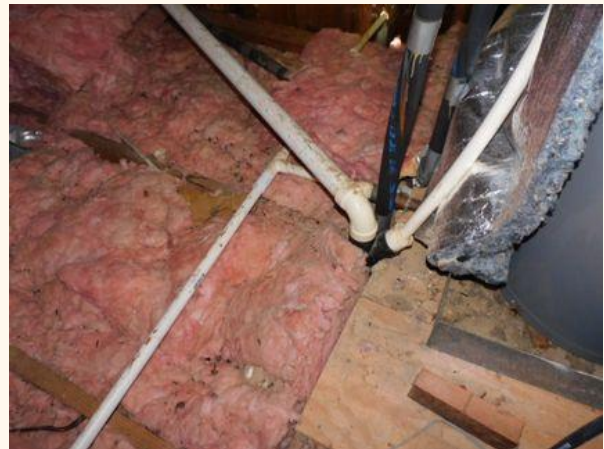
🔧 **(P2-7) Review:** Water pvc piping installed in attic without protective insulation cover.

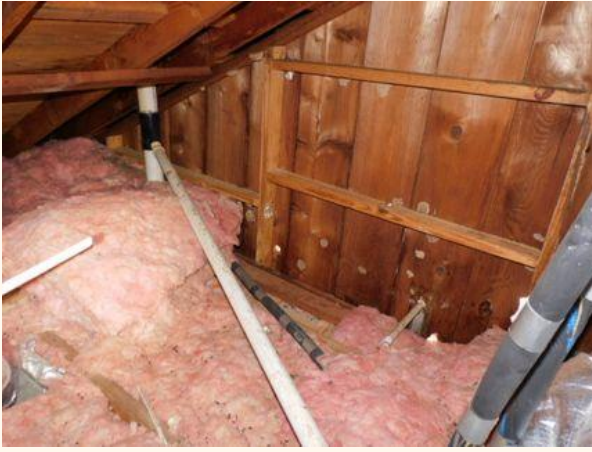
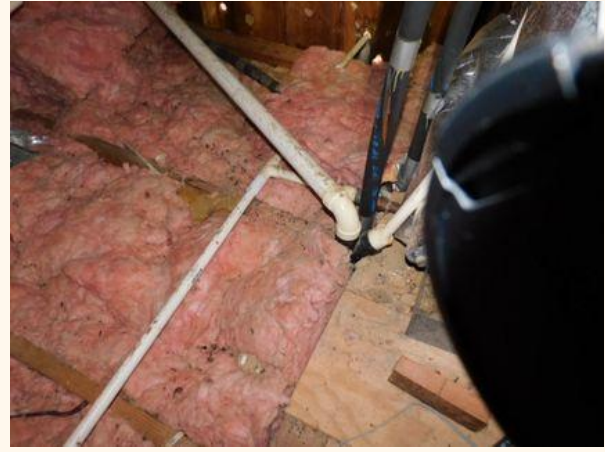
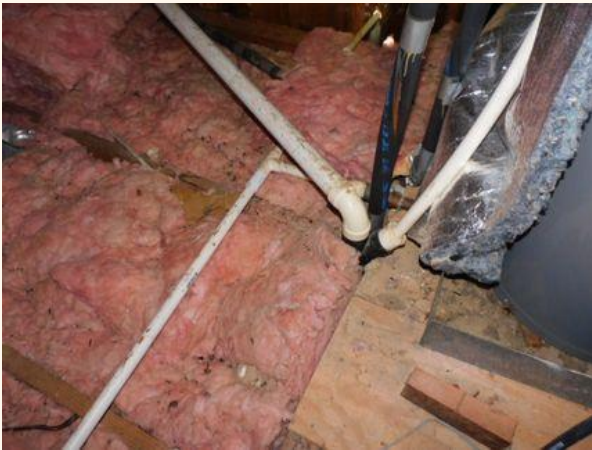
🔧 **(P2-8) Review:** vent pipe questionable improper slope.

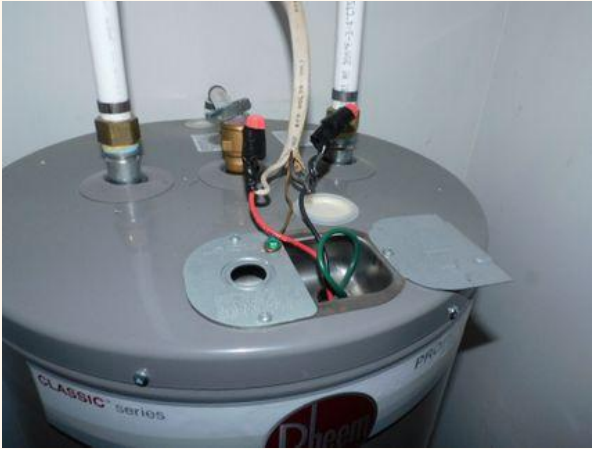
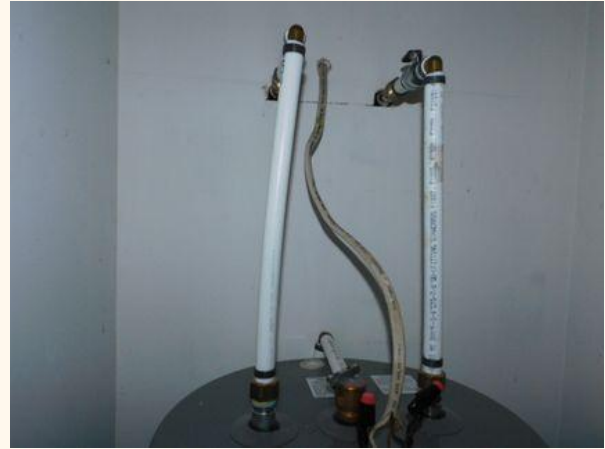
🔧 (P2-10) Review: Water heater electrical improper and exposed. NO means of electrical disconnect noted at appliance.

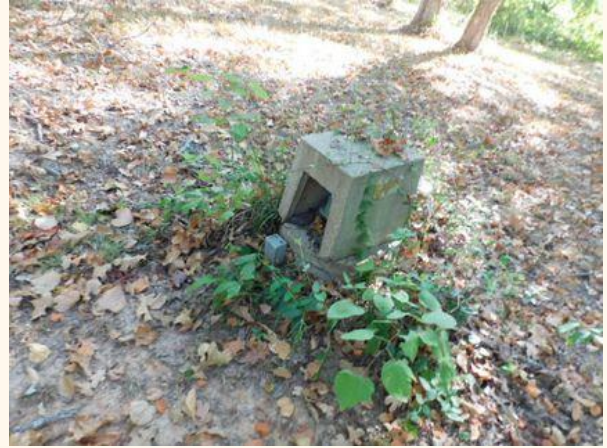
🔗 **(AP-1) Review:** Private waste system noted but not part of the home inspection. These types of systems need to be checked and certified by local health department.

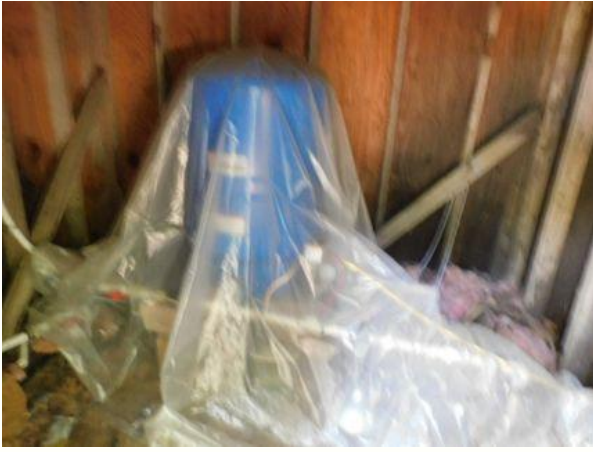
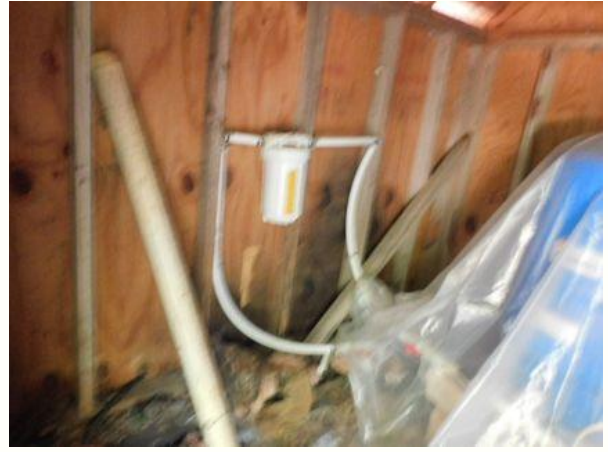
🔗 **(AP-4) Note:** well system noted at home not part of the home inspection recommend review and testing.

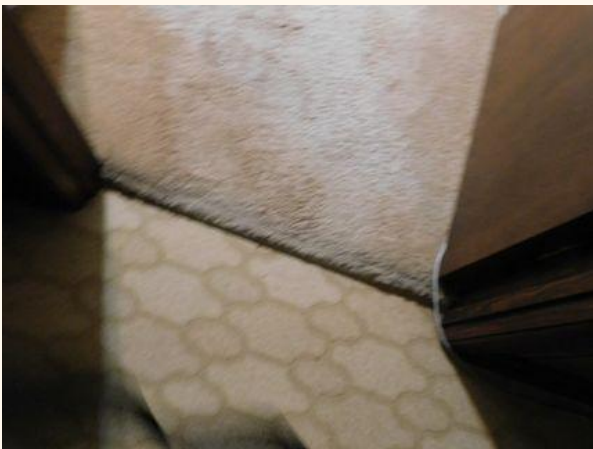
(I-3) Review: Carpets soiled and damaged.

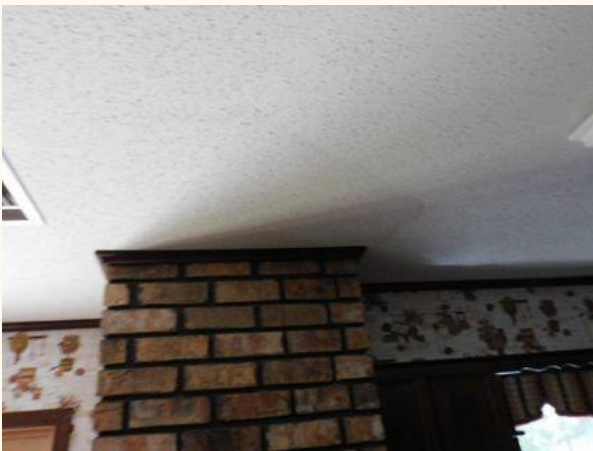
🔍 (I-5) **Review:** Signs of water leaks noted in ceiling of kitchen.

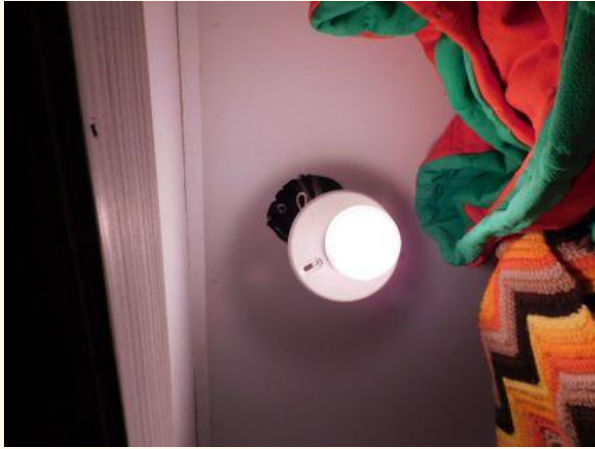
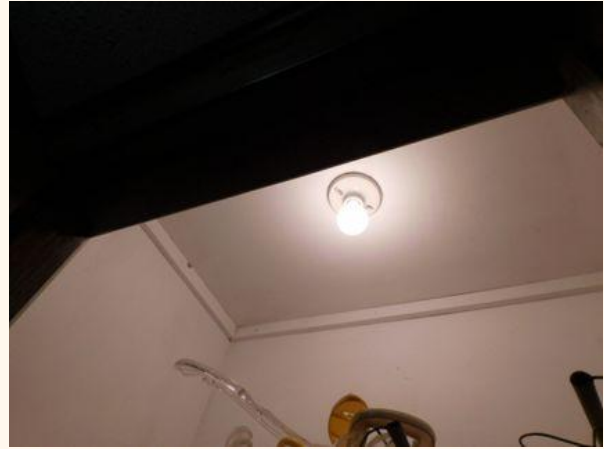
🔍 (I-6) **Review:** Incandescent light bulb fixtures noted in closets.

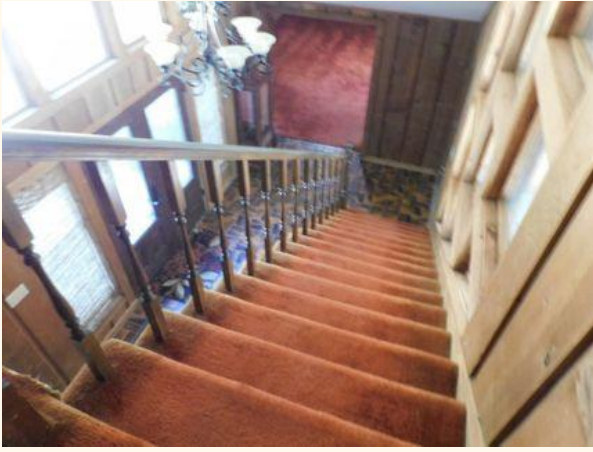
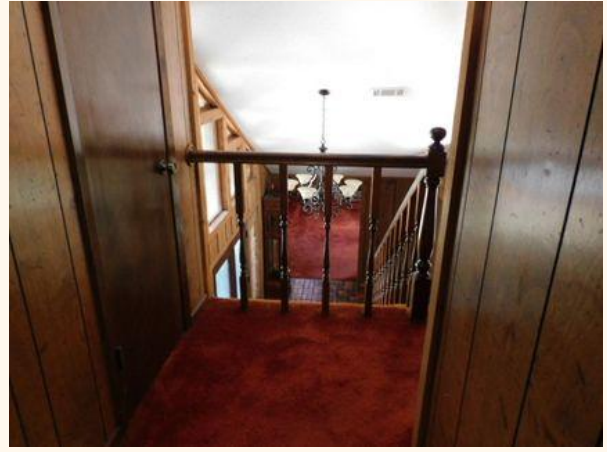
🔧 **I-7 Interior:** A guardrail is needed for the interior stairs to eliminate a safety hazard, especially for children. The current guardrail system is incomplete - see to the 2nd floor. Guardrails with openings no larger than 4 inches are recommended for all stairs with three or more stairs. Handrails that have returns into the walls are needed for the length of the stairs. Hire a carpenter to repair and bring guardrail and handrail up to modern standards. Please note that there are a few exceptions for the 4-inch opening rule:

- The triangular openings at the open side of stair, formed by the riser, tread and bottom rail of a *guard*, shall not allow passage of a sphere 6 inches (153 mm) in diameter.
- *Guards* on the open side of stairs shall not have openings that allow passage of a sphere 4³/₈ inches (111 mm) in diameter

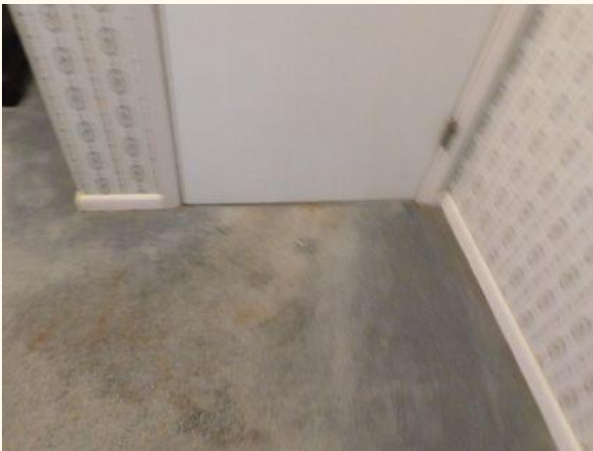
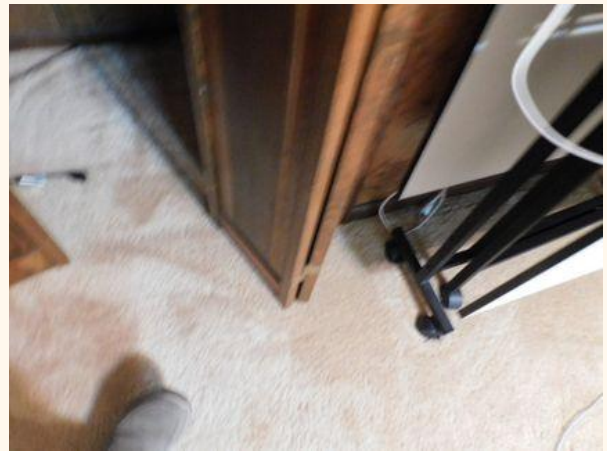
🔧 (I-8) Review: Door clearance to floor improper in several locations

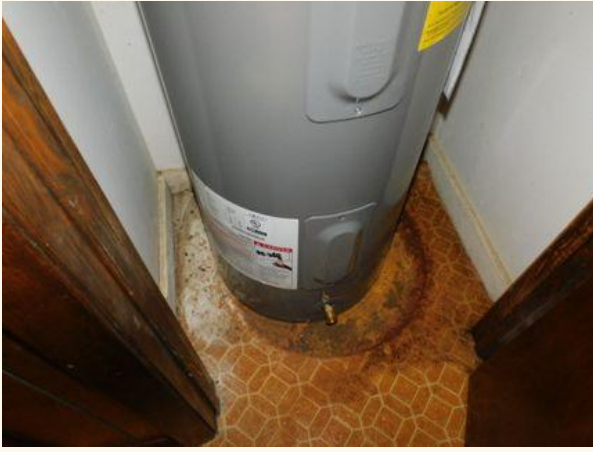
🔧 (I-9) Review: Flooring stained

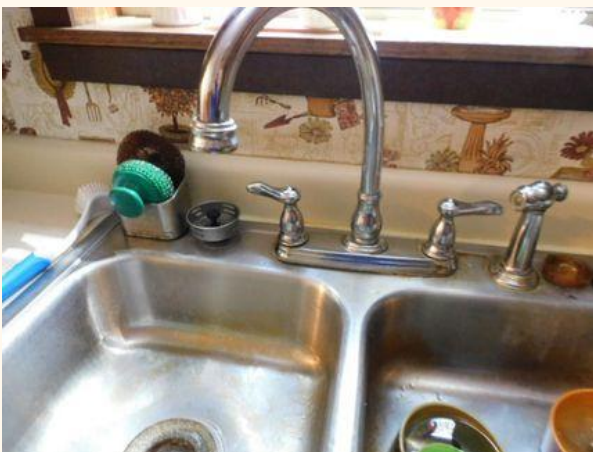
🔧 (K-2) Review: faucet leaking.

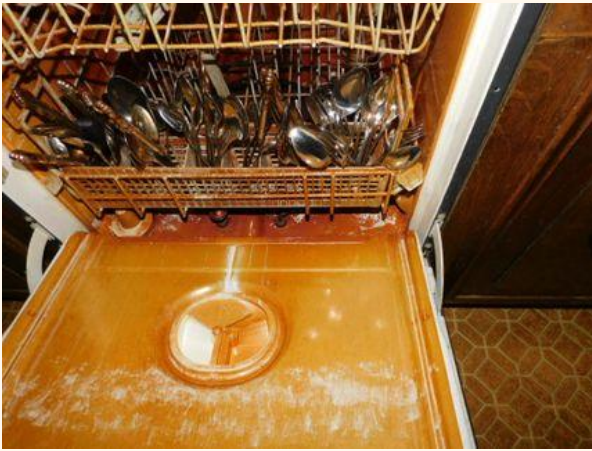
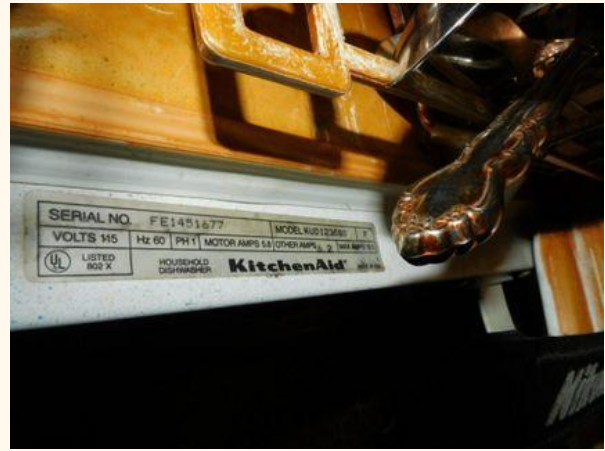
🔧 (K-5) Review: Dishwasher needs service or repairs.

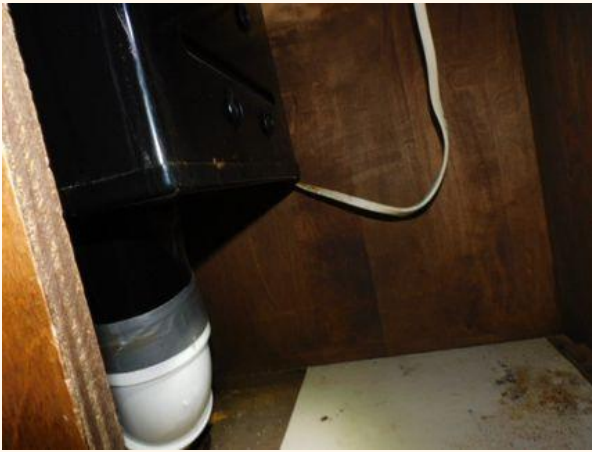
🔧 (K-6) Review: cooktop electrical improper

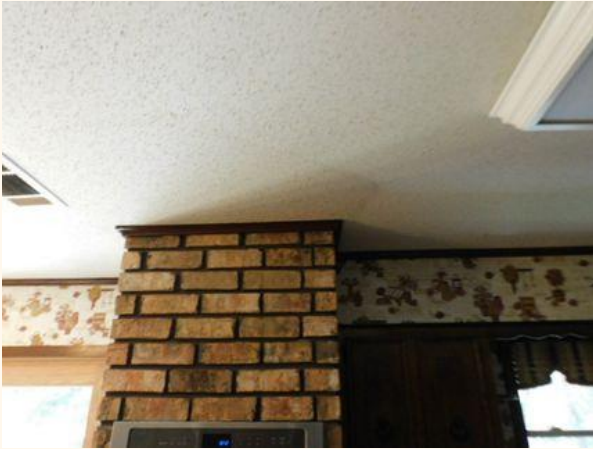
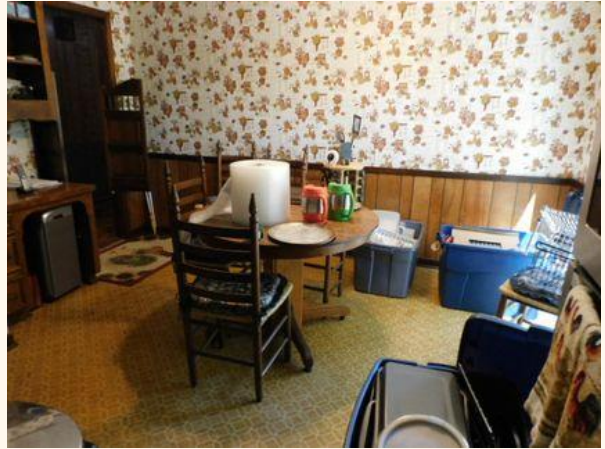
🔍 (K-7) Review: Ceiling stained over wall mount oven.

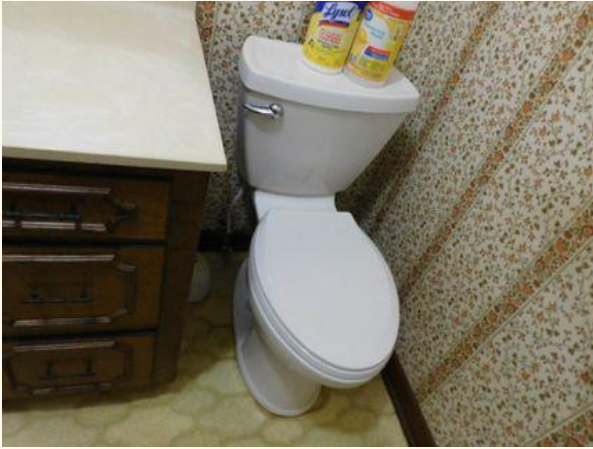
🔧 (B-3) Review: Commode loose on the floor.

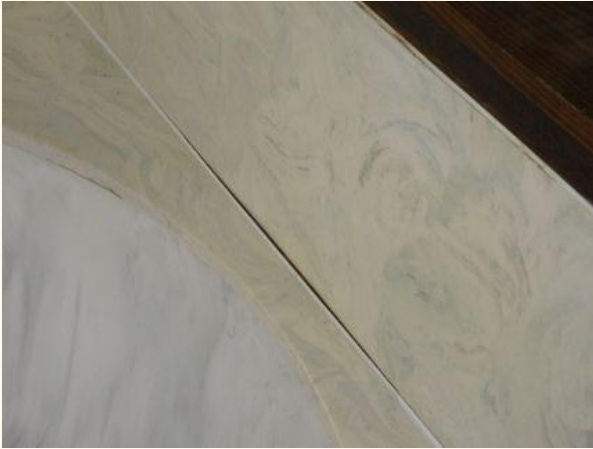
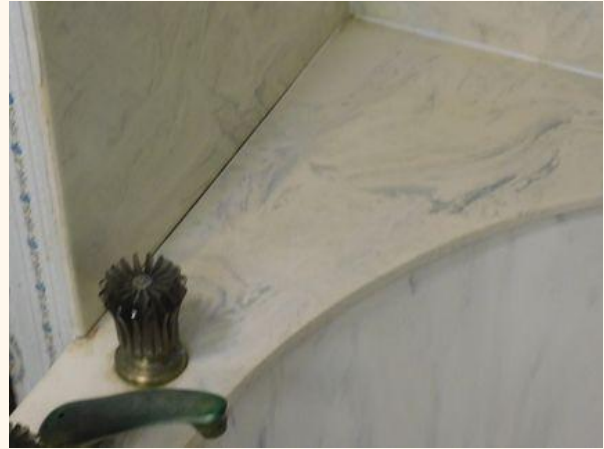
**(B-6) Review:** General caulking and sealant need at plumbing fixtures.

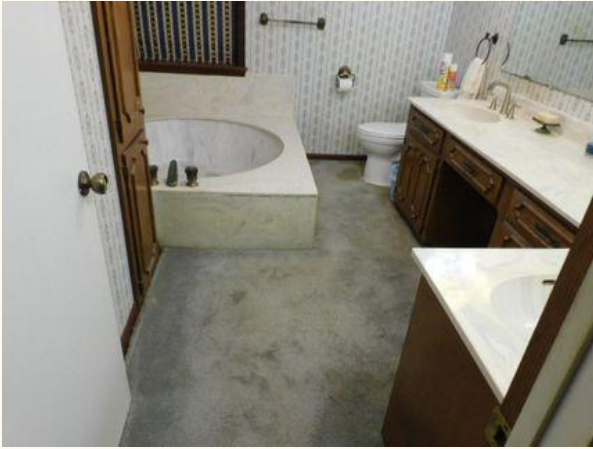
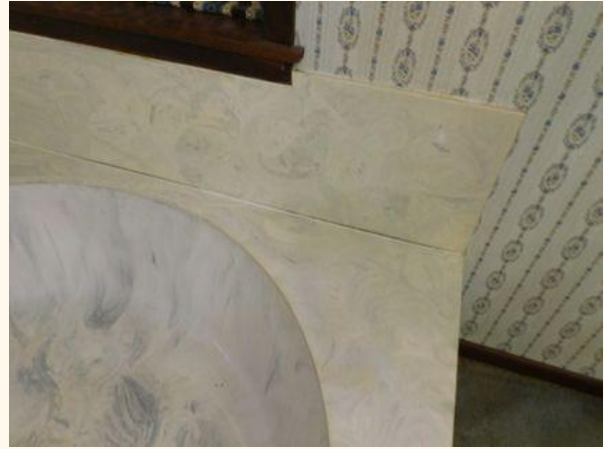
**(B-7) Review:** flooring stained.
