Inspection report for the property at
785 California , Camden, Ark.

This report is prepared exclusively for **southern Meat Market**
Inspected On: **07-11-2024**

The Professional Real Estate Inspection Report

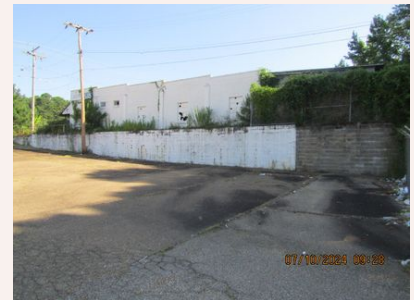
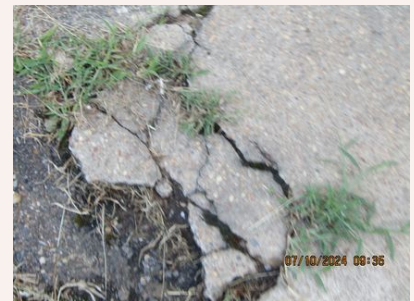
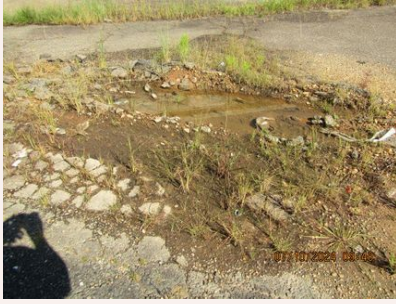
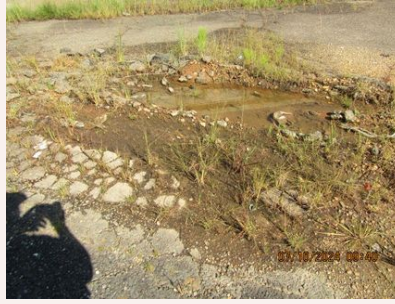
(G-1) Recommended Preventive Maintenance:

Typical concrete cracks noted in parking lot. Repaving parking lot cost could range from \$15,000 and up. Patching the Parking lot may cost around \$10,000 or less.

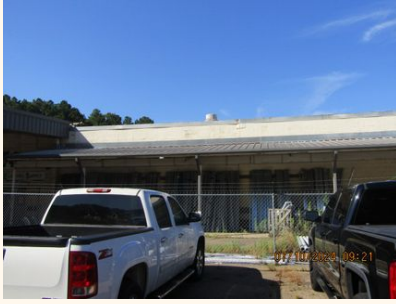
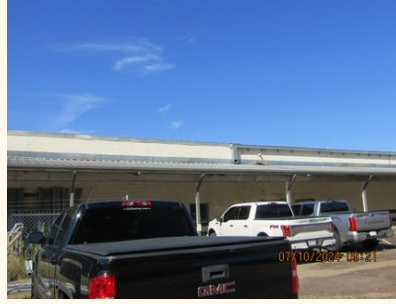
**(ED-2) Review:** Metal roof flashing damaged and appears loose. Metal siding damaged repairs could cost approximately \$3000.00

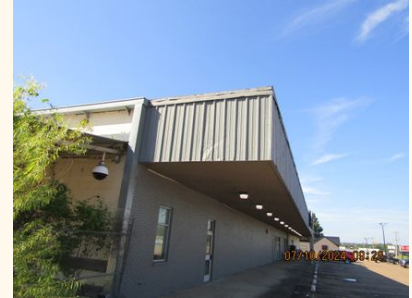
(ED-3) Review:
metal siding damaged. Estimated cost of repairs \$5000.00

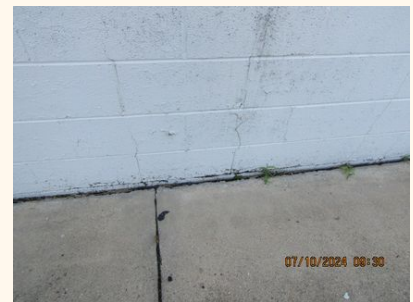
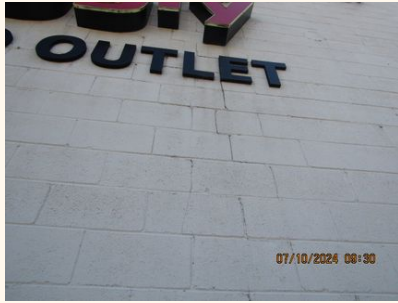
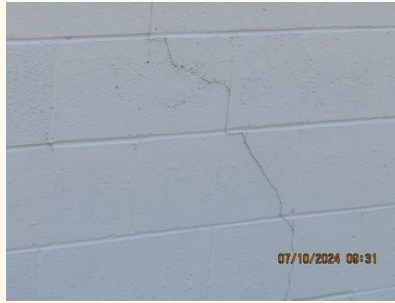
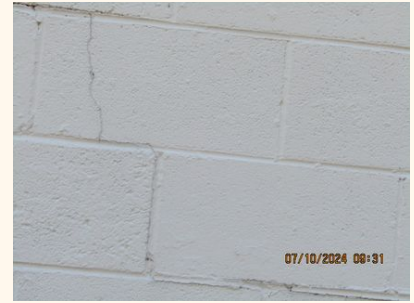
(ED-5) Review: CMU walls cracked. Repairs to CMU walls \$1000.00 to 2000.00

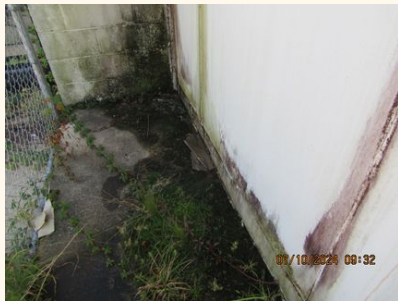
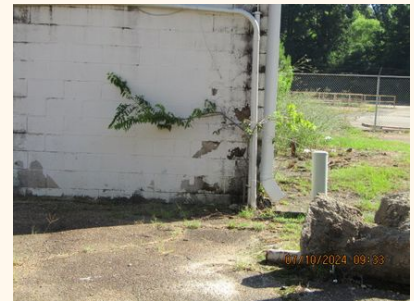
🔧 (ED-6) Review: Siding appears to be water damaged. Repairs for water damage \$5000 to \$1000.00

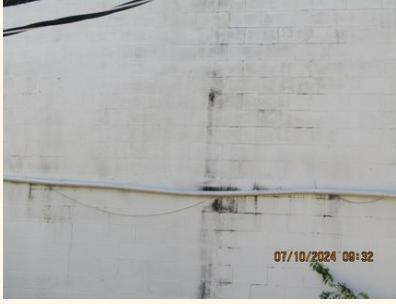
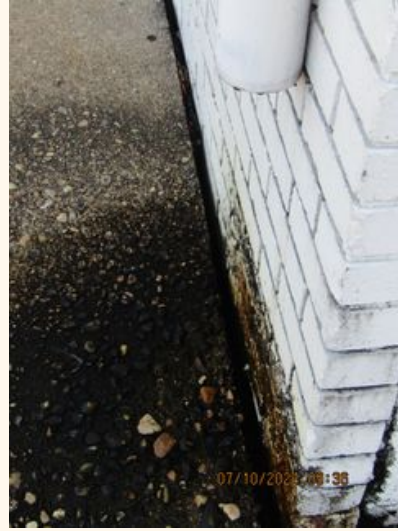
🔧 (ED-7) Review: Masonry blocks stained Cleaning cost approx. \$2500.00

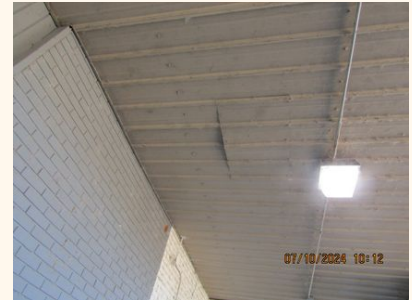
(ED-8) Review:

Front overhang metal damaged or sagging. Estimated cost \$500.00

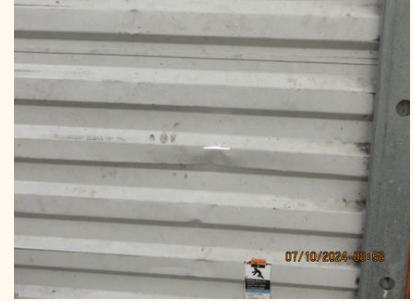
🔧 (RCG-1) Review:

Holes noted in the roof. Repairs to roof \$1000 to 1500.

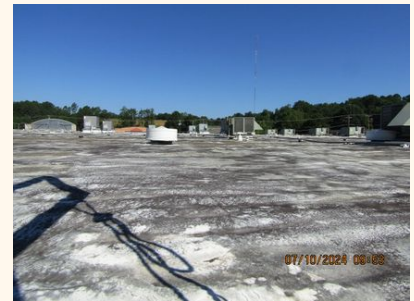
🔧 (RCG-2) Review:

Roof appears to sag in numerous locations. Repairs to roof cost \$15000 to 20000.

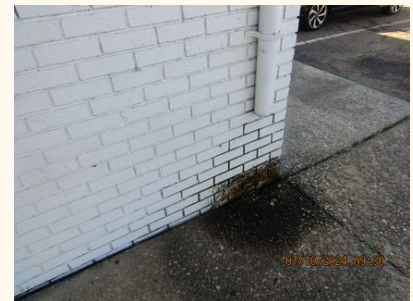
🔧 (RCG-4) Review:

Gutter downspouts missing parts. Repairs to gutters \$5000.00

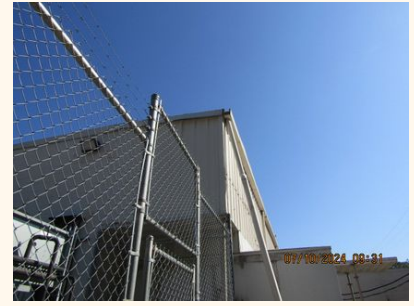
🔧 (RCG-5) Review:

Gutter downspout not secured. Repairs to gutter \$1500

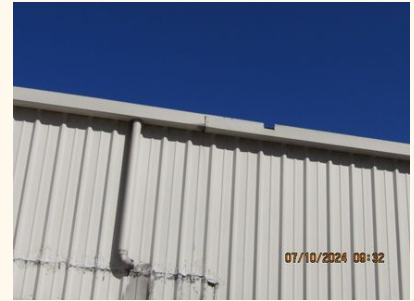
🔧 (RCG-6) Review: Gutter downspouts damaged. see above

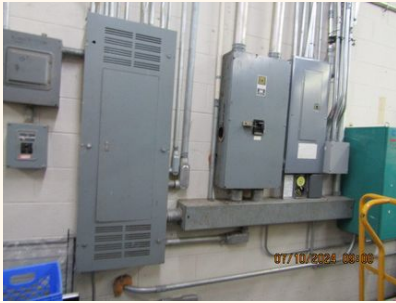
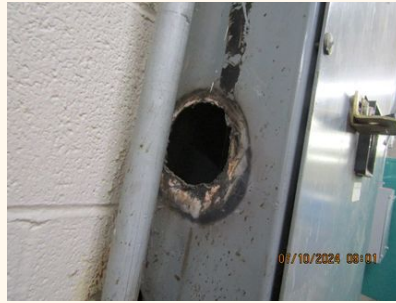
(ES-1) Review: Electrical panel damaged. Repairs to panels \$500.00

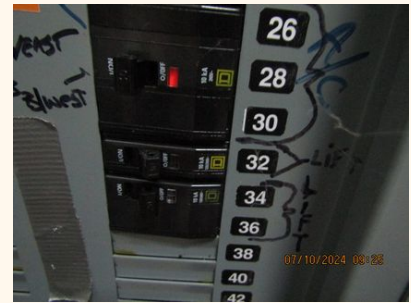
(ES-2) Review:
Breaker tripped. Repairs to breaker \$500.00

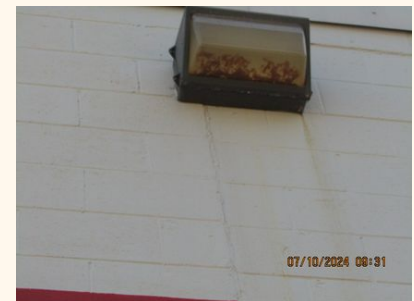
🔧 (EDFW-3) Review:
Exterior light damaged.

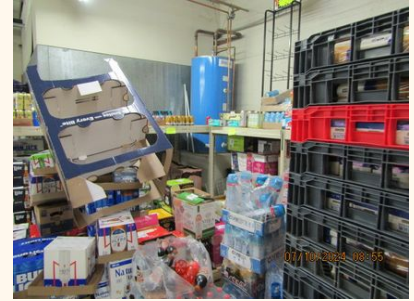
🔑 (P-1) Review:

Water heater access blocked.

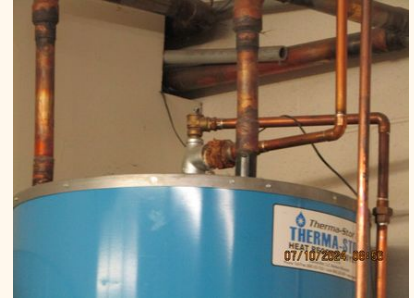
🔑 (P-2) Review:

Water heater fittings rusting.

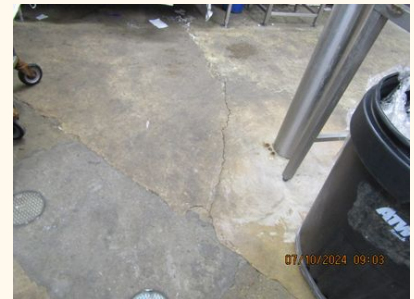
(I-2) Review: Patches and cracks noted in concrete floors.

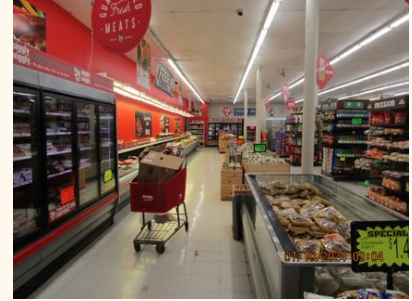
🔑 (I-3) Review:

Floor tiles damaged or stained. Repairs to floor estimate cost \$1500 to 6000.

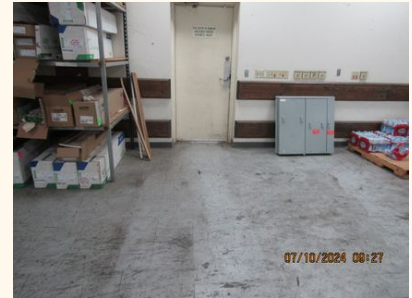
🔑 (I-4) Review:

Floors stained.

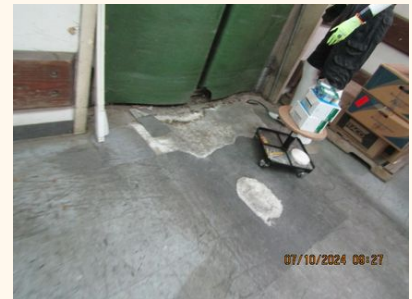
🔑 (I-5) Review:

warehouse floors damaged.

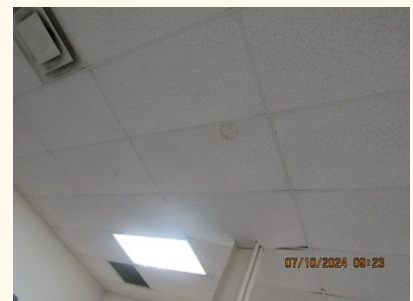
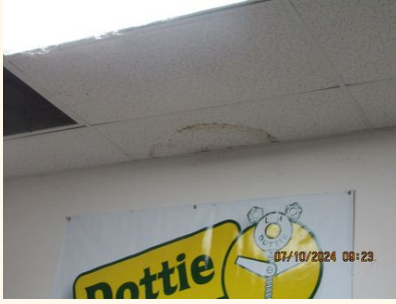
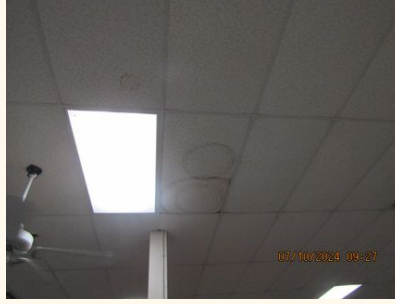
🔑 (I-6) Review: Water stains noted in ceiling tiles. Replacement of damaged and stained tiles estimate \$1000 to \$2500

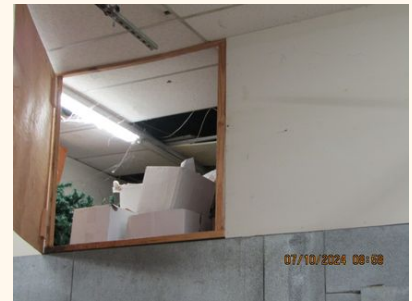
(I-8) Review:
Ceiling tiles missing.

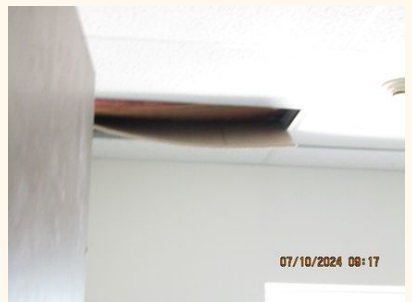
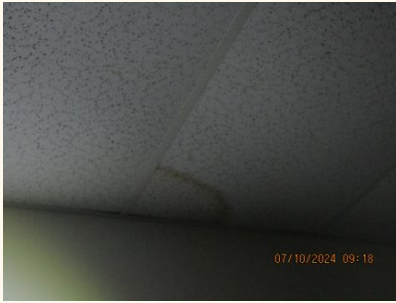
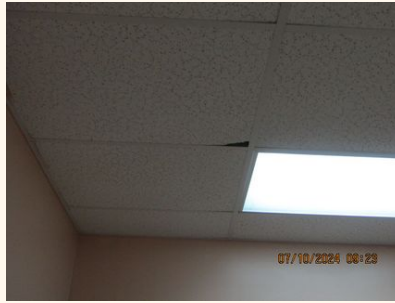
(I-9) Review: Ceiling tiles sagging and damaged. Repair of damage tiles \$500 to \$1000

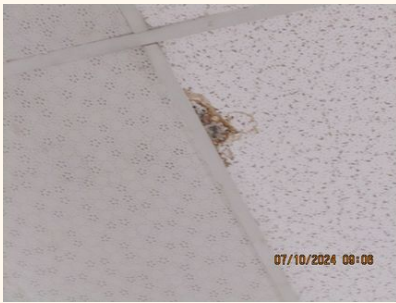
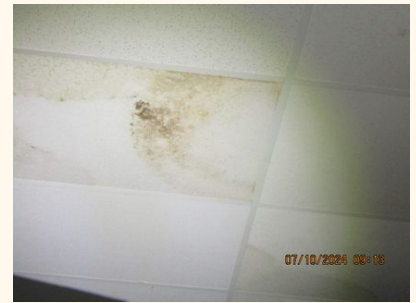
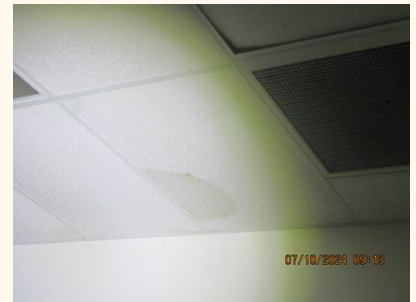
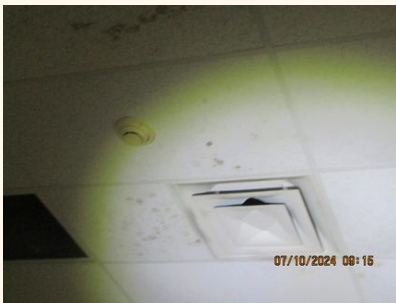
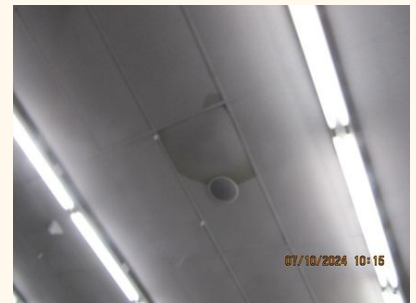
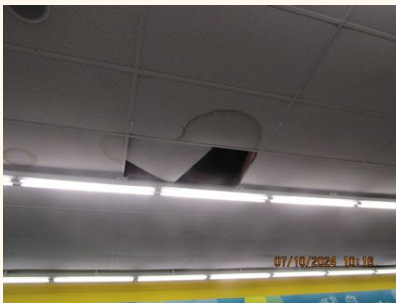
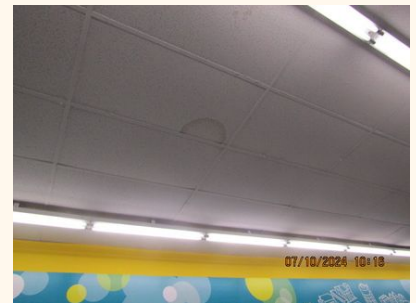
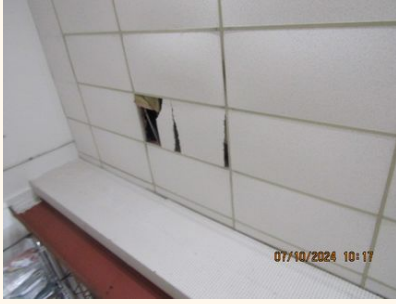
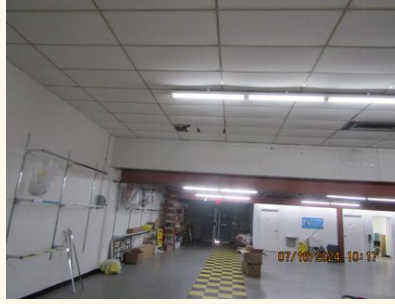
(I-10) Review: Signs of water stains and possible mold noted in several units and locations.

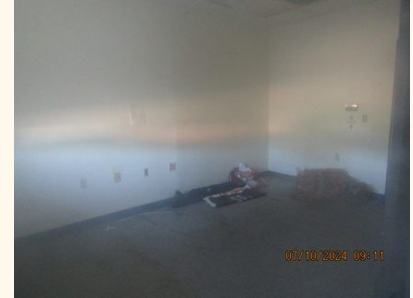
(I-11) Review:
Walls stained.

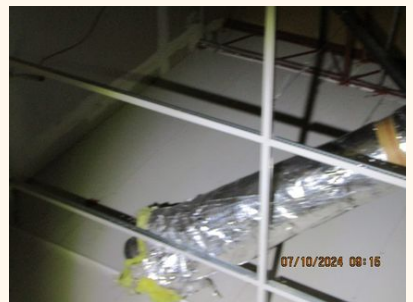
(I-13) Review: Ceiling tiles stained and missing in various locations.

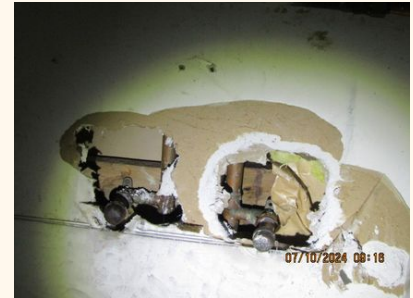
(I-14) Review:

Walls damaged. Repair of wall damage \$500 to 1500.

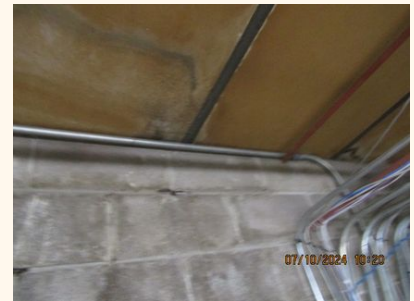
(I-15) Review: Signs of excessive water noted in warehouse. Cost estimate \$5000 to 8000.

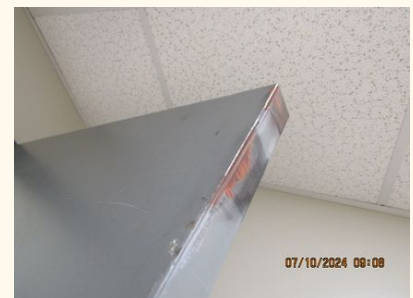
(I-16) Review:

Restroom doors drags - mens restroom. cost estimate \$300.00

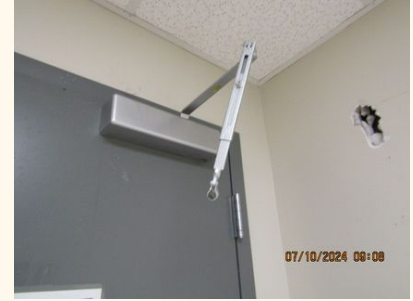
🔧 (I-17) Review:

Door closure damage and loose. repairs to closure \$300.

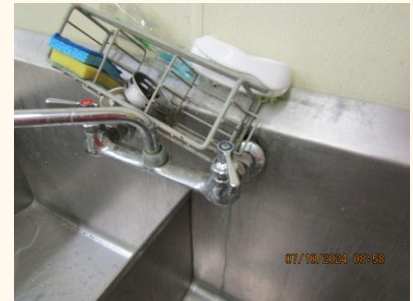
🔧 (K-1) Review:

faucet leaking at valves. Repairs to faucet \$300.00

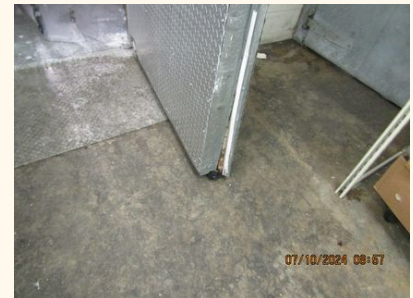
🔧 (K-3) Review:

Walk in cooler door damaged. cost of repairs 1500.00

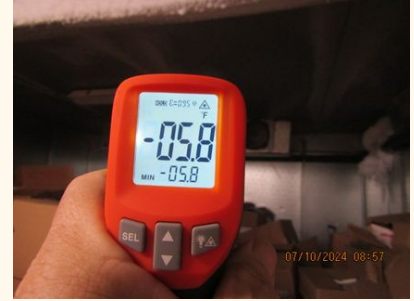
🔧 (K-4) Review: Freezer unit icing up.

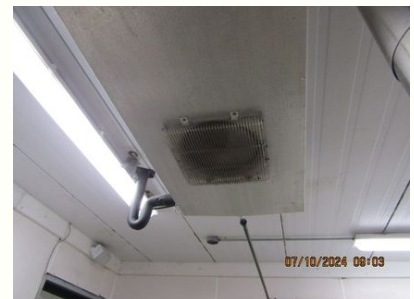
(K-2) Note: Coolers and freezers test and found operational but in need of maintenance. Cleaning and servicing of cooler equipment \$4000.00 to 7000

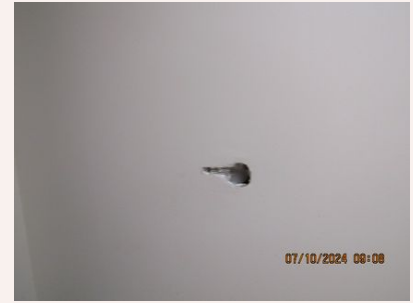
**(B-1) Recommended Preventive Maintenance:**
Bathroom wall damaged. repair of damaged wall \$300

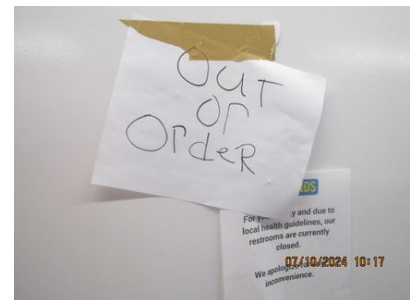
Restroom out of order - sign posted.

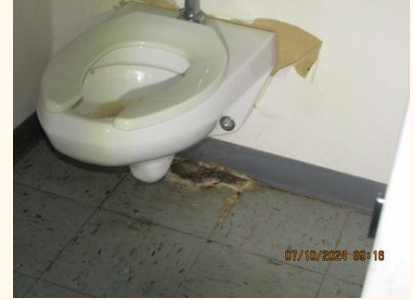
🔑 (B-5) Review: NO water on to unit could not test restroom. Signs of past excessive leaking noted at commode. Cost of cure unknown due testing not possible.

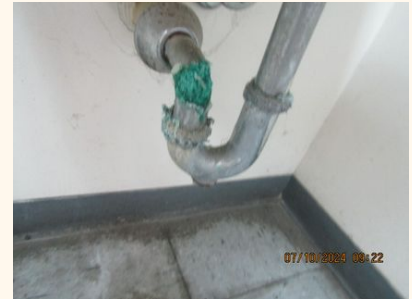
🔑 (B-6) Review:
Drain line corroded. repairs to drain line estimate 300 to 400.00

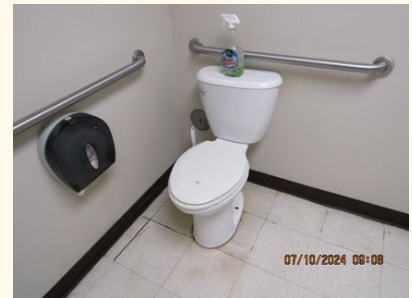
🔑 (B-7) Review:
Loose on the floor. Securing commode estimate 200.00

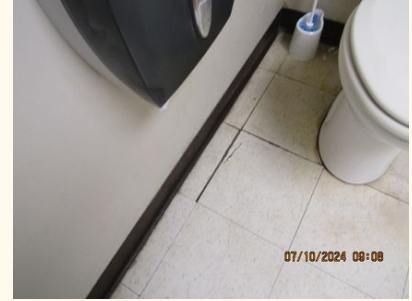
🔑 (B-8) Review:
Floor tiles amiss.

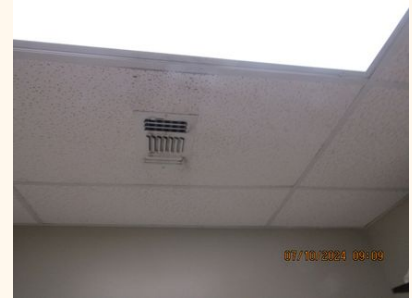
🔑 (B-9) Review:
AC register dirty

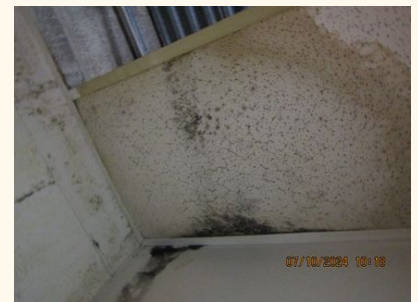
🔑 (B-11) Review: Ceiling tiles water damaged, stained and possible mold noted. Repair of water damage \$5000 to 10000
