The Uniform Building Inspection Report™ Condensed

Commercial - Retail:
Pier One Building, Monroe, LA

Inspection Date:
5/15/2021, 9:00:00 AM

Report Number:
052021A

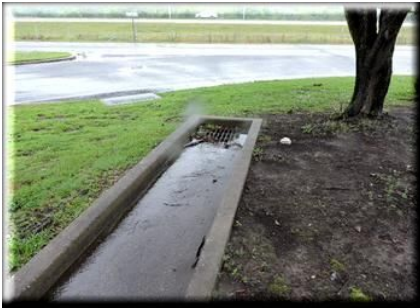
Photo: 0020 (1)

[A] [N] 0020: Erosion potential noted (lack of vegetation / diversion, etc.).

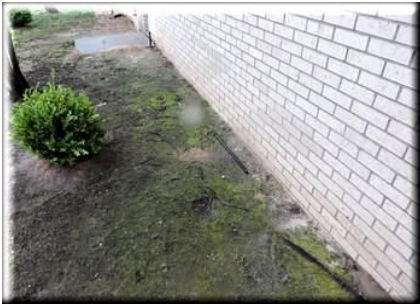
Photo: 0800.02 (1)

[P] [N] 0800.02: Earth separation from building inadequate.

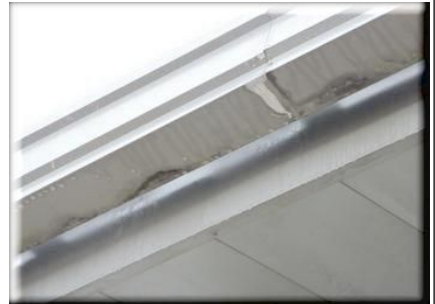
Photo: 1280.04 (2)

[R] [P] [N] [M] 1280.04: Gutter appears to leak.
Monitor the situation on a regular basis. Corrections by a qualified licensed contractor, if and when necessary, are recommended. Discretion advised. The significance of the finding is uncertain. Further study by a qualified licensed contractor is advised. Correction or modification decreases the probability of continued and excessive deterioration. It is recommended that the finding be reviewed, and corrected as needed, by a qualified licensed contractor before purchasing the property.
See Photo(s) 1280.04.

[R] [P] [N] 1280.04: Gutter appears to leak.
Discretion advised. The significance of the finding is uncertain. Further study by a qualified licensed contractor is advised. Correction or modification decreases the probability of continued and excessive deterioration. It is recommended that the finding be reviewed, and corrected as needed, by a qualified licensed contractor before purchasing the property.
See Photo(s) 1280.04.

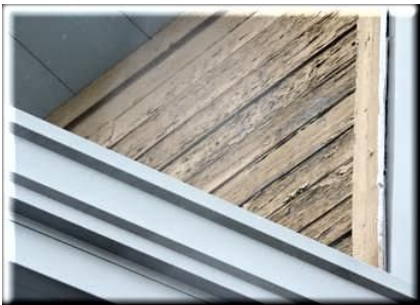
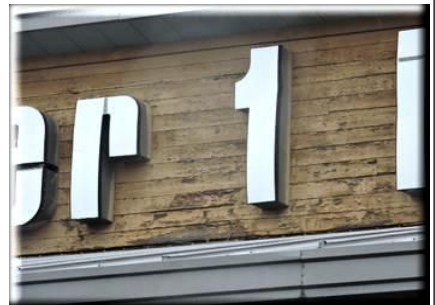
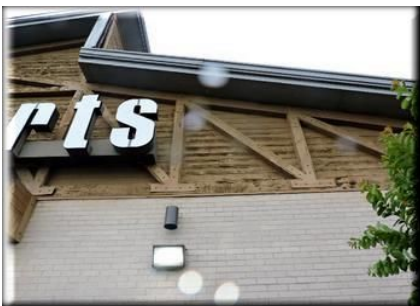
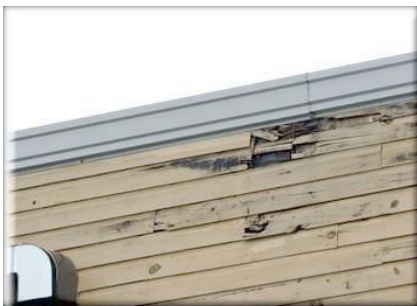
[U] [P] [N] [M] [C] [A] 1310: Siding cracked / holed / gapped / damaged / weathered / stained.
Maintenance, alteration or repair could be expected to improve component appearance and may decrease deterioration. Caution is advised. The finding could be, or could become, hazardous under certain circumstances. The opinion of a qualified licensed contractor is recommended. Monitor the situation on a regular basis. Corrections by a qualified licensed contractor, if and when necessary, are recommended. Discretion advised. The significance of the finding is uncertain. Further study by a qualified licensed contractor is advised. Correction or modification decreases the probability of continued and excessive deterioration. Modification or addition is generally considered an upgrade which should improve safety or efficiency. The opinion of a qualified licensed contractor is recommended.
See Photo(s) 1310.

[U] [R] [P] [N] [M] 1310: Siding cracked / holed / gapped / damaged / weathered / stained.
Monitor the situation on a regular basis. Corrections by a qualified licensed contractor, if and when necessary, are recommended. Discretion advised. The significance of the finding is uncertain. Further study by a qualified licensed contractor is advised. Correction or modification decreases the probability of continued and excessive deterioration. It is recommended that the finding be reviewed, and corrected as needed, by a qualified licensed contractor before purchasing the property. Modification or addition is generally considered an upgrade which should improve safety or efficiency. The opinion of a qualified licensed contractor is recommended.
See Photo(s) 1310.

[U] [R] [P] [N] 1310: Siding cracked / holed / gapped / damaged / weathered / stained.
Discretion advised. The significance of the finding is uncertain. Further study by a qualified licensed contractor is advised. Correction or modification decreases the probability of continued and excessive deterioration. It is recommended that the finding be reviewed, and corrected as needed, by a qualified licensed contractor before purchasing the property. Modification or addition is generally considered an upgrade which should improve safety or efficiency. The opinion of a qualified licensed contractor is recommended.
See Photo(s) 1310.

[A] [U] [R] [P] [N] [M] [H] 1310: Siding cracked / holed / gapped / damaged / weathered / stained.
The finding should be considered hazardous. Corrections by a qualified licensed contractor, before purchasing the property, are advised. Monitor the situation on a regular basis. Corrections by a qualified licensed contractor, if and when necessary, are recommended. Discretion advised. The significance of the finding is uncertain. Further study by a qualified licensed contractor is advised. It is recommended that the finding be reviewed, and corrected as needed, by a qualified licensed contractor before purchasing the property. Modification or addition is generally considered an upgrade which should improve safety or efficiency. The opinion of a qualified licensed contractor is recommended. Maintenance, alteration or repair could be expected to improve component appearance and may decrease deterioration.

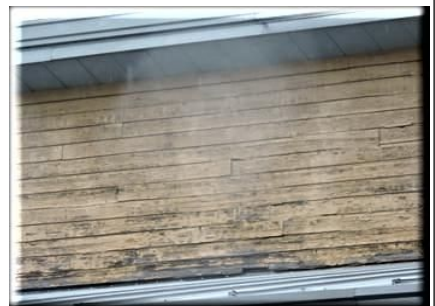
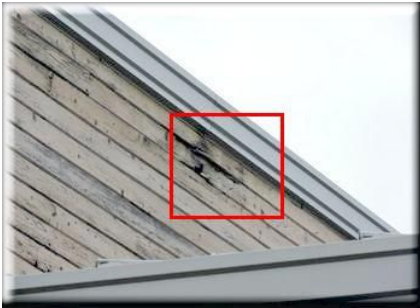
Photo: 1310.04 (1)

[U] [R] [P] [N] [M] 1310.04: Siding damaged.
Monitor the situation on a regular basis. Corrections by a qualified licensed contractor, if and when necessary, are recommended. Discretion advised. The significance of the finding is uncertain. Further study by a qualified licensed contractor is advised. Correction or modification decreases the probability of continued and excessive deterioration. It is recommended that the finding be reviewed, and corrected as needed, by a qualified licensed contractor before purchasing the property. Modification or addition is generally considered an upgrade which should improve safety or efficiency. The opinion of a qualified licensed contractor is recommended.

[R] [P] [N] [M] 1310.04: Siding damaged.
Monitor the situation on a regular basis. Corrections by a qualified licensed contractor, if and when necessary, are recommended. Discretion advised. The significance of the finding is uncertain. Further study by a qualified licensed contractor is advised. Correction or modification decreases the probability of continued and excessive deterioration. It is recommended that the finding be reviewed, and corrected as needed, by a qualified licensed contractor before purchasing the property. Noted at numerous and various locations around the exterior of the building.
See Photo(s) 1310.04.

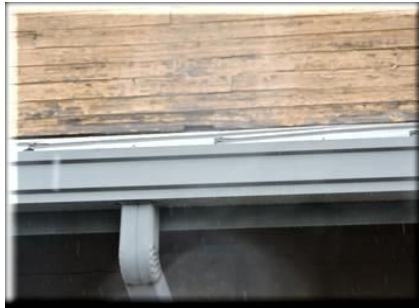
Photo: 1310.05 (1)

[U] [R] [P] [N] 1310.05: Siding weathered.
Discretion advised. The significance of the finding is uncertain. Further study by a qualified licensed contractor is advised. Correction or modification decreases the probability of continued and excessive deterioration. It is recommended that the finding be reviewed, and corrected as needed, by a qualified licensed contractor before purchasing the property. Modification or addition is generally considered an upgrade which should improve safety or efficiency. The opinion of a qualified licensed contractor is recommended.
See Photo(s) 1310.05.

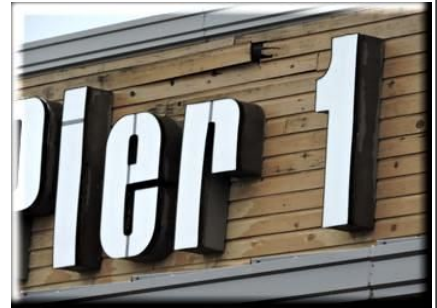
Photo: 1320.01 (1)

[R] [P] [N] [M] 1320.01: Siding loose.
Monitor the situation on a regular basis. Corrections by a qualified licensed contractor, if and when necessary, are recommended. Discretion advised. The significance of the finding is uncertain. Further study by a qualified licensed contractor is advised. Correction or modification decreases the probability of continued and excessive deterioration. It is recommended that the finding be reviewed, and corrected as needed, by a qualified licensed contractor before purchasing the property. Recommend reposition and secure siding components to prevent water penetration.
See Photo(s) 1320.01.

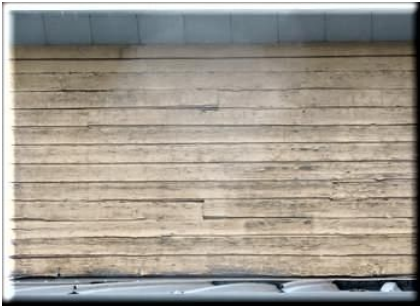
Photo: 1320.02 (1)

[U] [P] [N] 1320.02: Siding buckled.
Discretion advised. The significance of the finding is uncertain. Further study by a qualified licensed contractor is advised. Correction or modification decreases the probability of continued and excessive deterioration. Modification or addition is generally considered an upgrade which should improve safety or efficiency. The opinion of a qualified licensed contractor is recommended. Noted at numerous and various locations around the exterior of the building.
See Photo(s) 1320.02.

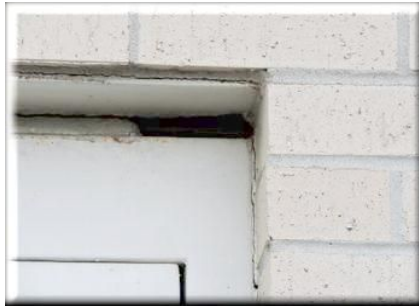
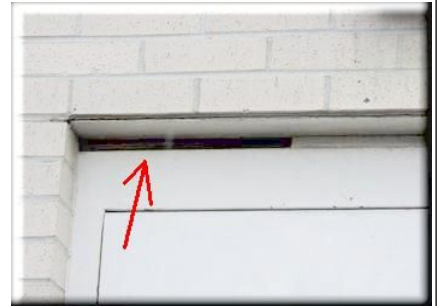
[P] [N] 1350.08: Mortar missing.
Discretion advised. The significance of the finding is uncertain. Further study by a qualified licensed contractor is advised. Correction or modification decreases the probability of continued and excessive deterioration.
See Photo(s) 1350.08.

[P] [N] 1350.08: Mortar missing.
Discretion advised. The significance of the finding is uncertain.
Further study by a qualified licensed contractor is advised.
Correction or modification decreases the probability of continued and excessive deterioration.
See Photo(s) 1350.08.

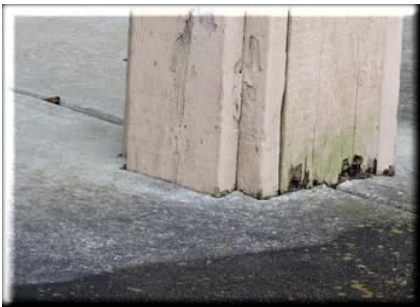
Photo: 1430.22 (1)

[A] [P] [N] 1430.22: Siding trim damaged.
Discretion advised. The significance of the finding is uncertain.
Further study by a qualified licensed contractor is advised.
Correction or modification decreases the probability of continued and excessive deterioration. Maintenance, alteration or repair could be expected to improve component appearance and may decrease deterioration. Noted at numerous and various locations around the exterior of the building.
See Photo(s) 1430.22.

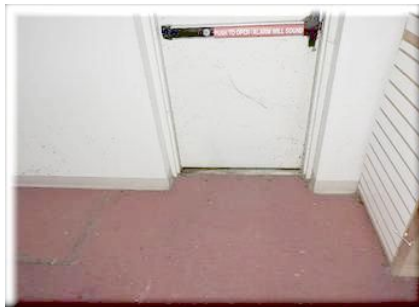
Photo: 1600.02 (1)

[P] [A] 1600.02: Door surface damaged.
Maintenance, alteration or repair could be expected to improve component appearance and may decrease deterioration. Correction or modification decreases the probability of continued and excessive deterioration.
See Photo(s) 1600.02.

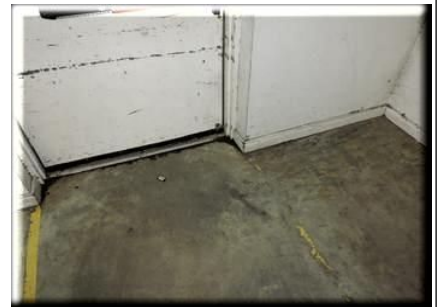
Photo: 1620.03 (1)

[P] [N] 1620.03: Door faulty or otherwise amiss.
Water stains noted at base of exterior doors not the interior of the building. Discretion advised. The significance of the finding is uncertain. Further study by a qualified licensed contractor is advised.
Correction or modification decreases the probability of continued and excessive deterioration.
See Photo(s) 1620.03.

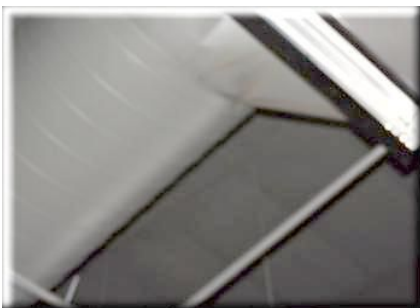
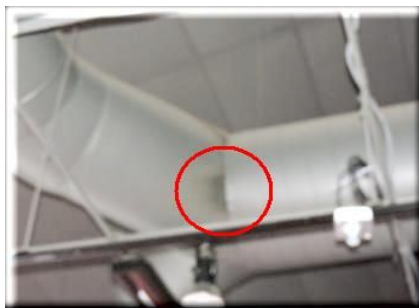
[E] [U] [R] [P] [N] [M] 2200.03: Ducting leaking.
Monitor the situation on a regular basis. Corrections by a qualified licensed contractor, if and when necessary, are recommended.
Discretion advised. The significance of the finding is uncertain.
Further study by a qualified licensed contractor is advised.
Correction or modification decreases the probability of continued and excessive deterioration. It is recommended that the finding be reviewed, and corrected as needed, by a qualified licensed contractor before purchasing the property. Modification or addition is generally considered an upgrade which should improve safety or efficiency.
The opinion of a qualified licensed contractor is recommended.
Repair, alteration or replacement usually improves the efficiency of the component or system.
See Photo(s) 2200.03.

[E] [A] 2200.03: Ducting leaking.
Maintenance, alteration or repair could be expected to improve

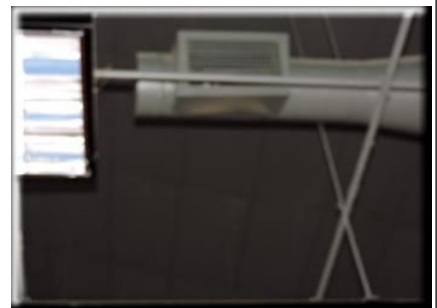
Photo: 2200.07 (1)

[P] [N] 2200.07: Duct cleaning recommended.
Discretion advised. The significance of the finding is uncertain. Further study by a qualified licensed contractor is advised. Correction or modification decreases the probability of continued and excessive deterioration.
See Photo(s) 2200.07.

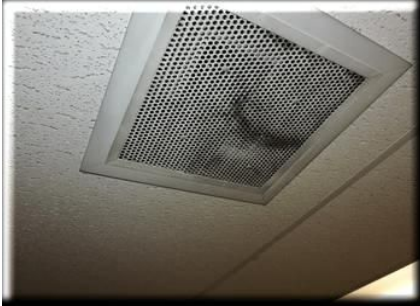
Photo: 2240 (1)

[P] [N] [M] 2240: Register loose / damaged / missing / amiss. Monitor the situation on a regular basis. Corrections by a qualified licensed contractor, if and when necessary, are recommended. Discretion advised. The significance of the finding is uncertain. Further study by a qualified licensed contractor is advised. Correction or modification decreases the probability of continued and excessive deterioration.
See Photo(s) 2240.

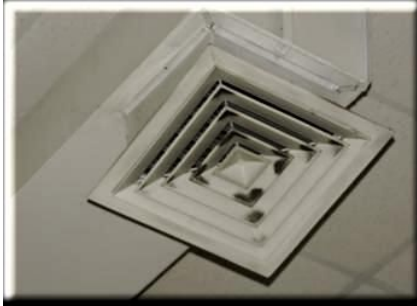
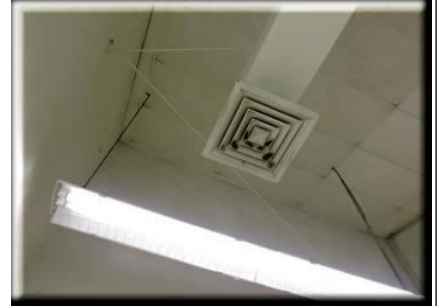
[U] [R] [P] [N] 2240.04: Register faulty or otherwise amiss. Registers appears to have suspected mold or dirty. Recommend duct cleaning and mold testing. Discretion advised. The significance of the finding is uncertain. Further study by a qualified licensed contractor is advised. Correction or modification decreases the probability of continued and excessive deterioration. It is recommended that the finding be reviewed, and corrected as needed, by a qualified licensed contractor before purchasing the property. Modification or addition is generally considered an upgrade which should improve safety or efficiency. The opinion of a qualified licensed contractor is recommended.
See Photo(s) 2240.04.

[A] 2240.04: Register faulty or otherwise amiss. Maintenance, alteration or repair could be expected to improve component appearance and may decrease deterioration.
See Photo(s) 2240.04.

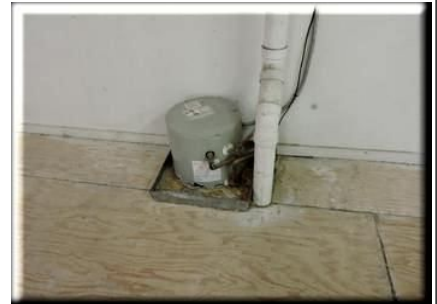
Photo: 4010.01 (1)

[N] 4010.01: Electric water heater electrical supply improper. Discretion advised. The significance of the finding is uncertain. Further study by a qualified licensed contractor is advised.
See Photo(s) 4010.01.

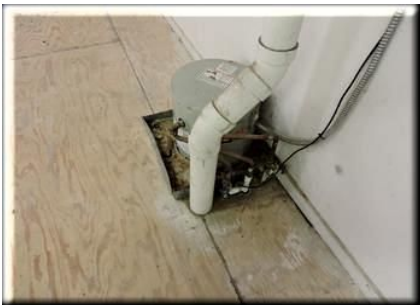
Photo: 4260.03 (1)

[M] 4260.03: Water heater stand faulty or otherwise amiss. Monitor the situation on a regular basis. Corrections by a qualified licensed contractor, if and when necessary, are recommended.
See Photo(s) 4260.03.

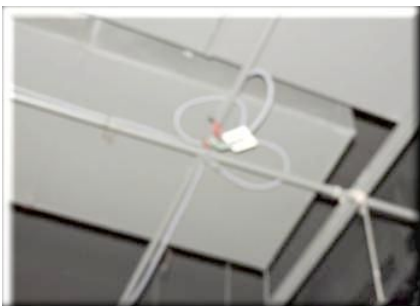
Photo: 5300 (1)

[P] 5300: Junction box not installed as required (exposed splice). Correction or modification decreases the probability of continued and excessive deterioration.
See Photo(s) 5300.

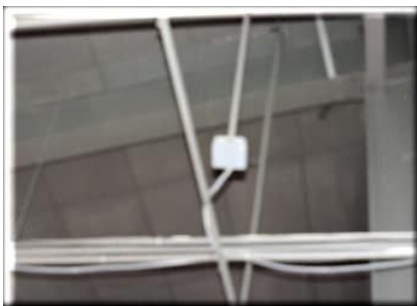
Photo: 5360.10 (1)

[P] 5360.10: Conduit not secured. Correction or modification decreases the probability of continued and excessive deterioration.
See Photo(s) 5360.10.

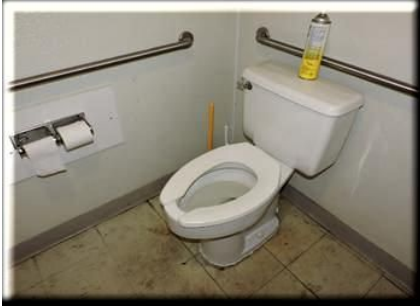
Photo: 6200.01 (1)

[P] [N] 6200.01: Water closet bowl loose on floor.
Discretion advised. The significance of the finding is uncertain. Further study by a qualified licensed contractor is advised. Correction or modification decreases the probability of continued and excessive deterioration.
See Photo(s) 6200.01.

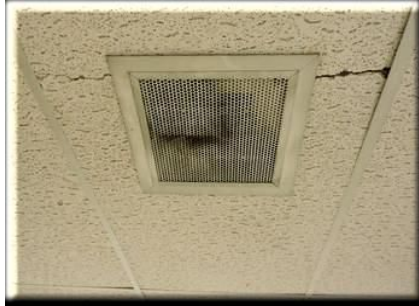
Photo: 6500.04 (1)

[P] [N] 6500.04: Exhaust fan needs cleaning.
Discretion advised. The significance of the finding is uncertain. Further study by a qualified licensed contractor is advised. Correction or modification decreases the probability of continued and excessive deterioration. Noted in men's restroom.
See Photo(s) 6500.04.

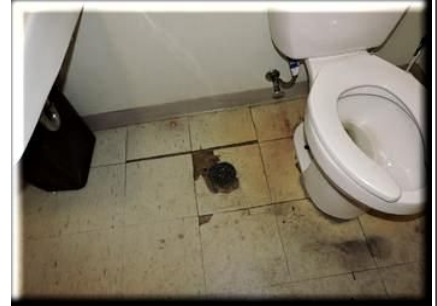
Photo: 6640.01 (1)

[A] [M] [P] 6640.01: Flooring damaged.
Noted in men's rest room. Correction or modification decreases the probability of continued and excessive deterioration. Monitor the situation on a regular basis. Corrections by a qualified licensed contractor, if and when necessary, are recommended. Maintenance, alteration or repair could be expected to improve component appearance and may decrease deterioration.
See Photo(s) 6640.01.

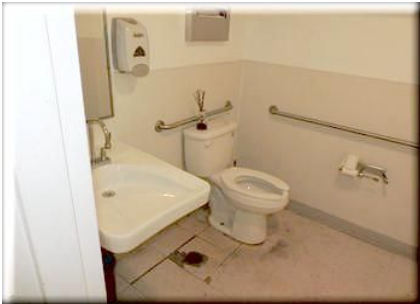
Photo: 6640.02 (1)

[A] [P] [N] 6640.02: Flooring deteriorated.
Discretion advised. The significance of the finding is uncertain. Further study by a qualified licensed contractor is advised. Correction or modification decreases the probability of continued and excessive deterioration. Maintenance, alteration or repair could be expected to improve component appearance and may decrease deterioration.
See Photo(s) 6640.02.

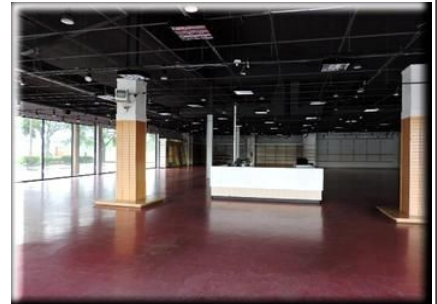
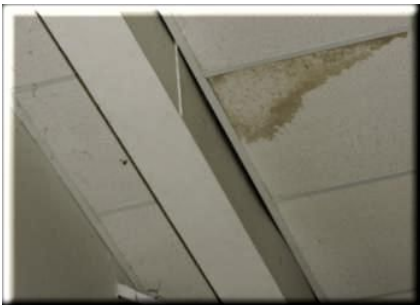
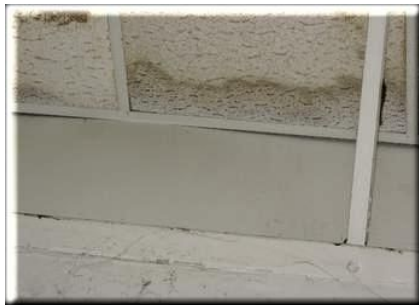
[R] [P] [N] 7000: Stain / discoloration noted on interior surface. Discretion advised. The significance of the finding is uncertain. Further study by a qualified licensed contractor is advised. Correction or modification decreases the probability of continued and excessive deterioration. It is recommended that the finding be reviewed, and corrected as needed, by a qualified licensed contractor before purchasing the property. See Photo(s) 7000.

[A] 7000: Stain / discoloration noted on interior surface. See Photo(s) 7000.

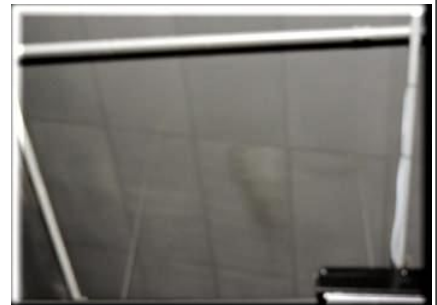
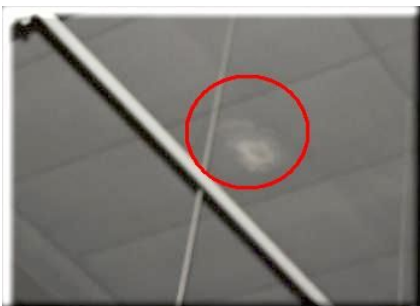
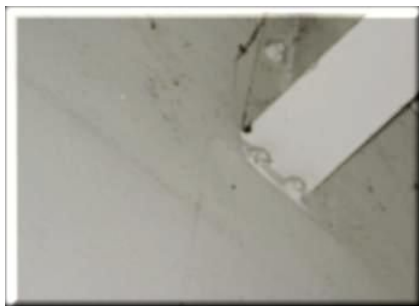
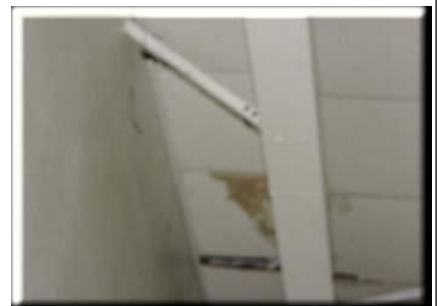
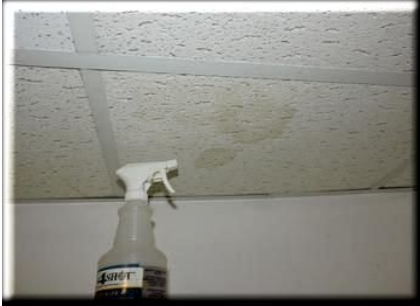
[M] [A] 7000.01: Stain noted on interior surface. Noted in ladies restroom. Maintenance, alteration or repair could be expected to improve component appearance and may decrease deterioration. Monitor the situation on a regular basis. Corrections by a qualified licensed contractor, if and when necessary, are recommended. See Photo(s) 7000.01.

[R] [P] [N] 7000.01: Stain noted on interior surface. Discretion advised. The significance of the finding is uncertain. Further study by a qualified licensed contractor is advised. Correction or modification decreases the probability of continued and excessive deterioration. It is recommended that the finding be reviewed, and corrected as needed, by a qualified licensed contractor before purchasing the property. See Photo(s) 7000.01.

[M] [A] 7000.01: Stain noted on interior surface. Maintenance, alteration or repair could be expected to improve component appearance and may decrease deterioration. Monitor the situation on a regular basis. Corrections by a qualified licensed contractor, if and when necessary, are recommended. See Photo(s) 7000.01.

[R] [P] [N] [M] [A] 7000.01: Stain noted on interior surface. Maintenance, alteration or repair could be expected to improve component appearance and may decrease deterioration. Monitor the situation on a regular basis. Corrections by a qualified licensed

[N] 7000.01: Stain noted on interior surface.
Discretion advised. The significance of the finding is uncertain. Further study by a qualified licensed contractor is advised.
See Photo(s) 7000.01.

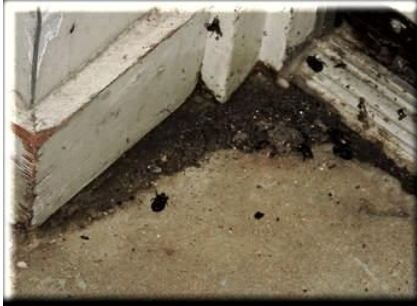
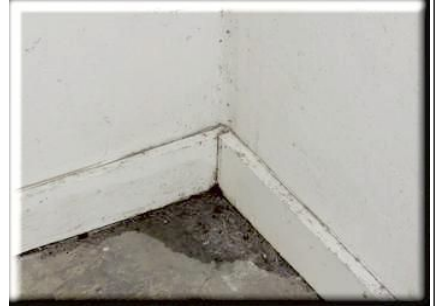
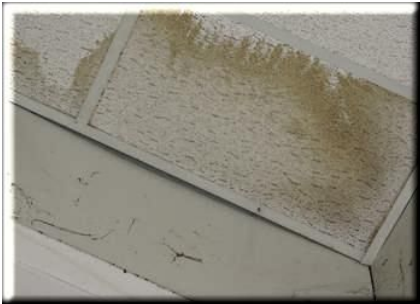
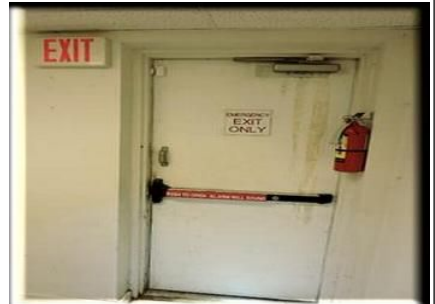
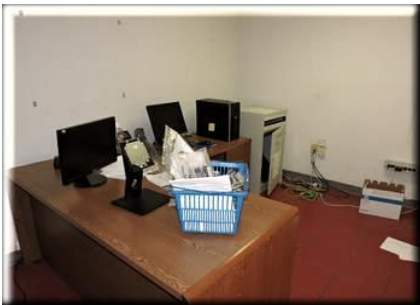
[M] [N] 7010: Water intrusion evidence or water damage noted. Discretion advised. The significance of the finding is uncertain. Further study by a qualified licensed contractor is advised. Monitor the situation on a regular basis. Corrections by a qualified licensed contractor, if and when necessary, are recommended.
See Photo(s) 7010.

[R] 7010: Water intrusion evidence or water damage noted. It is recommended that the finding be reviewed, and corrected as needed, by a qualified licensed contractor before purchasing the property.
See Photo(s) 7010.

[P] [N] 7010: Water intrusion evidence or water damage noted. Noted in storage room to exterior. Discretion advised. The significance of the finding is uncertain. Further study by a qualified licensed contractor is advised. Correction or modification decreases the probability of continued and excessive deterioration.
See Photo(s) 7010.

[R] [P] [N] 7010: Water intrusion evidence or water damage noted. Discretion advised. The significance of the finding is uncertain. Further study by a qualified licensed contractor is advised. Correction or modification decreases the probability of continued and excessive deterioration. It is recommended that the finding be reviewed, and corrected as needed, by a qualified licensed contractor before purchasing the property.
See Photo(s) 7010.

[M] 7010: Water intrusion evidence or water damage noted. Monitor the situation on a regular basis. Corrections by a qualified

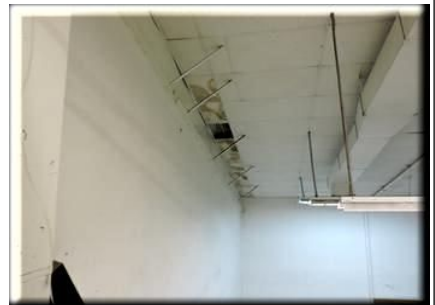
Photo: 7040 (1)

[R] [P] [N] [M] 7040: Wall / ceiling cracked / gapped / holed / damaged
Monitor the situation on a regular basis. Corrections by a qualified licensed contractor, if and when necessary, are recommended.
Discretion advised. The significance of the finding is uncertain.
Further study by a qualified licensed contractor is advised.
Correction or modification decreases the probability of continued and excessive deterioration. It is recommended that the finding be reviewed, and corrected as needed, by a qualified licensed contractor before purchasing the property.
See Photo(s) 7040.

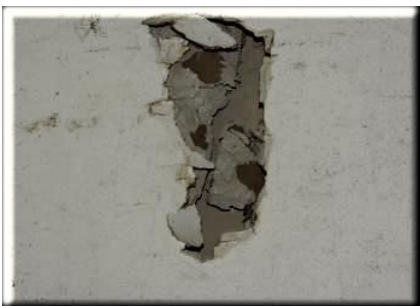
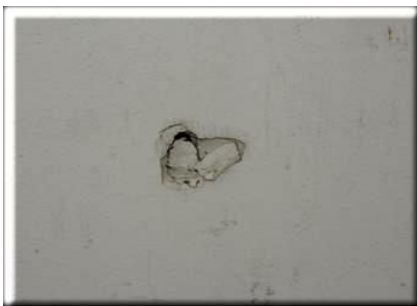
[P] [N] 7040.03: Wall holed.
Discretion advised. The significance of the finding is uncertain.
Further study by a qualified licensed contractor is advised.
Correction or modification decreases the probability of continued and excessive deterioration. NOTed in storage room.
See Photo(s) 7040.03.

[P] [N] 7040.03: Wall holed.
Discretion advised. The significance of the finding is uncertain.
Further study by a qualified licensed contractor is advised.
Correction or modification decreases the probability of continued and excessive deterioration.
See Photo(s) 7040.03.

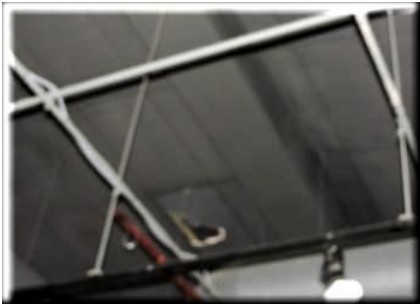
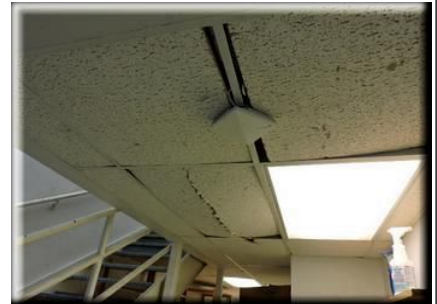
[A] 7060.04: Ceiling covering damaged.
See Photo(s) 7060.04.
