The Uniform Building Inspection Report™ Condensed

Single Family Residence:

1860 HWY 577, Winnsboro, LA 71295

Inspection Date:

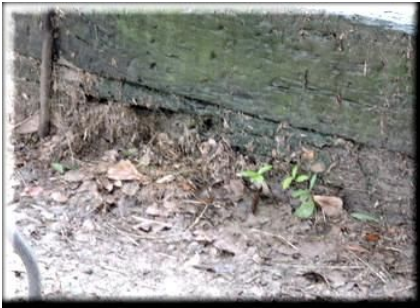
Photo: 0160.03 (1)

[P] [N] 0160.03: Retaining wall deteriorated or otherwise damaged. Discretion advised. The significance of the finding is uncertain. Further study by a qualified licensed contractor is advised. Correction or modification decreases the probability of continued and excessive deterioration. See Photo(s) 0160.03.

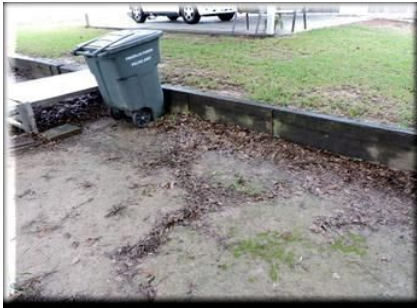
Photo: 0180 (1)

[U] [R] [P] [N] 0180: Retaining wall weep holes appear inadequate or not provided. Discretion advised. The significance of the finding is uncertain. Further study by a qualified licensed contractor is advised. Correction or modification decreases the probability of continued and excessive deterioration. It is recommended that the finding be reviewed, and corrected as needed, by a qualified licensed contractor before purchasing the property. Modification or addition is generally considered an upgrade which should improve safety or efficiency. The opinion of a qualified licensed contractor is recommended. It may be possible that an underground drainage system removes any water from behind the wall. See Photo(s) 0180.

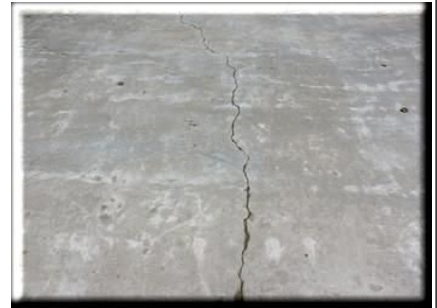
Photo: 0210.01 (1)

[P] [N] [A] 0210.01: Concrete cracks noted. Maintenance, alteration or repair could be expected to improve component appearance and may decrease deterioration. Discretion advised. The significance of the finding is uncertain. Further study by a qualified licensed contractor is advised. Correction or modification decreases the probability of continued and excessive deterioration. See Photo(s) 0210.01.

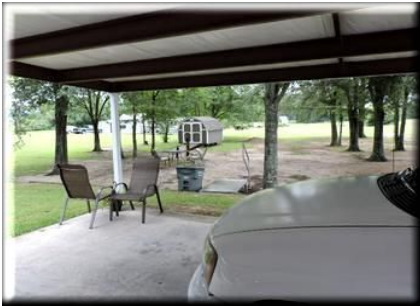
Photo: 0960 (1)

[Note] 0960: Finding not covered in the narratives. Outbuildings present on site but not included in the home inspection. Most outbuilding will need some maintenance or repairs. The inspector did not inspect these additional structures at the time of the inspection.

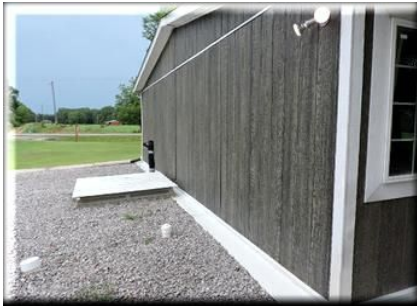
Photo: 1320 (1)

[P] [N] 1320: Siding loose / buckled / warped.
Discretion advised. The significance of the finding is uncertain.
Further study by a qualified licensed contractor is advised.
Correction or modification decreases the probability of continued and excessive deterioration. Noted at various locations.
See Photo(s) 1320.

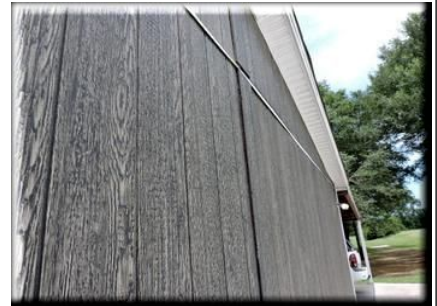
Photo: 1320.01 (1)

[P] 1320.01: Siding loose.
Correction or modification decreases the probability of continued and excessive deterioration.
See Photo(s) 1320.01.

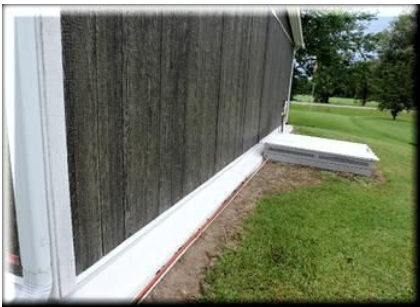
Photo: 1320.02 (1)

[P] [N] 1320.02: Siding buckled.
Discretion advised. The significance of the finding is uncertain.
Further study by a qualified licensed contractor is advised.
Correction or modification decreases the probability of continued and excessive deterioration.
See Photo(s) 1320.02.

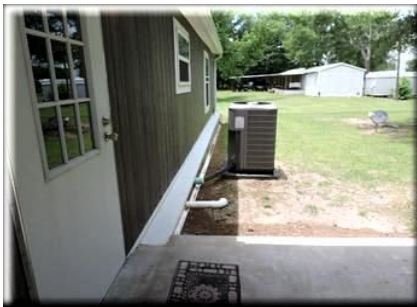
Photo: 2070.05 (1)

[P] 2070.05: Compressor not level.
Correction or modification decreases the probability of continued and excessive deterioration.
See Photo(s) 2070.05.

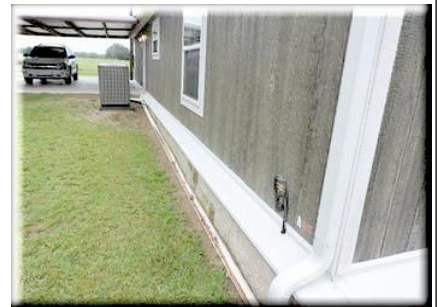
Photo: 2400.21 (1)

[P] [N] 2400.21: AC safety shut-off missing.
Discretion advised. The significance of the finding is uncertain.
Further study by a qualified licensed contractor is advised.
Correction or modification decreases the probability of continued and excessive deterioration.
See Photo(s) 2400.21.

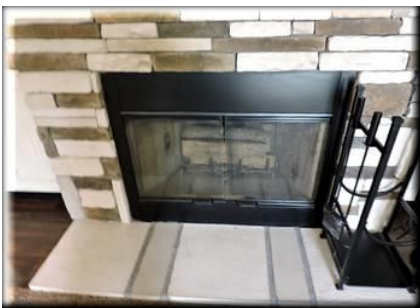
Photo: 2650 (1)

[R] 2650: Clean and review chimney and firebox (soot / creosote / debris noted).
It is recommended that the finding be reviewed, and corrected as needed, by a qualified licensed contractor before purchasing the property.
See Photo(s) 2650.

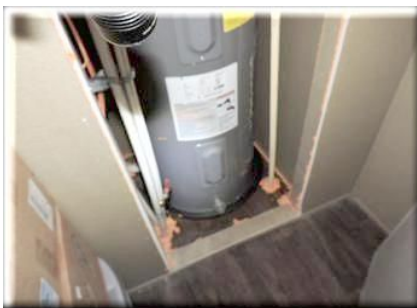
Photo: 4260.10 (1)

[P] [N] 4260.10: No water heater overflow pan (also known as a drip pan or smitty pan).

Pan appears to be improperly sized for size of tank. Discretion advised. The significance of the finding is uncertain. Further study by a qualified licensed contractor is advised. Correction or modification decreases the probability of continued and excessive deterioration. See Photo(s) 4260.10.

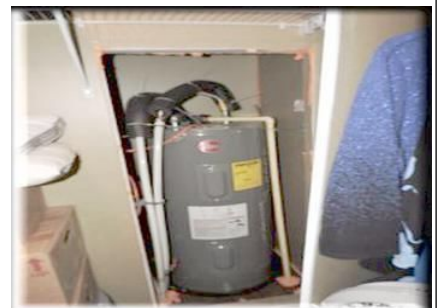
Photo: 4381.01 (1)

[P] 4381.01: Water pipe(s) not supported. Water lines not properly strapped. Correction or modification decreases the probability of continued and excessive deterioration. See Photo(s) 4381.01.

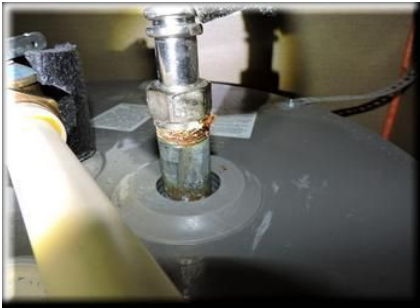
Photo: 4430 (1)

[R] [P] [N] 4430: Water pipes or fittings corroded and/or leaking. Discretion advised. The significance of the finding is uncertain. Further study by a qualified licensed contractor is advised. Correction or modification decreases the probability of continued and excessive deterioration. It is recommended that the finding be reviewed, and corrected as needed, by a qualified licensed contractor before purchasing the property. Noted on the water heater. See Photo(s) 4430.

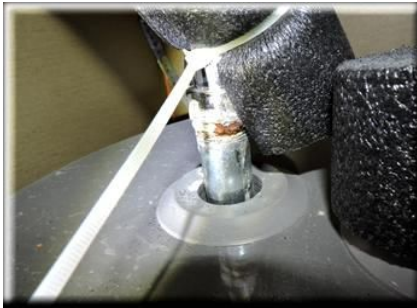
Photo: 4430 (2)

[U] [M] [P] [N] 4430: Water pipes or fittings corroded and/or leaking. Noted on the water heater. Discretion advised. The significance of the finding is uncertain. Further study by a qualified licensed contractor is advised. Correction or modification decreases the probability of continued and excessive deterioration. Monitor the situation on a regular basis. Corrections by a qualified licensed contractor, if and when necessary, are recommended. Modification or addition is generally considered an upgrade which should improve safety or efficiency. The opinion of a qualified licensed contractor is recommended. See Photo(s) 4430.

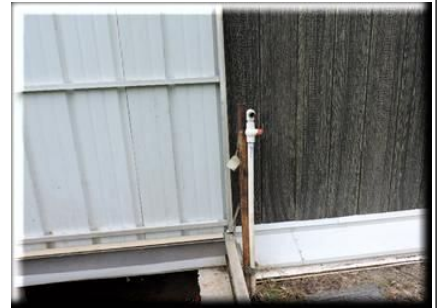
Photo: 4470 (1)

[U] [P] [N] 4470: Water pipes exposed to freeze. (plastic / metallic) Discretion advised. The significance of the finding is uncertain. Further study by a qualified licensed contractor is advised. Correction or modification decreases the probability of continued and excessive deterioration. Modification or addition is generally considered an upgrade which should improve safety or efficiency. The opinion of a qualified licensed contractor is recommended. Recommend keeping all installed insulation in good repair. See Photo(s) 4470.

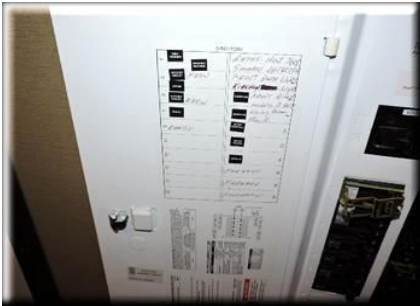
Photo: 5100.13 (1)

[U] [T] 5100.13: Sub panel faulty or otherwise amiss. Interior sub panel does not appear to be wired as required by for sub panels. Although typical or common for the age of the structure or component, modifications and/or repairs may be in order. Modification or addition is generally considered an upgrade which should improve safety or efficiency. The opinion of a qualified licensed contractor is recommended.

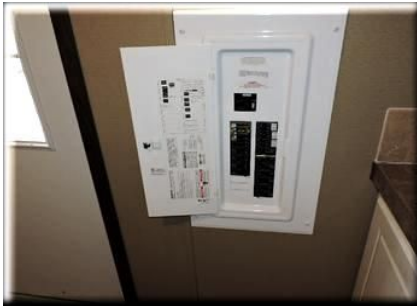
Photo: 5161 (1)

[Note] 5161: Main or sub panel is labeled but not verified.
See Photo(s) 5161.

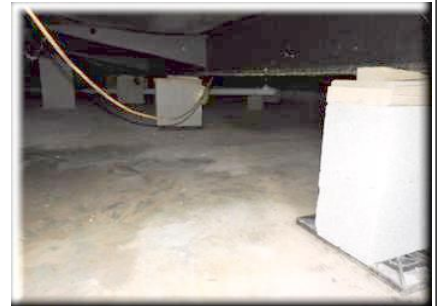
Photo: 5360.01 (1)

[P] 5360.01: Wiring not secured.
Correction or modification decreases the probability of continued and excessive deterioration.
See Photo(s) 5360.01.

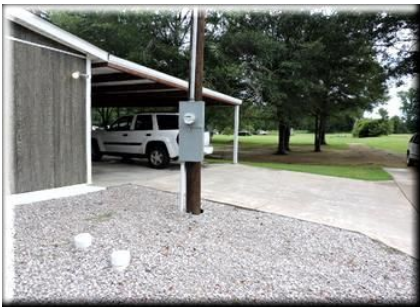
Photo: 5910 (1)

[Note] 5910: Finding not covered in narratives.
Main disconnect located in exterior panel.
See Photo(s) 5910.

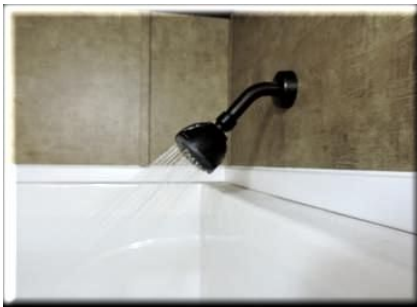
Photo: 6180.03 (1)

[U] [N] [P] 6180.03: Shower head sprays backward.
Correction or modification decreases the probability of continued and excessive deterioration. Discretion advised. The significance of the finding is uncertain. Further study by a qualified licensed contractor is advised. Modification or addition is generally considered an upgrade which should improve safety or efficiency. The opinion of a qualified licensed contractor is recommended.
See Photo(s) 6180.03.

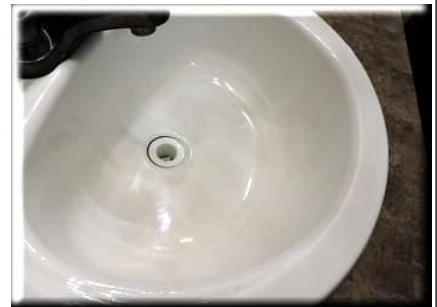
Photo: 6340.01 (1)

[P] 6340.01: Lavatory overflow not installed.
Correction or modification decreases the probability of continued and excessive deterioration.
See Photo(s) 6340.01.

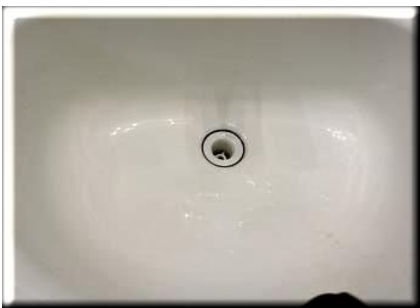
Photo: 6360.03 (1)

[P] [N] 6360.03: Drain stop part(s) missing.
Discretion advised. The significance of the finding is uncertain. Further study by a qualified licensed contractor is advised.
Correction or modification decreases the probability of continued and excessive deterioration.
See Photo(s) 6360.03.

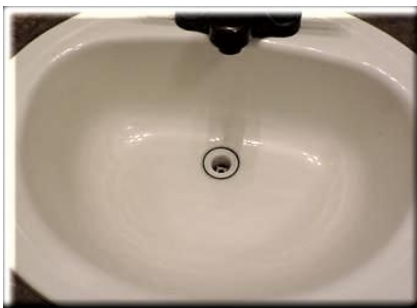
Photo: 6360.03 (2)

[P] 6360.03: Drain stop part(s) missing.
Correction or modification decreases the probability of continued and excessive deterioration.
See Photo(s) 6360.03.

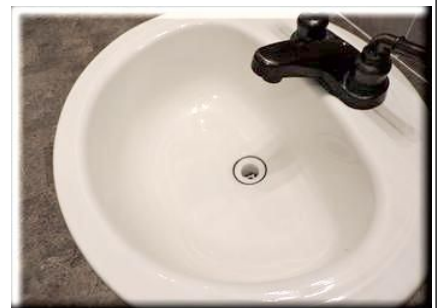
Photo: 6360.03 (3)

[P] [N] 6360.03: Drain stop part(s) missing.
Discretion advised. The significance of the finding is uncertain. Further study by a qualified licensed contractor is advised.
Correction or modification decreases the probability of continued and excessive deterioration.
See Photo(s) 6360.03.

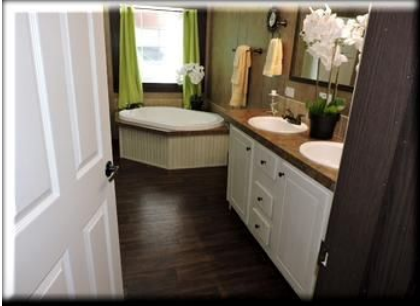
Photo: 6540 (1)

[P] [N] 6540: Window near tub or shower does not appear to be safety glaze.
Discretion advised. The significance of the finding is uncertain.

Further study by a qualified licensed contractor is advised. Correction or modification decreases the probability of continued and excessive deterioration. Glazing in any portion to a building wall enclosing tub or shower compartments where the bottom exposed edging or the glazing is less than 60 inches above a standing surface and drain inlet should be tempered glass. Window which are not tempered or shatterproof that are near tubs or showers can be dangerous. If the position of the window is such that someone could slip or fall against it, breaking the glass, the result could be server personal injury.

Older homes did not require this particular glazing. This item is often mention to bring to your attention a helpful safety reminder. See Photo(s) 6540.

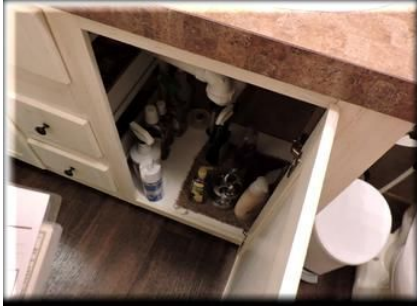
Photo: 6850 (1)

[Note] 6850: Access impaired. cabinets full limiting inspector view of sink plumbing and interior cabinet conditions. See Photo(s) 6850.

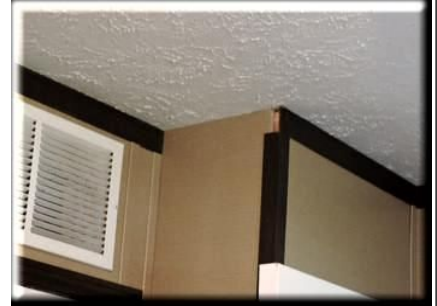
Photo: 7090.01 (1)

[A] [P] 7090.01: Interior trims missing. Correction or modification decreases the probability of continued and excessive deterioration. Maintenance, alteration or repair could be expected to improve component appearance and may decrease deterioration. See Photo(s) 7090.01.

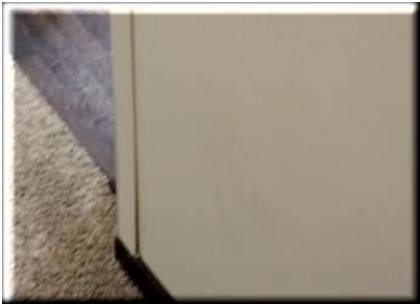
Photo: 7090.04 (1)

[A] 7090.04: Interior trims faulty or otherwise amiss. See Photo(s) 7090.04.

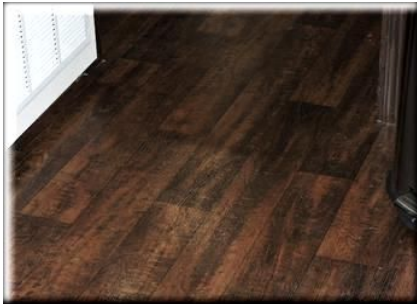
Photo: 7250.01 (1)

[P] 7250.01: Wood flooring damaged. Correction or modification decreases the probability of continued and excessive deterioration. See Photo(s) 7250.01.

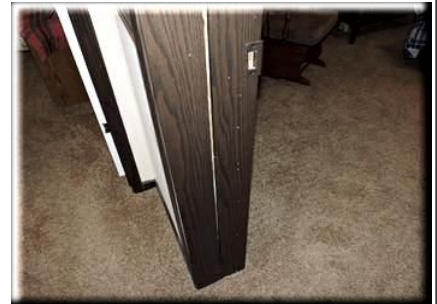
Photo: 7310.03 (1)

[R] [P] [N] 7310.03: Door jamb damaged. Discretion advised. The significance of the finding is uncertain. Further study by a qualified licensed contractor is advised. Correction or modification decreases the probability of continued and excessive deterioration. It is recommended that the finding be reviewed, and corrected as needed, by a qualified licensed contractor before purchasing the property. See Photo(s) 7310.03.

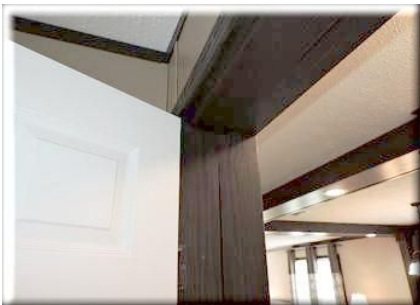
Photo: 7340.13 (1)

[N] [P] 7340.13: Door trims damaged. Door stop trim missing. Correction or modification decreases the probability of continued and excessive deterioration. Discretion advised. The significance of the finding is uncertain. Further study by a qualified licensed contractor is advised. See Photo(s) 7340.13.

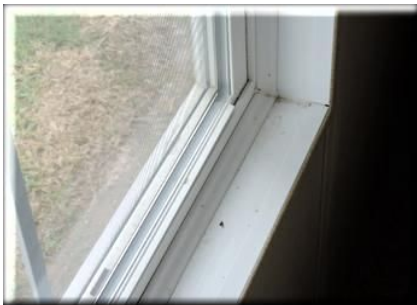
Photo: 7540.04 (1)

[P] [N] 7540.04: Stains noted around window(s).
Discretion advised. The significance of the finding is uncertain.
Further study by a qualified licensed contractor is advised.
Correction or modification decreases the probability of continued and excessive deterioration.
See Photo(s) 7540.04.

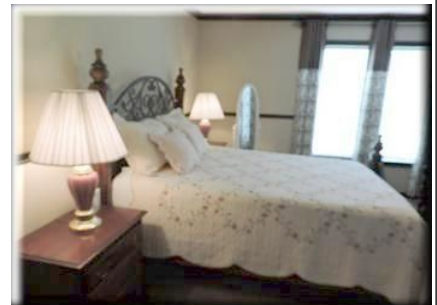
Photo: 7920 (1)

[Note] [+] 7920: Access impaired.
Furniture around walls prevents full review. Personal items prevented complete review of several areas. Picture shown is an example.
See Photo(s) 7920.

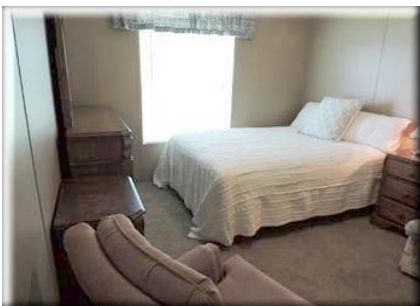
Photo: 7920 (2)

[Note] 7920: Access impaired.
Furniture around walls prevents full review. Personal items prevented complete review of several areas. Picture shown is an example.
See Photo(s) 7920.

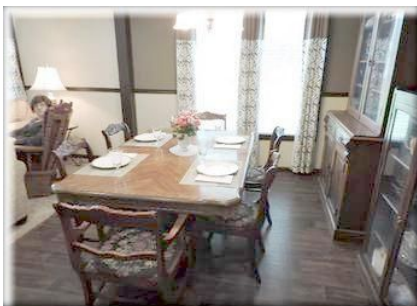
Photo: 7920 (3)

[Note] 7920: Access impaired.
Furniture around walls prevents full review. Personal items prevented complete review of several areas. Picture shown is an example.
See Photo(s) 7920.

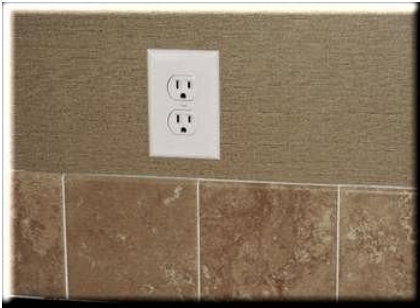
Photo: 8190.01 (1)

[P] [N] 8190.01: Receptacle outlet(s) intended for kitchen countertop use not GFCI type.
Discretion advised. The significance of the finding is uncertain.
Further study by a qualified licensed contractor is advised.
Correction or modification decreases the probability of continued and excessive deterioration.
See Photo(s) 8190.01.

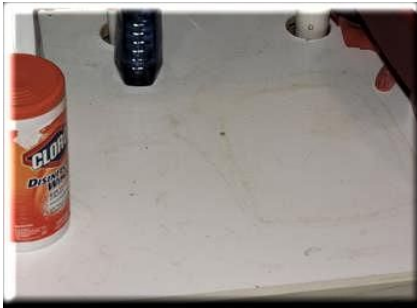
Photo: 8880 (1)

[A] 8880: Evidence of prior leaks (damage / stains under sink / at supply valves).
Maintenance, alteration or repair could be expected to improve component appearance and may decrease deterioration.
See Photo(s) 8880.

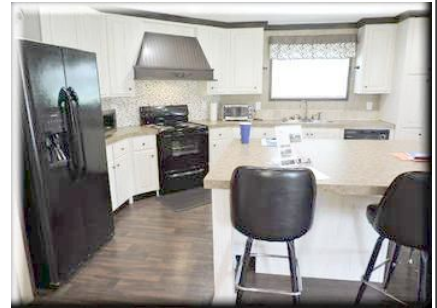
Photo: 8900 (1)

[Note] 8900: Access impaired.
Cabinets full limiting inspector view.
See Photo(s) 8900.

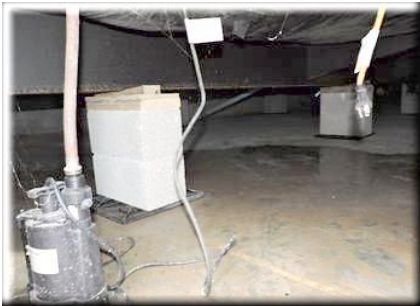
Photo: 9400.10 (1)

[P] [N] 9400.10: Prior or present moisture noted in the crawlspace area.

Discretion advised. The significance of the finding is uncertain.
Further study by a qualified licensed contractor is advised.
Correction or modification decreases the probability of continued and excessive deterioration.
See Photo(s) 9400.10.

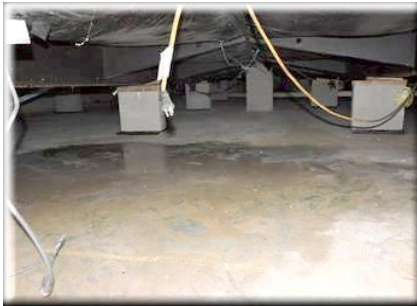
Photo: 9400.10 (2)

[R] [P] [N] 9400.10: Prior or present moisture noted in the crawlspace area.

Discretion advised. The significance of the finding is uncertain.
Further study by a qualified licensed contractor is advised.
Correction or modification decreases the probability of continued and excessive deterioration. It is recommended that the finding be reviewed, and corrected as needed, by a qualified licensed contractor before purchasing the property.
See Photo(s) 9400.10.
