# The Uniform Building Inspection Report™ Condensed

**Single Family Residence:**  
368 Bella court, Frierson, LA

**Inspection Date:**  
10/6/2021, 9:00:00 AM

**Report Number:**  
100521L

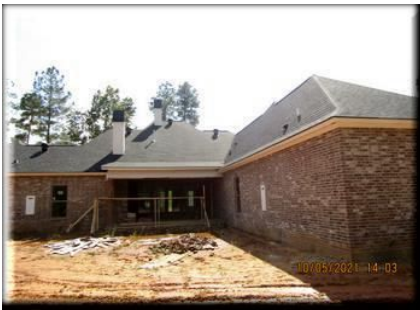
Photo: 0020 (1)

[N] 0020: Erosion potential noted (lack of vegetation / diversion, etc.).

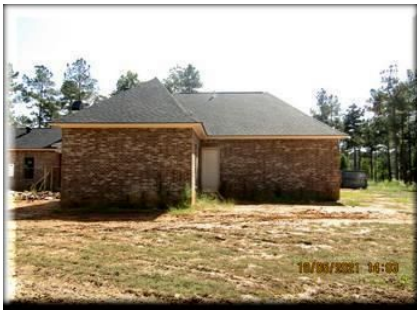
Photo: 0090 (1)

Discretion advised. The significance of the finding is uncertain. Further study by a qualified licensed contractor is advised. Correction or modification decreases the probability of continued and excessive deterioration. It is recommended that the finding be reviewed, and corrected as needed, by a qualified licensed contractor before purchasing the property. Modification or addition is generally considered an upgrade which should improve safety or efficiency. The opinion of a qualified licensed contractor is recommended. See Photo(s) 0090.

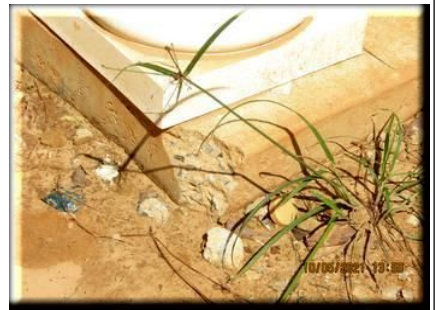
Photo: 0210.02 (1)

[P] 0210.02: Concrete cracks and general deterioration noted. Correction or modification decreases the probability of continued and excessive deterioration. See Photo(s) 0210.02.

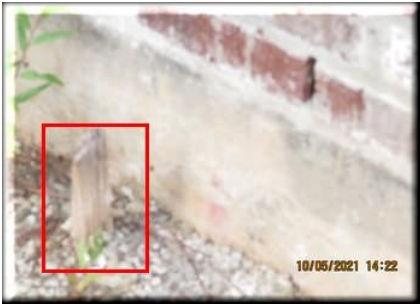
Photo: 0960 (1)

[U] [P] [N] 0960: Finding not covered in the narratives. Construction debris near foundation with may rot or cause possible termites. Discretion advised. The significance of the finding is uncertain. Further study by a qualified licensed contractor is advised. Correction or modification decreases the probability of continued and excessive deterioration. Modification or addition is generally considered an upgrade which should improve safety or efficiency. The opinion of a qualified licensed contractor is recommended. See Photo(s) 0960.

[P] [N] [M] 0960: Finding not covered in the narratives. Construction debris near foundation with may rot or cause possible

termites. Monitor the situation on a regular basis. Corrections by a qualified licensed contractor, if and when necessary, are recommended. Discretion advised. The significance of the finding is uncertain. Further study by a qualified licensed contractor is advised. Correction or modification decreases the probability of continued and excessive deterioration.  
See Photo(s) 0960.

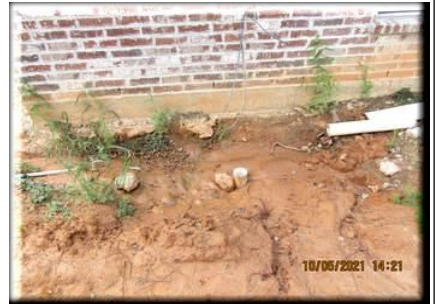
Photo: 0960.20 (1)

[U] [R] [P] [N] [M] 0960.20: Sod installation incomplete. Monitor the situation on a regular basis. Corrections by a qualified licensed contractor, if and when necessary, are recommended. Discretion advised. The significance of the finding is uncertain. Further study by a qualified licensed contractor is advised. Correction or modification decreases the probability of continued and excessive deterioration. It is recommended that the finding be reviewed, and corrected as needed, by a qualified licensed contractor before purchasing the property. Modification or addition is generally considered an upgrade which should improve safety or efficiency. The opinion of a qualified licensed contractor is recommended. See Photo(s) 0960.20.

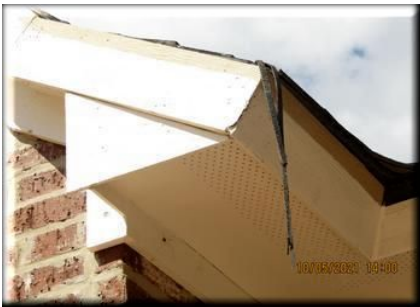
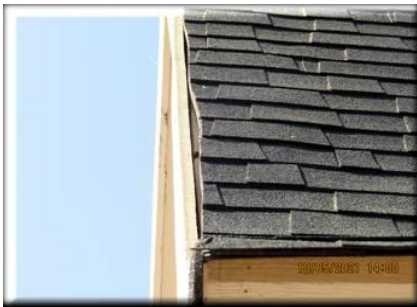
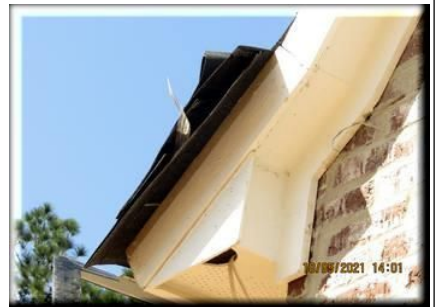
[P] [N] 1000: Roof repairs / general maintenance needed. Discretion advised. The significance of the finding is uncertain. Further study by a qualified licensed contractor is advised. Correction or modification decreases the probability of continued and excessive deterioration.  
See Photo(s) 1000.

[U] [R] [P] [N] [M] 1000: Roof repairs / general maintenance needed. Monitor the situation on a regular basis. Corrections by a qualified licensed contractor, if and when necessary, are recommended. Discretion advised. The significance of the finding is uncertain. Further study by a qualified licensed contractor is advised. Correction or modification decreases the probability of continued and excessive deterioration. It is recommended that the finding be reviewed, and corrected as needed, by a qualified licensed contractor before purchasing the property. Modification or addition is generally considered an upgrade which should improve safety or efficiency. The opinion of a qualified licensed contractor is recommended. See Photo(s) 1000.

[U] [P] [N] 1000: Roof repairs / general maintenance needed. Discretion advised. The significance of the finding is uncertain. Further study by a qualified licensed contractor is advised. Correction or modification decreases the probability of continued and excessive deterioration. Modification or addition is generally considered an upgrade which should improve safety or efficiency. The opinion of a qualified licensed contractor is recommended. See Photo(s) 1000.

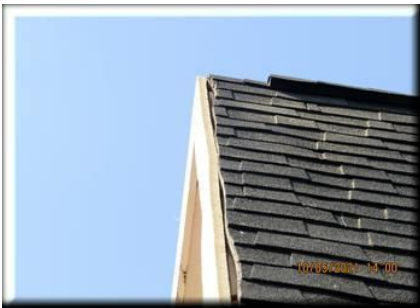
Photo: 1030.02 (1)

[R] [P] [N] 1030.02: Shingles out of position, loose.  
Discretion advised. The significance of the finding is uncertain.  
Further study by a qualified licensed contractor is advised.  
Correction or modification decreases the probability of continued and excessive deterioration. It is recommended that the finding be reviewed, and corrected as needed, by a qualified licensed contractor before purchasing the property.  
See Photo(s) 1030.02.

[R] 1190: Full evaluation and written findings with costs to cure by a qualified Roofing Contractor advised.  
It is recommended that the finding be reviewed, and corrected as needed, by a qualified licensed contractor before purchasing the property.

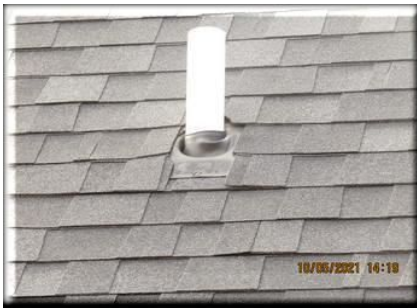
Photo: 1240.04 (1)

[R] [P] [N] 1240.04: Mineral flashing faulty or otherwise amiss.  
Discretion advised. The significance of the finding is uncertain.  
Further study by a qualified licensed contractor is advised.  
Correction or modification decreases the probability of continued and excessive deterioration. It is recommended that the finding be reviewed, and corrected as needed, by a qualified licensed contractor before purchasing the property.  
See Photo(s) 1240.04.

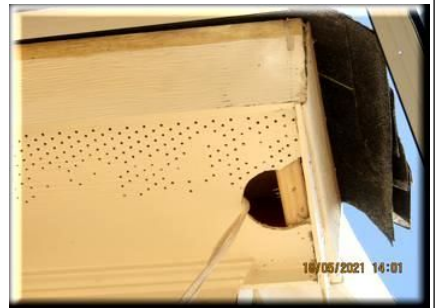
Photo: 1310.02 (1)

[U] [R] [P] [N] 1310.02: Siding holed.  
opening in the soffit for a junction box improper. Discretion advised.  
The significance of the finding is uncertain. Further study by a qualified licensed contractor is advised. Correction or modification decreases the probability of continued and excessive deterioration. It is recommended that the finding be reviewed, and corrected as needed, by a qualified licensed contractor before purchasing the property. Modification or addition is generally considered an upgrade which should improve safety or efficiency. The opinion of a qualified licensed contractor is recommended.  
See Photo(s) 1310.02.

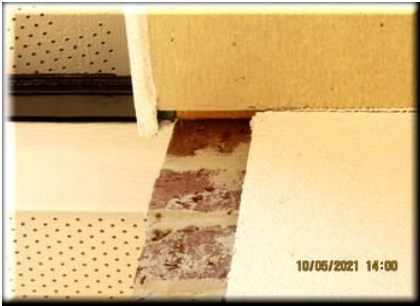
Photo: 1310.03 (1)

[U] [P] [N] 1310.03: Siding gapped.  
Discretion advised. The significance of the finding is uncertain.  
Further study by a qualified licensed contractor is advised.  
Correction or modification decreases the probability of continued and excessive deterioration. Modification or addition is generally considered an upgrade which should improve safety or efficiency. The opinion of a qualified licensed contractor is recommended.  
See Photo(s) 1310.03.

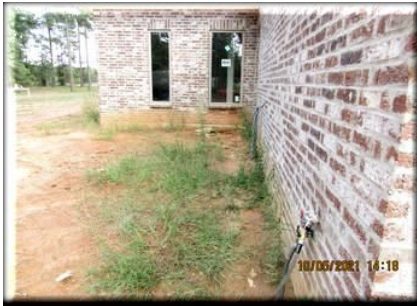
Photo: 1310.06 (1)

[P] [N] 1310.06: Siding stained.  
Discretion advised. The significance of the finding is uncertain.

Further study by a qualified licensed contractor is advised.  
Correction or modification decreases the probability of continued and excessive deterioration.  
See Photo(s) 1310.06.

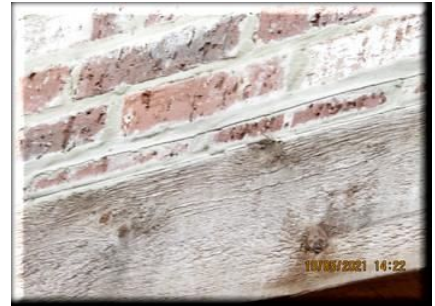
Photo: 1350.01 (1)

[M] [A] 1350.01: Masonry cracked.  
Maintenance, alteration or repair could be expected to improve component appearance and may decrease deterioration. Monitor the situation on a regular basis. Corrections by a qualified licensed contractor, if and when necessary, are recommended.  
See Photo(s) 1350.01.

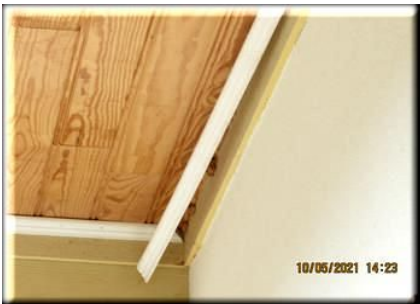
Photo: 1430.21 (1)

[A] [P] [N] 1430.21: Siding trim loose.  
Discretion advised. The significance of the finding is uncertain.  
Further study by a qualified licensed contractor is advised.  
Correction or modification decreases the probability of continued and excessive deterioration. Maintenance, alteration or repair could be expected to improve component appearance and may decrease deterioration.  
See Photo(s) 1430.21.

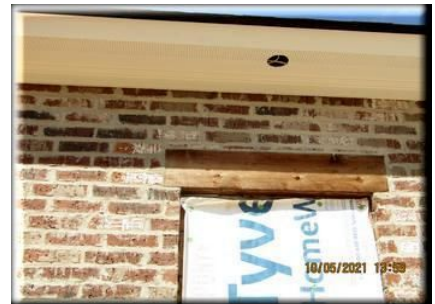
Photo: 1530.03 (1)

[P] [N] 1530.03: Window faulty or otherwise amiss.  
Discretion advised. The significance of the finding is uncertain.  
Further study by a qualified licensed contractor is advised.  
Correction or modification decreases the probability of continued and excessive deterioration.  
See Photo(s) 1530.03.

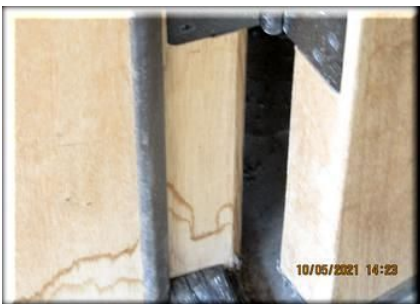
Photo: 1620.03 (1)

[U] [R] [P] [N] 1620.03: Door faulty or otherwise amiss.  
Door appear out of square. Doors not even at entry. Discretion advised. The significance of the finding is uncertain. Further study by a qualified licensed contractor is advised. Correction or modification decreases the probability of continued and excessive deterioration. It is recommended that the finding be reviewed, and corrected as

needed, by a qualified licensed contractor before purchasing the property. Modification or addition is generally considered an upgrade which should improve safety or efficiency. The opinion of a qualified licensed contractor is recommended.  
See Photo(s) 1620.03.

[A] 1620.03: Door faulty or otherwise amiss.  
Door appears to be water stained. Maintenance, alteration or repair could be expected to improve component appearance and may decrease deterioration.  
See Photo(s) 1620.03.

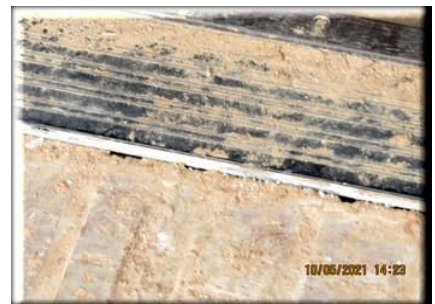
Photo: 1680.04 (1)

[U] [P] [N] 1680.04: Threshold faulty or otherwise amiss.  
Threshold not sealed. Discretion advised. The significance of the finding is uncertain. Further study by a qualified licensed contractor is advised. Correction or modification decreases the probability of continued and excessive deterioration. Modification or addition is generally considered an upgrade which should improve safety or efficiency. The opinion of a qualified licensed contractor is recommended.  
See Photo(s) 1680.04.

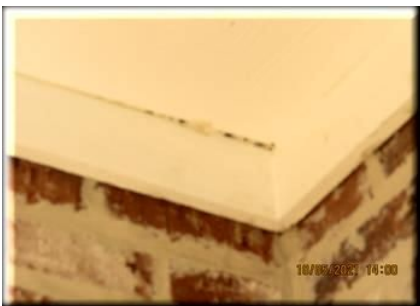
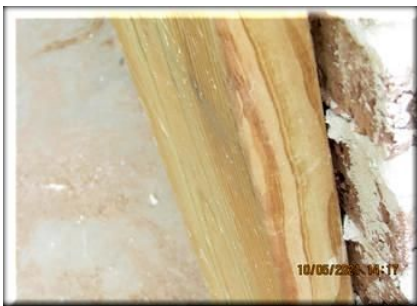
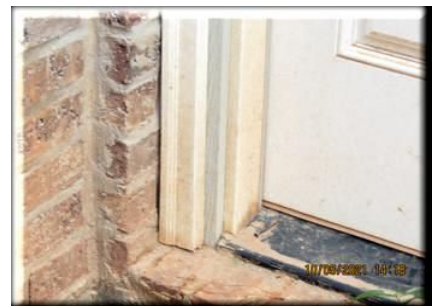
[P] 1910: Caulking, sealing and general repairs to siding / doors / windows needed.  
Correction or modification decreases the probability of continued and excessive deterioration. General caulking and sealing need at plumbing fixtures and piping. Caulking maintenance needed at windows and doors. Caulking or sealing needed at all electrical penetrations.  
See Photo(s) 1910.

[P] 1910: Caulking, sealing and general repairs to siding / doors / windows needed.  
Correction or modification decreases the probability of continued and excessive deterioration.  
See Photo(s) 1910.

[P] [N] 1910: Caulking, sealing and general repairs to siding / doors / windows needed.  
Discretion advised. The significance of the finding is uncertain. Further study by a qualified licensed contractor is advised. Correction or modification decreases the probability of continued and excessive deterioration. General caulking and sealing need at plumbing fixtures and piping. Caulking maintenance needed at windows and doors. Caulking or sealing needed at all electrical penetrations.  
See Photo(s) 1910.

[P] [A] 1910: Caulking, sealing and general repairs to siding / doors / windows needed.

Maintenance, alteration or repair could be expected to improve component appearance and may decrease deterioration. Correction or modification decreases the probability of continued and excessive deterioration.

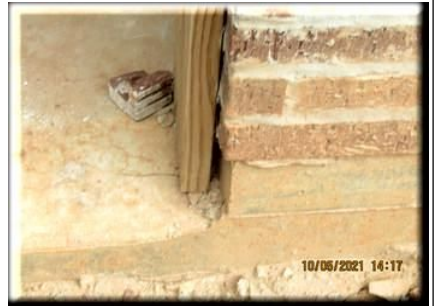
Photo: 1910.01 (1)

[P] 1910.01: Caulking, sealing and general repairs at windows recommended.

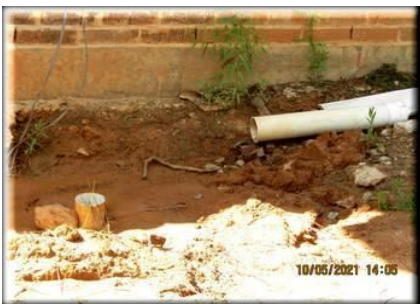
Photo: 4600.04 (1)

[P] [N] 4600.04: Sewer line faulty or otherwise amiss. Discretion advised. The significance of the finding is uncertain. Further study by a qualified licensed contractor is advised. Correction or modification decreases the probability of continued and excessive deterioration. See Photo(s) 4600.04.

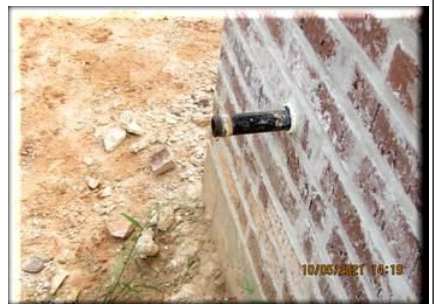
Photo: 4980 (2)

[Note] 4980: Finding not covered in narratives. Private waste system noted by inspector. These types of systems must be inspected by the local health department. This system was not part of the home inspection. See Photo(s) 4980.

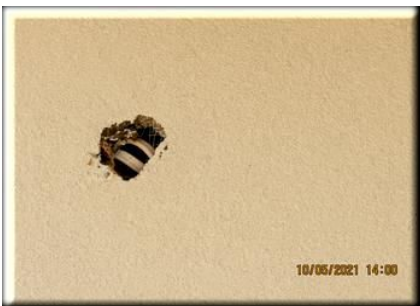
Photo: 5300 (1)

[P] [N] 5300: Junction box not installed as required (exposed splice). Discretion advised. The significance of the finding is uncertain. Further study by a qualified licensed contractor is advised. Correction or modification decreases the probability of continued and excessive deterioration. See Photo(s) 5300.

[P] [N] [M] 5300: Junction box not installed as required (exposed splice). Monitor the situation on a regular basis. Corrections by a qualified licensed contractor, if and when necessary, are recommended. Discretion advised. The significance of the finding is uncertain. Further study by a qualified licensed contractor is advised. Correction or modification decreases the probability of continued and excessive deterioration. This item is entered if the inspector recognizes wiring which appears to have been added or Altered, whether or not the work of amateurs. Building officials normally would not allow this, therefore the inspector is quite certain the work was done without building permits. The visual inspection is not a code compliance inspection and connections made to the electrical system are covered by stringent code requirements. Extra risk may be implied here. Municipal permits may not have been obtained for the work. It is recommended you contact an Electrical Contractor for additional information and addition opinion.

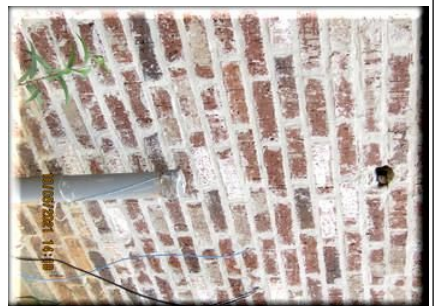
Photo: 5890 (1)

[P] [N] 5890: Unexpected repairs and maintenance. Electrical incomplete. Discretion advised. The significance of the finding is uncertain. Further study by a qualified licensed contractor is advised. Correction or modification decreases the probability of continued and excessive deterioration. See Photo(s) 5890.

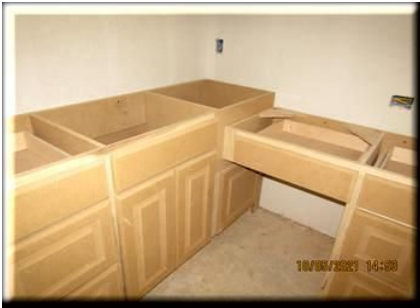
Photo: 6410.03 (1)

[U] [R] [P] [N] [M] 6410.03: Vanity countertop faulty or otherwise amiss. countertops not installed. Monitor the situation on a regular basis. Corrections by a qualified licensed contractor, if and when necessary, are recommended. Discretion advised. The significance of the finding is uncertain. Further study by a qualified licensed contractor is advised. Correction or modification decreases the probability of continued and excessive deterioration. It is recommended that the finding be reviewed, and corrected as needed, by a qualified licensed contractor before purchasing the property. Modification or addition is generally considered an upgrade which should improve safety or efficiency. The opinion of a qualified licensed contractor is recommended. See Photo(s) 6410.03.

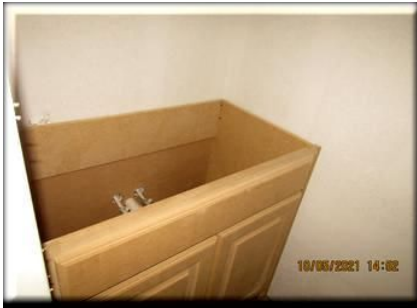
Photo: 6420.03 (1)

[N] [P] 6420.03: Vanity cabinet faulty or otherwise amiss. Correction or modification decreases the probability of continued and excessive deterioration. Discretion advised. The significance of the finding is uncertain. Further study by a qualified licensed contractor is advised. See Photo(s) 6420.03.

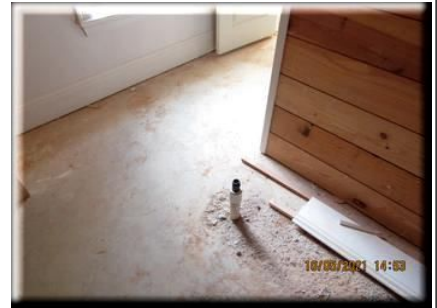
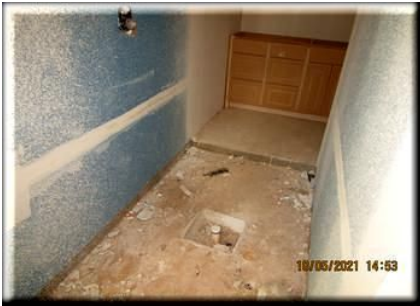
[R] [P] [N] [M] 6870: Unexpected repairs and maintenance. Bathroom unfinished. Monitor the situation on a regular basis. Corrections by a qualified licensed contractor, if and when necessary, are recommended. Discretion advised. The significance of the finding is uncertain. Further study by a qualified licensed contractor is advised. Correction or modification decreases the probability of continued and excessive deterioration. It is recommended that the finding be reviewed, and corrected as needed, by a qualified licensed contractor before purchasing the property. See Photo(s) 6870.

[U] [R] [P] [N] 6870: Unexpected repairs and maintenance. Bathroom incomplete. Discretion advised. The significance of the finding is uncertain. Further study by a qualified licensed contractor is advised. Correction or modification decreases the probability of continued and excessive deterioration. It is recommended that the finding be reviewed, and corrected as needed, by a qualified licensed contractor before purchasing the property. Modification or addition is generally considered an upgrade which should improve safety or efficiency. The opinion of a qualified licensed contractor is recommended.  
See Photo(s) 6870.

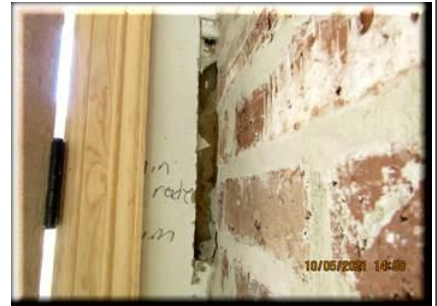
Photo: 7040.02 (1)

[C] [A] [M] [P] [N] 7040.02: Wall gapped.  
Discretion advised. The significance of the finding is uncertain. Further study by a qualified licensed contractor is advised. Correction or modification decreases the probability of continued and excessive deterioration. Monitor the situation on a regular basis. Corrections by a qualified licensed contractor, if and when necessary, are recommended. Maintenance, alteration or repair could be expected to improve component appearance and may decrease deterioration. Caution is advised. The finding could be, or could become, hazardous under certain circumstances. The opinion of a qualified licensed contractor is recommended.  
See Photo(s) 7040.02.

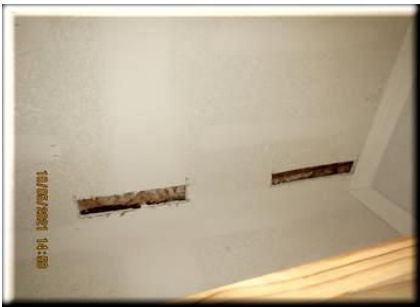
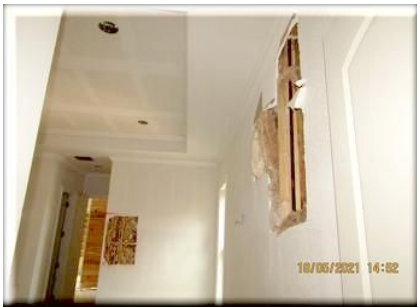
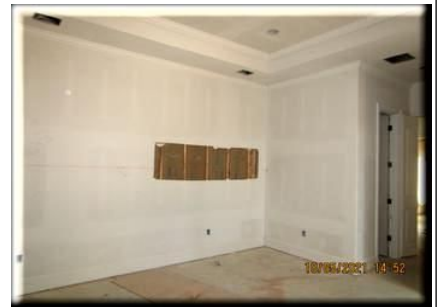
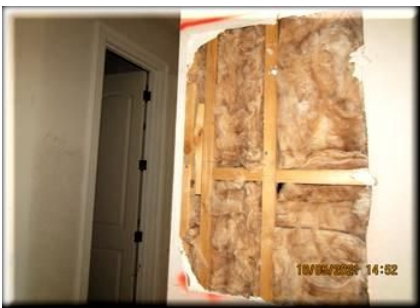
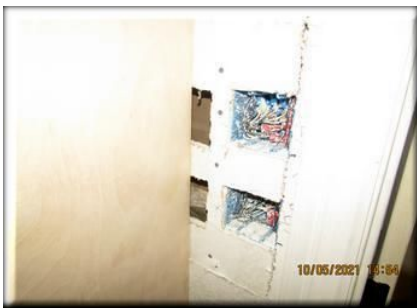
[U] [R] [P] [N] 7040.03: Wall holed.  
Discretion advised. The significance of the finding is uncertain. Further study by a qualified licensed contractor is advised. Correction or modification decreases the probability of continued and excessive deterioration. It is recommended that the finding be reviewed, and corrected as needed, by a qualified licensed contractor before purchasing the property. Modification or addition is generally considered an upgrade which should improve safety or efficiency. The opinion of a qualified licensed contractor is recommended.

[U] [R] [P] [N] [M] 7040.03: Wall holed.  
Monitor the situation on a regular basis. Corrections by a qualified licensed contractor, if and when necessary, are recommended. Discretion advised. The significance of the finding is uncertain. Further study by a qualified licensed contractor is advised. Correction or modification decreases the probability of continued and excessive deterioration. It is recommended that the finding be reviewed, and corrected as needed, by a qualified licensed contractor before purchasing the property. Modification or addition is generally considered an upgrade which should improve safety or efficiency. The opinion of a qualified licensed contractor is recommended. See Photo(s) 7040.03.

[A] [C] [U] [P] [N] 7040.03: Wall holed.  
Discretion advised. The significance of the finding is uncertain. Further study by a qualified licensed contractor is advised. Correction or modification decreases the probability of continued and excessive deterioration. Modification or addition is generally considered an upgrade which should improve safety or efficiency. The opinion of a qualified licensed contractor is recommended. Caution is advised. The finding could be, or could become, hazardous under certain circumstances. The opinion of a qualified licensed contractor is recommended. Maintenance, alteration or repair could be expected to improve component appearance and may decrease deterioration. See Photo(s) 7040.03.

[U] [P] [N] [M] 7040.03: Wall holed.  
Monitor the situation on a regular basis. Corrections by a qualified licensed contractor, if and when necessary, are recommended. Discretion advised. The significance of the finding is uncertain. Further study by a qualified licensed contractor is advised. Correction or modification decreases the probability of continued and excessive deterioration. Modification or addition is generally considered an upgrade which should improve safety or efficiency. The opinion of a qualified licensed contractor is recommended. See Photo(s) 7040.03.

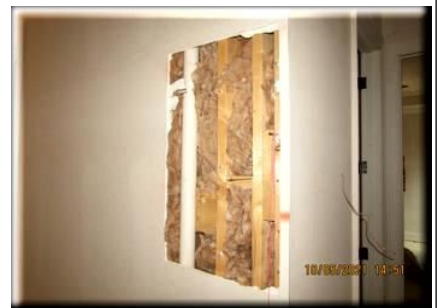
Photo: 7040.06 (1)

Monitor the situation on a regular basis. Corrections by a qualified licensed contractor, if and when necessary, are recommended. Discretion advised. The significance of the finding is uncertain. Further study by a qualified licensed contractor is advised. Correction or modification decreases the probability of continued and excessive deterioration. It is recommended that the finding be reviewed, and corrected as needed, by a qualified licensed contractor before purchasing the property. Modification or addition is generally considered an upgrade which should improve safety or efficiency. The opinion of a qualified licensed contractor is recommended. See Photo(s) 7040.06.
