# The Uniform Building Inspection Report™ Condensed

## Single Family Residence:

7310 Camelback Drive, Shreveport, LA 71105

20220113B

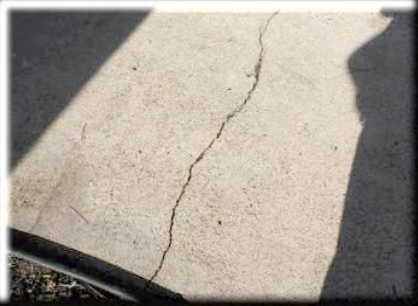
Photo: 0210.02 (1)

[A] [T] 0210.02: Concrete cracks and general deterioration noted. Although typical or common for the age of the structure or component, modifications and/or repairs may be in order. Maintenance, alteration or repair could be expected to improve component appearance and may decrease deterioration. See Photo(s) 0210.02.

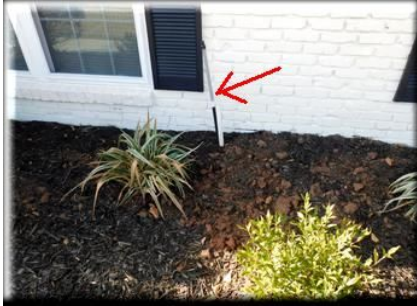
Photo: 0350 (1)

[Note] 0350: Irrigation system needs general repairs, maintenance and adjustments. Irrigation system is not part of the normal home inspections and was not inspected by your home inspector. Recommend having home owners operate the system for you to ensure proper operation. See Photo(s) 0350.

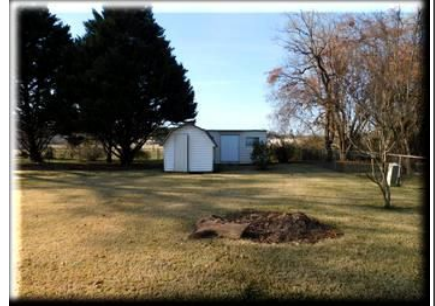
Photo: 0710.01 (1)

[P] [T] 0710.01: Shed in need of repairs and maintenance. Although typical or common for the age of the structure or component, modifications and/or repairs may be in order. Correction or modification decreases the probability of continued and excessive deterioration. See Photo(s) 0710.01.

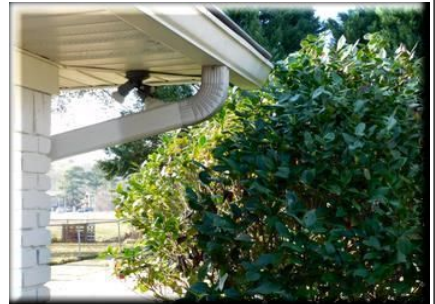
Photo: 0860.02 (1)

[P] 0860.02: Shrubbery against building.  
Correction or modification decreases the probability of continued and excessive deterioration.  
See Photo(s) 0860.02.

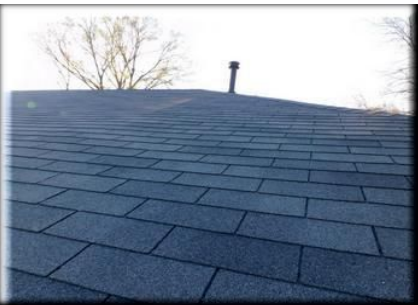
Photo: 1000 (1)

[P] [N] 1000: Roof repairs / general maintenance needed.  
Roof sagging. Discretion advised. The significance of the finding is uncertain. Further study by a qualified licensed contractor is advised.  
Correction or modification decreases the probability of continued and excessive deterioration.  
See Photo(s) 1000.

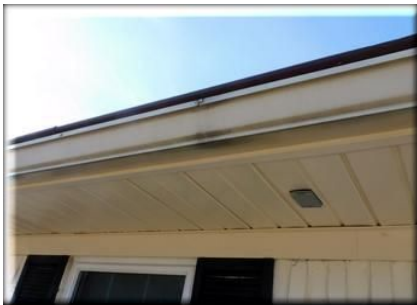
Photo: 1280.04 (1)

[M] [P] [N] 1280.04: Gutter appears to leak.  
Discretion advised. The significance of the finding is uncertain. Further study by a qualified licensed contractor is advised.  
Correction or modification decreases the probability of continued and excessive deterioration. Monitor the situation on a regular basis.  
Corrections by a qualified licensed contractor, if and when necessary, are recommended.  
See Photo(s) 1280.04.

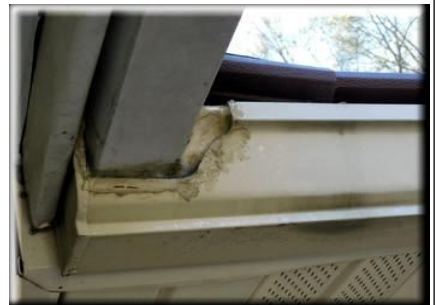
Photo: 1280.05 (1)

[P] [N] 1280.05: Gutter appears faulty or otherwise amiss.  
Discretion advised. The significance of the finding is uncertain. Further study by a qualified licensed contractor is advised.  
Correction or modification decreases the probability of continued and excessive deterioration.  
See Photo(s) 1280.05.

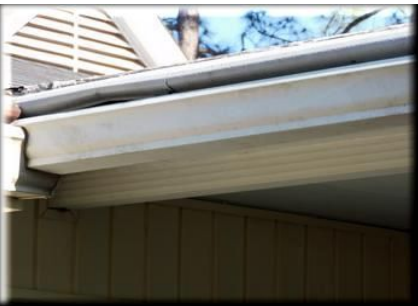
Photo: 1280.05 (2)

[U] [R] [P] [N] 1280.05: Gutter appears faulty or otherwise amiss.  
Discretion advised. The significance of the finding is uncertain. Further study by a qualified licensed contractor is advised.  
Correction or modification decreases the probability of continued and excessive deterioration. It is recommended that the finding be reviewed, and corrected as needed, by a qualified licensed contractor before purchasing the property. Modification or addition is generally considered an upgrade which should improve safety or efficiency.  
The opinion of a qualified licensed contractor is recommended.  
See Photo(s) 1280.05.

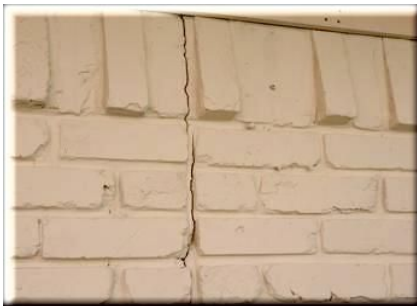
Photo: 1310.01 (1)

[R] [P] [N] 1310.01: Siding cracked.  
Discretion advised. The significance of the finding is uncertain. Further study by a qualified licensed contractor is advised.  
Correction or modification decreases the probability of continued and excessive deterioration. It is recommended that the finding be reviewed, and corrected as needed, by a qualified licensed contractor before purchasing the property.  
See Photo(s) 1310.01.

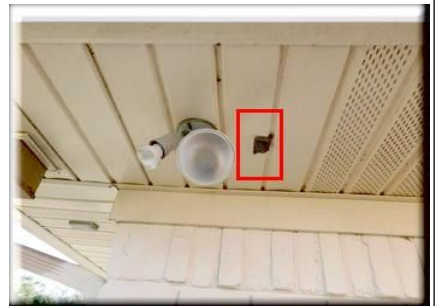
Photo: 1310.02 (1)

Discretion advised. The significance of the finding is uncertain.  
Further study by a qualified licensed contractor is advised.  
Correction or modification decreases the probability of continued and excessive deterioration.  
See Photo(s) 1310.02.

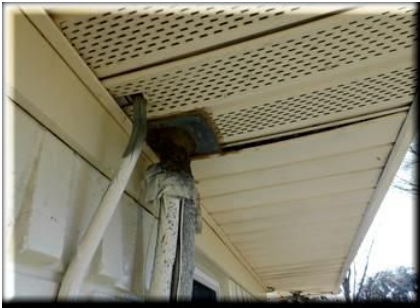
Photo: 1320 (1)

[A] [U] [R] [P] [N] 1320: Siding loose / buckled / warped.  
Discretion advised. The significance of the finding is uncertain.  
Further study by a qualified licensed contractor is advised.  
Correction or modification decreases the probability of continued and excessive deterioration. It is recommended that the finding be reviewed, and corrected as needed, by a qualified licensed contractor before purchasing the property. Modification or addition is generally considered an upgrade which should improve safety or efficiency.  
The opinion of a qualified licensed contractor is recommended.  
Maintenance, alteration or repair could be expected to improve component appearance and may decrease deterioration.  
See Photo(s) 1320.

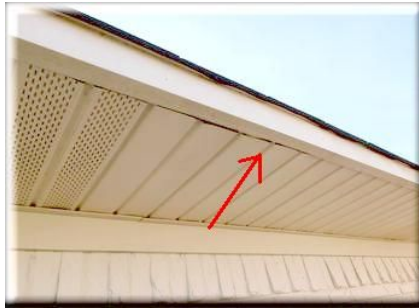
Photo: 1320.01 (1)

[A] [C] [U] [P] [N] 1320.01: Siding loose.  
Discretion advised. The significance of the finding is uncertain.  
Further study by a qualified licensed contractor is advised.  
Correction or modification decreases the probability of continued and excessive deterioration. Modification or addition is generally considered an upgrade which should improve safety or efficiency.  
The opinion of a qualified licensed contractor is recommended.  
Caution is advised. The finding could be, or could become, hazardous under certain circumstances. The opinion of a qualified licensed contractor is recommended. Maintenance, alteration or repair could be expected to improve component appearance and may decrease deterioration. Recommend reposition and secure siding components to prevent water penetration. Noted at numerous and various locations around the exterior of the building.  
See Photo(s) 1320.01.

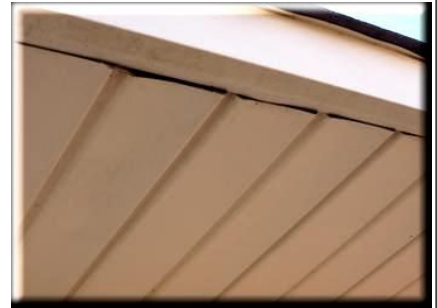
Photo: 1320.01 (2)

[P] [N] 1320.01: Siding loose.  
Discretion advised. The significance of the finding is uncertain.  
Further study by a qualified licensed contractor is advised.  
Correction or modification decreases the probability of continued and excessive deterioration. Recommend reposition and secure siding components to prevent water penetration.  
See Photo(s) 1320.01.

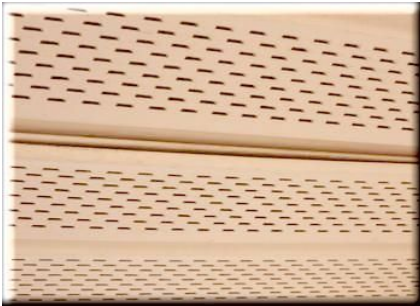
Photo: 1320.01 (3)

[A] [U] [P] [N] 1320.01: Siding loose.  
Discretion advised. The significance of the finding is uncertain.  
Further study by a qualified licensed contractor is advised.  
Correction or modification decreases the probability of continued and excessive deterioration. Modification or addition is generally considered an upgrade which should improve safety or efficiency.  
The opinion of a qualified licensed contractor is recommended.  
Maintenance, alteration or repair could be expected to improve component appearance and may decrease deterioration.  
See Photo(s) 1320.01.

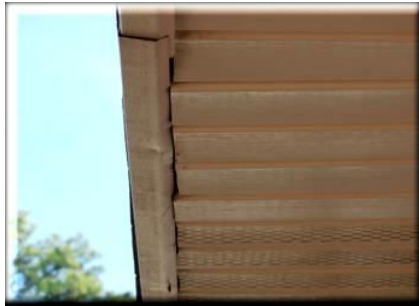
Photo: 1320.01 (4)

[P] [N] 1320.01: Siding loose.  
Discretion advised. The significance of the finding is uncertain.  
Further study by a qualified licensed contractor is advised.  
Correction or modification decreases the probability of continued and excessive deterioration.  
See Photo(s) 1320.01.

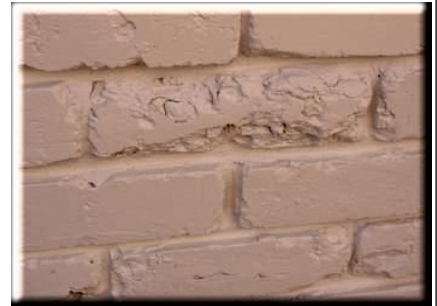
Photo: 1350.04 (1)

[U] [R] [P] [N] 1350.04: Masonry damaged.  
Discretion advised. The significance of the finding is uncertain.  
Further study by a qualified licensed contractor is advised.  
Correction or modification decreases the probability of continued and excessive deterioration. It is recommended that the finding be reviewed, and corrected as needed, by a qualified licensed contractor before purchasing the property. Modification or addition is generally considered an upgrade which should improve safety or efficiency.  
The opinion of a qualified licensed contractor is recommended.  
See Photo(s) 1350.04.

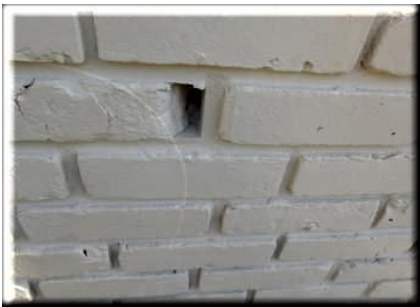
Photo: 1350.04 (2)

[A] [P] [N] 1350.04: Masonry damaged.  
Discretion advised. The significance of the finding is uncertain.  
Further study by a qualified licensed contractor is advised.  
Correction or modification decreases the probability of continued and excessive deterioration. Maintenance, alteration or repair could be expected to improve component appearance and may decrease deterioration.  
See Photo(s) 1350.04.

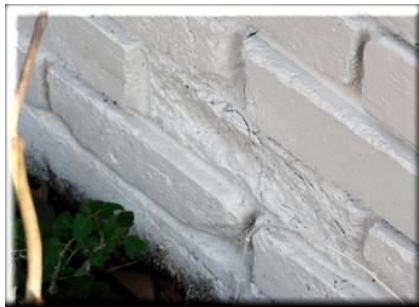
Photo: 1350.04 (3)

[A] [P] [N] 1350.04: Masonry damaged.  
Discretion advised. The significance of the finding is uncertain.  
Further study by a qualified licensed contractor is advised.  
Correction or modification decreases the probability of continued and excessive deterioration. Maintenance, alteration or repair could be expected to improve component appearance and may decrease deterioration.  
See Photo(s) 1350.04.

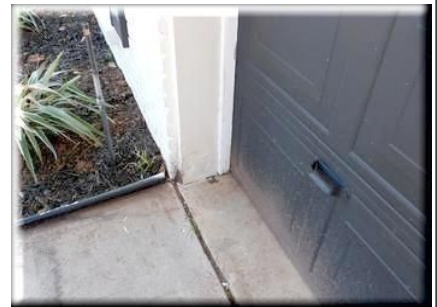
Photo: 1430.03 (1)

[A] 1430.03: Door trim damaged.  
Maintenance, alteration or repair could be expected to improve component appearance and may decrease deterioration.  
See Photo(s) 1430.03.

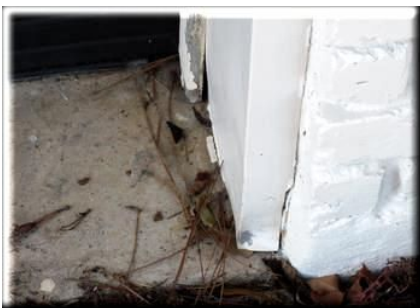
Photo: 1430.03 (2)

[A] 1430.03: Door trim damaged.  
Maintenance, alteration or repair could be expected to improve component appearance and may decrease deterioration. Noted at the garage door.  
See Photo(s) 1430.03.

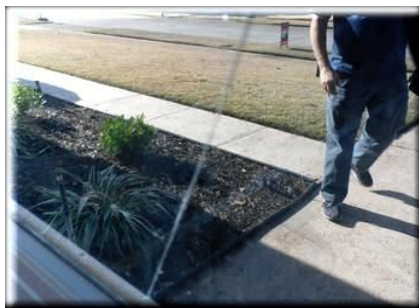
Photo: 1530.02 (1)

[P] [N] 1530.02: Window damaged.  
Discretion advised. The significance of the finding is uncertain.  
Further study by a qualified licensed contractor is advised.  
Correction or modification decreases the probability of continued and excessive deterioration. Noted at the garage door.  
See Photo(s) 1530.02.

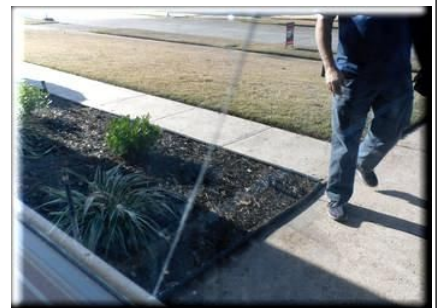
Photo: 1700.01 (1)

[P] [N] 1700.01: Vehicle door damaged.  
window damaged Discretion advised. The significance of the finding is uncertain. Further study by a qualified licensed contractor is advised. Correction or modification decreases the probability of continued and excessive deterioration.  
See Photo(s) 1700.01.

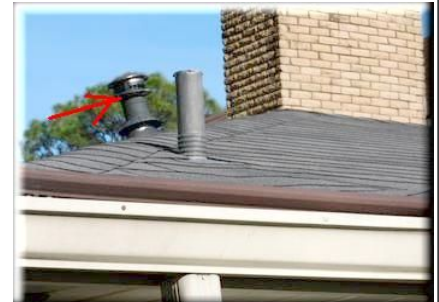
Photo: 2150.04 (1)

[U] [P] [N] 2150.04: Heat system vent improper.  
Heat exhaust vent not standing straight (leaning) through roof.  
Discretion advised. The significance of the finding is uncertain. Further study by a qualified licensed contractor is advised. Correction or modification decreases the probability of continued and excessive deterioration. Modification or addition is generally considered an upgrade which should improve safety or efficiency. The opinion of a qualified licensed contractor is recommended.  
See Photo(s) 2150.04.

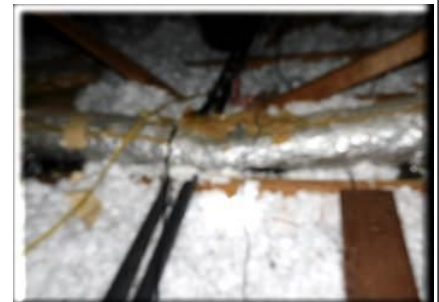
Photo: 2200.01 (1)

[E] [U] [R] [P] [N] [M] 2200.01: Ducting damaged. Monitor the situation on a regular basis. Corrections by a qualified licensed contractor, if and when necessary, are recommended. Discretion advised. The significance of the finding is uncertain. Further study by a qualified licensed contractor is advised. Correction or modification decreases the probability of continued and excessive deterioration. It is recommended that the finding be reviewed, and corrected as needed, by a qualified licensed contractor before purchasing the property. Modification or addition is generally considered an upgrade which should improve safety or efficiency. The opinion of a qualified licensed contractor is recommended. Repair, alteration or replacement usually improves the efficiency of the component or system. See Photo(s) 2200.01.

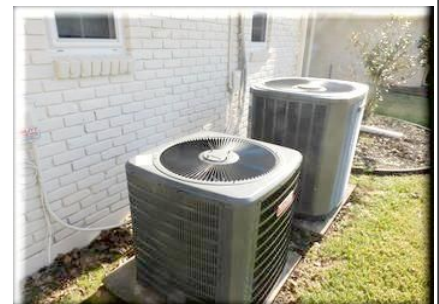
Photo: 2300.02 (1)

[E] [U] [P] [N] 2300.02: Refrigerant line insulation missing. Discretion advised. The significance of the finding is uncertain. Further study by a qualified licensed contractor is advised. Correction or modification decreases the probability of continued and excessive deterioration. Modification or addition is generally considered an upgrade which should improve safety or efficiency. The opinion of a qualified licensed contractor is recommended. Repair, alteration or replacement usually improves the efficiency of the component or system.  
See Photo(s) 2300.02.

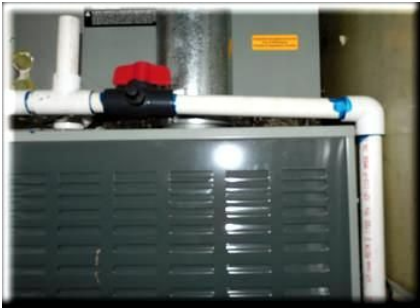
Photo: 2310.05 (1)

[E] [A] [P] [N] 2310.05: Condensate drain faulty or otherwise amiss. Condensate drain line not insulated which may lead to water spots. Discretion advised. The significance of the finding is uncertain. Further study by a qualified licensed contractor is advised. Correction or modification decreases the probability of continued and excessive deterioration. Maintenance, alteration or repair could be expected to improve component appearance and may decrease deterioration. Repair, alteration or replacement usually improves the efficiency of the component or system.  
See Photo(s) 2310.05.

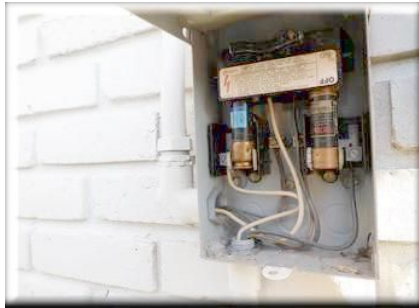
Photo: 2400.22 (1)

[P] [N] 2400.22: AC safety shut-off faulty or otherwise amiss. Parts missing. Discretion advised. The significance of the finding is uncertain. Further study by a qualified licensed contractor is advised. Correction or modification decreases the probability of continued and excessive deterioration.  
See Photo(s) 2400.22.

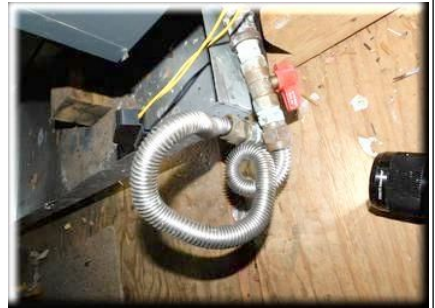
Photo: 2830 (1)

[R] [P] [N] 2830: Unexpected repairs and maintenance. Gas valve at heating unit location questionable. Discretion advised. The significance of the finding is uncertain. Further study by a qualified licensed contractor is advised. Correction or modification decreases the probability of continued and excessive deterioration. It is recommended that the finding be reviewed, and corrected as needed, by a qualified licensed contractor before purchasing the property.  
See Photo(s) 2830.

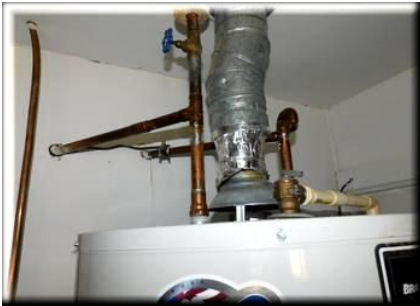
Photo: 4080.10 (1)

[R] [P] [N] 4080.10: Water heater draft hood improper. Discretion advised. The significance of the finding is uncertain. Further study by a qualified licensed contractor is advised.

Correction or modification decreases the probability of continued and excessive deterioration. It is recommended that the finding be reviewed, and corrected as needed, by a qualified licensed contractor before purchasing the property.  
See Photo(s) 4080.10.

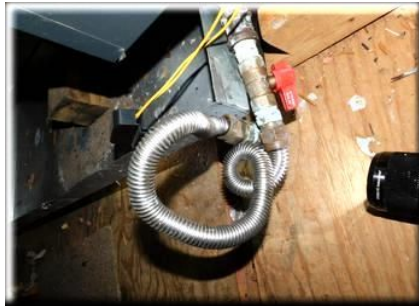
Photo: 4380.04 (1)

[B] [U] [R] [P] [N] [M] 4380.04: Fuel pipe(s) faulty or otherwise amiss.  
The gas shut off valve installed on the wrong side of the flex gas line. Monitor the situation on a regular basis. Corrections by a qualified licensed contractor, if and when necessary, are recommended. Discretion advised. The significance of the finding is uncertain. Further study by a qualified licensed contractor is advised.  
Correction or modification decreases the probability of continued and excessive deterioration. It is recommended that the finding be reviewed, and corrected as needed, by a qualified licensed contractor before purchasing the property. Modification or addition is generally considered an upgrade which should improve safety or efficiency. The opinion of a qualified licensed contractor is recommended. The finding does not conform to building standards and practices in effect at the time of construction or installation. Before purchasing the property, further study and corrections, as needed, by a qualified licensed contractor are advised.

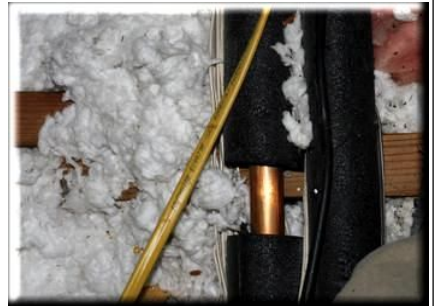
Photo: 4440.02 (1)

[P] [N] [E] 4440.02: Water pipe(s) insulation incomplete.  
Repair, alteration or replacement usually improves the efficiency of the component or system. Discretion advised. The significance of the finding is uncertain. Further study by a qualified licensed contractor is advised. Correction or modification decreases the probability of continued and excessive deterioration.  
See Photo(s) 4440.02.

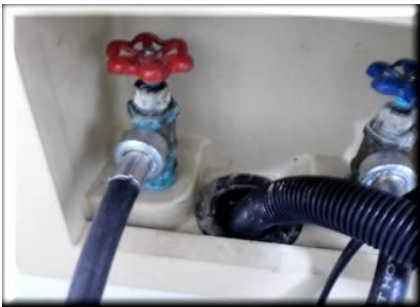
Photo: 4550.12 (1)

[U] [P] [M] 4550.12: Water valve faulty or otherwise amiss.  
Water valves at laundry machine is corroded. Monitor the situation on a regular basis. Corrections by a qualified licensed contractor, if and when necessary, are recommended. Correction or modification decreases the probability of continued and excessive deterioration. Modification or addition is generally considered an upgrade which should improve safety or efficiency. The opinion of a qualified licensed contractor is recommended.  
See Photo(s) 4550.12.

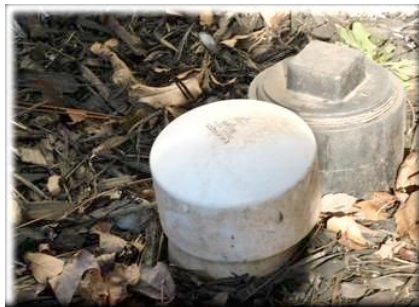
Photo: 4600.04 (1)

[P] [N] 4600.04: Sewer line faulty or otherwise amiss.  
Cover not secured. Discretion advised. The significance of the finding is uncertain. Further study by a qualified licensed contractor is advised. Correction or modification decreases the probability of continued and excessive deterioration.  
See Photo(s) 4600.04.

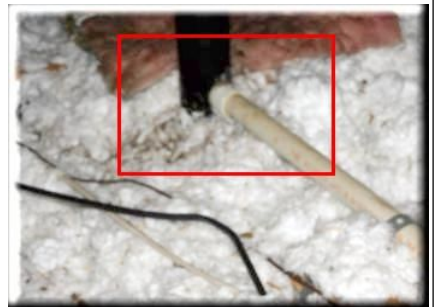
Photo: 4600.12 (1)

[C] [U] [R] [P] [N] 4600.12: Fixture drain line improper.  
Condensate line discharge pipe termination improper with signs of leakage in the insulation. Discretion advised. The significance of the finding is uncertain. Further study by a qualified licensed contractor is

advised. Correction or modification decreases the probability of continued and excessive deterioration. It is recommended that the finding be reviewed, and corrected as needed, by a qualified licensed contractor before purchasing the property. Modification or addition is generally considered an upgrade which should improve safety or efficiency. The opinion of a qualified licensed contractor is recommended. Caution is advised. The finding could be, or could become, hazardous under certain circumstances. The opinion of a qualified licensed contractor is recommended.  
See Photo(s) 4600.12.

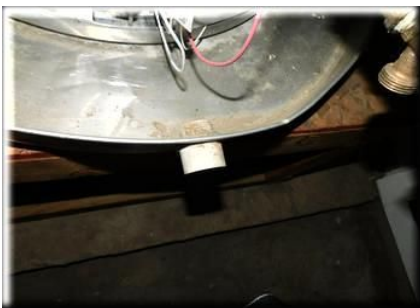
Photo: 4960 (1)

[U] [P] [N] 4960: Unexpected repairs and maintenance.  
Pan at water heater not piped. Discretion advised. The significance of the finding is uncertain. Further study by a qualified licensed contractor is advised. Correction or modification decreases the probability of continued and excessive deterioration. Modification or addition is generally considered an upgrade which should improve safety or efficiency. The opinion of a qualified licensed contractor is recommended.  
See Photo(s) 4960.

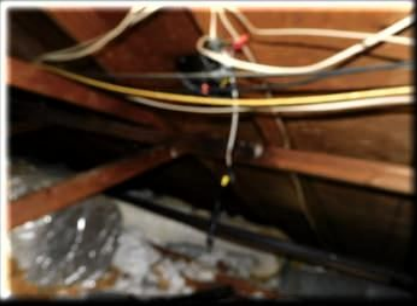
Photo: 5300 (1)

[R] [P] [N] 5300: Junction box not installed as required (exposed splice).  
Discretion advised. The significance of the finding is uncertain. Further study by a qualified licensed contractor is advised. Correction or modification decreases the probability of continued and excessive deterioration. It is recommended that the finding be reviewed, and corrected as needed, by a qualified licensed contractor before purchasing the property. Noted in the attic.  
See Photo(s) 5300.

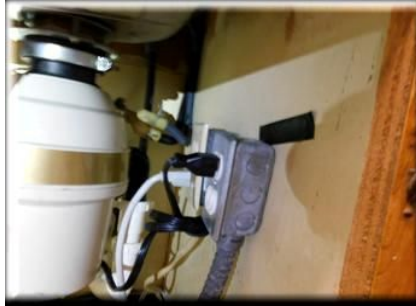
Photo: 5320.01 (1)

[C] [U] [P] [N] 5320.01: Conduit not designed for exposure to weather or damp areas. Metal junction box under kitchen sink without water tight cover. Box should be water tight box and non conductive type.  
Discretion advised. The significance of the finding is uncertain. Further study by a qualified licensed contractor is advised. Correction or modification decreases the probability of continued and excessive deterioration. Modification or addition is generally considered an upgrade which should improve safety or efficiency. The opinion of a qualified licensed contractor is recommended. Caution is advised. The finding could be, or could become,

hazardous under certain circumstances. The opinion of a qualified licensed contractor is recommended.  
See Photo(s) 5320.01.

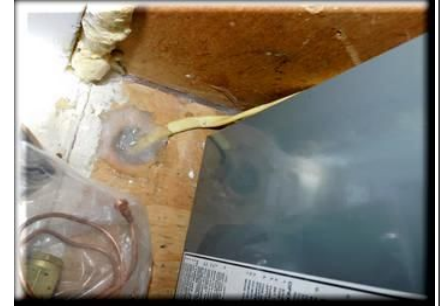
Photo: 5440 (1)

[U] [P] [N] 5440: Nonmetallic sheathed cable exposed where could be damaged.

Discretion advised. The significance of the finding is uncertain. Further study by a qualified licensed contractor is advised. Correction or modification decreases the probability of continued and excessive deterioration. Modification or addition is generally considered an upgrade which should improve safety or efficiency. The opinion of a qualified licensed contractor is recommended.  
See Photo(s) 5440.

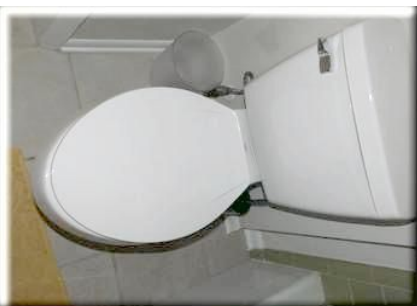
Photo: 6200 (1)

[P] 6200: Water closet bowl loose on floor / flange bolt(s) / nut(s) / cap(s) missing.  
Correction or modification decreases the probability of continued and excessive deterioration. Noted in the hall bath.  
See Photo(s) 6200.
