The Uniform Building Inspection Report™

Single Family Residence:
235 Price Road, Pollock, LA 71467

Inspection Date:
11/7/2019, 9:00:00 AM

Report Number: 110119L
Inspection Type: Punch List

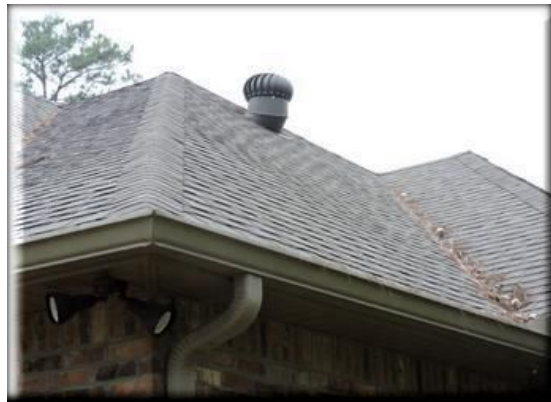
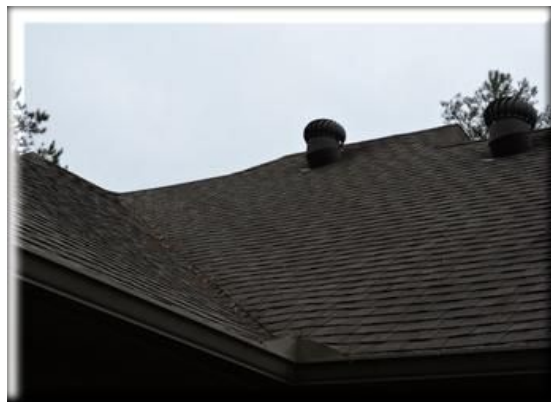
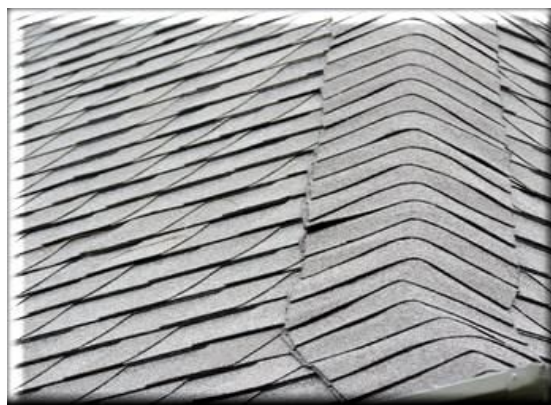
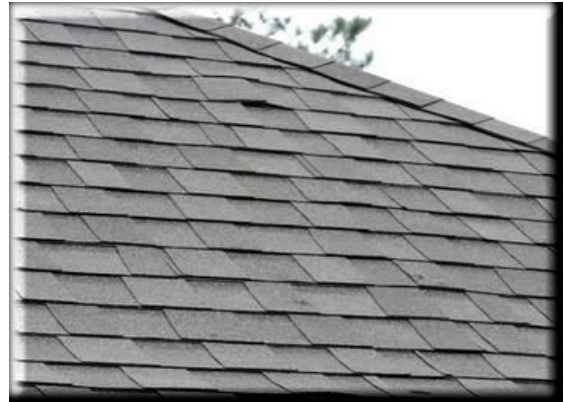
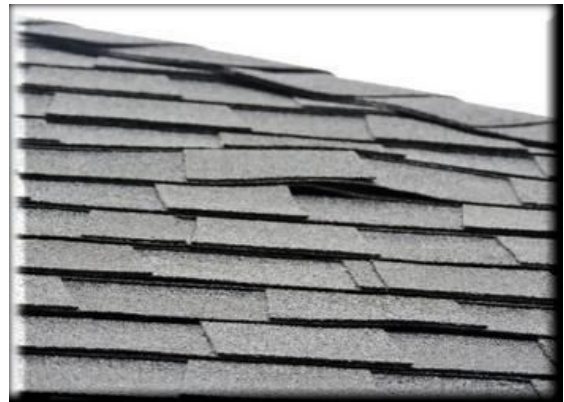
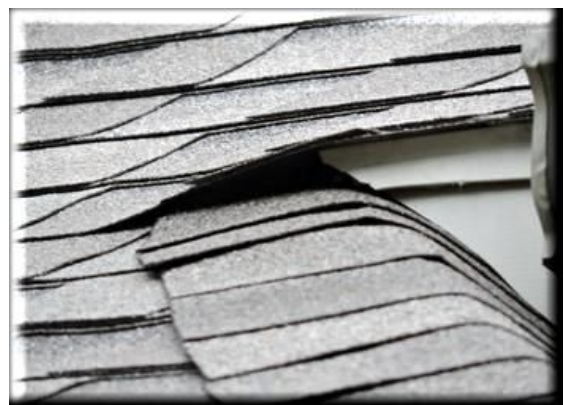
[N] 1000: Roof repairs / general maintenance needed. Roof appears to sag over eaves. Discretion advised. The significance of the finding is uncertain. Further study by a qualified licensed contractor is advised. See Photo(s) 1000.

[P] [N] [M] 1000: Roof repairs / general maintenance needed. shingles gapped at transitions. Monitor the situation on a regular basis. Corrections by a qualified licensed contractor, if and when necessary, are recommended. Discretion advised. The significance of the finding is uncertain. Further study by a qualified licensed contractor is advised. Correction or modification decreases the probability of continued and excessive deterioration. See Photo(s) 1000.

Nails backing up through shingles. Noted at numerous and various locations around the exterior of the building. Discretion advised. The significance of the finding is uncertain. Further study by a qualified licensed contractor is advised. Correction or modification decreases the probability of continued and excessive deterioration. Monitor the situation on a regular basis. Corrections by a qualified licensed contractor, if and when necessary, are recommended.
See Photo(s) 1000.

[R] 1000: Roof repairs / general maintenance needed. Roof vent does not appear to be level and not operating properly. It is recommended that the finding be reviewed, and corrected as needed, by a qualified licensed contractor before purchasing the property.
See Photo(s) 1000.

[M] [N] 1000: Roof repairs / general maintenance needed. Shingle lifting on ridge. Discretion advised. The significance of the finding is uncertain. Further study by a qualified licensed contractor is advised. Monitor the situation on a regular basis. Corrections by a qualified licensed contractor, if and when necessary, are recommended.
See Photo(s) 1000.

[R] [P] 1190: Full evaluation and written findings with costs to cure by a qualified Roofing Contractor advised. Correction or modification decreases the probability of continued and excessive deterioration. It is recommended that the finding be reviewed, and corrected as needed, by a qualified licensed contractor before purchasing the property.

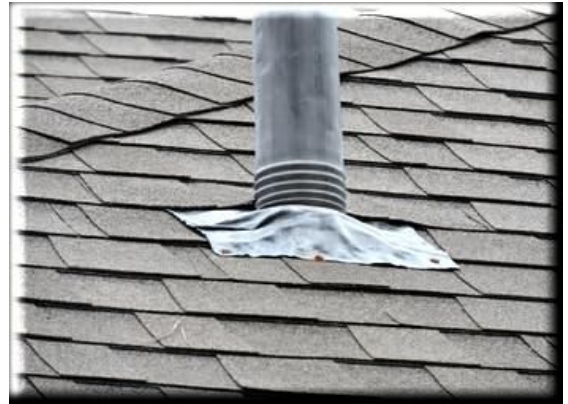
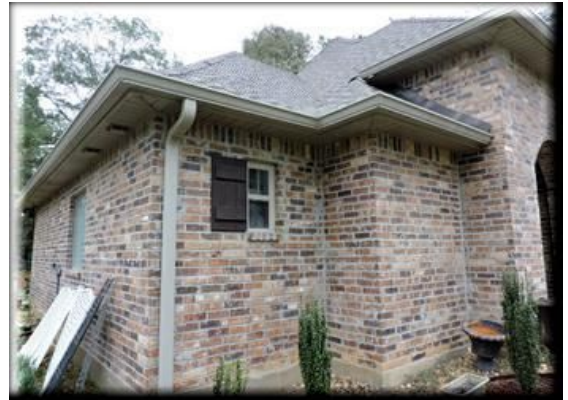
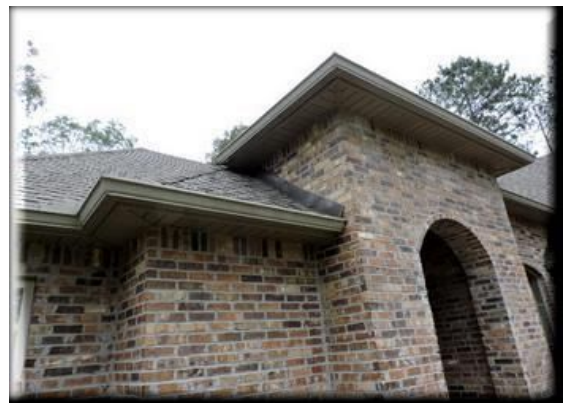
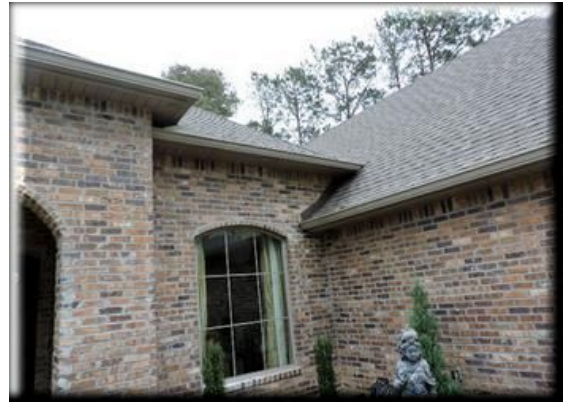
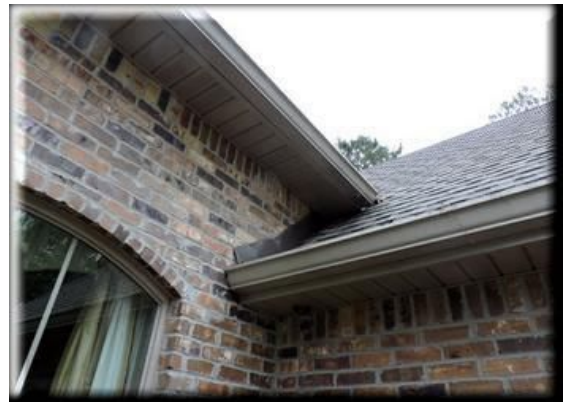
[M] [P] [N] 1230.04: Metal flashing faulty or otherwise amiss. Kickout flashings missing allowing roof run off to go down the side of the home on the masonry. Discretion advised. The significance of the finding is uncertain. Further study by a qualified licensed contractor is advised. Correction or modification decreases the probability of continued and excessive deterioration. Monitor the situation on a regular basis. Corrections by a qualified licensed contractor, if and when necessary, are recommended.
See Photo(s) 1230.04.

[P] [N] 1230.04: Metal flashing faulty or otherwise amiss. Nail heads exposed in metal flashings. Discretion advised. The significance of the finding is uncertain. Further study by a qualified licensed contractor is advised. Correction or modification decreases the probability of continued and excessive deterioration.
See Photo(s) 1230.04.

[P] [N] 1230.04: Metal flashing faulty or otherwise amiss. Flashings appear to be improperly installed Discretion advised. The significance of the finding is uncertain. Further study by a qualified licensed contractor is advised. Correction or modification decreases the probability of continued and excessive deterioration. See Photo(s) 1230.04.

[R] [P] [N] 1230.04: Metal flashing faulty or otherwise amiss. Metal roof to wall flashing and counter flashing appear to be improperly installed See Photo(s) 1230.04.

[P] [N] 1230.04: Metal flashing faulty or otherwise amiss. Kickout flashing appears to be missing. Discretion advised. The significance of the finding is uncertain. Further study by a qualified licensed contractor is advised. Correction or modification decreases the probability of continued and excessive deterioration. See Photo(s) 1230.04.

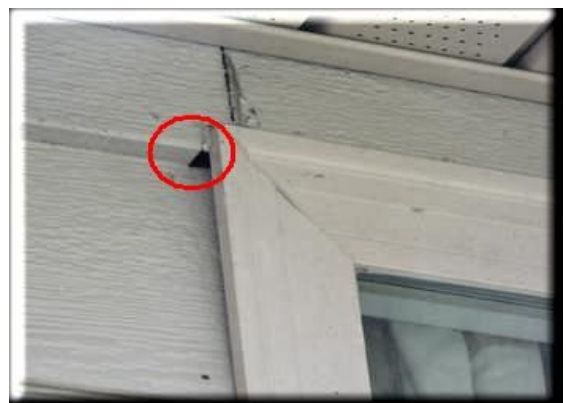
Photo: 1310.03 (1)

[P] [N] 1310.03: Siding gapped. Discretion advised. The significance of the finding is uncertain. Further study by a qualified licensed contractor is advised. Correction or modification decreases the probability of continued and excessive deterioration. See Photo(s) 1310.03.

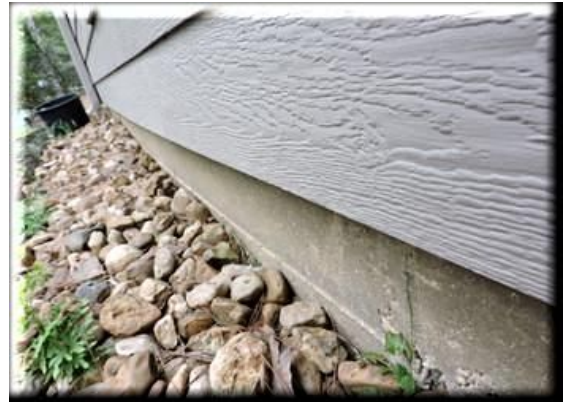
Photo: 1320 (1)

[P] [N] 1320: Siding loose / buckled / warped. siding appears to bow or be loose in various locations. Discretion advised. The significance of the finding is uncertain. Further study by a qualified licensed contractor is advised. Correction or modification decreases the probability of continued and excessive deterioration. See Photo(s) 1320.

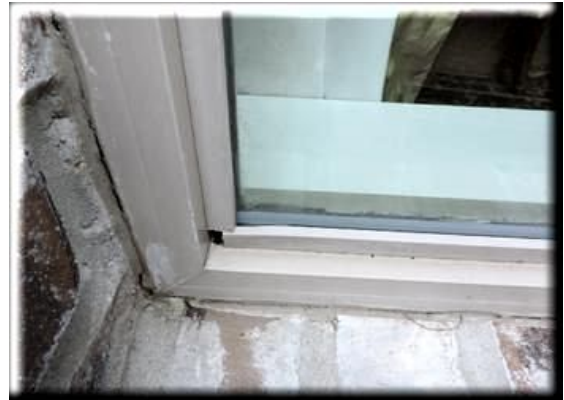
Photo: 1510 (1)

[P] [N] [M] 1510: Insulated window (I.G.) lost seal / damaged / amiss. gap noted in window frame on the exterior of the home Monitor the situation on a regular basis. Corrections by a qualified licensed contractor, if and when necessary, are recommended. Discretion advised. The significance of the finding is uncertain. Further study by a qualified licensed contractor is advised. Correction or modification decreases the probability of continued and excessive deterioration. See Photo(s) 1510.

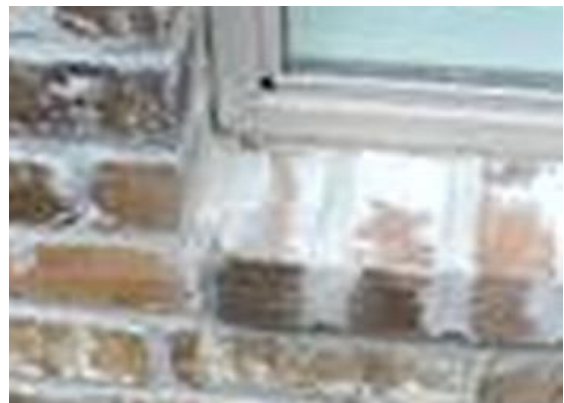
Photo: 1510.03 (1)

[R] [P] [N] [M] 1510.03: Insulated window (I.G.) faulty or otherwise amiss.
Monitor the situation on a regular basis. Corrections by a qualified licensed contractor, if and when necessary, are recommended. Discretion advised. The significance of the finding is uncertain. Further study by a qualified licensed contractor is advised. Correction or modification decreases the probability of continued and excessive deterioration. It is recommended that the finding be reviewed, and corrected as needed, by a qualified licensed contractor before purchasing the property.
See Photo(s) 1510.03.

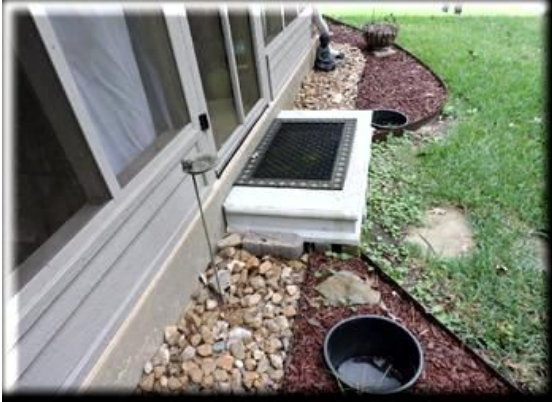
Photo: 1630.01 (1)

[P] [N] 1630.01: Door opens over landing 8" lower than floor level.
Stoop had to be added to prevent tripping due to door opening outward over landing (grade) in excess of 8". Discretion advised. The significance of the finding is uncertain. Further study by a qualified licensed contractor is advised. Correction or modification decreases the probability of continued and excessive deterioration.
See Photo(s) 1630.01.

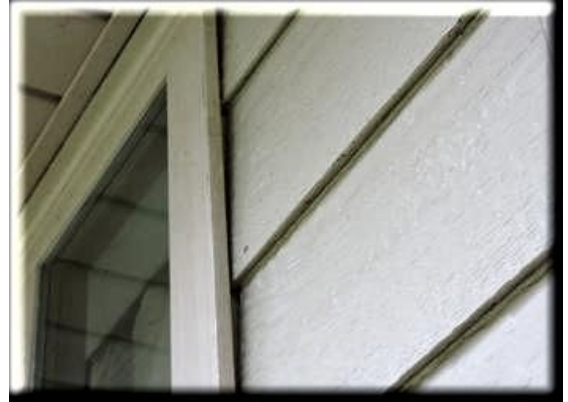
Photo: 1910 (1)

[P] 1910: Caulking, sealing and general repairs to siding / doors / windows needed.
Correction or modification decreases the probability of continued and excessive deterioration.
See Photo(s) 1910.

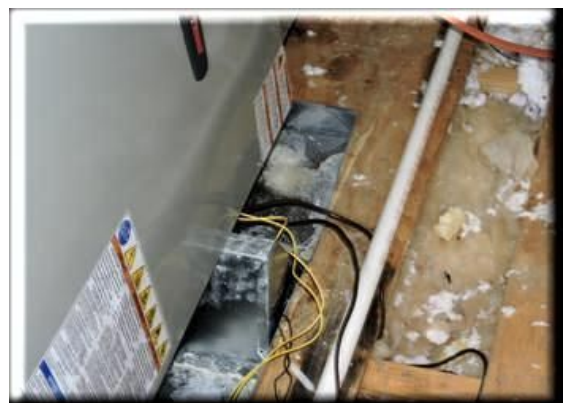
Photo: 2310.05 (1)

[U] [R] [P] [N] 2310.05: Condensate drain faulty or otherwise amiss.
Condensate drain line not insulated in attic which may lead to water spots on ceiling.. Discretion advised. The significance of the finding is uncertain. Further study by a qualified licensed contractor is advised. Correction or modification decreases the probability of continued and excessive deterioration. It is recommended that the finding be reviewed, and corrected as needed, by a qualified licensed contractor before purchasing the property. Modification or addition is generally considered an upgrade which should improve safety or efficiency. The opinion of a qualified licensed contractor is recommended.
See Photo(s) 2310.05.

[R] 2440: Review by qualified HVAC contractor advised (correct as needed).
It is recommended that the finding be reviewed, and corrected as needed, by a qualified licensed contractor before purchasing the property.

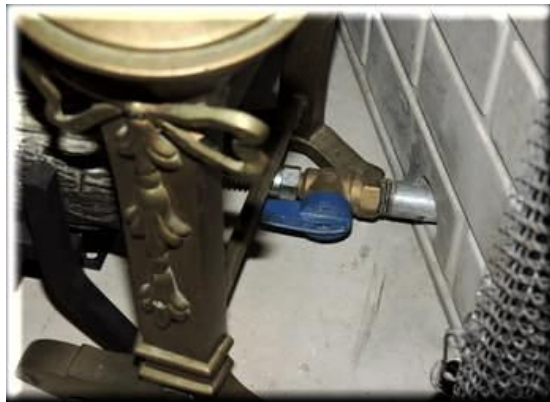
Photo: 2560 (1)

[R] [P] [N] 2560: Fireplace lighter valve / log set / burner damaged / amiss / caulk gas line entering firechamber. Discretion advised. The significance of the finding is uncertain. Further study by a qualified licensed contractor is advised. Correction or modification decreases the probability of continued and excessive deterioration. It is recommended that the finding be reviewed, and corrected as needed, by a qualified licensed contractor before purchasing the property.
See Photo(s) 2560.

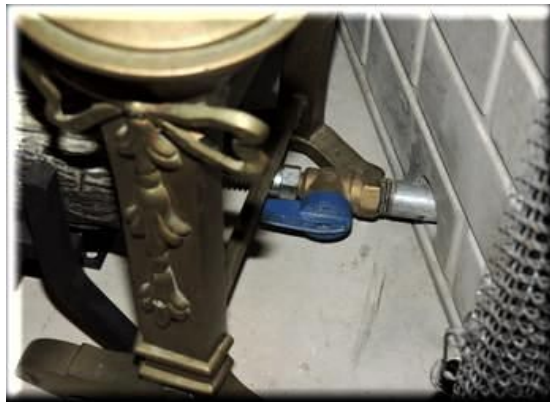
Photo: 2560.02 (1)

[R] [P] [N] 2560.02: Fireplace log lighter valve faulty or otherwise amiss.
Gas log safety shut off valve placement questionable - valve installed in firebox partially under logs and not outside of the device. Discretion advised. The significance of the finding is uncertain. Further study by a qualified licensed contractor is advised. Correction or modification decreases the probability of continued and excessive deterioration. It is recommended that the finding be reviewed, and corrected as needed, by a qualified licensed contractor before purchasing the property.
See Photo(s) 2560.02.

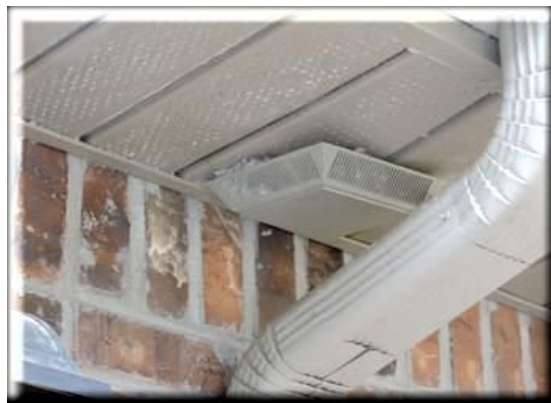
Photo: 4810.24 (1)

Discretion advised. The significance of the finding is uncertain. Further study by a qualified licensed contractor is advised. Correction or modification decreases the probability of continued and excessive deterioration.

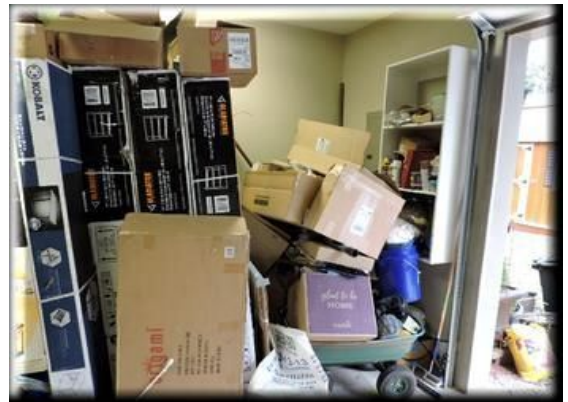
Photo: 5850 (1)

[Note] 5850: Access impaired.
Electrical panel blocked or painted to the wall. Inspector could not fully inspect panel.
See Photo(s) 5850.

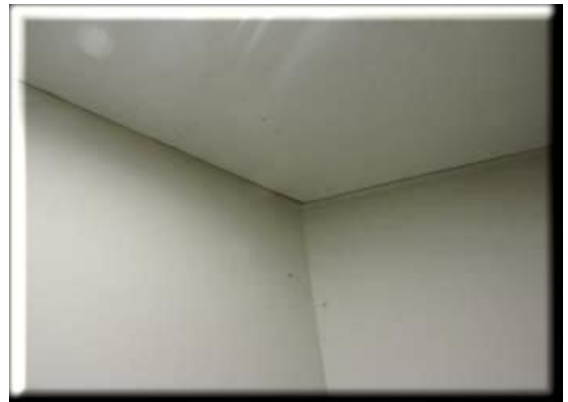
Photo: 6680.03 (1)

[M] [N] [A] 6680.03: Paint or other wall surface moldy. Maintenance, alteration or repair could be expected to improve component appearance and may decrease deterioration. Discretion advised. The significance of the finding is uncertain. Further study by a qualified licensed contractor is advised. Monitor the situation on a regular basis. Corrections by a qualified licensed contractor, if and when necessary, are recommended. See Photo(s) 6680.03.

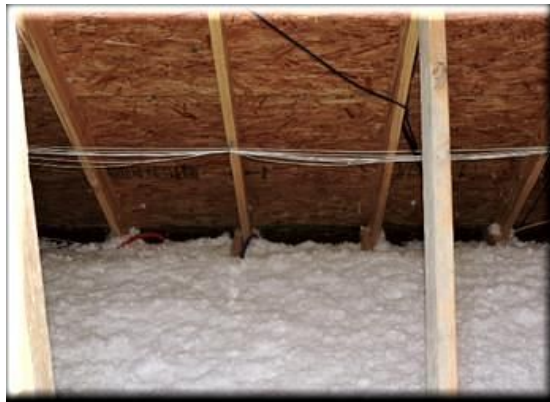
Photo: 9620.01 (1)

[E] [P] [N] 9620.01: Attic ventilation appears insufficient. Soffit vent blocked by insulation. Discretion advised. The significance of the finding is uncertain. Further study by a qualified licensed contractor is advised. Correction or modification decreases the probability of continued and excessive deterioration. Repair, alteration or replacement usually improves the efficiency of the component or system. See Photo(s) 9620.01.

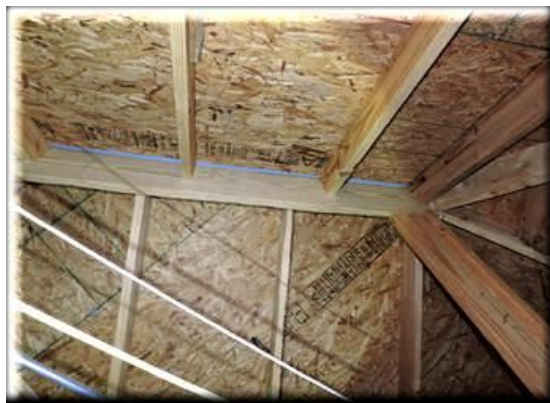
Photo: 9620.01 (2)

[P] [N] 9620.01: Attic ventilation appears insufficient. Ridge vent appears to be blocked by roofing paper. Discretion advised. The significance of the finding is uncertain. Further study by a qualified licensed contractor is advised. Correction or modification decreases the probability of continued and excessive deterioration. See Photo(s) 9620.01.

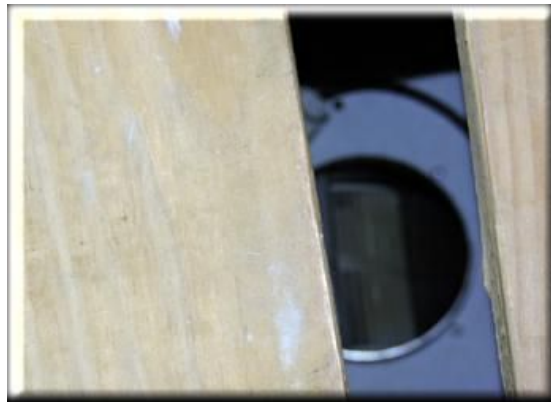
Photo: 9660 (1)

[R] [N] [F] [H] [C] [B] 9660: Kitchen, bath, or laundry ventilation terminates in attic. M1503.1 General. Range hoods shall discharge to the outdoors through a single-wall duct. The duct serving the hood shall have a smooth interior surface, shall be air tight, shall be equipped with a back-draft damper, and shall be independent of all other exhaust systems. Ducts serving range hoods shall not terminate in an attic or crawl space or areas inside the building. The range hood does not appear to make it into the attic nor does it terminate on the exterior. The finding does not conform to building standards and practices in effect at the time of construction or installation. Before purchasing the property, further study and corrections, as

needed, by a qualified licensed contractor are advised. Caution is advised. The finding could be, or could become, hazardous under certain circumstances. The opinion of a qualified licensed contractor is recommended. The finding should be considered hazardous. Corrections by a qualified licensed contractor, before purchasing the property, are advised. A system or component fails to function, or to function properly. Before purchasing the property a total review of all affected systems by a qualified licensed contractor is advised. Discretion advised. The significance of the finding is uncertain. Further study by a qualified licensed contractor is advised. It is recommended that the finding be reviewed, and corrected as needed, by a qualified licensed contractor before purchasing the property. See Photo(s) 9660.

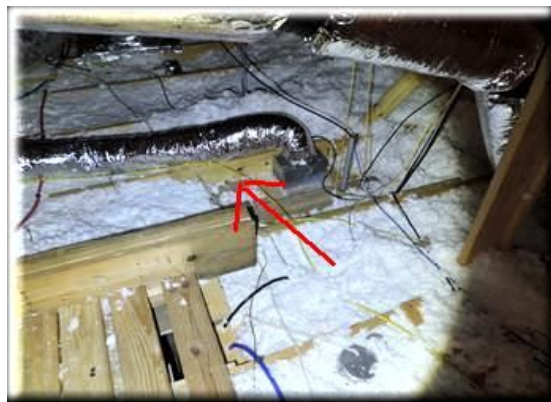
Photo: 9700 (1)

[E] [P] [N] 9700: Insulation insufficient / missing / compressed / amiss.

Discretion advised. The significance of the finding is uncertain. Further study by a qualified licensed contractor is advised. Correction or modification decreases the probability of continued and excessive deterioration. Repair, alteration or replacement usually improves the efficiency of the component or system. See Photo(s) 9700.
