The Uniform Building Inspection Report™

Single Family Residence:

246 Avondale Lane, Bossier City , LA 71112

12/14/2021, 9:00:00 AM

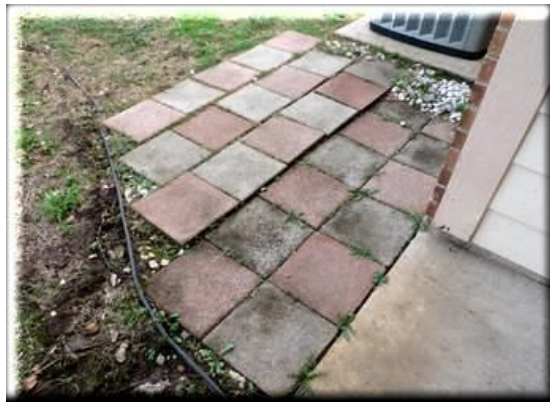
Photo: 0220 (1)

The finding should be considered hazardous. Corrections by a qualified licensed contractor, before purchasing the property, are advised. Noted at the rear of the structure. See Photo(s) 0220.

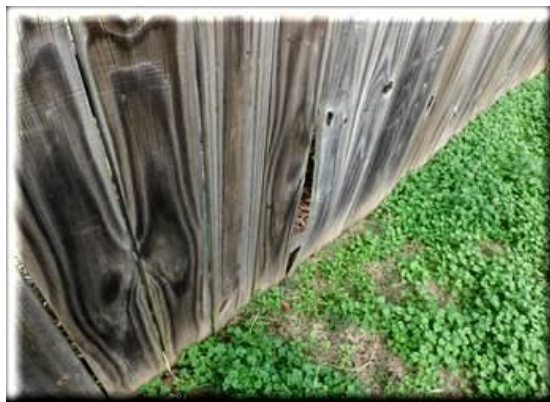
Photo: 0510.03 (1)

[P] [N] 0510.03: Fence slat(s) damaged. Discretion advised. The significance of the finding is uncertain. Further study by a qualified licensed contractor is advised. Correction or modification decreases the probability of continued and excessive deterioration. See Photo(s) 0510.03.

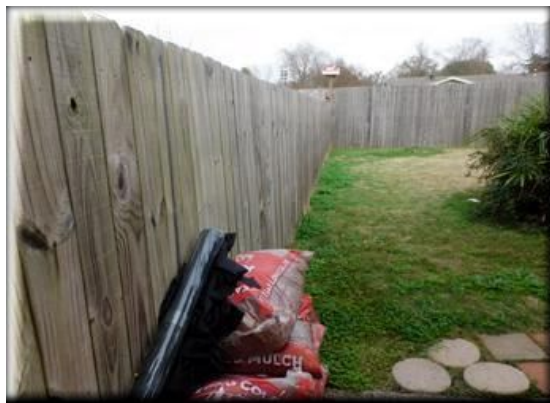
Photo: 0510.23 (1)

[P] [N] 0510.23: General fence repairs needed. Discretion advised. The significance of the finding is uncertain. Further study by a qualified licensed contractor is advised. Correction or modification decreases the probability of continued and excessive deterioration. See Photo(s) 0510.23.

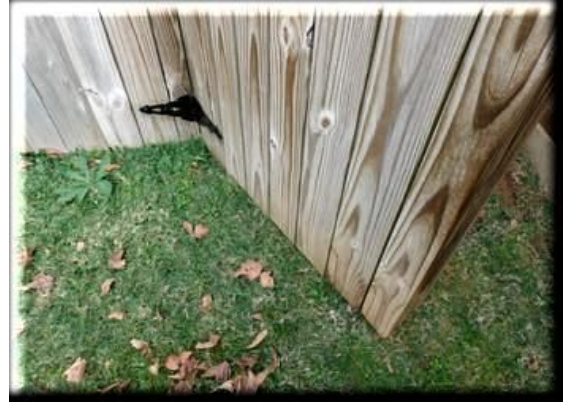
Photo: 0630.05 (1)

[P] [N] [M] 0630.05: Gate(s) drag ground surfaced or walk. Monitor the situation on a regular basis. Corrections by a qualified licensed contractor, if and when necessary, are recommended. Discretion advised. The significance of the finding is uncertain. Further study by a qualified licensed contractor is advised. Correction or modification decreases the probability of continued and excessive deterioration. See Photo(s) 0630.05.

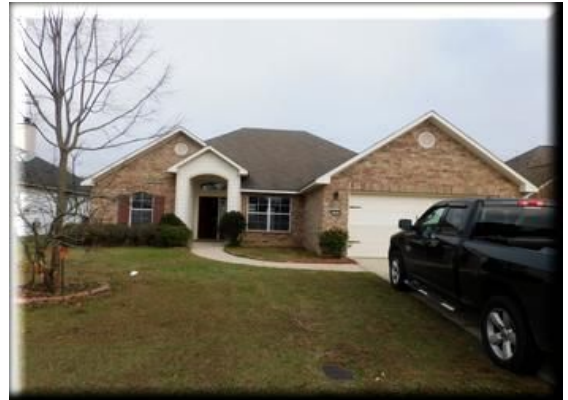
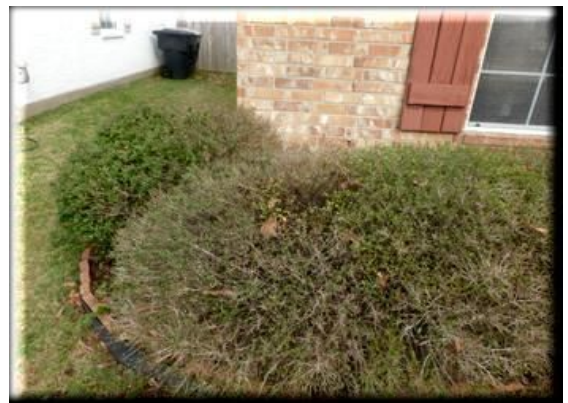
[P] 0860.02: Shrubbery against building.
Correction or modification decreases the probability of continued and excessive deterioration.
See Photo(s) 0860.02.

[M] 0860.02: Shrubbery against building.
Monitor the situation on a regular basis. Corrections by a qualified licensed contractor, if and when necessary, are recommended.
See Photo(s) 0860.02.

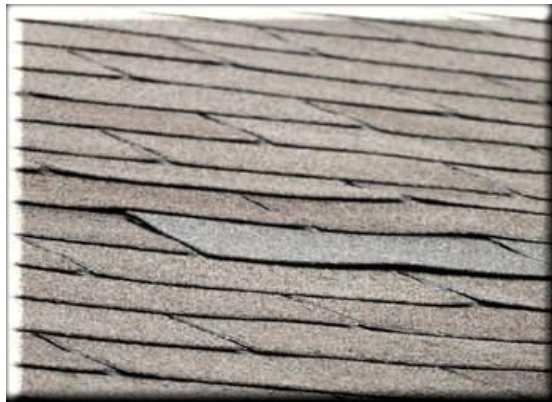
Photo: 1000 (1)

[U] [R] [P] [N] [M] 1000: Roof repairs / general maintenance needed.

Signs of roof repairs noted in various locations on the roof. Monitor the situation on a regular basis. Corrections by a qualified licensed contractor, if and when necessary, are recommended. Discretion advised. The significance of the finding is uncertain. Further study by a qualified licensed contractor is advised. Correction or modification decreases the probability of continued and excessive deterioration. It is recommended that the finding be reviewed, and corrected as needed, by a qualified licensed contractor before purchasing the property. Modification or addition is generally considered an upgrade which should improve safety or efficiency. The opinion of a qualified licensed contractor is recommended.

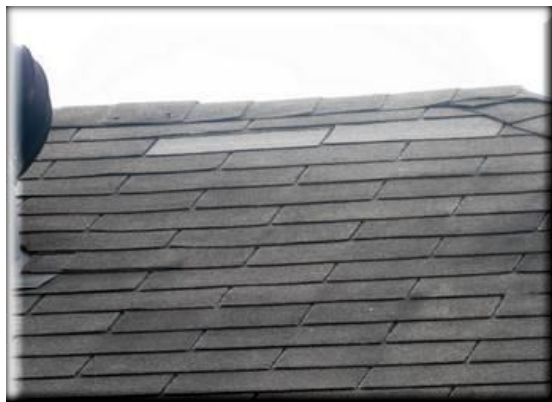
Photo: 1190 (1)

[M] [N] 1190: Full evaluation and written findings with costs to cure by a qualified Roofing Contractor advised.

Roof patched in several locations. Discretion advised. The significance of the finding is uncertain. Further study by a qualified licensed contractor is advised. Monitor the situation on a regular basis. Corrections by a qualified licensed contractor, if and when necessary, are recommended.

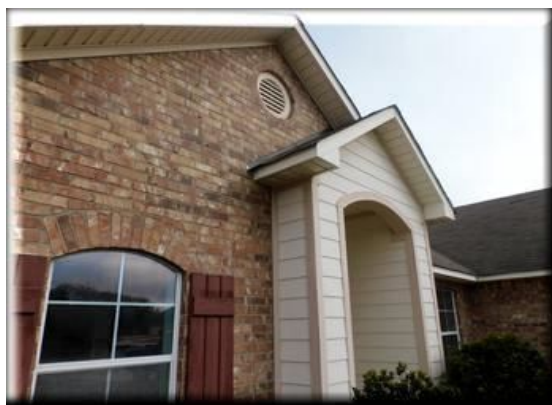
Photo: 1230.04 (1)

[U] [P] [N] 1230.04: Metal flashing faulty or otherwise amiss.

Kickout flashings have been required by the International Residential Code (IRC) since 2009, yet I've rarely seen them installed on new homes. Part of that might be the original awkward language that didn't even include the term kickout flashing." In the 2012 IRC, Section R903. Roof kickout flashings not installed allowing for roof run off to flow down the siding. In Section R903. 2 Flashings, a kick-out flashing now is required for steep-slope roof systems to divert runoff water from where an eave intersects a vertical sidewall. When a metal kick-out flashing is used, it should be corrosion-resistant and at least 0.19 of an inch thick (26-gauge galvanized steel). Roof kickout flashings not installed allowing for roof run off to flow down the siding. Discretion advised. The significance of the finding is uncertain. Further study by a qualified licensed contractor is advised. Correction or modification decreases the probability of continued and excessive deterioration. Modification or addition is generally considered an upgrade which should improve safety or efficiency. The opinion of a qualified licensed contractor is recommended. Noted at numerous and various locations around the exterior of the building. See Photo(s) 1230.04.

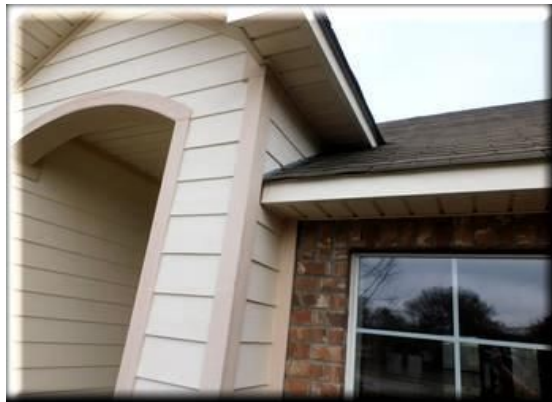
Photo: 1230.04 (2)

[D] [U] [R] [P] [N] 1230.04: Metal flashing faulty or otherwise amiss.

In Section R903. 2 Flashings, a kick-out flashing now is required for steep-slope roof systems to divert runoff water from where an eave intersects a vertical sidewall. When a metal kick-out flashing is used, it should be corrosion-resistant and at least 0.19 of an inch thick (26-gauge galvanized steel). Roof kickout flashings not installed allowing for roof run off to flow down the siding. Discretion advised. The significance of the finding is uncertain. Further study by a qualified licensed contractor is advised. Correction or modification decreases the probability of continued and excessive deterioration. It is recommended that the finding be reviewed, and corrected as needed, by a qualified licensed contractor before purchasing the property. Modification or addition is generally considered an upgrade which should improve safety or efficiency. The opinion of a qualified licensed contractor is recommended. Significant component damage and/or ongoing damage apparent. Before purchasing the property, needed corrections by a qualified licensed contractor are advised. See Photo(s) 1230.04.

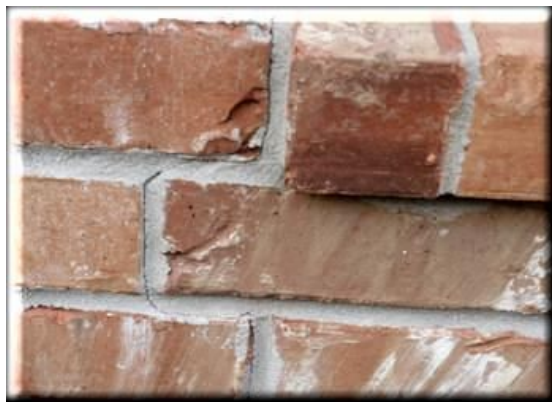
Photo: 1350.01 (1)

[P] [M] 1350.01: Masonry cracked.

Monitor the situation on a regular basis. Corrections by a qualified licensed contractor, if and when necessary, are recommended. Correction or modification decreases the probability of continued and excessive deterioration. See Photo(s) 1350.01.

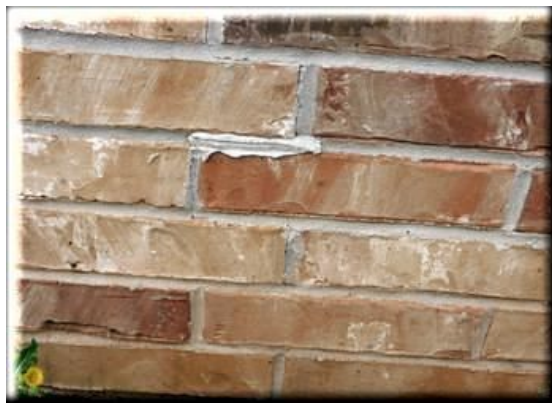
Photo: 1350.01 (2)

[N] [M] 1350.01: Masonry cracked.

Noted at numerous and various locations around the exterior of the building. Monitor the situation on a regular basis. Corrections by a qualified licensed contractor, if and when necessary, are recommended. Discretion advised. The significance of the finding is uncertain. Further study by a qualified licensed contractor is advised. See Photo(s) 1350.01.

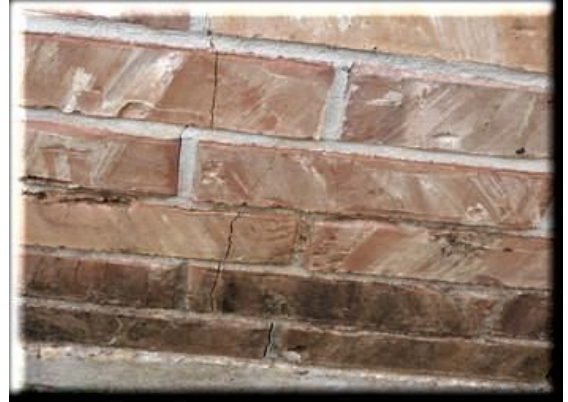
Photo: 1350.01 (3)

[R] [P] [N] 1350.01: Masonry cracked.

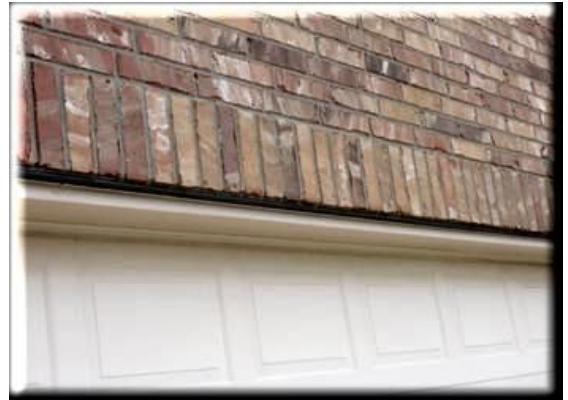
Photo: 1350.10 (1)

[N] [N] 1350.10: Masonry weep holes missing.

Discretion advised. The significance of the finding is uncertain. Further study by a qualified licensed contractor is advised. Discretion advised. The significance of the finding is uncertain. Further study by a qualified licensed contractor is advised. R703.7 Stone and Masonry Veneer, General Stone and masonry veneer shall be installed in accordance with this chapter, Table R703.4 and Figure R703.7.

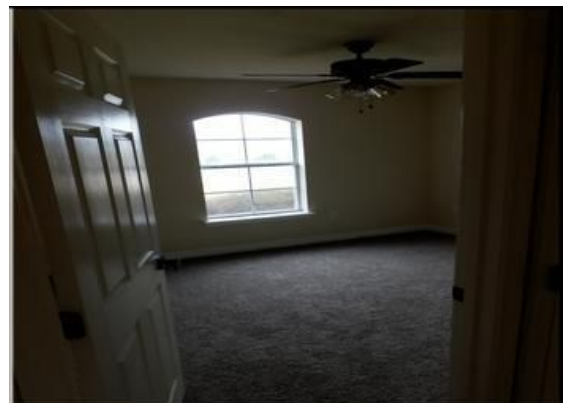
Photo: 1510.01 (1)

[A] [U] [P] [N] 1510.01: Insulated window (I.G.) appears to have lost seal.

Discretion advised. The significance of the finding is uncertain. Further study by a qualified licensed contractor is advised. Correction or modification decreases the probability of continued and excessive deterioration. Modification or addition is generally considered an upgrade which should improve safety or efficiency. The opinion of a qualified licensed contractor is recommended. Maintenance, alteration or repair could be expected to improve component appearance and may decrease deterioration.
See Photo(s) 1510.01.

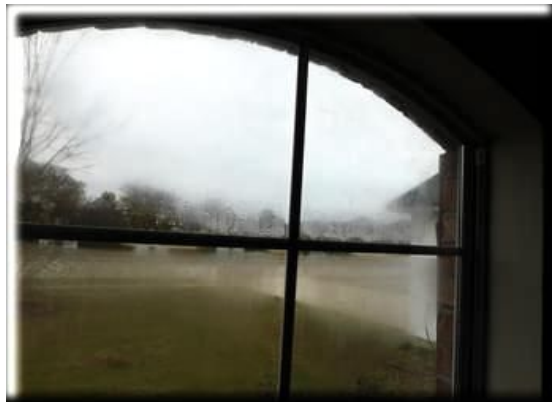
Photo: 1510.01 (2)

[E] [A] [P] [N] 1510.01: Insulated window (I.G.) appears to have lost seal.

Noted at the front of the building. Discretion advised. The significance of the finding is uncertain. Further study by a qualified licensed contractor is advised. Correction or modification decreases the probability of continued and excessive deterioration. Maintenance, alteration or repair could be expected to improve component appearance and may decrease deterioration. Repair, alteration or replacement usually improves the efficiency of the component or system.
See Photo(s) 1510.01.

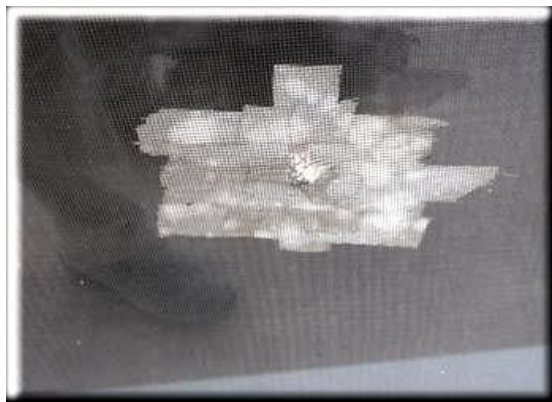
Photo: 1550.02 (1)

[U] [P] [N] 1550.02: Window screen(s) damaged. Discretion advised. The significance of the finding is uncertain. Further study by a qualified licensed contractor is advised. Correction or modification decreases the probability of continued and excessive deterioration. Modification or addition is generally considered an upgrade which should improve safety or efficiency. The opinion of a qualified licensed contractor is recommended.
See Photo(s) 1550.02.

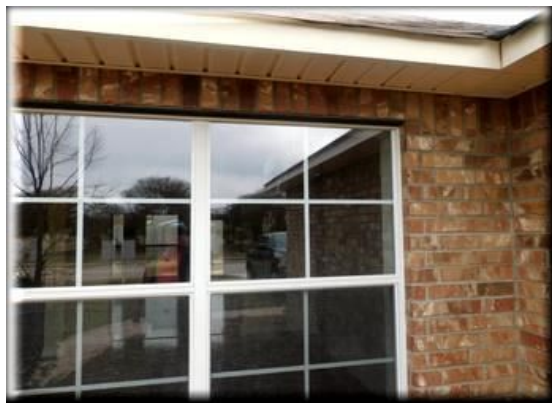
Photo: 1900 (1)

[A] [N] [M] 1900: Paint maintenance recommended. (spot / overall / wood only)

METAL LINTELS RUSTING OR NOT PAINTED. Monitor the situation on a regular basis. Corrections by a qualified licensed contractor, if and when necessary, are recommended. Discretion advised. The significance of the finding is uncertain. Further study by a qualified licensed contractor is advised. Maintenance, alteration or repair could be expected to improve component appearance and may decrease deterioration.
See Photo(s) 1900.

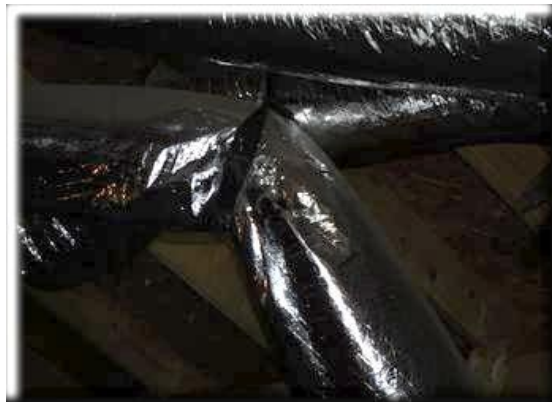
Photo: 2200.06 (1)

[R] [P] [N] 2200.06: Ducting faulty or otherwise amiss. Discretion advised. The significance of the finding is uncertain. Further study by a qualified licensed contractor is advised. Correction or modification decreases the probability of continued and excessive deterioration. It is recommended that the finding be reviewed, and corrected as needed, by a qualified licensed contractor before purchasing the property. See Photo(s) 2200.06.

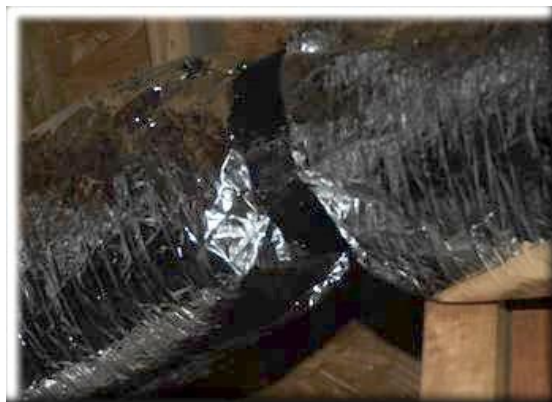
Photo: 2200.06 (2)

[P] [N] 2200.06: Ducting faulty or otherwise amiss. Discretion advised. The significance of the finding is uncertain. Further study by a qualified licensed contractor is advised. Correction or modification decreases the probability of continued and excessive deterioration. See Photo(s) 2200.06.

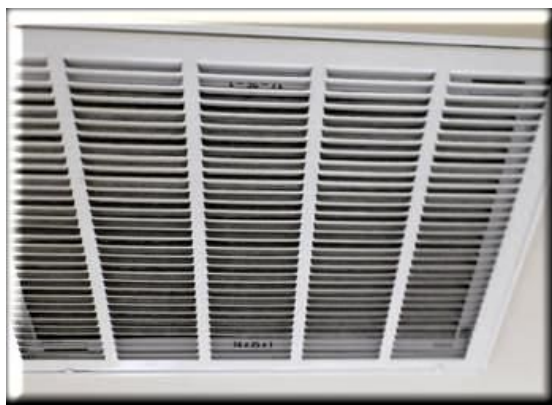
Photo: 2250.01 (1)

[P] 2250.01: Filter dirty. Correction or modification decreases the probability of continued and excessive deterioration. See Photo(s) 2250.01.

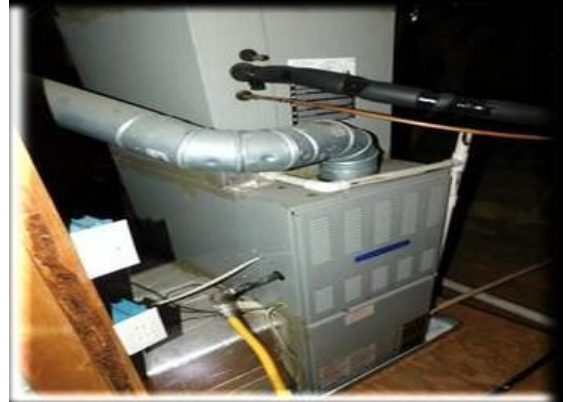
Photo: 2310.05 (1)

[U] [P] [N] [M] 2310.05: Condensate drain faulty or otherwise amiss. Condensate drain line not insulated which may lead to water spots on ceiling.. Monitor the situation on a regular basis. Corrections by a qualified licensed contractor, if and when necessary, are recommended. Discretion advised. The significance of the finding is uncertain. Further study by a qualified licensed contractor is advised. Correction or modification decreases the probability of continued and

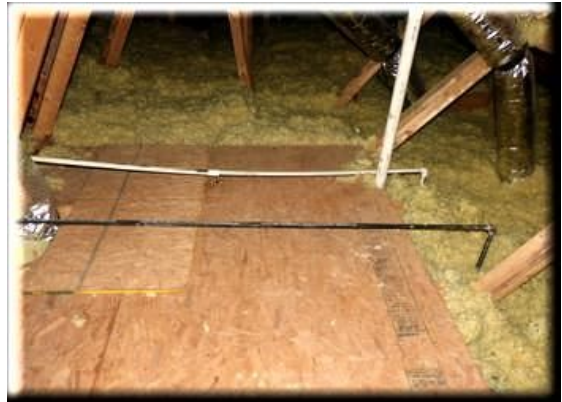
Photo: 4380.01 (1)

[P] [N] 4380.01: Fuel pipe(s) not supported.

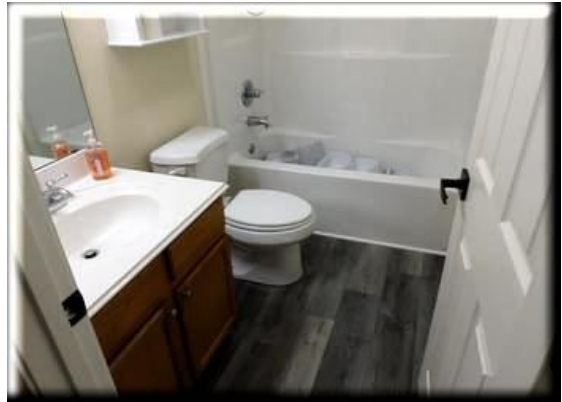
Photo: 6200.01 (1)

[P] [N] 6200.01: Water closet bowl loose on floor. Noted in the master bath. Discretion advised. The significance of the finding is uncertain. Further study by a qualified licensed contractor is advised. Correction or modification decreases the probability of continued and excessive deterioration. See Photo(s) 6200.01.

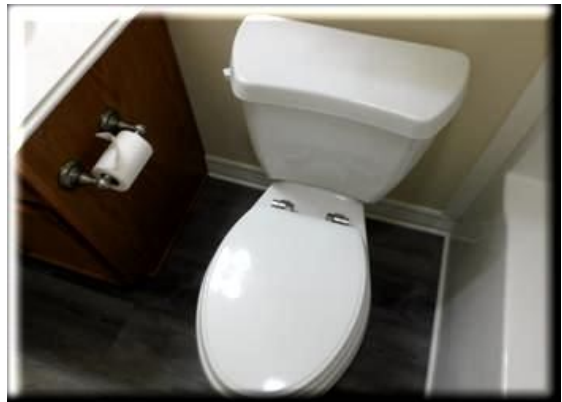
Photo: 6200.01 (2)

[R] [P] [N] 6200.01: Water closet bowl loose on floor. Discretion advised. The significance of the finding is uncertain. Further study by a qualified licensed contractor is advised. Correction or modification decreases the probability of continued and excessive deterioration. It is recommended that the finding be reviewed, and corrected as needed, by a qualified licensed contractor before purchasing the property. Noted in the hall bath. See Photo(s) 6200.01.

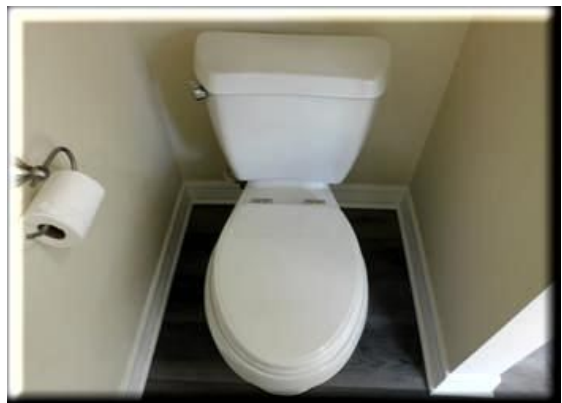
Photo: 6200.01 (3)

[U] [P] [N] 6200.01: Water closet bowl loose on floor. Discretion advised. The significance of the finding is uncertain. Further study by a qualified licensed contractor is advised. Correction or modification decreases the probability of continued and excessive deterioration. Modification or addition is generally considered an upgrade which should improve safety or efficiency. The opinion of a qualified licensed contractor is recommended. Noted in the hall bath. See Photo(s) 6200.01.

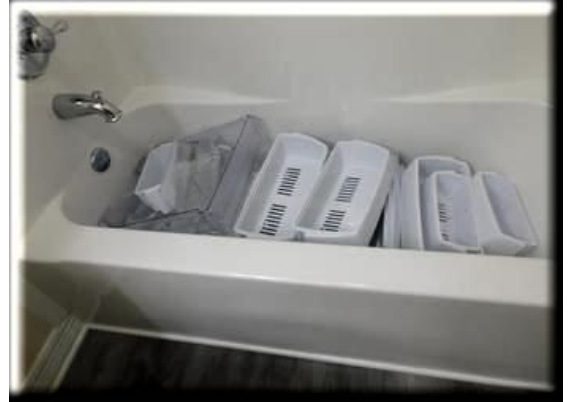
Photo: 6850 (1)

[M] [P] [N] 6850: Access impaired. Noted in the hall bath. Tub full stored items and could not be properly tested by inspector. Discretion advised. The significance of the finding is uncertain. Further study by a qualified licensed contractor is advised. Correction or modification decreases the probability of continued and

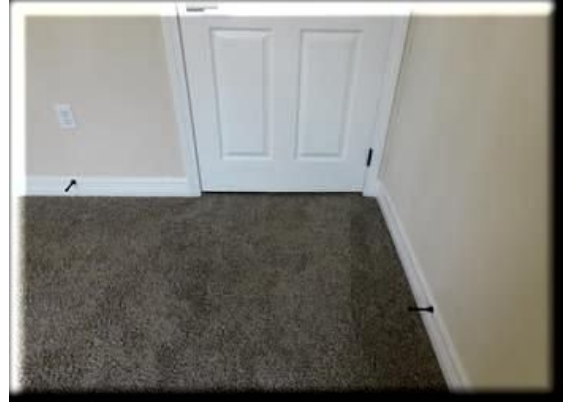
Photo: 7300.04 (1)

[P] 7300.04: Insufficient clearance under door for adequate a/c or heating air return.
Correction or modification decreases the probability of continued and excessive deterioration.
See Photo(s) 7300.04.

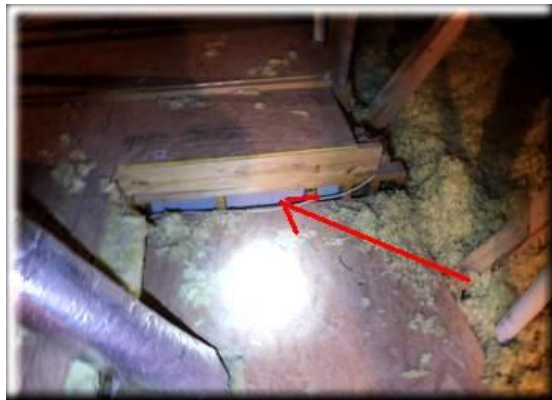
Photo: 9700.02 (1)

[P] [N] [M] 9700.02: Insulation missing. Monitor the situation on a regular basis. Corrections by a qualified licensed contractor, if and when necessary, are recommended. Discretion advised. The significance of the finding is uncertain. Further study by a qualified licensed contractor is advised. Correction or modification decreases the probability of continued and excessive deterioration. See Photo(s) 9700.02.

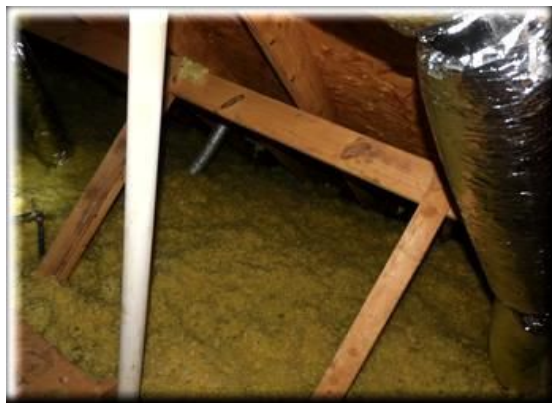
Photo: 9700.04 (1)

[P] [N] 9700.04: Insulation faulty or otherwise amiss. Insulation cover bathroom vent fans. Discretion advised. The significance of the finding is uncertain. Further study by a qualified licensed contractor is advised. Correction or modification decreases the probability of continued and excessive deterioration. See Photo(s) 9700.04.

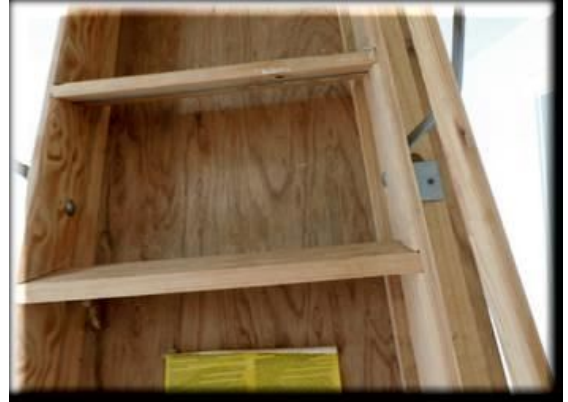
Photo: 9860 (1)

[H] [C] [U] [P] [N] [B] 9860: Unexpected repairs and maintenance. Attached garage firewall / separation wall questionable. Attached garage firewall material should be used on the garage side of walls and ceiling common to the house must meet certain requirements in order to slow the spread of fire. IRC (International Building Code) specifies that single and 2-family building must have a one hour rated surface, half an hour if an automatic sprinkler system has been installed. Pull down ladders in attached garages should be fire rated as well. The finding does not conform to building

standards and practices in effect at the time of construction or installation. Before purchasing the property, further study and corrections, as needed, by a qualified licensed contractor are advised. Discretion advised. The significance of the finding is uncertain. Further study by a qualified licensed contractor is advised. Correction or modification decreases the probability of continued and excessive deterioration. Modification or addition is generally considered an upgrade which should improve safety or efficiency. The opinion of a qualified licensed contractor is recommended. Caution is advised. The finding could be, or could become, hazardous under certain circumstances. The opinion of a qualified licensed contractor is recommended. The finding should be considered hazardous. Corrections by a qualified licensed contractor, before purchasing the property, are advised. See Photo(s) 9860.
