Az Superior Home Inspections

Summary Report

Client: Mr Sample Report
Inspection Address: 1234 E Sample Lane, Phoenix, Arizona 85050
Inspection Date: 5/28/2024 Start: 7:00 am End: 12:00 pm
Inspected by: Bryan Snyder

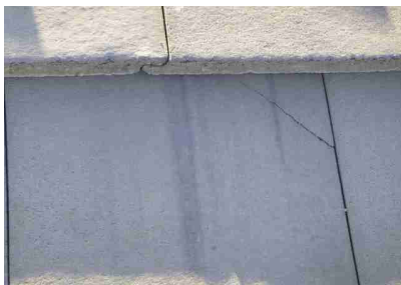
- I observed cracked or broken tiles, that may expose the waterproof membrane, which should be serviced or the roof could leak. Lower edge chipped tiles are common, this is the most likely place for a tile to chip, this type of chip does not expose the water proof membrane underneath due to the tile below. E.G.

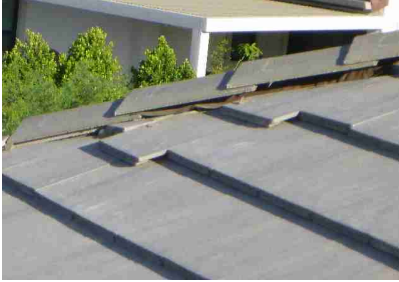
- I observed number of slipped tiles that will need service. E.G. South facing roof.

I observed a number of slipped tiles that will need service - *Continued*

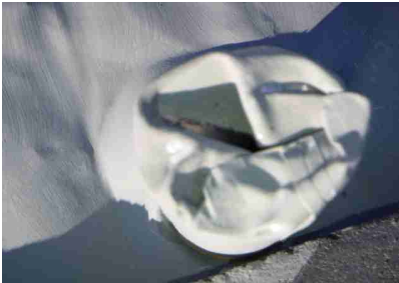
- Plumbing vent stack flashing needs wrapped properly. E.G. The flashing is blocking the vent pipe top restricting the venting. South facing roof.

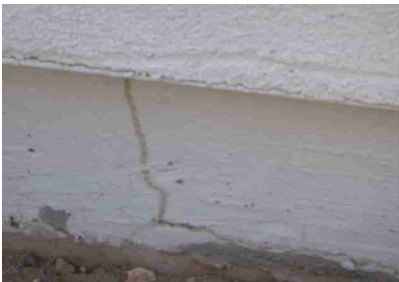
- There is evidence of either past or present termites that should be evaluated by a licensed termite inspector. E.G. Termite tubes located at the east exterior stem wall.

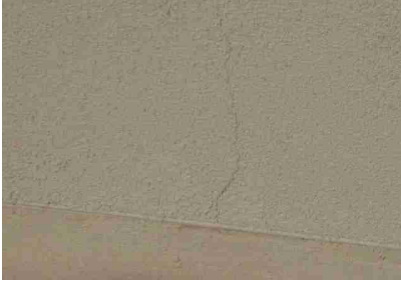
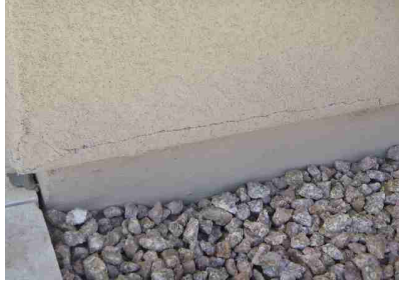
- There are typical cracks in the stucco, which you should view for yourself. All cracks result from movement, thermal cycling, and are not structural in that respect, but the vast majority of them have only a cosmetic significance. Most common at corners of windows and doors. E.G. East facing wall.

There are typical cracks in the stucco which you should view for yourself - *Continued*

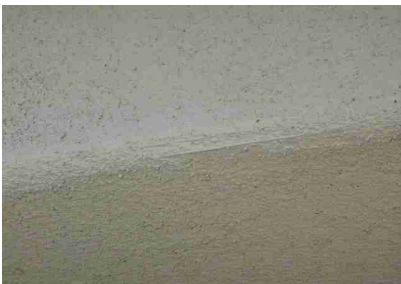
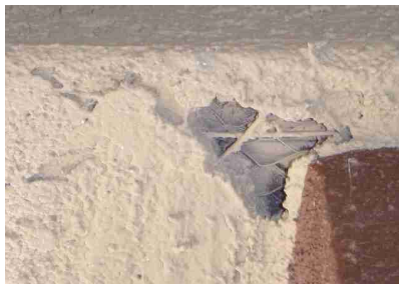
- I observed areas where the stucco lath is exposed. Repairs should be made so that the lath does not rust. E.G. Underside of the rear patio. Underside of the front entry.

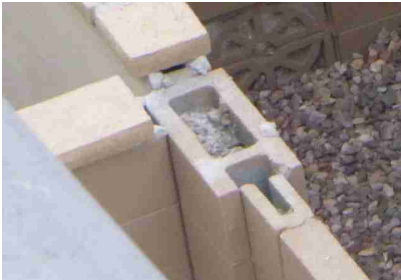
- There is a missing cap on the cinder block yard walls, which should be repaired. E.G. South west corner of the yard wall.

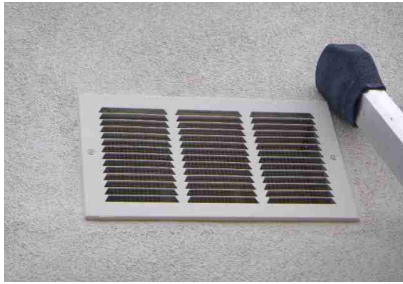
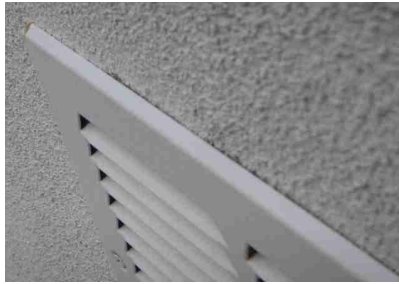
- Garage combustion vent needs sealed to prevent water from running down the wall and entering the wall. E.G. Upper exterior garage vent.

Garage combustion vent needs sealed - *Continued*

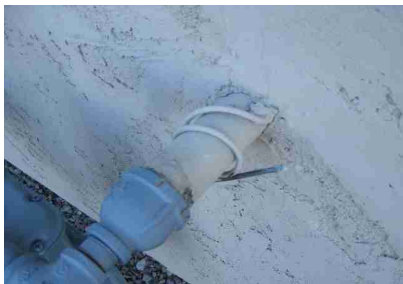
- The bonding wire clamp is missing. Bonding is provided primarily to prevent a possible electric shock to people who come in contact with the gas piping and other metal objects connected to the grounding system.

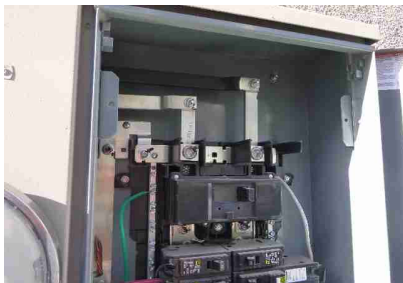
- The protective cover for the service entry conductors is missing and will need to be replaced.

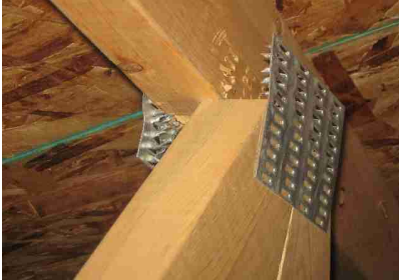
- One of the truss members is damaged and should be repaired. I strongly recommend getting a copy of the Truss Repair Design Drawing (TRDD) once repair is completed.

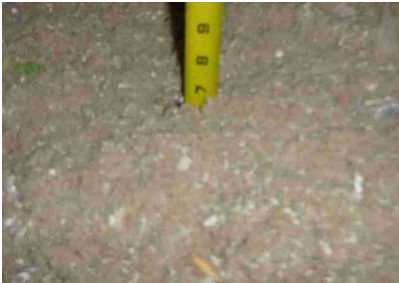
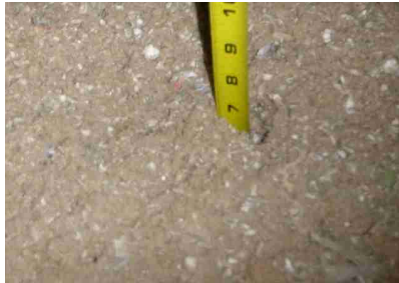
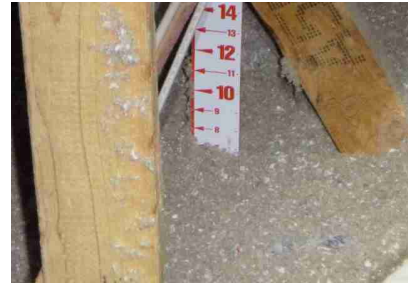
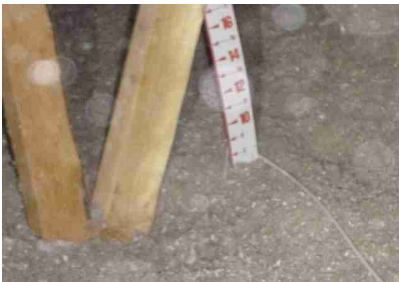
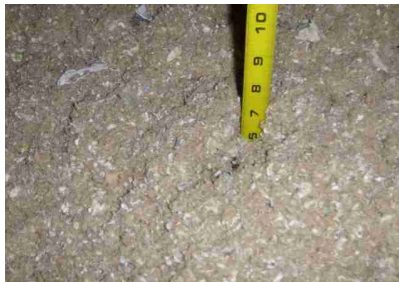
- The current R-30 standards for natural blown in fiber is 8.5 settled inches, I observed anywhere from X inches to X inches as shown in the pictures below.

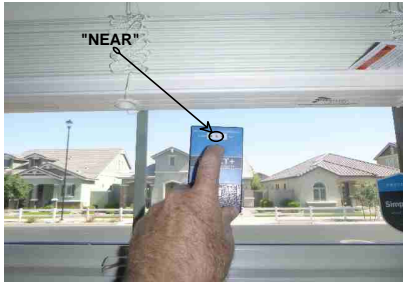
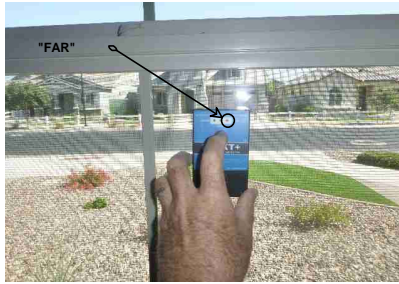
- Low E film is inconsistent with one or more of the windows. E.G. All the Windows and Doors tested for the Low E film on the "FAR" side when testing from the interior of the house with the exception of the Downstairs Living room window upper pane. which tested on the "NEAR" side only.

Low E film is inconsistent with one or more of the windows - *Continued*

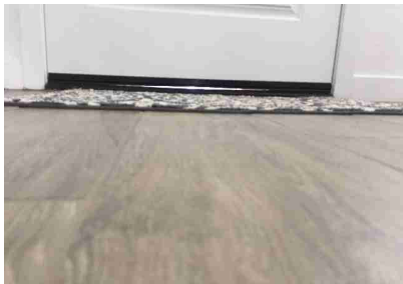
- The door threshold needs to be adjusted. E.G. You can see daylight between the door sweep and threshold.

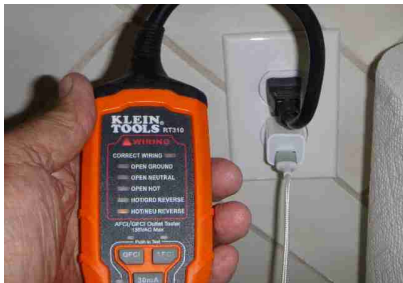
- An outlet has reversed polarity, and should be serviced. E.G. Hot and Neutral wires are reversed.

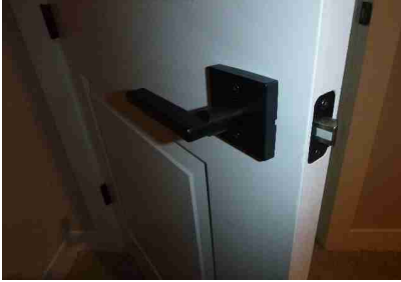
- The door does not have a privacy lock for the Master bedroom. E.G. Door handle has no locking device.

The door does not have a privacy lock for the Master bedroom - *Continued*

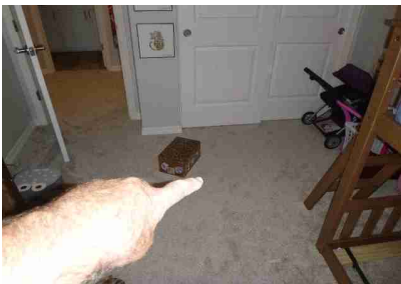
- There are audible sub-floor squeaks at points on the second floor. E.G. Home owner pointed out as well.
