**INSPECTION
REPORT
FOR THE
EASTFIELD SLOPES CONDO. ASSOC.
WATER TREATMENT PLANT
HYDROPNEUMATIC TANK**

PWS ID. No.: 6294856

**9529 Fieldview Circle
Thonotosassa, Hillsborough County, Florida**

May 15, 2024

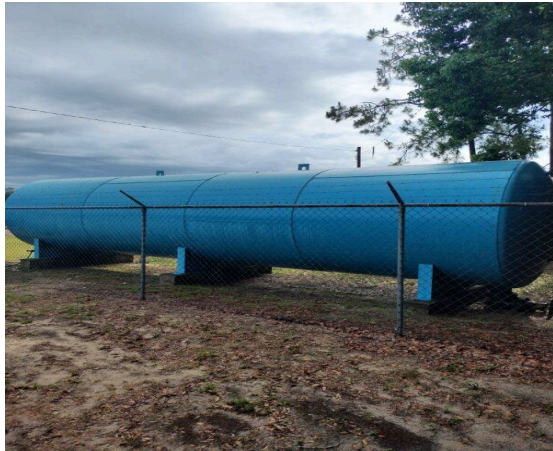
Exterior of the Hydropneumatic Tank (HPT)

- The exterior structure of the hydropneumatic tank was in overall good condition. There were no signs of deteriorated welds, pitting or structural damage.
- The exterior coating was observed to be in good condition with no signs of blistered paint or corrosion.

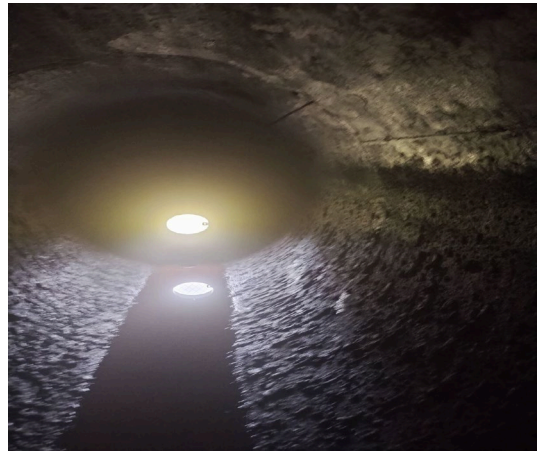
Interior of the HPT

- The interior epoxy coating of the HPT was observed to be in poor condition with severe corrosion, pitting, metal delamination and weld separation.

- The hydropneumatic tank's interior epoxy coating was not examined for dry film thickness as the interior was observed to void of coating and have severe corrosion, pitting, metal delamination and weld separation.

- The structural integrity of the hydropneumatic tank was in poor condition, with no interior epoxy coating, severe corrosion, pitting, metal delamination and weld separation. It is our recommendation that the hydropneumatic tank be replaced with an ASME Code certified pressure vessel of the same gross volume in order to prevent a potential catastrophic tank failure.
