RE: Cedar Lake Dam (MO40189) St. Charles County

| ID #: MO40189 | CEDAR LAKE DAM | INSPECTION DATE: September 10, 2025 |

## DAM & RESERVOIR SAFETY PROGRAM DAM INSPECTION REPORT

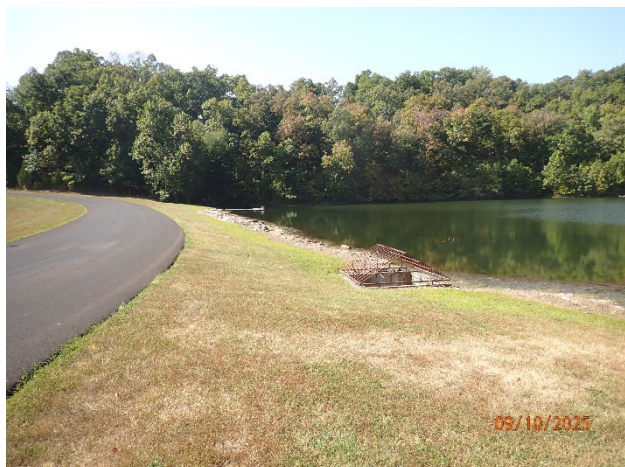
Upstream face

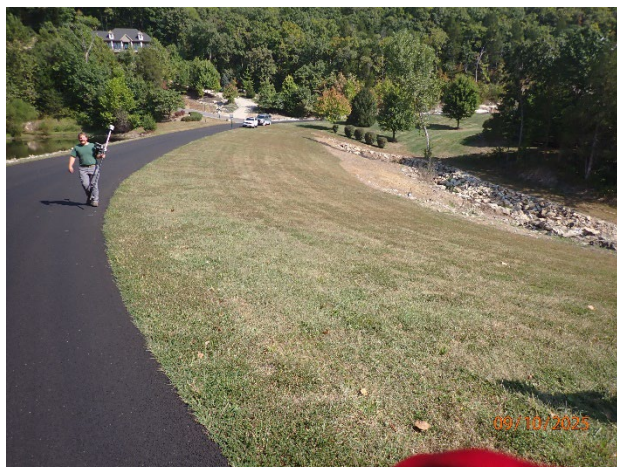
Downstream face

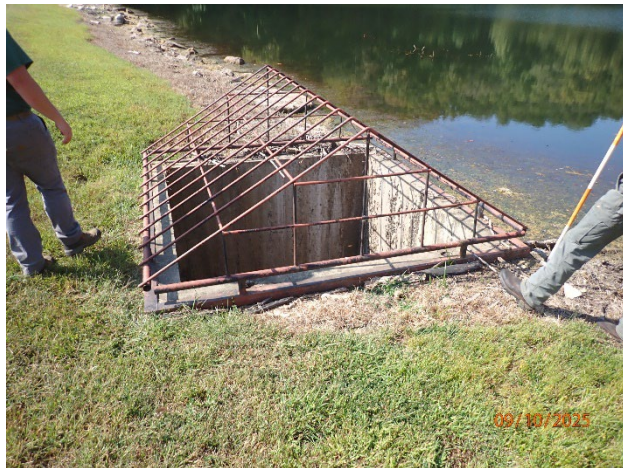
Principal spillway

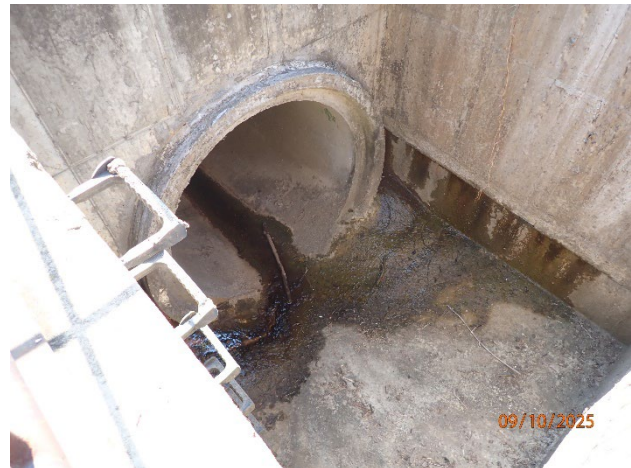
Principal spillway inlet

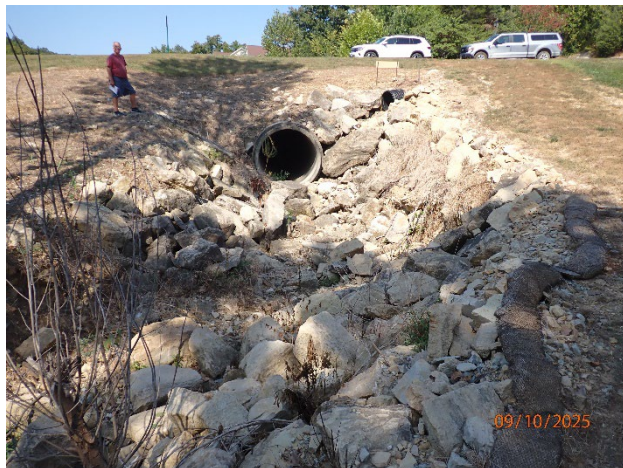
Principal spillway outlet pipe and channel – looking upstream

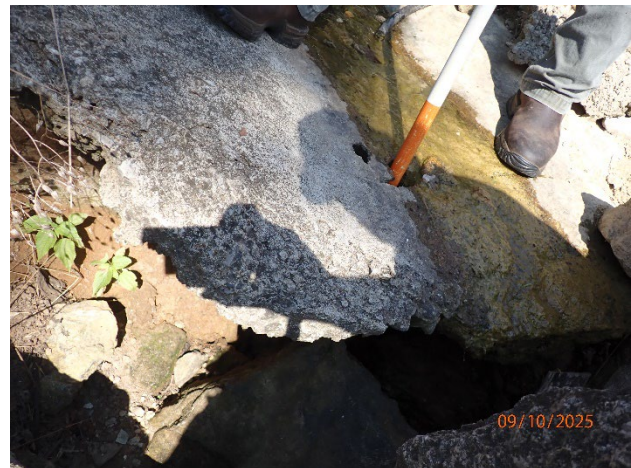
Principal spillway outlet – note undercutting of concrete

| Item | Condition | Issue | Comments |
|---|---|---|---|
| 8. Principal spillway outlet | OR | | Monitor undercutting at principal spillway outlet. Repair and/or placing material may be necessary as erosion progresses. |

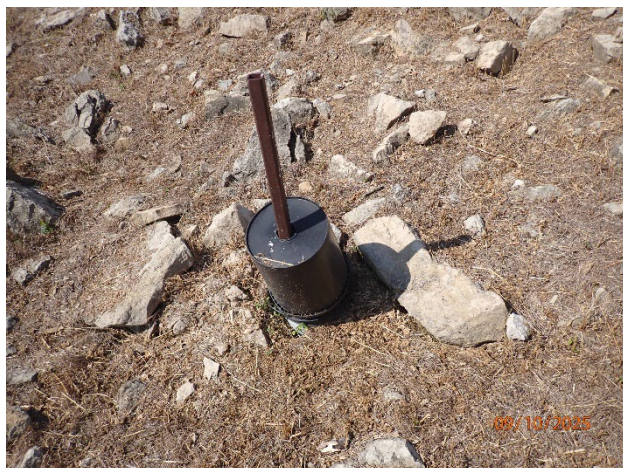
Drawdown valve pit on the downstream face

| Item | Condition | Issue | Comments |
|---|---|---|---|
| 12. Lake drain gates/valves | OR | Unknown Condition | Monitor the pipe and valve for any indication of leaking. Consider hiring qualified personnel to investigate the condition of the pipe and valve. |

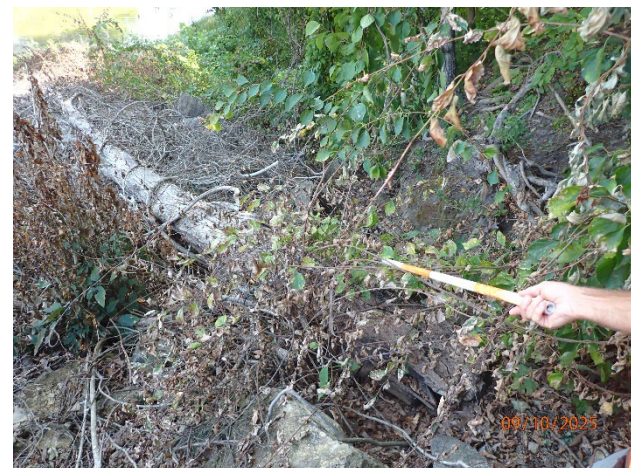
Erosion and downed tree in the right groin

| Item | Condition | Issue | Comments |
|---|---|---|---|
| 5. Right groin | OR | Erosion | Erosion gullies are forming in the right groin. Repair and/or rock armor may be necessary as erosion progresses into the embankment. Recommend removing the downed tree from the right groin to facilitate vegetation management. |
