SMD CONSTRUCTION CO., INC.

Inspection No.: 202211010

Inspection Date's: 11/06/2022 & 11/10/2022

Address: 1111 Anywhere Lane, Anywhere, CA

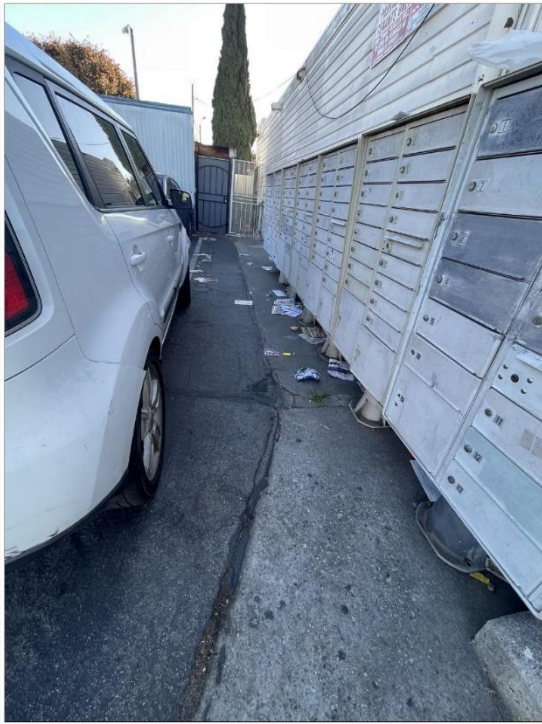
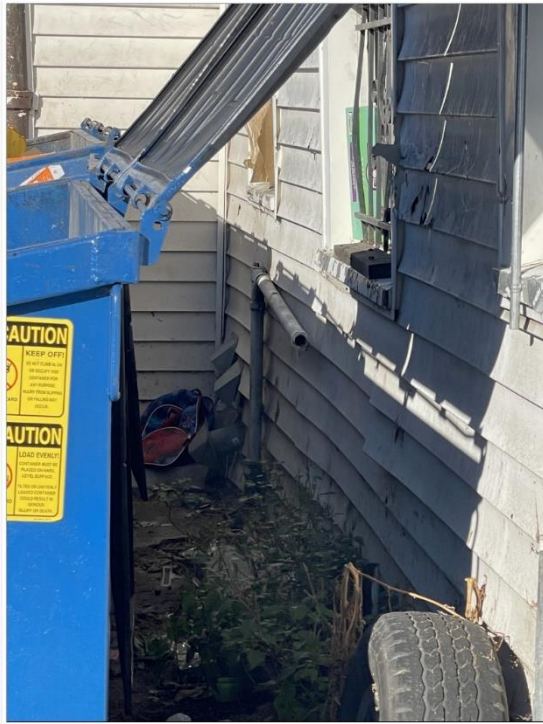
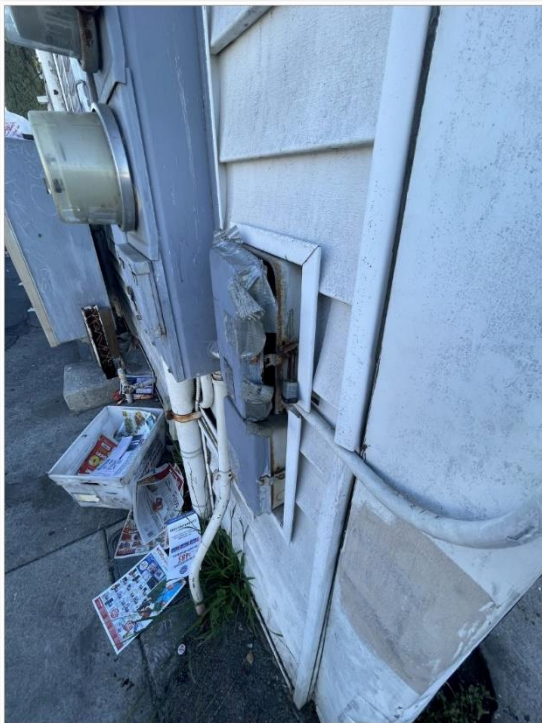
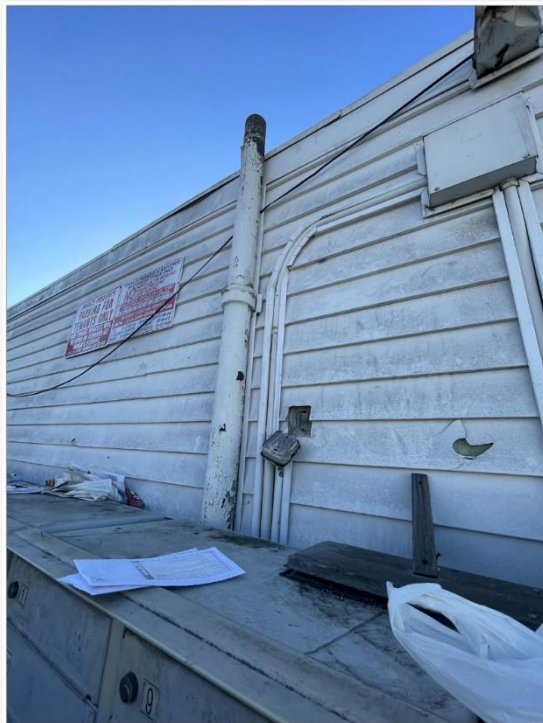
Excessive debris observed at various areas around the outside perimeter of the building. Advise periodic removal of debris as part of routine maintenance.

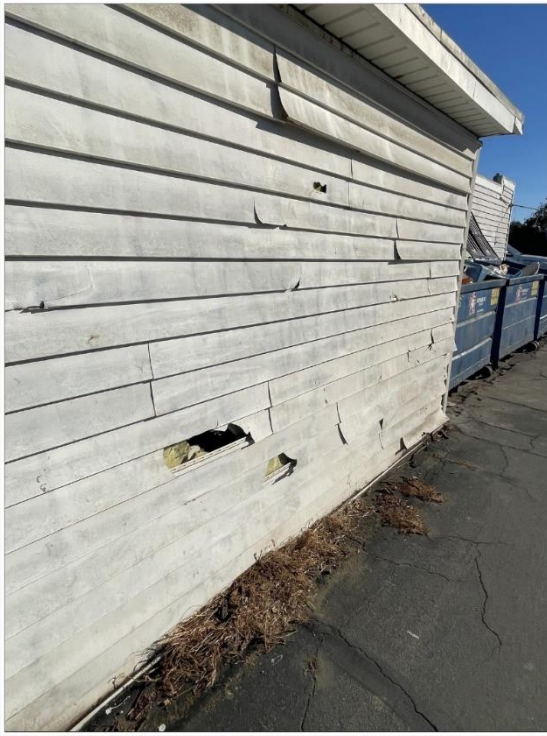
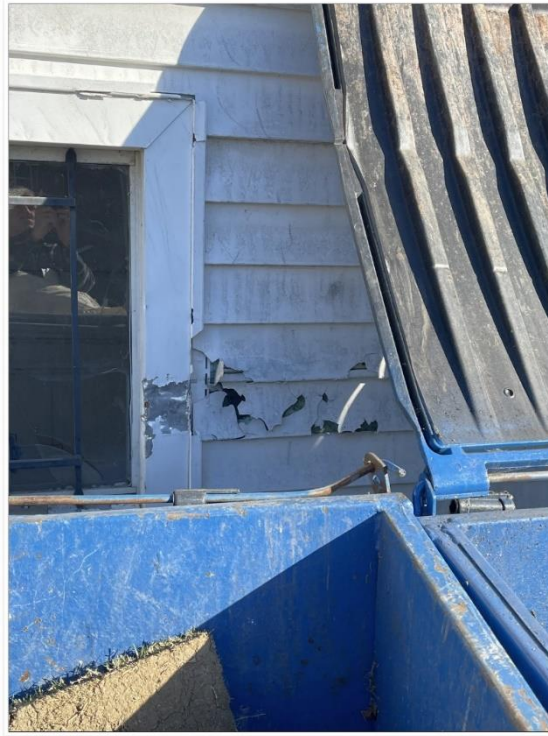
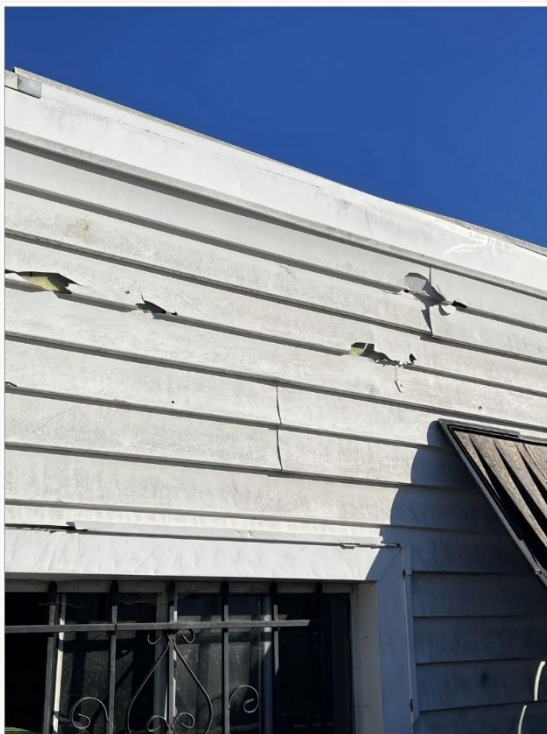
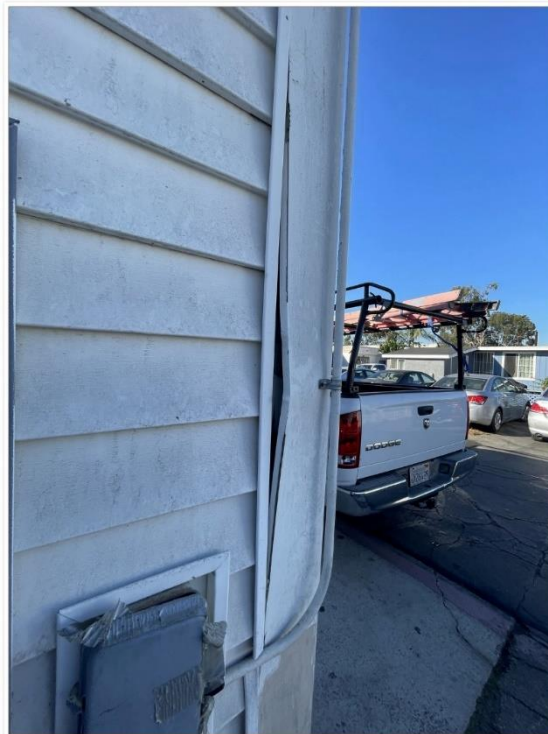
**Holes, bent, chipped, peeling, torn and missing siding noted at various areas;
we advise making necessary corrections.**

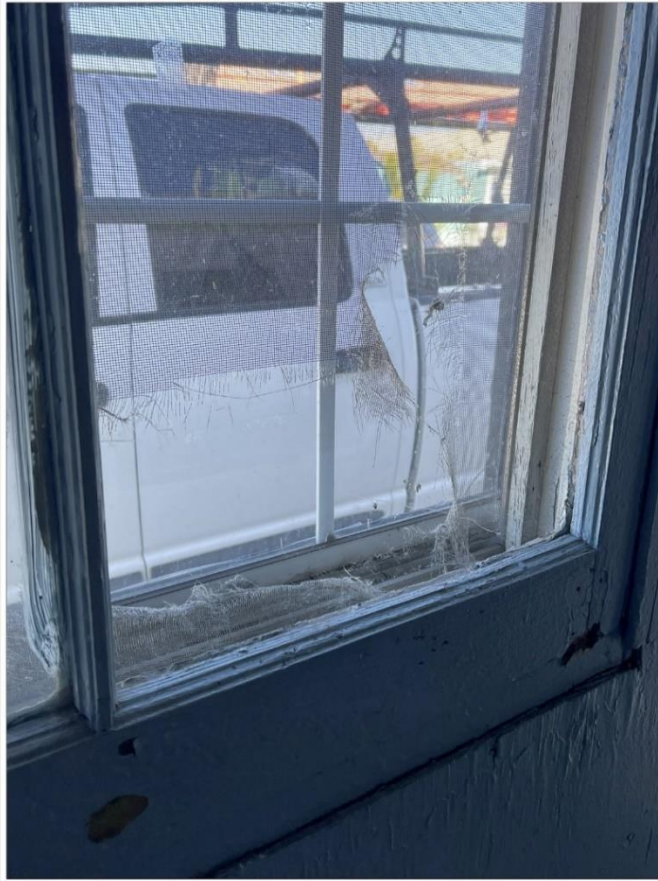
- 105 Trim: **Bent, broken, chipped, missing, peeling trim noted at various/many areas; we advise making necessary corrections.**
-
- 106 Window Frames: **Bent, broken, chipped, missing, peeling window frames noted at various/many areas; we advise making necessary corrections.**
-
- 106a Screens: **Most screen noted are missing; we advise making necessary corrections. Existing screens noted are deteriorated and torn.**

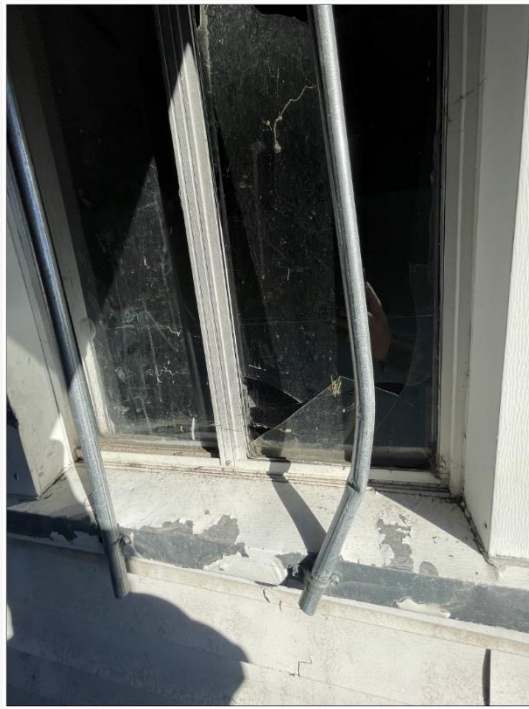
Conduit noted blocking windows; suggest removing as a safety upgrade.

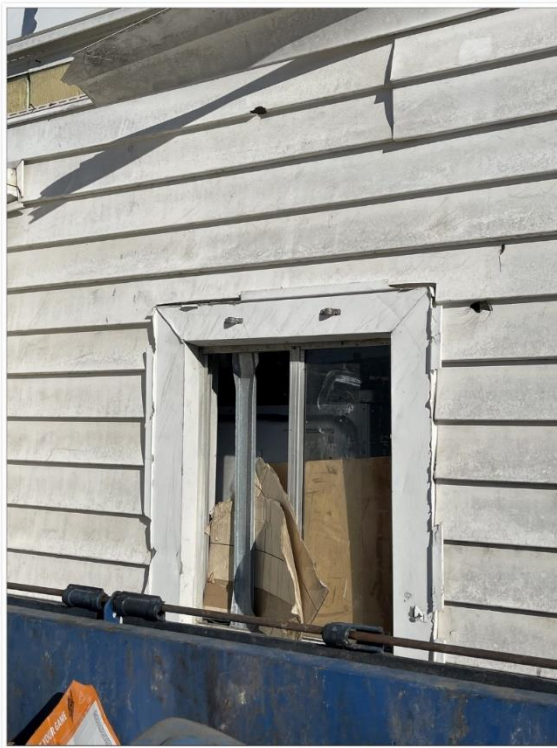
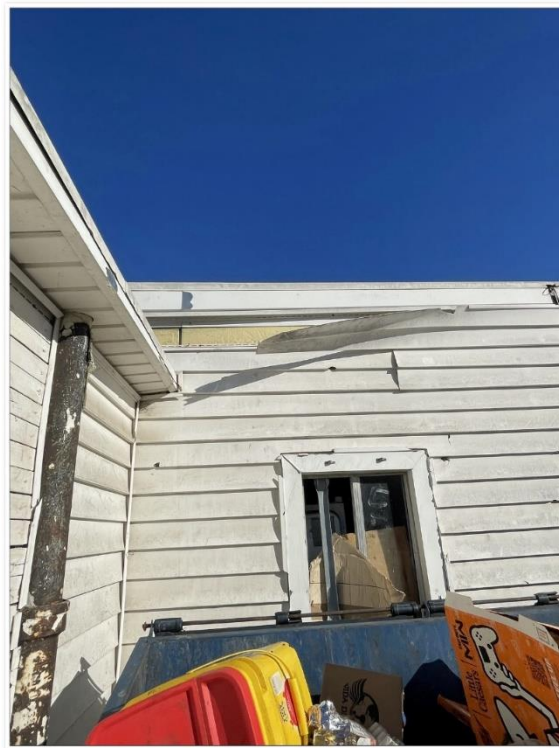
Several windows noted are broken, chipped and have missing panes.

Windows noted blocked with debris; suggest removing as a safety upgrade.

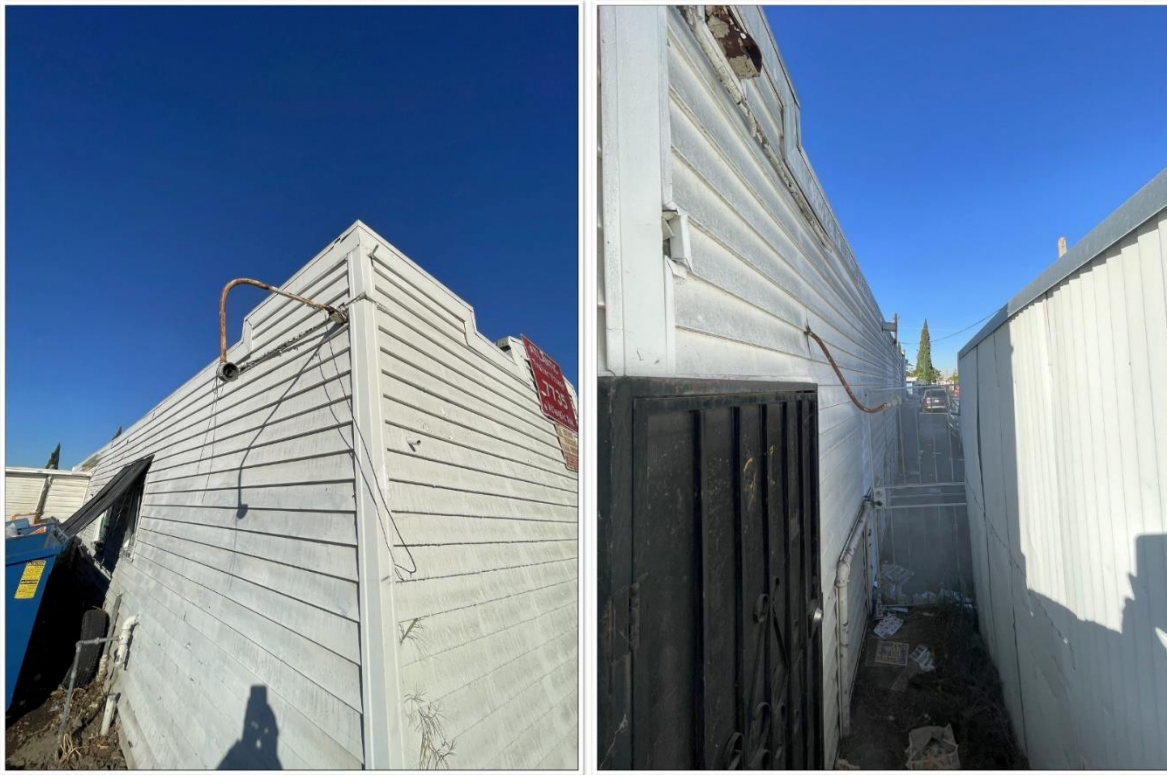
Unable to test lights no light bulbs in fixtures.

Light fixtures bent, hanging, rusted, missing covers noted in various areas; we advise making necessary corrections.

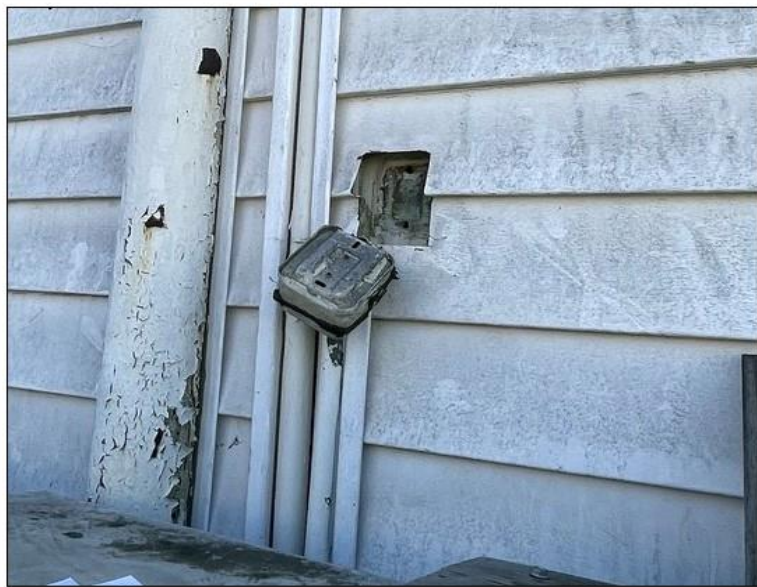
Missing, loose/hanging or damaged exterior box noted at side; suggest repairs/replacement as needed to ensure safety.

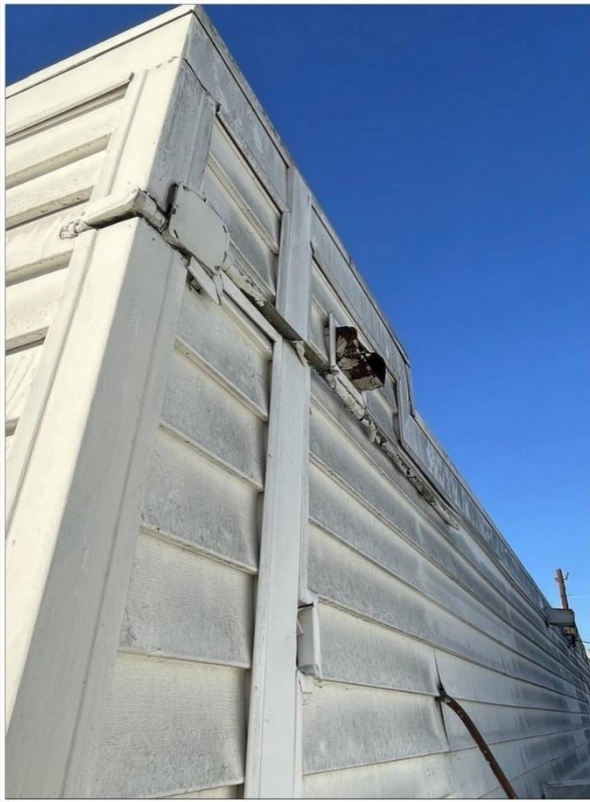
- 108 Gutters/Downspouts: **Deteriorated, rusted, disconnected and missing gutters and downspouts noted at various areas; we advise making necessary corrections.**

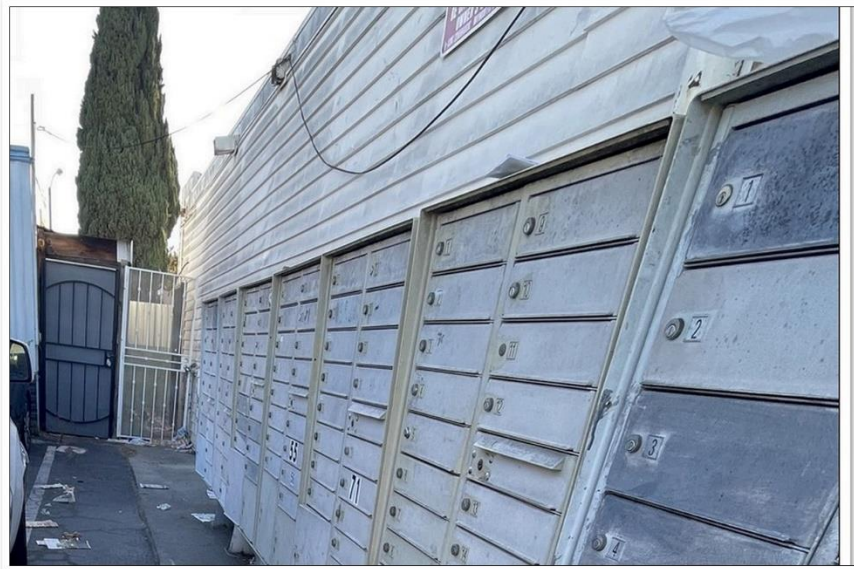
Running water dripping down from downspouts onto mailboxes; we advise making necessary corrections.

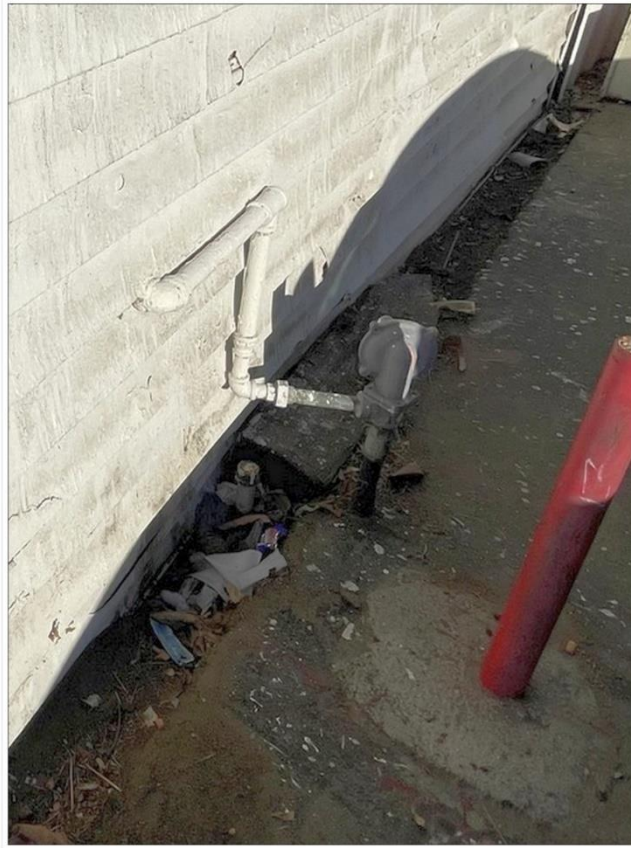
Located at side. **Unable to determine if seismic valve has been installed as a safety upgrade.**

Unable to determine if gas meter is correctly installed; suggest checking with gas company.

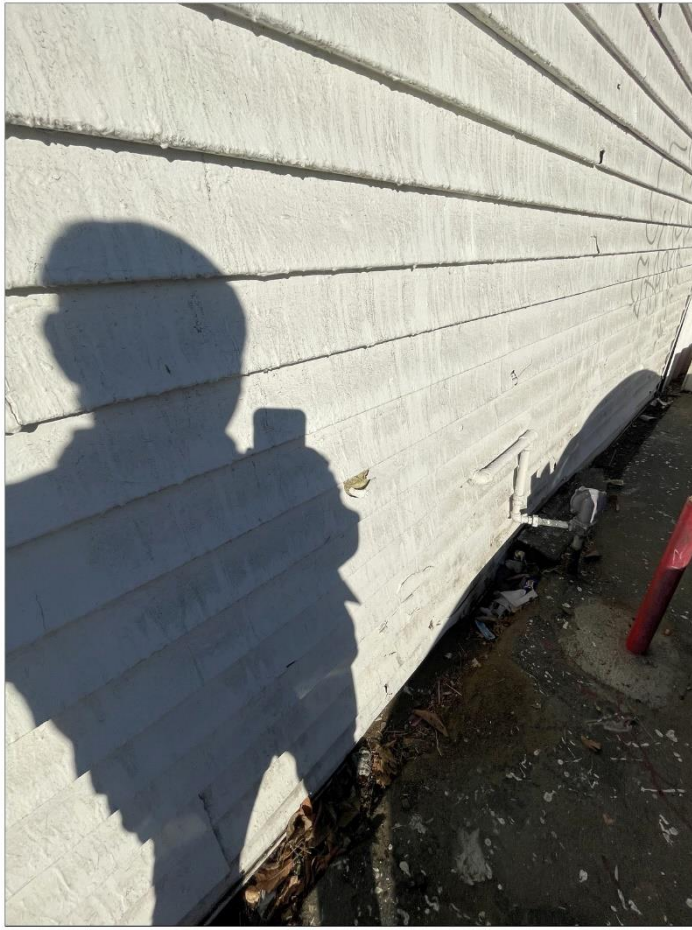
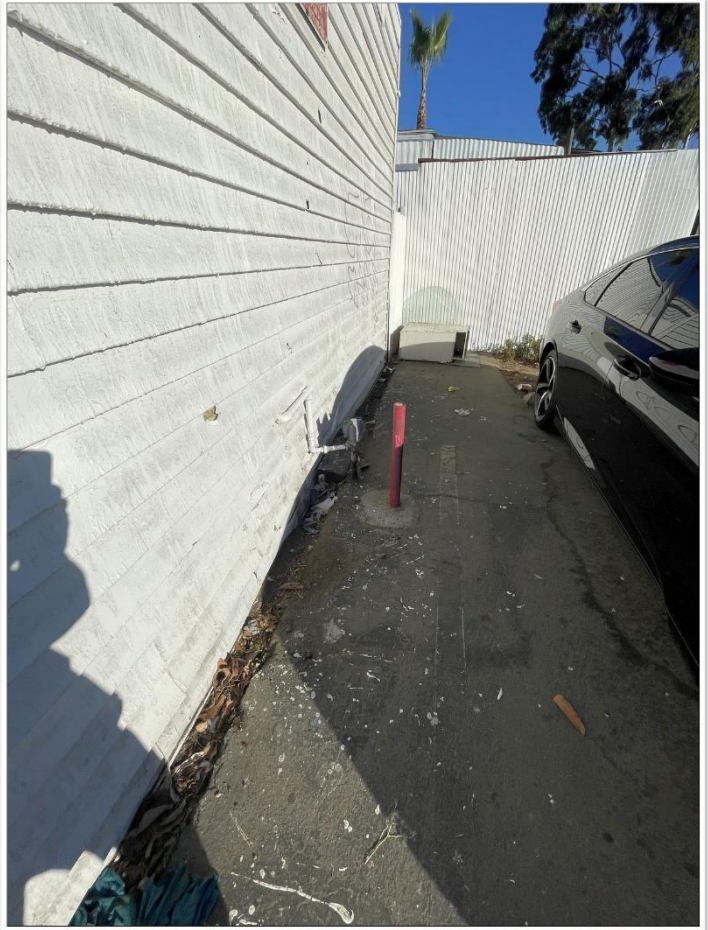
115 Foundation: **Gaps and missing concrete noted at various areas.**

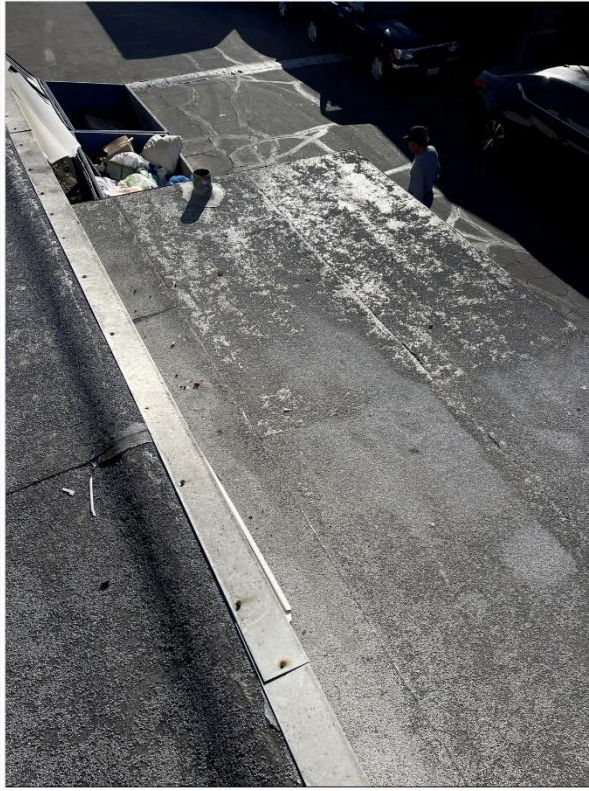
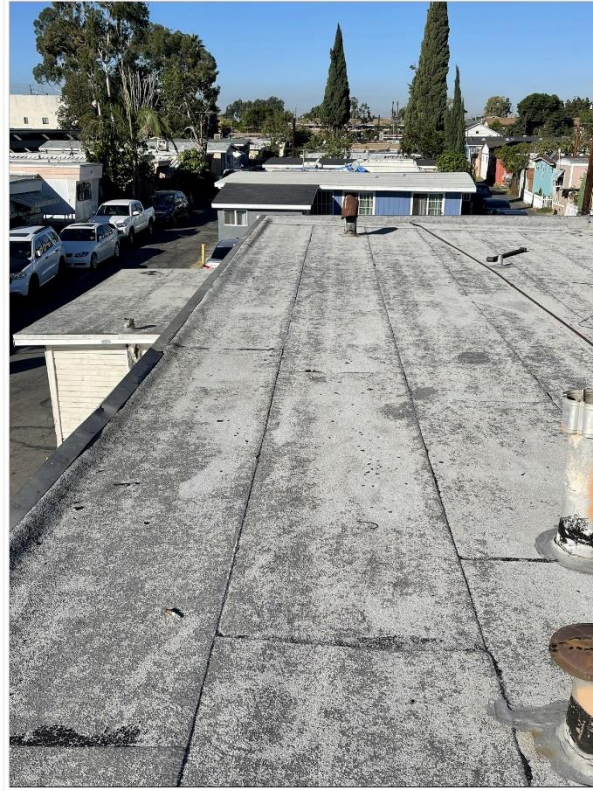
127 Roof Comments: **Roof shows extensive wear and deterioration at various areas. we advise making necessary corrections.**

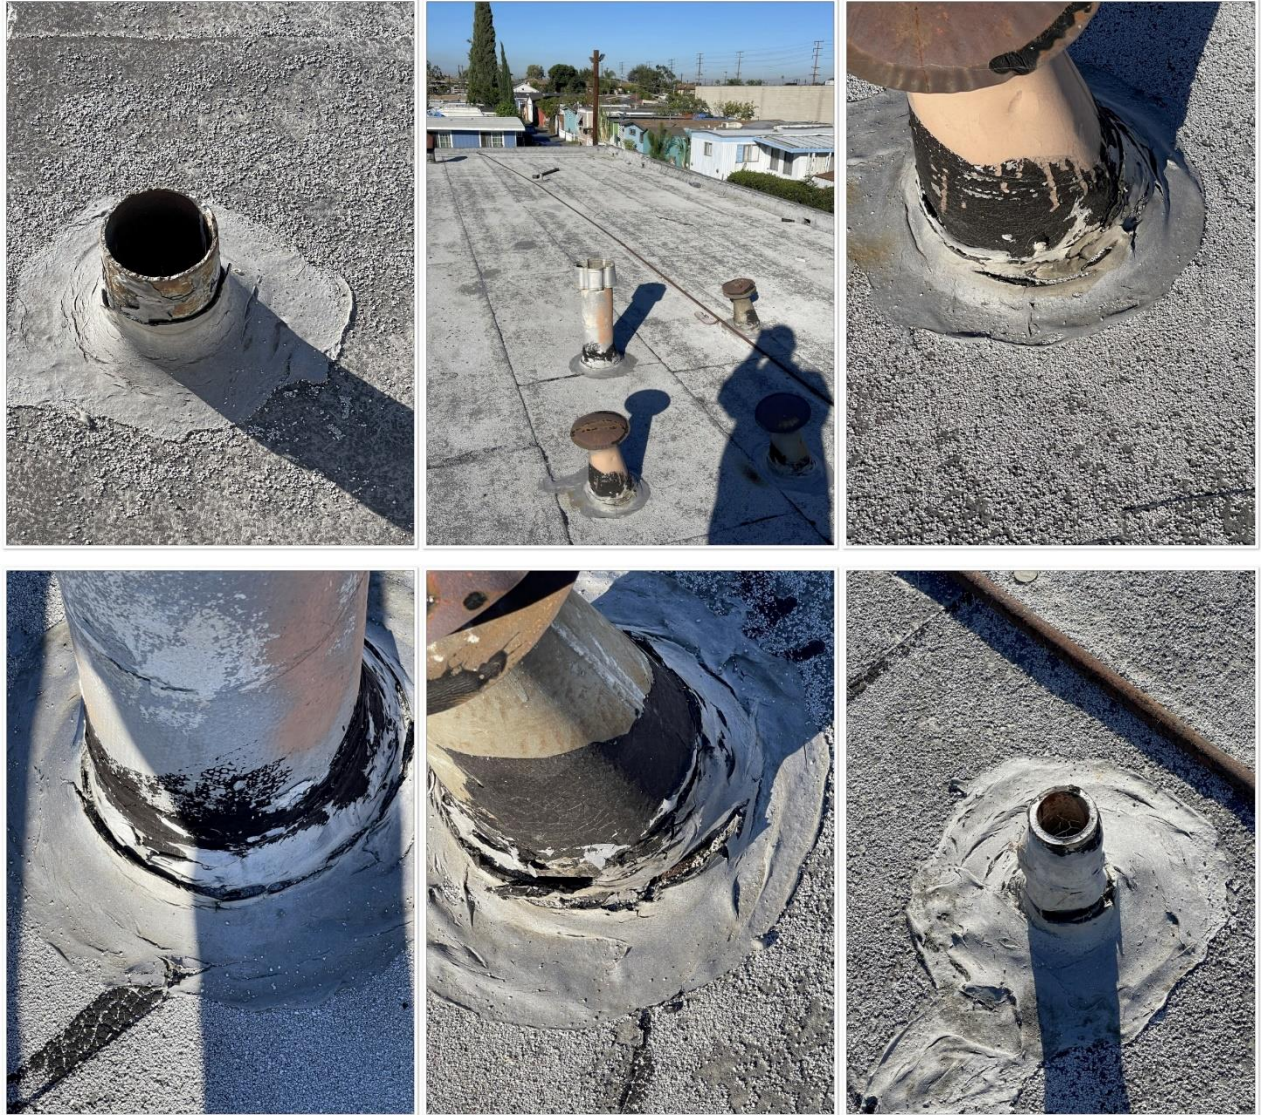
127 Roof Comments Cont'd: **Missing vent cap noted at various areas; we advise making necessary corrections.**

We advise resealing all through roof vents and projections as part of routine maintenance.

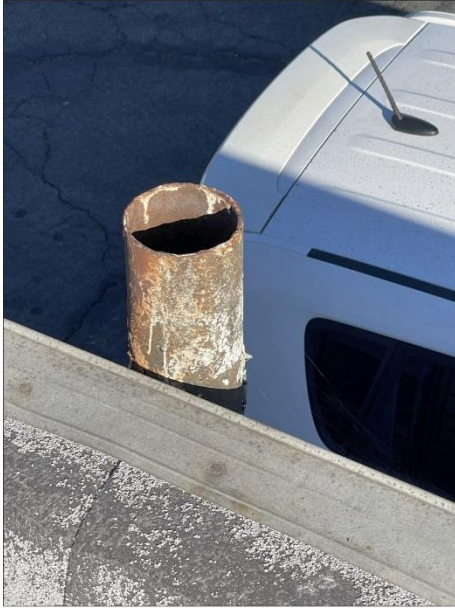
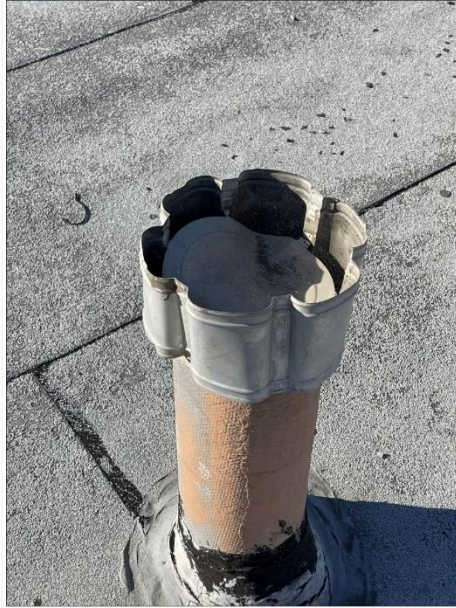
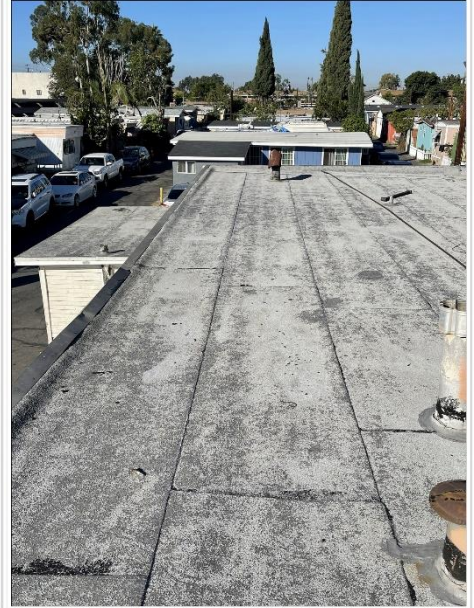
127 Roof Comments Cont'd: **Missing vent cap noted at various areas; we advise making necessary corrections.**

We advise resealing all through roof vents and projections as part of routine maintenance.

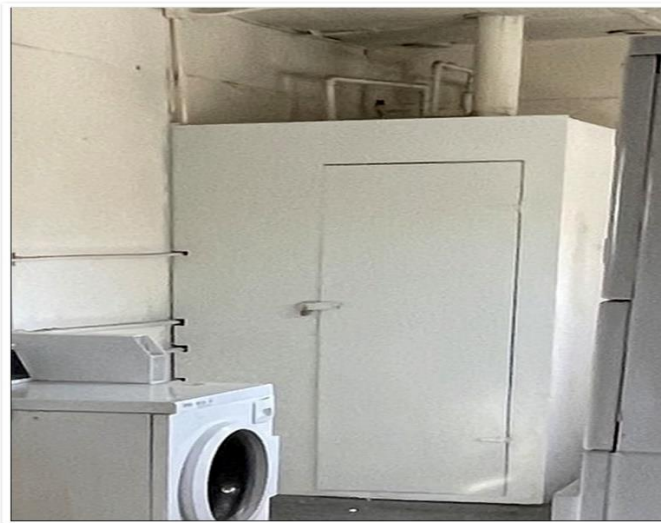
201 Heating:	None.
201a Venting:	None
202 Air Conditioning:	None.
203 Thermostat:	Non-Applicable.
204 Ducting:	Non-Applicable.
205 Plumbing:	Per owner an outside plumber previously inspected plumbing; please see plumbers notes.
206 Drain/Waste Vent:	Please see number 401.
207 Water Heater:	Unable to inspect water heater; there was no key present to the water heater closet at the time of the inspection. Please see number 405.

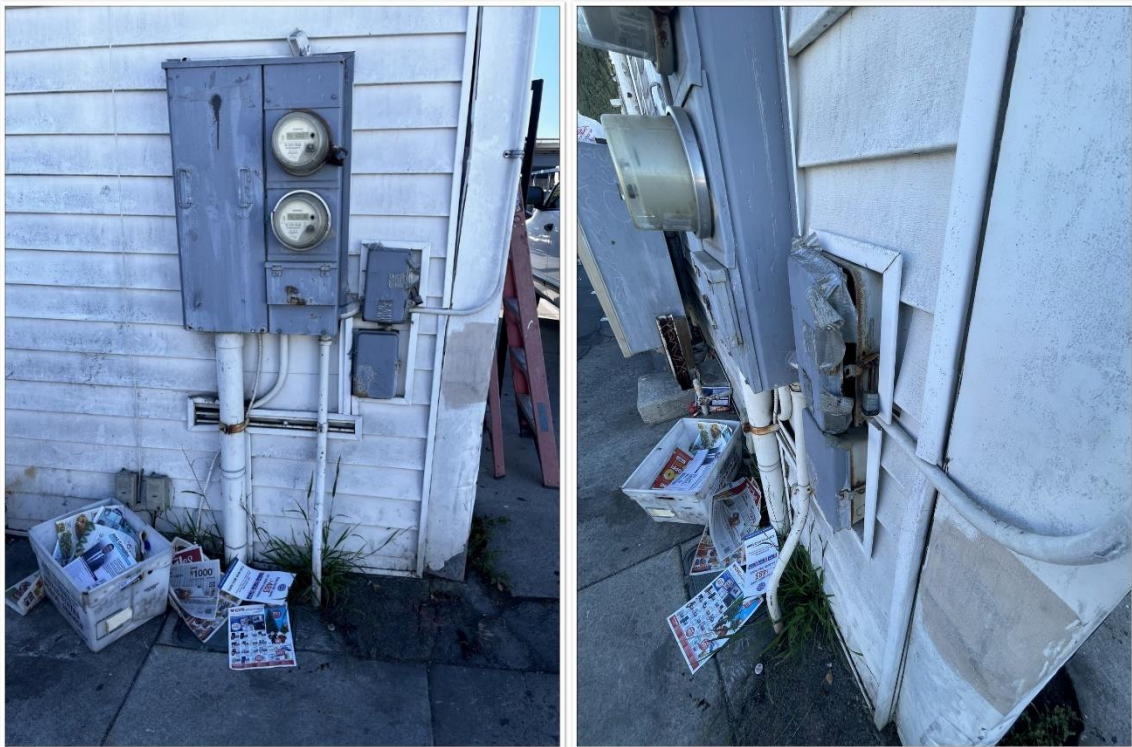
The main electrical service is approximately 200 amps 120/240-volt single phase with two (2) 100-amp meters underground feed with one 50-amp breaker for unit 42 and one 100-amp breaker for this unit. main panel located at north west corner of this unit. Overload protection is provided by breakers. No futures provided for possible expansion; maximum allowable amperage is 100 amps 120/240 volts. Main feeders are aluminum 350 KCMIL rated for 210 amps per NEC. 100-amp Sub panel located in first room of this unit to left.

The main service panel capacity for unit 42 is under 100 amps. While this system was standard at the time of original construction and appears serviceable, we advise upgrading the panel to meet today's higher electrical demands. A licensed electrician should perform all upgrades and work.

Deterioration noted at boxes and tape noted to hold box closed; suggest replacing boxes as a safety upgrade.

Suggest adding 100-amp sub panel breaker to the sub panel.

Suggest cleaning up debris underneath panel.

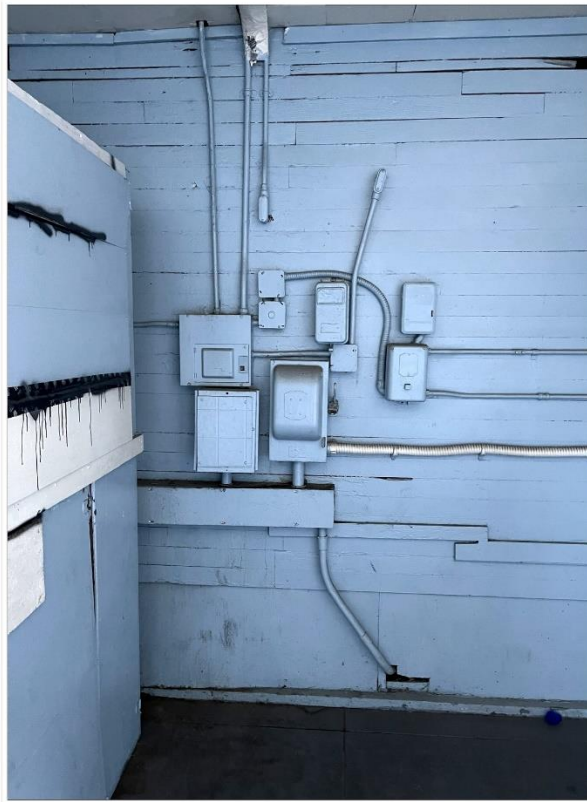
Disconnect switches feeding some of the electrical equipment throughout unit. There are also junction boxes used as pull poking between electrical panel and disconnect switches; While this system may have been standard at the time of original construction if there was an inspection at the time of installation; although if there was no inspection at the time of installation you may receive correction notices, we advise upgrading to meet today's higher electrical demands as it may not pass inspection. A licensed electrician should perform all upgrades and work.

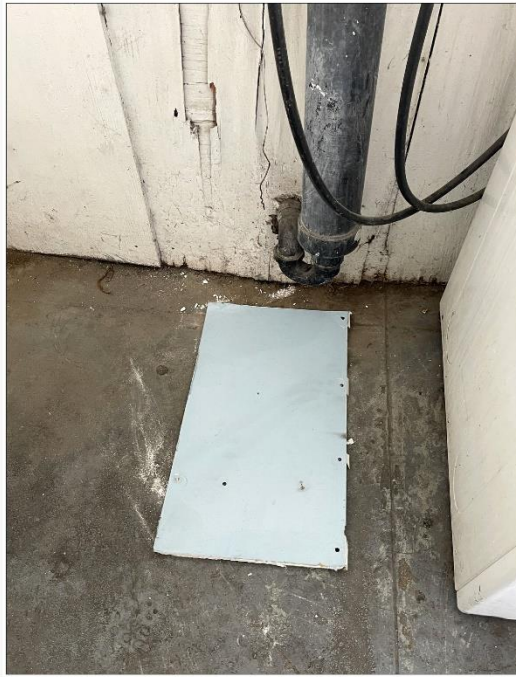
Extensive damage and foreign objects used for patching repairs to flooring; we advise making necessary corrections.

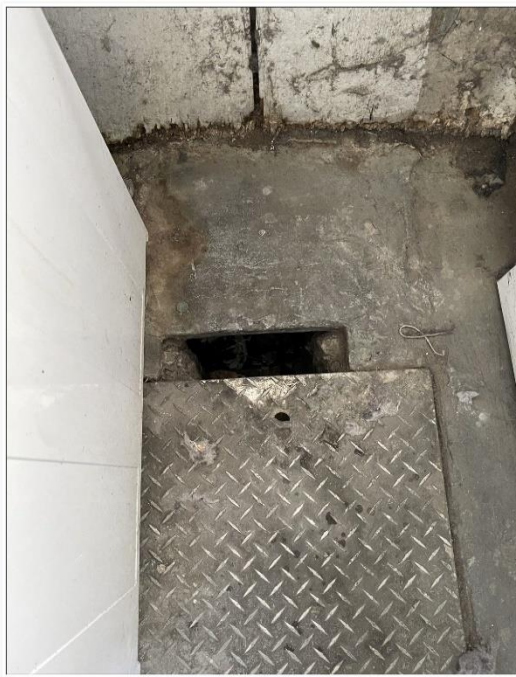
Large hole partially covered with metal plate is a possible trip hazard and a possibility of foot or feet falling into the exposed portion of hole. This is a safety concern. We advise repair/replacement as needed to ensure safety.

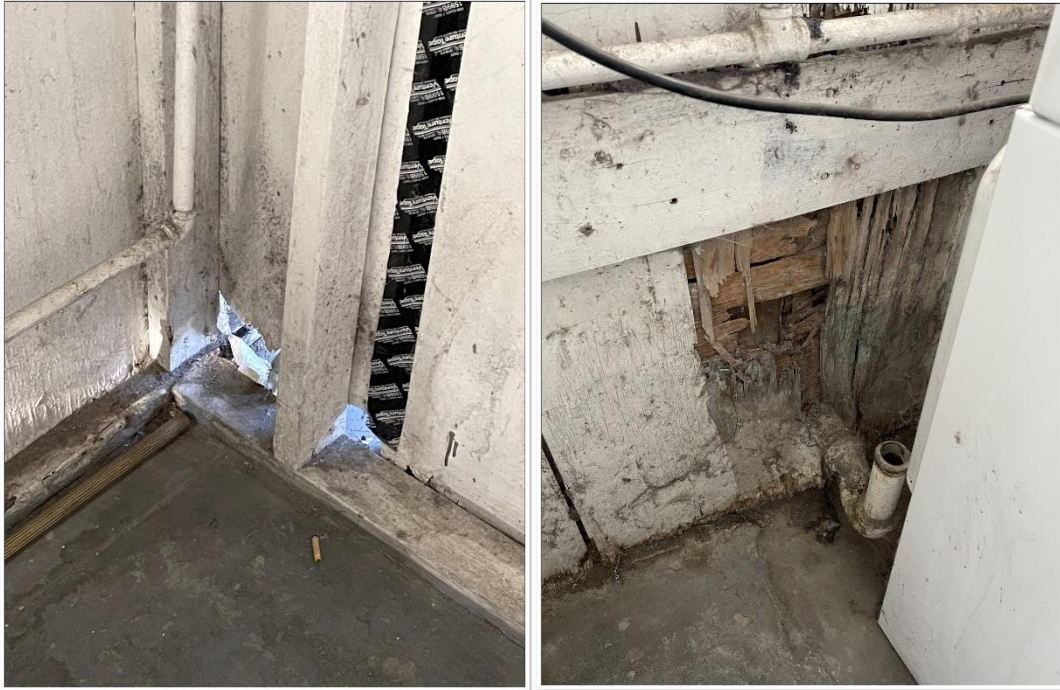
Extensive damage noted to walls

Broken, deteriorated, rotted, missing portions of wall noted at various areas.

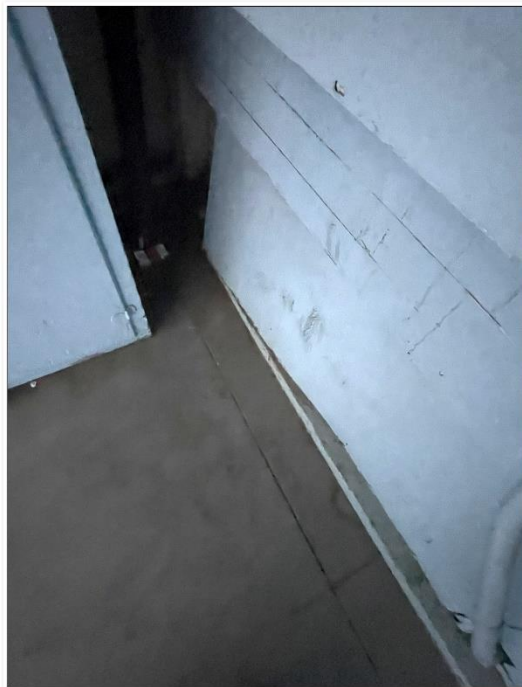
Cracked, deteriorated separating noted.

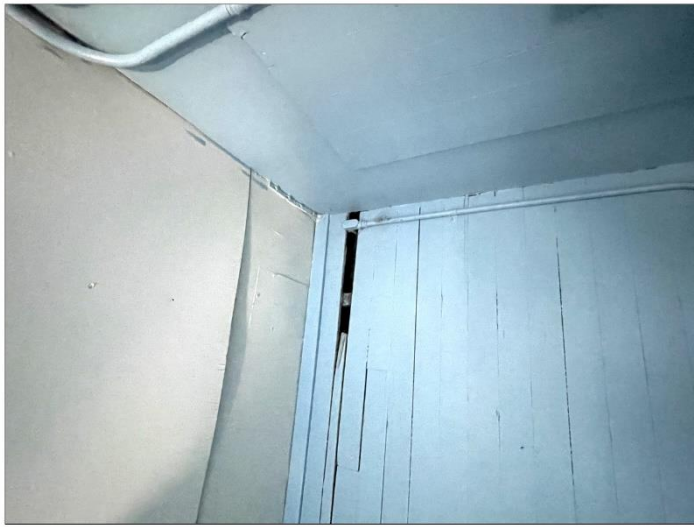
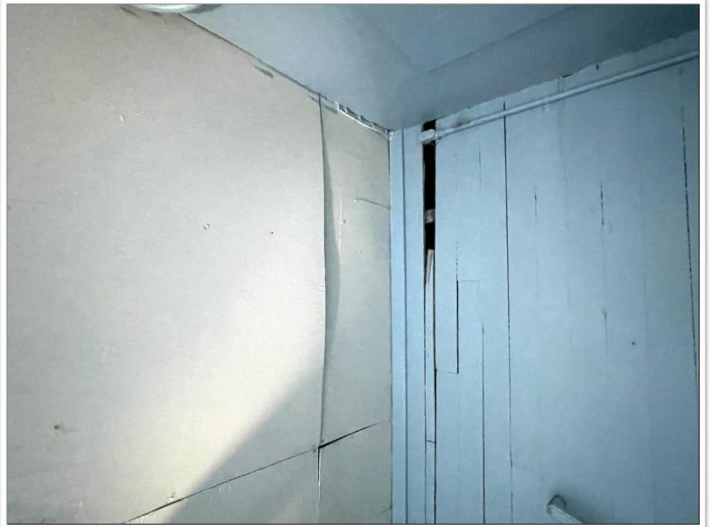
302 Walls Cont'd: **Cracks, holes and warping noted in walls.**

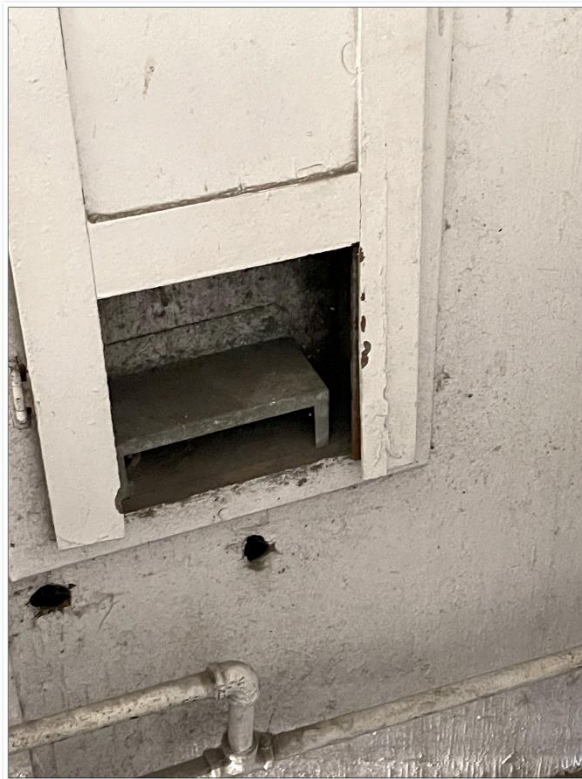
Holes, missing material and unknown opening in wall; unable to determine purpose; we advise making necessary corrections.

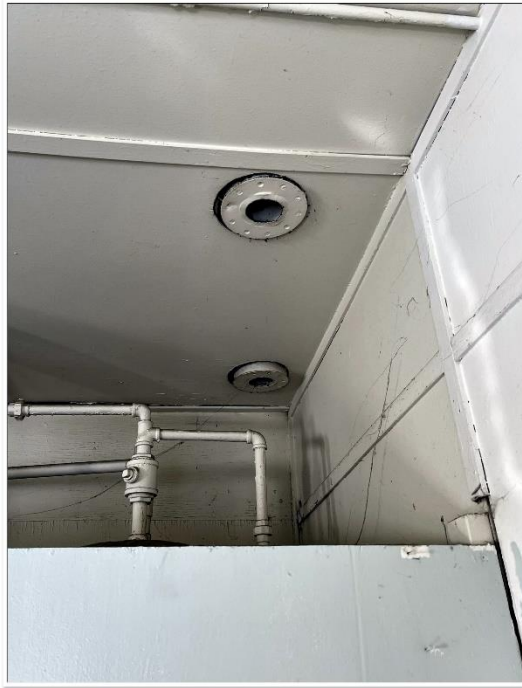
Holes and unknown vents noted in ceiling; we advise making necessary corrections.

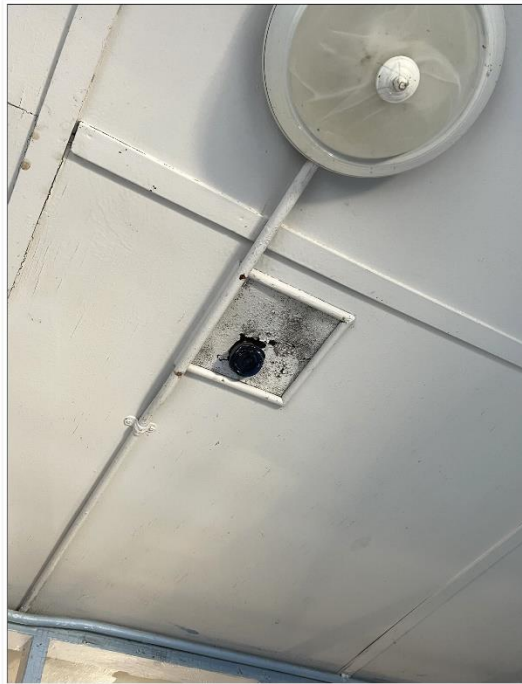
Deterioration, holes and unknown object noted in ceiling; we advise making necessary corrections.

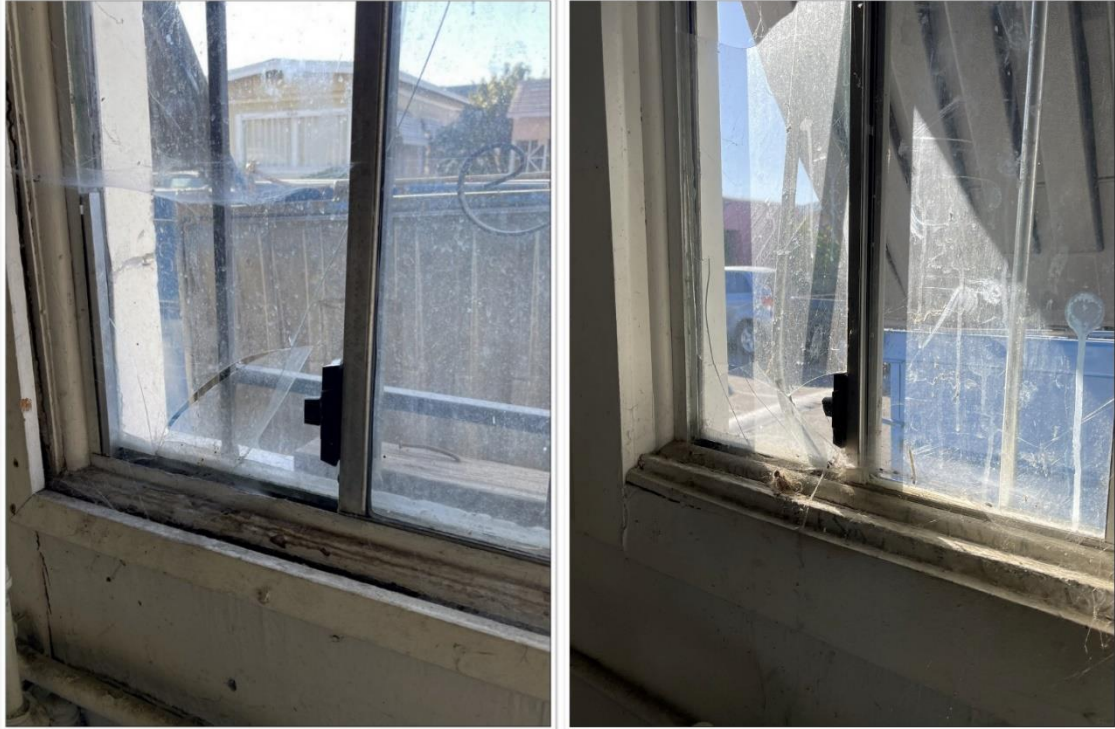
Window frames noted are broken, chipping, deteriorated and separating from windows noted at various areas; we advise making necessary corrections.

Broken windows and torn screen noted at various locations.

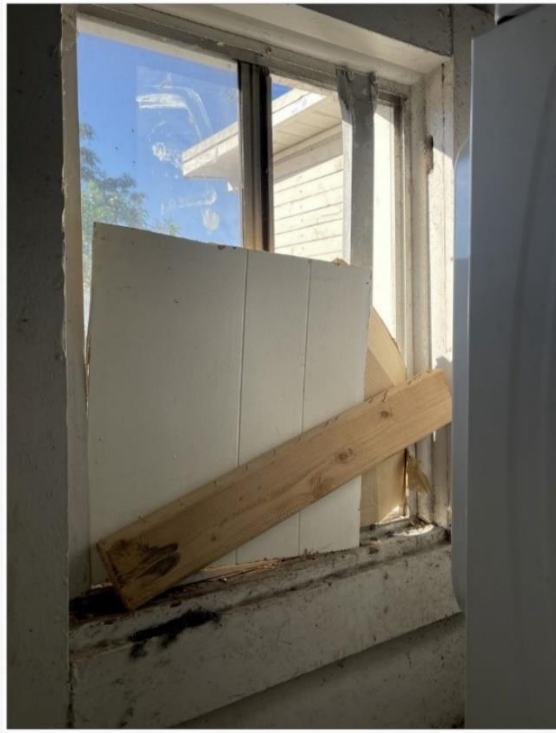
Windows noted blocked with debris; suggest removing as a safety upgrade.

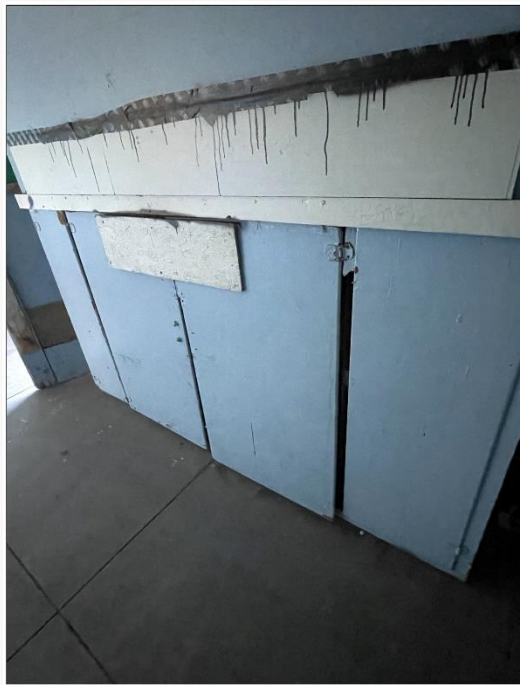
Excessive damage noted to cabinets; we advise making necessary corrections.

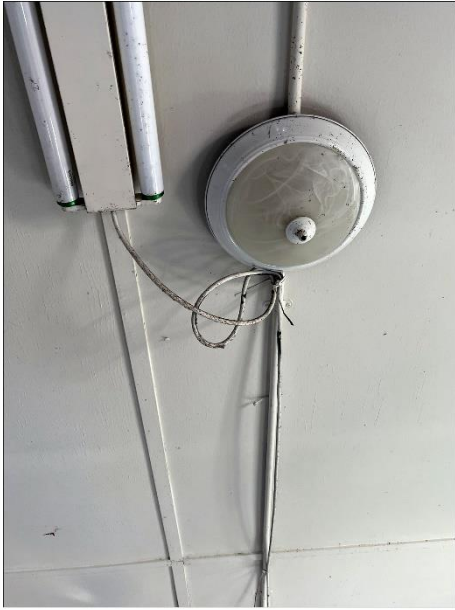
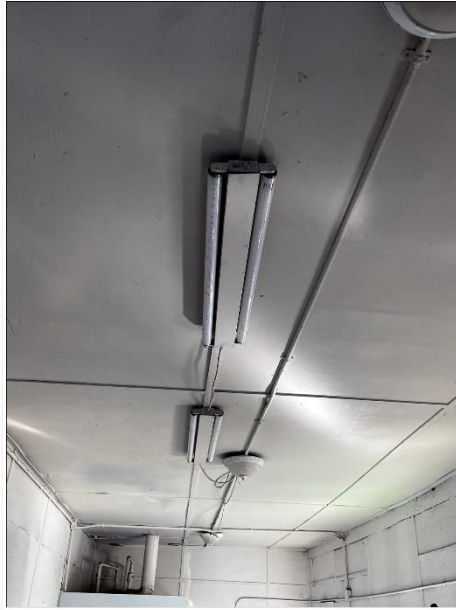
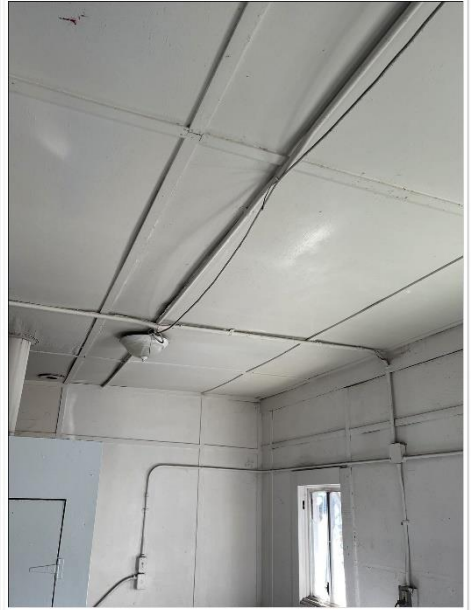
There is no ground fault interrupter noted at three (3) outlets behind washer and dryers which may not have been standard at the time of construction. However, today's standards require ground fault interrupters at all areas within five feet of running water and external outlets. We suggest installing a ground fault interrupter in this area as a safety upgrade.

There are five (5) existing lights only one is operational; suggest replacing light bulbs and replacing light fixtures to title 24.

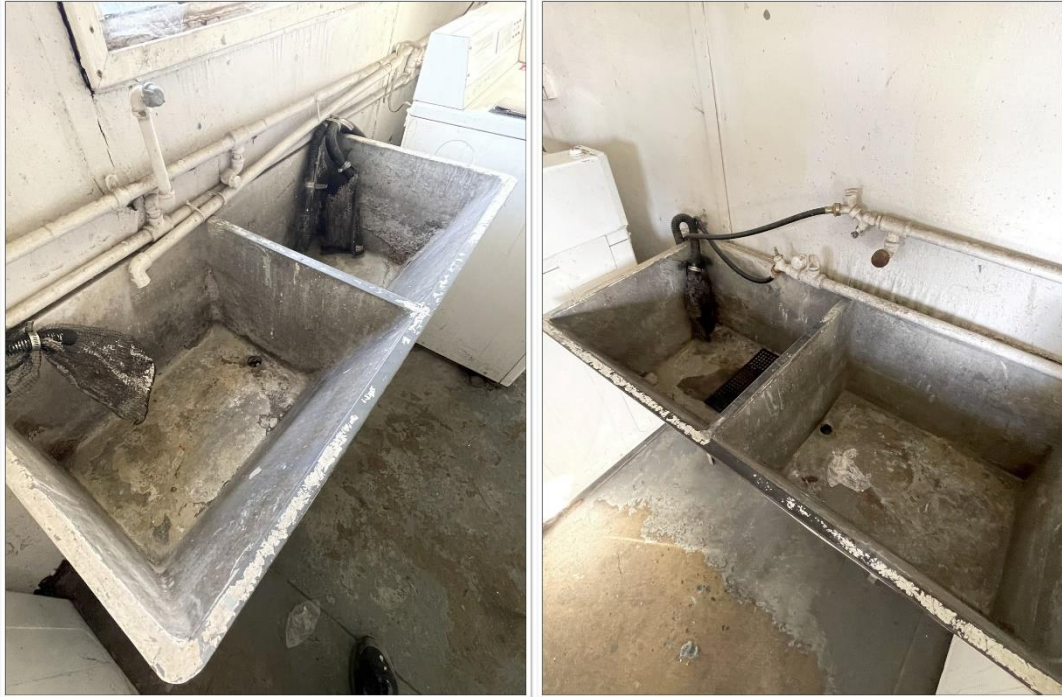
Excessive corrosion and damage noted to laundry tubs; we advise either removing or making necessary corrections as a safety upgrade.

Unable to test water, hot and cold knobs missing; we advise making necessary corrections.
