Email Memorandum	
To:	Glide Rural Fire Protection District Attn: Beth Werner	Email :	glidefire@glidefire.org
From:	Matt Keller, PE, CSI	Subject:	Shear Wall Repair Plan
Date:	19 May 2022	Project #:	21855.12

A NEW MAIN FIRE STATION FOR:

GLIDE RURAL FIRE PROTECTION DISTRICT
 HWY 138
 GLIDE, OR

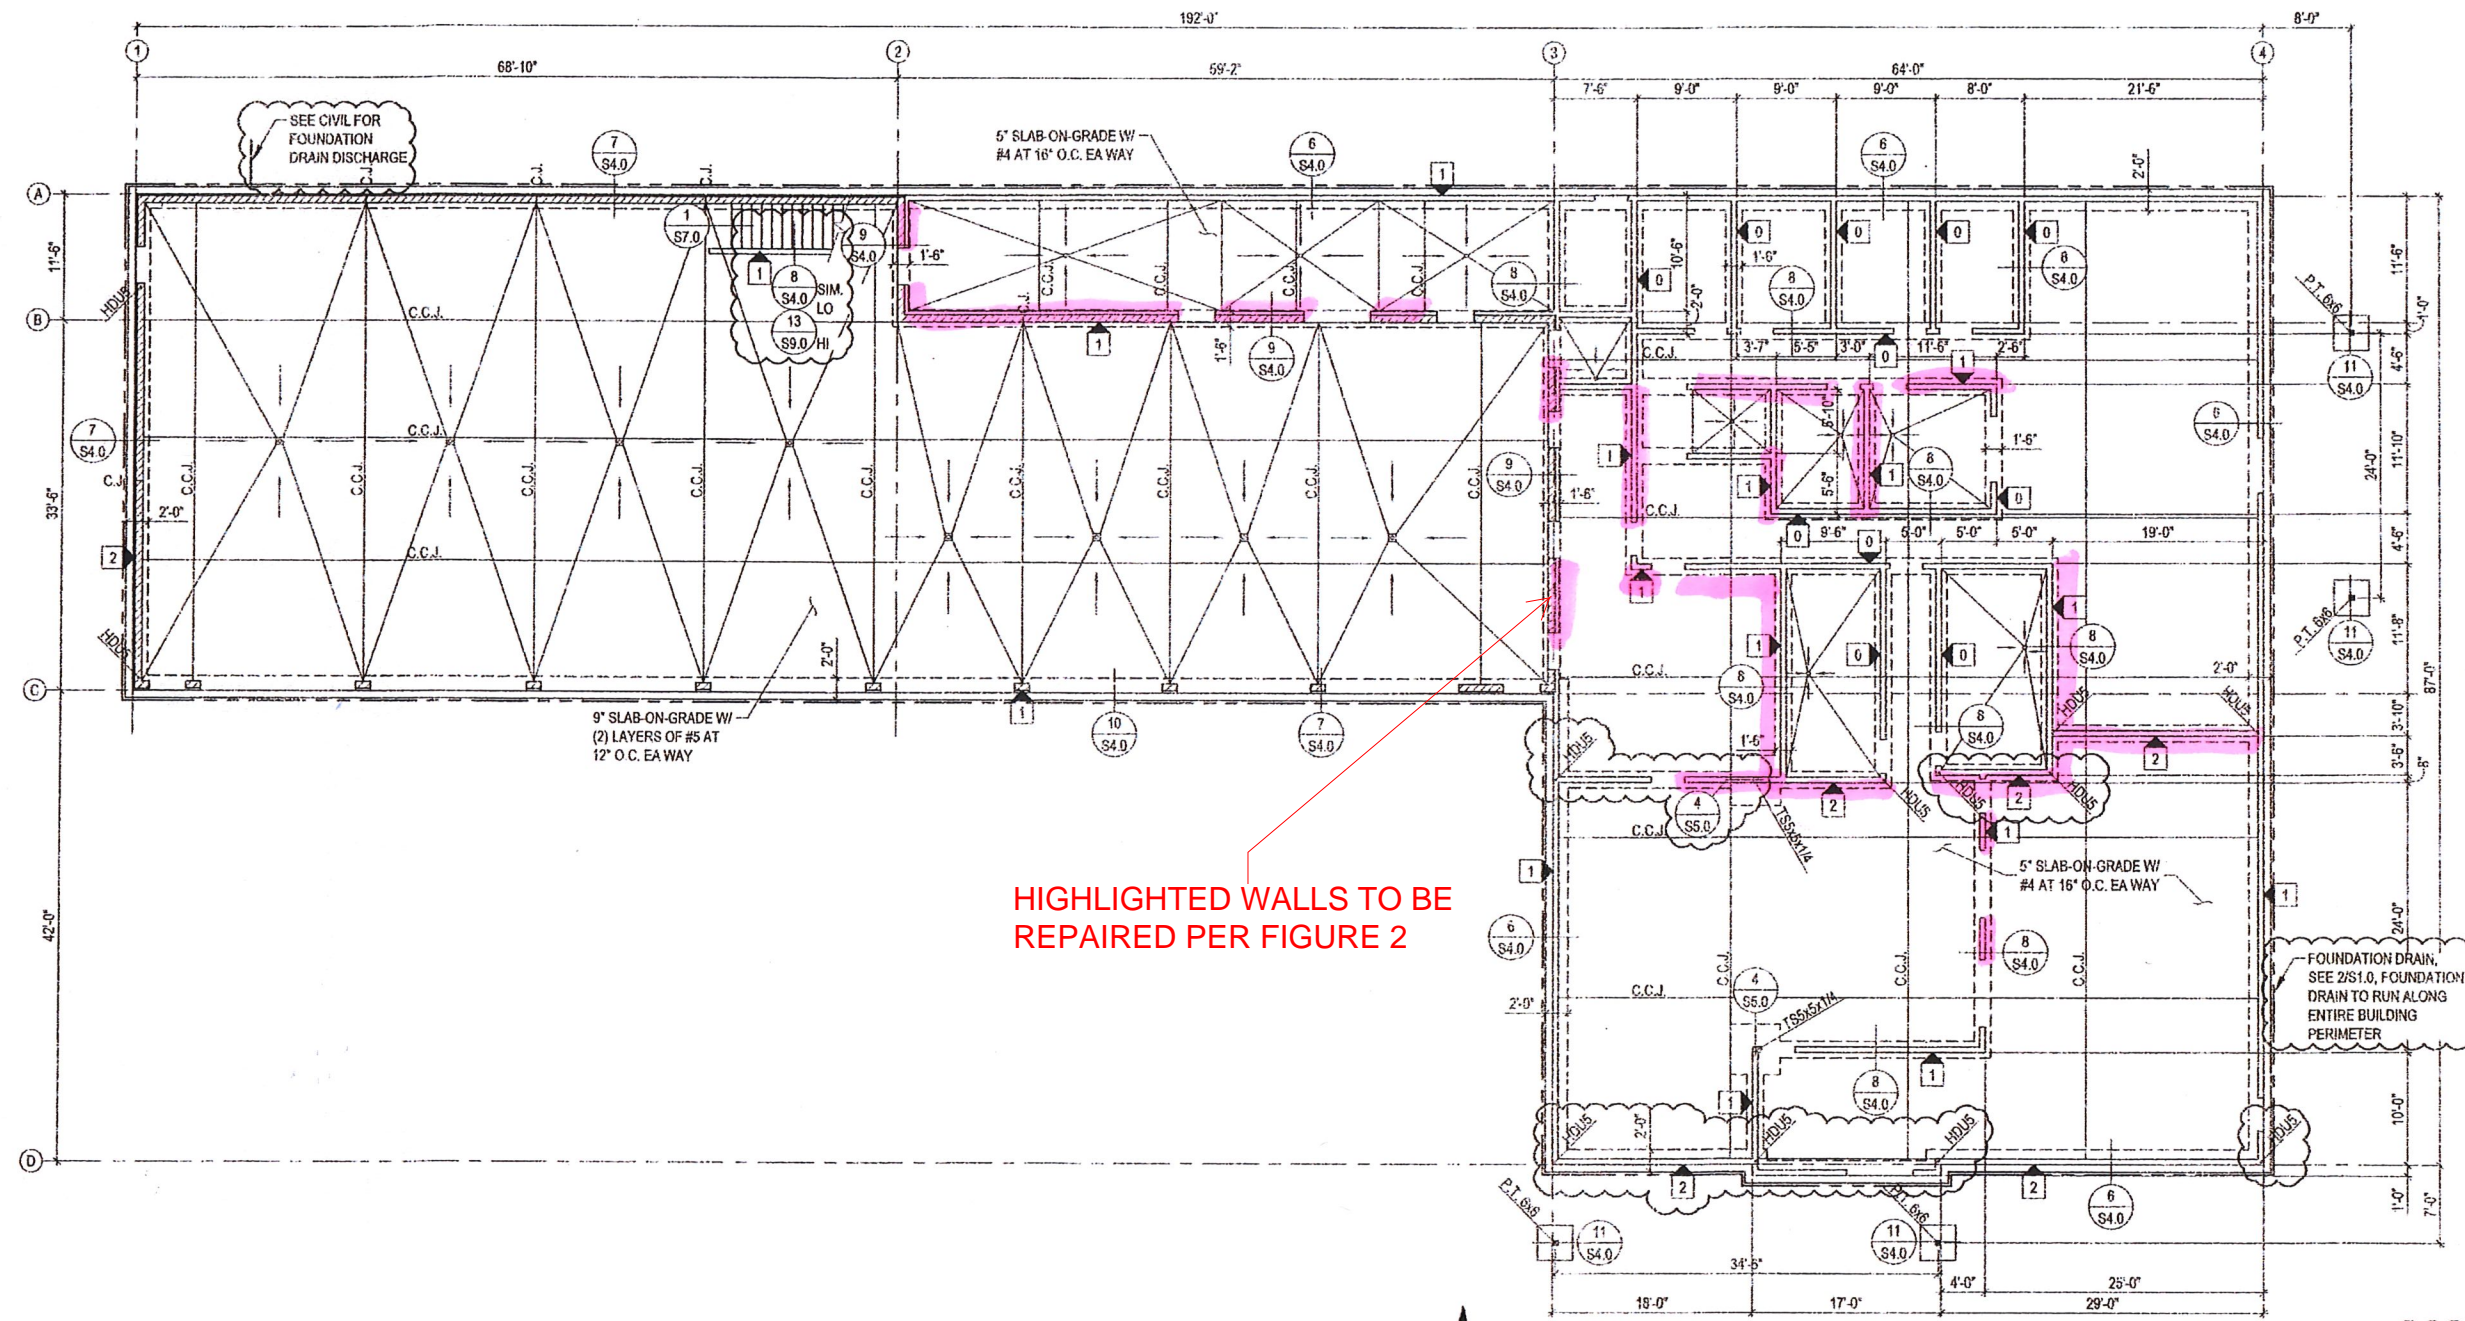
FIGURE 1

In response to your question regarding repair of damaged shear walls that have had the existing structural sheathing removed along the bottom 24 inches of the wall, Pinnacle Engineering, Inc. (PEI) has prepared a repair plan.

HIGHLIGHTED WALLS TO BE REPAIRED PER FIGURE 2

The repair plan shows the locations, as outlined by Glide Rural Fire Protection District, that require the repair and what nailing pattern is required for the repaired sections. Additional 2x blocking will be required to be installed at the edge of the existing panel edge, approximately 24" above the finished floor.
