PROPERTY INSPECTION REPORT FORM

John & Jane Doe <i>Name of Client</i>	02/10/2026 <i>Date of Inspection</i>
1234 Sample Street, Dallas, TX 75000 <i>Address of Inspected Property</i>	
Jay Wilkinson <i>Name of Inspector</i>	TREC #20338 <i>TREC License #20338</i>
<i>Name of Sponsor (if applicable)</i>	<i>TREC License #</i>

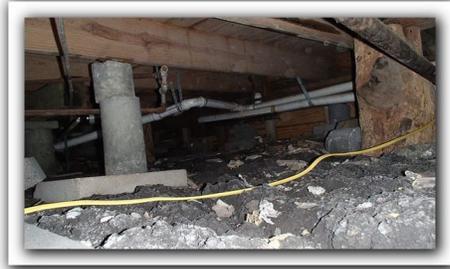
One or more of the piers have shifted somewhat, as is typical of many houses due to expansive soils in the North Texas area. These should be monitored periodically.

One or more of the piers were not touching the beam or floor joist. Shimming or other repairs are recommended.

One or more of the wood beams were twisting or rotating in the crawlspace.

One or more joists or beams were notched in the crawlspace. If notching is done improperly it can reduce the altered joist or beam's structural strength. Monitoring is recommended.

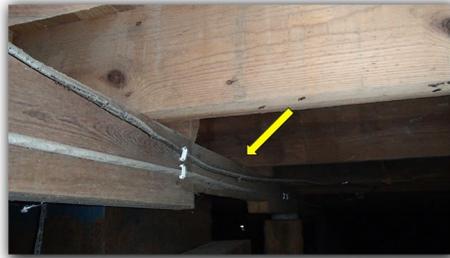
There was evidence of previous water penetration in the crawl space. This condition may vary seasonally. Water penetration may negatively affect the performance of the pier and beam foundation. Lot drainage improvements and/or the installation of a moisture barrier should be addressed as a first step to controlling water penetration of the crawl space. This condition should then be monitored to determine if other drainage improvements are necessary.

The wood, paper, and other debris in the crawlspace should be removed to avoid baiting wood destroying insects.

One or more piers were observed to be shimmed with wood. Replacing all wood shims with metal is recommended the next time the piers are adjusted.

Openings were observed in the flooring or subflooring in various locations including at and around the plumbing penetrations. Sealing these will help prevent vermin egress.

Visible evidence of animal/ vermin activity was observed in the crawl space area. Further evaluation by a Certified Pest Control Operator is recommended to make corrections as necessary. All potential vermin entry points to the crawl space should be sealed.

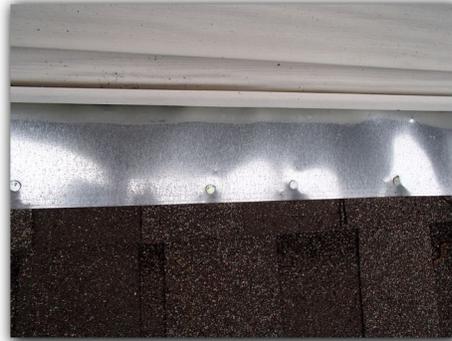
Roof fasteners (nails and/or staples) were observed to be exposed on various locations of the roof including the ridge caps and flashing areas. All exposed fasteners should be sealed with the appropriate roofing caulk or sealant.

The roofing felt paper was observed to be installed under the lower metal drip edge flashing detail and in some places felt paper did not cover all of the decking. This may allow water to seep behind the fascia board and soffit/eave areas over time. Monitoring is recommended to determine if corrective measures are necessary or cost effective.

The slope on the southeast corner of the house was lower than recommended for composition shingles. Monitoring is recommended.

Debris (leaves, limbs, etc.) was observed on the roof. Debris should be removed seasonally.

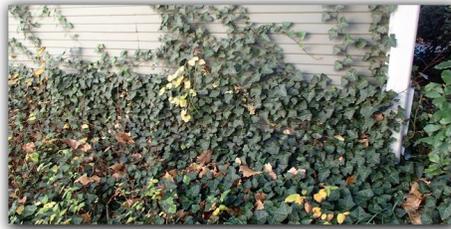
Note: The heavy foliage growing on, over or around the exterior walls of the structure should be trimmed back at least 18-inches. The heavy foliage will limit the Inspectors visual observation of the exterior surfaces.

The wood siding and wooden supports were making wood to ground contact by design. This condition may promote wood rot and may attract wood destroying insects. These areas should be monitored and corrective measures taken if necessary.

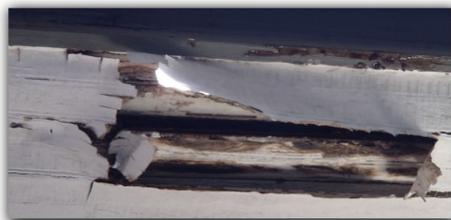
The soffit was observed to be deteriorated or damaged at the south side of the house. Repair is recommended.

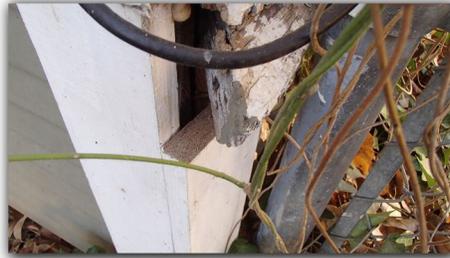
The wood siding and trim was observed to be damaged or deteriorated at the north, east, west, and south sides of the house, particularly along the lower edges of the siding. Repair is recommended.

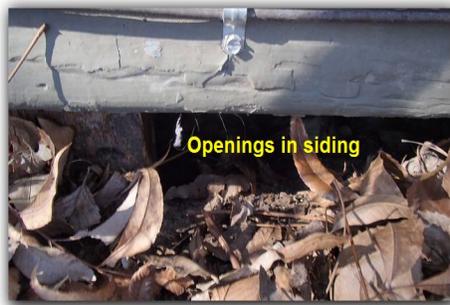
There were openings in the exterior veneer in various locations including at the north and east sides of the house that need to be sealed to prevent water or pest intrusion into the crawlspace.

Peeling paint was observed on all of the exterior wood surfaces. Painting is needed to protect the structure. Further evaluation by a specialist qualified in lead paint remediation is recommended for homes built before 1978

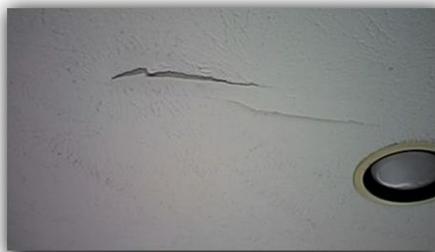
Ceiling texture was observed to be damaged in the carport. Repair is recommended.

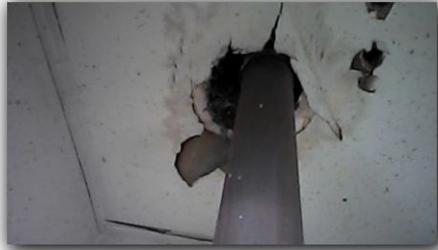
Water stains were observed at or around the water heater flue in the garage. The cause and remedy should be further evaluated and corrected as necessary.

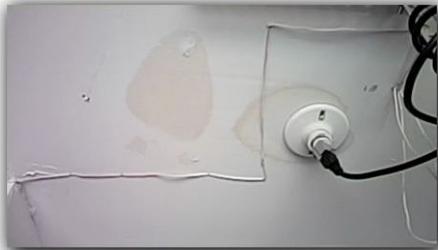
Water stains were observed on the ceiling finish in the garage in the northeast corner bedroom. The cause and remedy should be further evaluated and corrected as necessary.

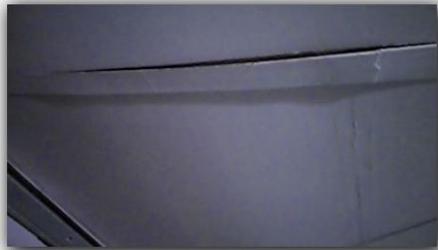
The ceiling of the attached garage adjacent to the living space was not fire taped at the joints or the fire taping is damaged or failing. Drywall cladding on garage ceilings and walls that are adjacent or common with the living space should have the joints taped and sealed to provide the required fire rating for attached garages.

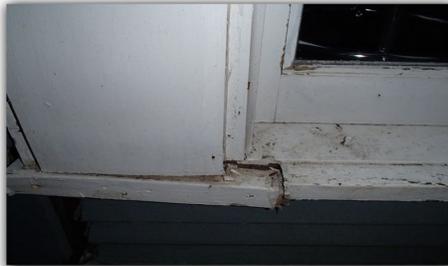
The trim was observed to be damaged or deteriorated on the windows at the north side of the house. Repair is recommended.

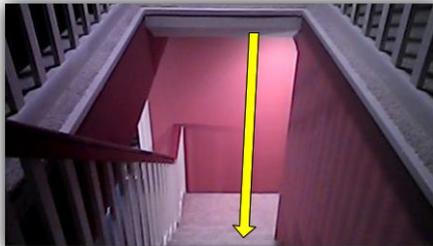
Ceiling height was observed to be insufficient at the middle landing of the staircase. If reconfiguration is impractical, care should be taken when using the stairs.

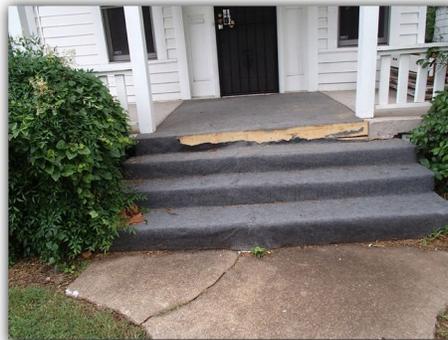
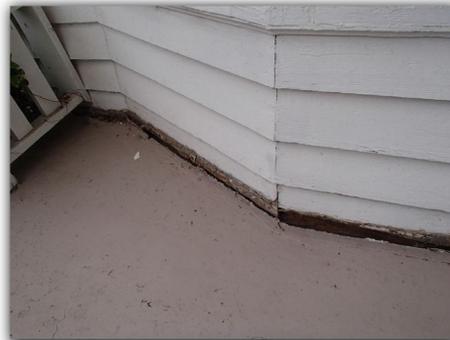
The porch or patio was settled at the east side of the house. Monitoring and repair is recommended as needed.

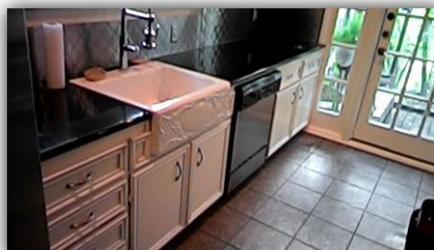
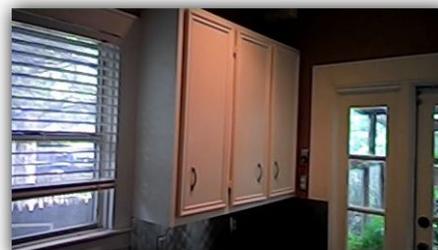
A door was misaligned due to a loose hinge in the cabinets in the kitchen.

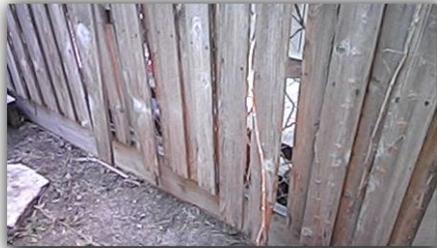
The wood fence was weathered and had numerous loose panels and fence boards.

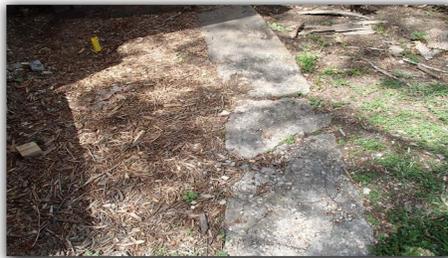
The walkway at the northeast corner of the house was cracked, damaged, or deteriorated. Improvements should be considered.

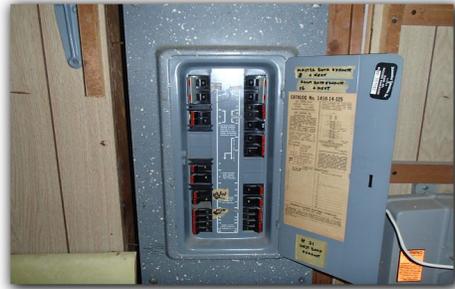
There is a Federal Pacific panel box in place at the time of the inspection. Due to the age of the panel box and the problems associated with this type of panel box, upgrading this panel box with a more current panel box is recommended. Full evaluation of this panel box is beyond the scope of this inspection. You are encouraged to have the panel box further evaluated by a qualified electrician *prior to closing*.

The electrical panel is located in a clothes closet. Under current electrical standards, this is no longer an accepted practice. This is an **“as-built”** condition but Per TREC standards of practice we are required to report this condition as a deficiency.

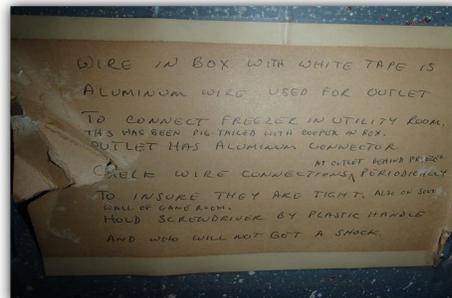
One aluminum wire circuit was documented. Aluminum wiring requires special connectors. A note was present on the panel box cover stating that the appropriate connectors were in use, but this could not be verified. If concerns exist, further evaluation by a licensed electrician is recommended.

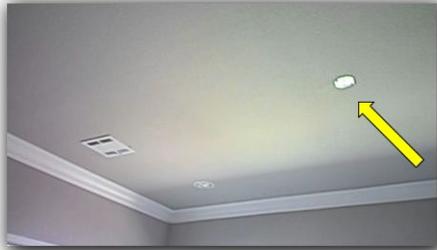
Ceiling fan or light fixture was not installed in the formal living room.

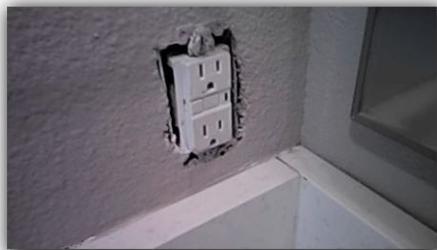
One or more of the light fixtures appear to be inoperative in the formal living room at the west side of the house. This may be due to a bad bulb or some other unknown condition. Further evaluation and repair is recommended as needed.

One or more of the receptacles is missing its cover plate in the half bathroom. Replacement of the cover plate is recommended.

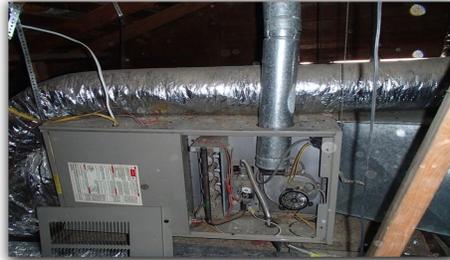
Central Heating System – *Energy Source:* Natural Gas, Goodman, 1997

The heating equipment appears to have reached the end of its serviceable life expectancy.

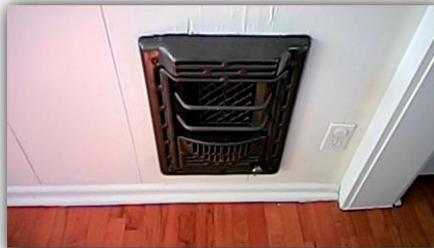
Unvented gas space heaters are present in the mudroom. Due to safety concerns, removal or replacement with a vented heater is recommended.

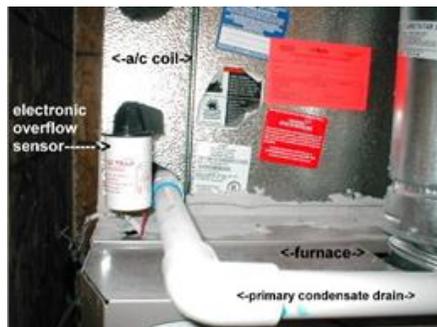
Example photo of an overflow switch

There is no secondary drain for the air conditioning coil. If piping a secondary drain line to the exterior is impractical, installation of a condensate overflow switch or alarm is recommended to avoid damage from obstructed primary condensate lines.

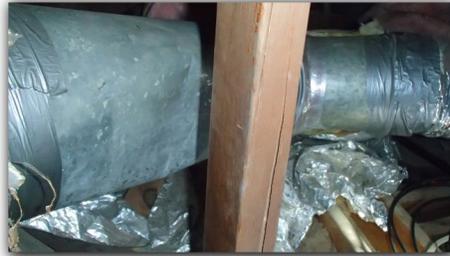
The covering on the ductwork that secures the insulation has deteriorated and the insulation is falling off in places, reducing the HVAC system efficiency. Repair or replacement of the damaged ductwork is recommended.

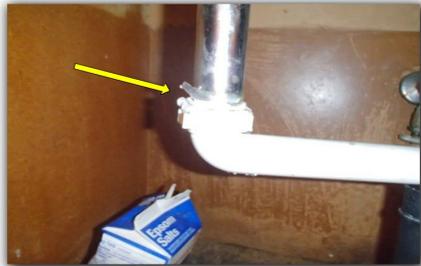
The sink was observed to have a leak at the drain in the kitchen. Repair is recommended.

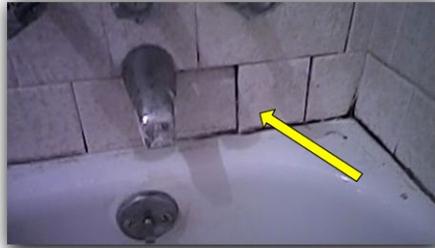
Damaged or missing tiles were observed in the shower stall in the shared bathroom. Repair is recommended.

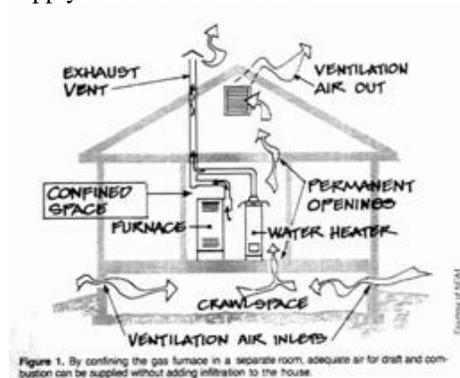
There is inadequate combustion air in the equipment closet. Combustion air for gas equipment should be supplied from an exterior source and not taken from the interior living space. Two metal pipes should be installed in the closet from the attic; one terminates near the ceiling and the other 12” from the floor to supply an outside air source.

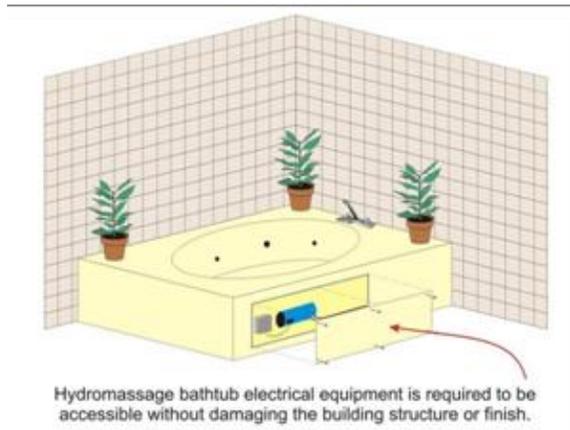
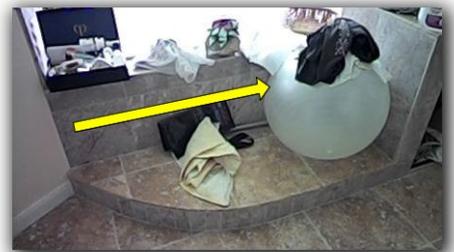
Although there is an access panel at the plumbing connections, the access to the hydro-massage therapy equipment motor and associated plumbing was not readily accessible and could not be visually inspected for proper configuration or leaks. This does not meet current installation standards.

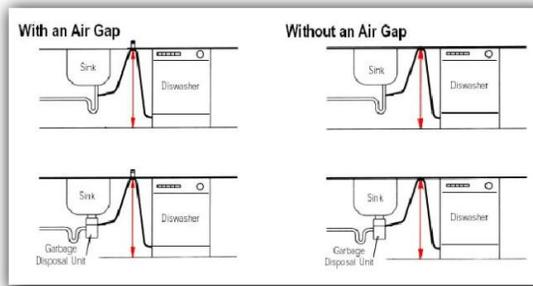
The dishwasher appears to be performing adequately for its age at the time of this inspection. The dishwasher drain hose is not properly installed to prevent back flow or anti-siphoning. It is recommended that an air gap device or high drain loop be installed in the drain line. Note: Almost all dishwashers may have built in anti-syphon devices.

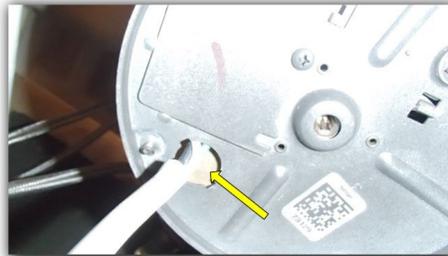
The food waste disposer appears to be performing adequately for its age at the time of this inspection. The wiring is poorly secured where it enters the housing. Installation of a wire clamp is recommended.

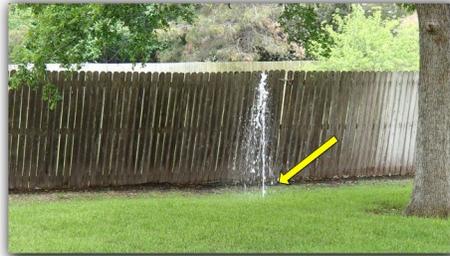
One or more sprinkler heads were damaged or missing in station 4 in the back yard. Repair is recommended.

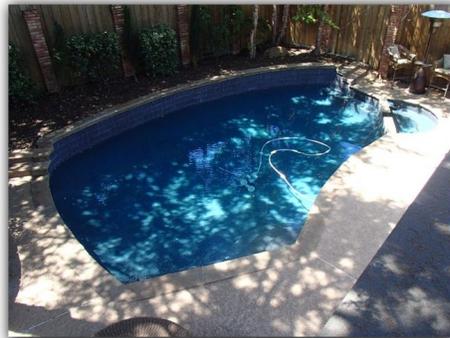
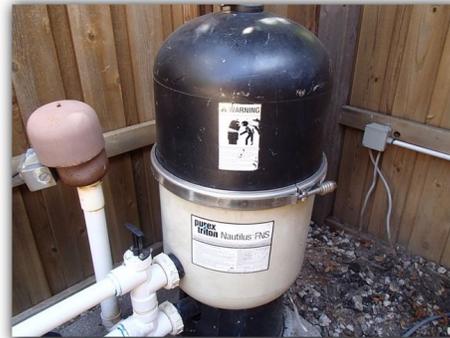
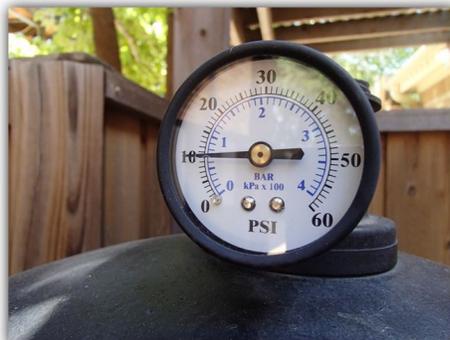
Visible deficiencies were observed in the pool and spa finished surface. Some resurfacing may be necessary. This condition should be further evaluated by a professional pool service.

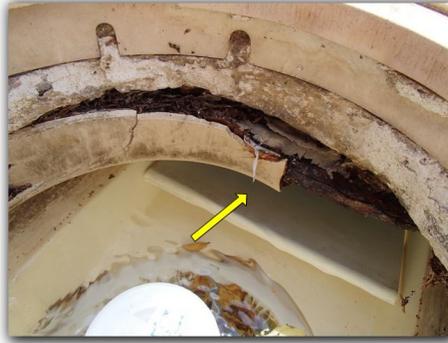
The skimmer basket housing was missing or damaged and needs repair to prevent water intrusion and damage to the decking and pool.

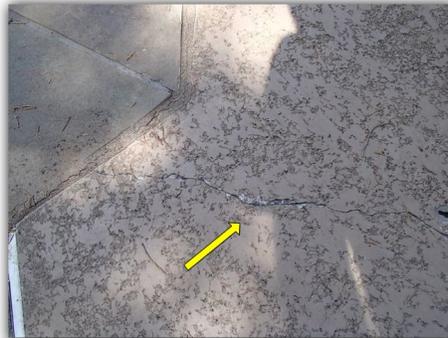
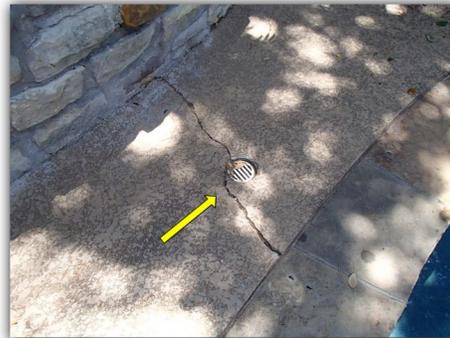
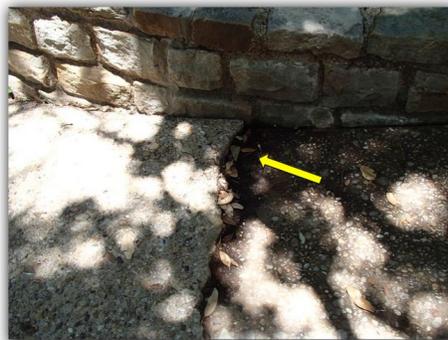
The deck was observed to be cracked or damaged and somewhat settled at the northwest corner of the pool. Repair is recommended.

The elastic caulk (Deck-O-Seal or other brand) between the deck and coping was observed to be in the early stages of cracking. Monitoring is recommended.

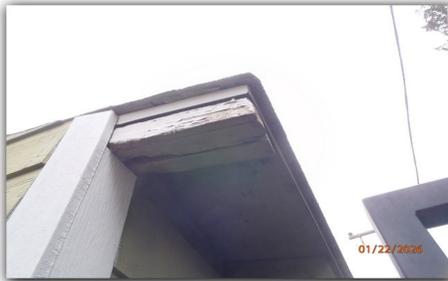
One or more of the decorative exposed rafter beams were weathered and deteriorated. Repair is recommended.

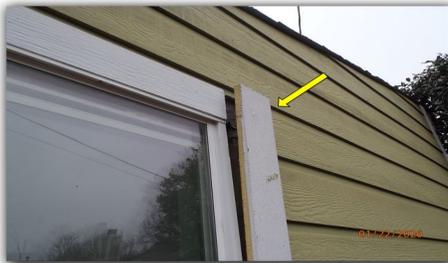
The siding trim was observed to be loose. Repair is recommended.

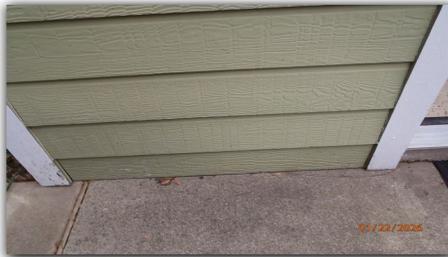
Siding lacks adequate clearance from grade or concrete flatwork. Monitoring is recommended.
