## Home Inspection Report

Happy Valley Rd, Roseburg, OR 97471

Wednesday January 24, 2018

180124A

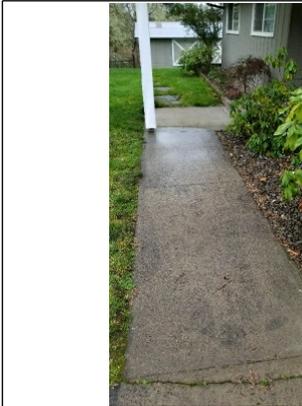
**Comments** Walkway had some typical cracking.

Sidewalk at front of home

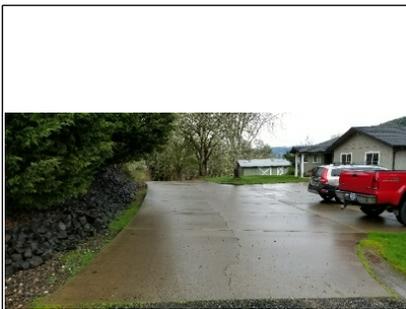
**Comments** Driveway had some typical cracking.

Driveway at front of home

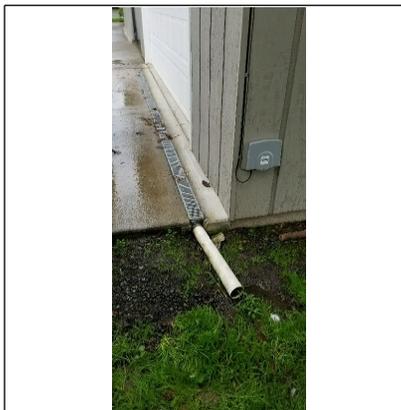
Drain line at NW corner of garage should extend 5 to 6 feet away from foundation.

Drain line at NW corner of garage

Extend drain line at NW corner of garage away from foundation 6 to 8 feet.

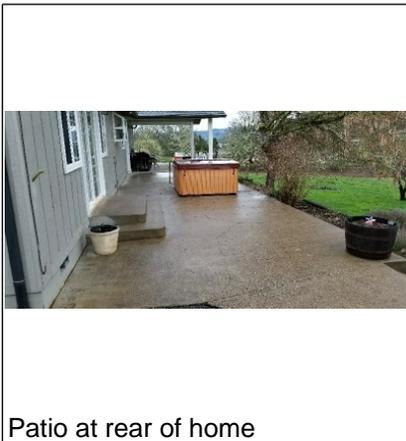
**Comments** Patio had some typical cracking and settlement.

Patio at rear of home

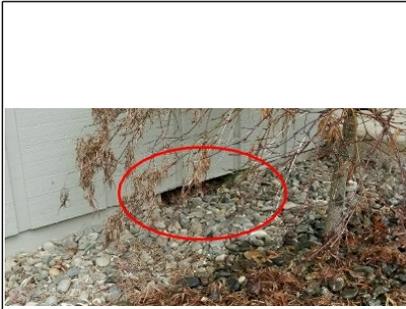
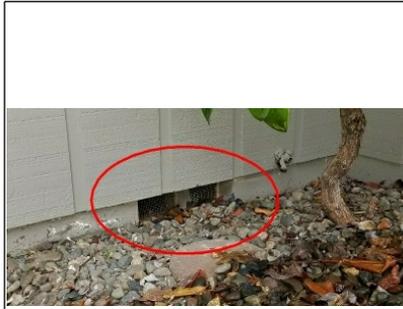
Ground cover partially blocking foundation vent on north side of home

Foundation vents should be cleared of ground cover.

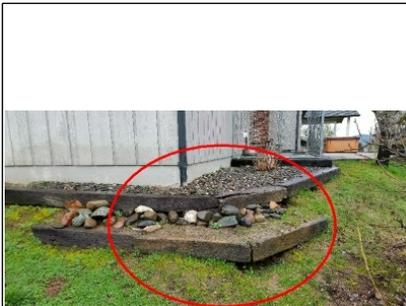
There is some ground erosion at the retaining wall ties at the SW corner of the garage. Recommend repair.

Ground erosion at SW corner of garage

Repair erosion at SW corner of garage.

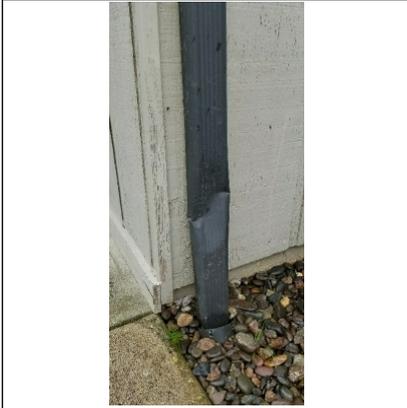
**Comments** Downspouts had some visible damage, recommend repair.

Damaged downspout at NW corner of the home

Repair damaged downspout at NW corner of home.

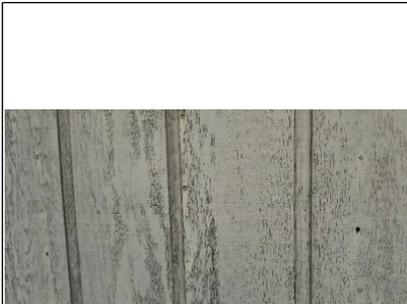
Some siding was in need of normal painting / staining maintenance, recommend painting/staining.

Weathered siding at west side of garage

Repair areas of weathered siding and trim caulking.

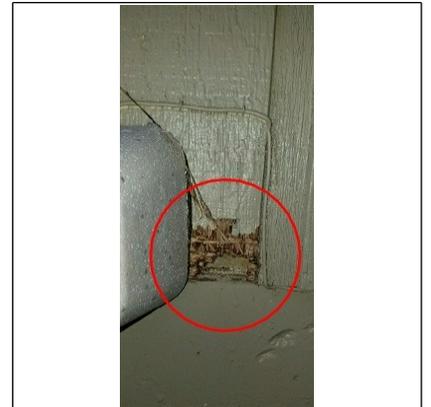
Small damaged area of siding on south side of home

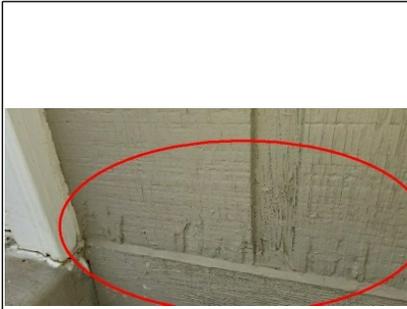
Weathered siding at south side of home

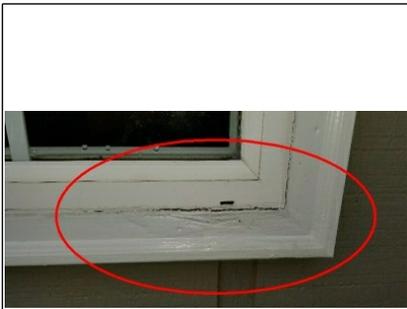
**Comments** Trim had some deterioration, recommend repair and painting.

Trim at family room window with moisture damage

Repair moisture damaged exterior window trim at family room window.

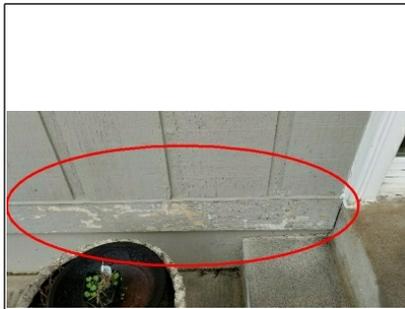
Weathered trim at south side of home

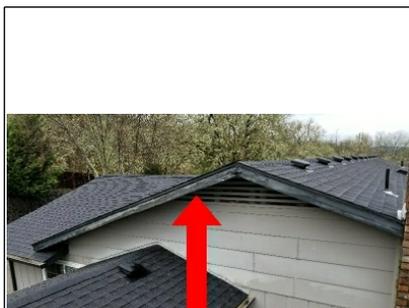
Fascia weathered/damaged, recommend repair.

Weathered fascia board at west side of main home structure

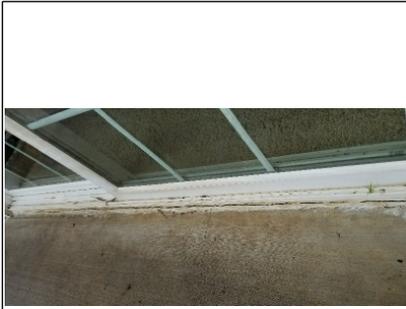
Caulking dried and cracked, recommend removing and replacing.

Caulking is weathered/cracked at family room patio door sill

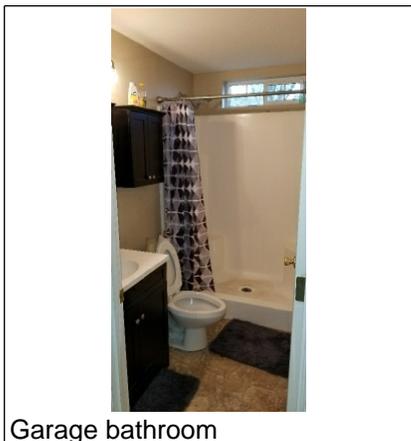
Zonal heater installed behind door could create a safety hazard if operated while door is open against unit.

Garage bathroom

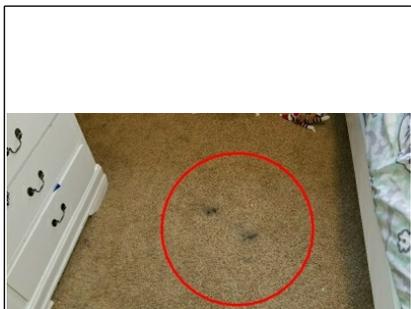
**Comments** Staining on bedroom carpet.

Staining on bedroom carpet

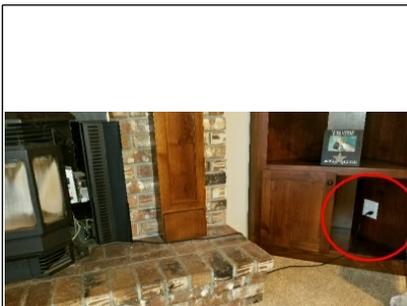
**Comments** Electrical power cord for pellet stove is plugged into a cabinet outlet, recommend dedicated wiring for unit.

Power cord for pellet stove plugged into cabinet electrical outlet

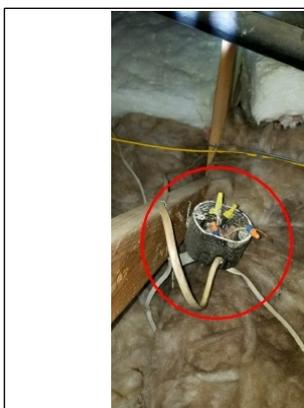
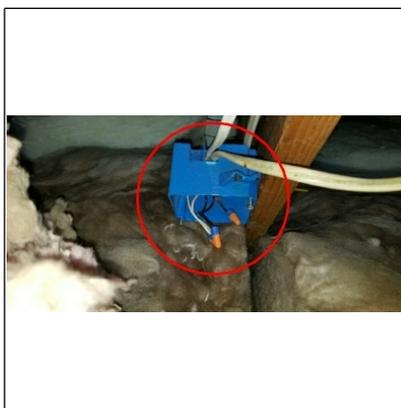
Open junction boxes in attic - need cover plates.

Open electrical junction box in attic

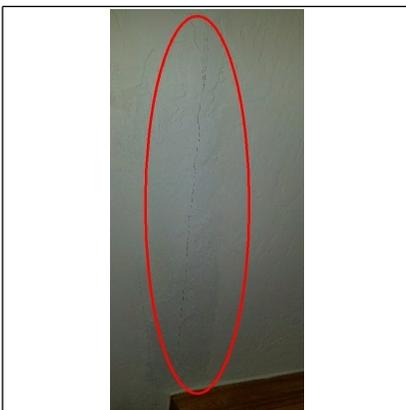
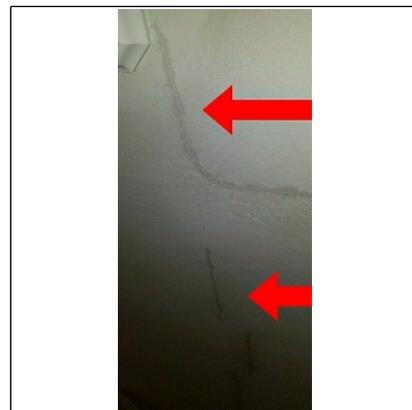
**Comments** Typical cracks.

Typical cracking at ceiling

Typical cracking in ceiling
