"Full" Reserve Study

Lakes at Deer Creek Deerfield Beach, FL

Report #: 36235-0
For Period Beginning: January 1, 2020
Expires: December 31, 2020

Date Prepared: August 28, 2019

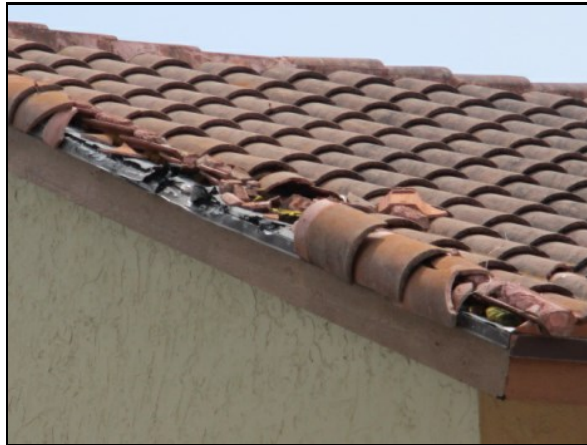
Useful Life:
30 years

Remaining Life:
15 years

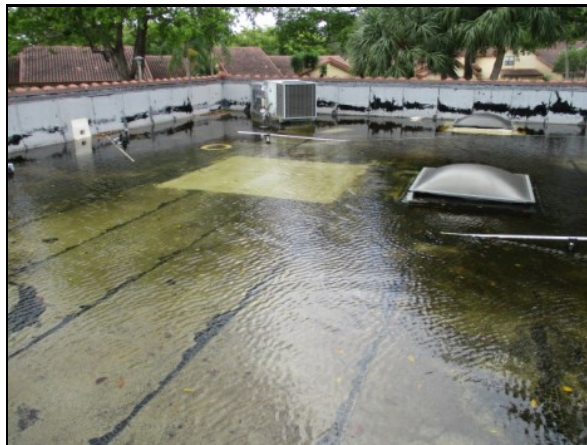
Useful Life:
20 years

Remaining Life:
5 years

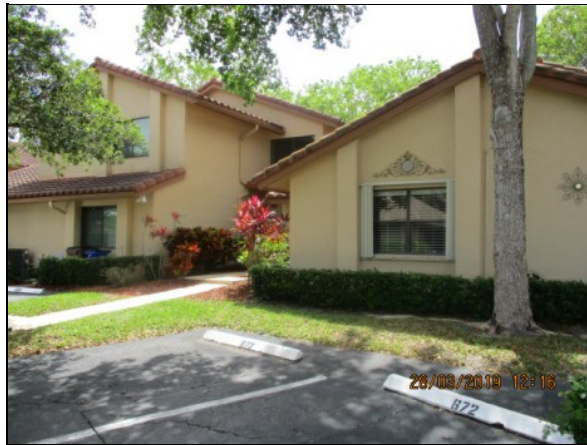
Useful Life:
7 years

Remaining Life:
0 years

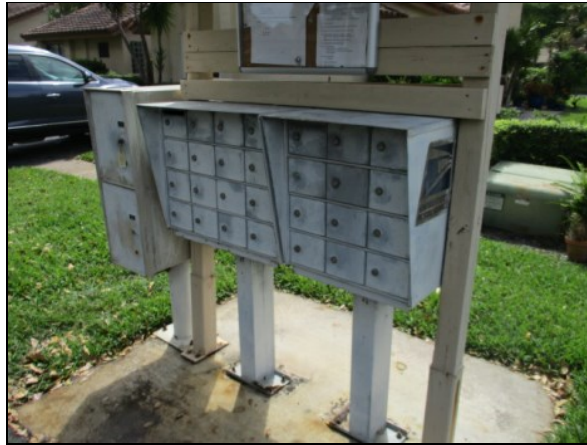
Useful Life:
20 years

Remaining Life:
0 years
