"Full" Reserve Study

Lakes at Deer Creek Deerfield Beach, FL

Report #: 36235-0
For Period Beginning: January 1, 2020
Expires: December 31, 2020

Date Prepared: August 28, 2019

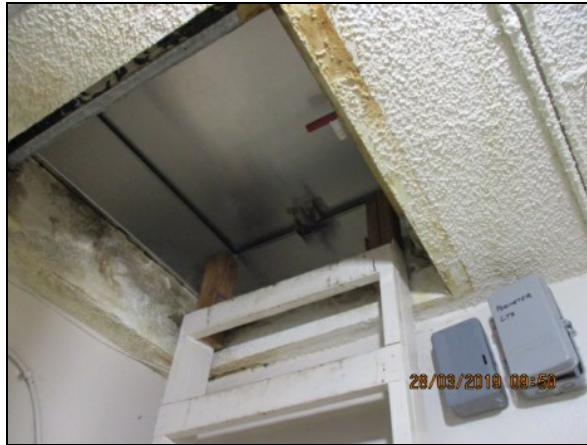
Useful Life:
20 years

Remaining Life:
5 years

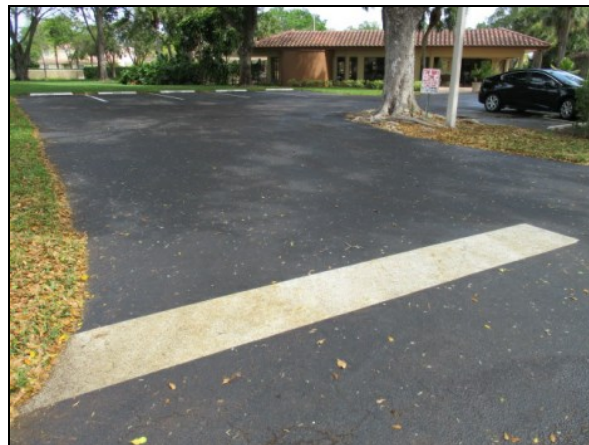
Useful Life:
4 years

Remaining Life:
2 years

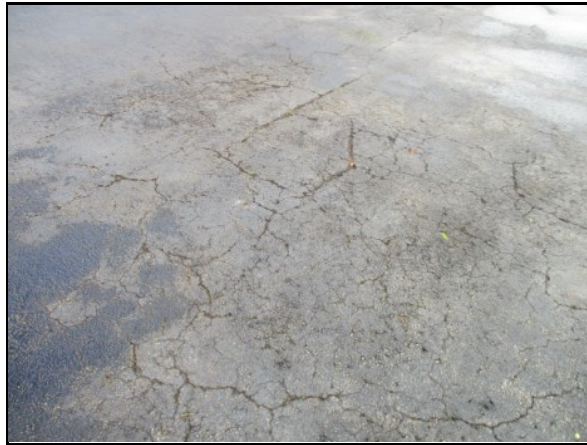
Useful Life:
20 years

Remaining Life:
5 years

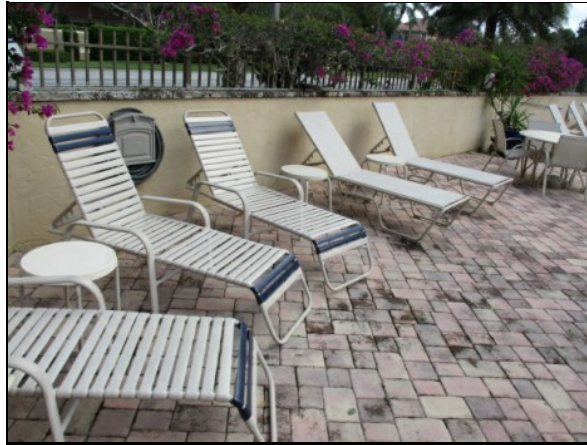
Useful Life:
8 years

Remaining Life:
6 years

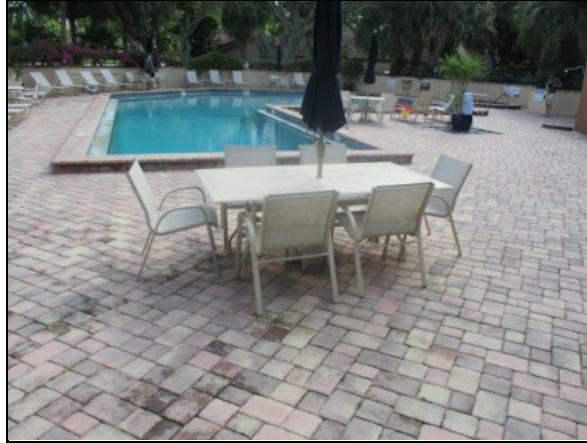
Useful Life:
30 years

Remaining Life:
23 years

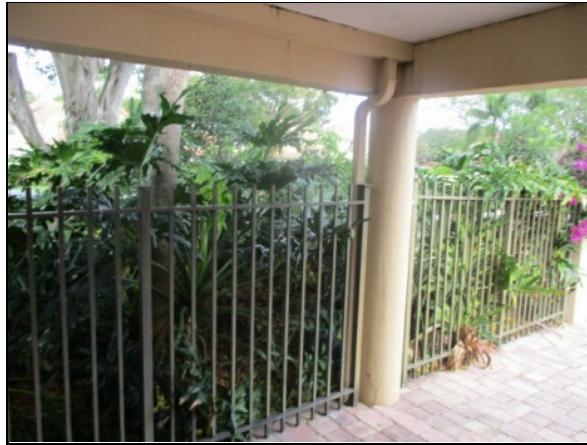
Useful Life:
20 years

Remaining Life:
5 years

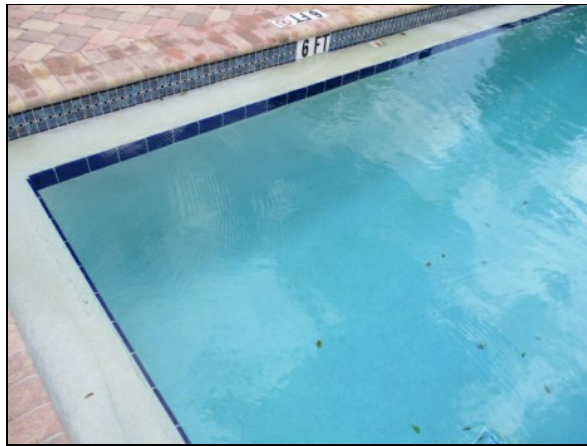
Useful Life:
12 years

Remaining Life:
4 years

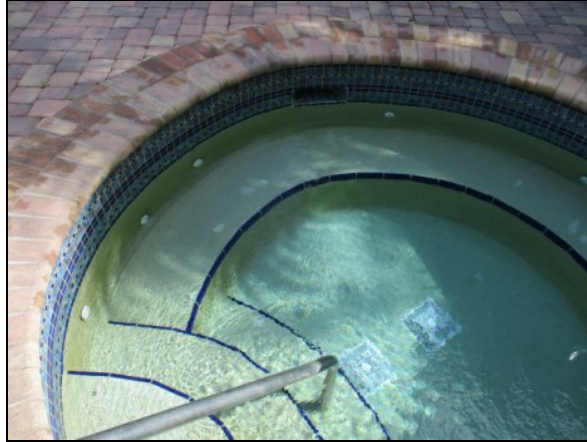
Useful Life:
12 years

Remaining Life:
0 years

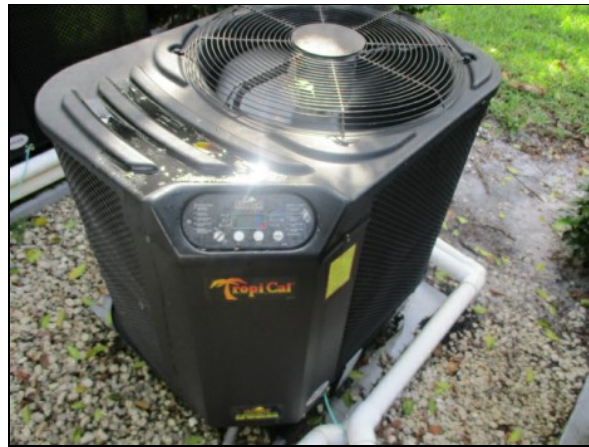
Useful Life:
8 years

Remaining Life:
1 years

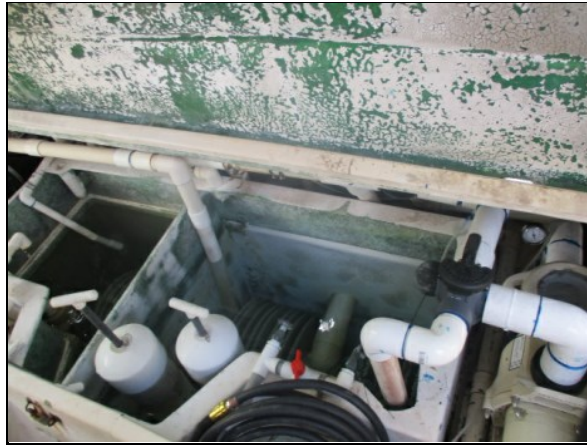
Useful Life:
5 years

Remaining Life:
1 years

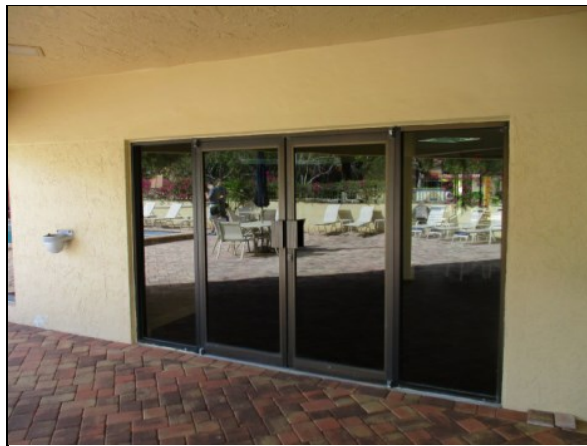
Useful Life:
40 years

Remaining Life:
3 years

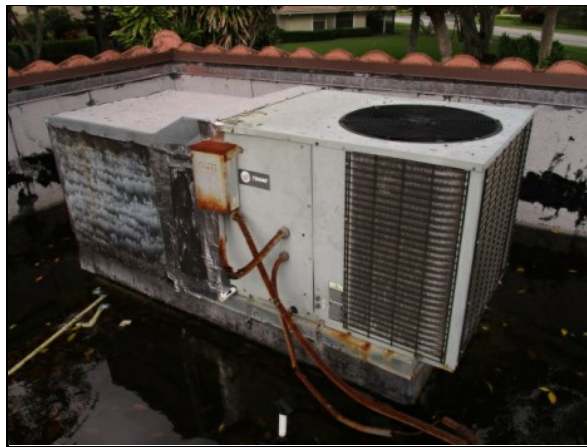
Useful Life:
15 years

Remaining Life:
3 years

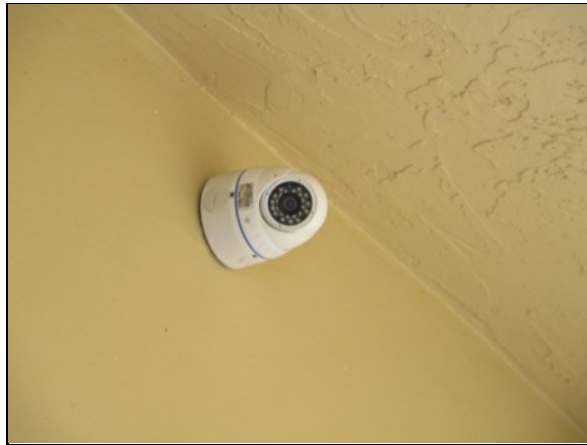
Useful Life:
10 years

Remaining Life:
6 years

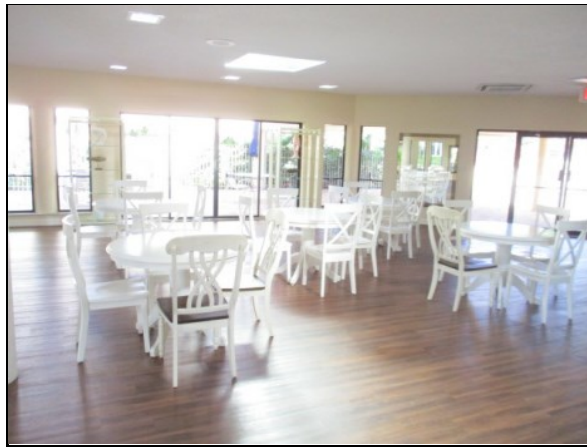
Useful Life:
10 years

Remaining Life:
7 years

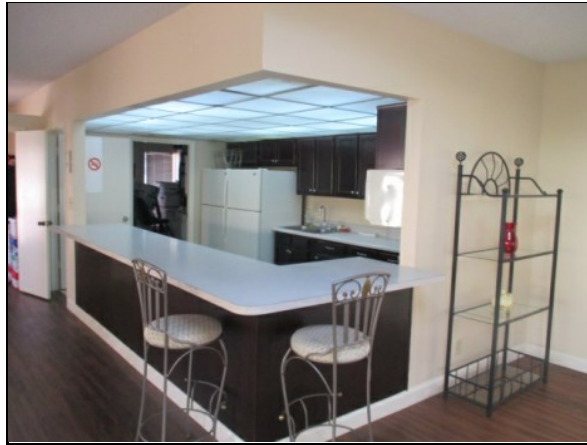
Useful Life:
20 years

Remaining Life:
7 years

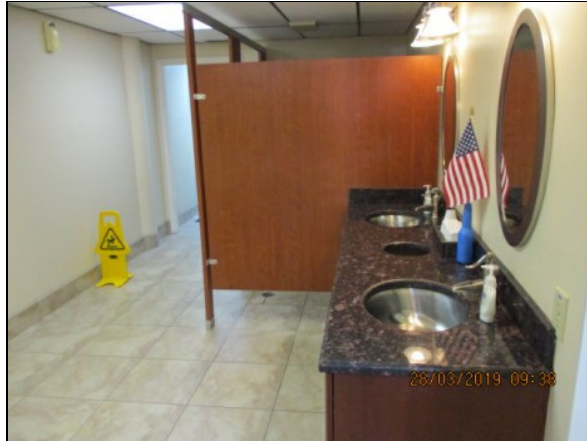
Useful Life:
20 years

Remaining Life:
7 years

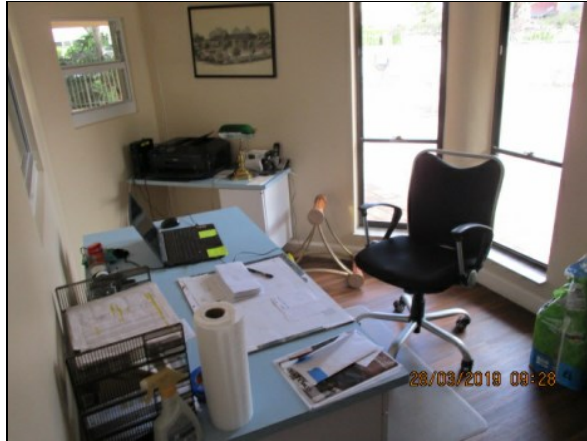
Useful Life:
20 years

Remaining Life:
7 years

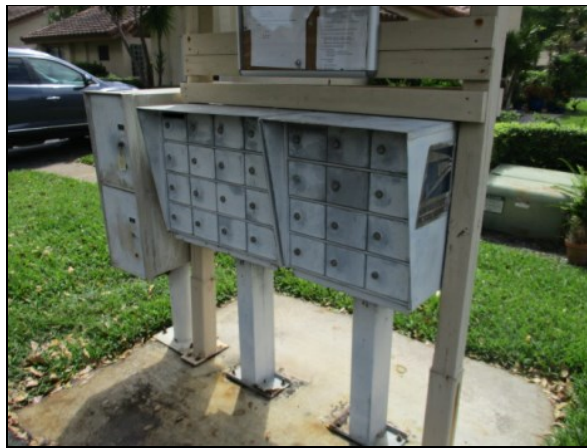
Useful Life:
20 years

Remaining Life:
0 years

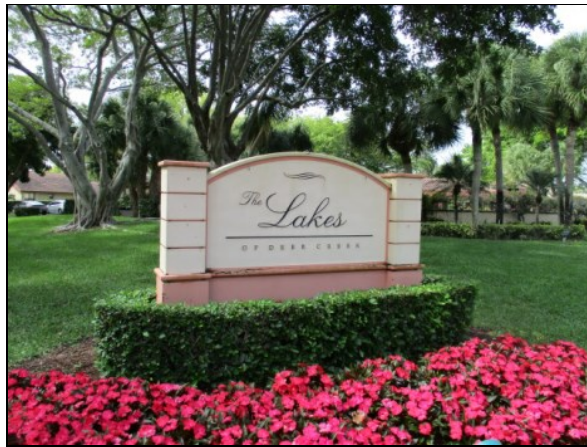
Useful Life:
20 years

Remaining Life:
4 years

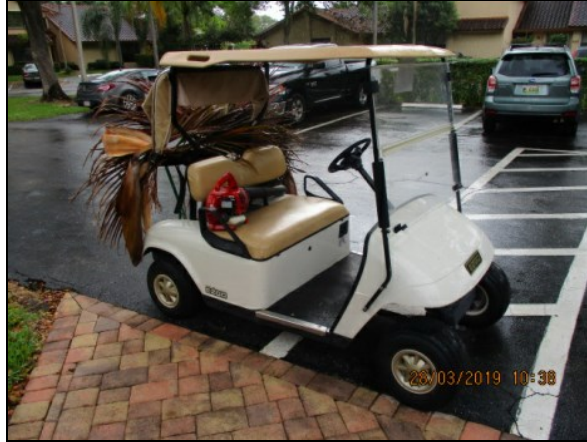
Useful Life:
10 years

Remaining Life:
2 years
