PROPERTY INSPECTION REPORT

501 N Broadway Ave
Indianapolis IN 46212

Wednesday, 9/16/2020

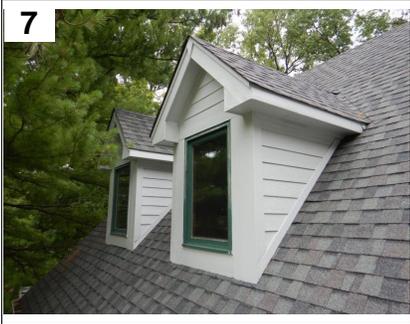
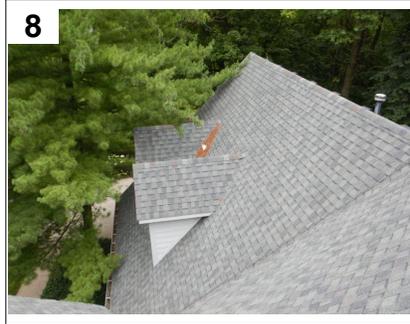
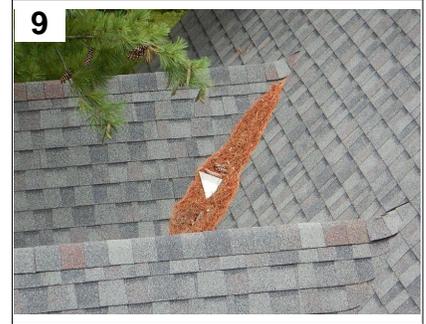
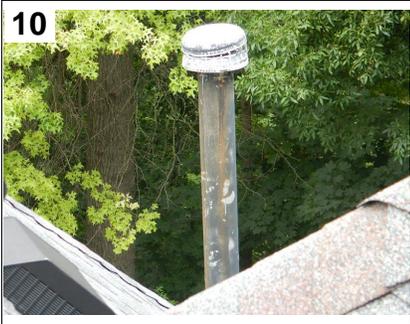
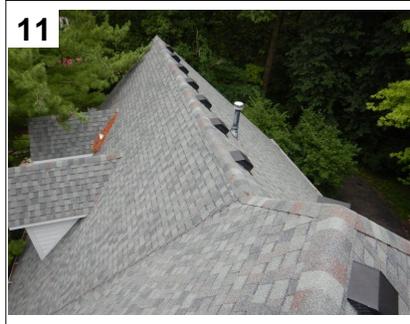
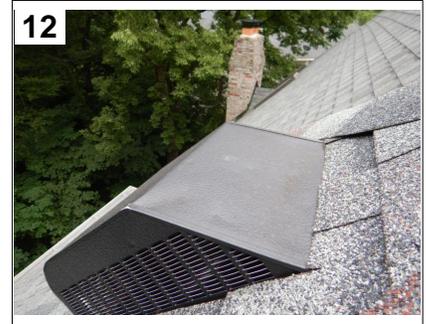
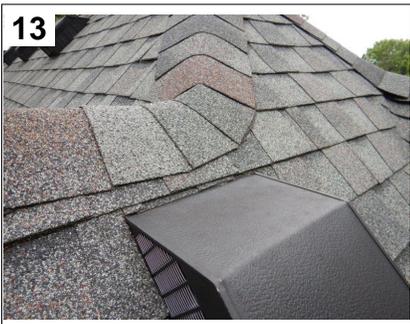
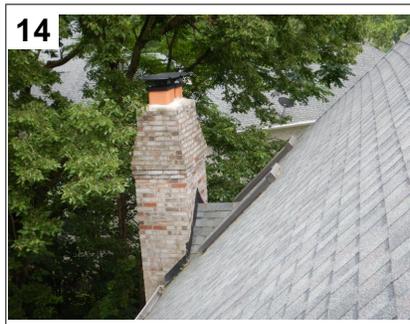
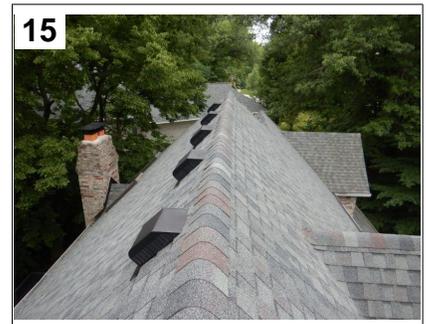
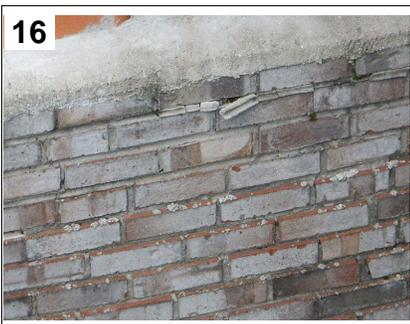
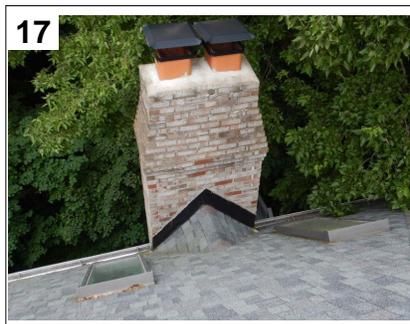
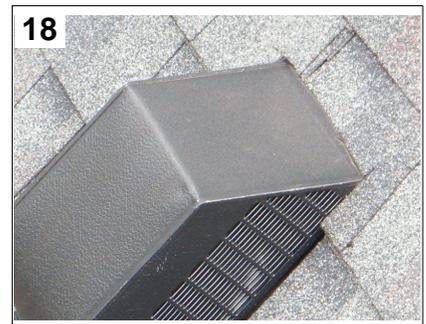
- There are two heating system flues with smashed covers. They appear to be restricting exhaust flow. - (See Photo 5) - (See Photo 10)
- There are dents and dings in the roof vents and metal covers where they have been hit by hail. There have been multiple hail events this year and in the last few years. We did not view damage to the shingles, but could not walk all areas due to the pitch. Recommend inspection by a qualified roofing contractor. - (See Photo 4) - (See Photo 5) - (See Photo 12) - (See Photo 13) - (See Photo 18)

- The chimney is not built high enough. It has not been built at least 2 foot above any structure within 10 feet of the chimney. It is recommended that the chimneys be inspected and evaluated (level 2 chimney inspection) by a qualified chimney contractor. - (See Photo 14) - (See Photo 15) - (See Photo 17)

- The master fireplace chimney flue does not appear to have proper clearances above the roof at the side wall for the upper level. Recommend evaluation by a qualified chimney/fireplace contractor. - (See Photo 4)

- Guttering has debris build up in them in several places. There are also areas where guttering is dented and some of the gutter corners are actively leaking. - (See Photo 1) - (See Photo 2) - (See Photo 3) - (See Photo 3)
- There are trees contacting the roof in multiple areas. - (See Photo 6) - (See Photo 8)
- There is debris on the shingles and valleys have debris build up. - (See Photo 9)
- The heating system flue has rust present where the rain cap is smashed. - (See Photo 10)

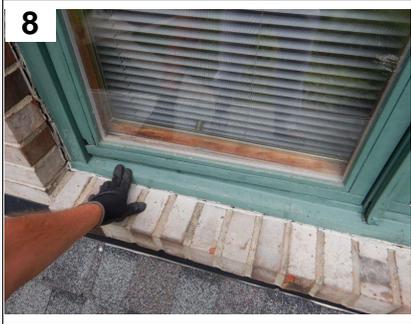
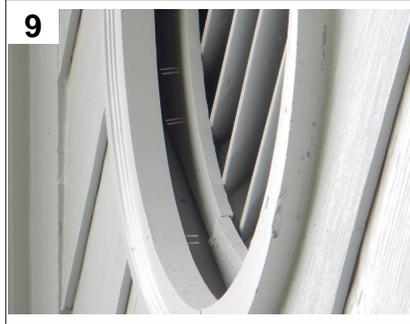
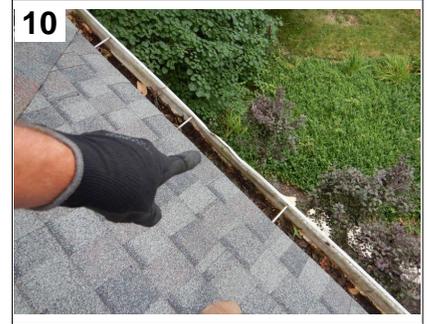
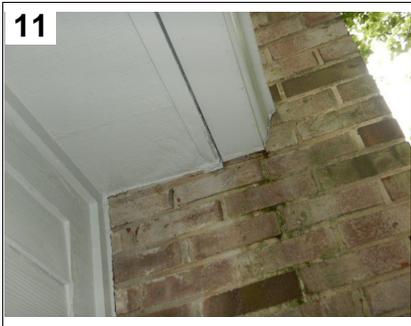
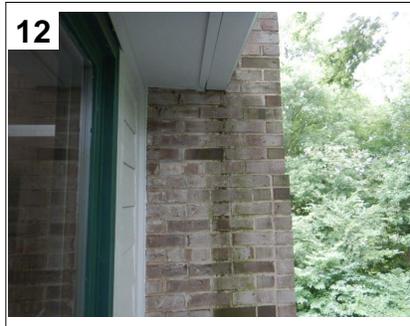
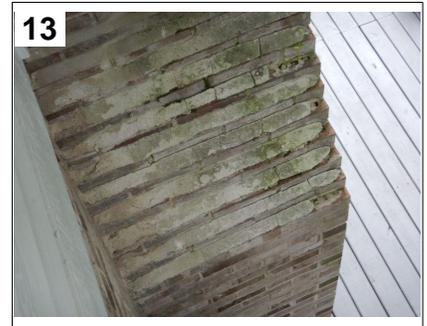
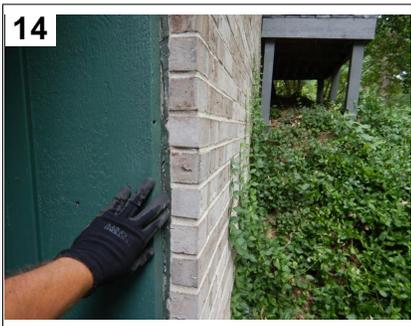
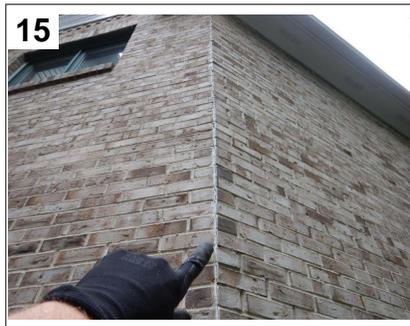
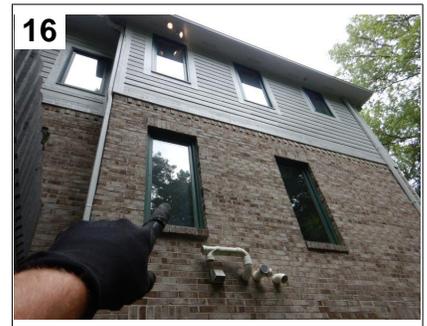
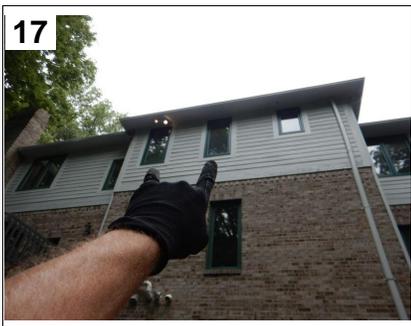
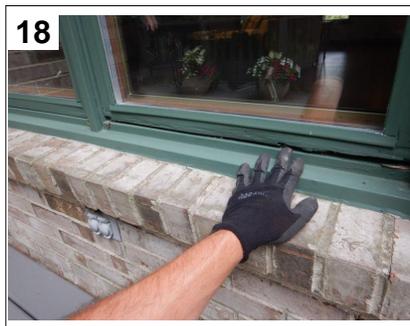
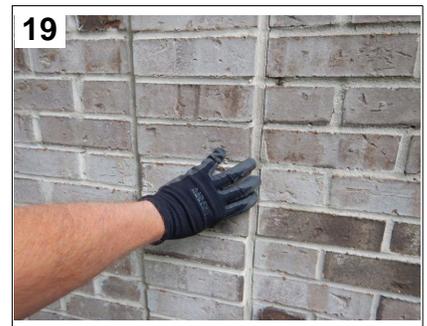
- The front upper level large three windows have rot damage in the window sashes, window frames and inner sills. One of the windows does not close and has cloth material packed into the jamb to prevent drafting. The North window has recessed into the brick opening leaving large gaps around it too. We recommend all three of the front upper level large windows be inspected/evaluated by a qualified window contractor. - (See Photo 1, 2, 5, 6, 7, 8)
- There are carpenter bee holes in the top of the front arched upper level window. See WDI inspection report attached to this report. - (See Photo 4)
- There are rotted areas in the rear basement window right of the fireplace. - (See Photo 18)
- There are additional failed thermal seals we were able to view from outside (rear of house). See interior page. - (See Photo 16) - (See Photo 17)

- The South end front porch gutter is damaged. - (See Photo 10)
- There are large gaps around the front gable vent and nails appear to be pulled loose. - (See Photo 9)

- Kick out flashing is missing from the sides of the chimney and the chimney now has deterioration in the mortar at the shoulders and stains from moisture draining behind the gutter ends. - (See Photo 11) - (See Photo 12)

- There is rot in the gutter board at the South side of the chimney by the soffit panel. - (See Photo 11)
- There are cracks in the decorative brick inset in the exterior of the back of the chimney. - (See Photo 19)

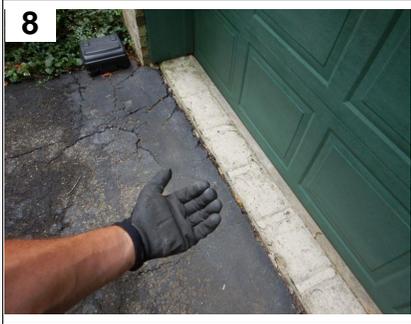
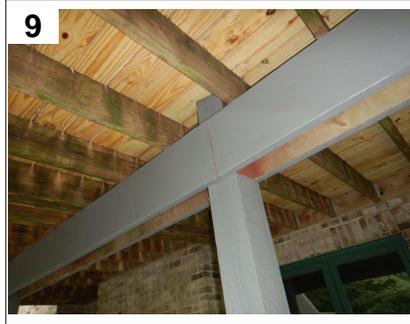
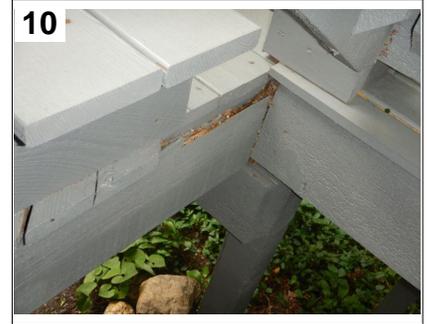
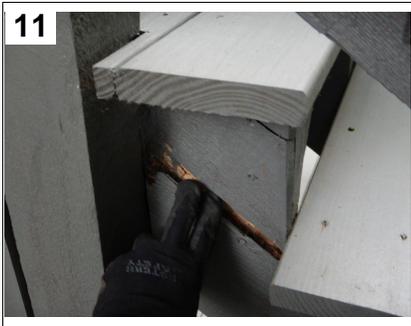
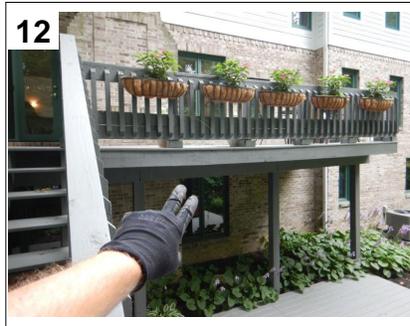
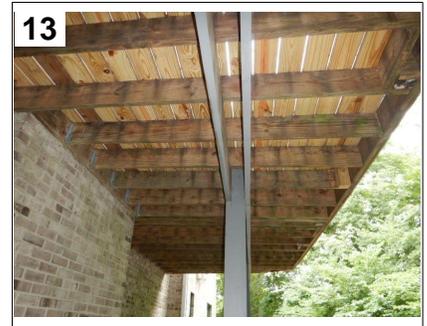
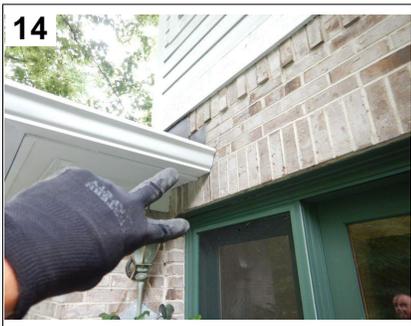
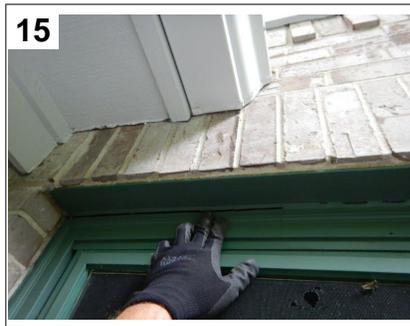
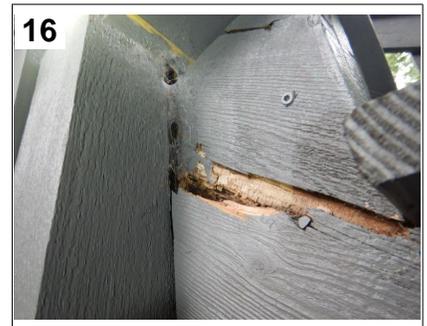
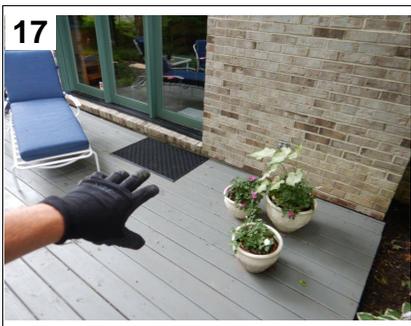
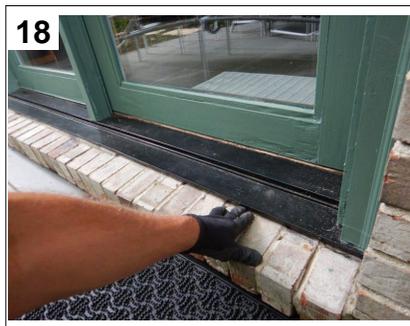
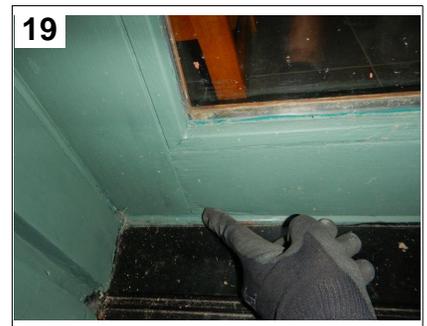
- Fall protection is missing from the corner of the South end of the front porch where it is high above the ground.
- The settlement in the driveway at the left large vehicle door opening is a trip hazard. Also, the small deck to the side entry door for the garage is also settled and not level . - (See Photo 2) - (See Photo 5) - (See Photo 7)

- The upper deck has improper cantilevered joists in the area around the chimney (50/50). The post at the improper cantilever area is sunken and the outer area in the deck slopes. 2/3 of the length of a cantilever should be behind the area where the cantilever bearing point. Most areas of the deck appear they may not be properly supported and the outer beam in the framing is not bolted or set in notched posts for support. Recommend evaluation of the deck construction by a qualified deck framing contractor. - (See Photo 9) - (See Photo 12) - (See Photo 13)

- There are rotted areas and insect damaged areas in the deck framing for the steps and trim around them. See WDI inspection report attached. - (See Photo 10) - (See Photo 11)

- There are gaps under door thresholds where they rest on brick and rot is present in the door panels for the rear basement doors. - (See Photo 18) - (See Photo 19)

- The driveway has settled in front of the garage opening on both sides where one side now has a trip hazard. The driveway control joints are also separated from settlement in the outer rear corner and middle section. - (See Photo 1) - (See Photo 2) - (See Photo 3)

- The asphalt driveway has some typical normal cracking and should be seal coated periodically to prolong the life of the asphalt. - (See Photo 4)
- The driveway has pitted areas and deterioration along with patching and cracked areas throughout. The lower section in front of the basement garage is also deteriorated and cracked. - (See Photo 4) - (See Photo 8)

- There are moisture stains in the basement ceiling below the rear deck doorway. There are gaps in the trim in the top of the door opening and a gutter terminated against the brick without kick out flashing above the gapped trim. - (See Photo 14) - (See Photo 15)

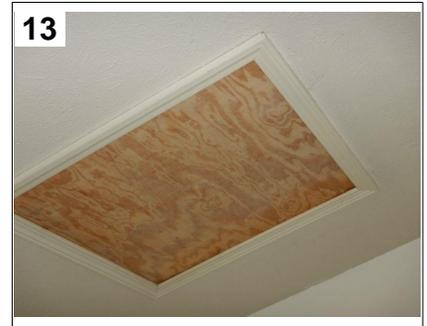
- The basement garage ceiling has rusted out areas in the metal under the concrete floor. The steel girders are rusted heavily and deteriorated at the ends where they rest on foundation walls. There are areas where metal is missing. It was disclosed that it was inspected by a structural engineer previously. Recommend consulting the engineer who inspected it and possibly having another inspection performed. - (See Photo 1) - (See Photo 2) - (See Photo 3)

- There are settlement cracks in the foundation walls with visible repairs. The repaired areas now have cracks and staining from moisture penetration through them (not wet during inspection). We also found signs of similar cracks and other repairs in the foundation under the front porch area (gun range room). We cannot determine if leaking is active or not at this time and recommend evaluation by a qualified foundation contractor. - (See Photo 4) - (See Photo 5)

- The main garage area floor bounces when walked on and has its control joints sealed. There is deterioration in the concrete at the outer edges by the vehicle door openings that are also sealed. These areas are where steel is most deteriorated in the basement garage below. - (See Photo 6) - (See Photo 10) - (See Photo 11)

- The service door to the side of the main level garage has signs of moisture penetration and gaps below the threshold where brick is pulled away or moved outward. - (See Photo 8)

- Three of the small main level garage vehicle door panels are damaged in the inside and the door is bowed outward. - (See Photo 9)
- There are ceiling penetrations for piping that are not fire sealed in the garage. - (See Photo 12)

- The garage attic space access panel is not fire rated material. - (See Photo 13)
- The front door step and step into the door are two different heights and a possible tripping hazard. The step into the house from the main level garage is also too high and a possible tripping hazard. - (See Photo 14) - (See Photo 15)

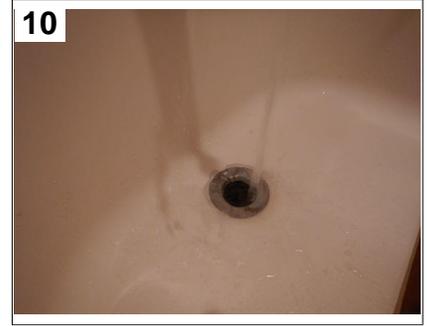
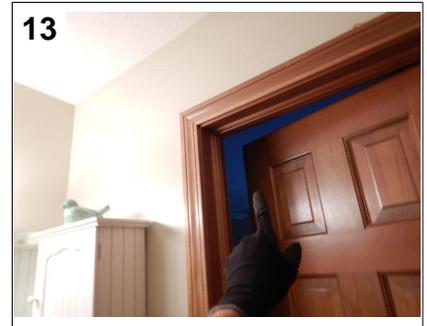
- The master tub has hot and cold reversed at the handles. - (See Photo 1)
- The toilet in the master bath is a little loose at the connection to the floor. - (See Photo 3)
- The door to one side of the Jack & Jill bath binds in the door frame. - (See Photo 11)
- Stoppers are missing from tubs. - (See Photo 10)
- The tub/shower bathroom shower diverters do not fully engage when testing. - (See Photo 7) - (See Photo 12)
- The window in the Jack & Jill water closet does not open (stuck). - (See Photo 9)
- There are slow drains in the sinks for the Jack & Jill bath. - (See Photo 13)
- The front bedroom door binds in the door frame. - (See Photo 6)
- The basement bathroom shower head leaks from the connection to the spout. - (See Photo 14)

- Shut off valves and some older chrome drain pipes/traps have corrosion present in the bathrooms. - (See Photo 2)
- There is evidence of the master bath skylight leaking and moisture staining is present in the drywall below it. - (See Photo 5)

- There are cosmetic nail pops and drywall cracks in a few areas upstairs. - (See Photo 8)

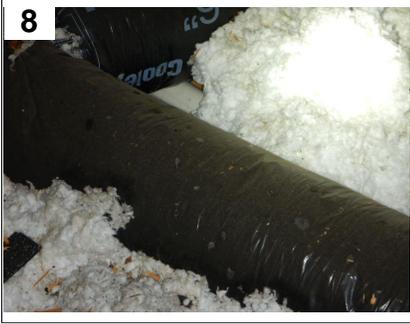
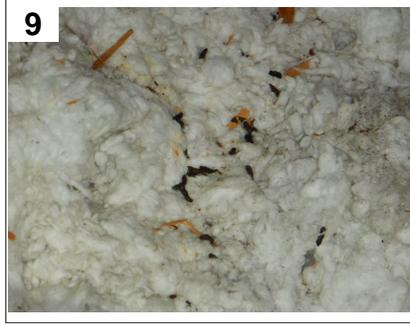
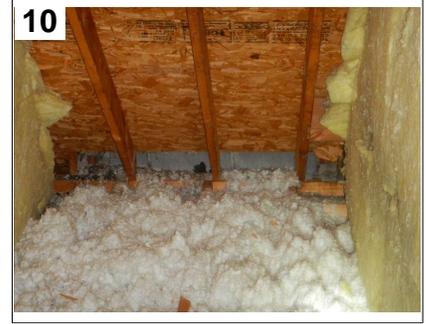
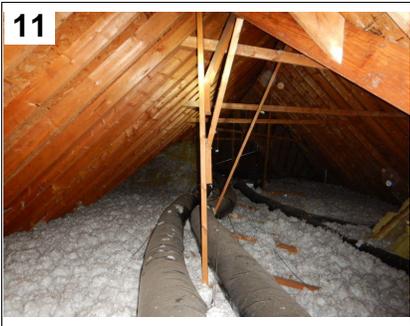
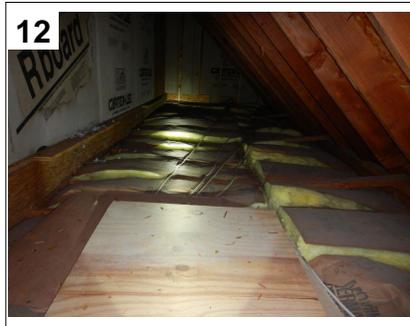
- There are small piles of bat droppings in the upper attic. There are stains on ductwork and insulation from bat urine in some areas too. Recommend evaluation and inspection by a qualified restoration contractor. - (See Photo 3) - (See Photo 8) - (See Photo 9)
- There are only a few collar ties present in the main attic rafters upstairs. There is a loose center support post that is no longer supporting the ridge beam. - (See Photo 5) - (See Photo 4)
- There is insulation installed in the garage attic area upside down with the paper facing left exposed and not covered with an approved building material. See warning label on insulation. - (See Photo 12)

- Metal exhaust flues from furnaces have visible moisture stains and corrosion from condensation leaks in the joints and elbows. - (See Photo 1)
