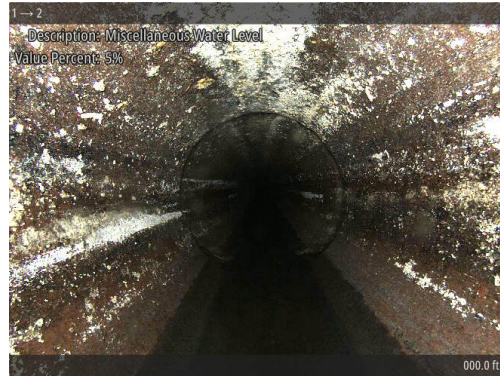
Miscellaneous Water Level at 000.0 ft

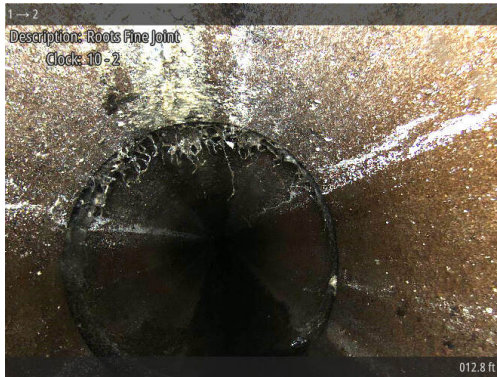
Roots Fine Joint at 012.8 ft, 10 - 2 o'clock

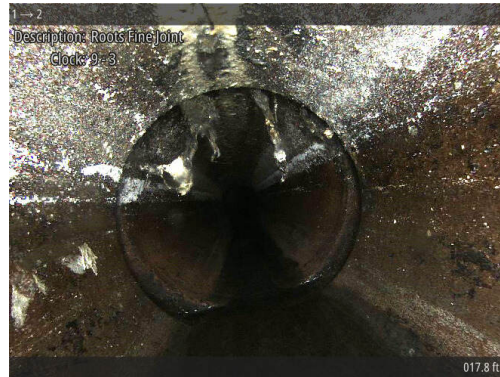
Roots Fine Joint at 017.8 ft, 9 - 3 o'clock

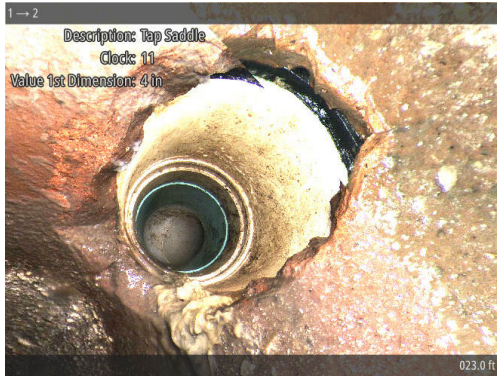
Tap Saddle at 023.0 ft, 11 o'clock

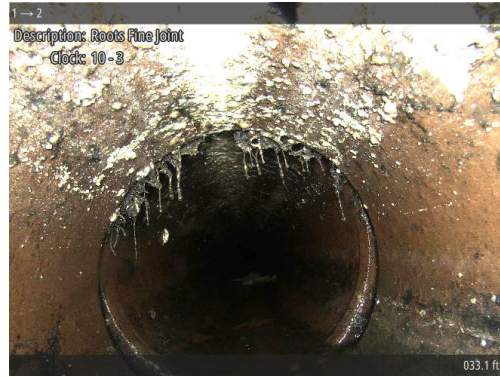
Roots Fine Joint at 033.1 ft, 10 - 3 o'clock

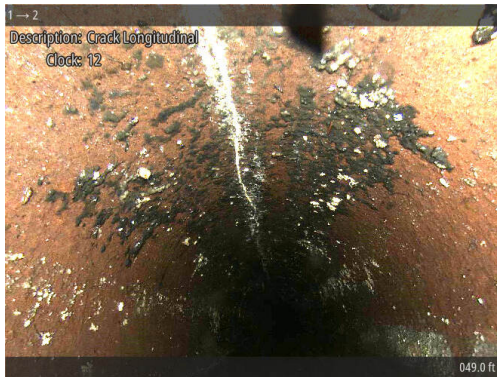
Crack Longitudinal at 049.0 ft, 12 o'clock

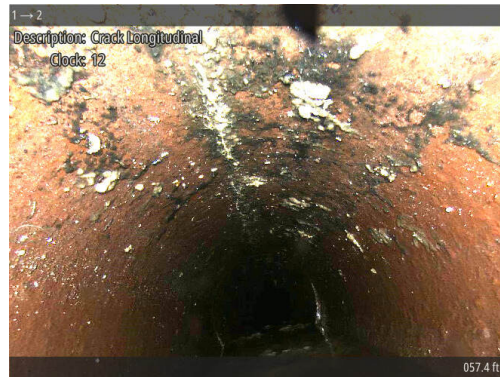
Crack Longitudinal at 057.4 ft, 12 o'clock

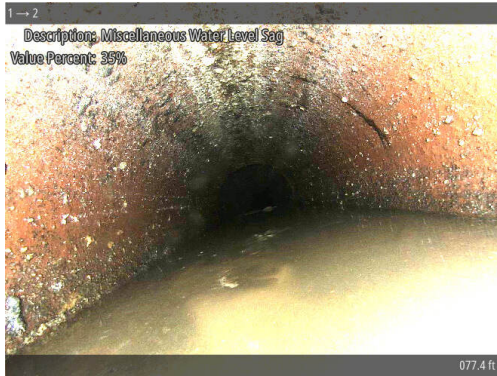
Miscellaneous Water Level Sag at 077.4 ft

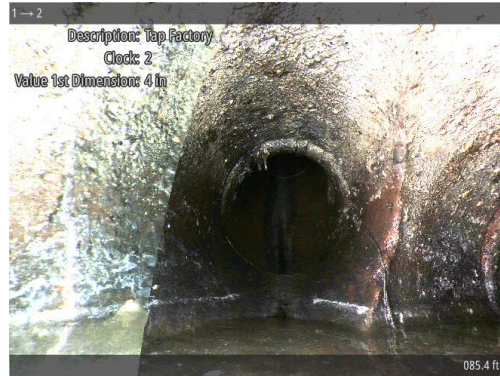
Tap Factory at 085.4 ft, 2 o'clock

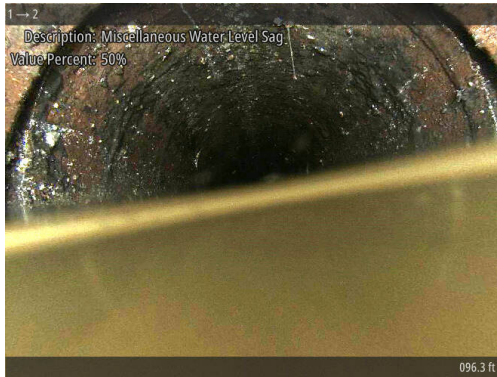
Miscellaneous Water Level Sag at 096.3 ft

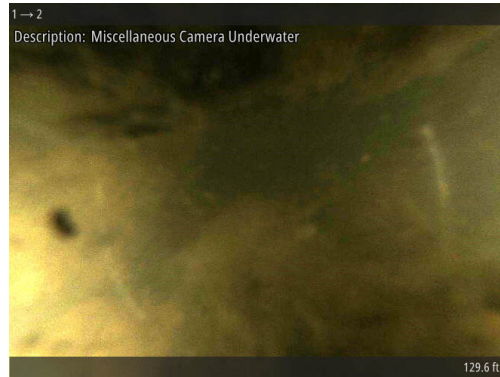
Miscellaneous Camera Underwater at 129.6 ft

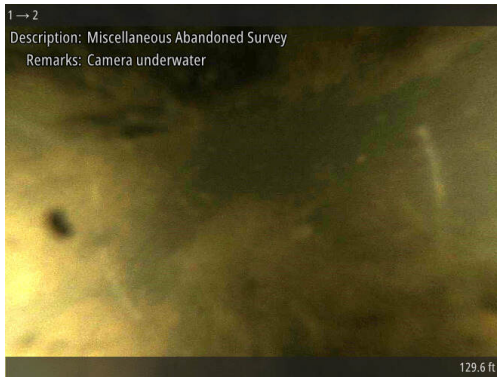
Miscellaneous Abandoned Survey at 129.6 ft |
Camera underwater
