**THE WATERFALL PROPERTY  
OWNERS ASSOCIATION  
LITTLE RIVER, SC**

**MARCH 31, 2022**

# FULL RESERVE STUDY

**GILES & FLYTHE**  
ENGINEERS

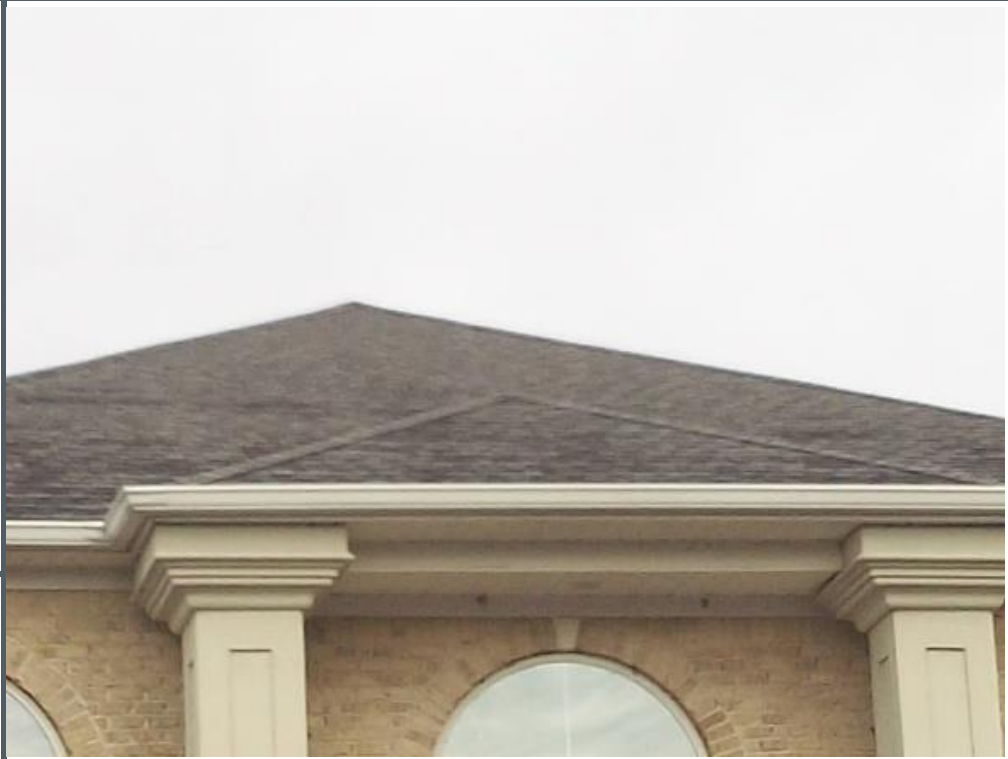
**Photo No.**  
**5**

The pitched roof surfaces over the buildings are covered in asphaltic-fiberglass shingles which are original to building construction. We are not aware of any major roofing issues to date. Typically, this type of architectural grade shingle will last approximately 20-25 years. We strongly recommend that any re-roofing project closely follow procedures outlined by the National Roofing Contractors Association's Roofing and Waterproofing Manual. A re-roofing sequence should include removal of the existing roofing material, replacement of any inadequate roof sheathing, damaged flashing and drip edge components. We anticipate the roof will be replaced in 2030 and funds are allocated for replacement in that year. It is likely that minor roofing repairs will be required in the interim including replacement of exhaust vent boots and minor flashing repairs. We have assumed these types of repairs will be funded from a general operating budget.

Closeup view of roofing  
shingles

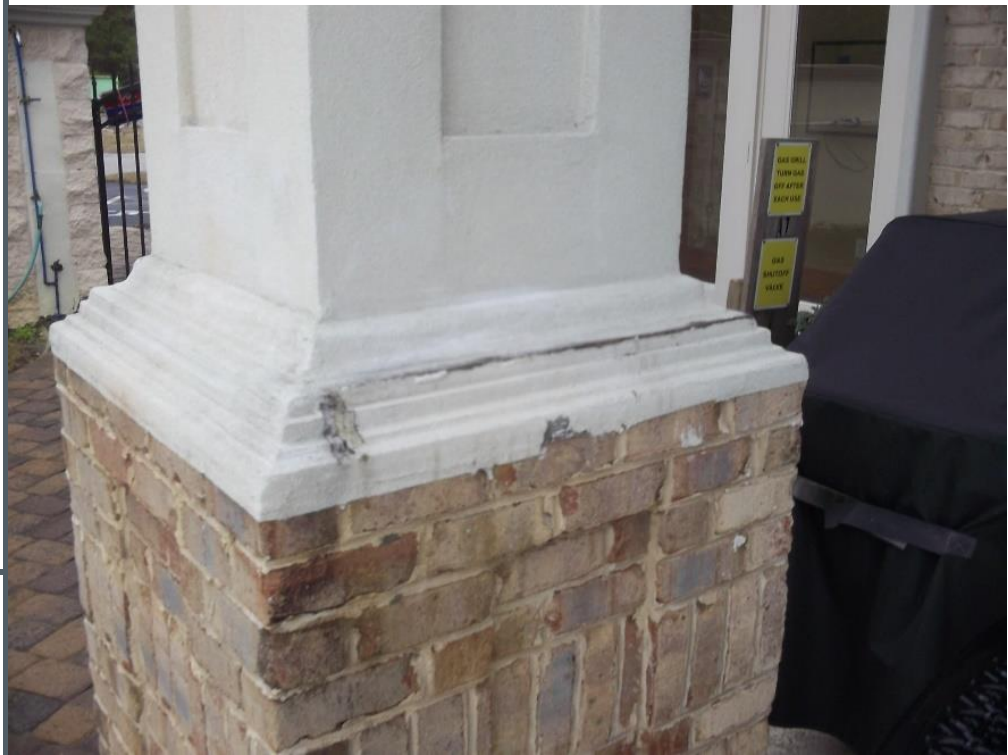
**Photo No.**  
**9**

The exterior of the amenity center building is comprised of brick with EIFS -covered columns and other trim finishes. We did observe deterioration to some painted EIFS surfaces at columns and other areas and believe the building painted surfaces should be repainted soon (including any minor trim/soffit repairs). The Board provided an estimate for painting the building and CMU wall surround the pool area behind the building. We have allocated funds for repainting the exterior siding and the CMU wall on a 10-year schedule beginning in 2022.

Deterioration in EIFS at  
rear column

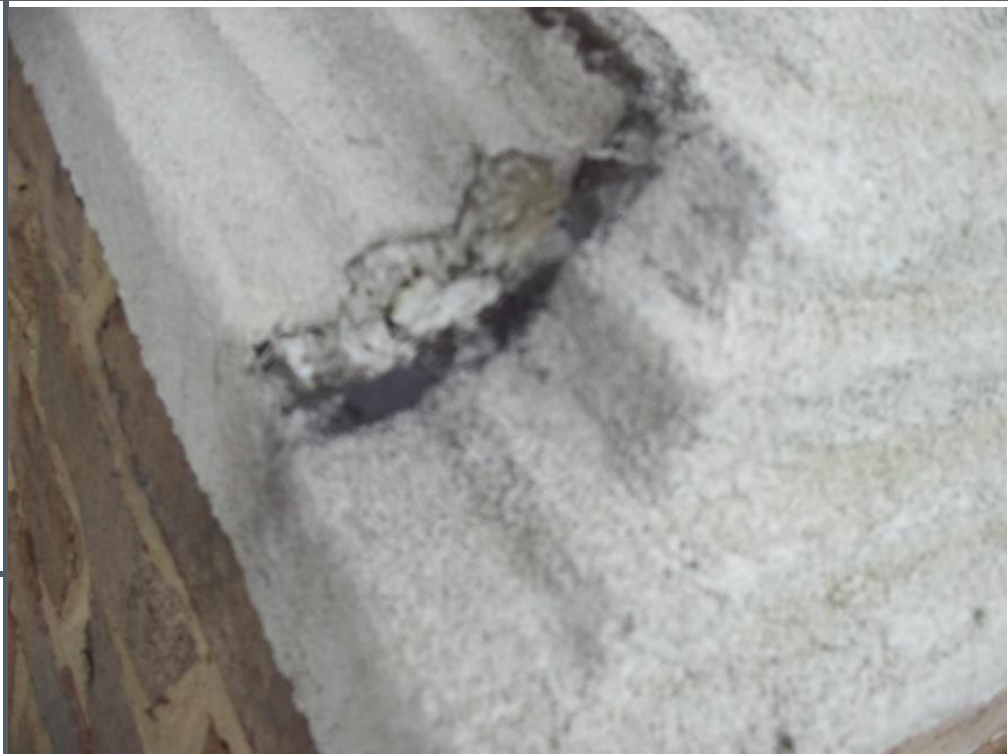
**Photo No.**  
**10**

Close-up view of  
damaged EIFS system

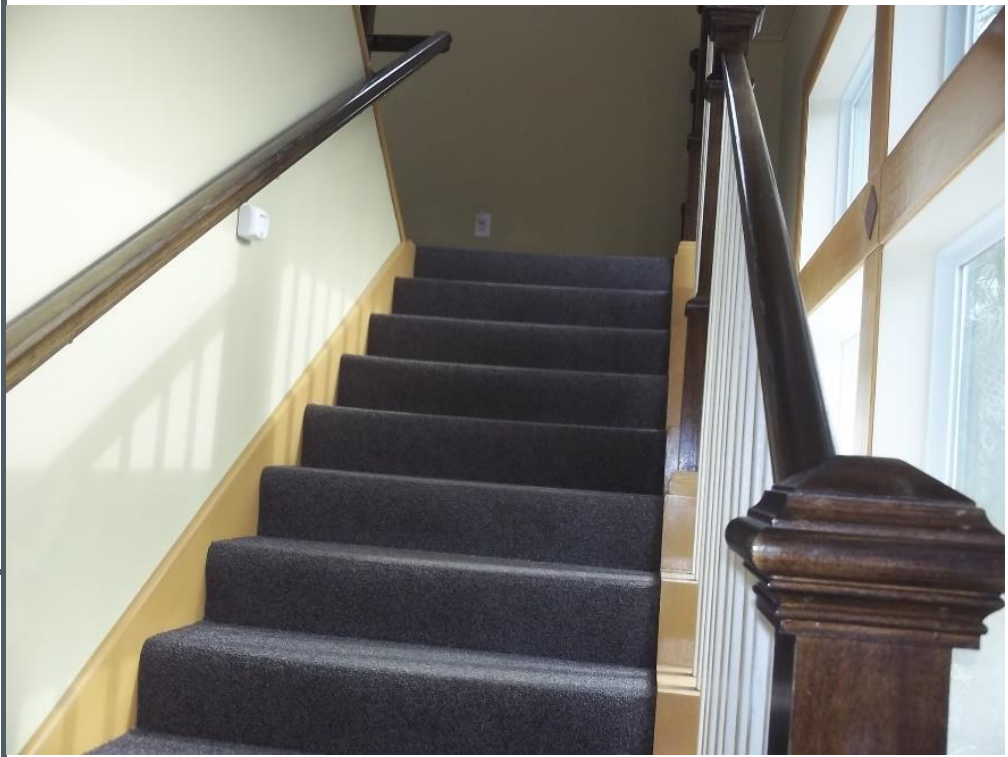
**Photo No.**  
**13**

The carpeted floor on the steps and in the fitness area appeared to be in adequate condition but showing some signs of uneven wear. We have allocated funds to replace the carpet on a 12-year cycle beginning in 2027. We did not inspect the laminate flooring (office area locked), but have allocated funds to replace the laminate flooring in 2030. Based on the limited use of the facility, we do not anticipate the tiled floors will require replacement or significant maintenance during the term of this study.

Stairway and carpeting

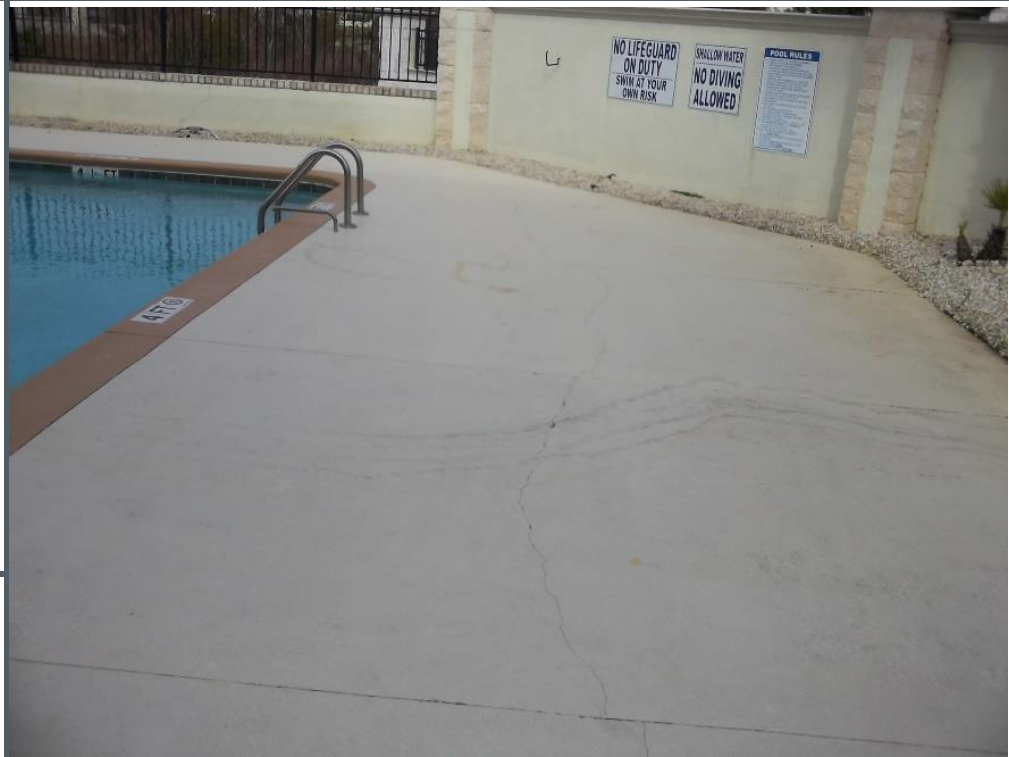
**Photo No.**  
**17**

Note some cracking in  
concrete pool deck

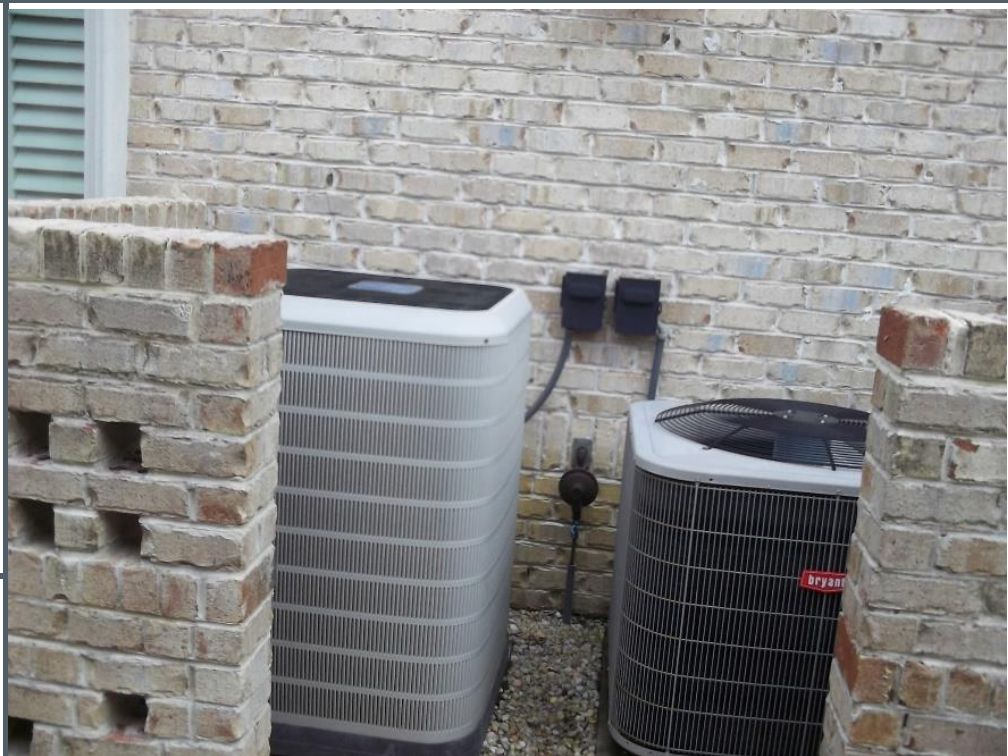
**Photo No.**  
**20**

The interior of the amenity center is conditioned by (2) split system electric heat pumps. The equipment appeared to be operating correctly at the time of the site inspection and one of the units appears to be original to amenity center construction (approximately 2007). The other HVAC unit was replaced in 2015. This type of equipment generally has an expected useful life of approximately 15-years, but this timeframe is highly dependent on usage. We have allocated funds to replace the original unit on a 15-year cycle beginning in 2024 after the Declarant moves out and the newer unit on the same cycle in 2030.

Two HVAC condenser  
units

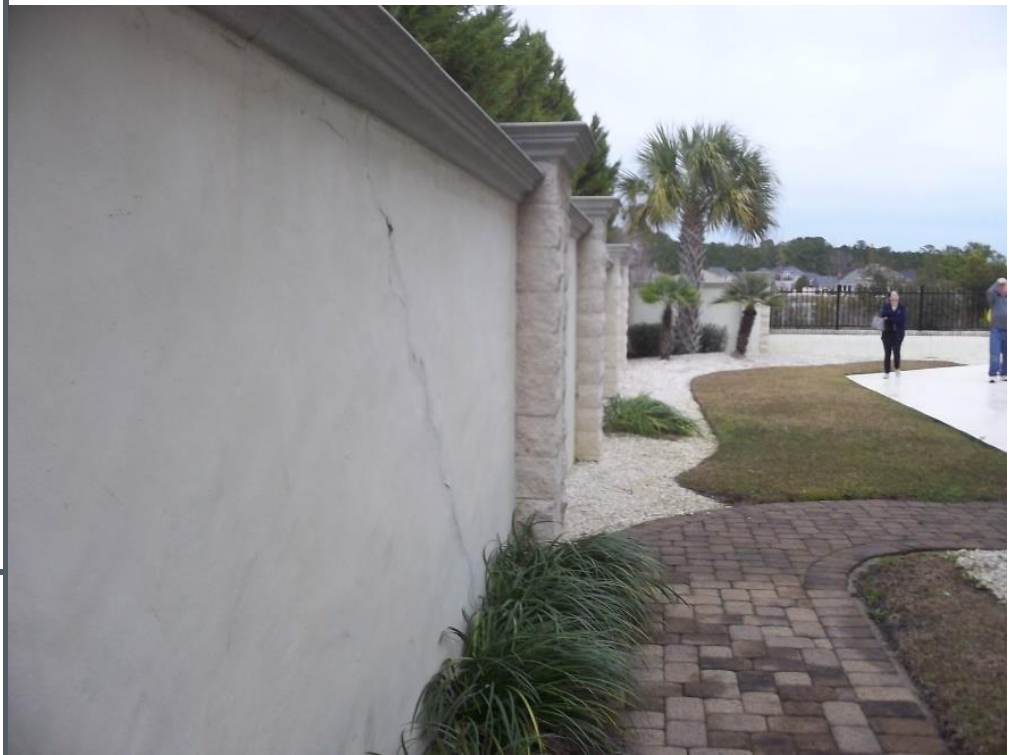
**Photo No.**  
**23**

View of cracking in  
masonry wall shown  
above

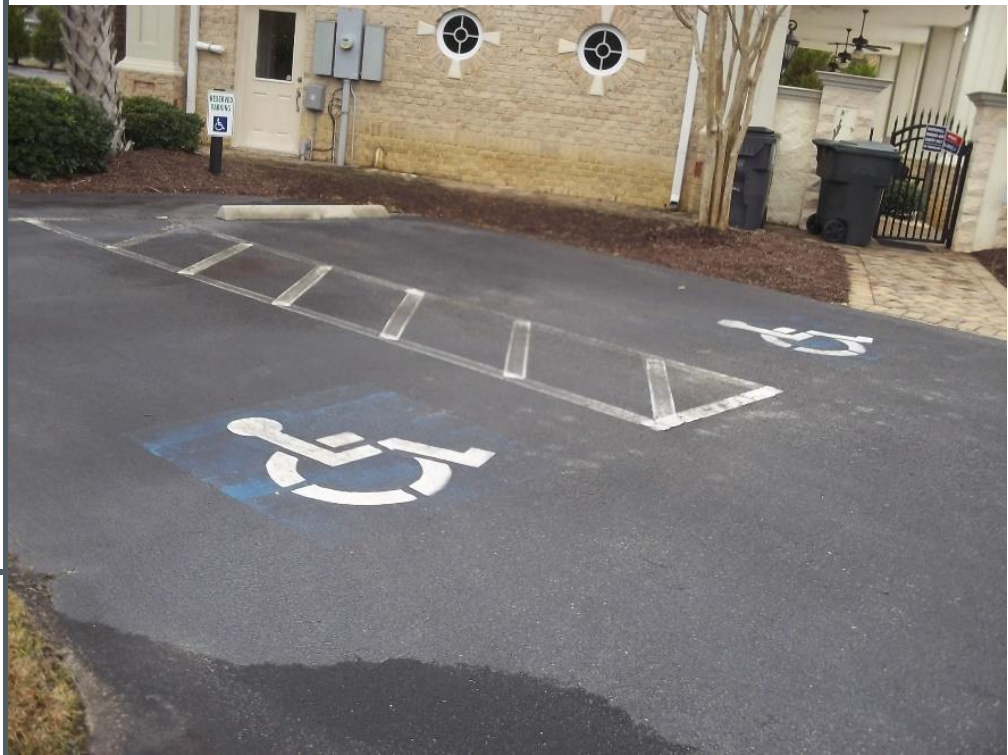
**Photo No.**  
**25**

The asphalt-paved parking lot at the amenity center and the asphalt-paved streets within the community are maintained by the Association. The paved areas are in fair-to-good condition with some longitudinal cracking and limited fatigue cracking noted. Additionally, we observed some water ponding in the amenity center parking lot, some areas of the streets are poorly drained and previous repairs to the street asphalt have been completed. We were advised by the Board that only 2-inches of asphalt were originally installed in the streets.

Faded parking lot  
striping

To help prolong the useful life of the paving, we have included funds for periodic street sealing/crack repair and parking lot sealing, striping and crack repair on a 7-year schedule beginning in 2024. At that time, we have also allocated funds for full depth repairs in the poorly drained areas of the streets. The asphalt paving is generally expected to last approximately 25 years, after which time we recommend resurfacing the pavement. Resurfacing would include some milling of the old pavement, repairs to inadequate areas of subgrade, re-sloping as needed to minimize water ponding and the installation of an approximately 1½ -inch thick layer of new asphalt. We have included funds for resurfacing the parking lot and the private streets in 2028.

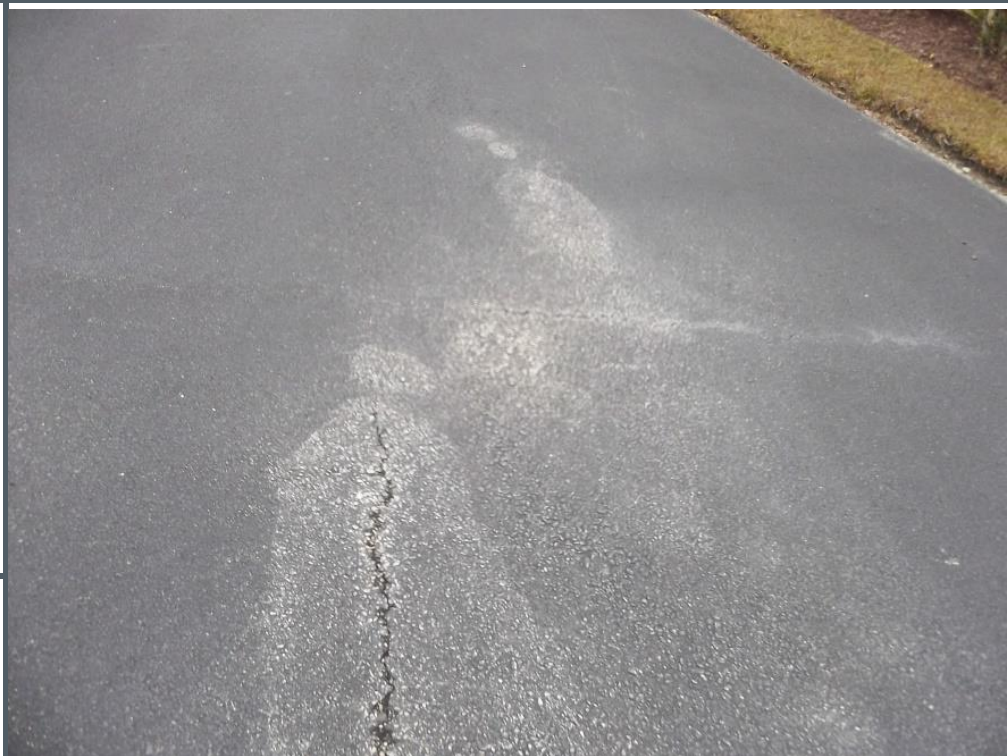
**Photo No.**  
**26**

Typical crack in amenity  
center parking lot

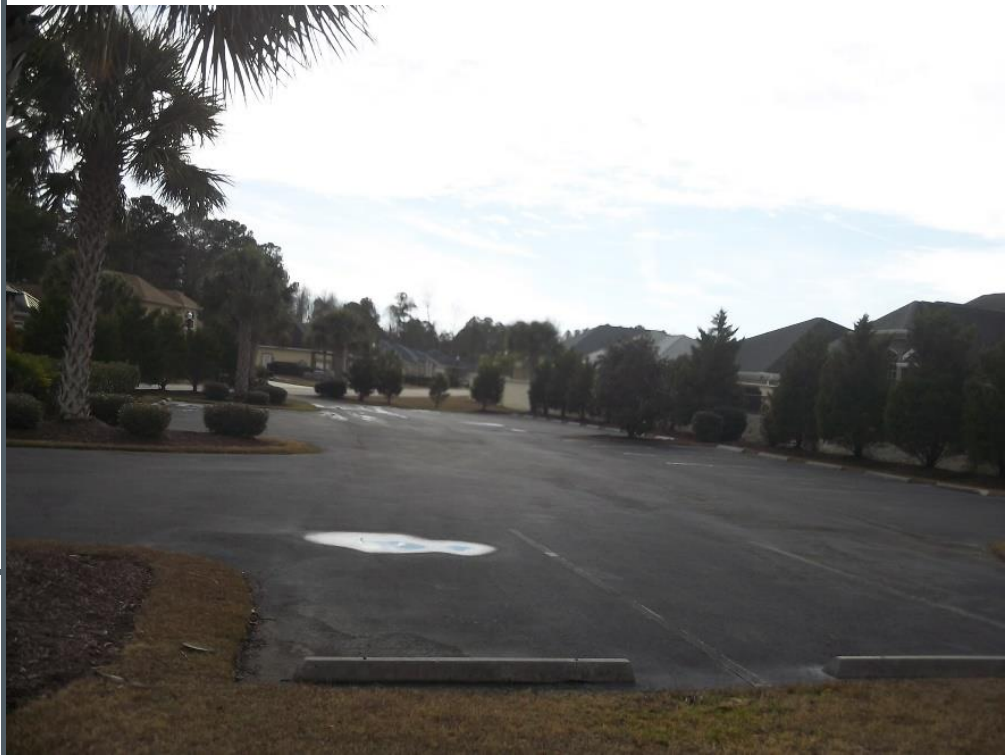
**Photo No.**  
**27**

View of amenity center  
parking lot and water  
ponding

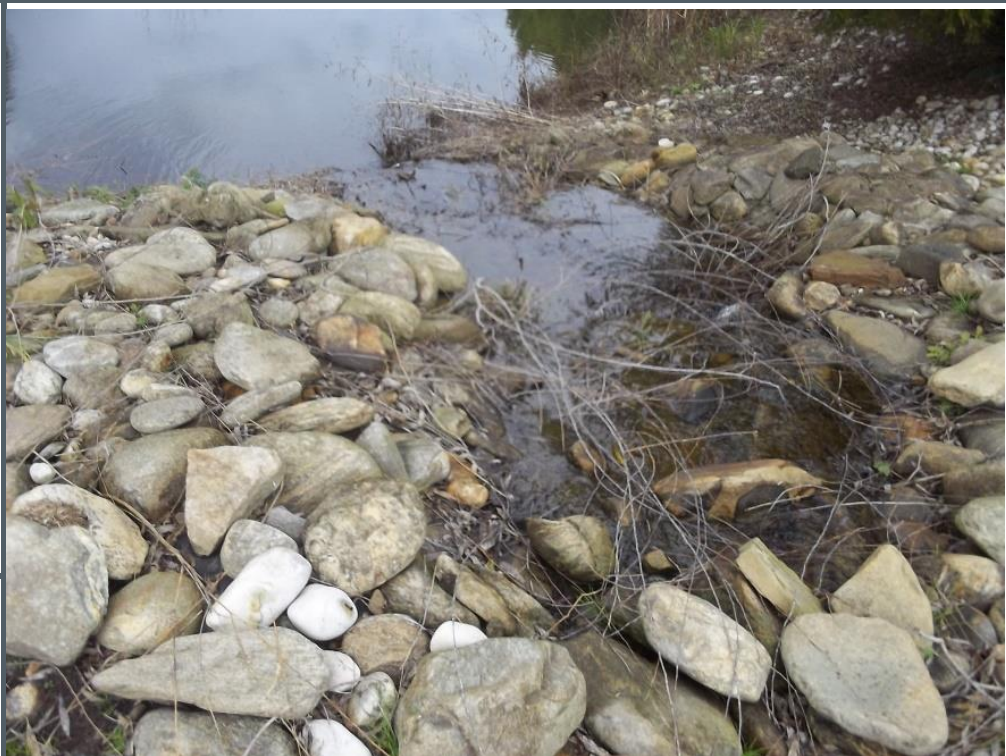
**Photo No.**  
**28**

A small waterfall feature over rip rap with well pump has been installed in the south end cove for algae control. We have allocated funds for well pump replacement in 2028 and on a 10-year cycle.

Waterfall area at south  
end of lake

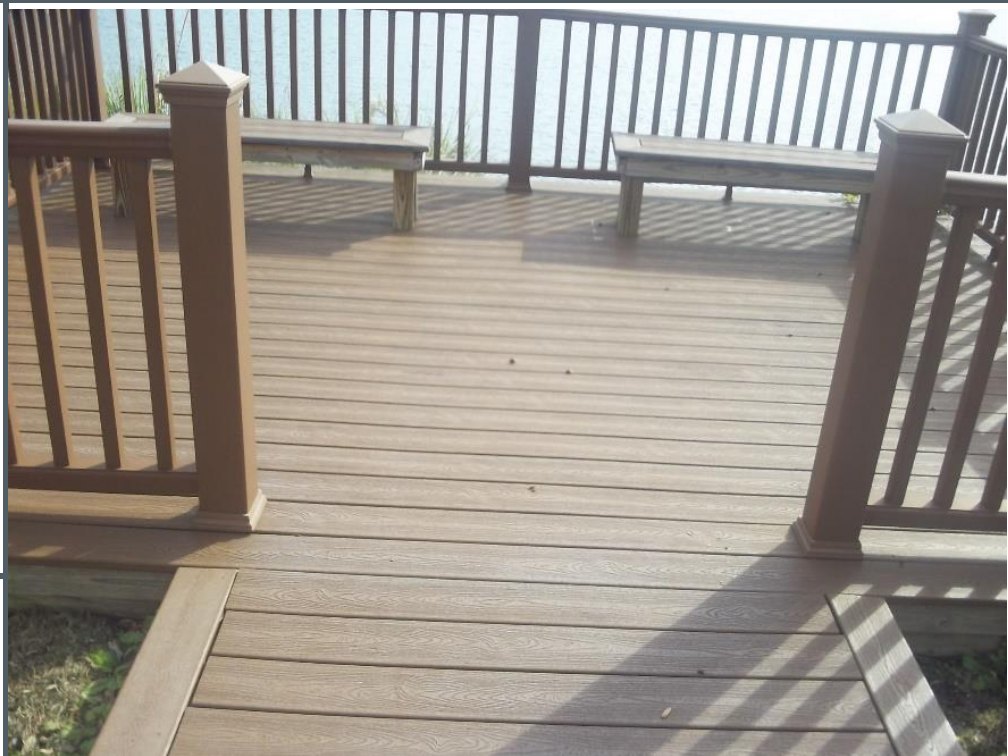
**Photo No.**  
**32**

A small overlook feature with composite decking installed at the west end of the lake. We anticipate replacement of the decking and railings and other small repairs will be required to this feature with funds allocated in 2030.

Composite decking on  
observation platform

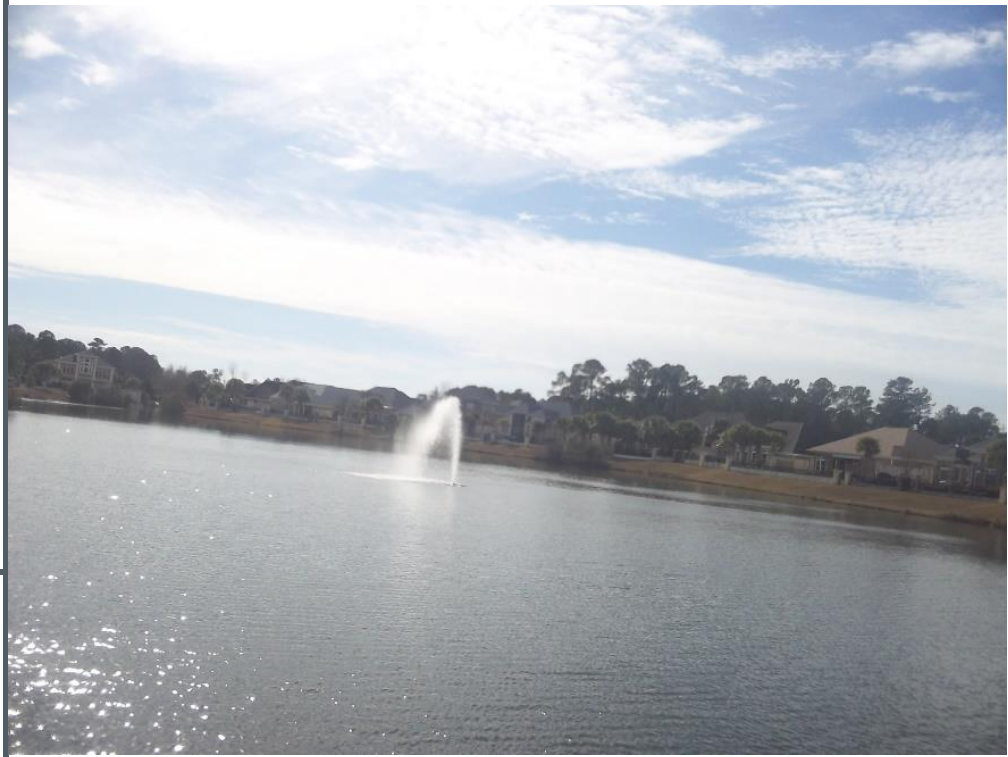
**Photo No.**  
**33**

The lake includes two large fountains that were operational at the time of inspection. We were advised by the Board that some components of the center area fountain were replaced as recently as 2018 and no significant repairs have been required to the newer fountain installed in 2009. This equipment has an expected life of approximately 6-8 years and funds are allocated for full replacement of the fountains and associated controllers/electrical components on a 7-year cycle beginning in 2024.

View of operational  
fountain in lake

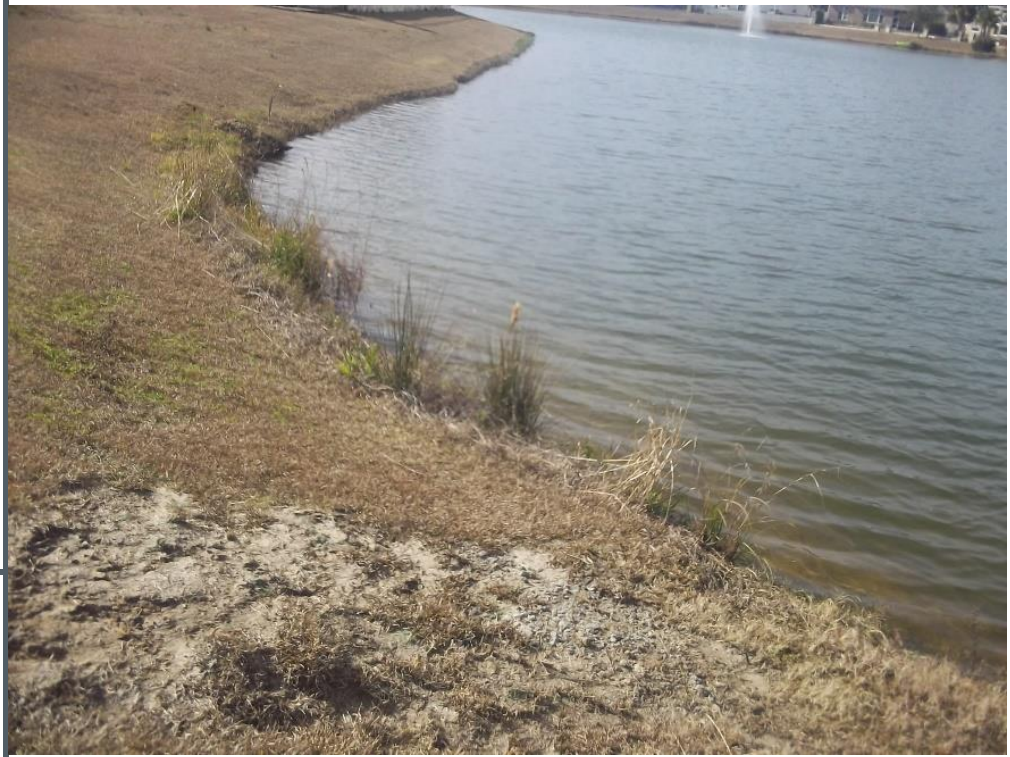
**Photo No.**  
**35**

Slight erosion on lake embankment (typical of other areas)

Stormwater drainage systems in the community consist of graded swales and standard catch basins along the curbs and in the landscaped areas which are connected to an underground piping network. The stormwater from the site is typically routed to the large onsite lake. We observed some areas of soil erosion at select locations, particularly at areas along the lake. Swales tend to accumulate sediment over time, and piping systems can clog, leading to poor drainage and ponding water. Future repairs will likely include retrenching of swales to improve flow, stabilizing steep or bare slopes, installation and repair of rip-rap armoring,

installing French drains or other types of subsurface drainage systems. We have allocated funds for these repairs beginning in 2027 and on an 8-year cycle.

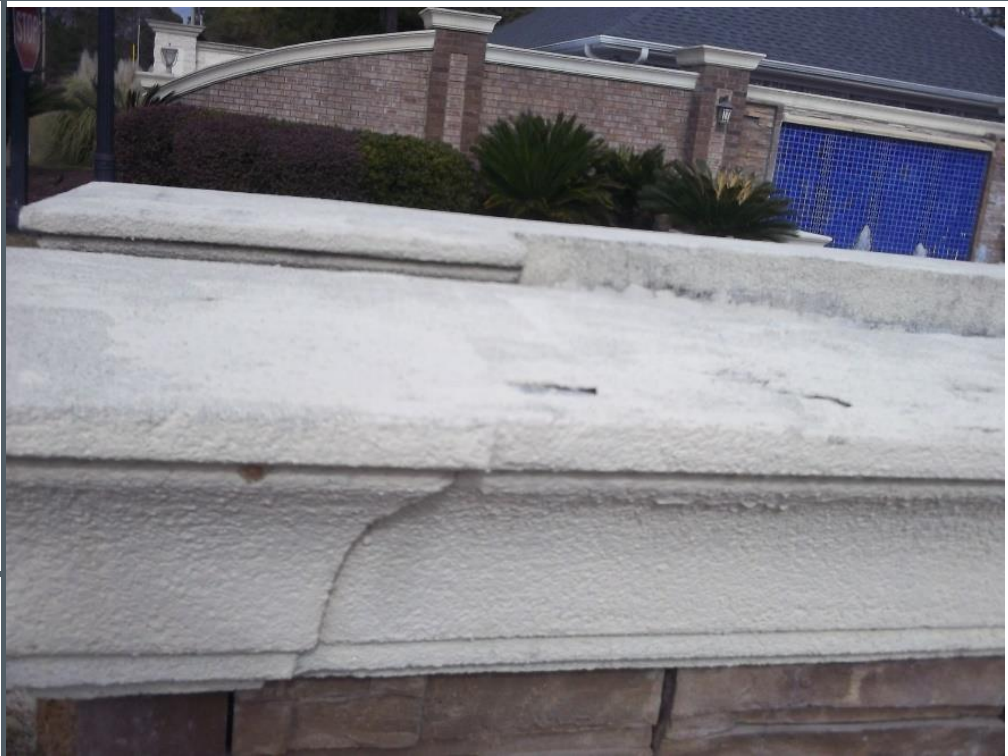
**Photo No.**  
**38**

The main entrance into the community includes stone masonry monuments/walls with EIFS and trim and metal lettering signage. Significant deterioration noted to the EIFS; however, the stone monuments/walls appeared to be in good condition and no major replacement of the walls is anticipated during the term of this study. To help maintain a pleasant aesthetic appearance of these prominent site elements, we have allocated funds to repair and repaint EIFS and repair/replace signs as required in 2022 and on a 10-year cycle.

Deterioration in EIFS  
monument cap

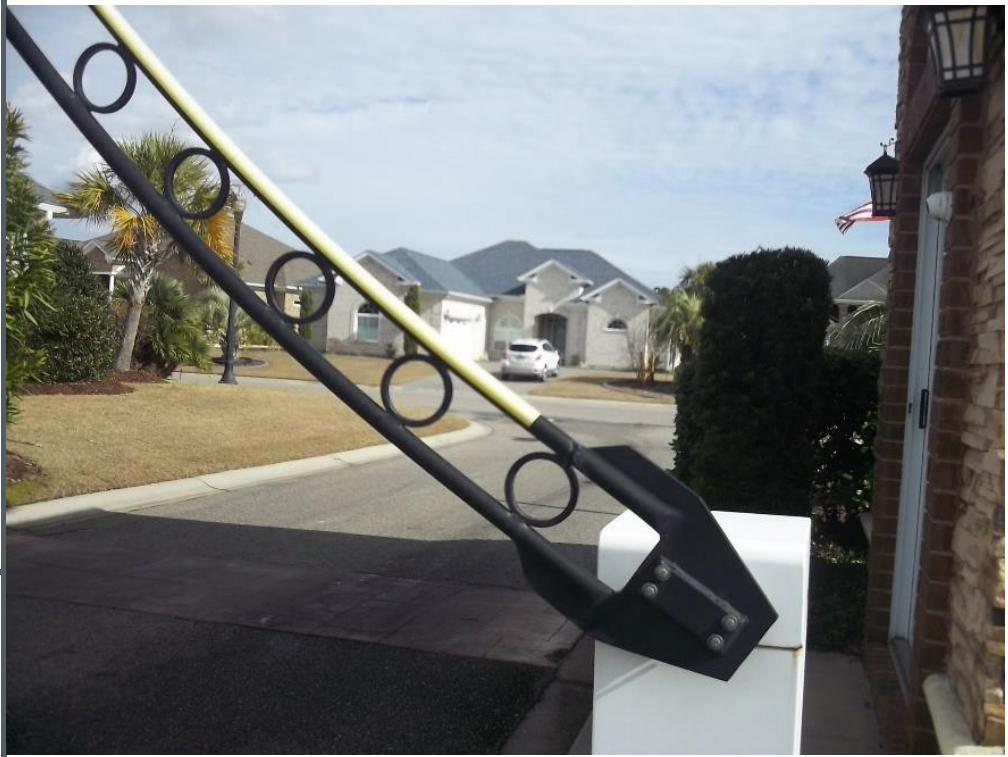
**Photo No.**  
**39**

The main entrance also incorporates two entrance/exit gates with operators and a DKS call box entrance system. The gates and operators are worn and only work intermittently and we have allocated funds to replace both the gates/operators and call box system in 2022 and on a 10-year cycle. Light fixtures are installed at the guard house and entrance walls/monuments and funds are allocated to replace these fixtures in 2027 and on a 15-year cycle.

View of entrance area  
gate and operator

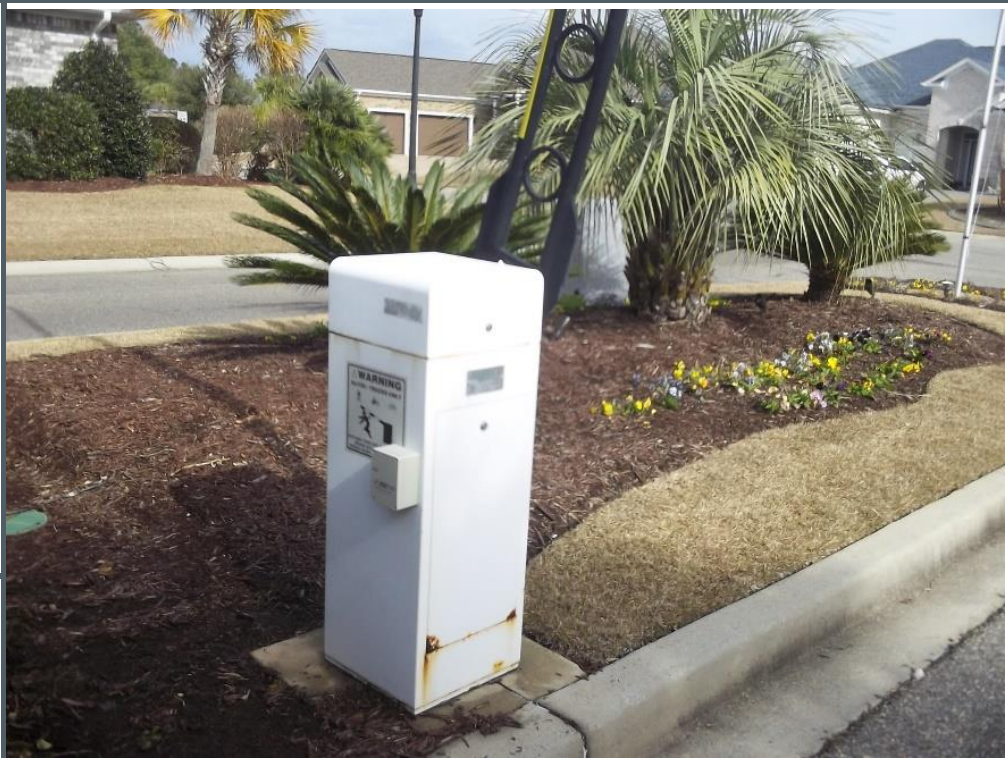
**Photo No.**  
**40**

Another view of gate  
and operator

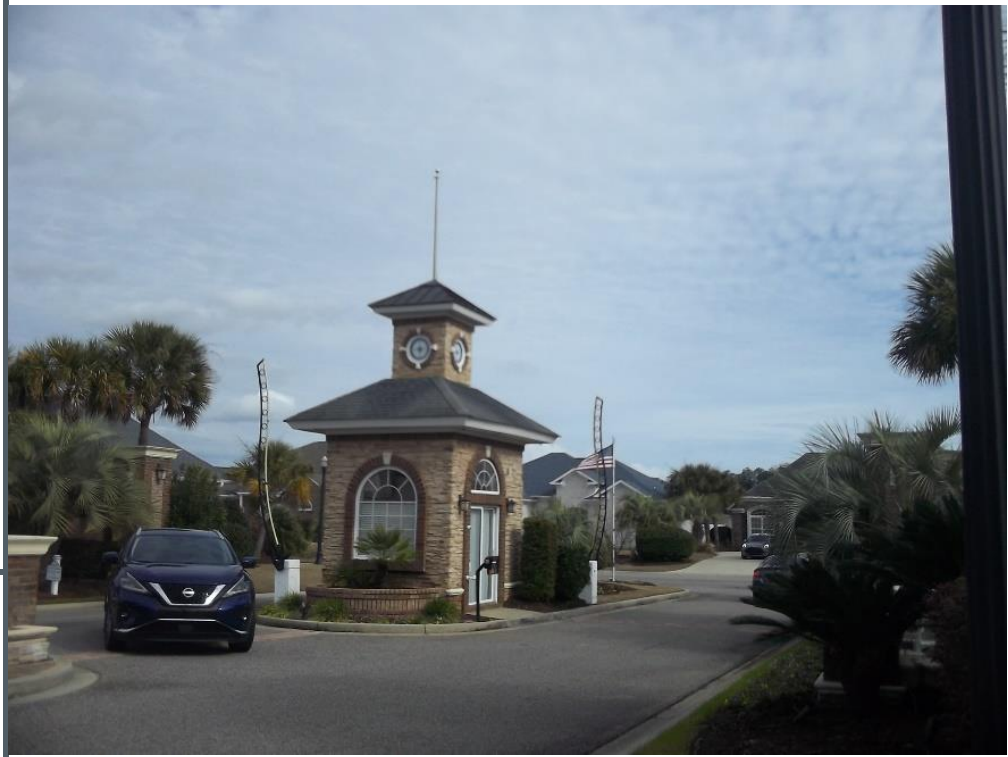
**Photo No.**  
**41**

The guardhouse is not in use, but doors are difficult to open and the roof will require replacement in the future. We have allocated funds for general guardhouse repairs in 2023 which should also include any desired interior repairs until the Board makes a decision on future use of this small structure.

View of guard house  
near entrance to  
community

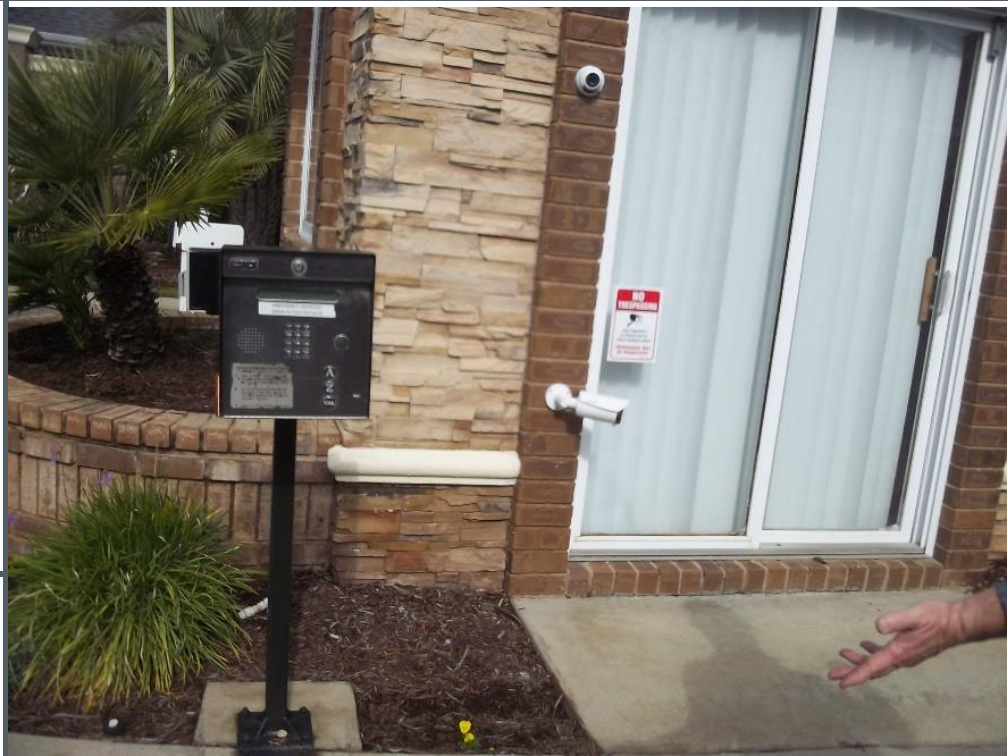
**Photo No.**  
**42**

Outdated sliding glass  
door to guard house and  
DKS gate entry system

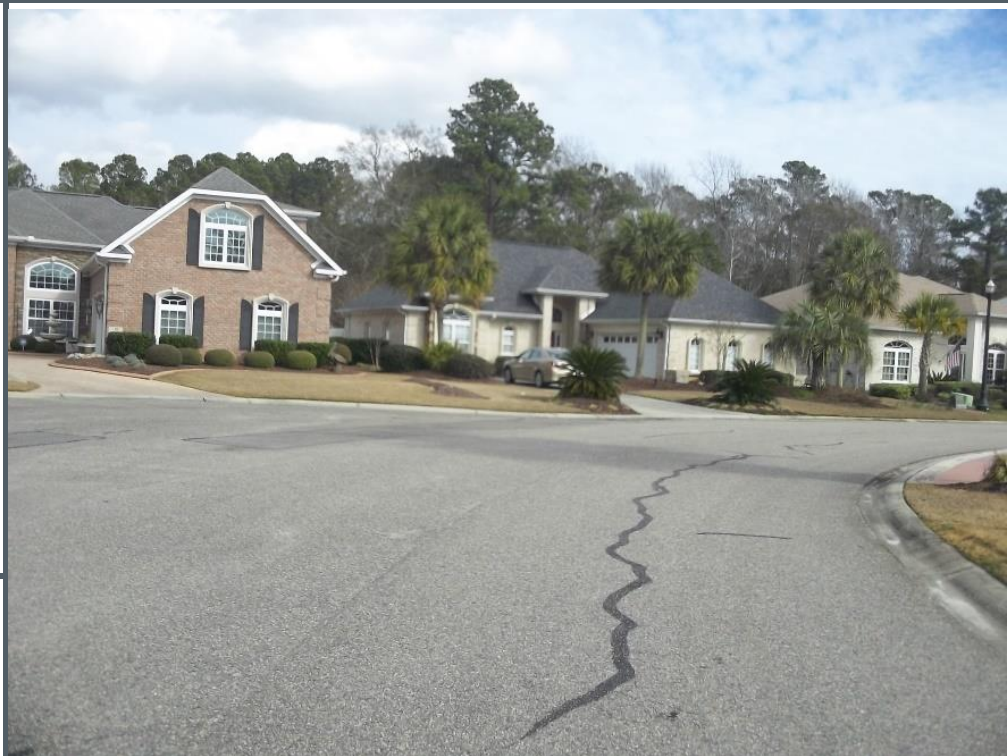
**Photo No.**  
**48**

Typical sealed crack in  
private street

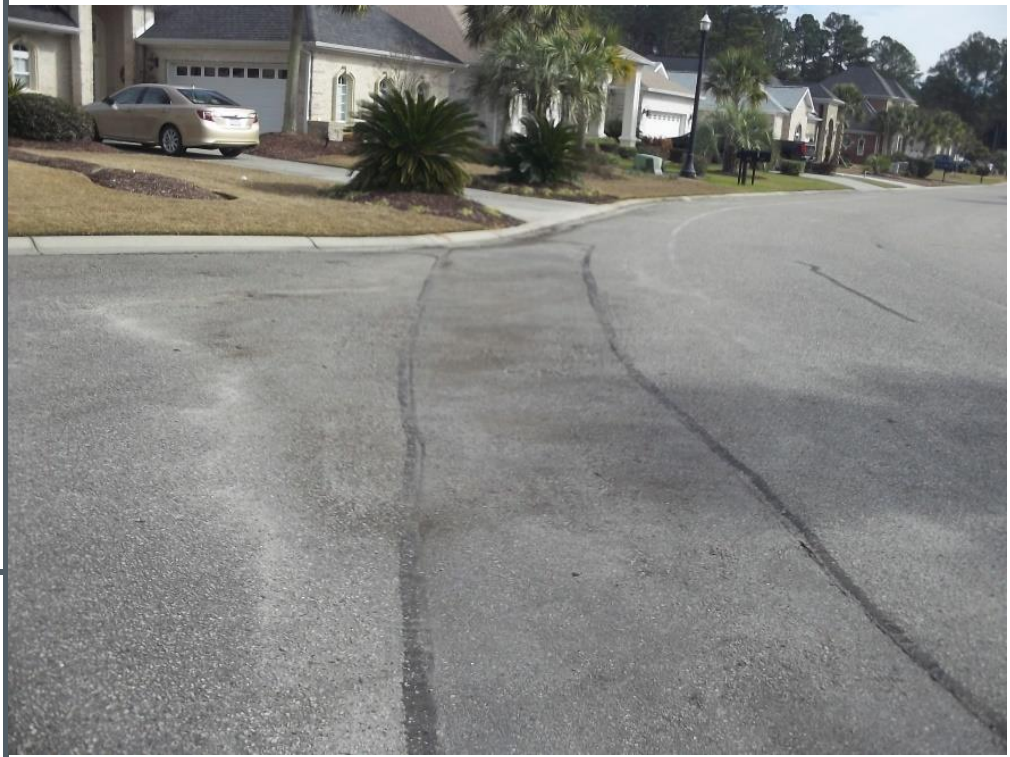
**Photo No.**  
**49**

View of previous repairs  
to asphalt street

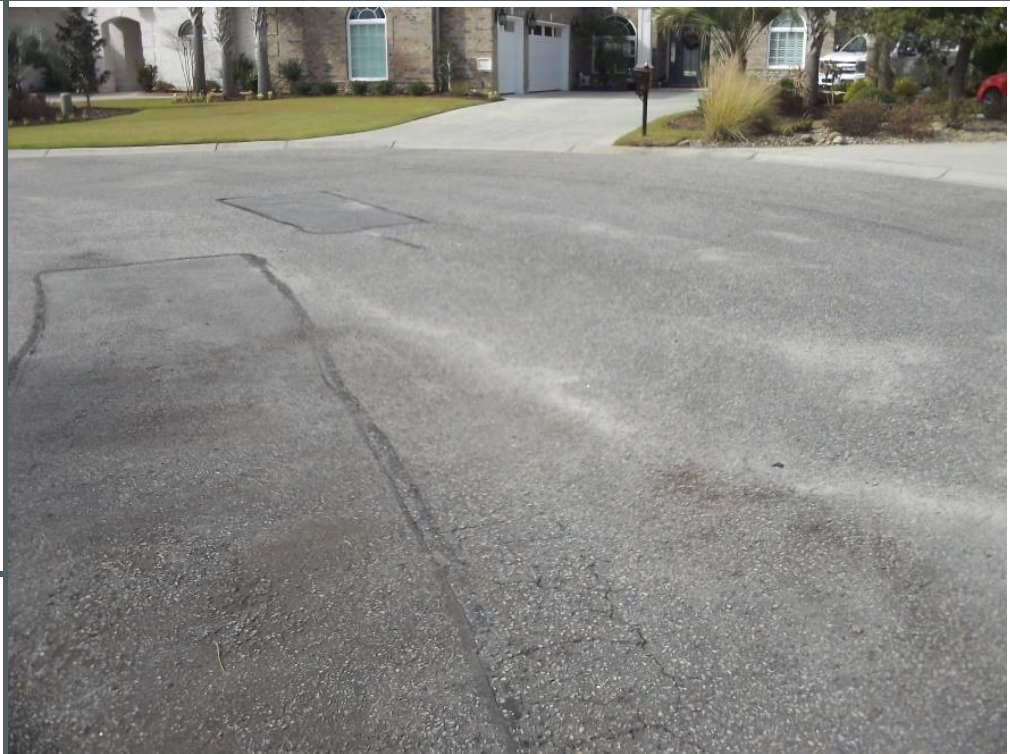
**Photo No.**  
**50**

Close-up view of  
previous asphalt patches

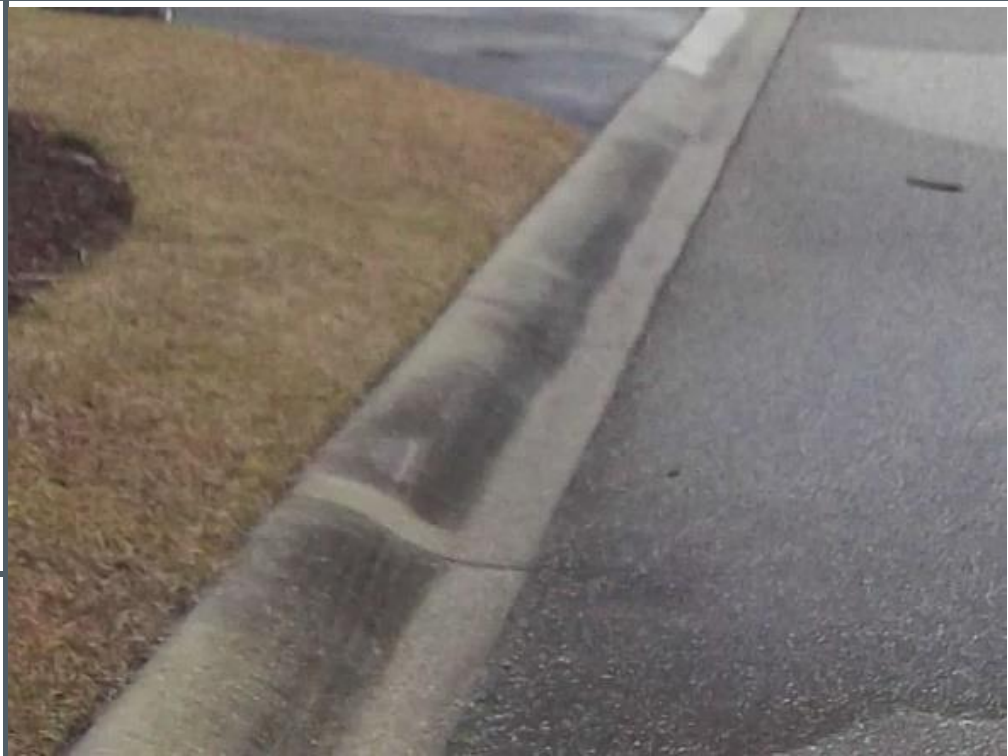
**Photo No.**  
**52**

The streets and parking areas are surrounded by a combination of concrete valley gutter with some curbing in areas. The valley gutters and curbing are in relatively good condition with only minor cracking observed. We have allocated funds for periodic replacement of curb and gutter sections in anticipation of future cracks, heaving and/or settling that are common in concrete construction. We have assumed 2% of the concrete gutters and curbing will require improvement every 10 years beginning in 2028.

View of typical valley  
gutter
