**FORMAL NOTICE OF ACTUAL KNOWLEDGE, STATUTORY VIOLATIONS, AND
DEMAND FOR IMMEDIATE ENFORCEMENT ACTION**

Re: Fraudulent Foundation Certifications
Property: 5055 Adagio Lane, Lakeland, Tennessee 38002
Parcel ID: L0150A F00006

REFERENCE: Evaluation of Foundation and Supporting Soil – Pereira v Regency Homebuilders
Location of Incident: Lakeland, Tennessee
EDT Case Number: BHM11338

Ms. Julie Pereira reported that there were construction defects to her residence, which was constructed from 2020-2021 by Regency Homebuilders, LLC. The Pereira residence was located at 5055 Adagio Lane in Lakeland, Tennessee.

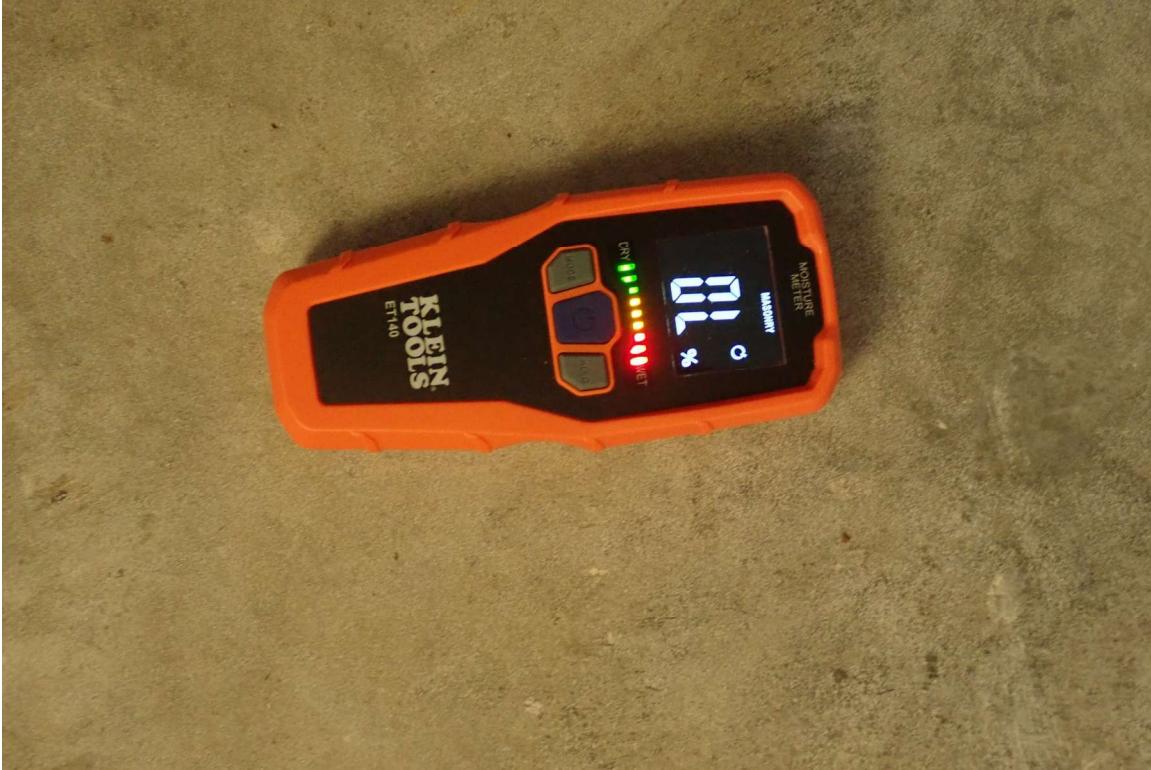
Figure 1 Concrete moisture reading inside

Interior slab moisture was tested and found high out of range in most locations. Only the location above a previous postconstruction excavation found moisture contents within the instrument's limits of 50% saturation. The source of moisture may be presumed, to a reasonable degree of engineering certainty, to originate from under the slab. Figures 1-4 show the instrument results.

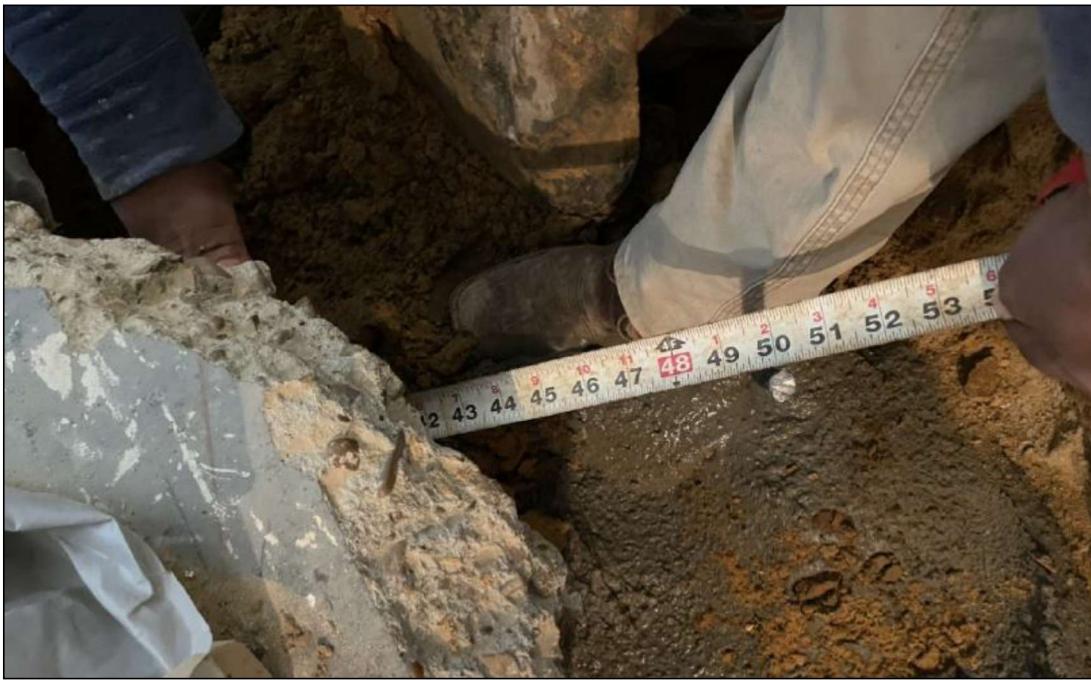
Figure 2 - Photograph taken by homeowner during plumbing repairs, which required demolition of main slab. Tape measure is inserted in area of required 30-inch by 30-inch footing.

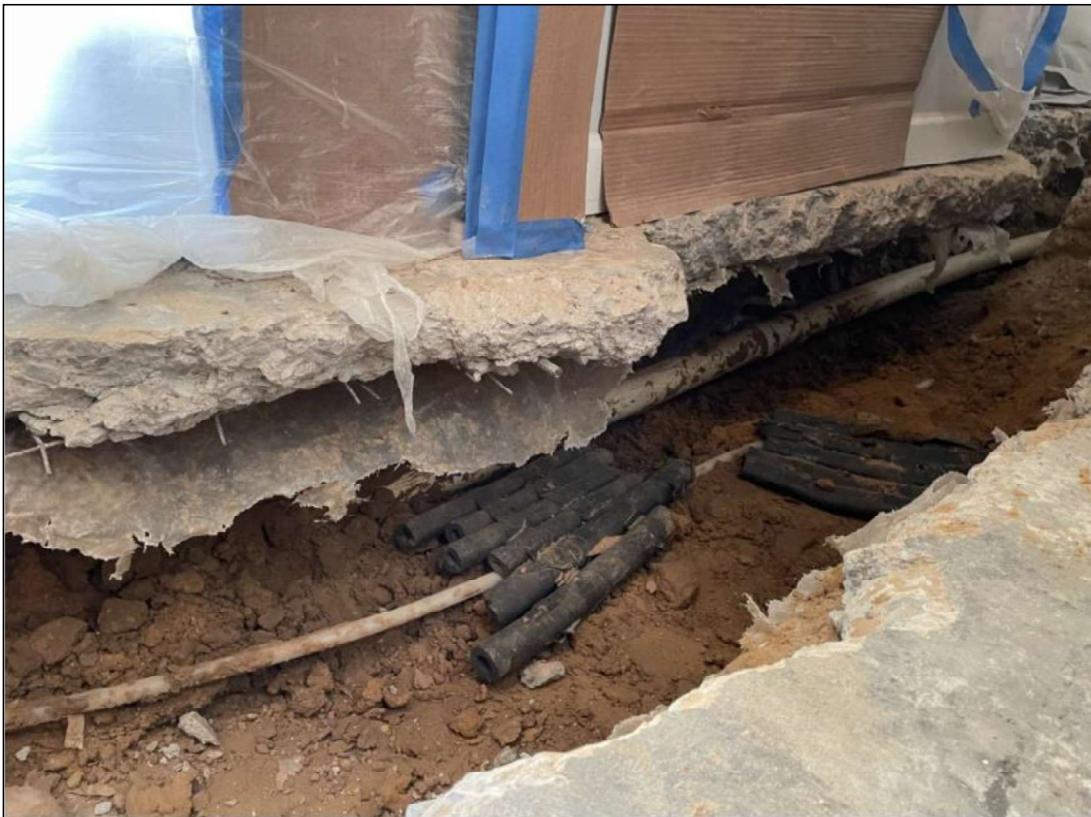
Figure 3—Photograph taken by homeowner during plumbing repairs, which required partial demolition of main slab. The Welded Wire Reinforcement (WWR) is observed to be lying directly on top of vapor retarder.

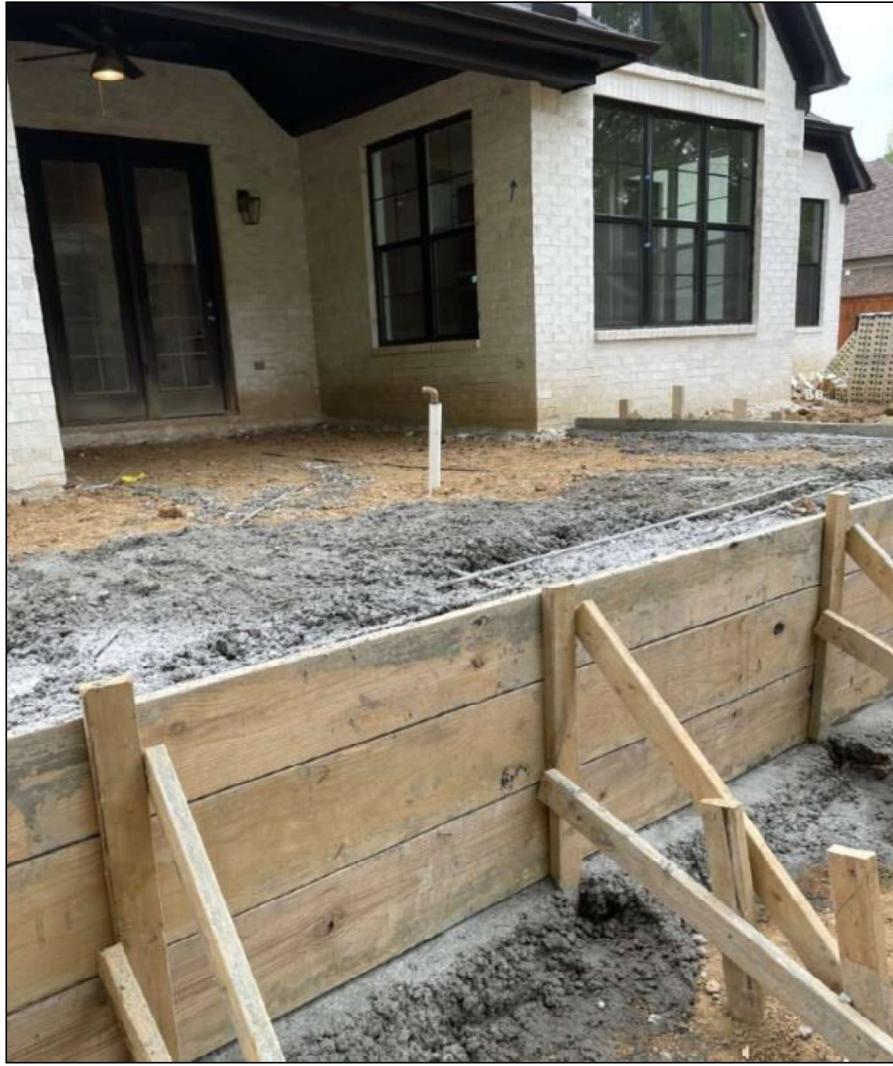
Figure 4—Photograph taken by homeowner during placement of OLA patio slab. Steel reinforcement is observed to be lying on the ground.

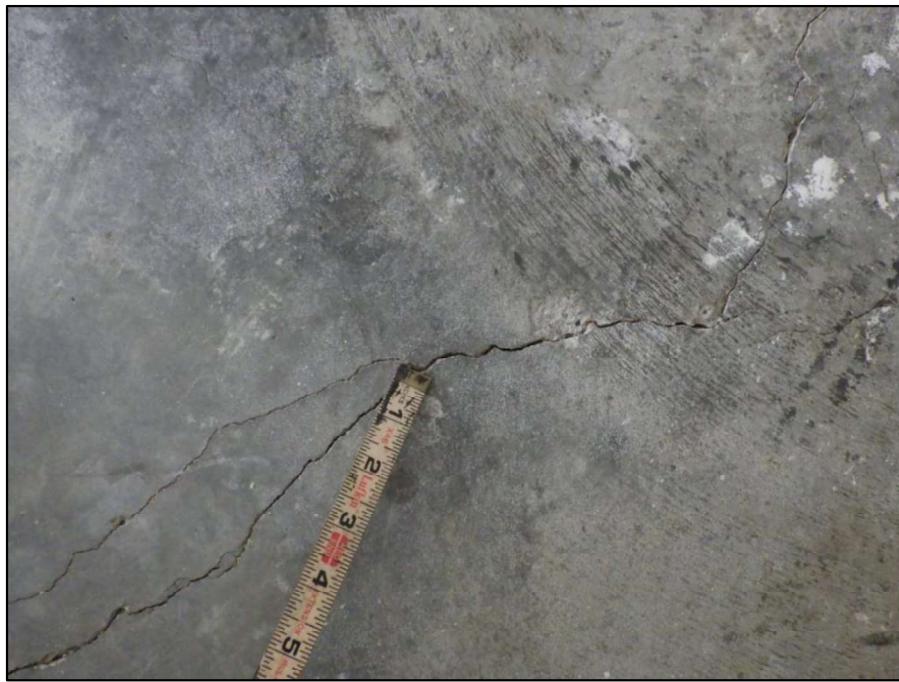
Photograph 5

- The concrete slab in the great room was exposed due to a previous plumbing repair and elevated moisture content, preventing the installation of flooring. The slab had cracks up to 1/8 inch in width (**Photographs 5 and 6**). The moisture content of the main slab was elevated (**Photographs 7 and 8**).

The main slab in the great room of the residence was exposed due to previous plumbing repairs. The slab had cracks up to 1/8 inch in width.

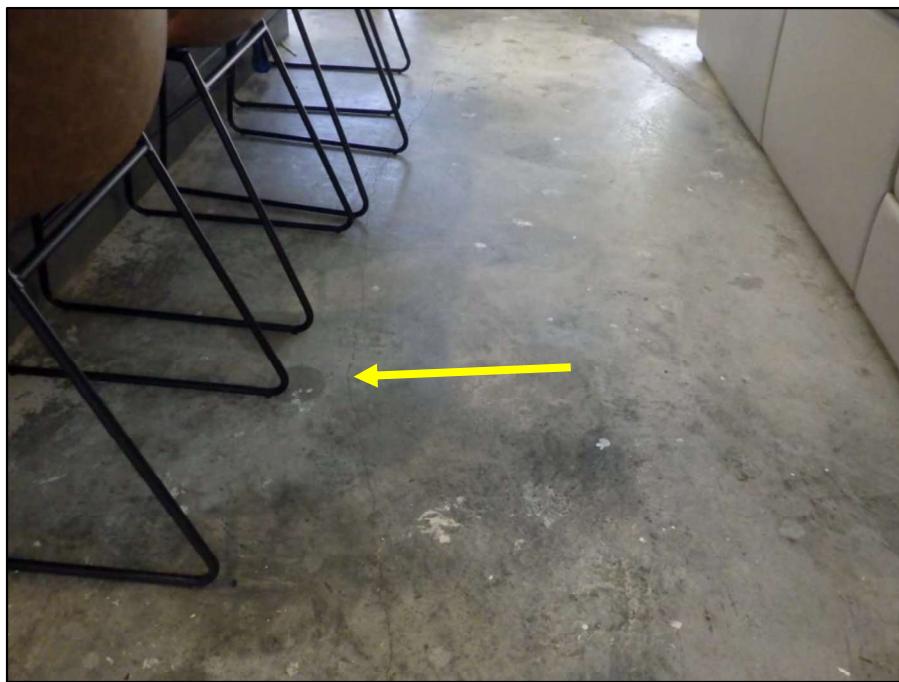
Photograph 6

The cracks in the main slab extended to the edges of the slab on the east and west sides of the interior.

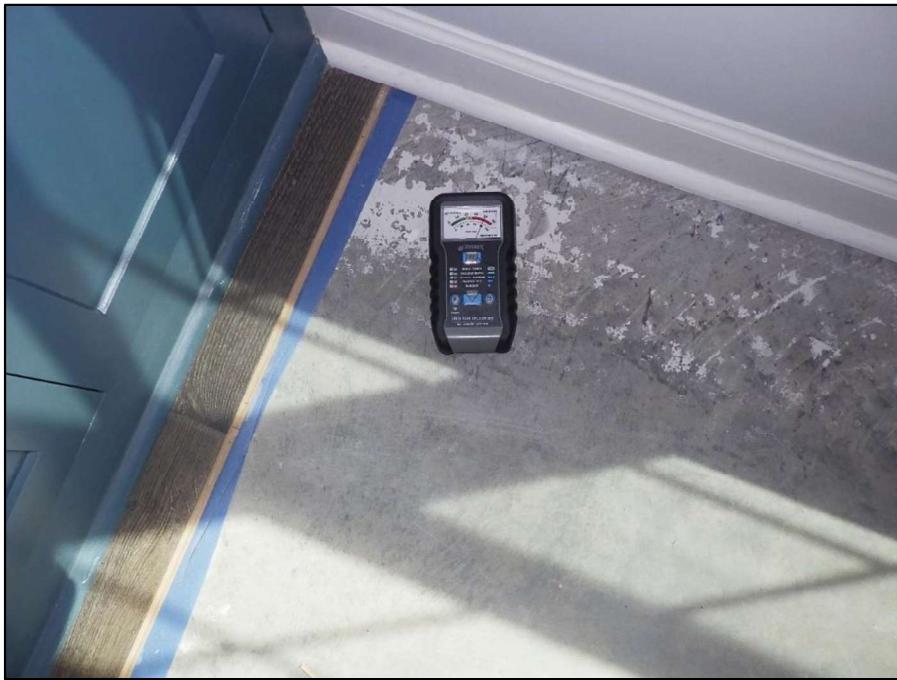
Photograph 7

The moisture content levels were elevated in the exposed portions of the main slab. The readings were above the NWFA maximum allowed for the installation of engineered wood flooring.

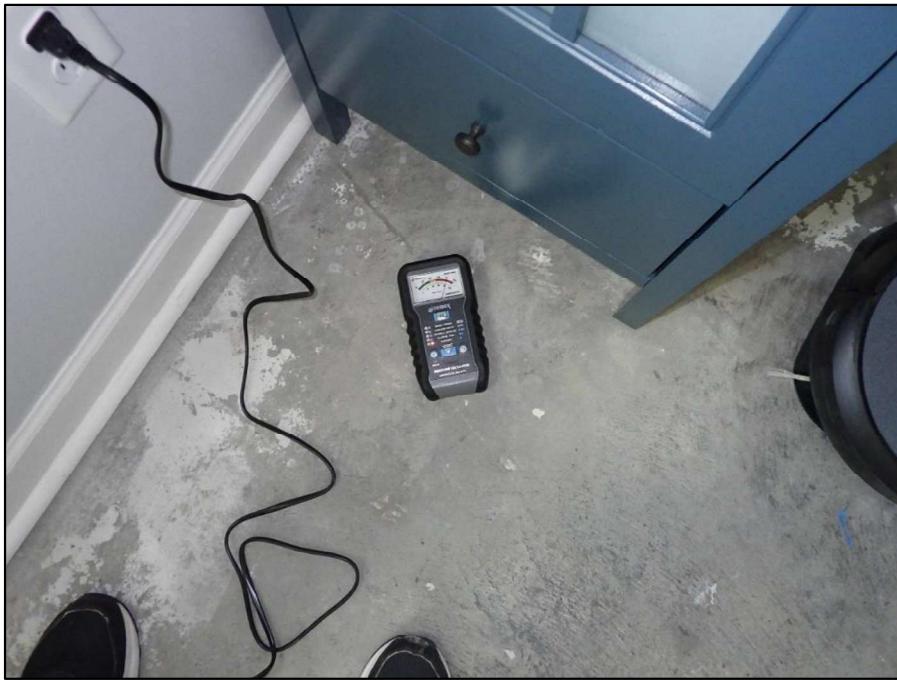
Photograph 8

Example of elevated moisture content reading in dining room. The readings were above the NWFA maximum allowed for the installation of engineered wood flooring.

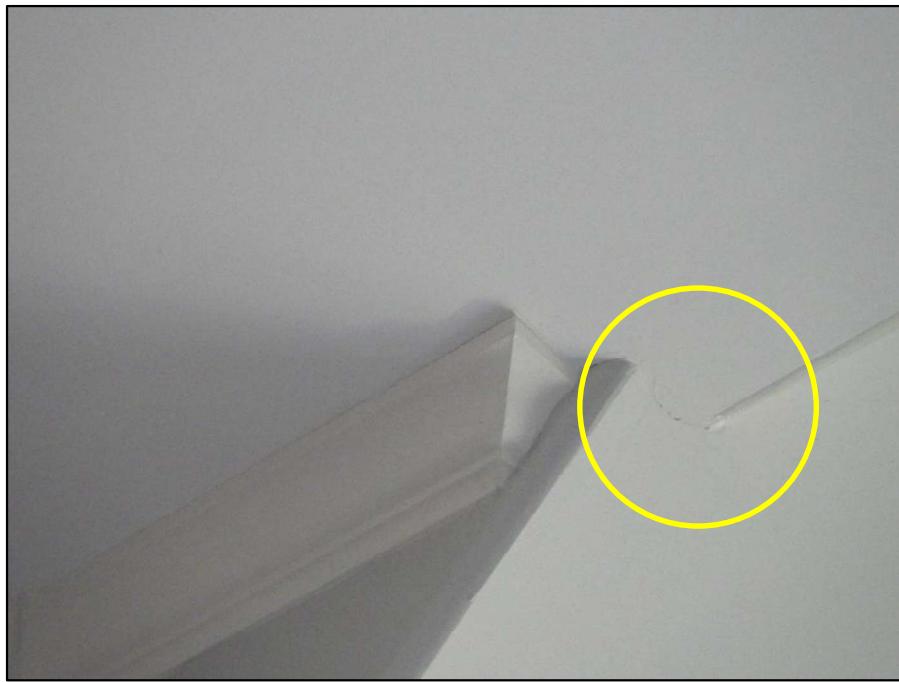
Photograph 9

There were isolated hairline-width cracks in the gypsum board ceiling in the great room and northeast bedroom on the ground floor.

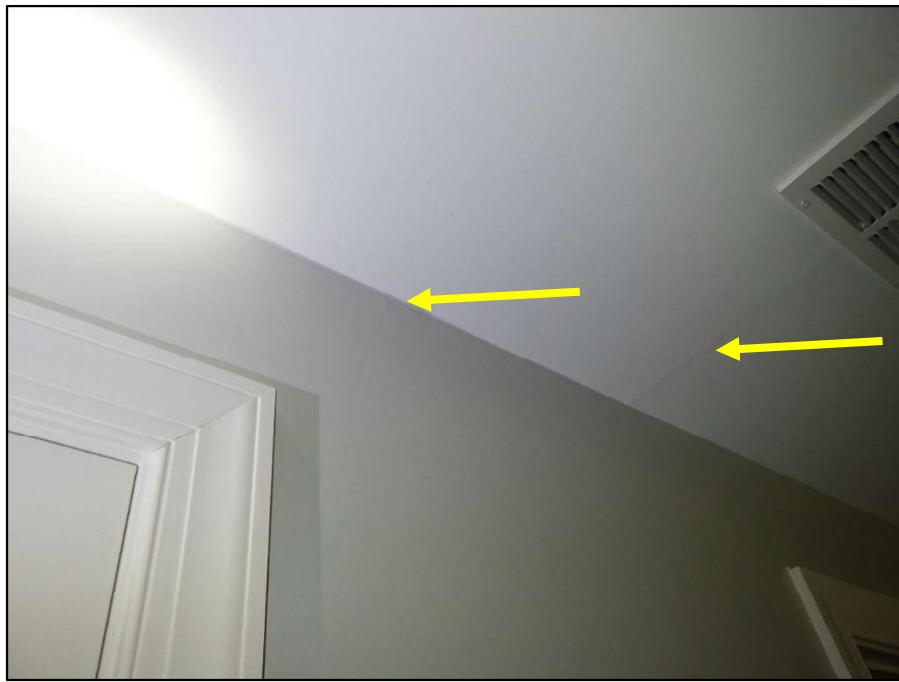
Photograph 10

Example of hairline-width crack and nail pop in gypsum board ceiling and wall in northeast bedroom on the ground floor.

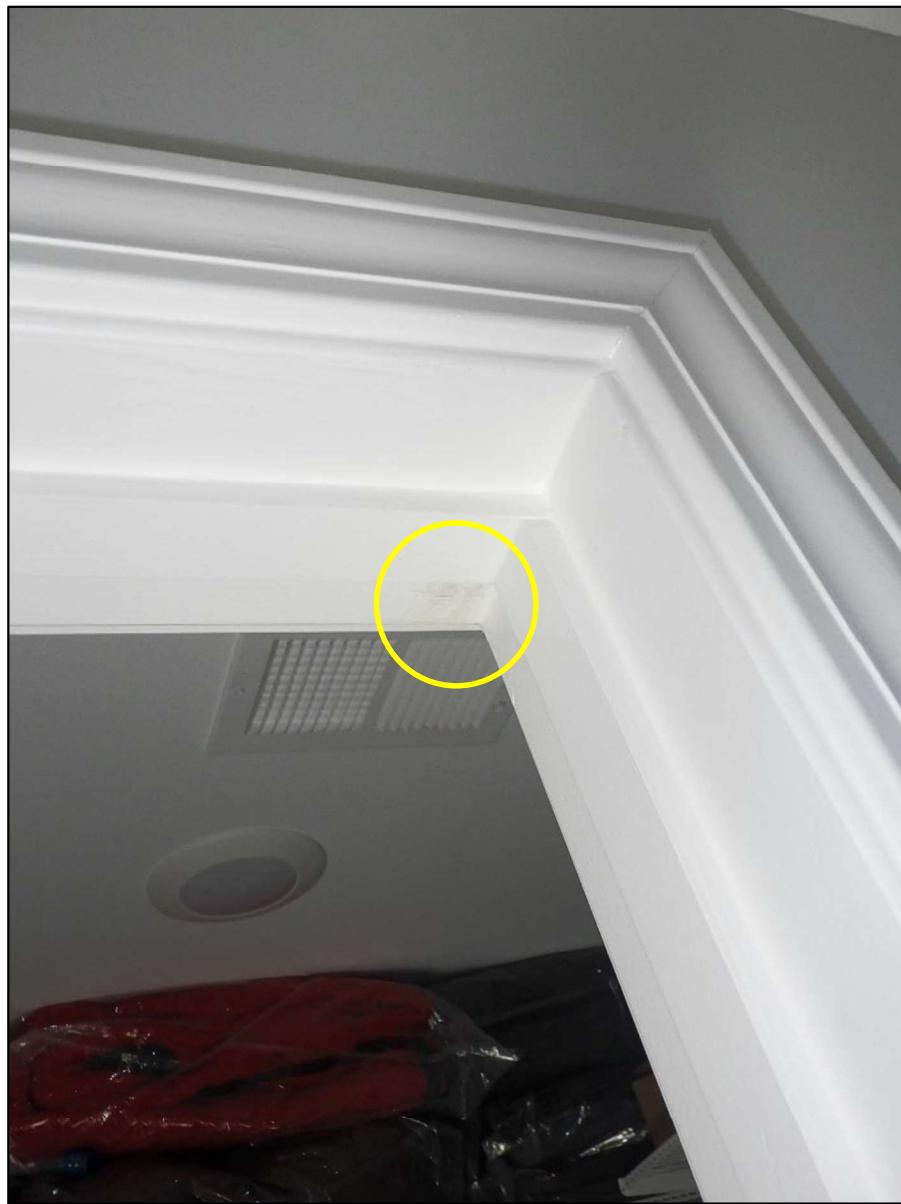
Photograph 11

A closet door on the second floor was difficult to open and close. The door and door frame were making contact in the upper right corner.

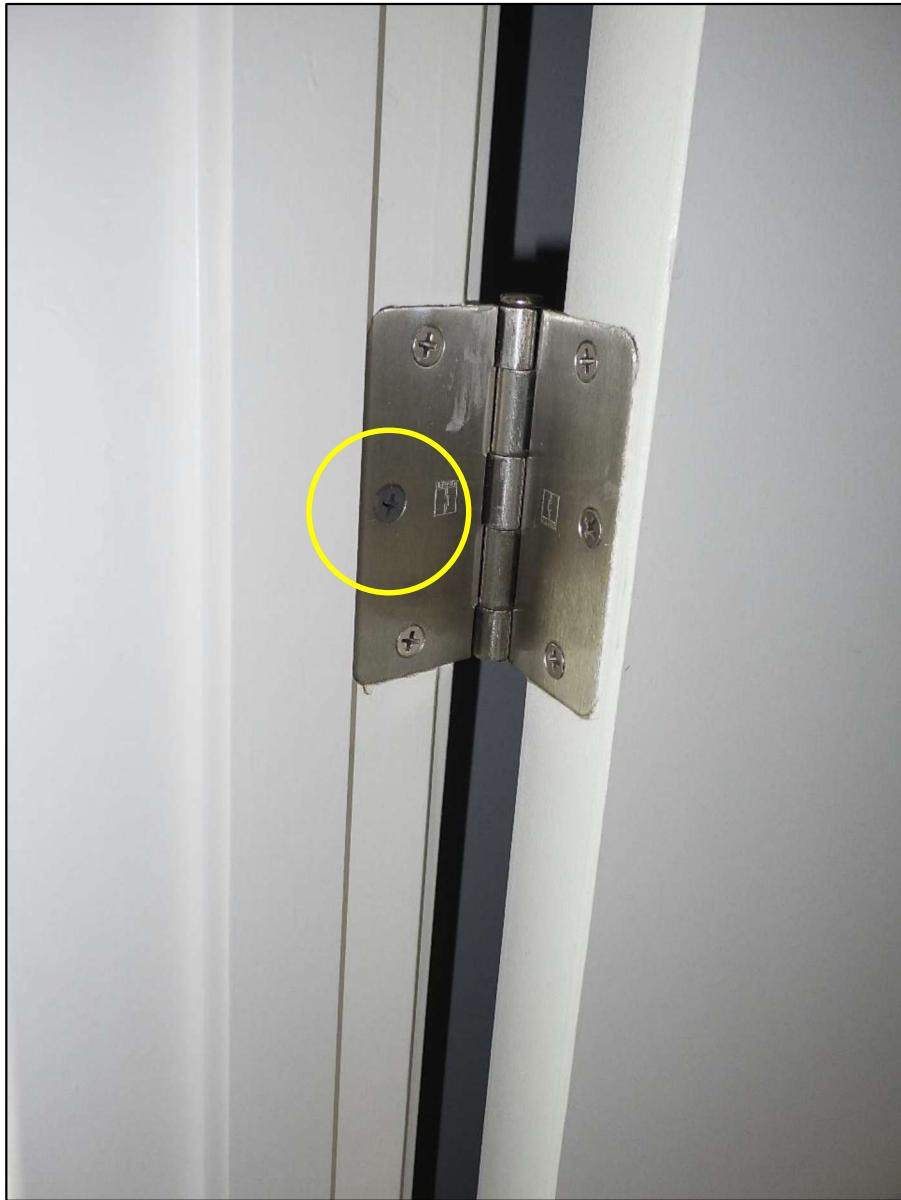
Photograph 12

The closet door from **Photograph 11** had evidence of previous repairs to the hinges.

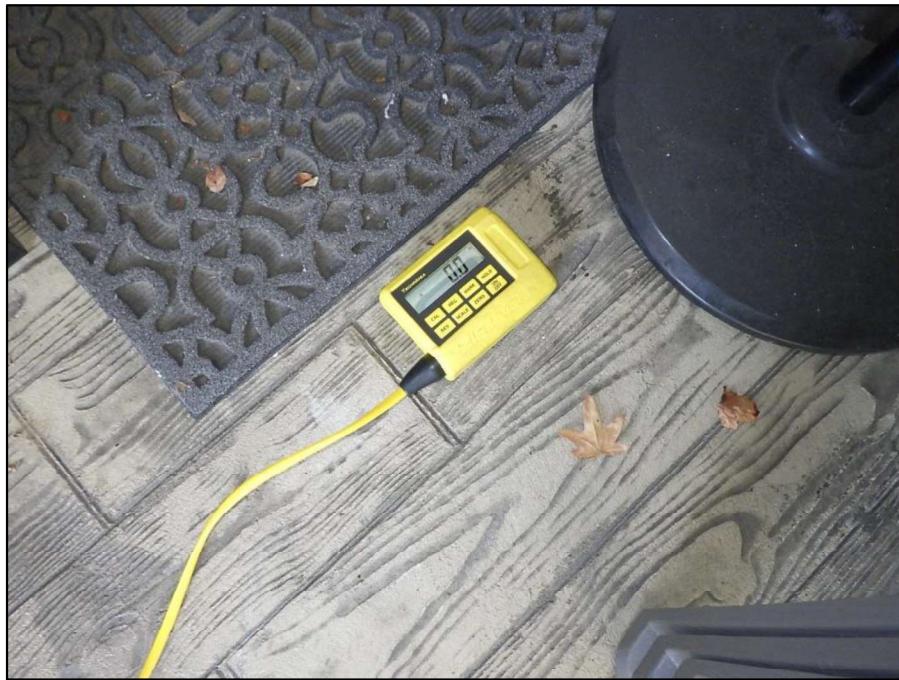
Photograph 13

The OLA patio deck was sloped to the southwest approximately 2 to 3 inches.

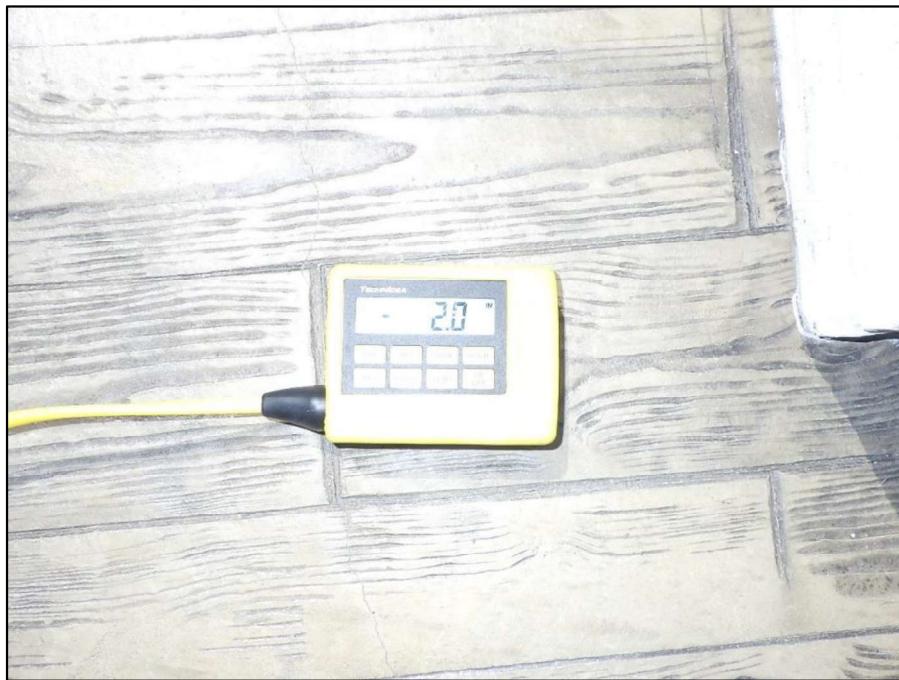
Photograph 14

The OLA patio deck was sloped to the southwest approximately 2 to 3 inches.

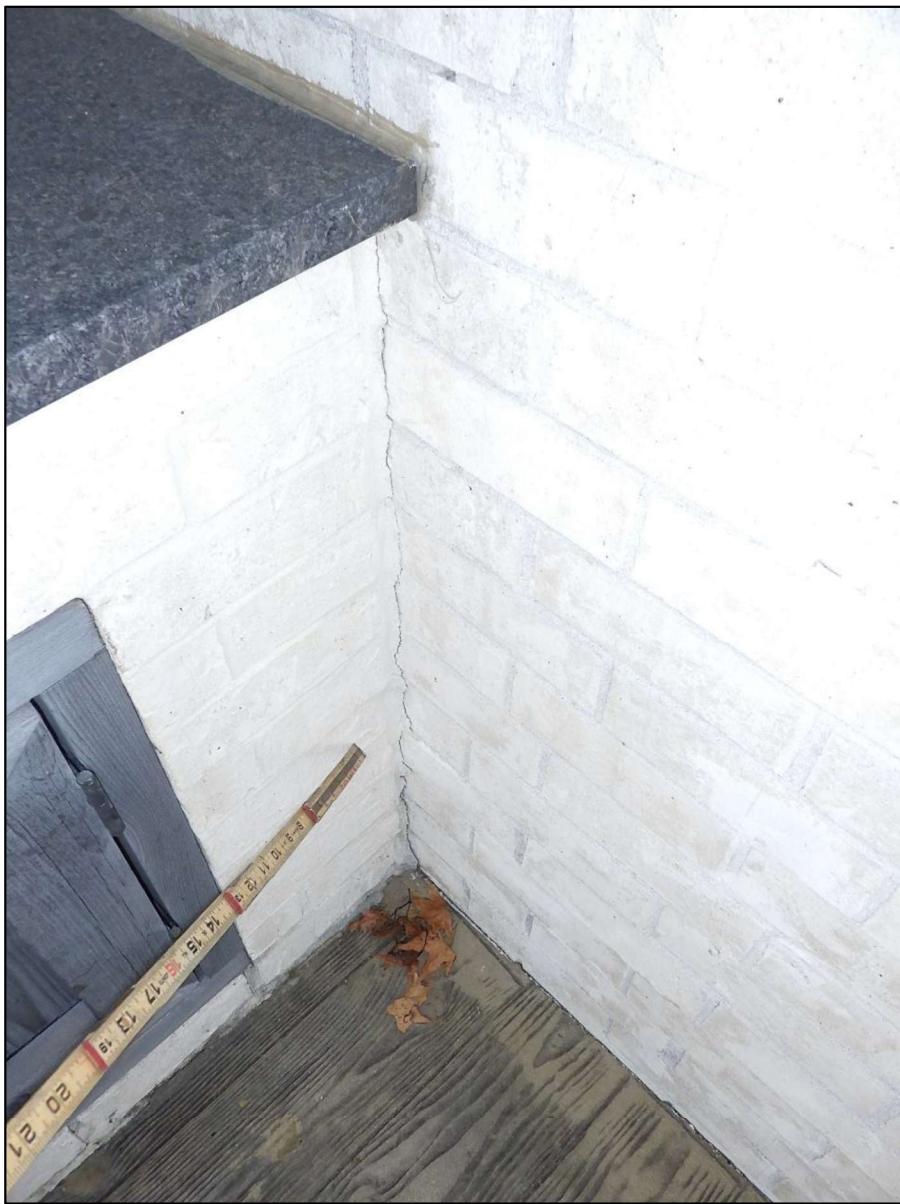
Photograph 15

There were cracks in the brick veneer wall where the OLA kitchen area joined the west wall of the porch.

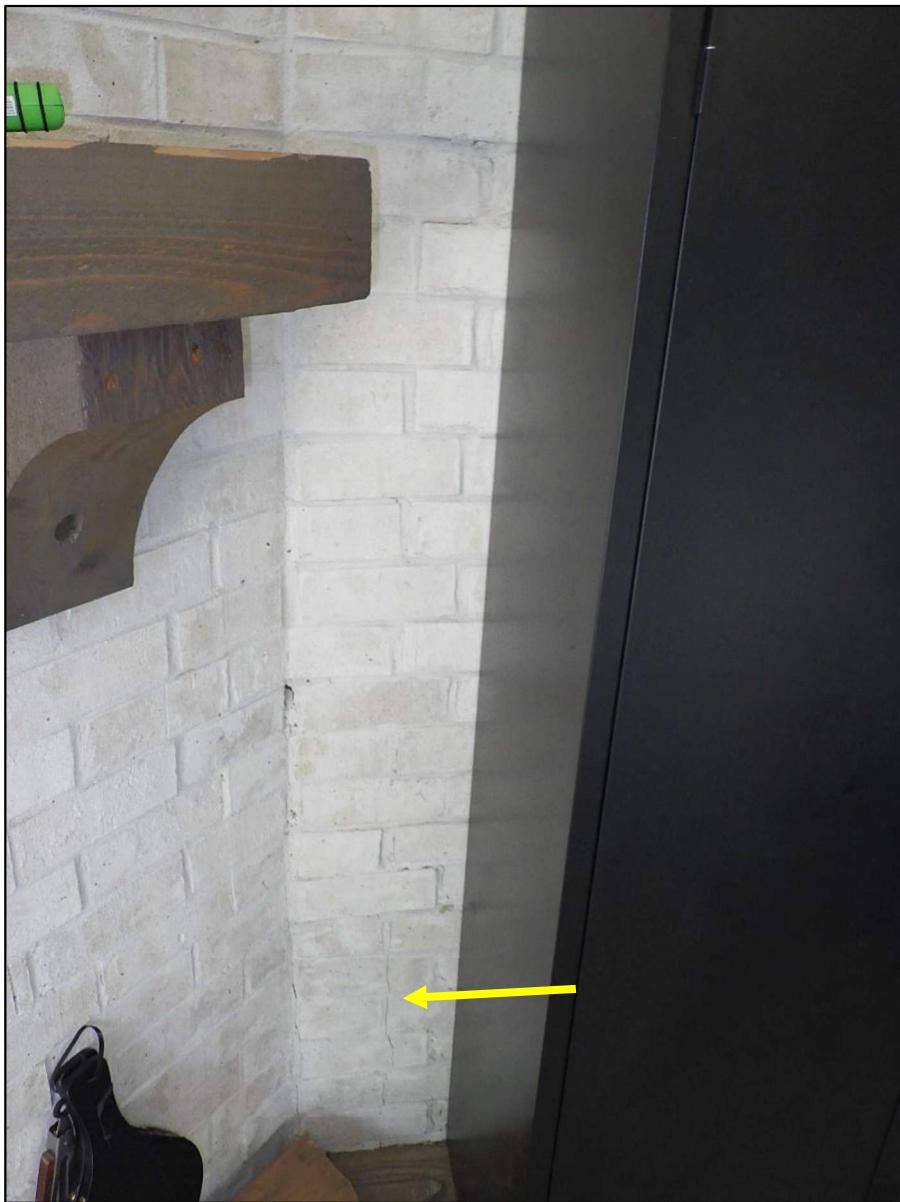
Photograph 16

The brick veneer wall on the OLA was cracked at the north side of the porch.

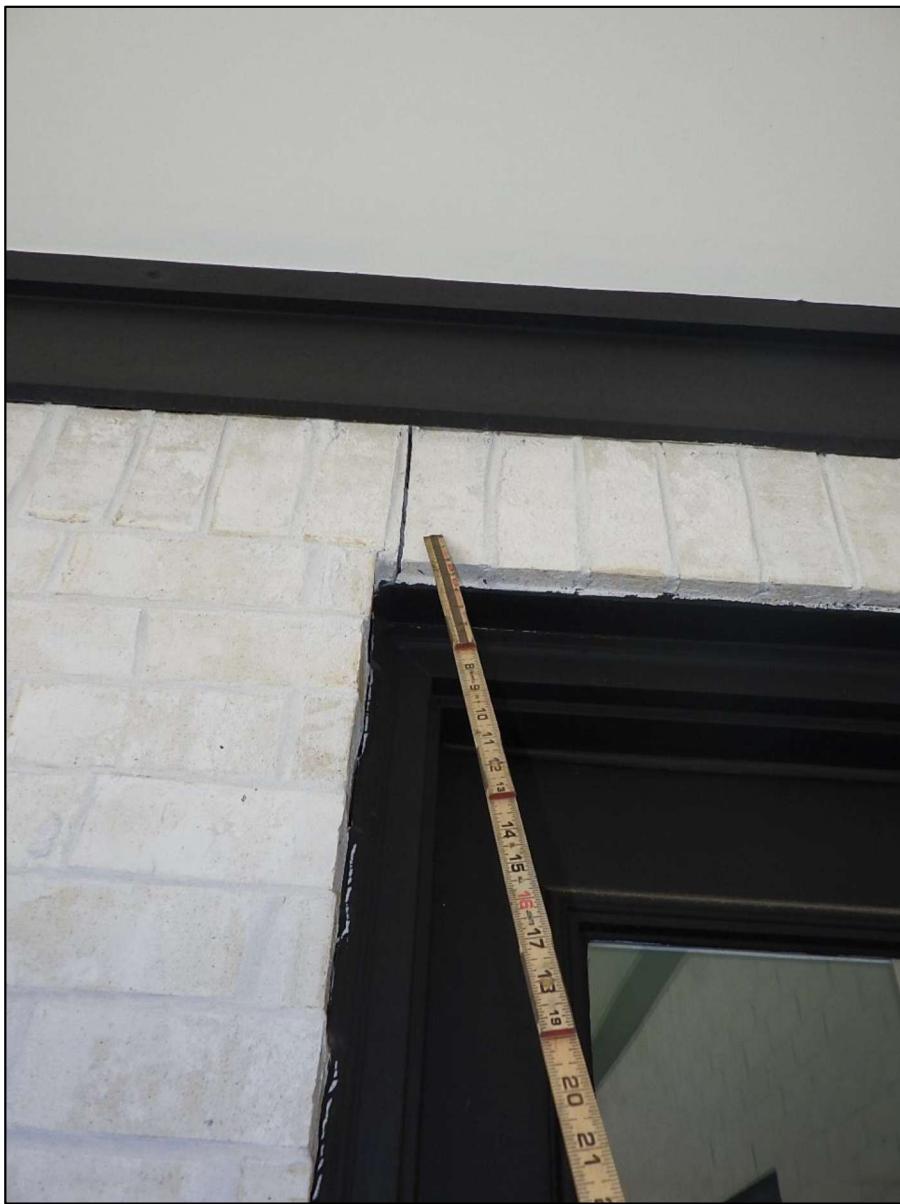
Photograph 17

There was a crack in the mortar of the soldier brick course above north door lintel of the OLA porch.

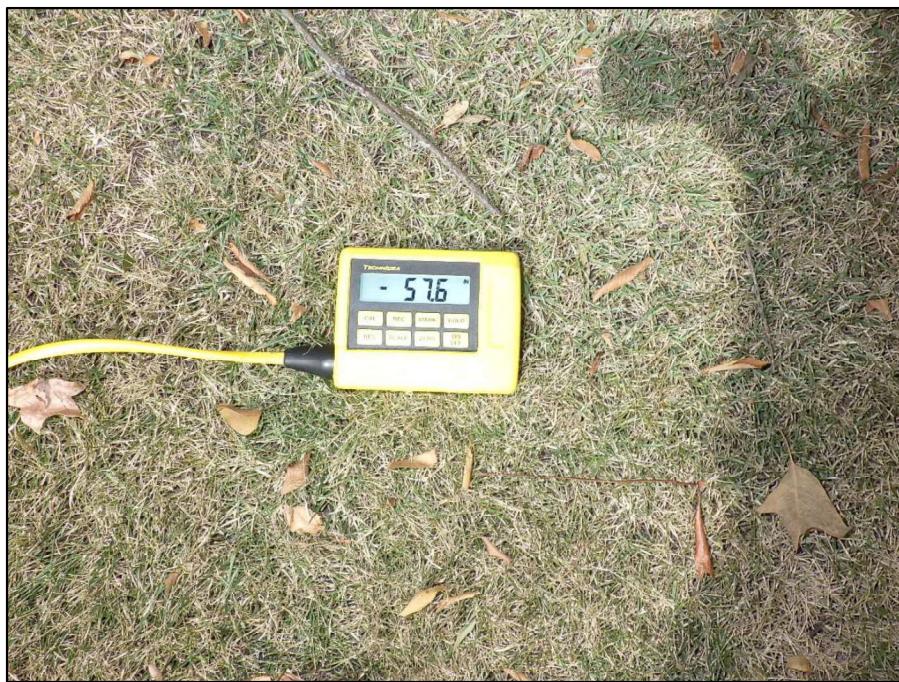
Photograph 19

A relative elevation survey of the back yard showed the undisturbed (native) soil along the west fence line to be 3 to 5 feet below the finished floor elevation.

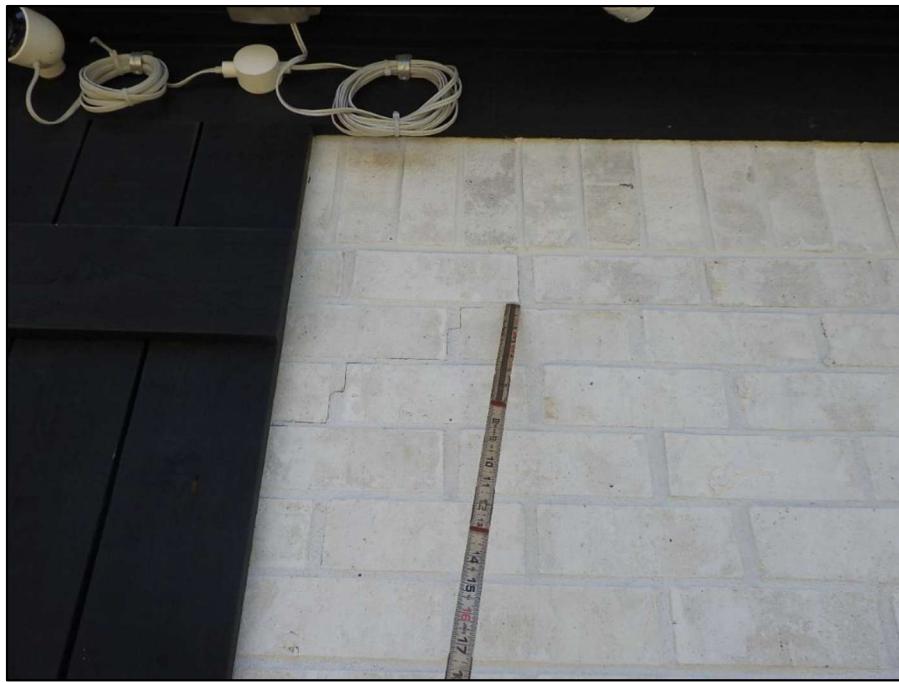
Photograph 20

There were isolated stair-step cracks in the mortar of the brick veneer on the north, east, and west sides of the residence.

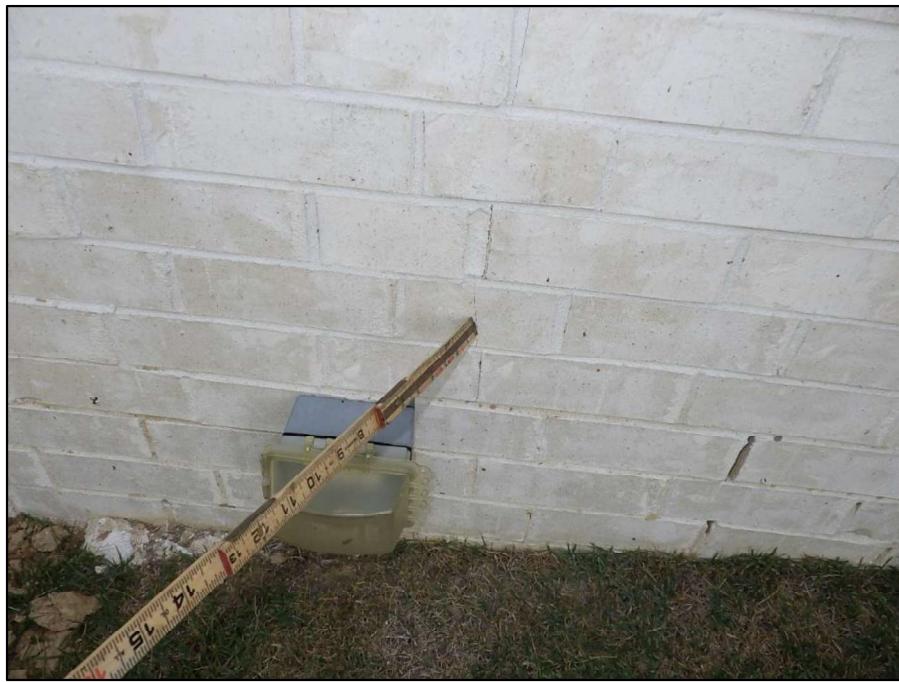
Photograph 21

There were isolated vertical cracks in the brick veneer on the north, east, and west sides of the residence.

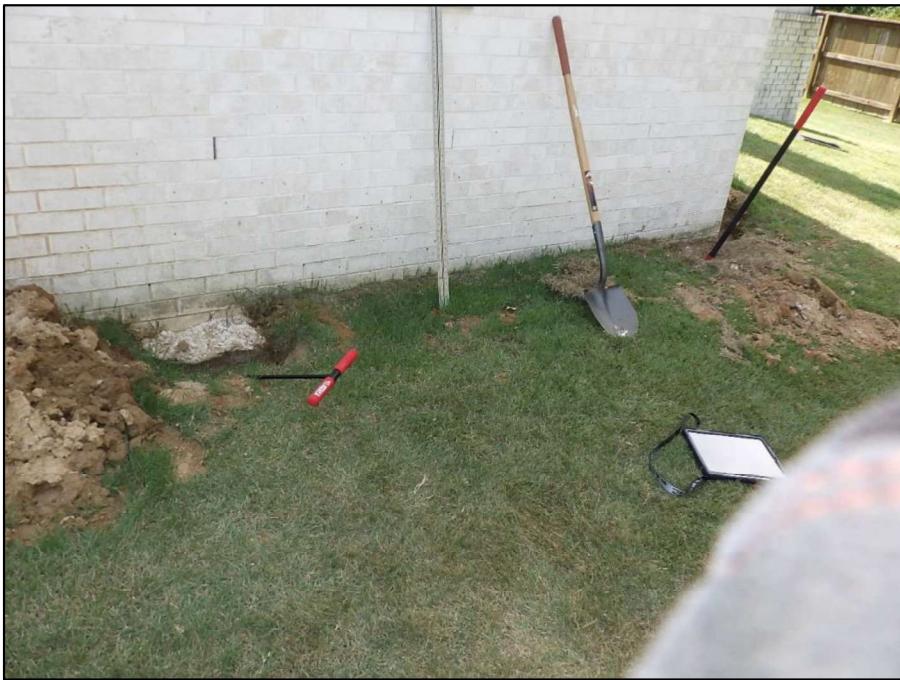
Photograph 22

There were three excavations at the footings around the perimeter of the residence.

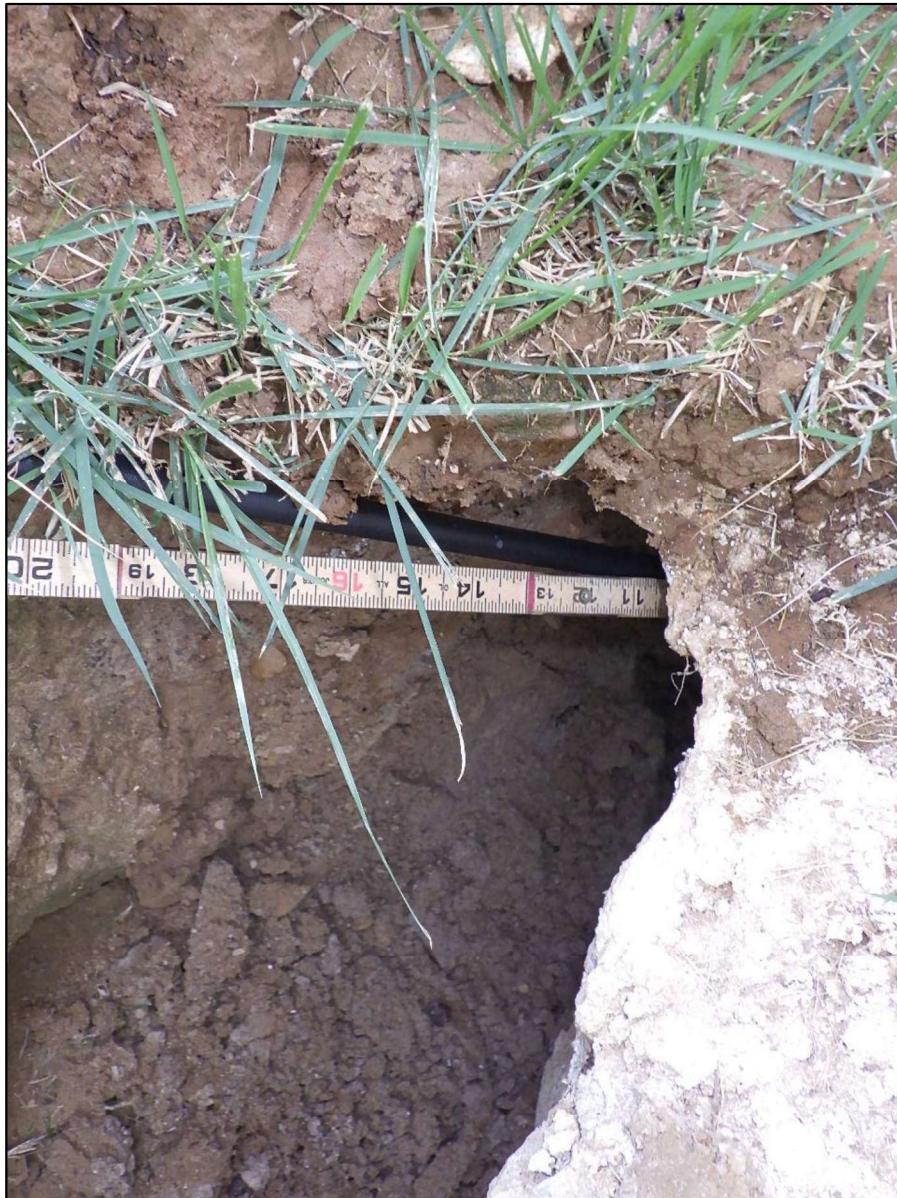
Photograph 23

Two of the three excavations had visible voids and/or honeycombing concrete.
