BHM11338

August 29, 2025

REFERENCE: Evaluation of Foundation and Supporting Soil – Pereira
Regency Homebuilders
Location of Incident: Lakeland, Tennessee
EDT Case Number: BHM11338

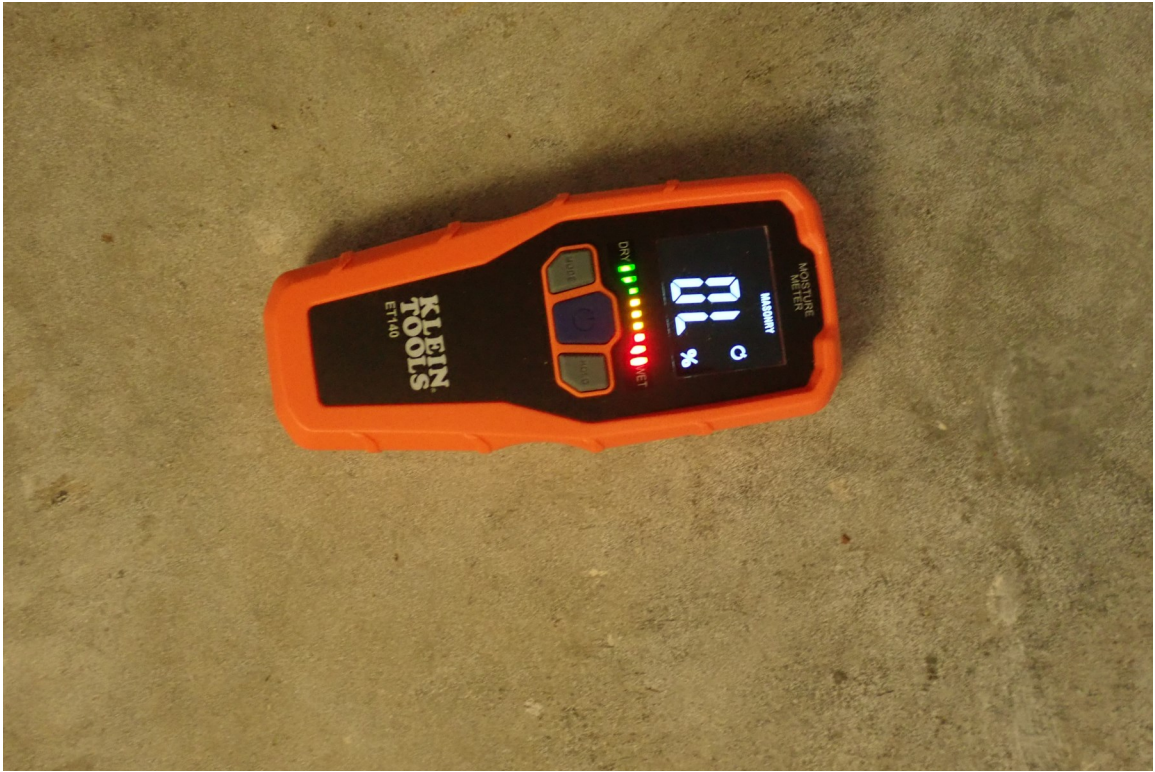
Interior slab moisture was tested and found high out of range in most locations. Only the location above a previous postconstruction excavation found moisture contents within the instrument's limits of 50% saturation. The source of moisture may be presumed, to a reasonable degree of engineering certainty, to originate from under the slab. Figures 1-4 show the instrument results.

Figure 1 Concrete moisture reading inside

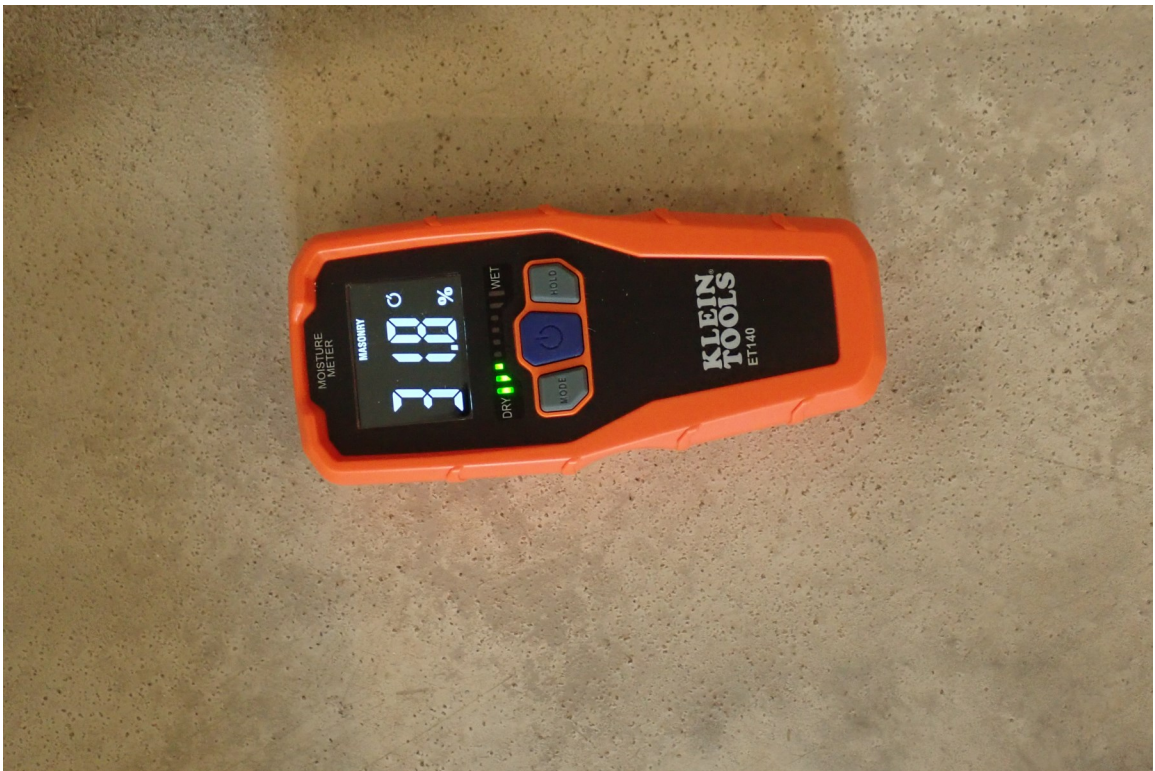
Figure 2 Concrete moisture reading at previous repair location

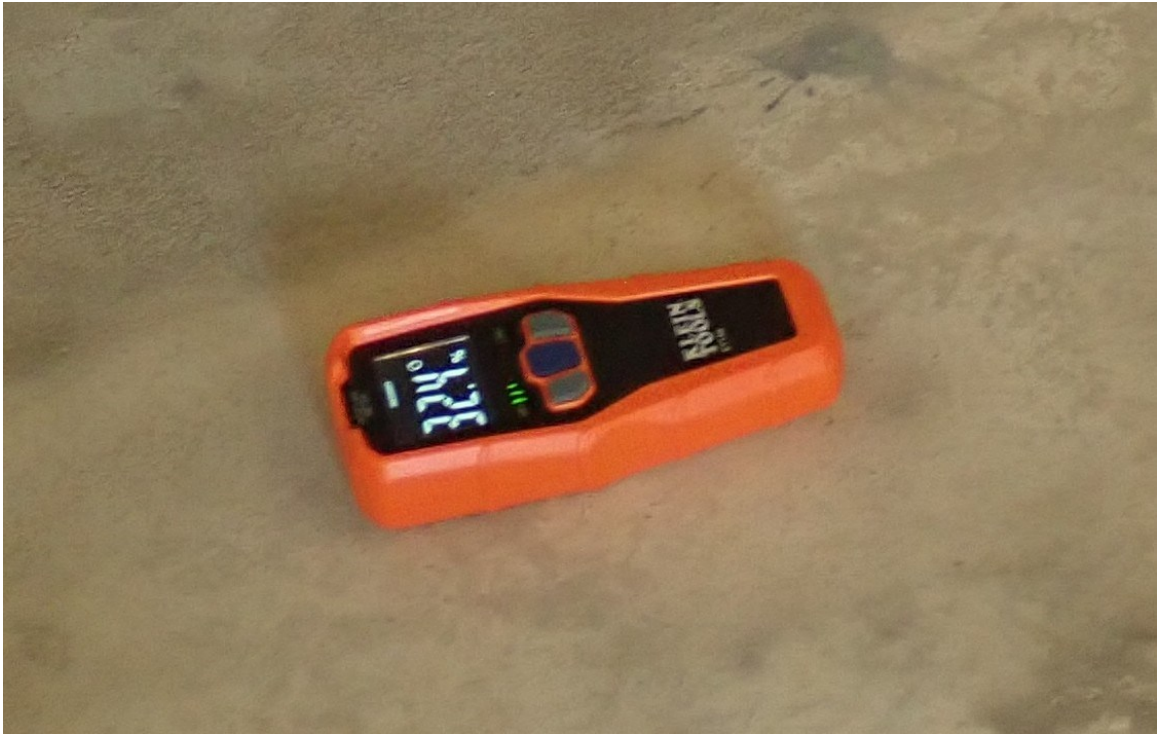
Figure 3 Concrete moisture reading at previous repair location

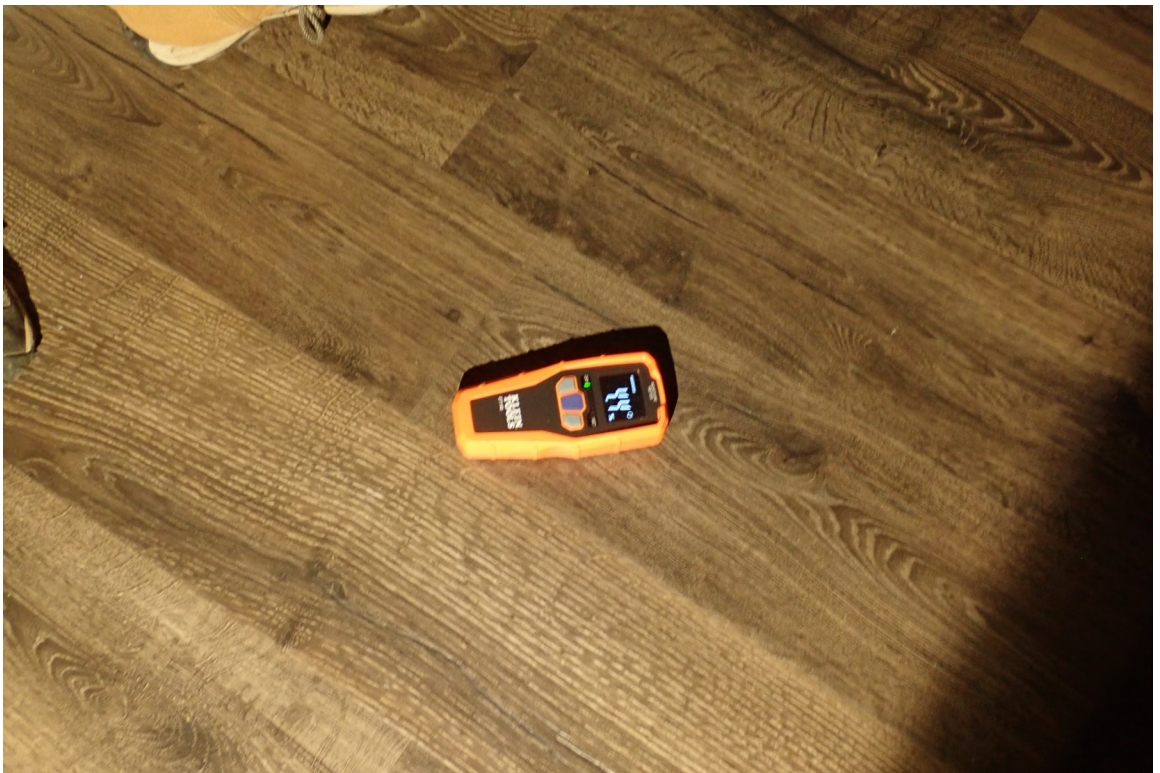
Figure 4 Concrete moisture reading at previous repair location
