Report of Findings

Pereira v. Regency Homebuilders, LLC Construction Evaluation
Cause No: 6016378

Rimkus Matter No: 100314106

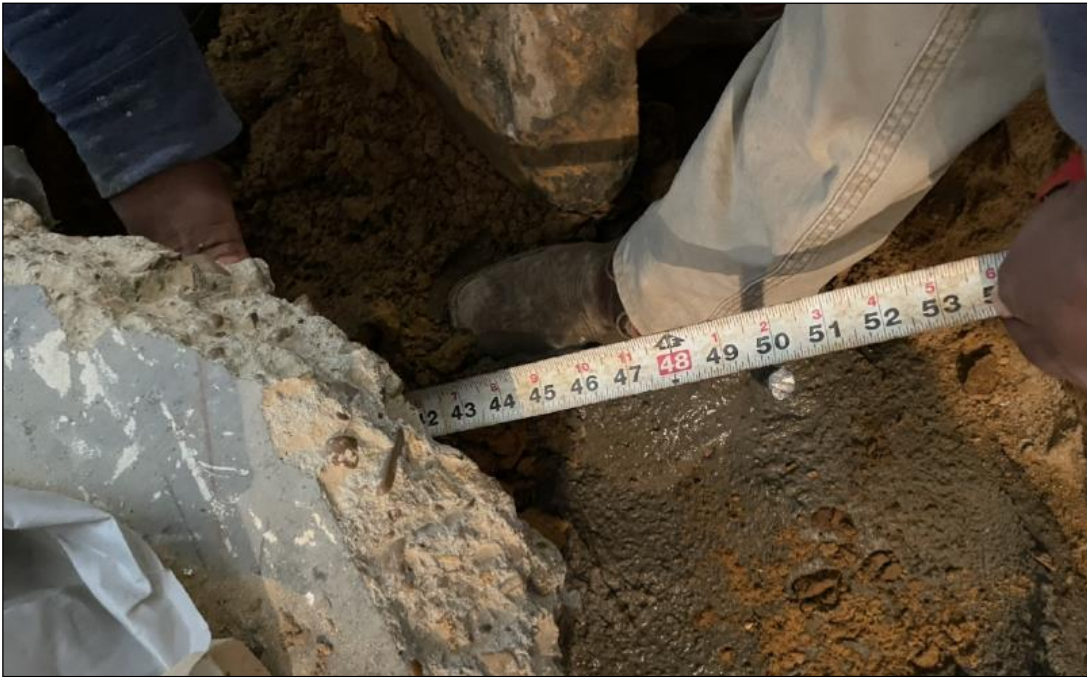
Figure 2 - Photograph taken by homeowner during plumbing repairs, which required demolition of main slab. Tape measure is inserted in area of required 30-inch by 30-inch footing.

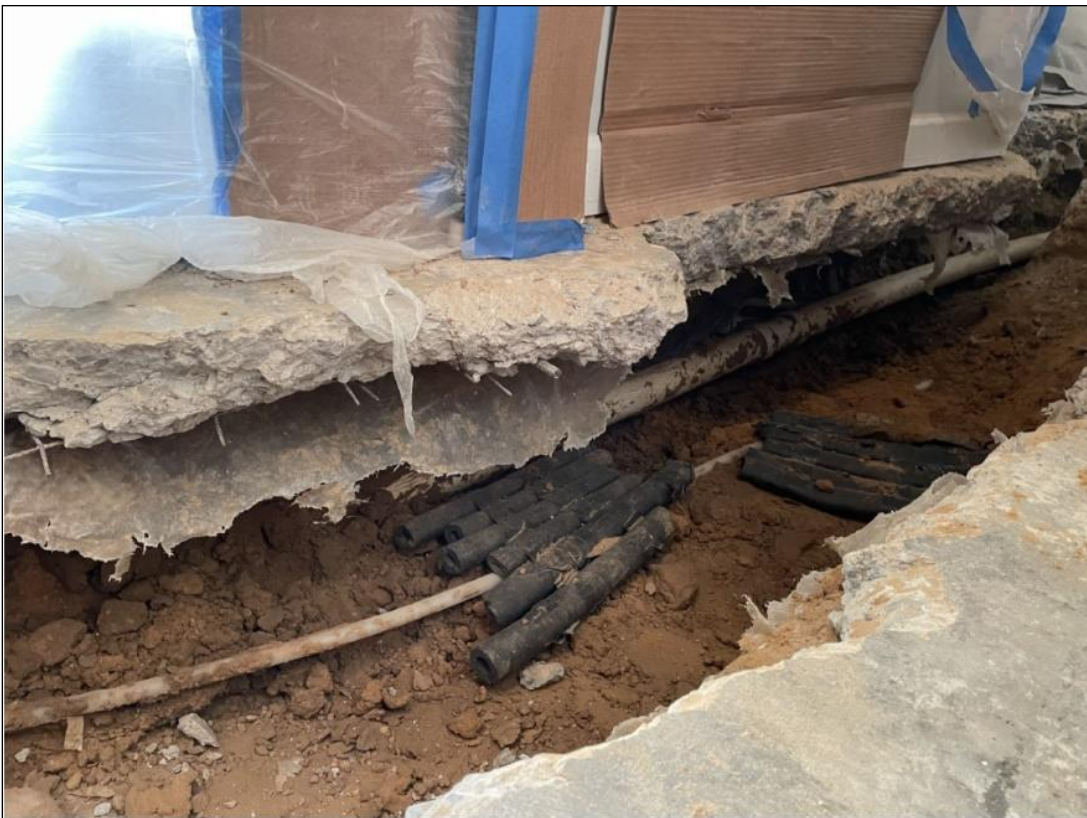
Figure 3—Photograph taken by homeowner during plumbing repairs, which required partial demolition of main slab. The Welded Wire Reinforcement (WWR) is observed to be lying directly on top of vapor retarder.

Note: Photos of the slab assembly during the plumbing repair show Welded Wire Reinforcement (WWR) located at the bottom of the slab, which would not comply with the requirements of R506.2.4.

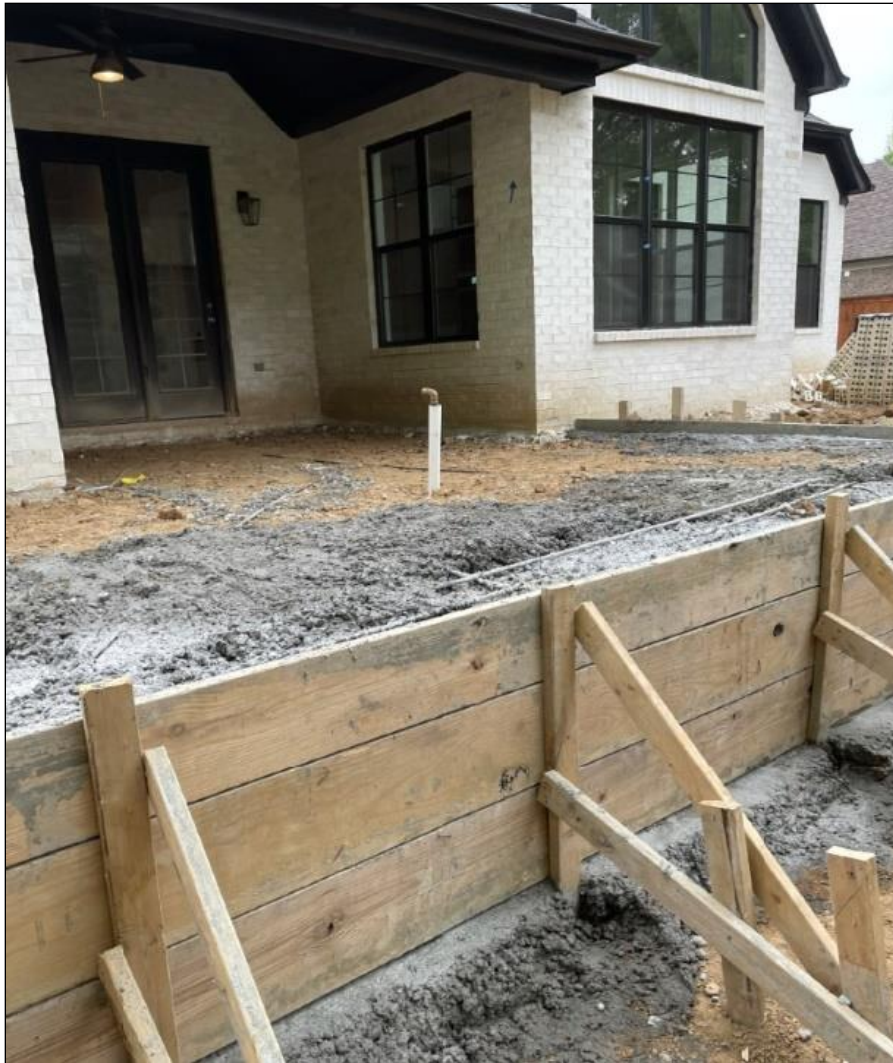
Figure 4—Photograph taken by homeowner during placement of OLA patio slab. Steel reinforcement is observed to be lying on the ground.

At the Pereira residence, photographs taken during the construction of the rear porch and patio show steel reinforcement lying on the ground without proper support in accordance with the IRC provisions outlined above. Additional photographs and videos showed control joints in the original concrete, but no control joints were placed in the slab when the patio was re-poured. Although the slab details were not fully indicated in the building plans, the 24-foot dimension of the slab would have required at least one, if not two, contraction joints to control the cracking of the concrete during the hydration process to comply with ACI 332-14. A review of NAHB construction performance standards indicates that cracks in finished/exposed slabs should be limited to 0.1875 inches. The measured cracks of up to 0.2 inches did not comply with the expected NAHB performance criteria. This analysis, our observations, and review of the provided documents, photographs, and videos led to our conclusion that the cracks in the Outdoor Living Area (OLA) concrete were the result of improper placement of reinforcing steel during the placement of the slab and/or the lack of contraction joints in the slab. The differential vertical movements of slab sections were further exacerbated by the inadequate compaction and subsequent consolidation of placed fill.

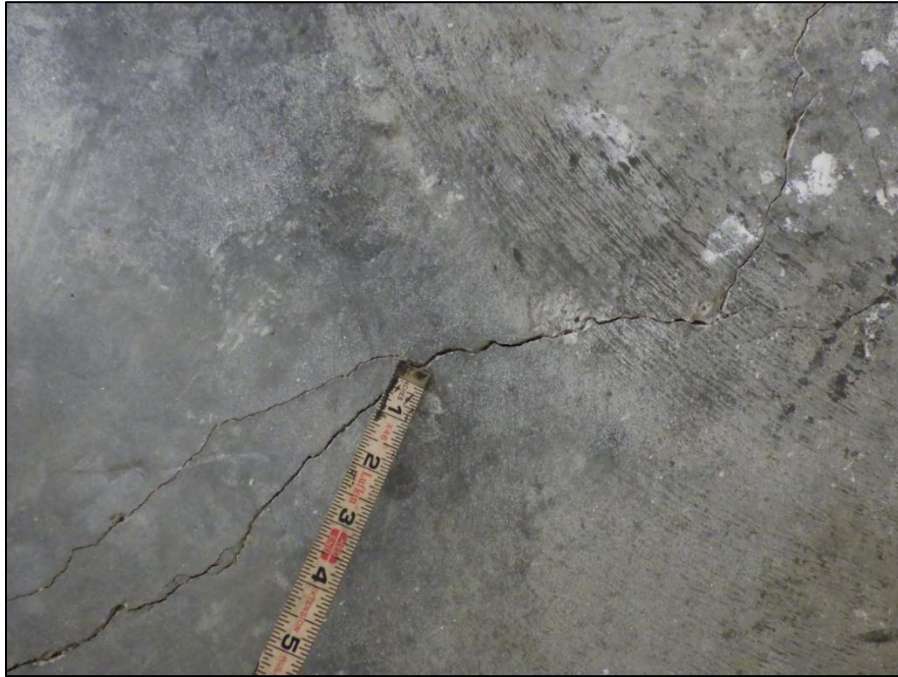
Photograph 5

- The concrete slab in the great room was exposed due to a previous plumbing repair and elevated moisture content, preventing the installation of flooring. The slab had cracks up to 1/8 inch in width (**Photographs 5 and 6**). The moisture content of the main slab was elevated (**Photographs 7 and 8**).

The main slab in the great room of the residence was exposed due to previous plumbing repairs. The slab had cracks up to 1/8 inch in width.

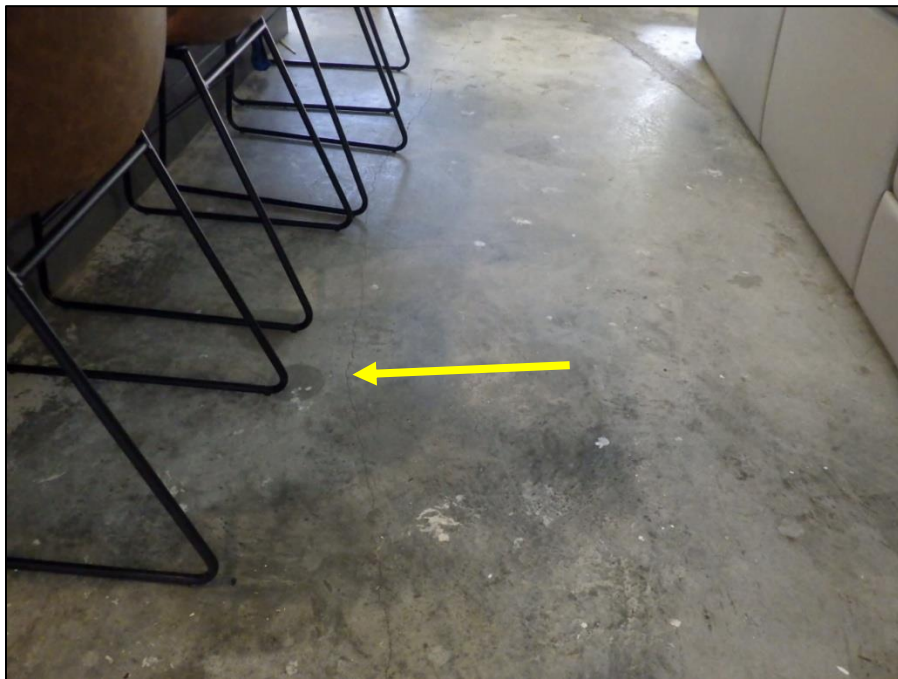
Photograph 6

The cracks in the main slab extended to the edges of the slab on the east and west sides of the interior.

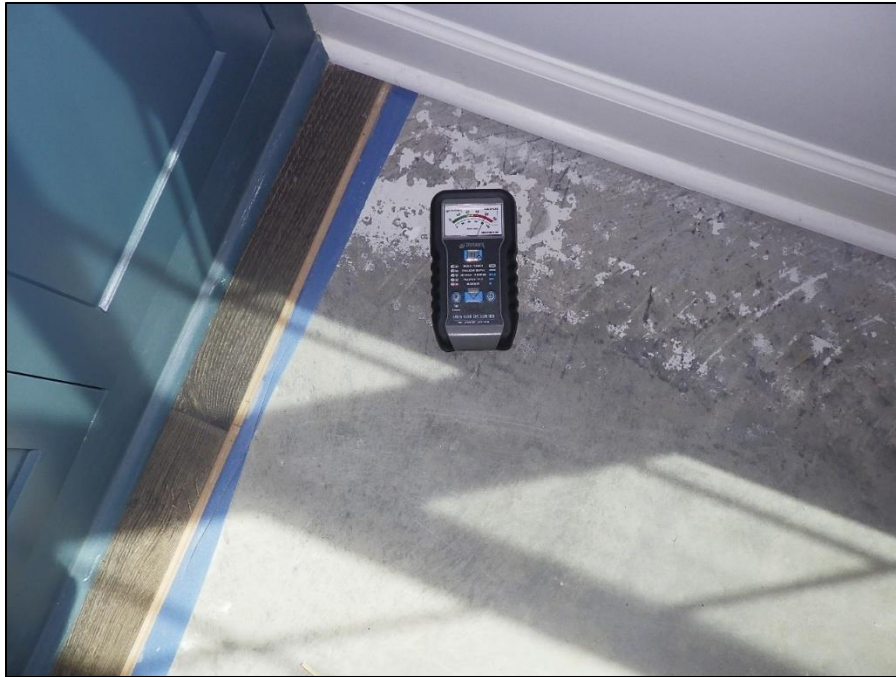
Photograph 7

The moisture content levels were elevated in the exposed portions of the main slab. The readings were above the NWFA maximum allowed for the installation of engineered wood flooring.

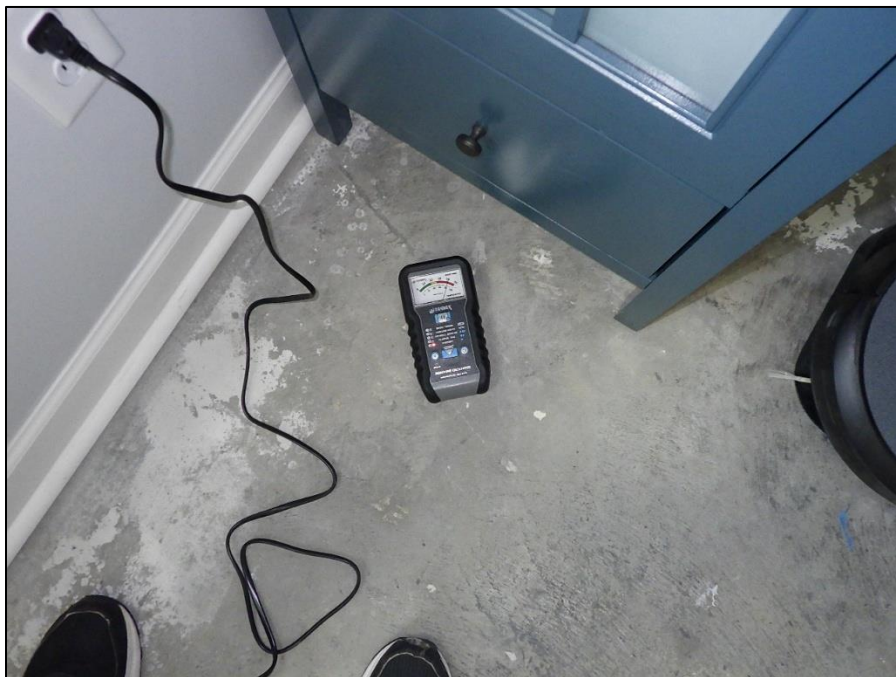
Photograph 8

Example of elevated moisture content reading in dining room. The readings were above the NWFA maximum allowed for the installation of engineered wood flooring.

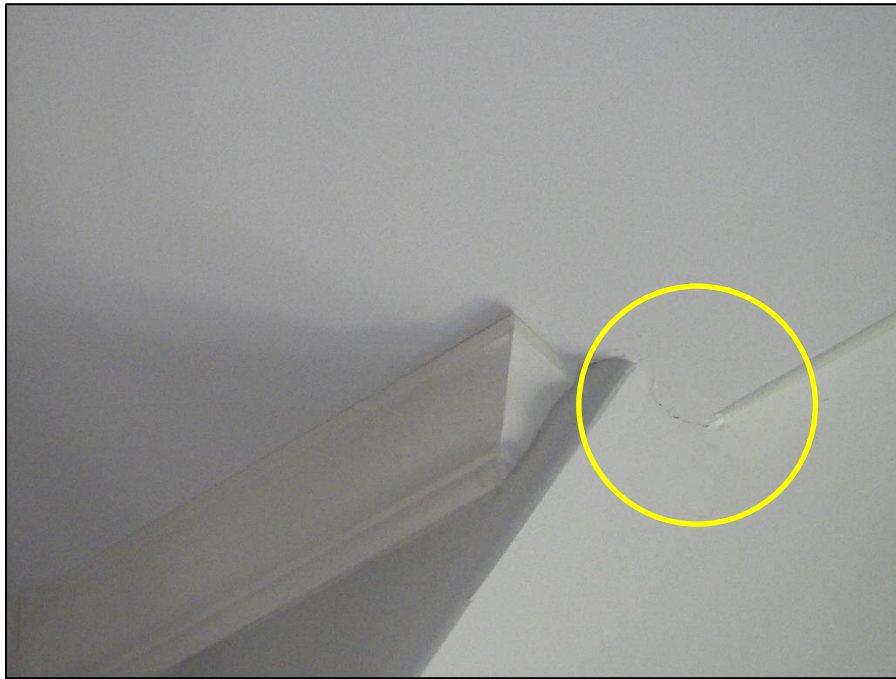
Photograph 9

There were isolated hairline-width cracks in the gypsum board ceiling in the great room and northeast bedroom on the ground floor.

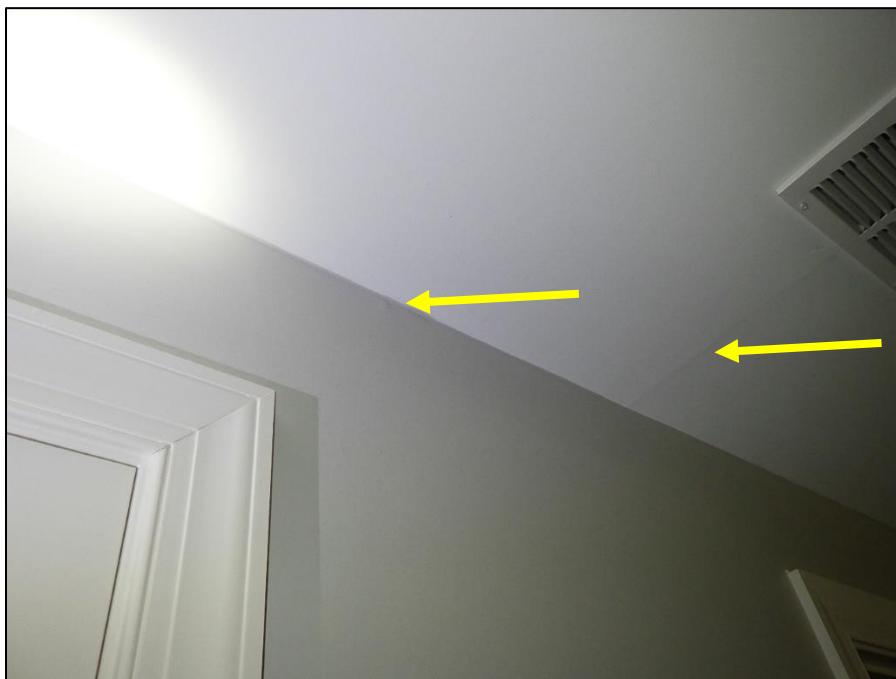
Photograph 10

Example of hairline-width crack and nail pop in gypsum board ceiling and wall in northeast bedroom on the ground floor.

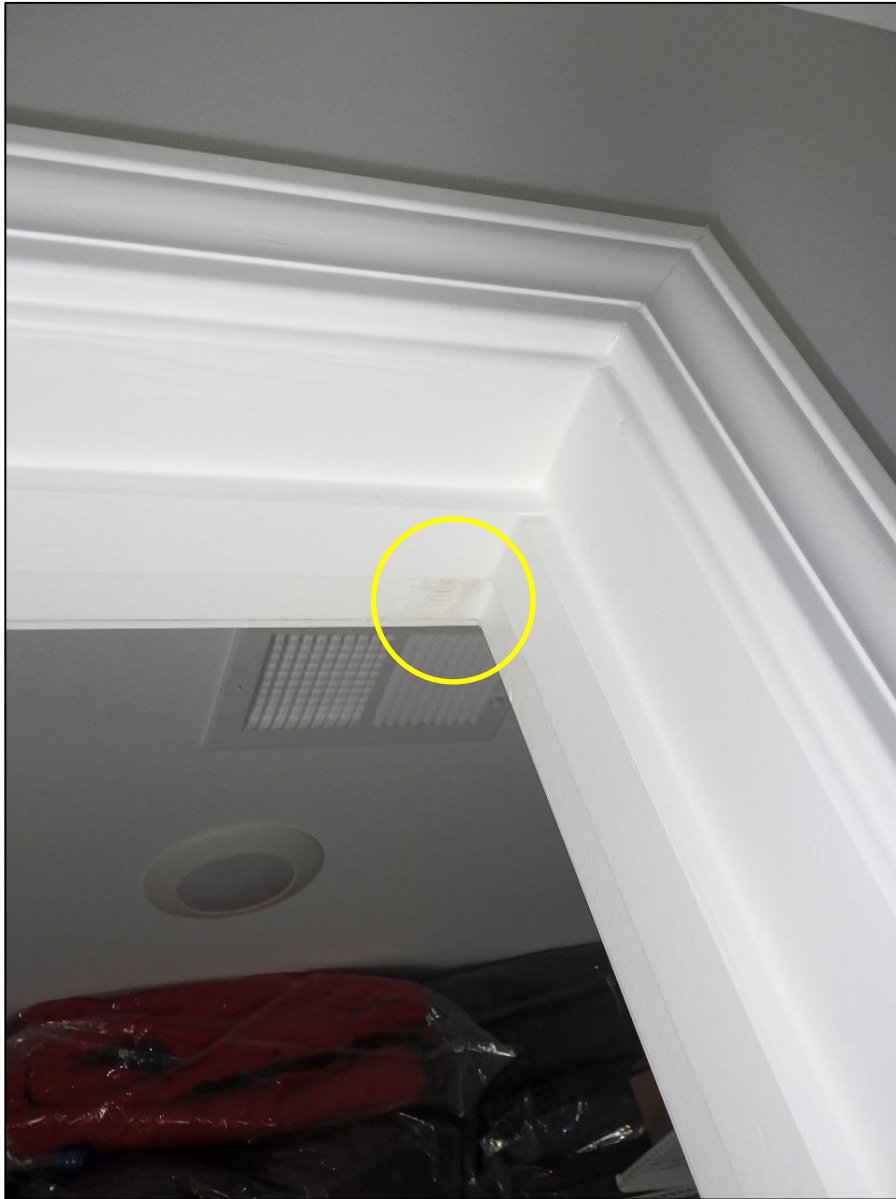
Photograph 11

A closet door on the second floor was difficult to open and close. The door and door frame were making contact in the upper right corner.

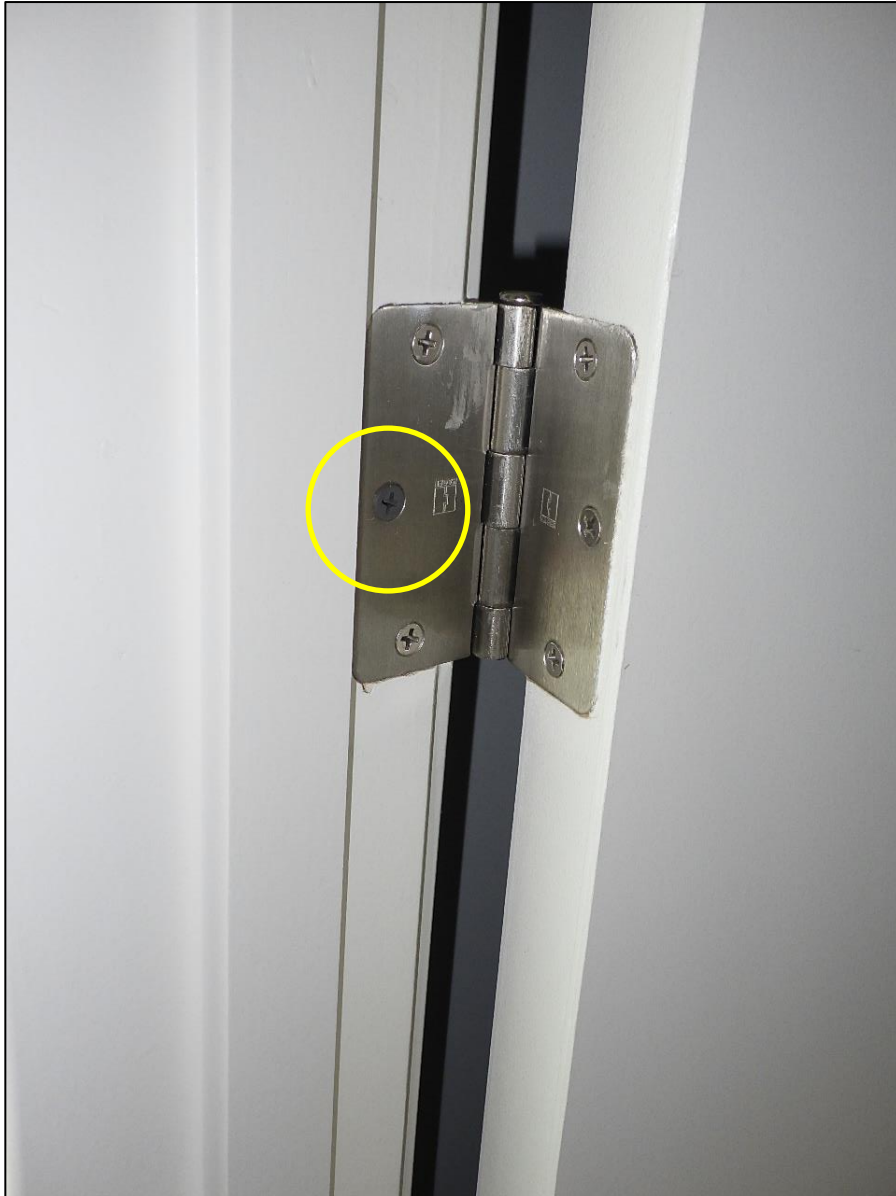
Photograph 12

The closet door from **Photograph 11** had evidence of previous repairs to the hinges.

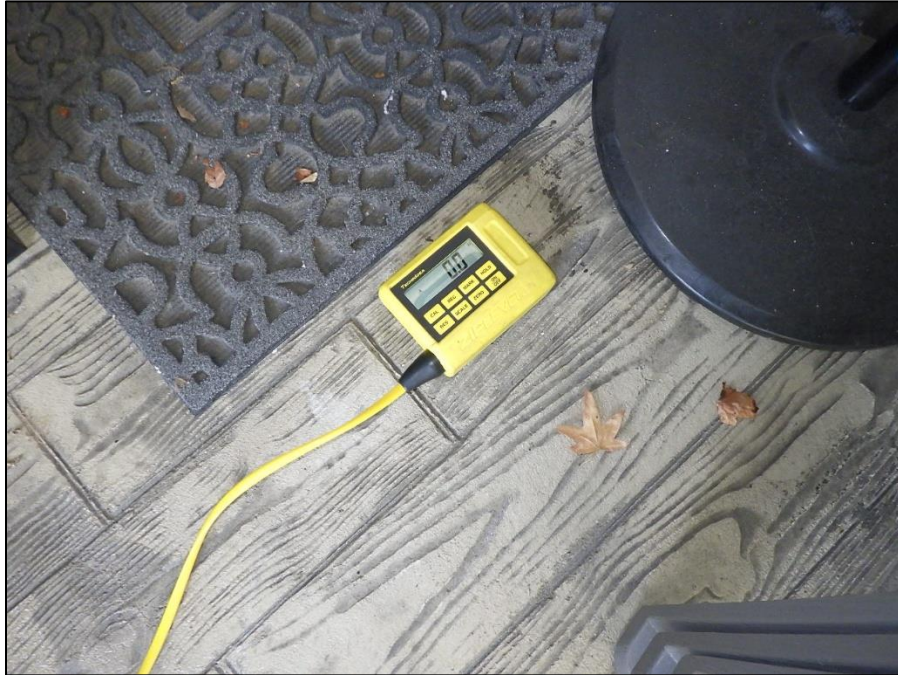
Photograph 13

- A relative elevation of the Outside Living Area (OLA) concrete deck was conducted during our inspection. The southwest corner of the patio was approximately 2 inches lower than the northwest corner (**Photographs 13 and 14**). There were cracks in the mortar and cracked bricks in the veneer of the porch and patio outdoor kitchen. (**Photographs 15 through 17**).

The OLA patio deck was sloped to the southwest approximately 2 to 3 inches.

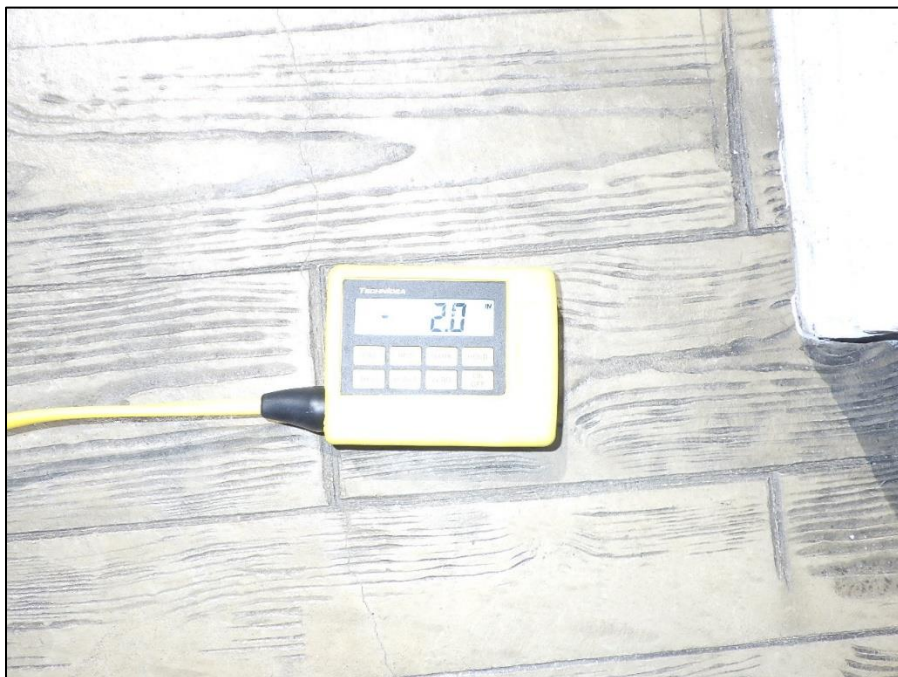
Photograph 14

The OLA patio deck was sloped to the southwest approximately 2 to 3 inches.

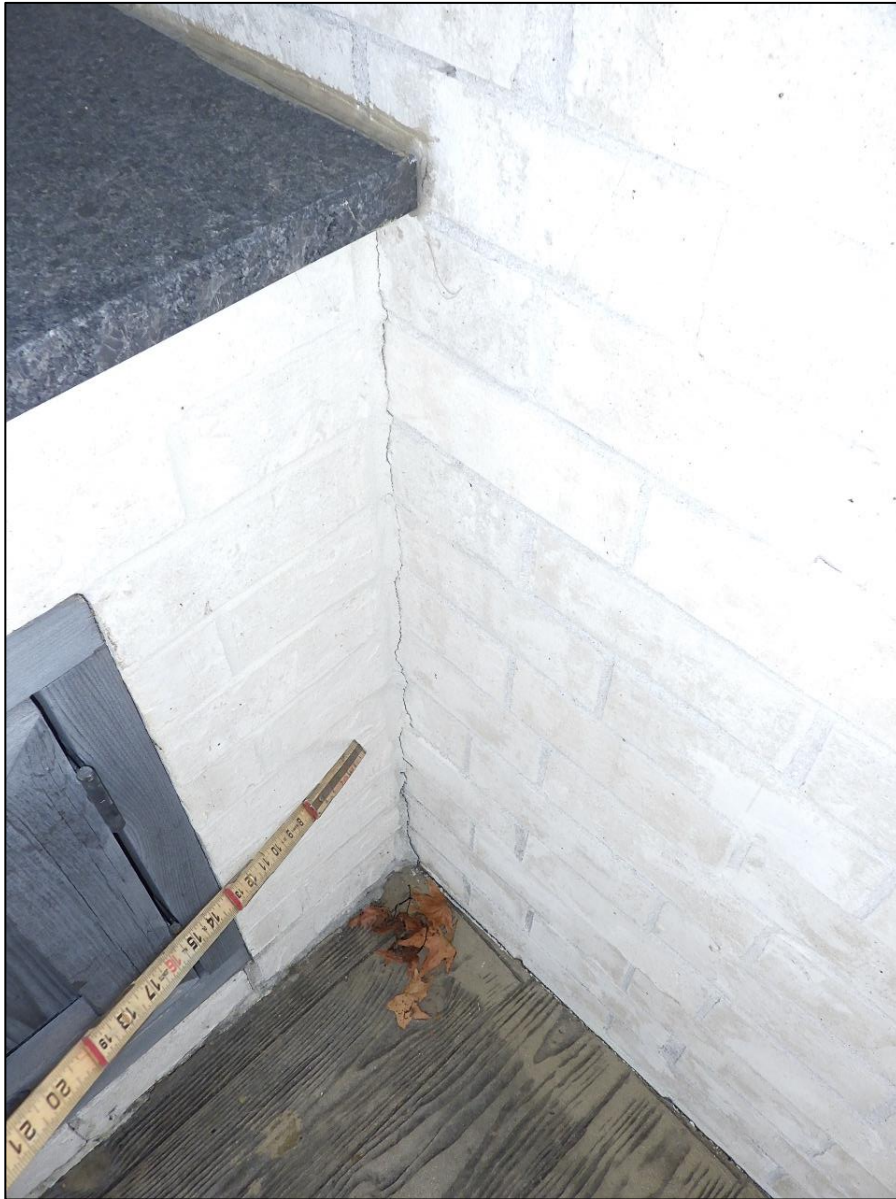
Photograph 15

There were cracks in the brick veneer wall where the OLA kitchen area joined the west wall of the porch.

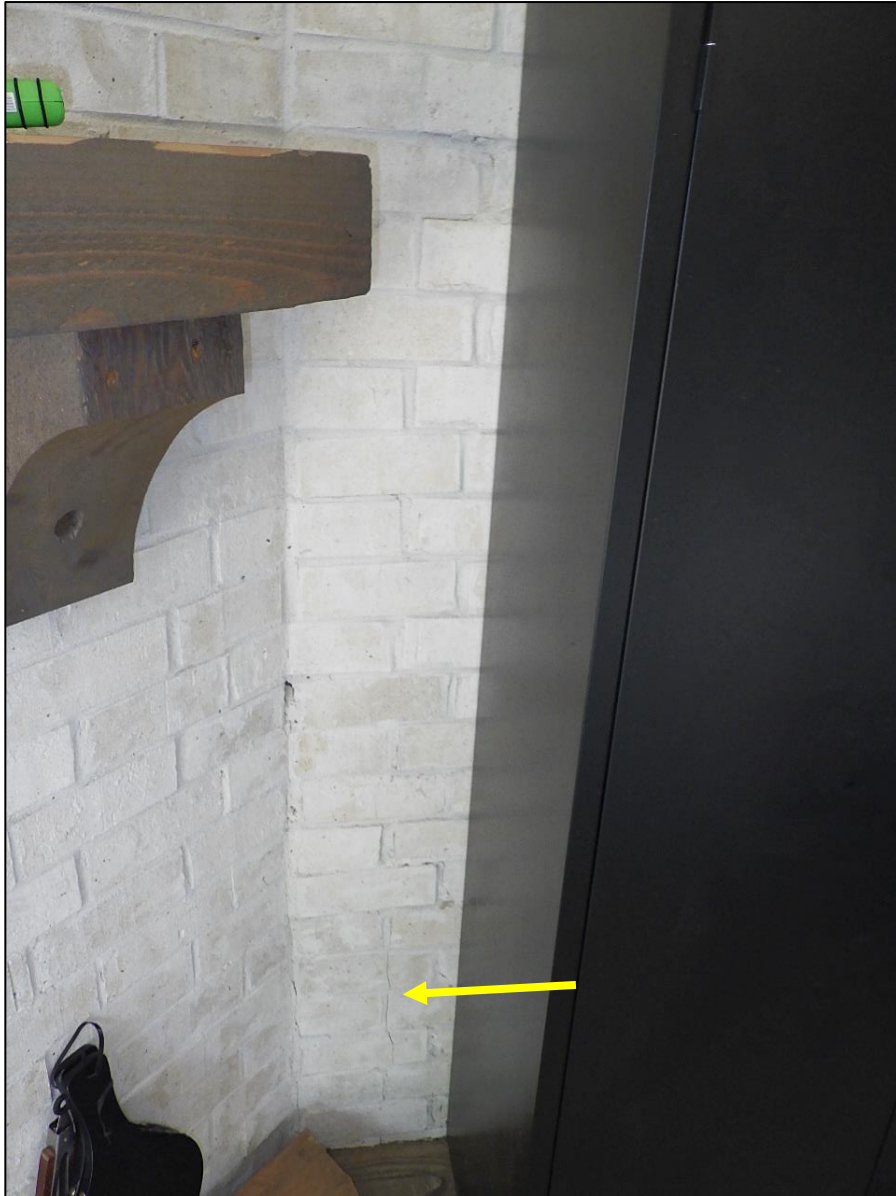
Photograph 16

The brick veneer wall on the OLA was cracked at the north side of the porch.

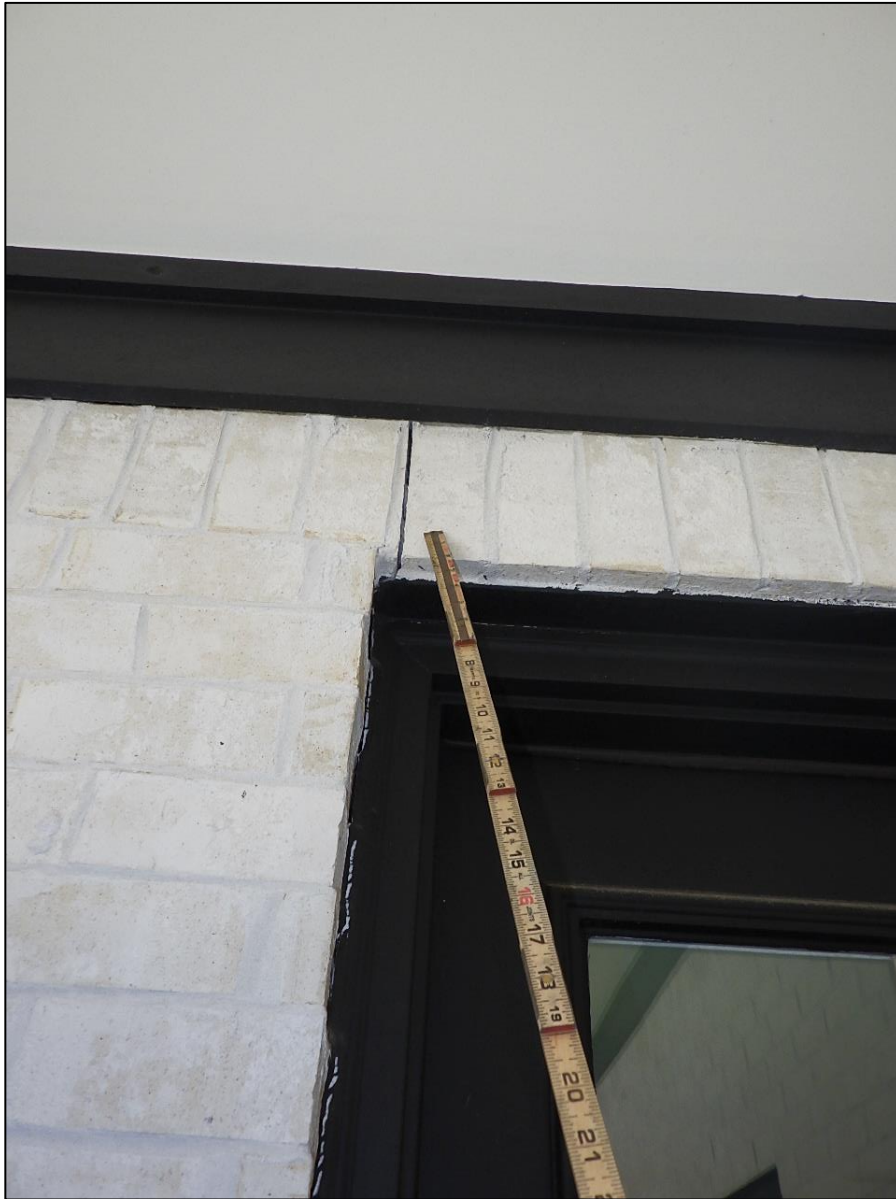
Photograph 17

There was a crack in the mortar of the soldier brick course above north door lintel of the OLA porch.

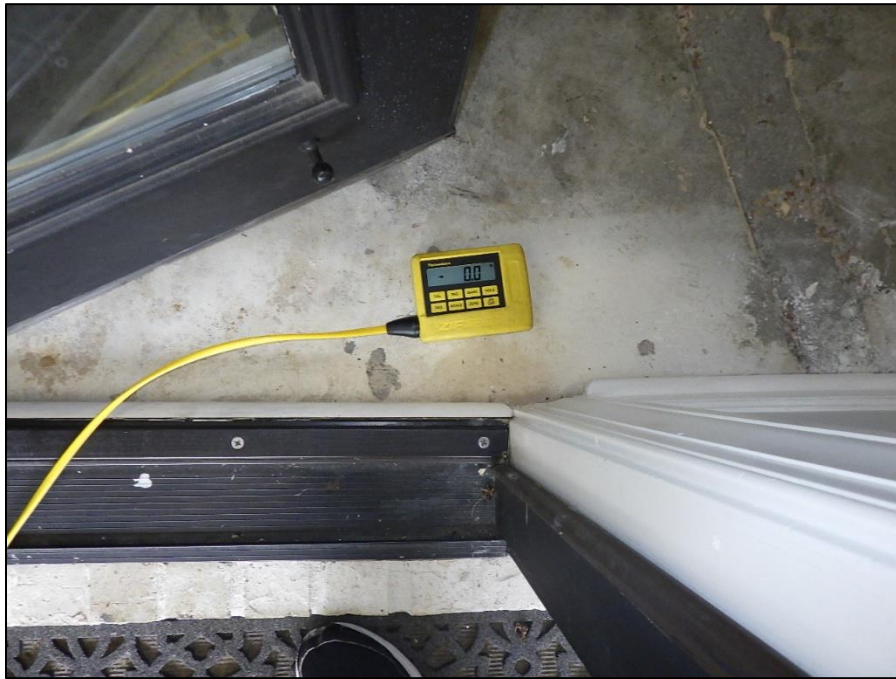
Photograph 18

A relative elevation survey of the back yard was performed with the finished floor used as a benchmark.

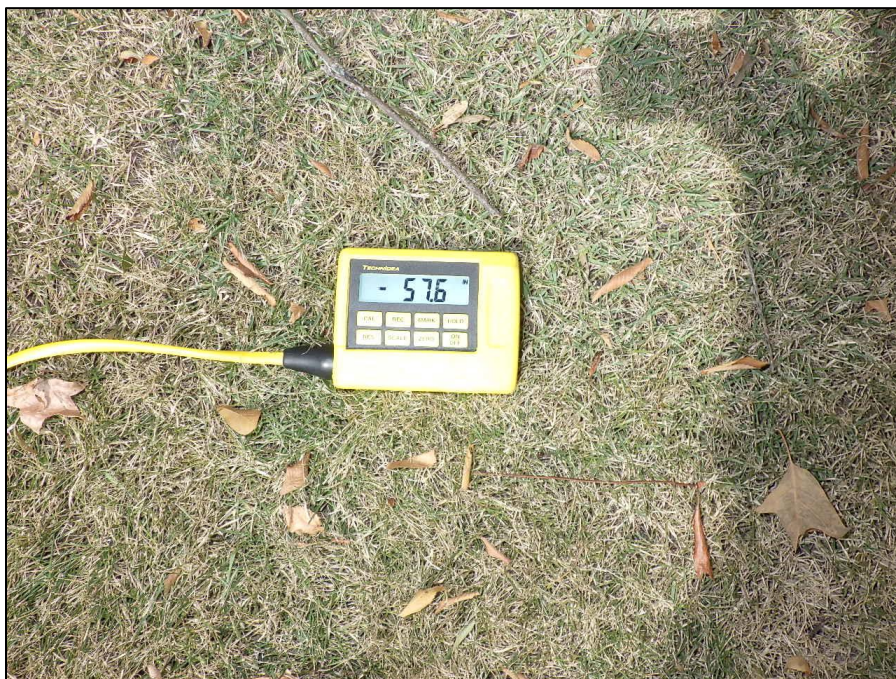
Photograph 19

- A relative elevation survey of the backyard was conducted during our inspection. The finished floor elevation of the residence was 3 to 5 feet higher than the apparently undisturbed soil along the west fence line (**Photographs 18 and 19**).

A relative elevation survey of the back yard showed the undisturbed (native) soil along the west fence line to be 3 to 5 feet below the finished floor elevation.

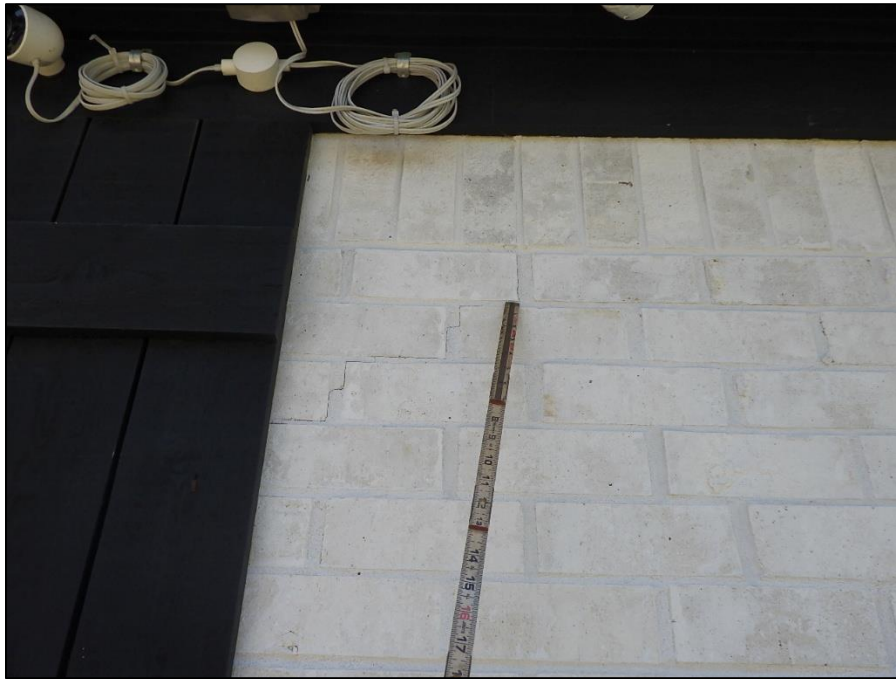
Photograph 20

There were isolated stair-step cracks in the mortar of the brick veneer on the north, east, and west sides of the residence.

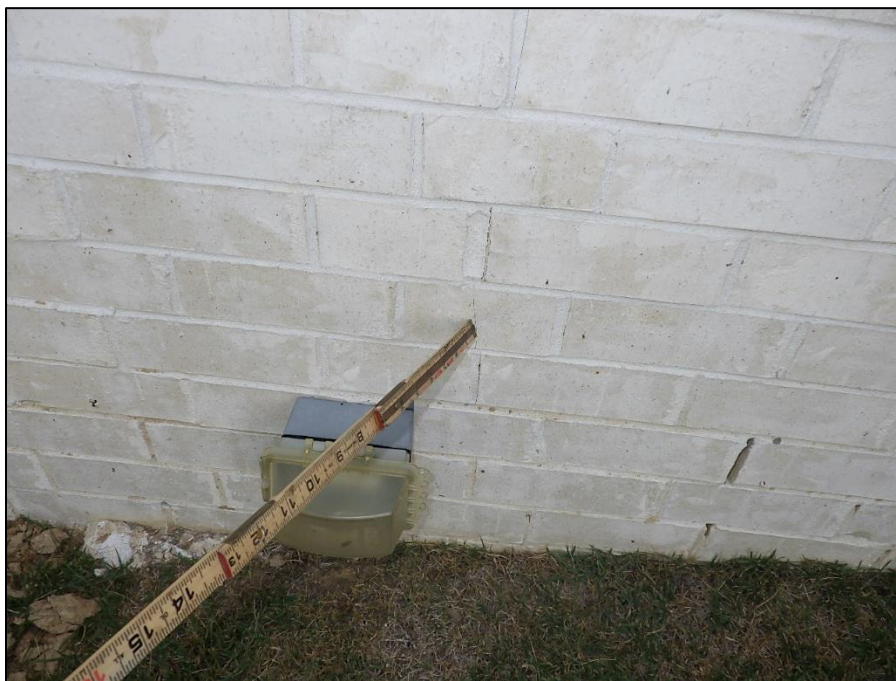
Photograph 21

There were isolated vertical cracks in the brick veneer on the north, east, and west sides of the residence.

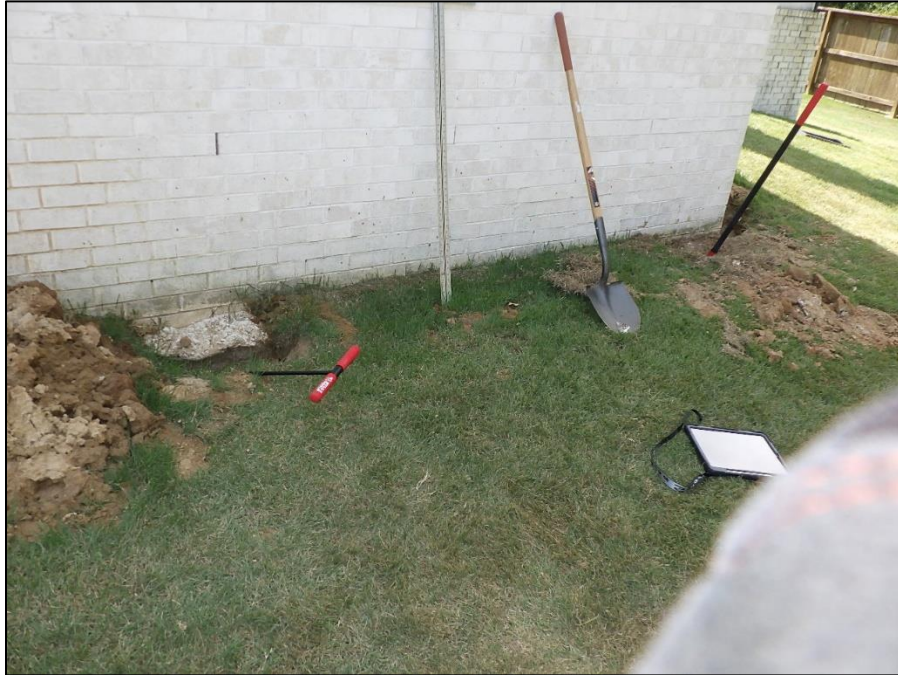
Photograph 22

Three excavations at the footings of the residence had been performed prior to our inspection, which allowed a visible inspection of the footings at these areas. The footing details were not made available at the time of this report for comparison. However, the following observations were made. The footing thickness ranged from 14 to 17 inches. The vertical surface of the footings below the brick ledge was not uniform and had voids at the bottom. At two of the three locations, non-continuous concrete was observed with voids near the top of the footing at/near the bearing of the brick veneer. This indicated that portions of the designed section of the footing were discontinuous. Photographs and measurements taken by the homeowner during the plumbing and slab repair in February of 2020 and reviewed as part of our investigation, revealed the absence of a required (per the drawings) footing under a load-bearing wall near the center of the residence. Additionally, the main slab reinforcement required by the plans was observed to be lying directly on the vapor retarder and not installed in accordance with IRC Section R506.2.4.

There were three excavations at the footings around the perimeter of the residence.

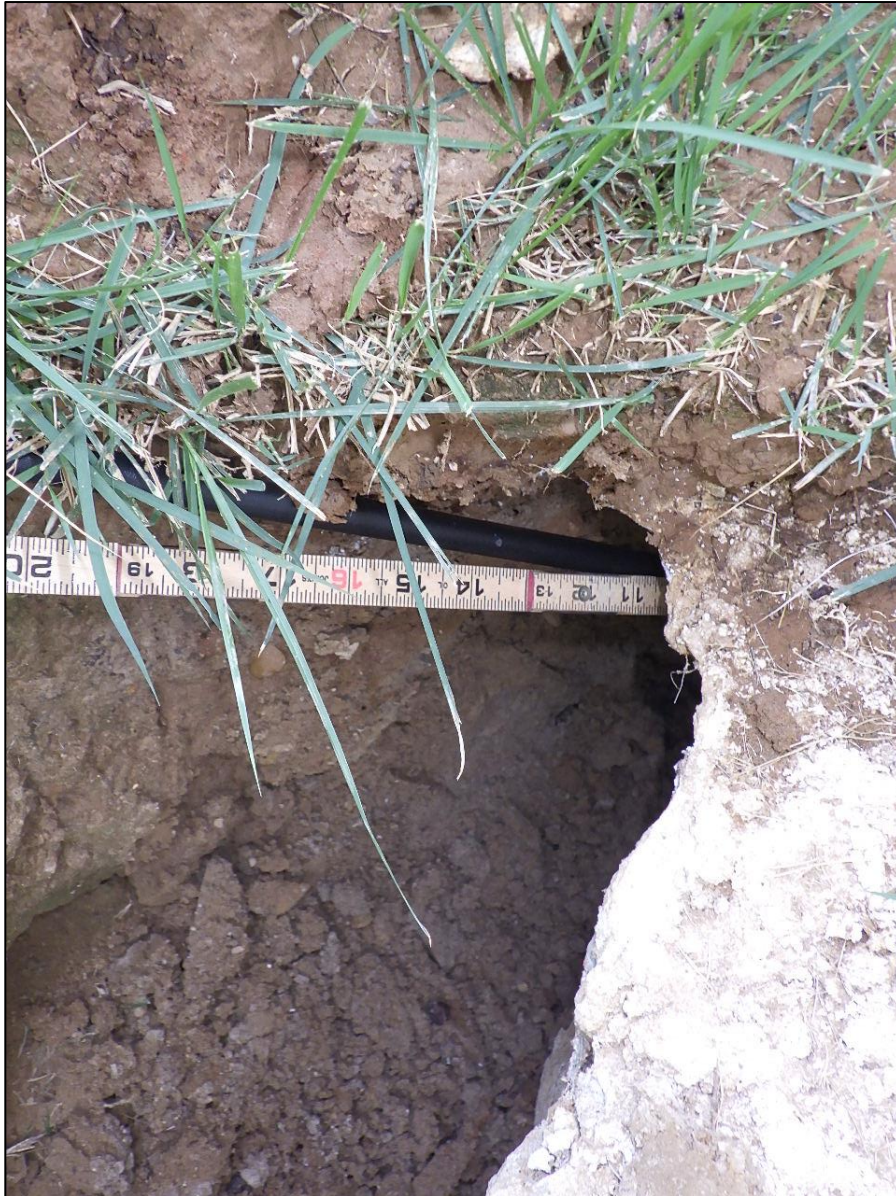
Photograph 23

- The exterior brick veneer had both stair-step cracks and cracked brick on the north, east, and west elevations (**Photographs 20 and 21**).
- Three areas around the footings of the residence had been excavated prior to our inspection. There were voids and honeycombing of the concrete visible. (**Photographs 22 and 23**).

Two of the three excavations had visible voids and/or honeycombing concrete.
