Executive Summary

Engineer's Foundation Evaluation

123 Sample Address, Your City, TX, 12345

ENGINEER'S FOUNDATION EVALUATION

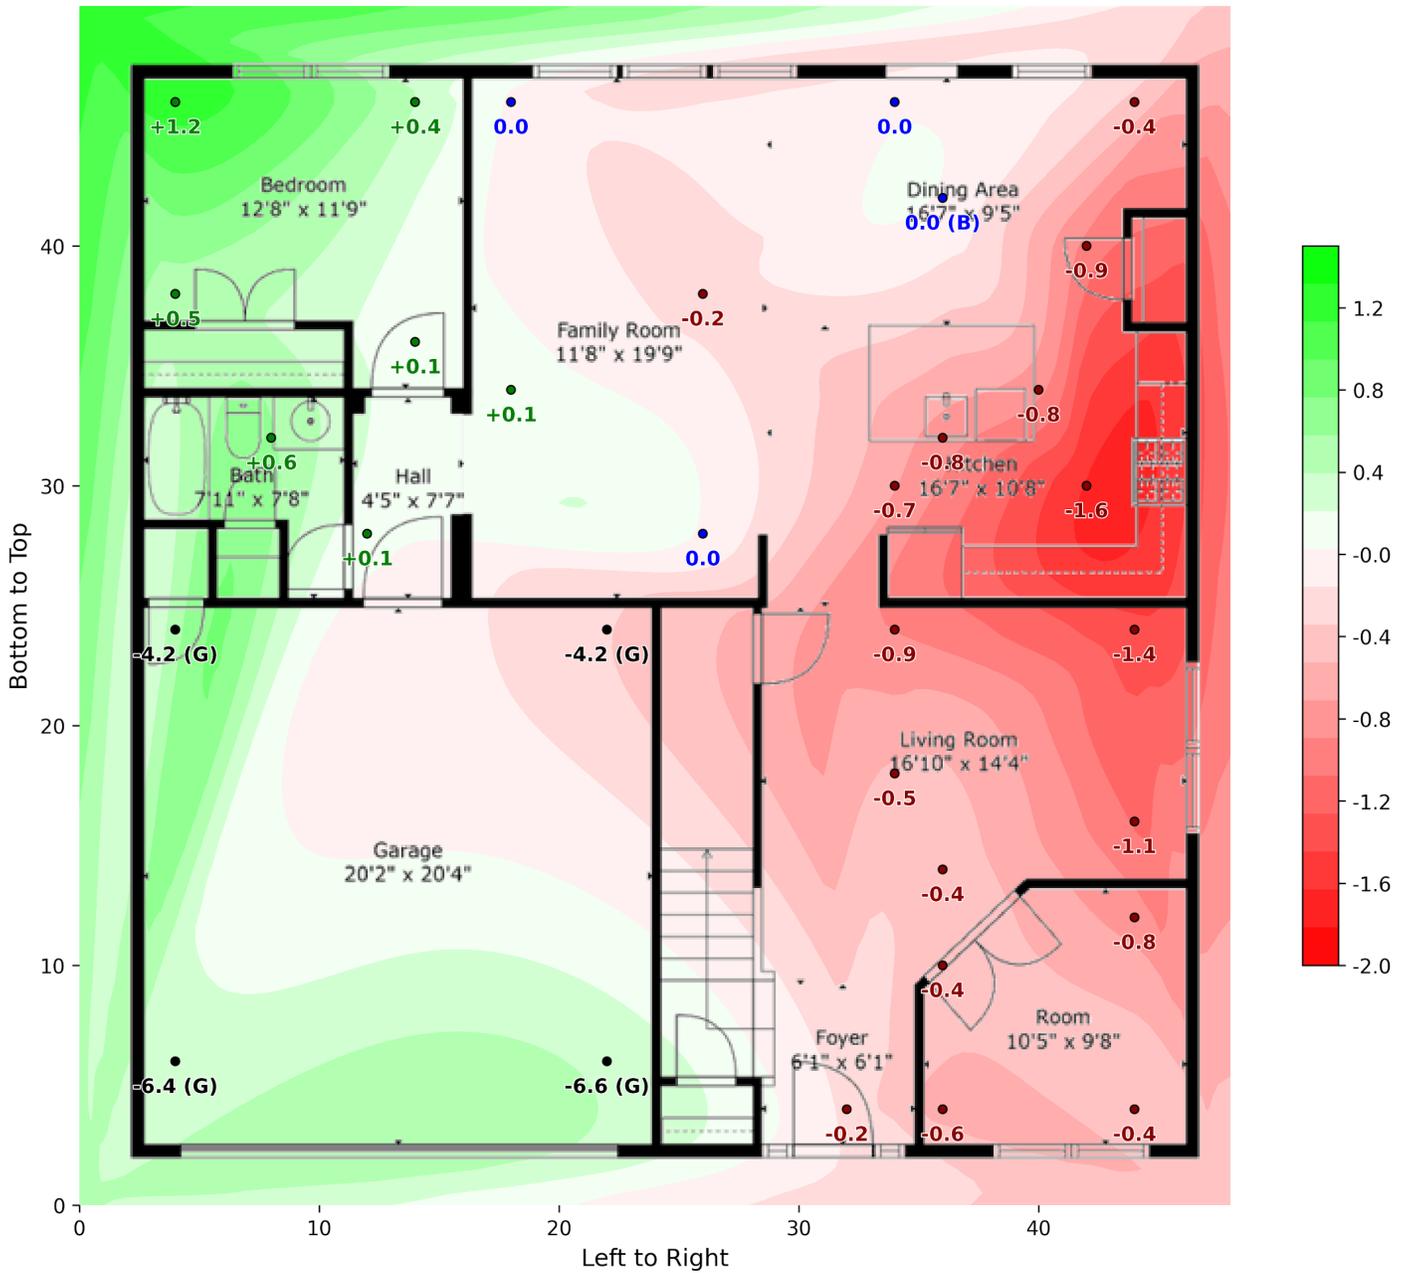
Elevation Plot Graphic (Figure A)

As documented above, the maximum elevation point of this structure was determined to be 1.2 inches and the minimum was -1.65 inches, resulting in an elevation difference of 2.85 inches of difference across the structure. The elevation deflection across an entire structure should remain within 0.5 to 1-inch depending on the age of the structure. Measured differences approaching 2-inches are a sign of foundation fatigue. The maximum allowable elevation difference is subjective, depending on other factors such as the visual condition and age of the structure (19 year(s) old).

Based on observed elevations of the foundation from the elevation plot, the structure cannot be considered fully stable. Elevation differences do not fall within industry standards or tolerable limits. These findings indicate that the foundation does not have consistent and uniform elevation demonstrating continued movement of the foundation.

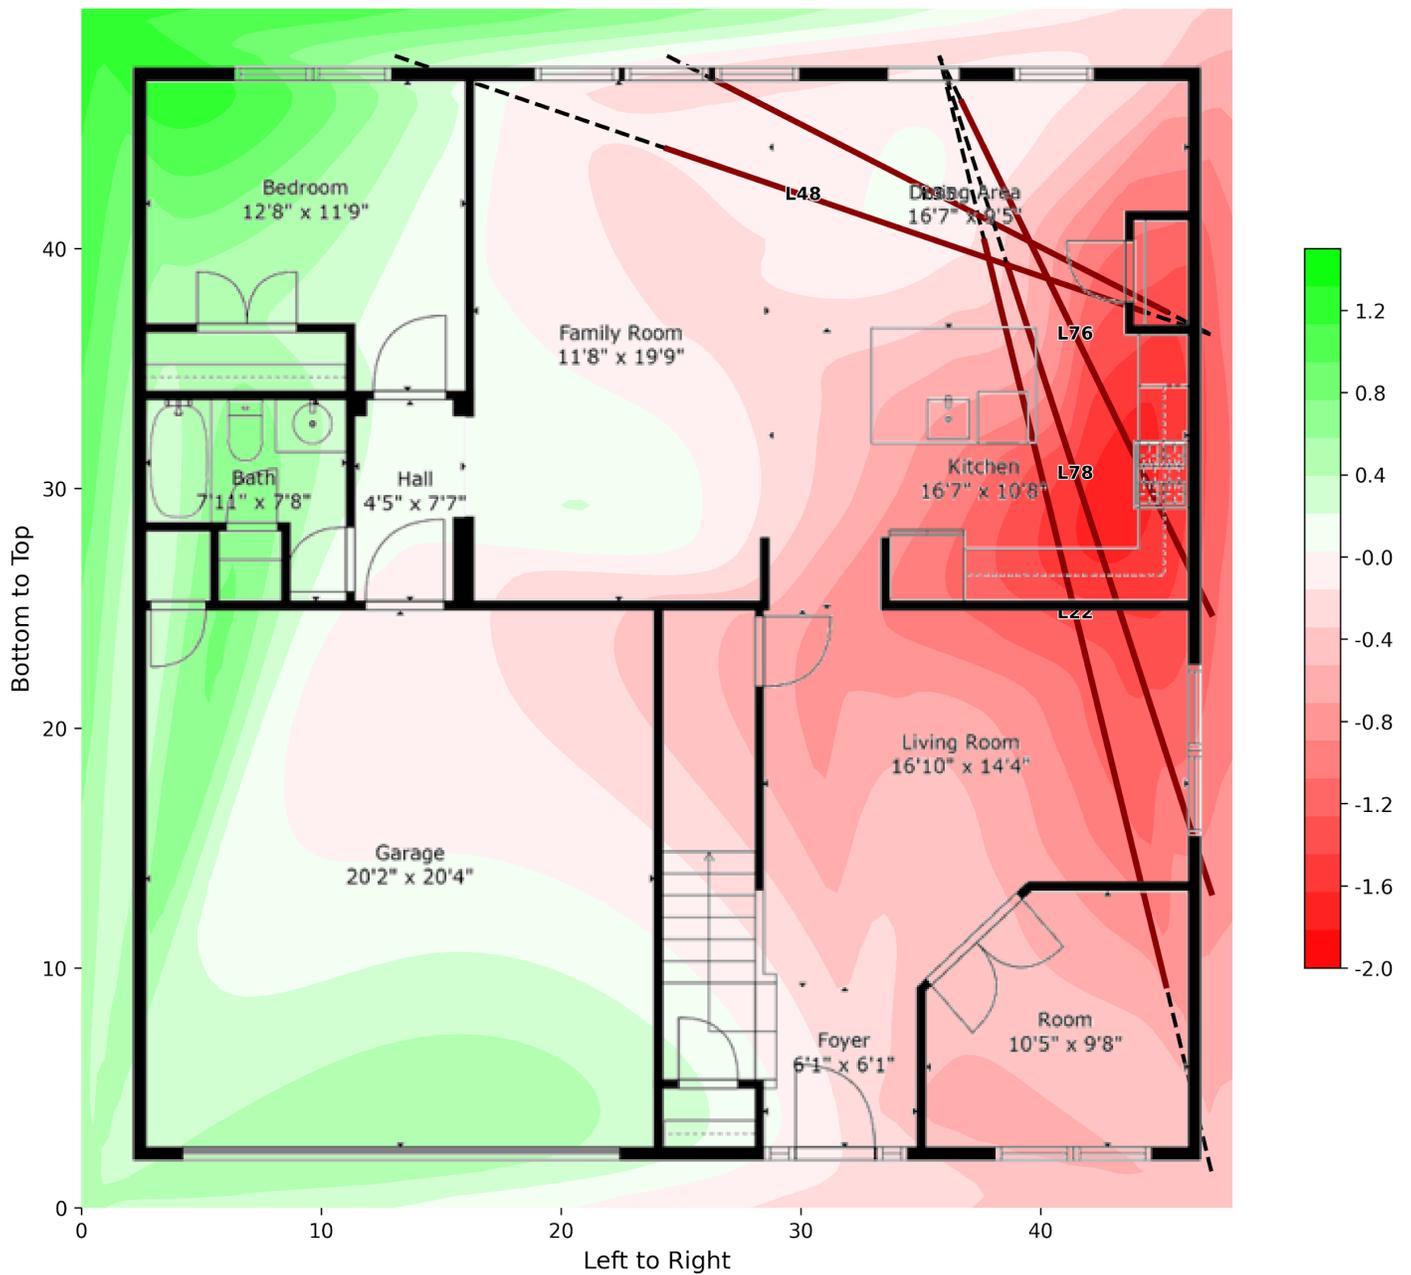
Deflection Failures Graphic (Figure D)

The above Figure D shows deflection failures along the foundation. Deflection failures can be considered localized failures of the foundation in (sometimes) isolated portions of the foundation. The profile lines that were calculated are represented by a dashed black line and the areas that the deflection failures occur are represented by a dark red line segment. Of the 75 deflection profiles calculated, 5 profile failures were identified.

Deflection failures can be considered localized failures of the foundation in (sometimes) isolated portions of the foundation. Of the 75 deflection profiles calculated, 5 failures were identified.

Deflection failures are above standard acceptable limits; they exceed industry-standard thresholds and the structure should be considered actively moving/settling in areas where deflection failures are occurring.

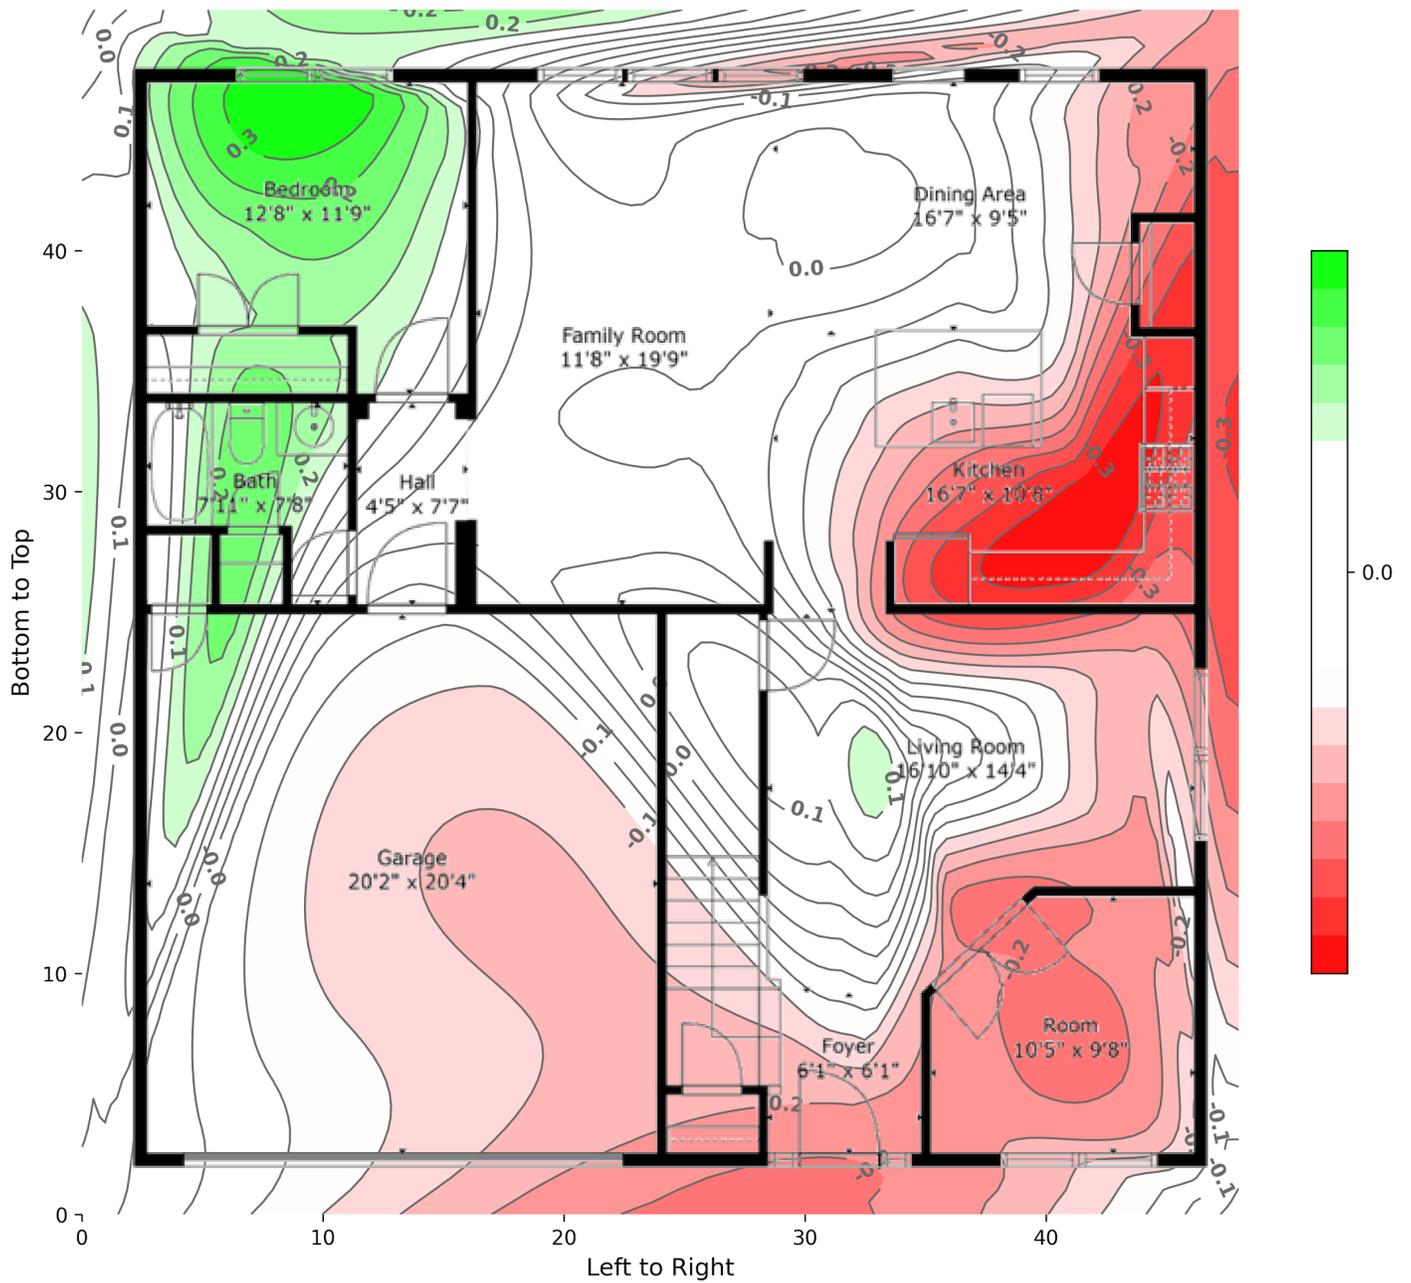
Elevation Plot Difference Graphic (Figure F)

The mesh contour graphic above in Figure F shows areas in red that are lower than the baseline elevation plot and areas of green that are higher than the baseline elevation plot (from the provided drawing completed in 1998). The darker the color (both red and green) the larger/smaller the elevation differences.

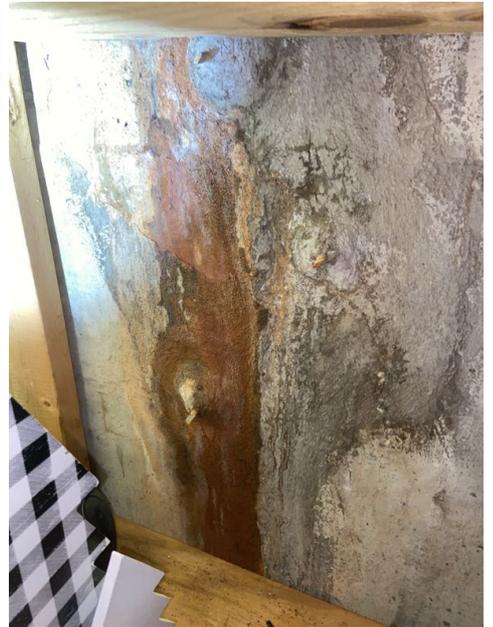
Assessment of true and present foundation deficiencies is difficult when foundation repair has been completed because inspector is unable to determine the extent of the stabilization and resolution of present foundation issues. Common indicators of foundation problems may be resolved or may continue to exhibit failure. It is difficult situation to fully understand without a timeline of events.

Recommend contacting the owner about the extent of the repairs to determine their validity as a true foundation stabilization, type of repair, and warranty. Recommend researching the previous foundation repair company to determine if they have quality reviews, have a long standing reputation, and if any warranty is transferable.

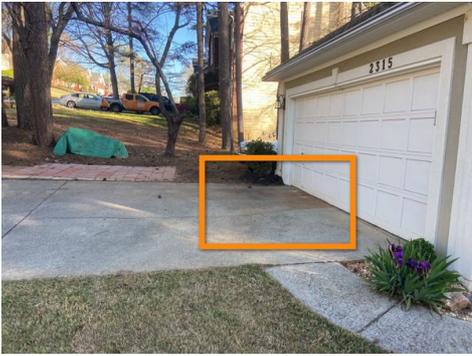
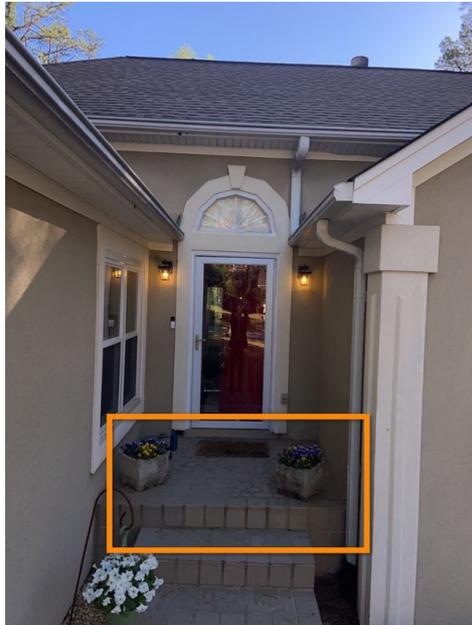
AREA WHERE WATER WILL STAND

Area where water can occur, which could indicate poor drainage and/or grading. Recommend monitor and/or have landscaper correct.

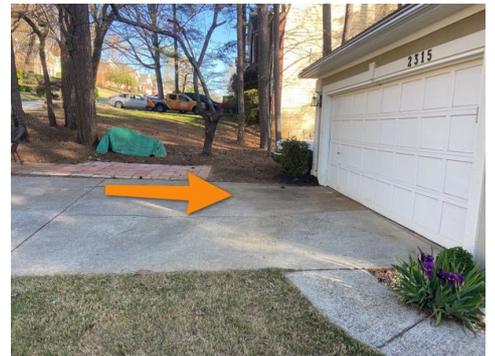
Front left of driveway

NEGATIVE GRADING SLOPE

Grading is sloping towards the structure in some areas. The slope away from the structure should be at least 0.5 inch per foot for 10 feet. This drainage slope could lead to water intrusion and foundation issues. Recommend qualified landscaper or foundation contractor regrade so water flows away from structure.

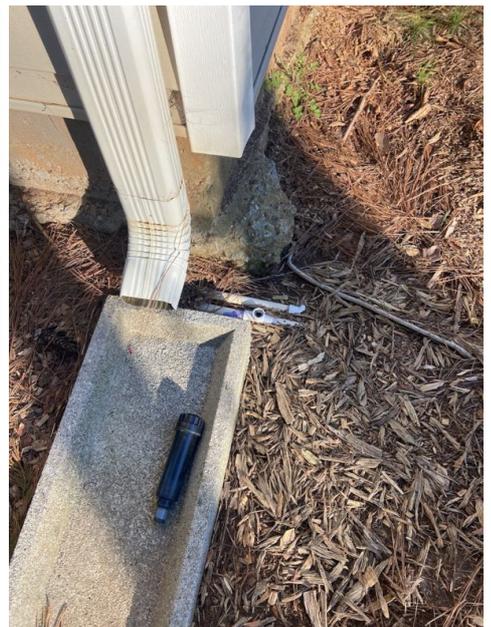
Erosion of soils is present. Erosion areas are significant to site drainage impact because they represent areas where stormwater velocities are high and water is "flowing." Erosive areas should be investigated and understood. Often these areas need above-average and more aggressive attention, such as concrete stabilization, re-grading, and/or drainage piping installation.

In this particular case, the erosion at the back right corner of the property appears to be due to a damaged landscape irrigation sprinkler.

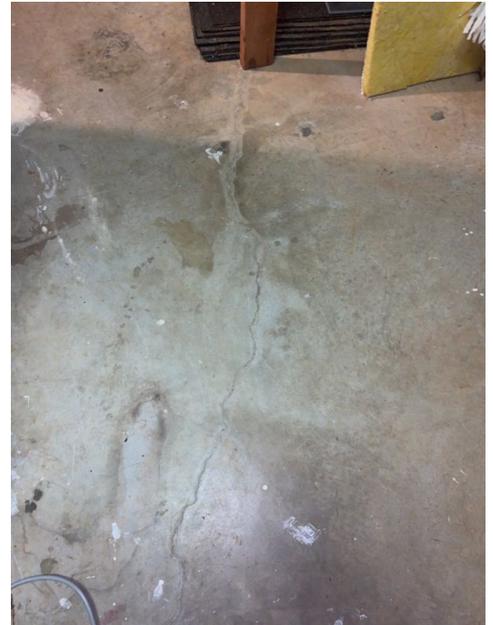
Areas of basement floor

FLOORING - CRACKS MINOR

Minor cracking observed on the flooring that is unlikely due to structural foundation issue. This is common in structures this age and is often determined to be cosmetic. Recommend patching the area and monitoring the cracking. The best way to monitor cracking is so patch it (with mortar, grout, calk, etc.) and see if it reappears.

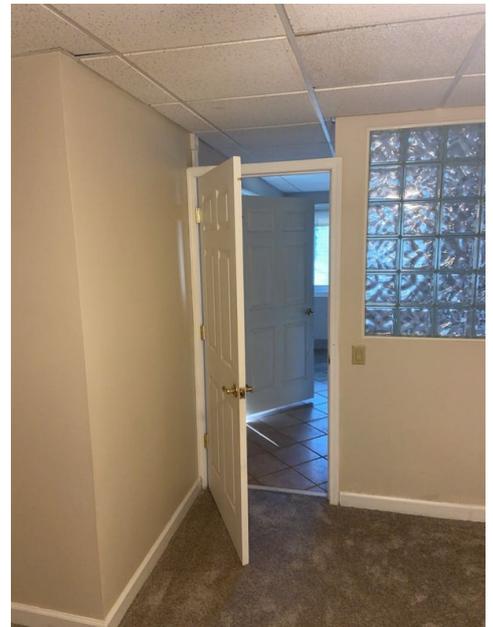
Basement bathroom door

DOOR DOESN'T LATCH TO CLOSE

Door doesn't latch to close properly. Recommend handyman repair door, latch, frame, and/or strike plate.

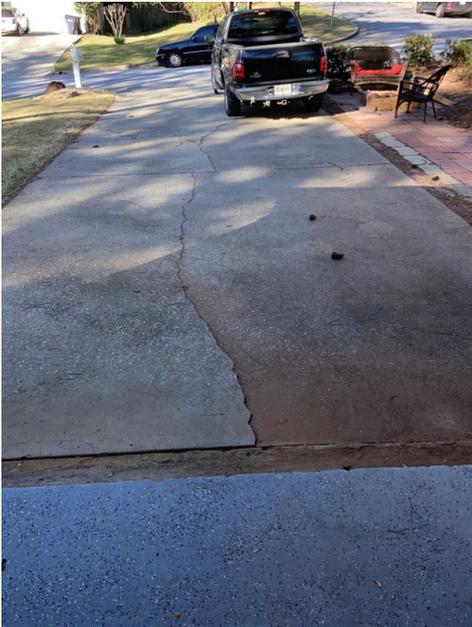
Driveway

OLD CONCRETE - CRACKS, SEPARATION, AND HEAVING

The driveway and/or sidewalks show signs of aged cracking, separation, heaving, and/or deterioration. This is common in areas of the state that have clay-based soils. Compromised concrete will continue to exhibit decay, failure, collapse, and uplift if not remediated. Recommend caulking larger cracks and applying a concrete sealer. Cracking can also be a safety hazard for pedestrians if it becomes (or is currently) a trip hazard.

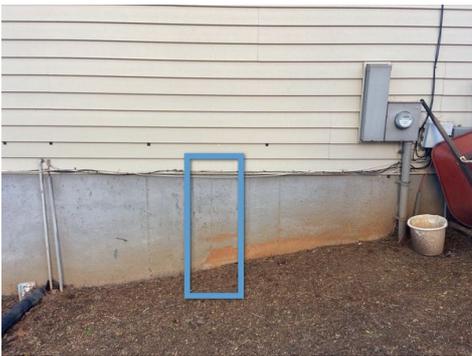
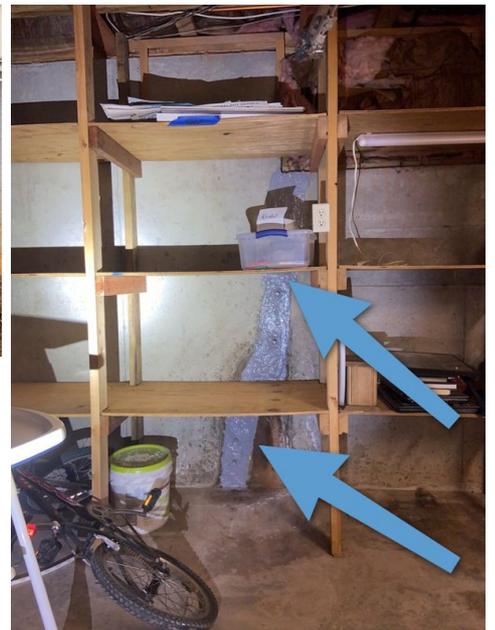
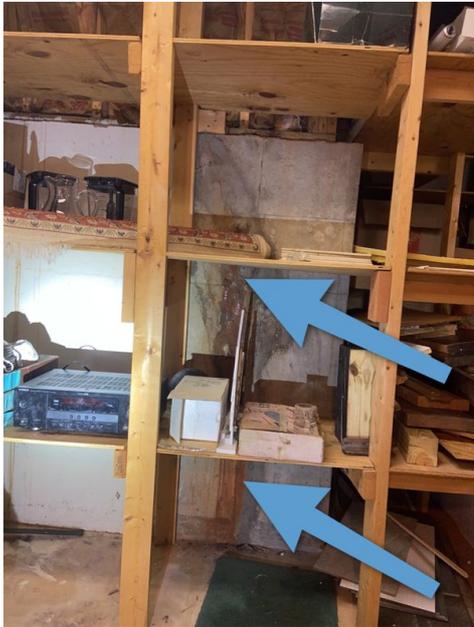
Vertical cracks can appear straight up and down or within 30 degrees of vertical, and are typically caused by settlement. In some cases, newly constructed homes can settle within the first few years, vertical cracks are common in both newly constructed and older homes.

Vertical cracks seldom indicate structural failure. That said, they can allow water to seep into a basement and allow for pest infestations to persist. Recommend sealing/caulking the vertical crack to prevent moisture intrusion and pests from entering the structure. This will also allow for the monitoring of the crack for possible foundation issues in the future.

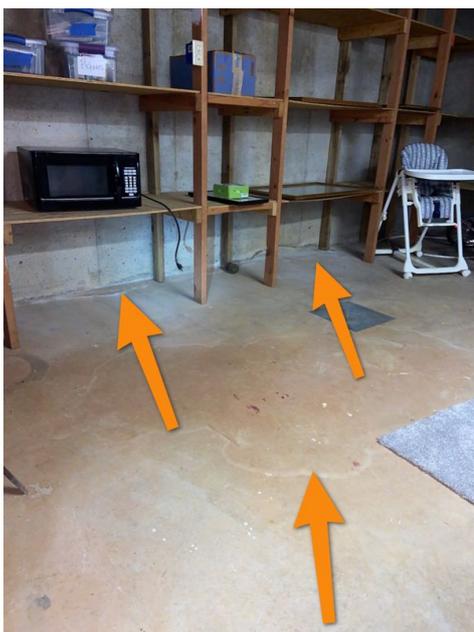
Basement walls and floor

Ultimately, efflorescence itself isn't dangerous. However, it can lead to potential moisture problems that can cause structural damage to building materials (particularly degradation of the internal rebar in concrete).

Recommend consulting with a concrete or foundation contractor that may apply a mild acid or efflorescence remover and seal the concrete. Monitor for future foundation issues.

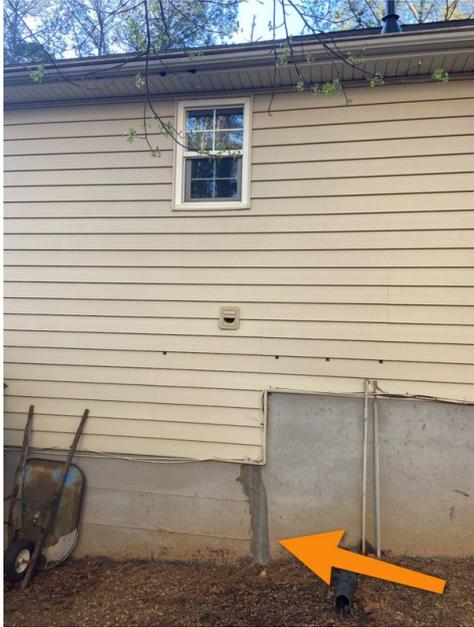
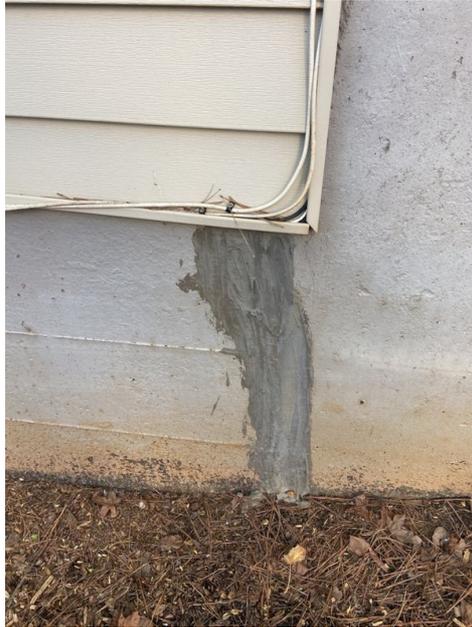
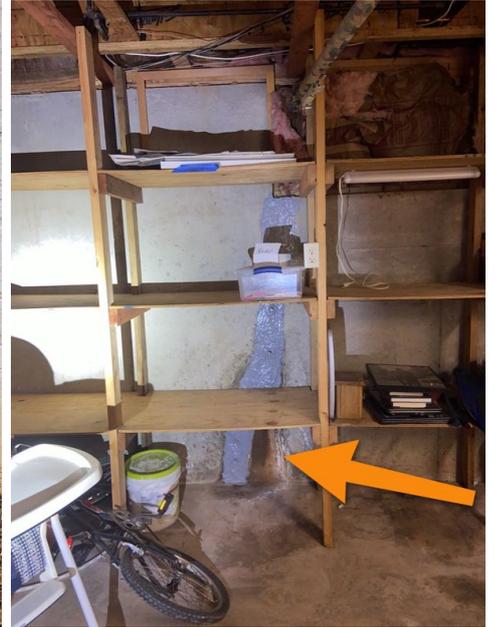
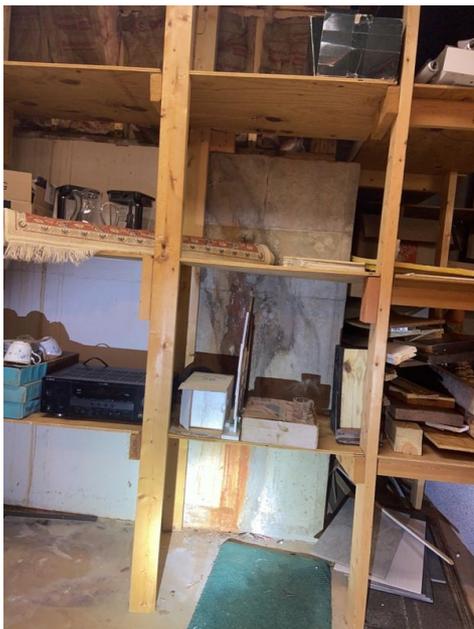
WALL - VERTICAL CRACK PATCHED

Hey patch was noted to a vertical crack on the basement wall To avoid water intrusion in the basement. Recommend monitoring this patch for further cracking.

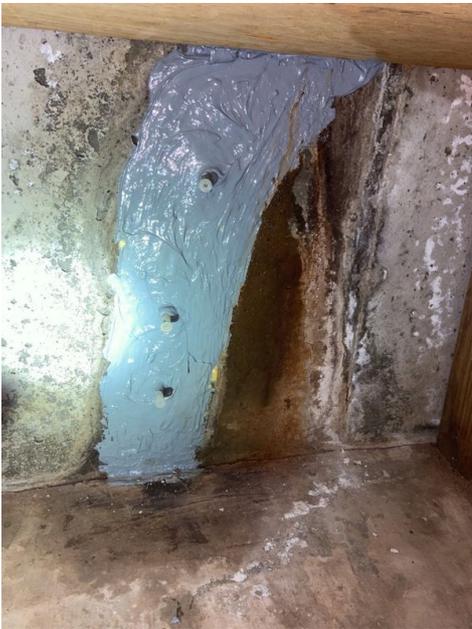
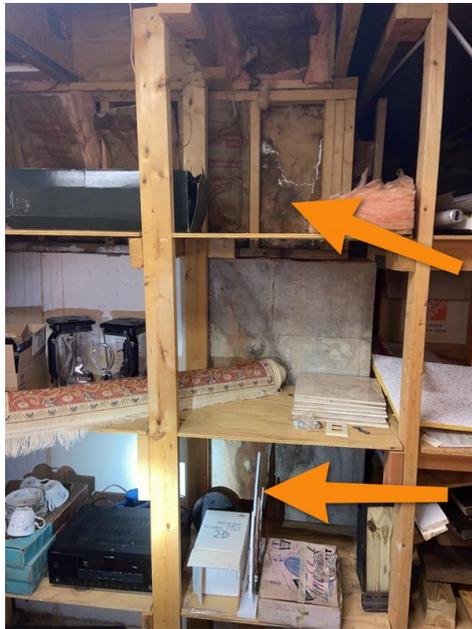
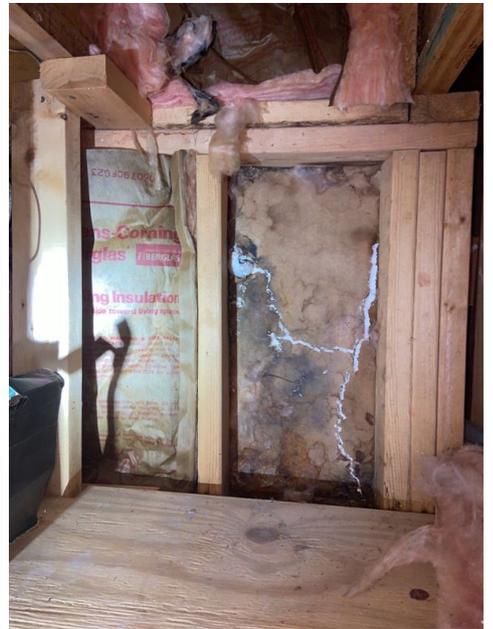
ACTIVE WATER INTRUSION IN BASEMENT

Active water intrusion was noted in the basement. Some of these areas have already been patched. Previously with a injectable epoxy sealant. It appears that settlement has continued since The repairs have been made allowing for more water intrusion. Recommend remediation by a waterproofing contractor.

Coming through stucco wall underneath the foyer

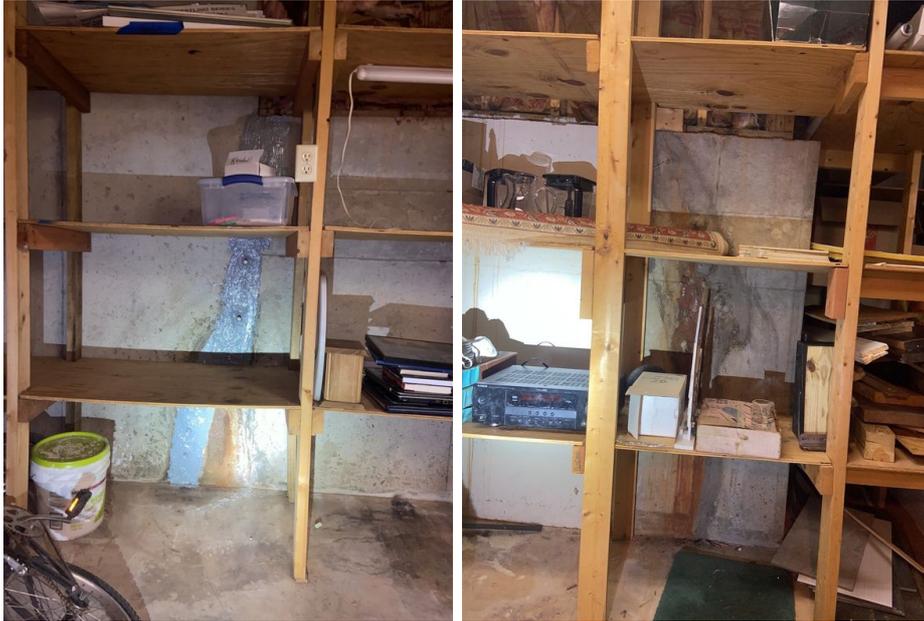
Left

Visual Condition Assessment: Visual Discovery of Previous Foundation Work

There exist signs of previous foundation improvements that were completed to the structure. Refer to the inspection report for approximate locations of the improvements to the structure. The exact extent (depth, width, type, etc.) could not be field-verified (other than capped field-observations reported herein). Existing underpinning is typically concealed entirely below grade. No invasive or destructive investigation nor subgrade radar readings were performed to confirm the presence or absence of any existing foundation underpinning.
